# National Transportation Safety Board

DCA24FA143

## **AIR TRAFFIC CONTROL**

Group Chairman's Factual Report

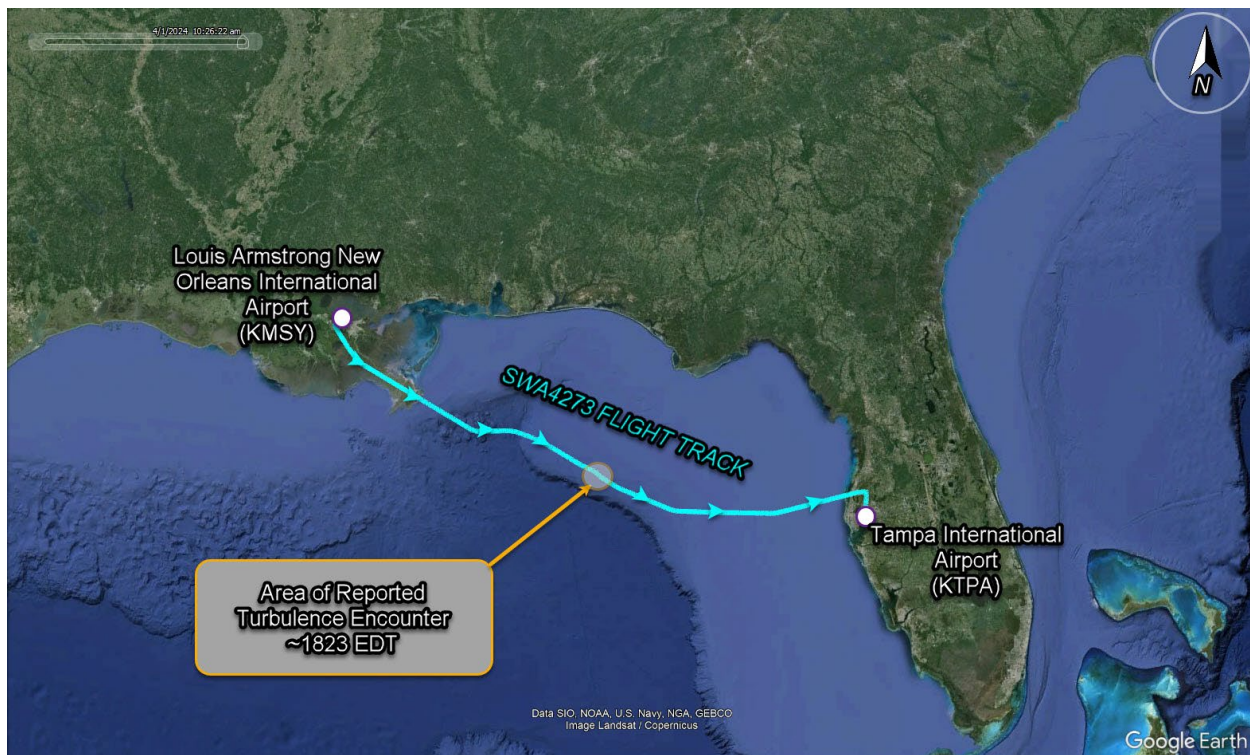
Figure 1 in section F illustrates SWA4273's flight track from MSY to TPA and depicts the approximate location where the flight encountered severe turbulence. Figure 2 in section F is a timeline from when SWA4273 entered ZJX ARTCC airspace until they landed at TPA. These figures were produced using ADS-B data and overlaid onto satellite imagery in Google Earth.

**Figure 1.** An overhead view of SWA4273's flight path from MSY to TPA with the area of reported turbulence depicted by the shaded circle.

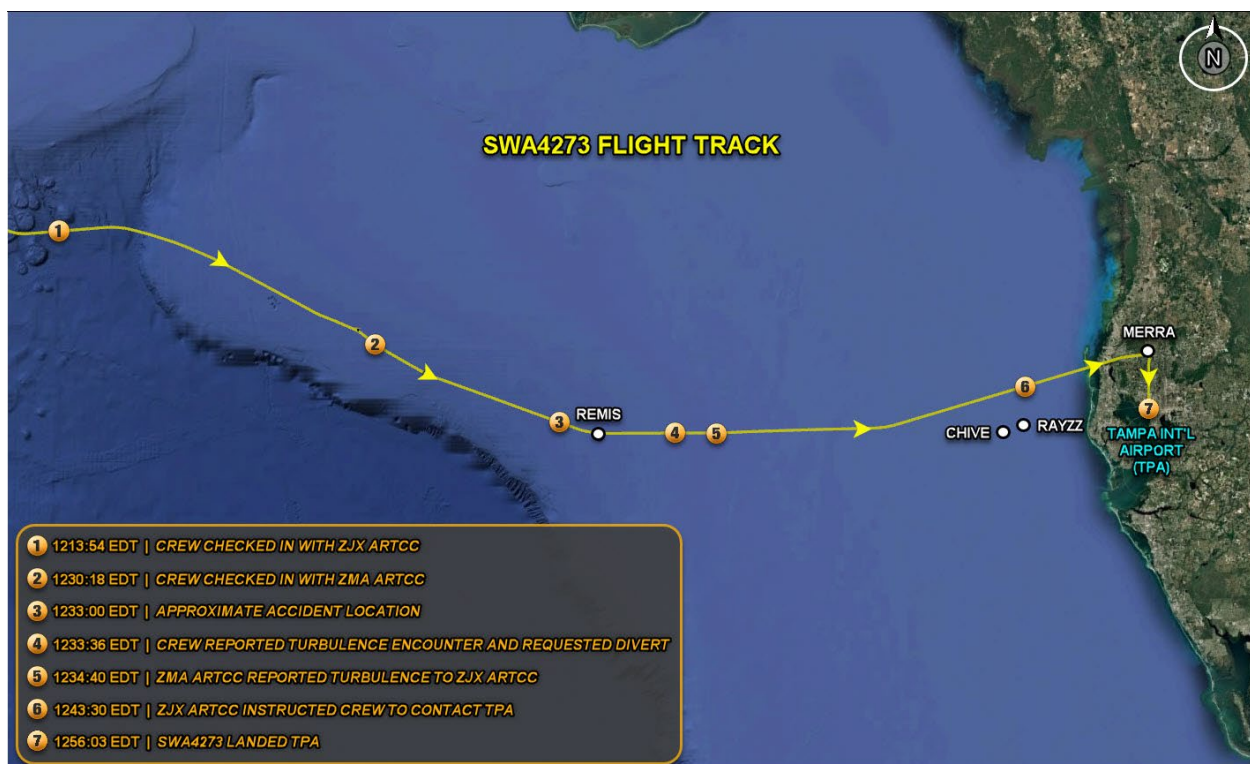
**Figure 2.** An overhead view of SWA4273's flight track from the time the aircraft entered ZJX airspace with timeline and fixes notated.

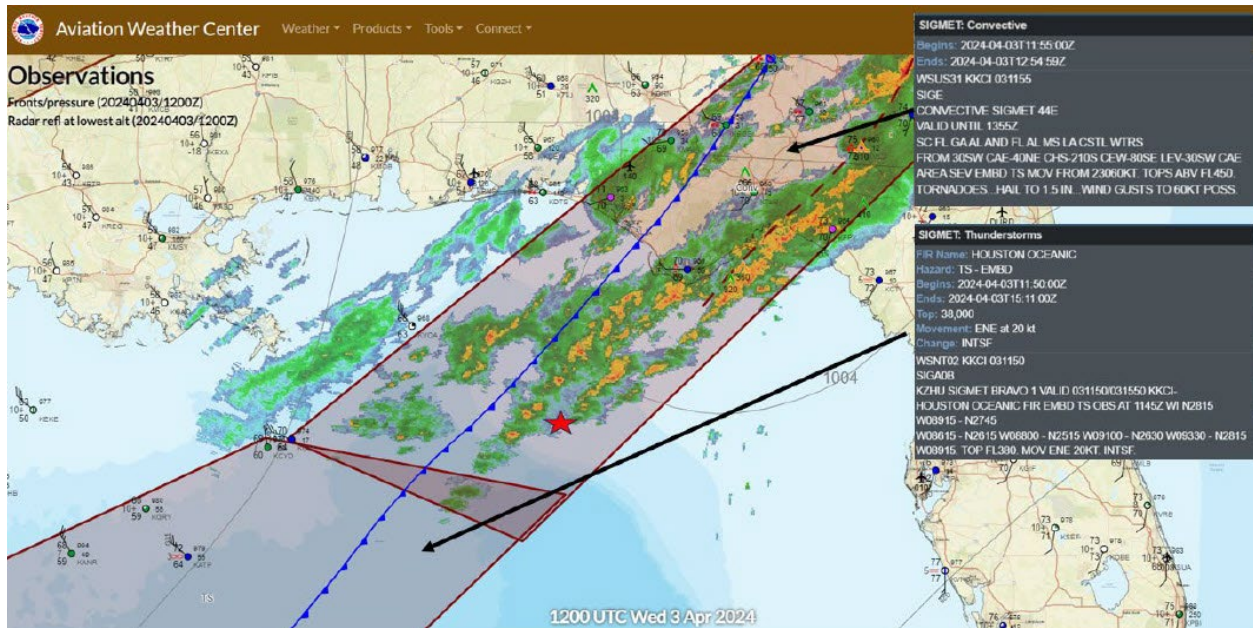
The National Weather Service (NWS) Aviation Weather Center (AWC) issued SIGMET<sup>17</sup> Bravo 1 for the Houston Flight Information Region (FIR) at 0750 EDT for embedded thunderstorms immediately south of the accident site over the Gulf of America. At 0755 EDT or immediately after the flight departed MSY, convective SIGMET 44E was issued which extended over the turbulence location. The advisory was issued for an area of severe embedded thunderstorms, with the area moving eastward at 60 knots, with thunderstorm tops above FL450. The advisory warned of the potential for tornadoes, hail to 1.5 inches, and wind gusts to 60 knots were possible with the storms. The advisory also implied the potential for severe and greater turbulence. Figure 3 in section F is a graphical depiction of the advisories from the NWS AWC display with the weather radar image at 0800 EDT, and the approximate turbulence location.

**Figure 3.** NWS AWC METAR display with fronts, radar, and SIGMETs overlaid at 0800 EDT immediately after the issuance of the advisories and with the approximate future accident site. This graphic was taken from the meteorology specialist's factual report.

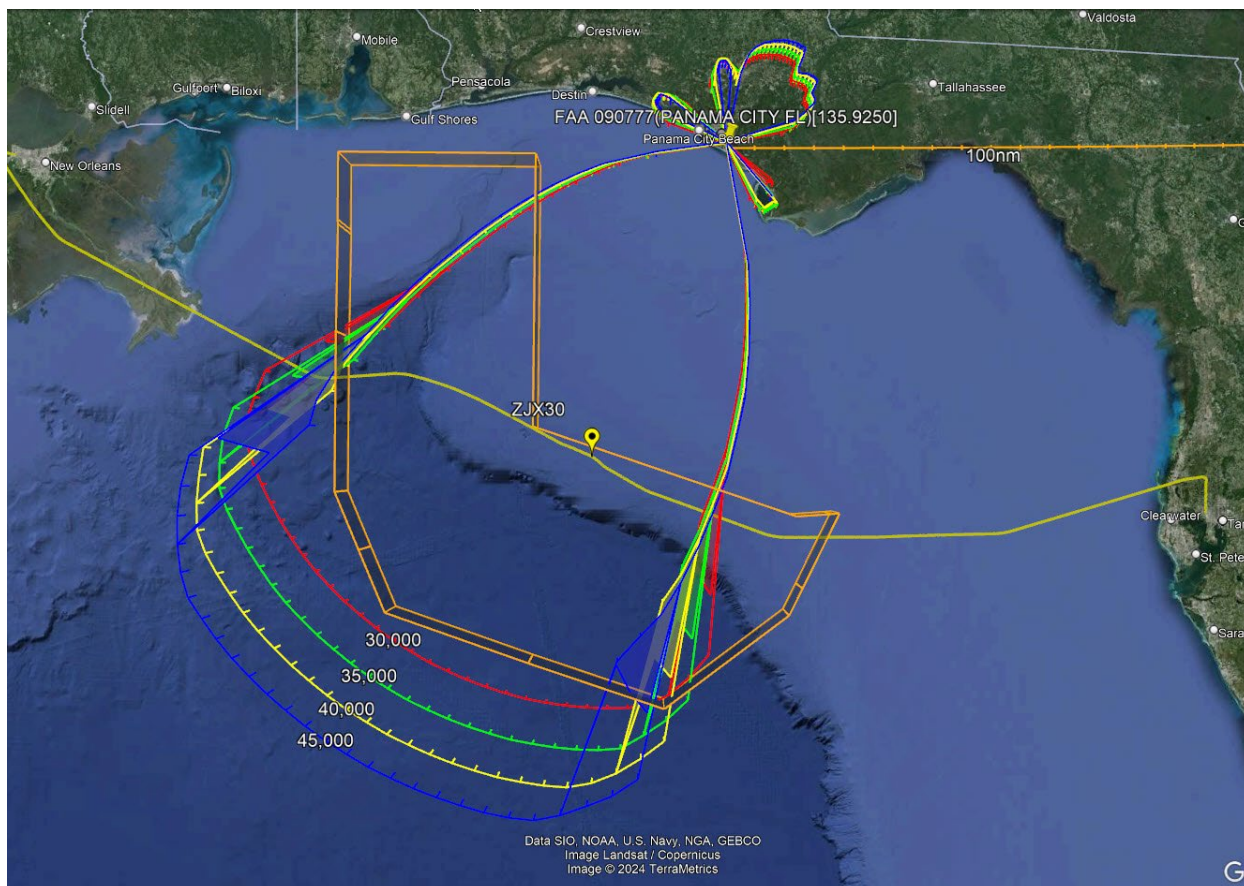
All personnel interviewed stated that there was an issue with the frequency in the sector, resulting in regular missed transmissions. This was evident in the audio recording surrounding the time of the accident. These transmissions that had to be repeated increased the workload and frequency congestion of the R30 controller. In documentation provided by the FAA, it was discovered that there had been a fire at the RCAG, which was located at Tyndall Air Force Base, on October 4, 2023. This fire had caused the frequencies to fail. On October 15, 2023, a mobile RCAG was placed into operation as a temporary facility.

As part of RCAG placement, FAA Telecommunications Infrastructure (FTI) had provided a satellite relay connection to assist with providing operational frequencies for Q75 RCAG. In this instance, satellite support refers to a temporary supplement to ground based services using satellite-based services (typically used in cases of natural disasters or other emergency situations, hurricanes, etc.). This relay resulted in a delay of transmission by 600 milliseconds round trip, but it was noted that there would be no degradation of service. However, in a systemic issue review report (SYSIR) dated January 10, 2024, it was stated that the temporary frequencies were low power 10-watt transmitters with limited coverage, delays in transmissions, and multiple “dead spots”.<sup>18</sup> Figure 6 in section F depicts the coverage area for the temporary RCAG site, the R30 sector boundaries, and the flight track of SWA4273 overlaid onto satellite imagery in Google Earth.

**Figure 6.** An overhead view of the temporary RCAG frequency range, SWA4273's flight track, and the R30 sector overlaid on satellite imagery from Google Earth.
