# National Transportation Safety Board

DCA24LA034

## **OPERATIONAL FACTORS/HUMAN PERFORMANCE**

Night Ground Handling Observation at Kahului Airport

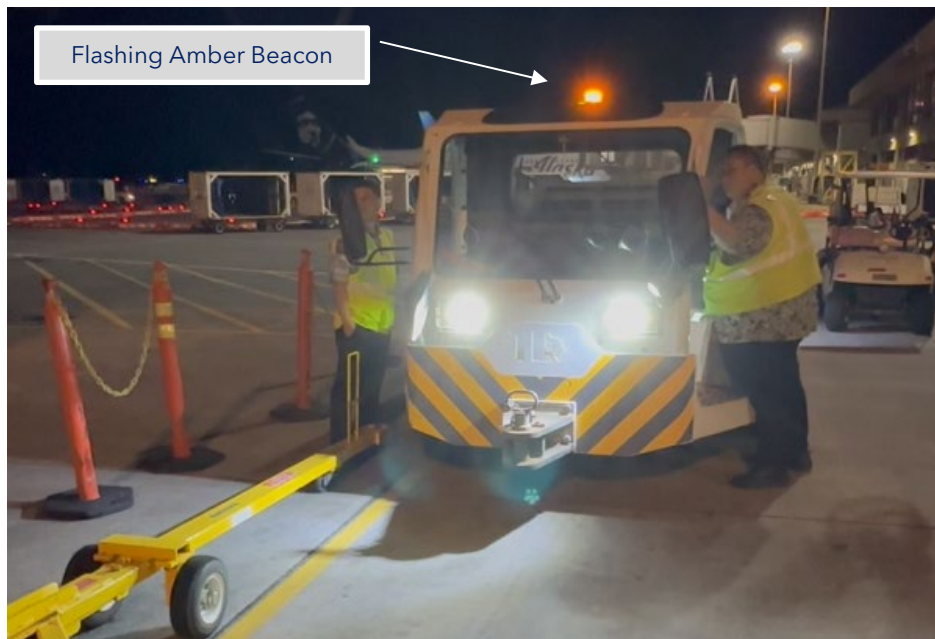
Investigators sounded the tug's horn and measured its volume from 10 ft away using a sound meter app called "Noise" on an Apple Watch version 10.3.1. The loudness of the horn was measured at 103 to 110 db.

**Figure 1: Exterior view of front of tug.**

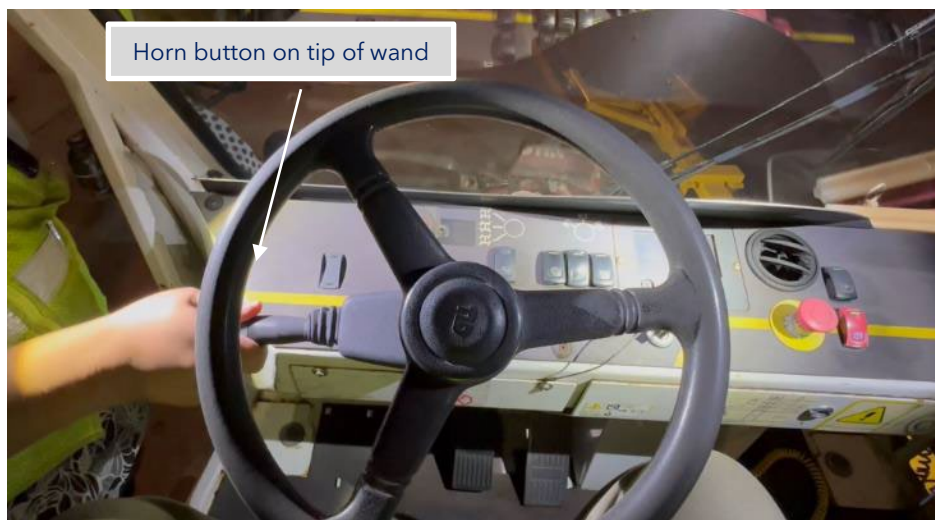
The NTSB human performance specialist entered the tug cab and documented driver controls. A horn button was located on the tip of a wand that extended outboard from the left side of the steering column.

**Figure 2: Tug steering wheel and wand with horn button.**

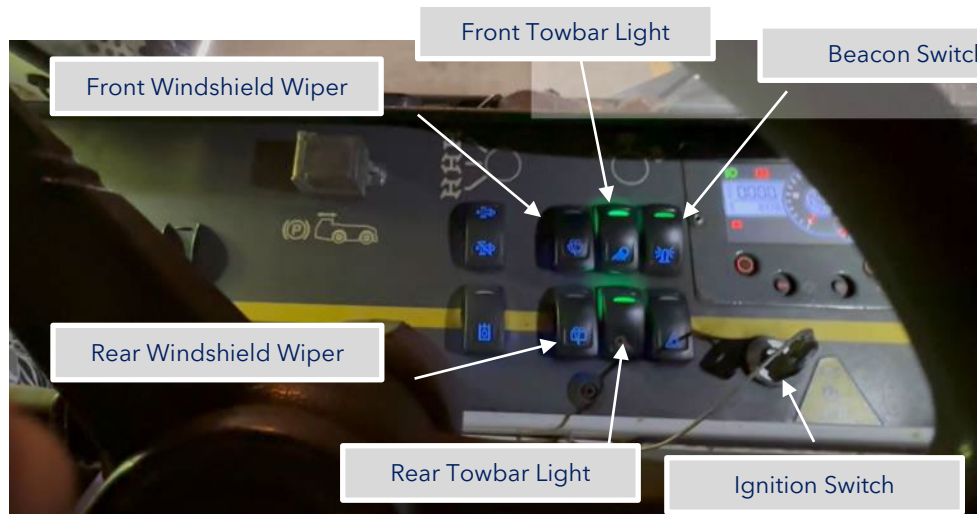
A cluster of pushbutton switches on the dashboard to the right of the steering column controlled the amber beacon, windshield wipers, headlights, and front and

rear headlights. Each switch was labeled with an icon, and each switch, except for the rear windshield wiper switch, was illuminated by a blue internal light. When a switch was selected ON a green dot also illuminated in the center of the switch.

**Figure 3: Tug dashboard switch cluster.**

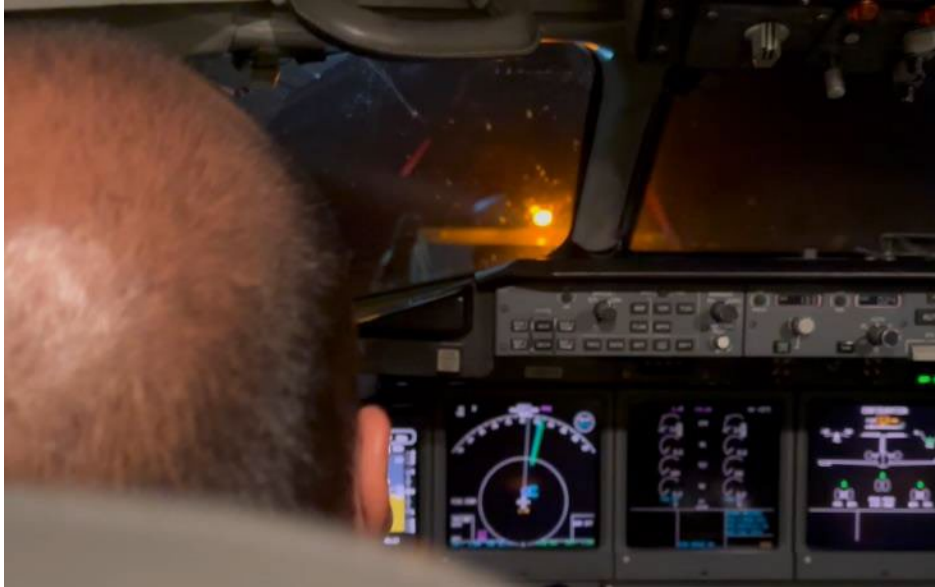
Group 1 waited in the front passenger seating row while the airplane was pushed back. When aircraft motion stopped and the parking brake was set, group 1 relocated to the cockpit area. The tug's flashing amber beacon was visible and highly salient directly in front of the airplane when viewed from the captain's seat position.

**Figure 13: Tug directly in front of the airplane.**

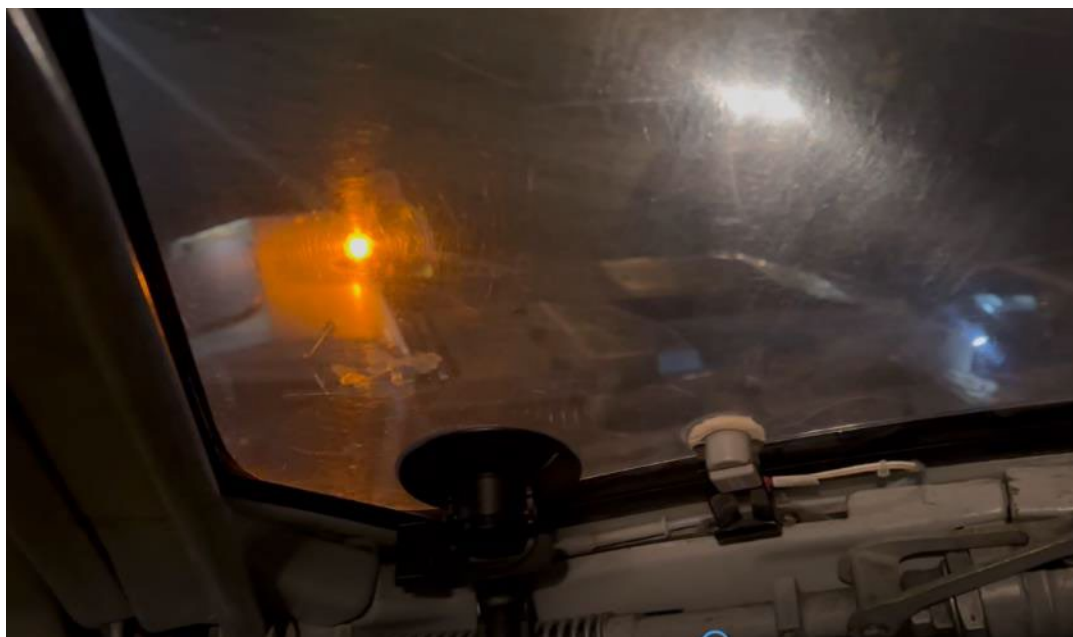
When the HP investigator looked to the left, the tug's amber beacon was seen slightly forward of the center post in the captain's side window, approximately 45 to 50 degrees left of the investigator's center of view when looking straight ahead. Because it was bright and flashing, the beacon was highly salient in the investigator's peripheral field of view. This made the tug's presence quite noticeable. When the beacon was off, the tug's presence was much less noticeable.

**Figure 16: Tug positioned 13 ft from the airplane with amber beacon illuminated.**

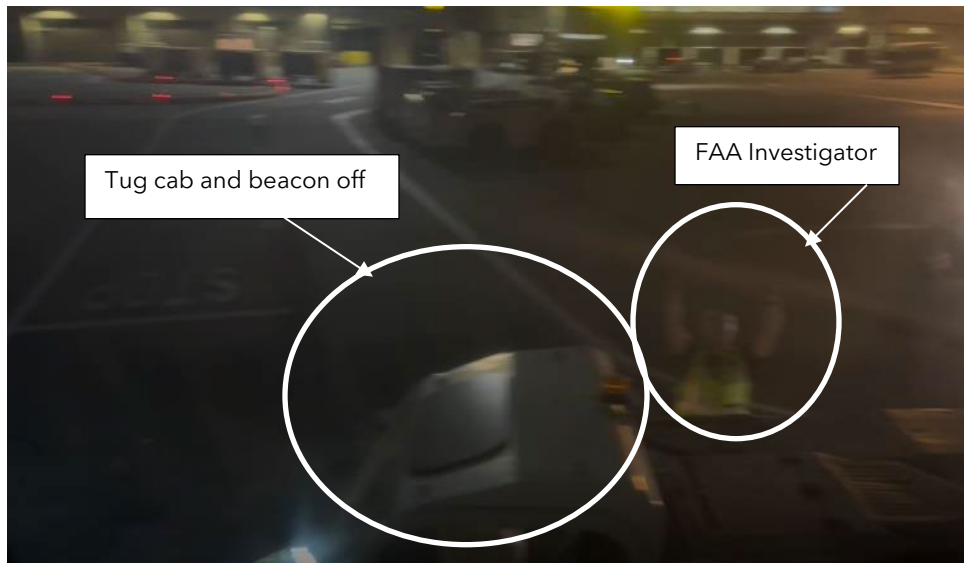
A member of the operations and human performance group stood on the opposite side of the tug and held his arms above his head as if he was holding the nosewheel bypass pin. When the tug's beacon on, he was illuminated by the flashing light. With the beacon off, he was a low contrast target, and spotting him required a more focused visual search.

**Figure 17: Tug with amber beacon off and FAA investigator simulating a display of the nosewheel steering bypass pin, with no illumination.**

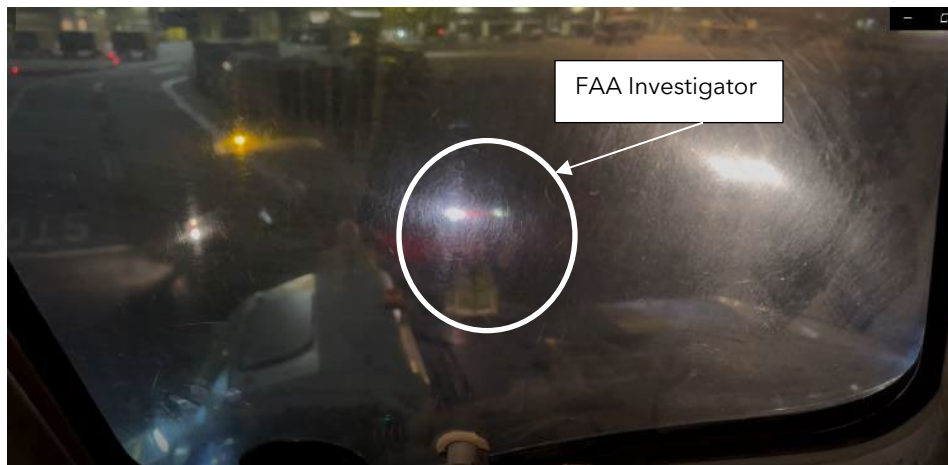
When a lighted wand was turned on in flashlight mode and held between the group member's outstretched arms, his presence was much more noticeable.

**Figure 18: FAA investigator simulating display of nosewheel steering bypass pin with ribbon illuminated by a handheld flashlight.**

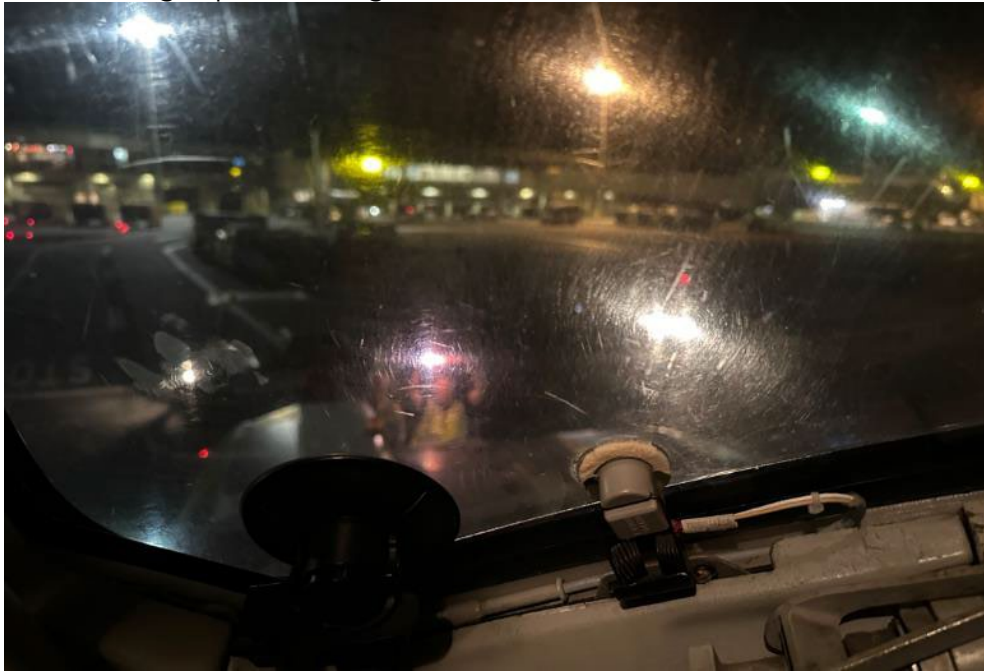
The HP investigator noted the presence of bright stadium lights in the gate area that were pointed toward the airplane and many small scratches in the captain's side

window that made outside objects more difficult to see and caused veiling luminance around bright points of light.

**Figure 19: Stadium lights illuminated facing the ramp area.**

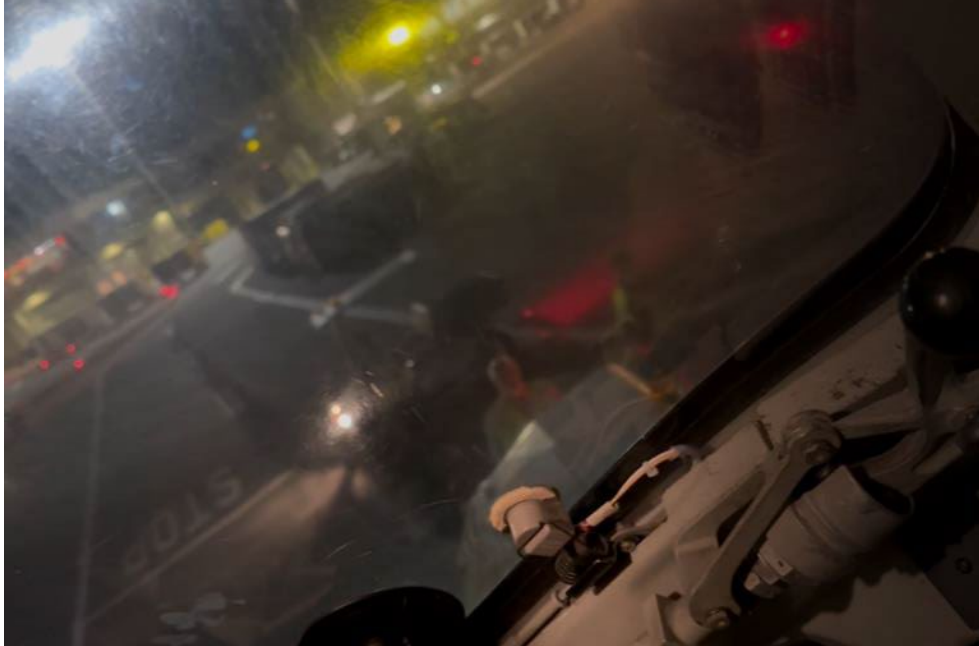
The HP investigator lowered his head to look at the MCDU<sup>3</sup> and then turned his head to the left. Most of the tug was no longer visible because it was obscured by the aircraft structure (the sill of the captain's side window), and the group member standing on the other side of the tug was adjacent to the window frame.

**Figure 20: View of tug with investigator's head lowered and rotated left.**

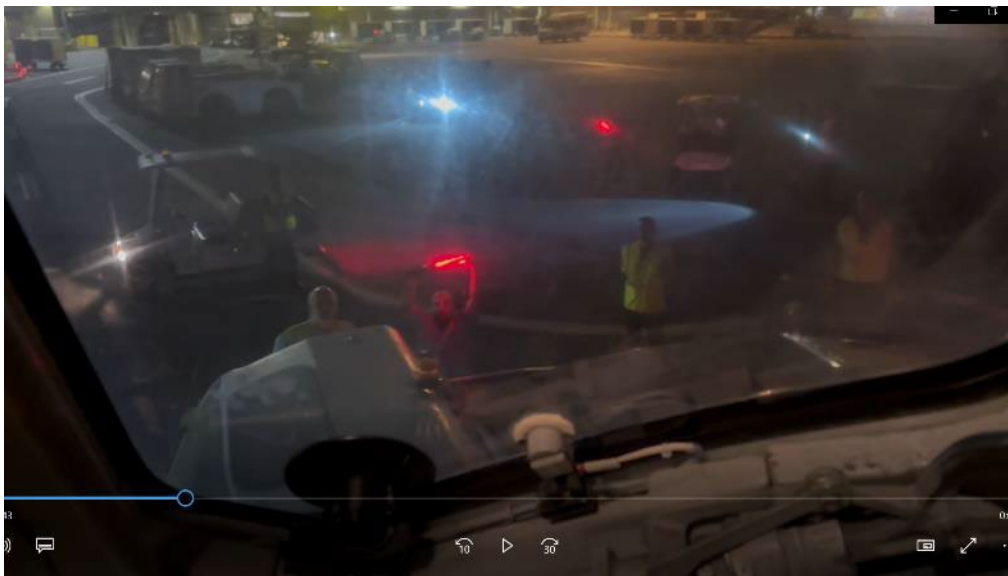
The tug was repositioned about 5 ft away from the side of the airplane. This made it less visible from the reference eye point.

**Figure 21: View of tug from reference eye point with tug positioned 5 ft from the side of the airplane.**

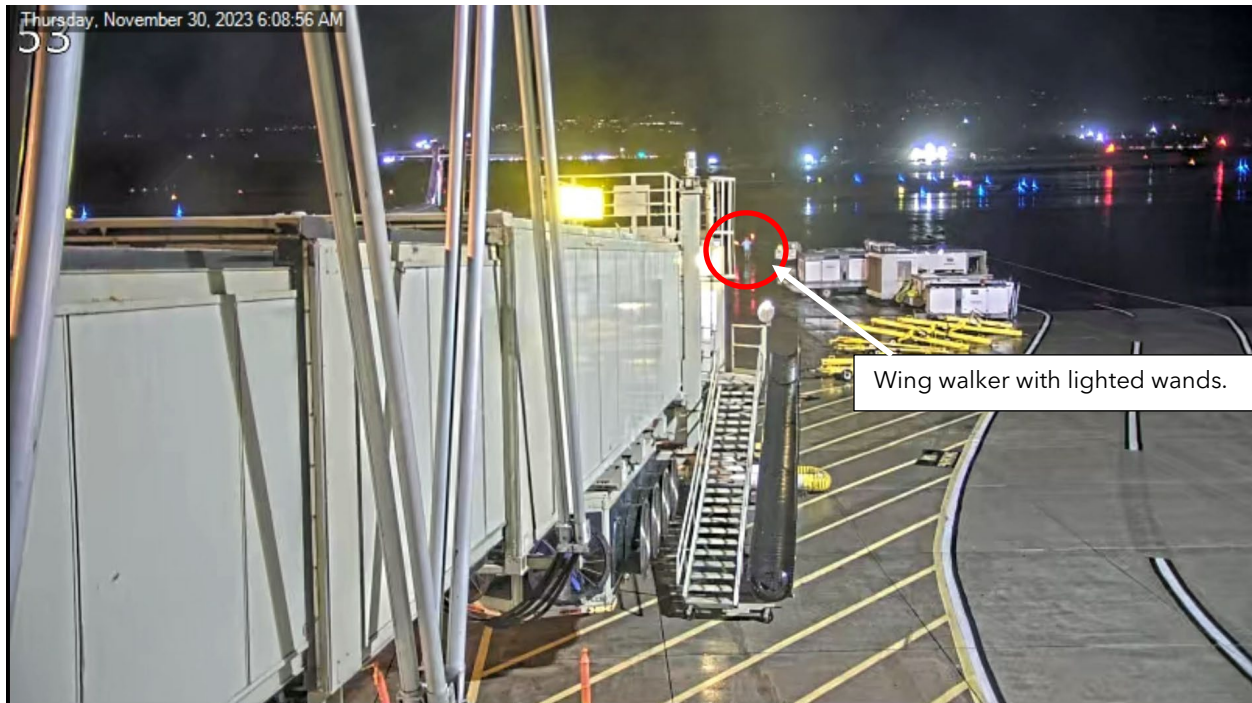
Figure 26 was a recording of the event pushback, in the screen shot you can see the wing walker on the left side of the airplane (in red circle) with the right illuminated wand held in the vertical position and the left illuminated wand held in a nearly horizontal position.

**Figure 26: Screen shot during pushback on November 30, 2023. Wing walker with lighted wands visible.**

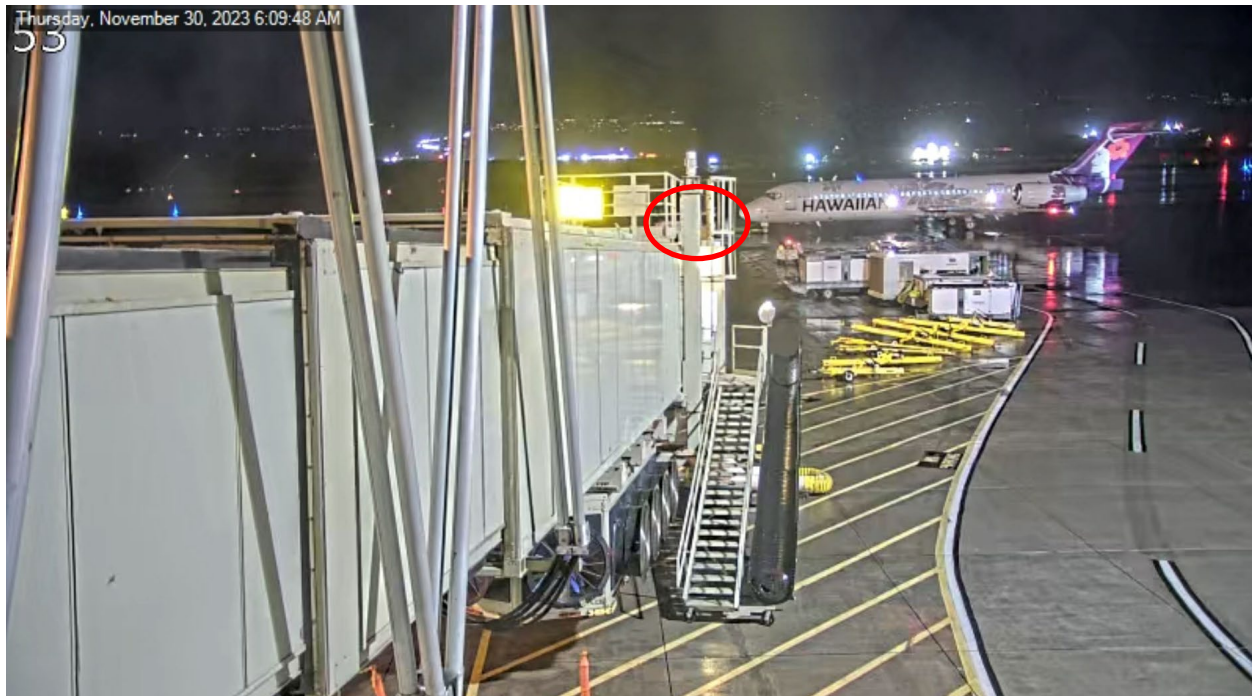
Figure 28 was a screen shot of a recording of the event pushback. The screen shot was after the airplane came to a stop following the pushback from gate 17. Although the tug (in red circle) is partially obscured by the ladder cage on the right side of the jet bridge, there was no visual indication on the recording of a yellow beacon on top of the tug being illuminated.

**Figure 28: Screen shot after pushback and airplane stopped on November 30, 2023.**

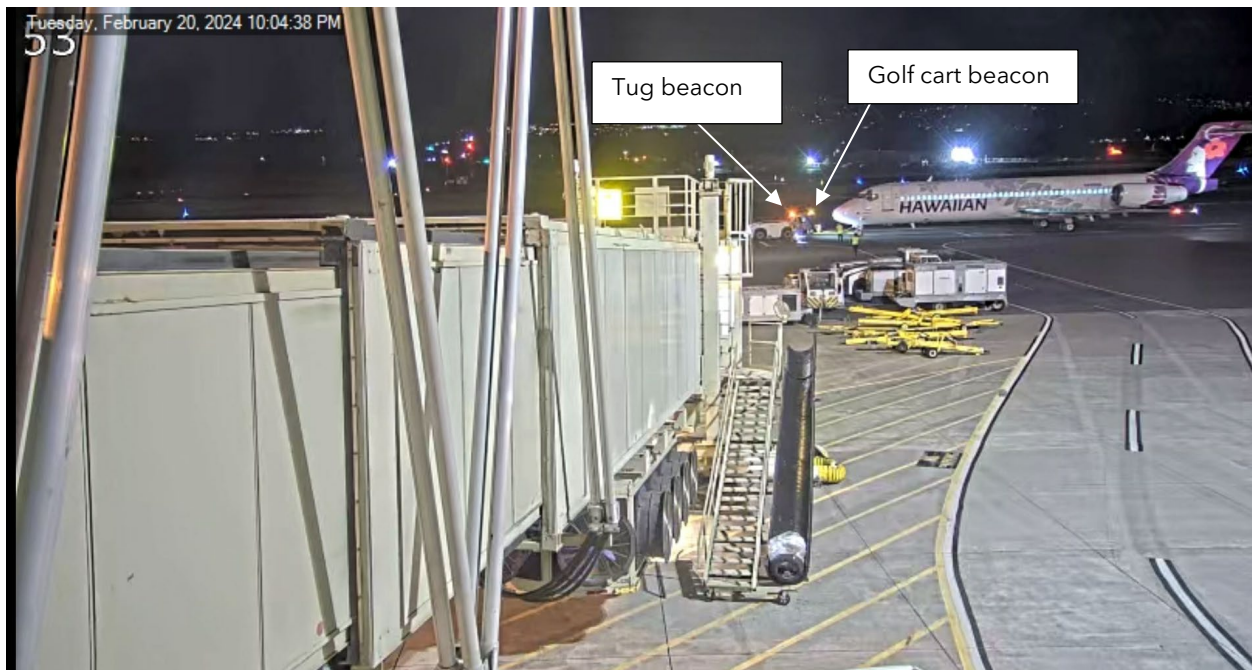
Figure 29 was a screen shot from security video recorded on February 20, 2024. The screen shot was captured after the airplane was stopped following pushback from gate 17. In that screen shot you can visually acquire the tug yellow beacon light. Additionally, the screen shot captured a golf cart's beacon, which was also being used during the night observations. Both lights are labeled in the figure.

**Figure 29: Screen shot after pushback and airplane stopped on February 20, 2024.**

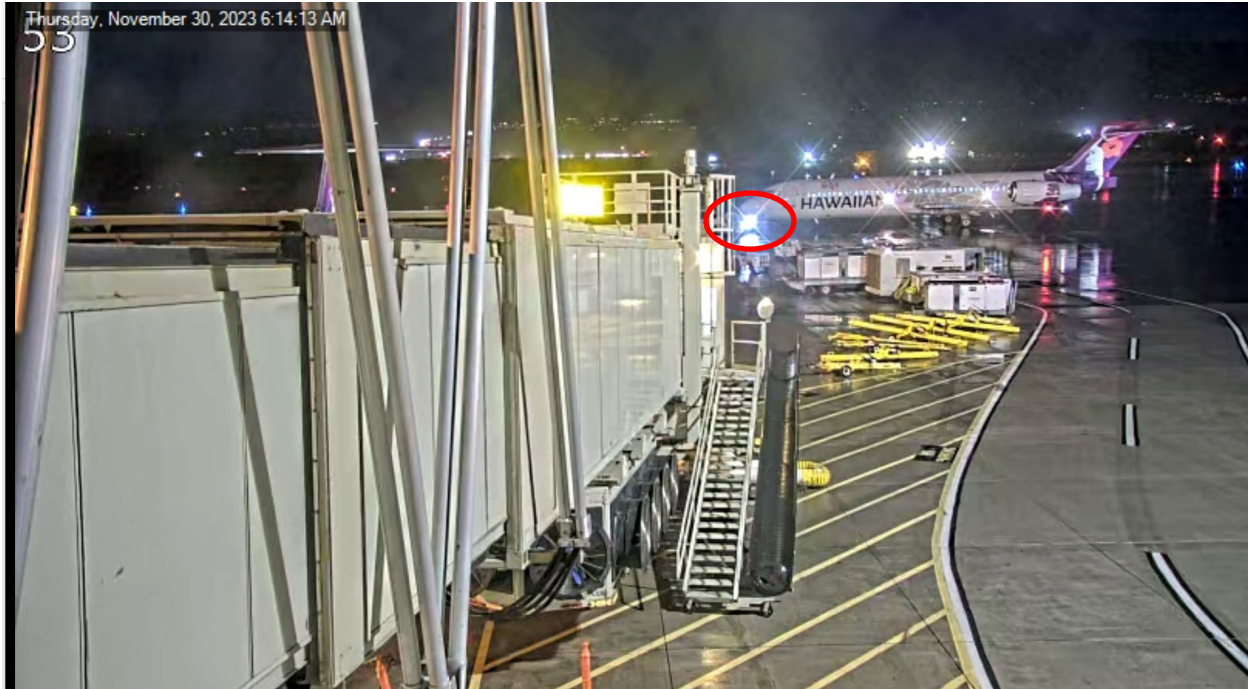
Figure 30 was a screen shot obtained from the security video recording of the event pushback. The screen shot captures the tug being positioned of the left side of the airplane's nose. In the screen shot, the tug's headlights (in red circle) are illuminated.

**Figure 30: Screen shot after towbar disconnected from airplane on November 30, 2023.**

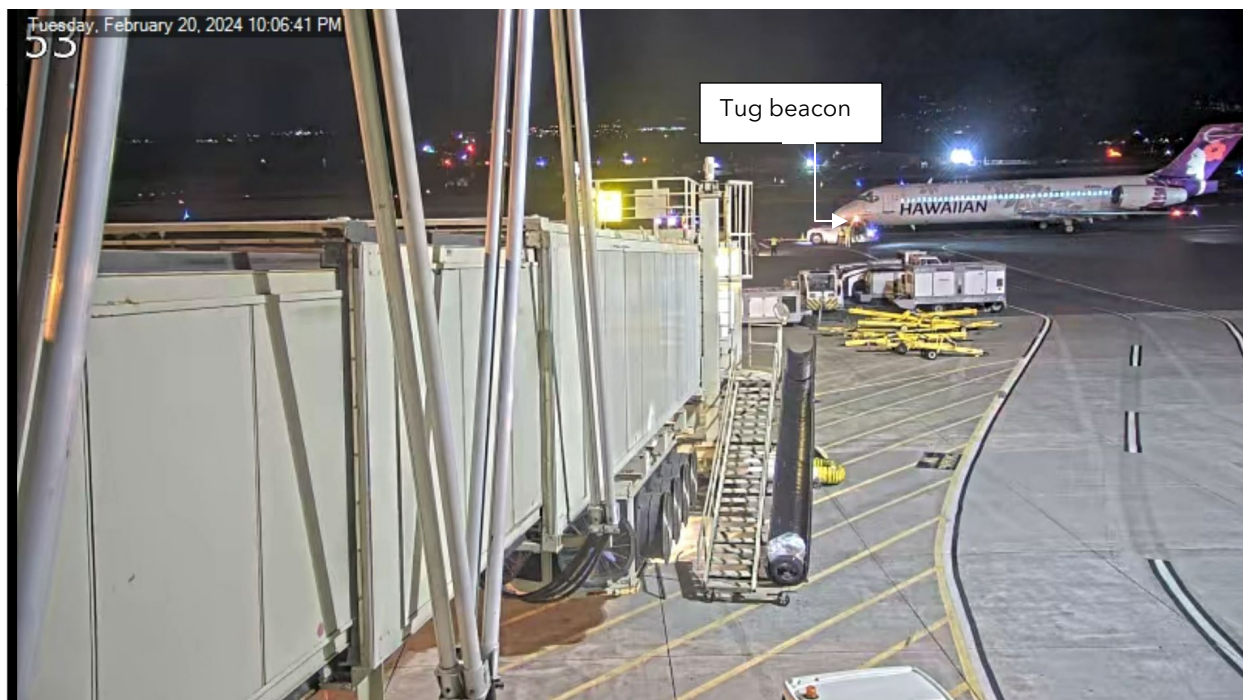
Figure 31 was a screen shot of the security camera video recording that occurred on February 20, 2024. In that screen shot the tug's yellow beacon is illuminated as indicated by the white arrow.

**Figure 31: Screen shot after tug placed approximately 10 ft from airplane on February 20, 2024.**
