# National Transportation Safety Board

DCA24LA097

## **AIR TRAFFIC CONTROL**

Group Chairman's Factual Report

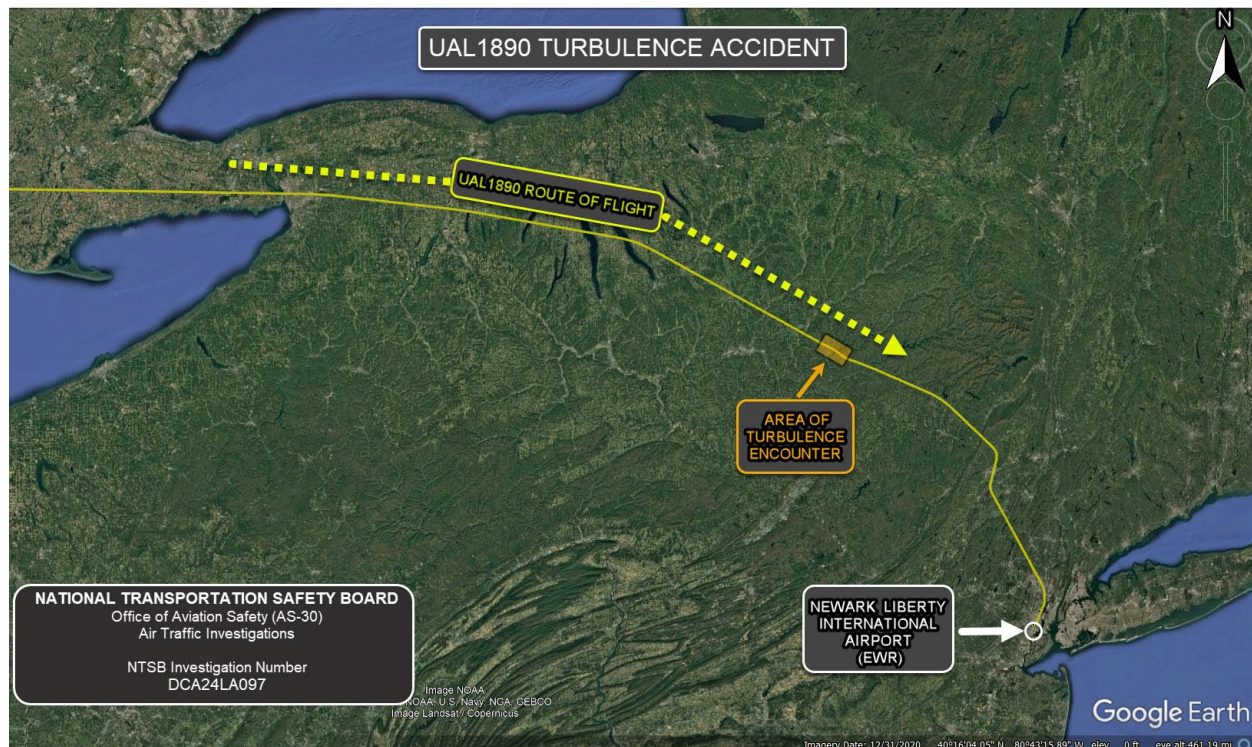
Figure 1 illustrates the approximate area where UAL1890 encountered turbulence along their route of flight.

**Figure 1.** A graphic depicting the area of turbulence encounter.

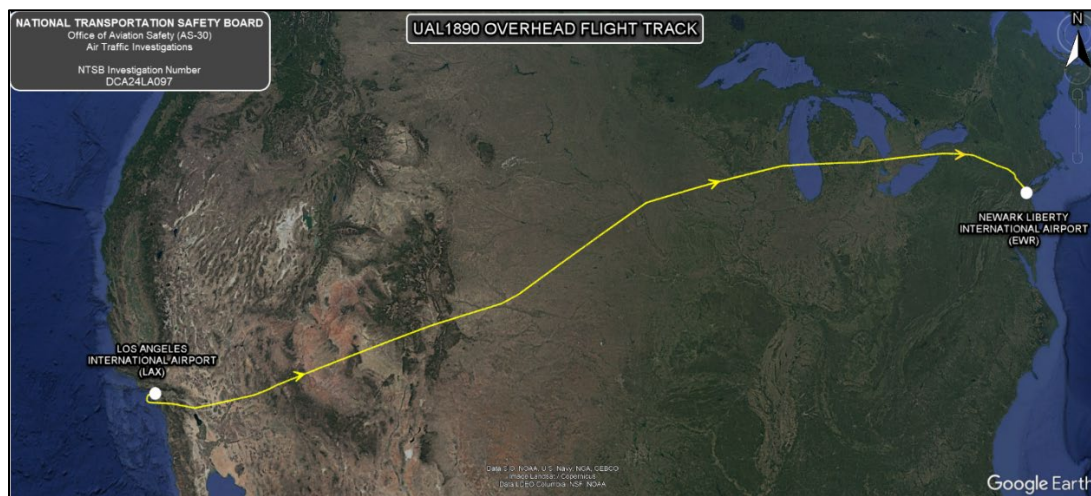
**Figure 2.** Overhead view of the accident flight track of UAL1890.

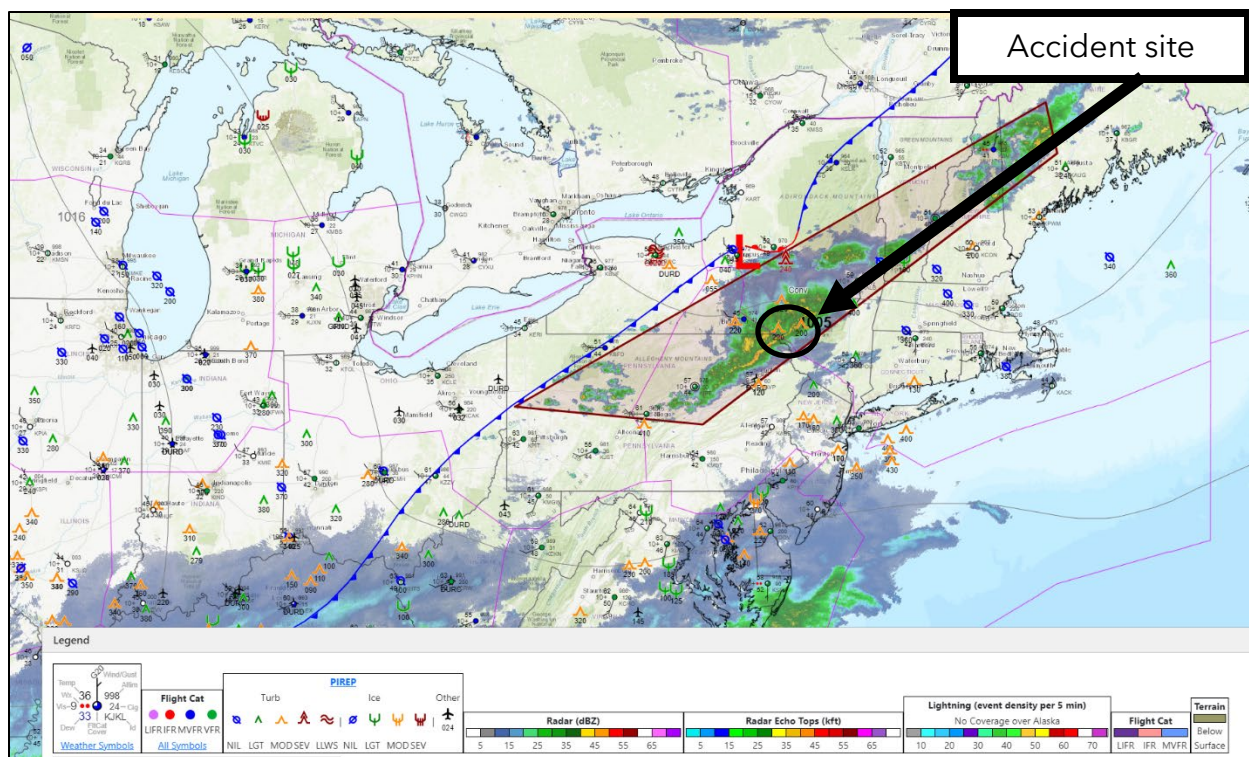
There was a convective significant meteorological information (SIGMET)<sup>25</sup> valid for the accident site at the accident time. SIGMET 29E issued at 1455 EST forecast an area of embedded thunderstorms with tops to FL 280 with the SIGMET box area moving from 250° at 40 knots:

Figure 3 below is a graphical representation of SIGMET 29E from the Aviation Weather Center's (AWC) observation page. The approximate location of the accident has been outlined with a black circle.

**Figure 3.** Aviation Weather Center observation page valid at 1545 EST with fronts, PIREPs, and the area of Convective SIGMET 29E highlighted. The location of the accident site is marked by the black circle.

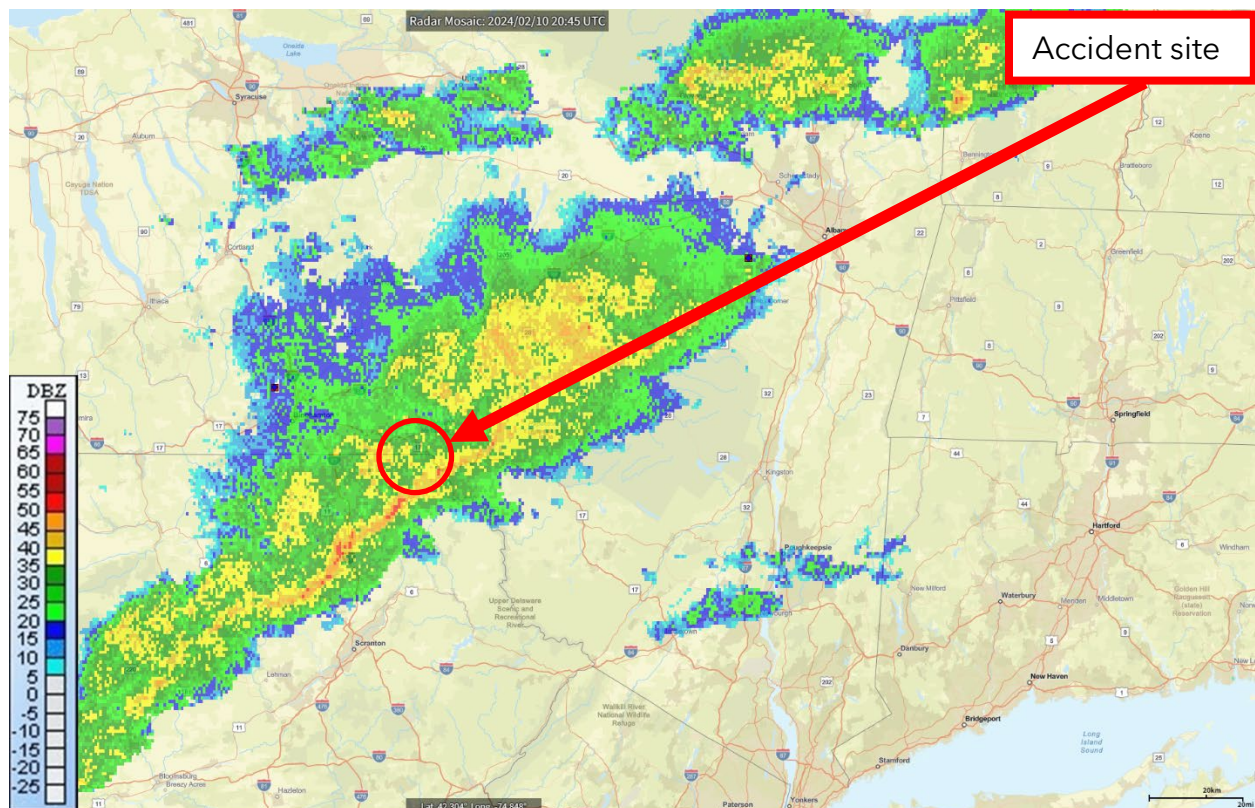
Figure 4 is a regional view of the National Weather Service (NWS) National Reflectivity Mosaic and the approximate location of the accident has been outlined with a red circle. The mosaic imagery depicted echoes of 25 to 40 dBZ<sup>27</sup> above the accident site.

**Figure 4.** National Reflectivity Mosaic for 1545 EST.
