## Equipment Quality Analysis Report

**EQA NUMBER:** AS13825  
**DATE:** October 30, 2024  
**MODEL NUMBER:** 767-300ERSF  
**AIRPLANE NUMBER:** VN967

**SUBJECT:** *Auxiliary Power Unit (APU) Access Doors Departed During Flight*

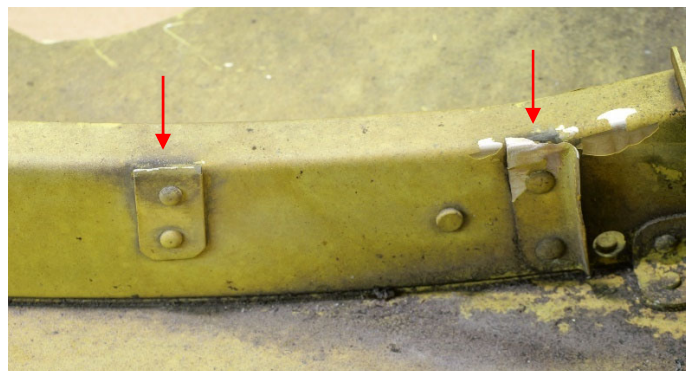
Two attachment tabs were fractured with material that remained riveted to the middle support rib; see Figure 11.

**Figure 11:** Fractured attachment tabs

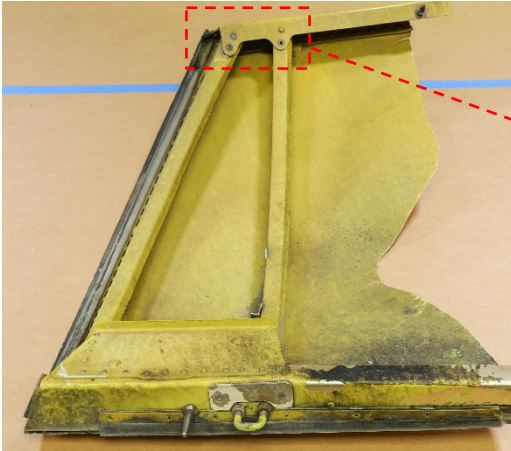
Three rivets were noted to be missing from the door structure on the inboard surface of the aft LH APU door section; see Figure 12 and Figure 13.

**Figure 12:** Aft LH APU door section, inboard surface.

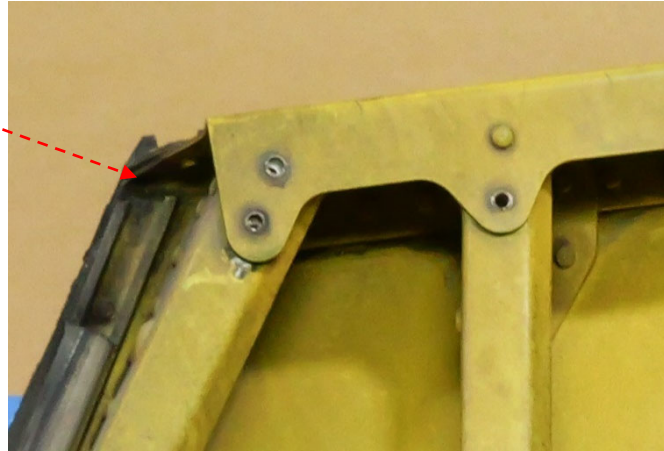
**Figure 13:** Missing rivets

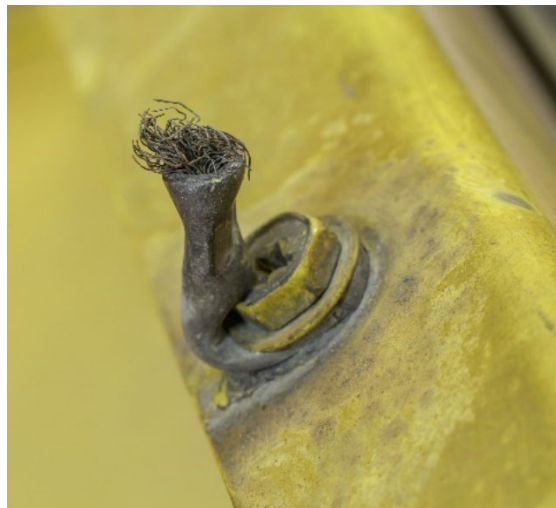
A broken electrical bonding strap was observed with the attachment fastener still in place; see Figure 14.

**Figure 14:** Broken bonding strap

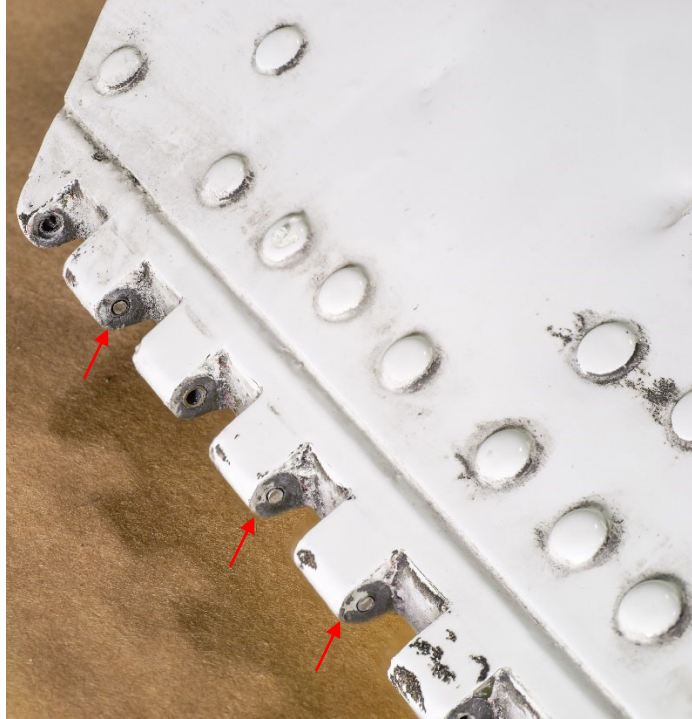
The hinge pin was sheared in multiple locations and missing from multiple locations of the hinge barrels on the aft LH APU door section. Five hinge pin pieces were observed within 12 of the hinge barrels. Figure 15 and Figure 16 show images of the hinge pin pieces lodged within the hinge barrels.

**Figure 15:** Hinge pin pieces within hinge barrels of the aft LH APU door section

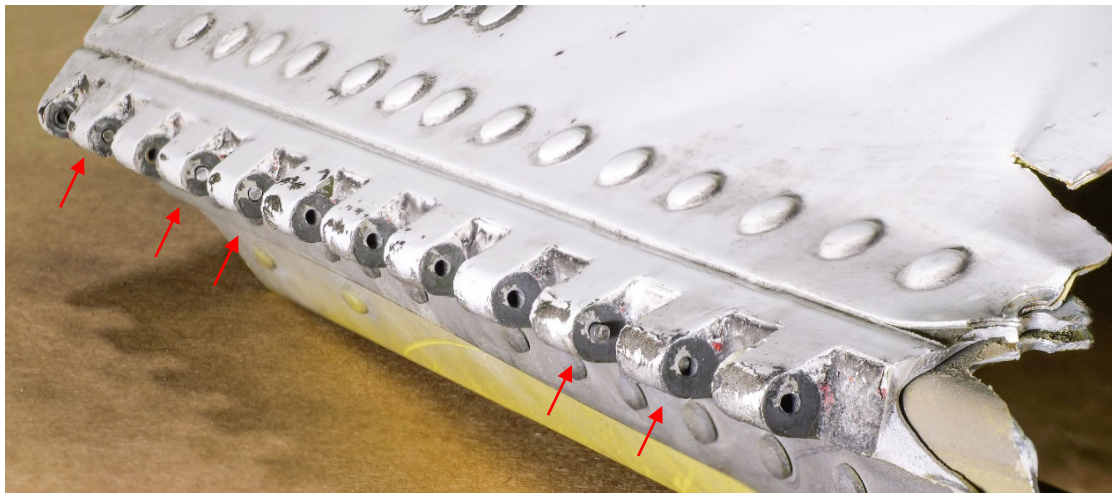
**Figure 16:** Hinge of the aft LH APU door section with hinge pin pieces within hinge barrels

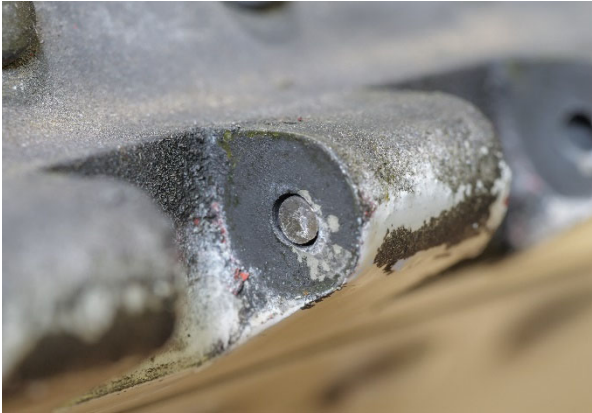
Some of the hinge barrel holes were damaged and ovalized. Figure 17 and Figure 18 show examples of the damaged and ovalized hinge barrel holes.

**Figure 17:** Example of ovalized hinge barrel hole

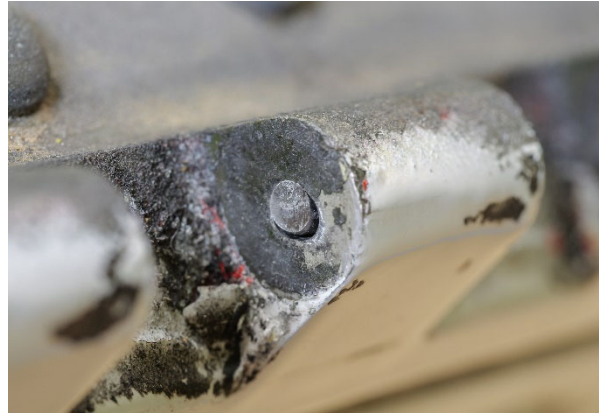
**Figure 18:** Example of ovalized hinge barrel hole

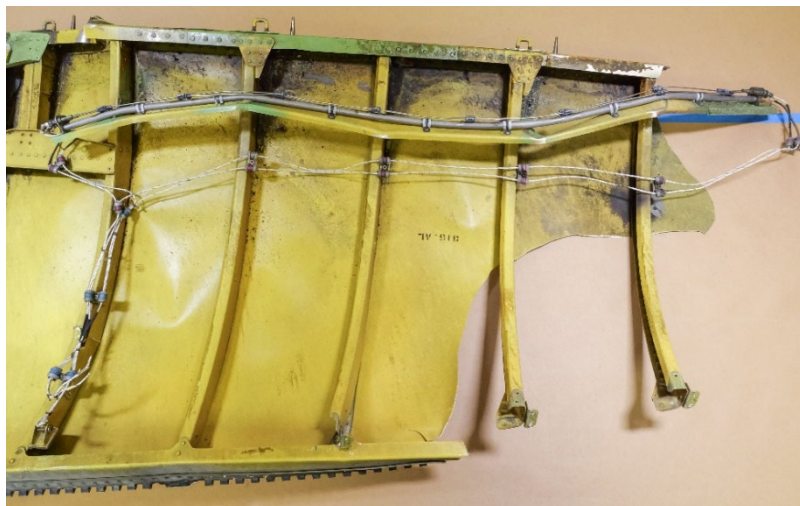
A section of skin along and support ribs were noted to be missing from the aft end of the LH APU door section; see Figure 22.

**Figure 22:** Missing section of skin and support ribs

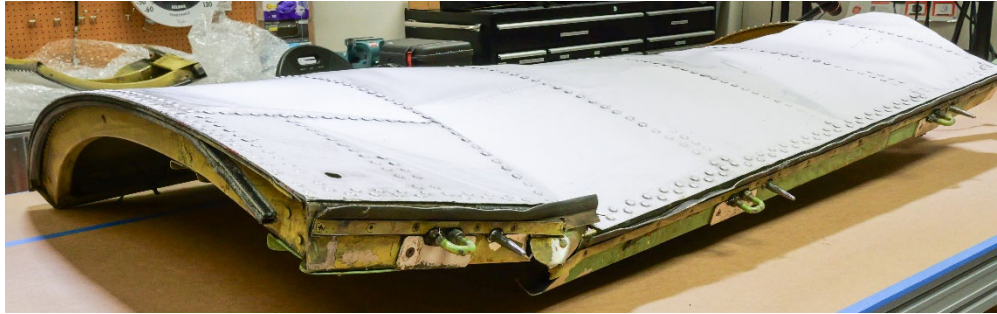
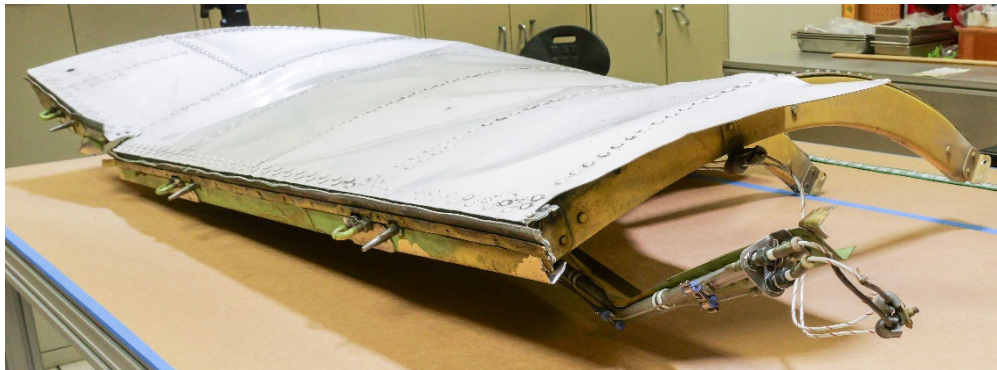
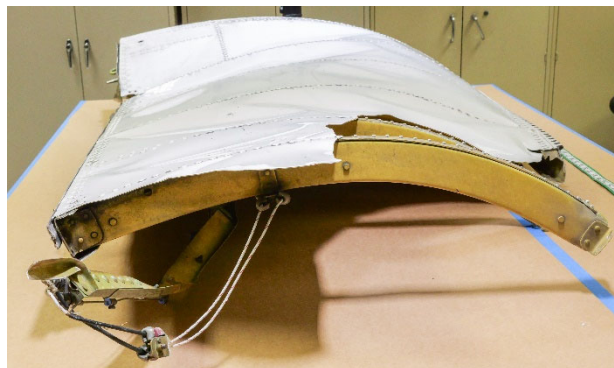
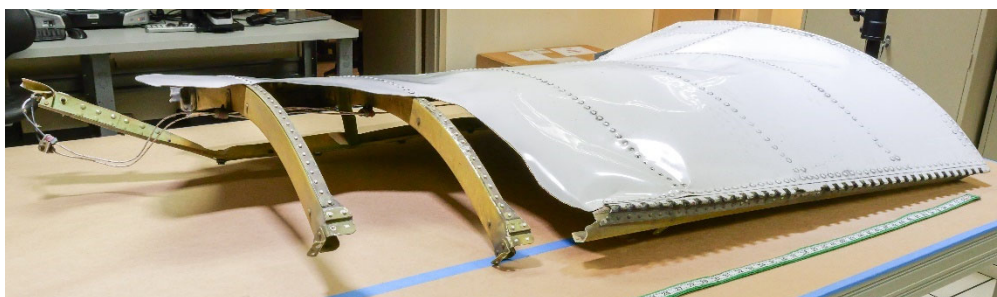
The door was misshapen, bent and the skin was wrinkled in multiple areas; see Figure 23 through Figure 26.

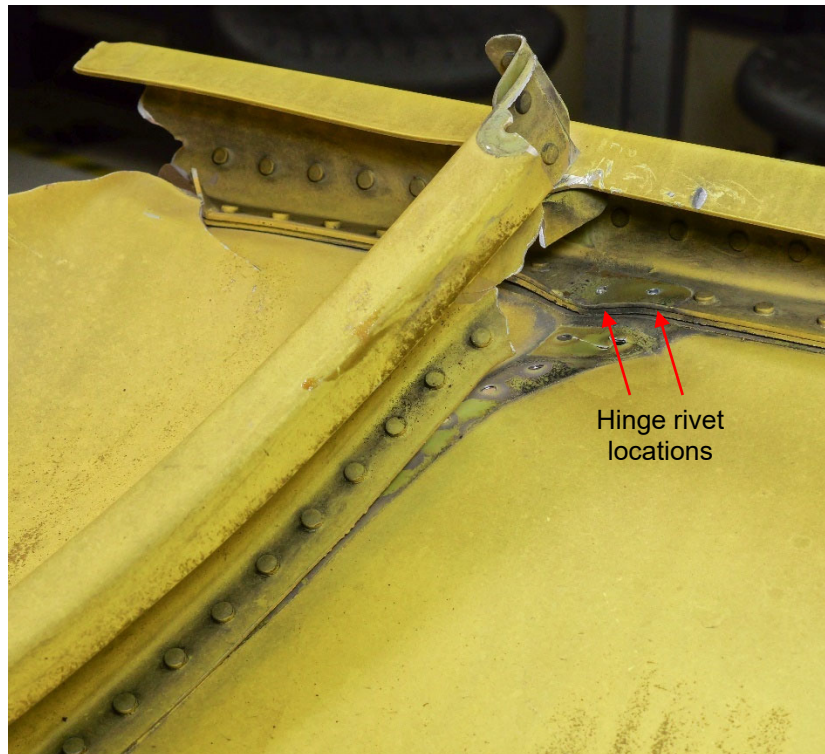
The fourth support rib was separated from the hinge edge and the skin panel. Two rivets were broken that attached the support rib to the hinge structural member. Seven rivets were broken that attached the support rib to the skin; see Figure 27 and Figure 28.

**Figure 27:** Fourth support rib separated from skin and hinge

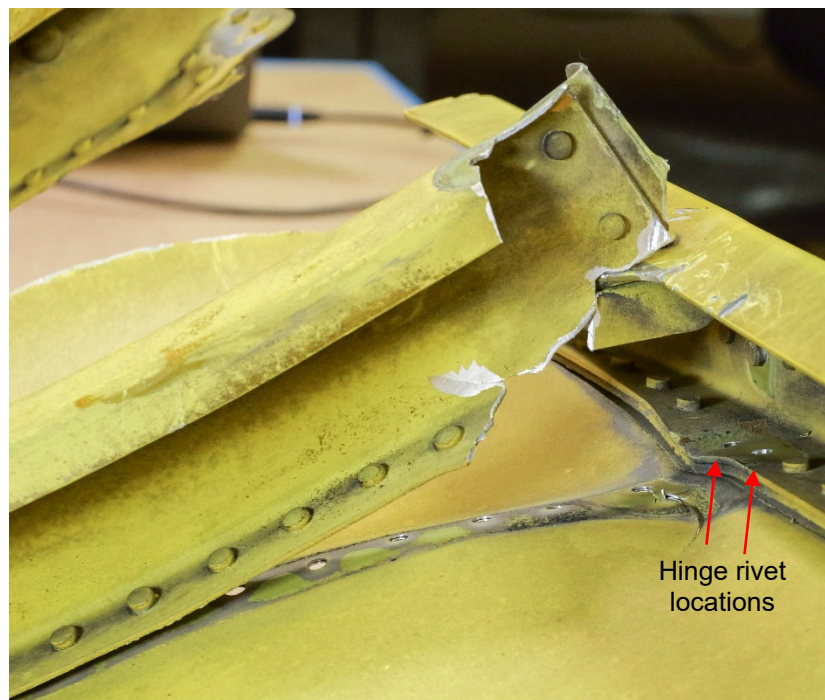
**Figure 28:** Fourth support rib separated from skin and hinge

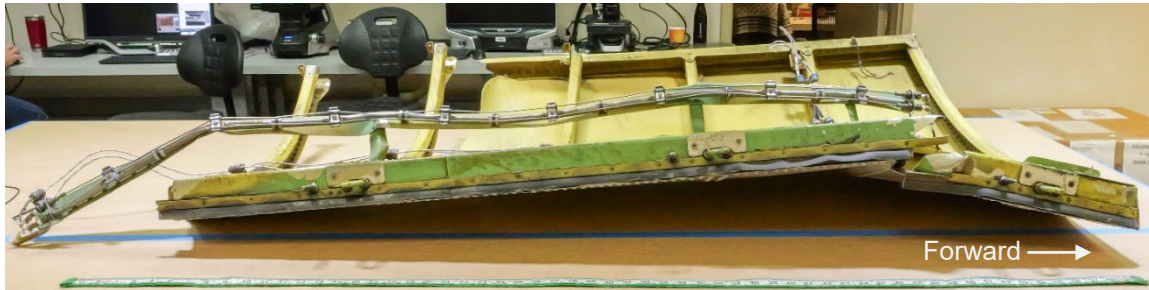
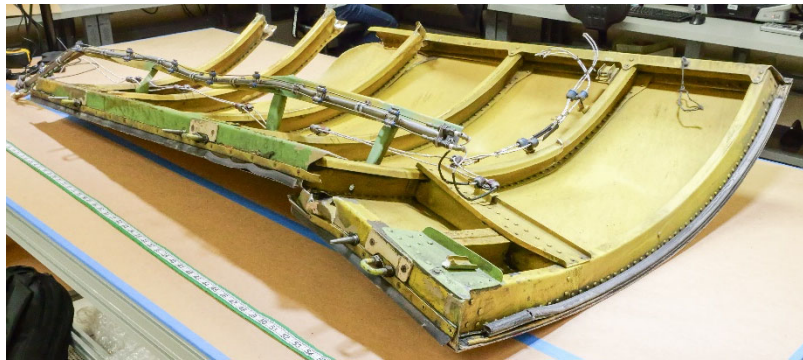
The skin was fractured and bent in the outboard direction at the second support rib from the forward edge of the door; see Figure 29 and Figure 30.

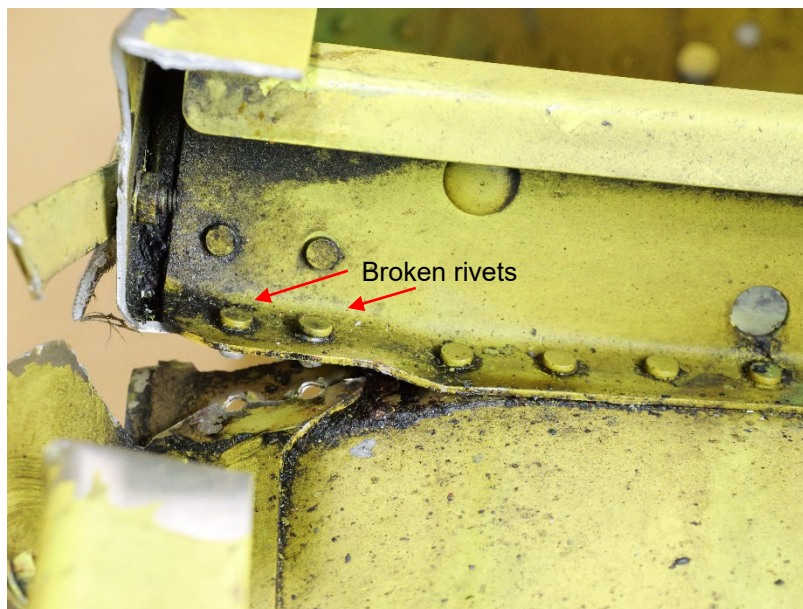
The skin was separated from the second support rib with portions of the rivet remaining in the second support rib; see Figure 31.

**Figure 31:** Broken rivets on second support rib

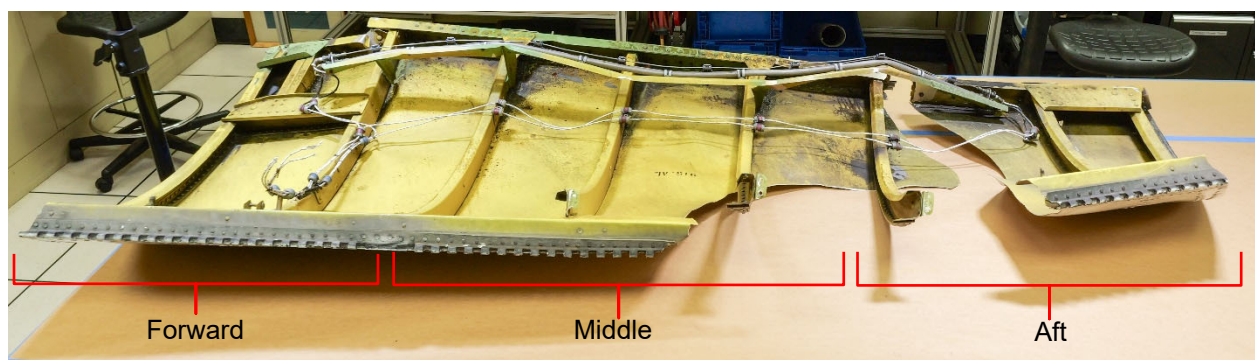
The hinges on the LH APU door sections were visually examined. The forward hinge section appeared straight. The middle hinge section appeared bent and broken with the aft section of the hinge noted to be missing. The aft hinge section was broken with the forward section of the hinge noted to be missing. An overview image from the hinge edge of the LH APU door sections is shown in Figure 33.

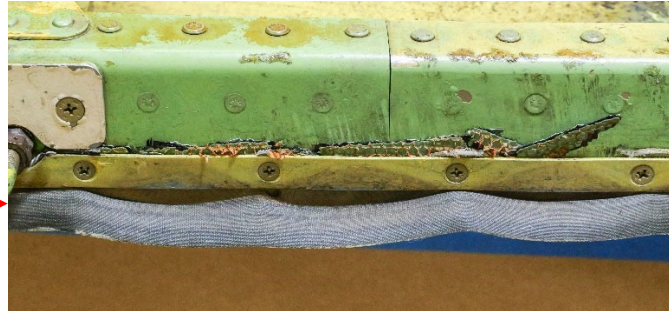
Approximately seven inches of honeycomb material was trapped between the door seal and the door frame between the second and third support ribs on the latch edge of the forward LH APU door section; see Figure 34 and Figure 35.

**Figure 35:** Trapped honeycomb material

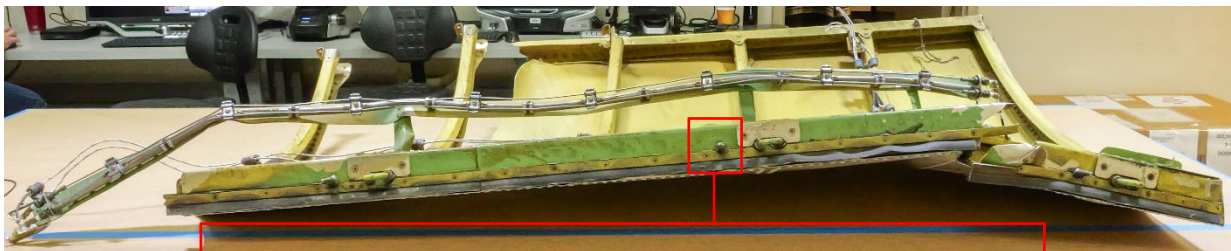
The three alignment pins on the forward LH APU door section were visually examined. There were no remarkable observations on the forward and aft alignment pins. The middle alignment pin displayed circumferential witness marks in a spiral pattern between approximately 1.0 to 1.2 inch section away from the base of the pin; see Figure 36 through Figure 38.

**Figure 36:** Middle alignment pin on the forward LH APU door section

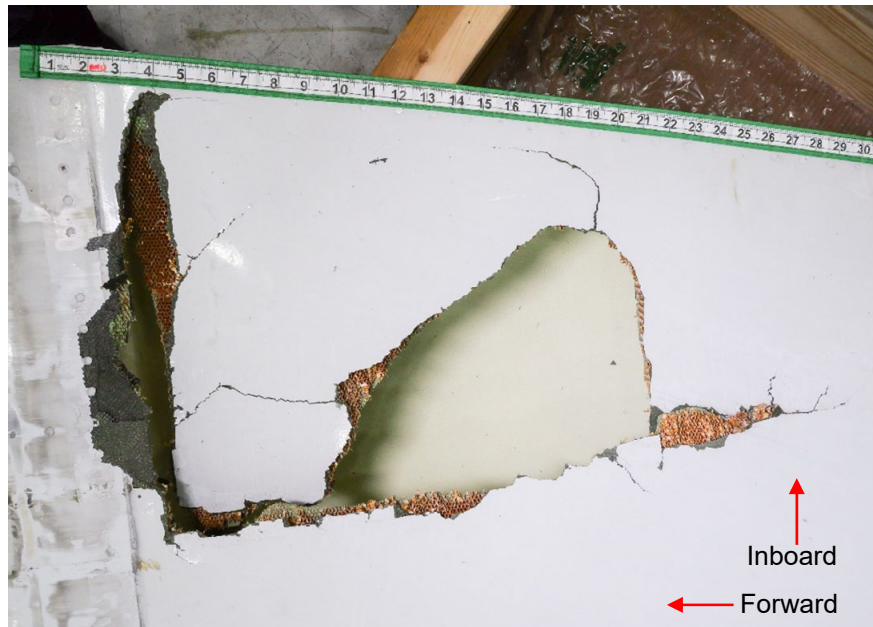
The damage observed on the lower forward inboard surface of the RH elevator assembly was photographed; see Figure 44 and Figure 45. The damage in this area of the RH elevator measured approximately 17 inches wide by 29 inches long.

**Figure 44:** Damage on lower forward inboard surface of RH elevator

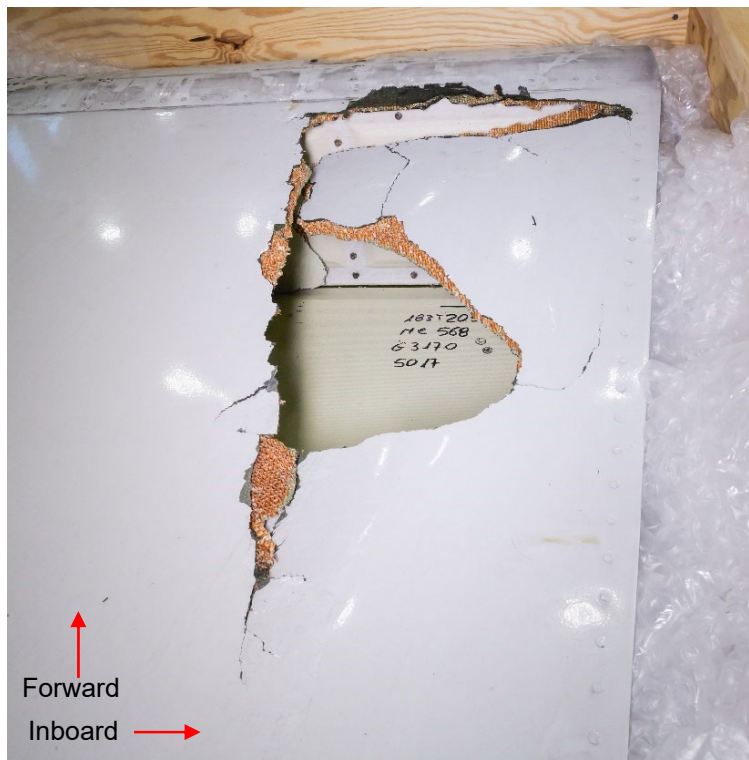
**Figure 45:** Damage on lower forward inboard surface of RH elevator

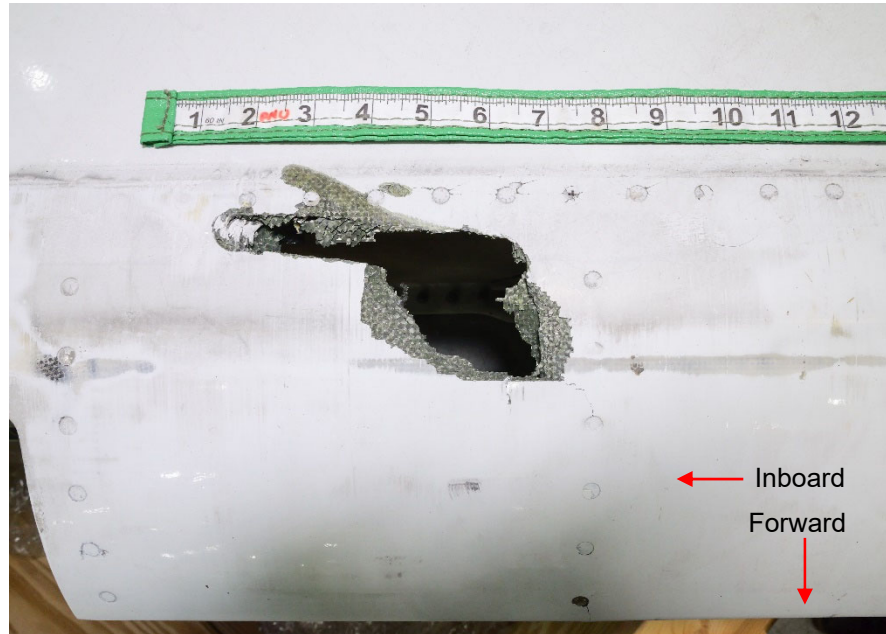
Damage was observed on the lower forward surface of the RH elevator assembly. The damaged area was located approximately five inches inboard of the center hinge fitting opening. Images of the damage were captured; see Figure 46 and Figure 47. The damaged area measured approximately five inches wide by seven inches long.

**Figure 46:** Damage on outer lower forward surface of RH elevator

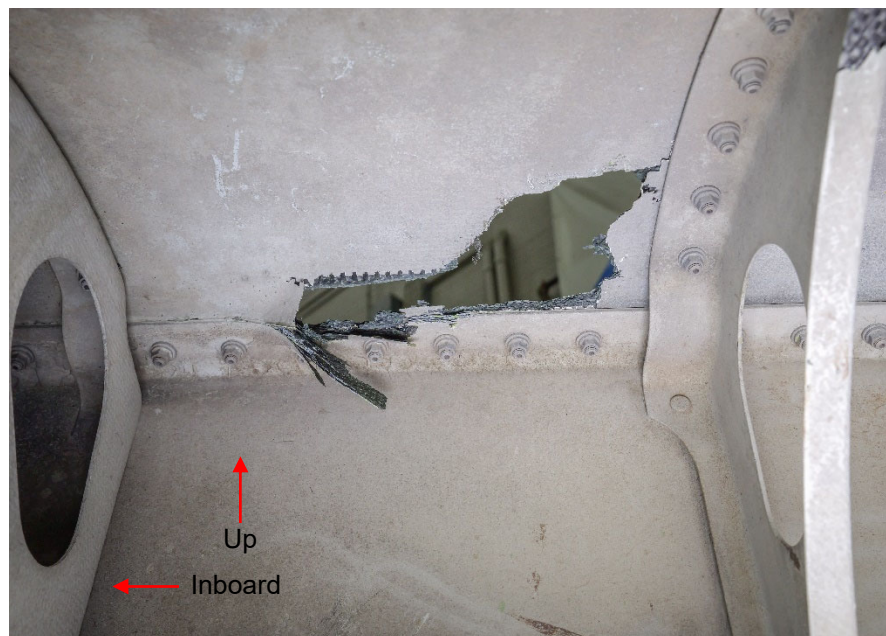
**Figure 47:** Inner surface of the RH elevator damage

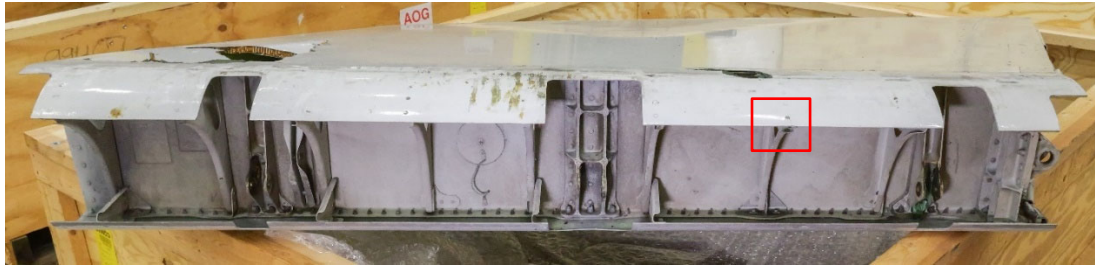
Cracking was observed toward the corner of a support rib and the outer surface of the RH elevator assembly. The location of the cracking is identified by a red square in Figure 48. An image of the crack in the support rib is shown in Figure 49 and an image of the crack on the outer surface of the RH elevator is shown in Figure 50.

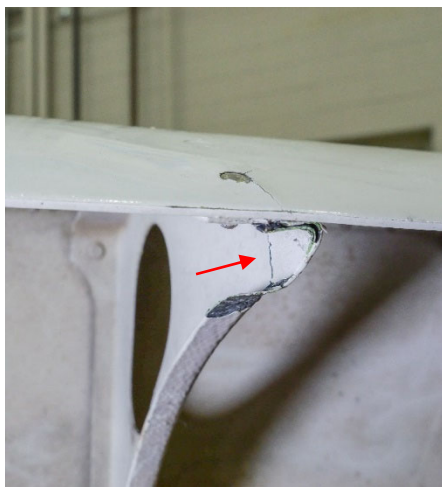
**Figure 49:** Crack on support rib

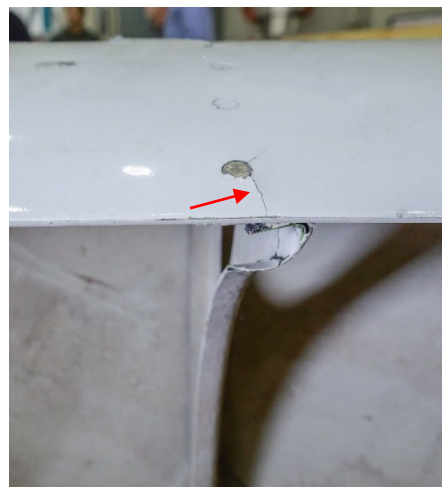
**Figure 50:** Crack on lower surface of RH elevator

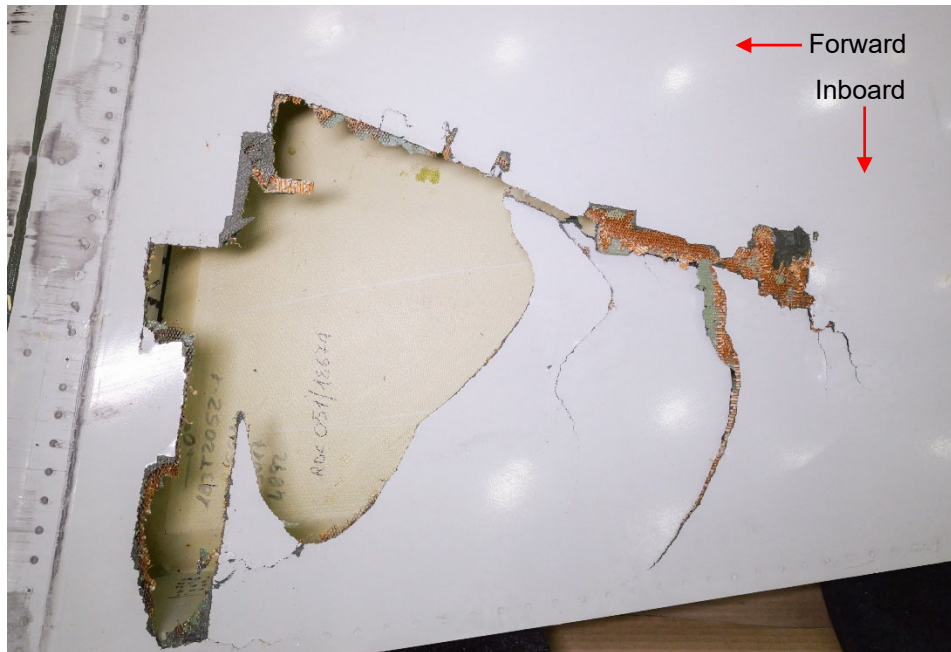
The damage observed on the lower forward inboard surface of the LH elevator assembly was photographed; see Figure 55 and Figure 56. The damage in this area of the LH elevator measured approximately 25 inches wide by 33 inches long.

**Figure 55:** Damage on lower forward inboard surface of LH elevator

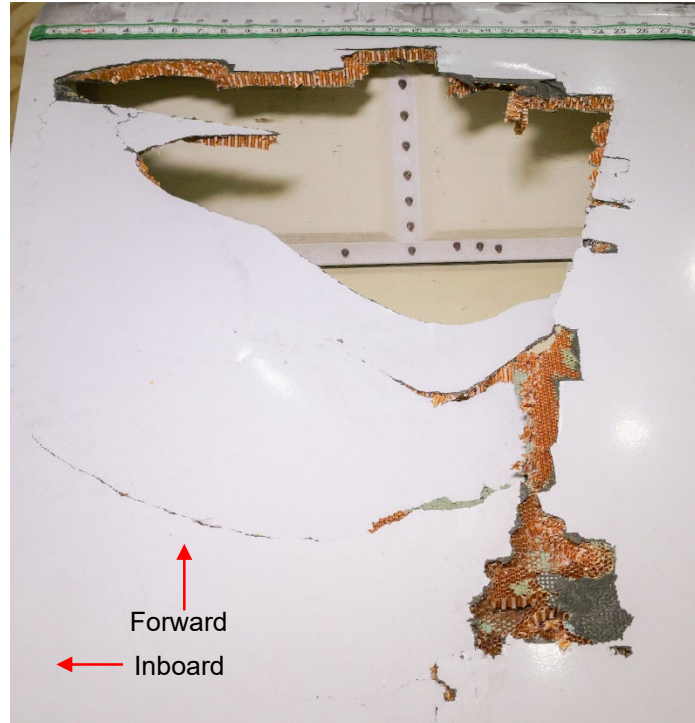
**Figure 56:** Damage on lower forward inboard surface of LH elevator

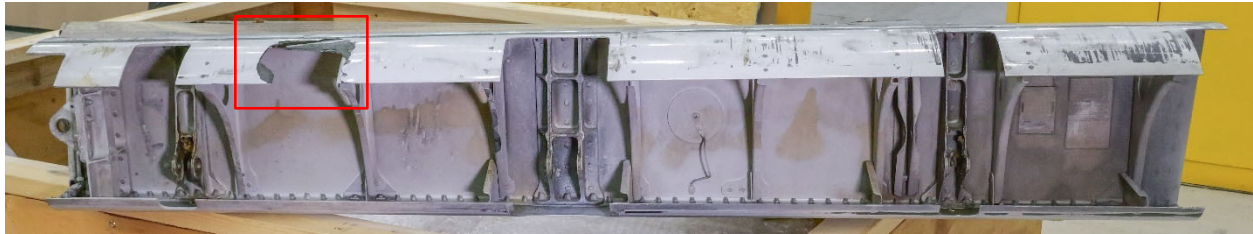
An approximate six inch wide by seven inch long section of material was missing from the forward lower edge of the LH elevator assembly. The location of the missing section of material on the LH elevator assembly is identified by a red square in Figure 57.

**Figure 57:** Section of material missing from LH elevator assembly, forward looking aft

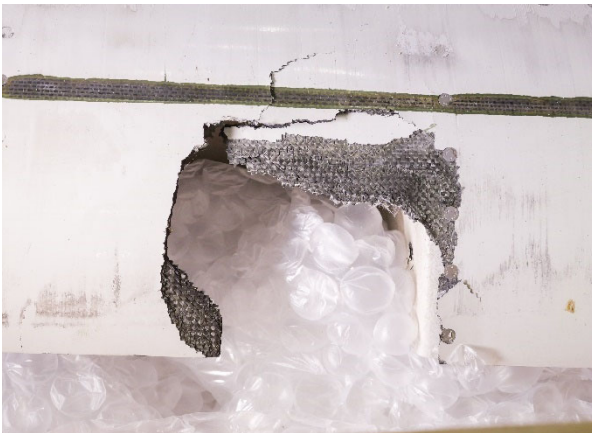
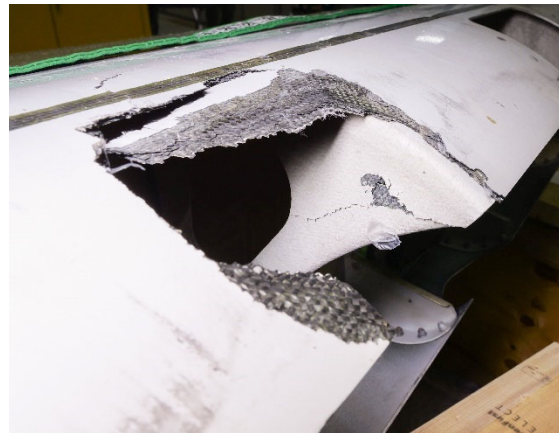
Images of the area with the missing section of material on the LH elevator assembly were captured; see Figure 58 and Figure 59.

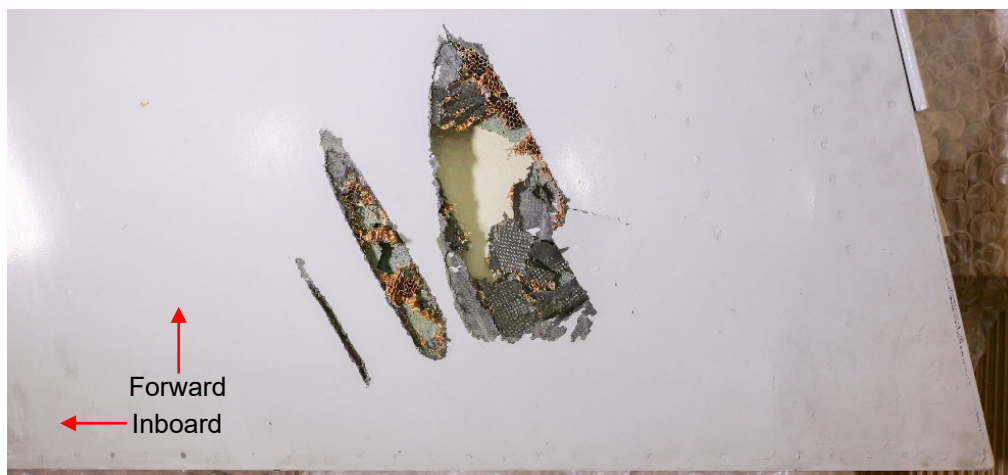
The damage observed on the lower aft outboard surface of the LH elevator assembly was photographed; see Figure 60. The damage was contained within an approximately 10 inch wide by 12 inch long area of the LH elevator.

**Figure 60:** Damage on lower aft outboard surface of LH elevator

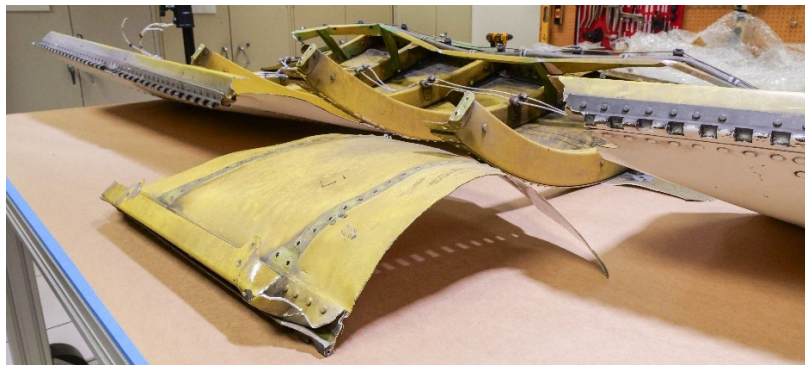
The LH APU door section was placed in its approximate originating location alongside the forward and aft sections of the LH APU door. An image of the LH APU door sections was captured; see Figure 65. Figure 66 shows an end view image of the remaining LH APU door section with the curvature in the outward direction.

**Figure 66:** End view of LH APU door section

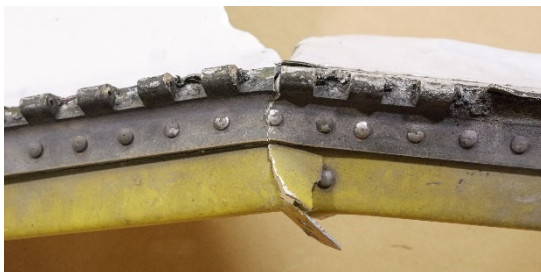
A bend and fracture existed common to the hinge and door frame structure towards the middle of the RH APU door section; see Figure 70 and Figure 71.

**Figure 70:** Bend and fracture common to RH APU door section

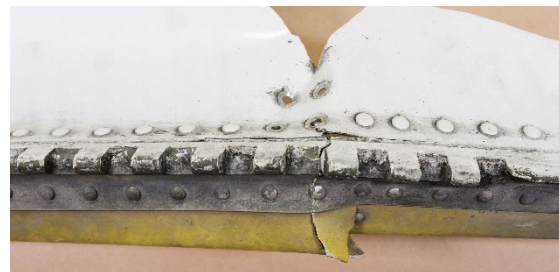
**Figure 71:** Bend and fracture common to RH APU door section

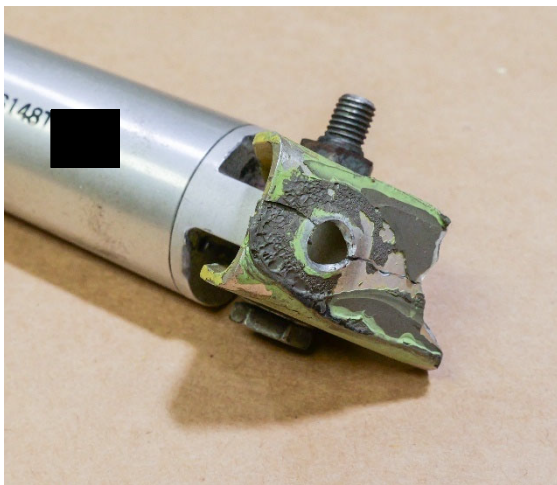
A fractured section of an attachment bracket was still attached to the hold open strut. A longitudinal crack existed that extended the entire length of the mounting surface on the fractured attachment bracket section; see Figure 77 and Figure 78.

**Figure 77:** Fractured attachment bracket, underside

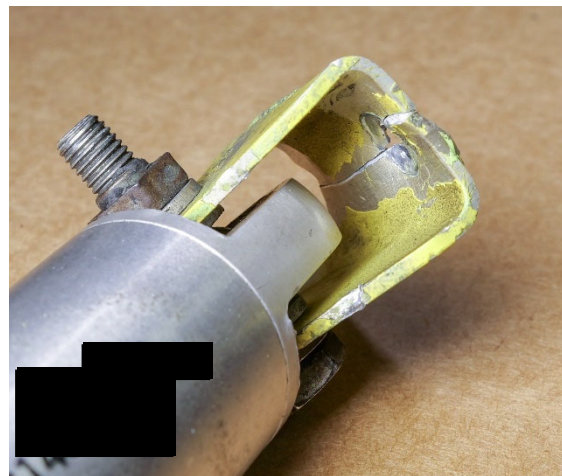
**Figure 78:** Fractured attachment bracket, top side

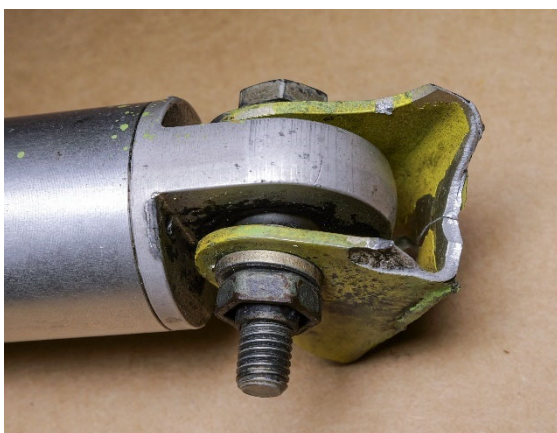
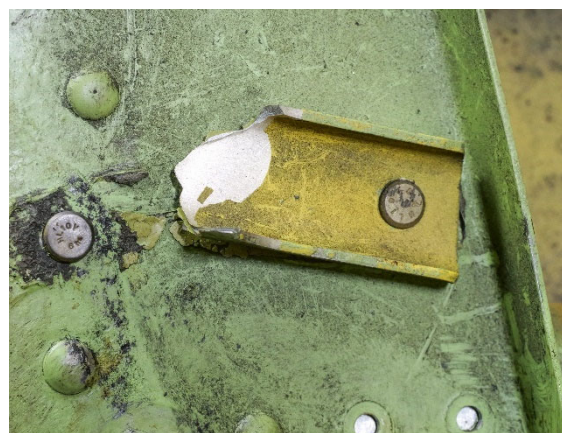
The profile of the fractured attachment bracket matched the profile of a fractured attachment bracket on the forward LH APU door section; see Figure 79 and Figure 80.

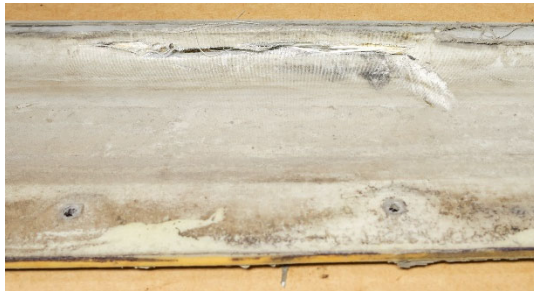
Damage was observed on the inner and outer surfaces of the panel seal measuring approximately six inches in length on both surfaces; see Figure 87 and Figure 88.

**Figure 87:** Damage on inner surface of panel seal

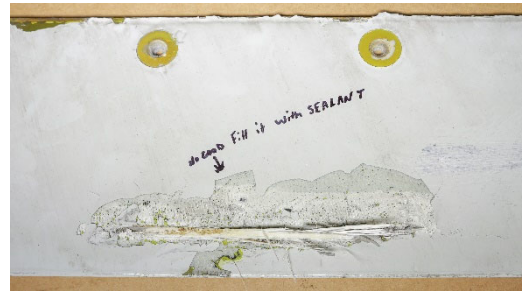
**Figure 88:** Damage on outer surface of panel seal
