# National Transportation Safety Board

## ATC Services Review Worksheet

DCA24LA318

On September 25, 2024, about 1526 central daylight time (CDT), Envoy Airlines flight 3936 (ENY3936), an Embraer 170-100 LR, N772MR, was cleared for the instrument landing system (ILS) approach to land on runway 10C at Chicago O'Hare International Airport (ORD), Chicago, Illinois, but the flight crew landed on runway 10L instead. None of the 68 occupants aboard the airplane were injured, and the airplane was not damaged. The regularly scheduled passenger flight was operating under the provisions of Title 14 Code of Federal Regulation Part 121 from Norfolk International Airport (ORF), Norfolk, Virginia, to ORD.

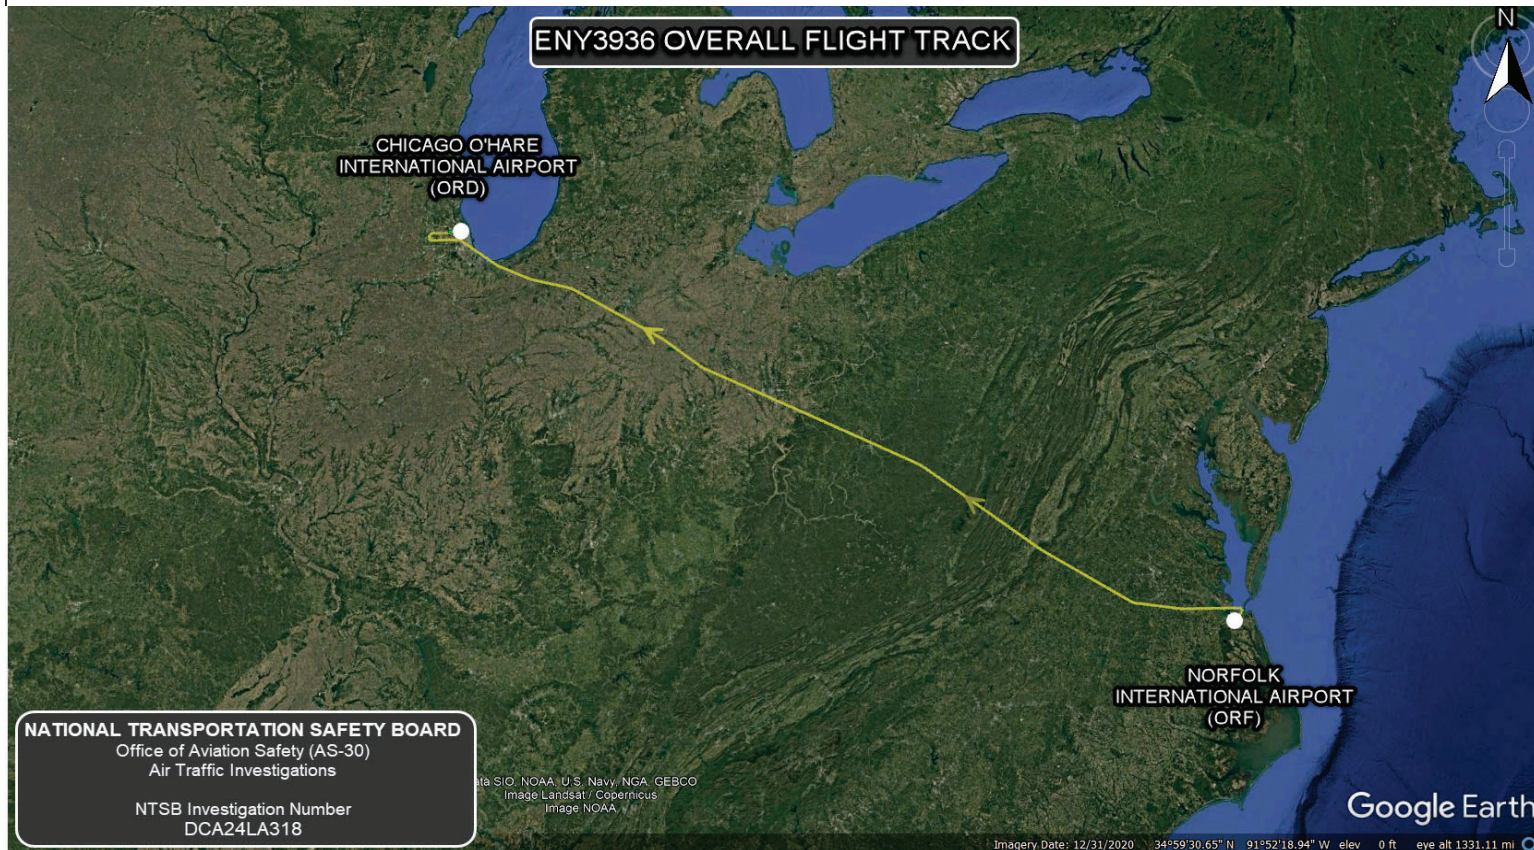
Figure 1

Caption: A graphic depicting the overall flight track of ENY3963.

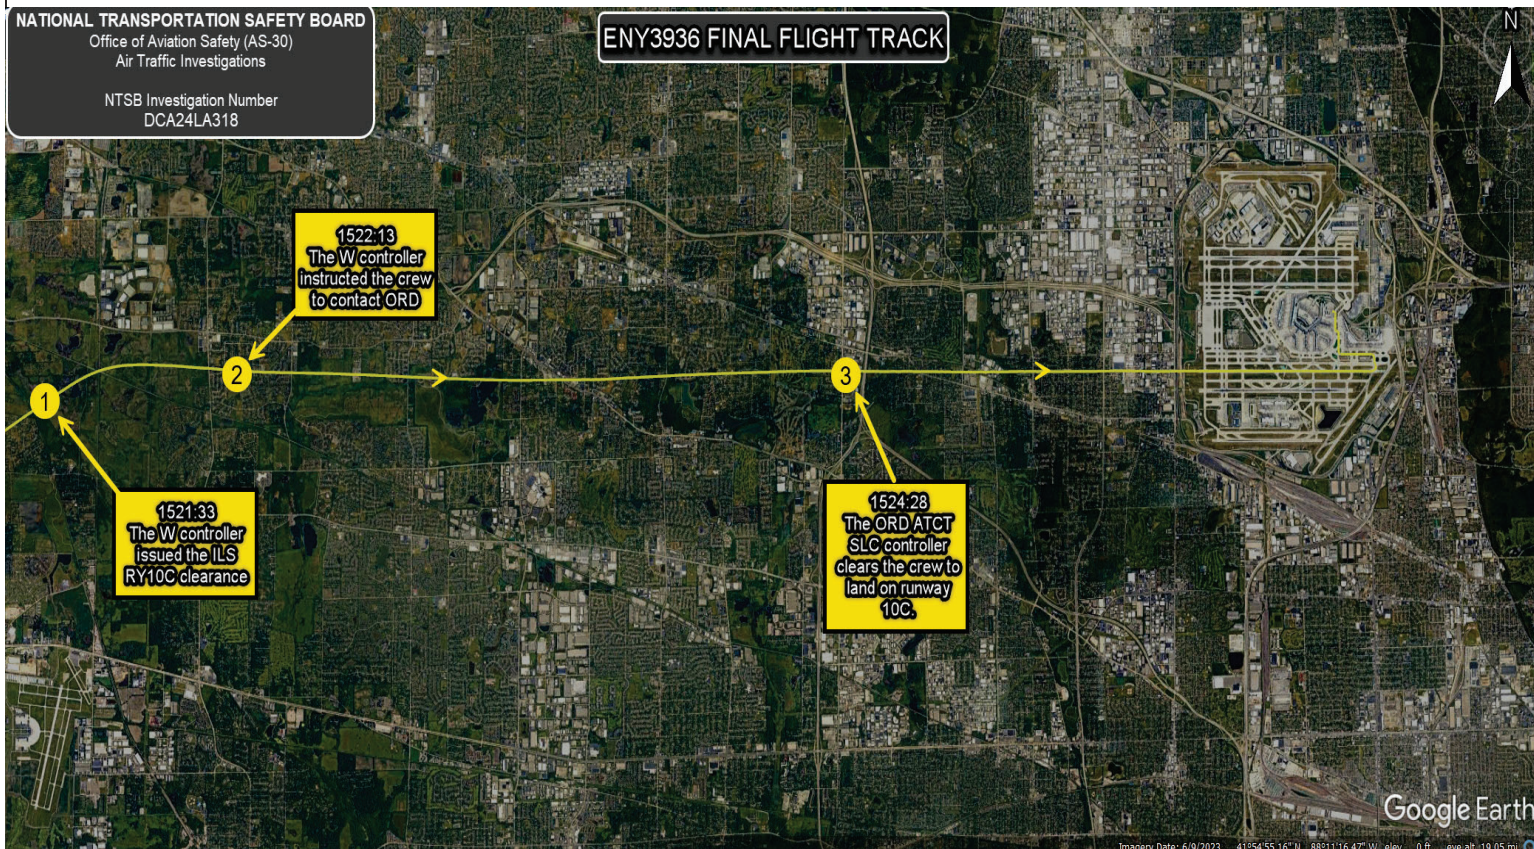
Figure 2

According to the FAA mandatory occurrence report (MOR) filed by ORD ATCT, the SLC controller observed ENY3936 lined up for RWY 10L when the airplane was on short final, then verbally coordinated with local control three (3LC) controller (the controller who was responsible for runway 10L) prior to ENY3936 landing. No overflight was observed, there was no traffic on or crossing RWY 10L, and there was no loss of standard separation.

Caption: A graphic depicting the final flight track of ENY3936.

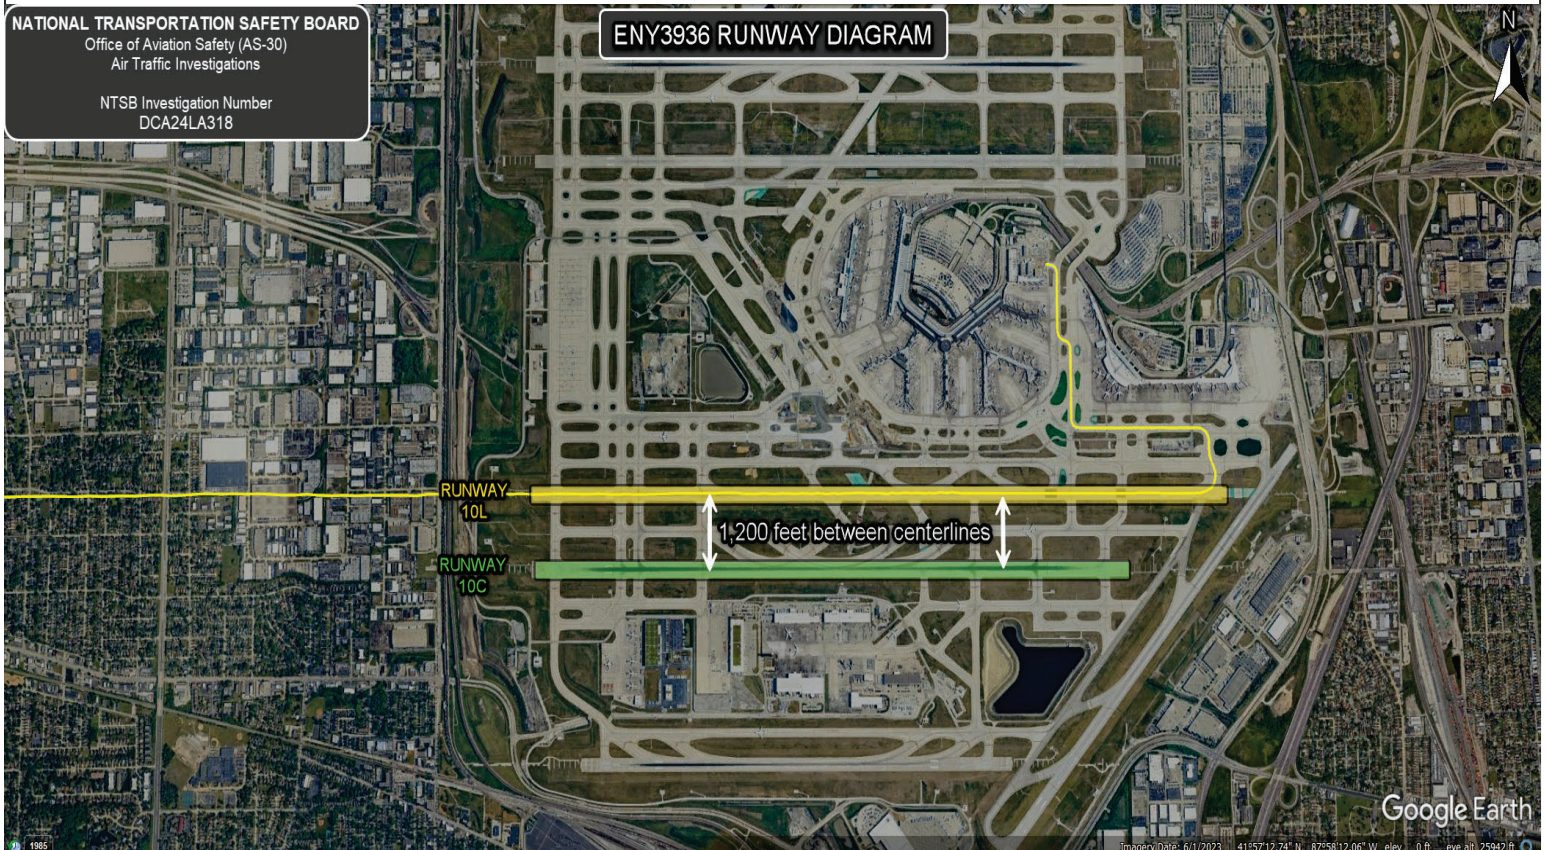
Figure 3

The ATC services provided by the SLC controller were deficient in accordance with FAA directives. Specifically, the SLC controller did not advise the crew of ENY3936 that they were aligned to the wrong runway and did not issue control instructions to prevent the wrong surface landing (see ATC Procedural References section below).

**Caption:** A graphic depicting the runway diagram for the wrong surface landing of ENY3936.
