National Transportation Safety Board  
Office of Aviation Safety  
Washington, DC 20594

DCA24LA318

## **OPERATIONAL FACTORS**

Group Chair's Factual Report  
September 25, 2025

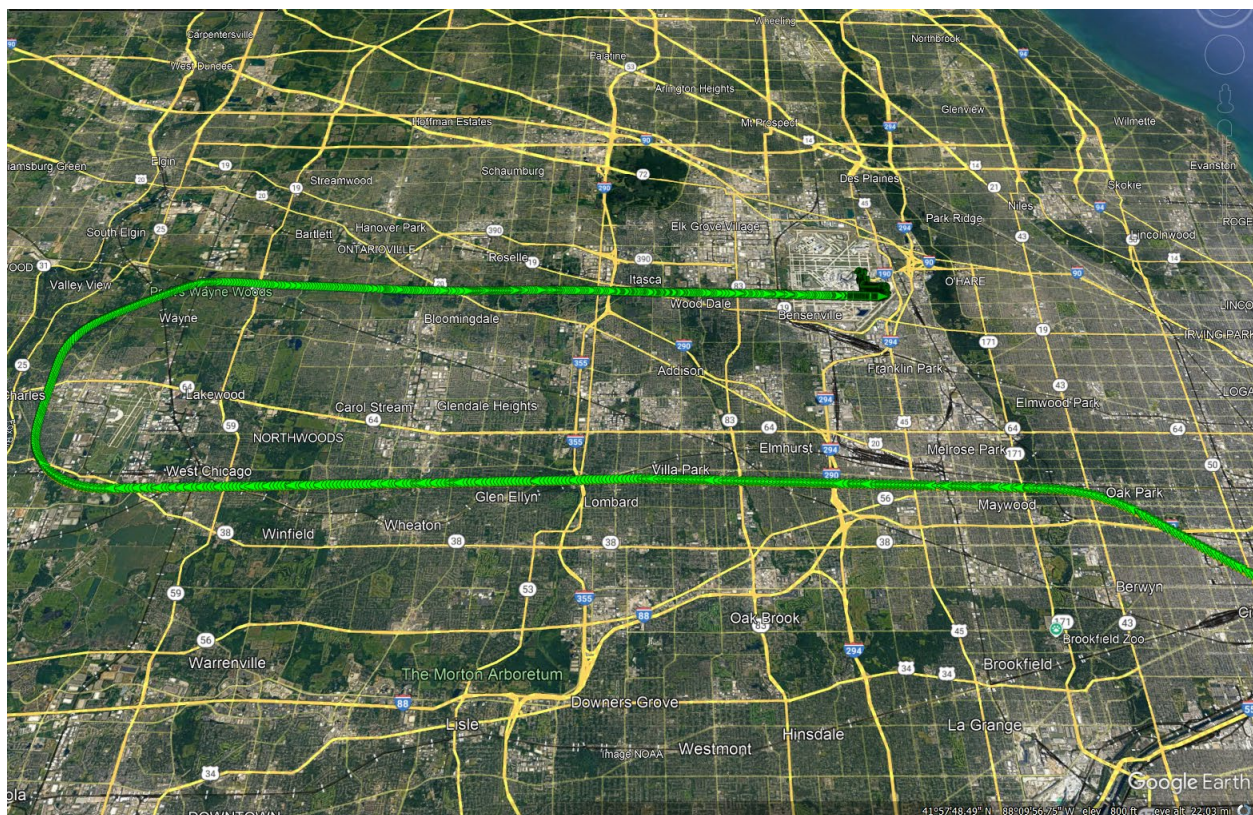
**Figure 2. ADS-B of airplane arrival (Source: FAA)**

When the flight contacted the Airport Traffic Control Tower (ATCT), they were cleared to land on runway 10C. The crew acknowledged and read back the landing clearance. According to radar data, approximately 16 miles from the runway the flight joined the final for runway 10L with a slight overshoot. Figures 2 and 3 show the aircraft's flight path.

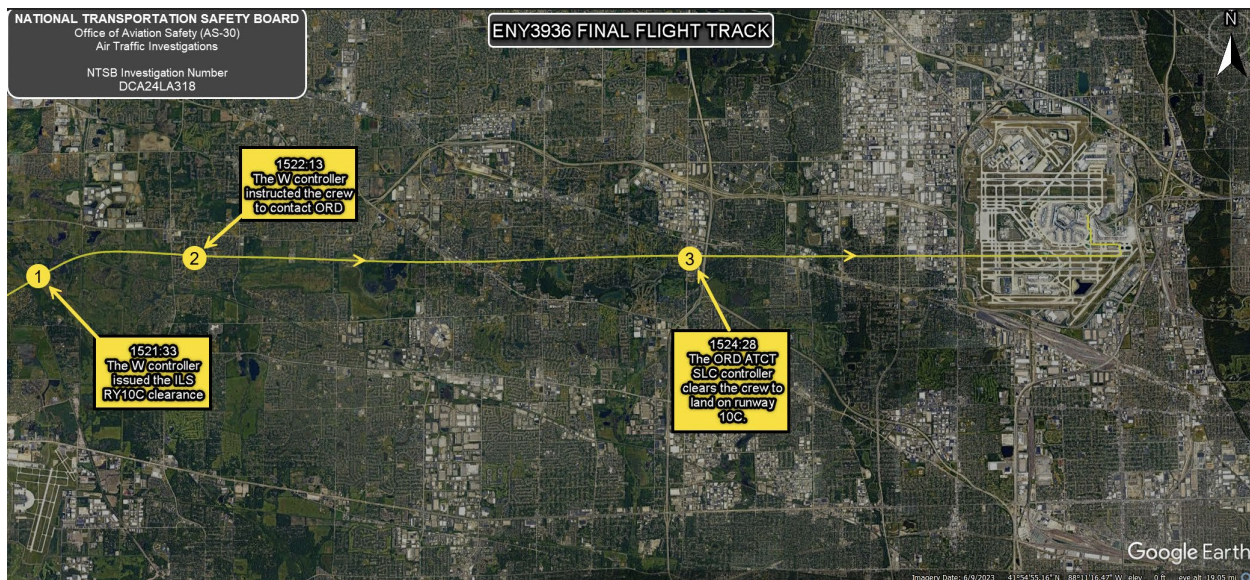
**Figure 3. Final Flight Track (Source: FAA)**

The airplane touched down on runway 10L. The crew was unaware they were lined up with the wrong runway until they touched down. The air traffic tower controller reported a possible pilot deviation and issued a Brasher Warning.<sup>11</sup>
