# National Transportation Safety Board

DCA24LA330

## POWERPLANT

Specialist's Factual Report

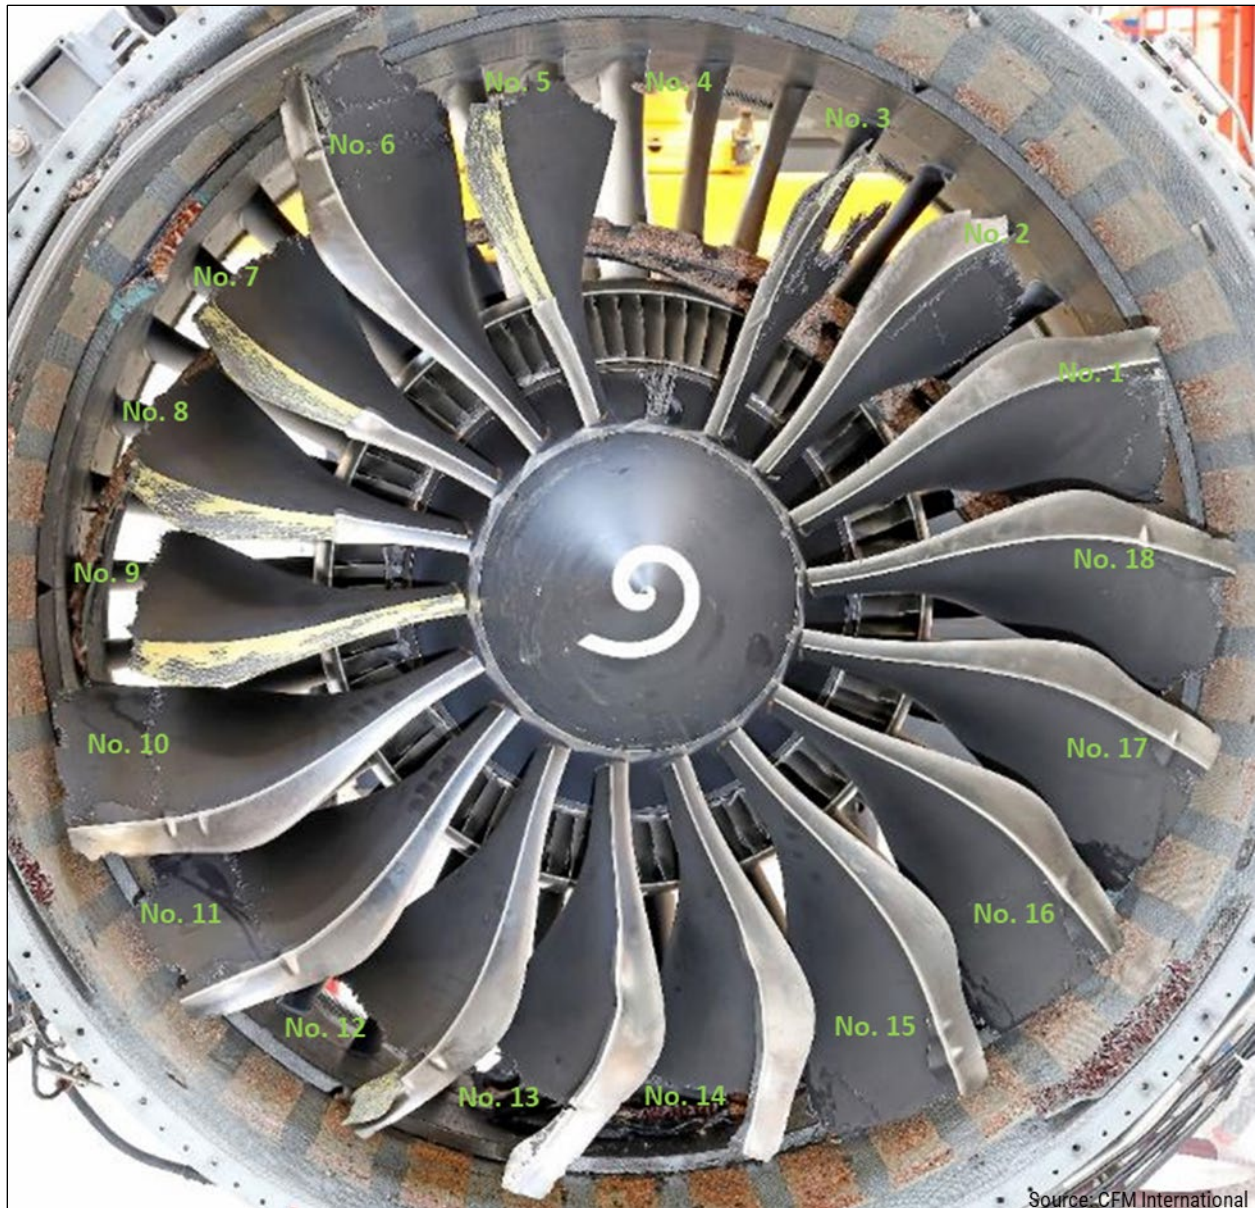
**Figure 5:** Fan blade and fan case damage

Significant damage was found to the fan module. The front spinner and platform front shroud were present. All 18 fan blades were present except for the No. 4 fan blade which was fractured at the blade platform. All remaining fan blades exhibited a combination of leading edge and blade tip damage and blade tip material loss. The fan case abradable seal was heavily worn and missing 360° around the circumference almost down to the case material (Figure 5).

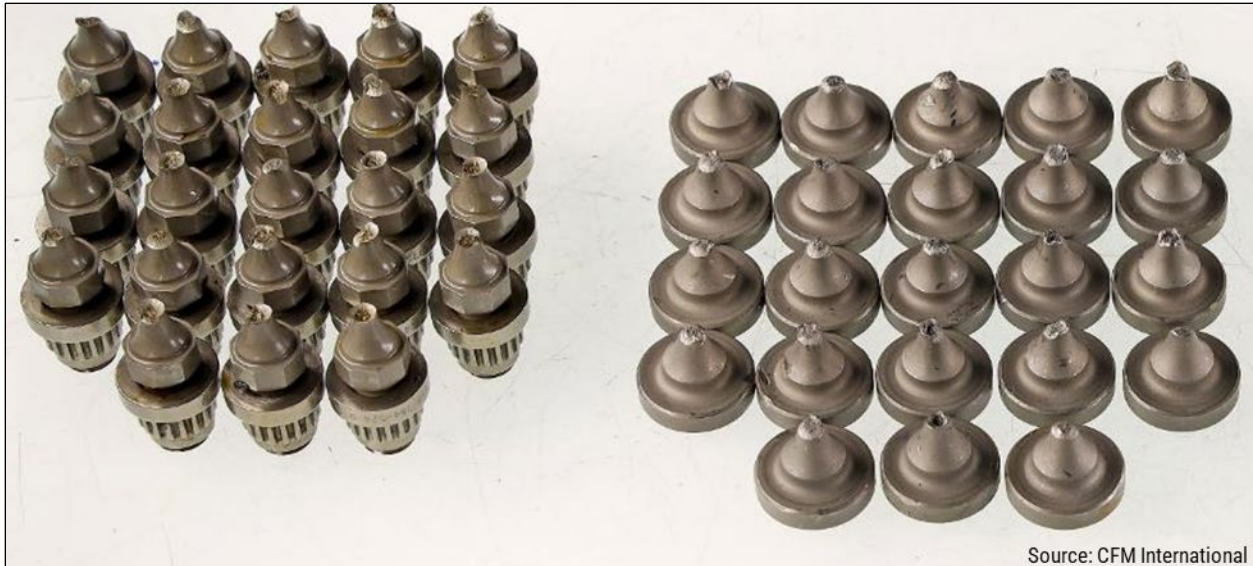
**Figure 6:** Fractured No. 1 bearing housing support shear bolts

The LRD was found activated. All 23 No. 1 bearing support shear bolts were found fractured (Figure 6) and all the No. 2 bearing support fuse pins were activated. This softened the load path to the engine structure, as designed, reducing the severity of the vibration transmitted into the airframe. Evidence of oil leakage was found inside the booster cavity and 4:00 o'clock position on the right side of the environmental control system (ECS) cavity (Figure 7). According to CFM, the condition of the remaining engine modules (booster, compressor, turbines) was consistent with damage from a very large bird strike and subsequent LRD activation.

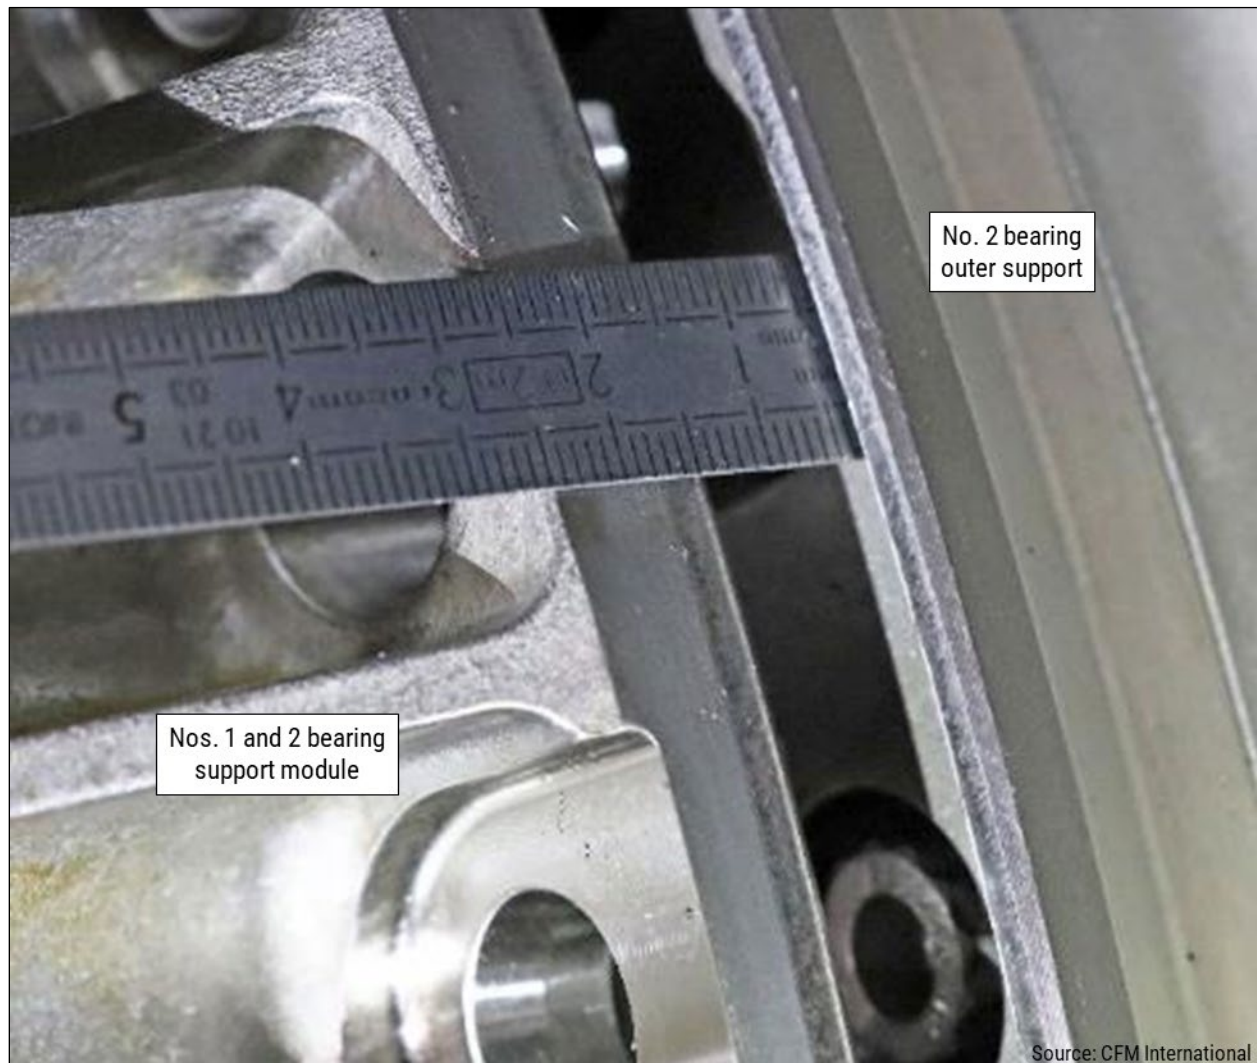
**Figure 8:** Gap between Nos. 1 and 2 bearing support module rear flange

An approximate 15 mm (0.6 inch) gap was measured between the Nos. 1 and 2 bearing support module rear flange and No. 2 bearing outer support (Figure 8). The No. 1 bearing oil tubes were found bent and disconnected.
