**PARTY SUBMISSION OF  
SOUTHWEST AIRLINES PILOTS ASSOCIATION  
TO THE NATIONAL TRANSPORTATION SAFETY BOARD**

**SOUTHWEST FLIGHT 554  
KMSY – KENNER, LA  
DECEMBER 20, 2023**

**DCA24LA330**

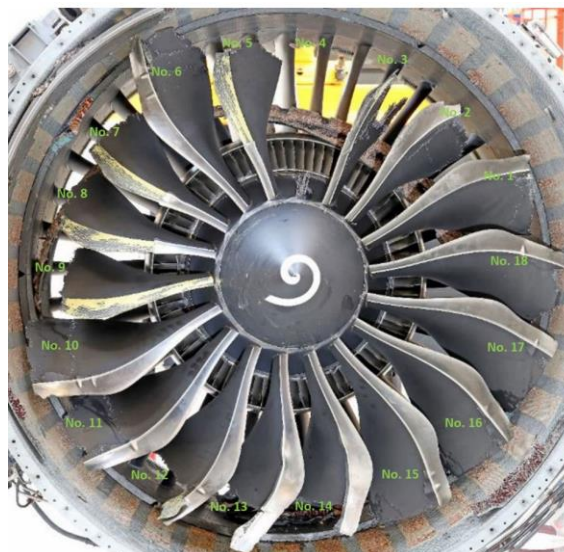
The LEAP-1B engine incorporates a mechanical Load Reduction Device (LRD) designed to reduce structural loads during severe fan-imbalance events. When activated, the No. 1 bearing support shear bolts fracture and the No. 2 bearing fuse pins shear, allowing the fan rotor to orbit around a new center of gravity and thereby reducing vibratory loads transmitted to the airframe. In this event, LRD activation occurred as designed following catastrophic fan damage.

Figure 2: Fan Blade and Fan Case Damage

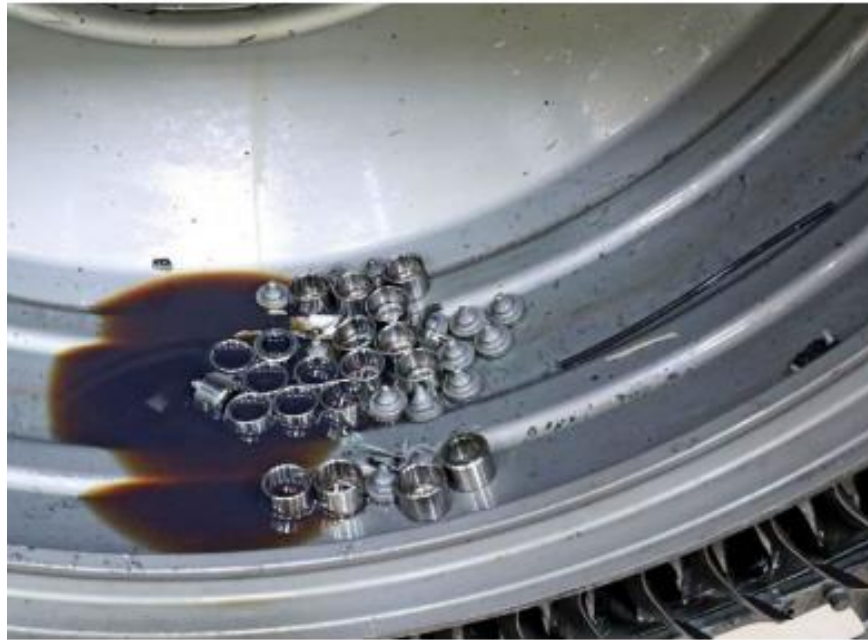
LRD activation disrupted the No. 1 bearing housing and associated oil tubes, resulting in a rapid release of engine oil into the core compressor upstream of the pneumatic bleed ports. Powerplant Group findings documented oil leakage within the booster cavity, bent and disconnected oil tubes, and a 15 mm gap between bearing support modules, all of which allowed oil to migrate into the compressor airflow path. This oil was subsequently entrained in the compressor airstream and carried to the bleed ports, where it entered the aircraft's pneumatic system.

*Figure 3: Oil and Sheared No. 1 Bearing Housing Support Bolts in Booster Cavity*

The design of the LEAP-1B engine and 737 bleed air system permits oil contamination of flight deck air before automatic isolation occurs. This is an unacceptable vulnerability. Boeing and CFM International must be required to:

- Eliminate or substantially reduce the potential for oil ingress into bleed ports following bearing support separation
- Implement design changes that prioritize immediate protection of flight deck air quality during severe engine damage
- Demonstrate that no single-engine mechanical failure can result in rapid and uncommanded flight deck smoke

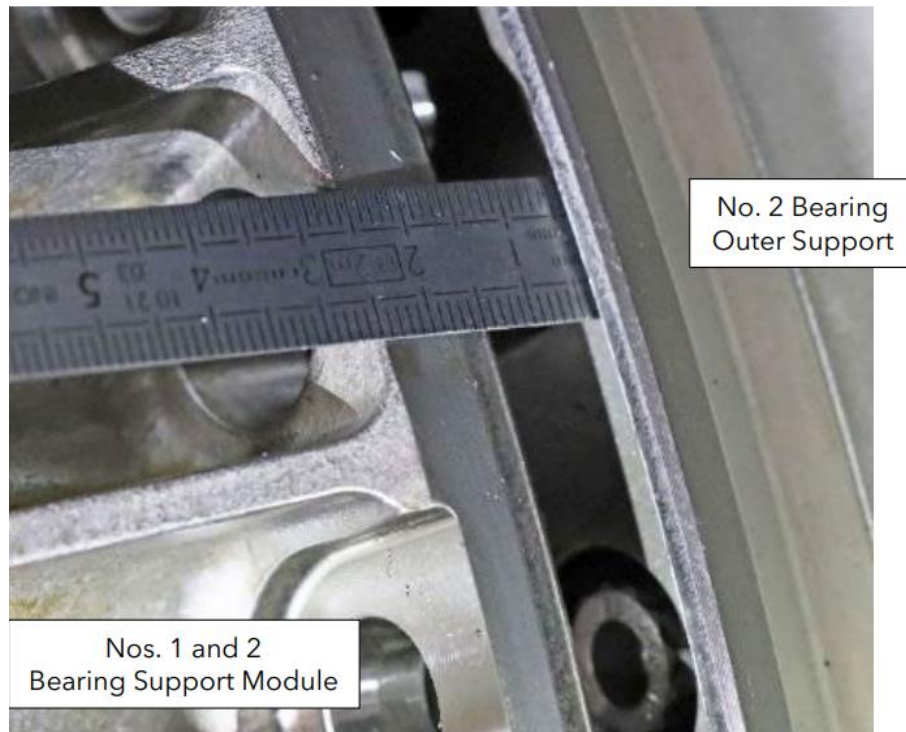
*Figure 4: Gap Between Nos. 1 and 2 Bearing Support Module Rear Flange*

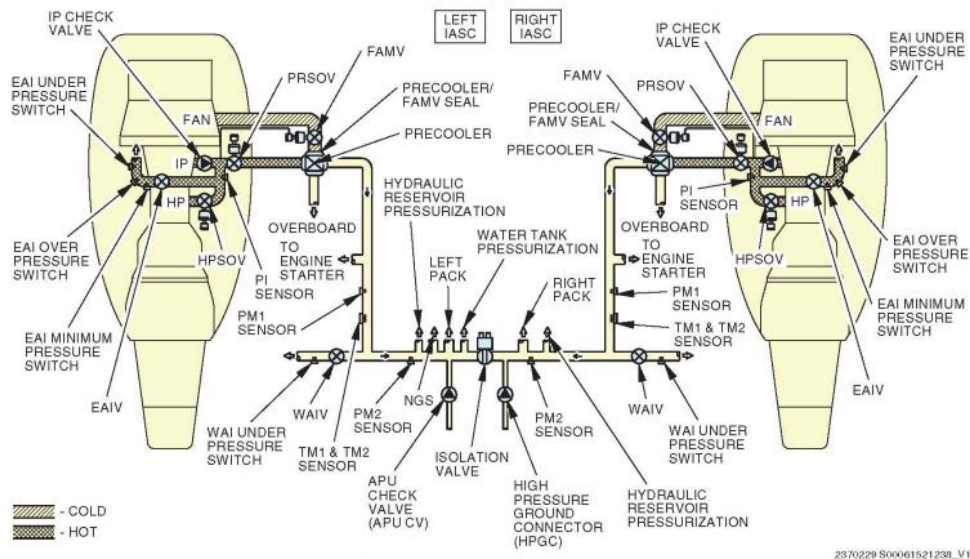
Because the left pack supplies the flight deck, contaminated bleed air from the No. 1 engine resulted in the immediate introduction of smoke into the flight deck, producing rapid visibility degradation and contributing to sensory overload during an already high-workload phase of flight. Although the PRSOV closed automatically when N2 decreased below 62 percent, the smoke had already entered the flight deck prior to valve closure.

Figure 5: Environmental Control System Schematic

This delay is operationally unacceptable. PRSOV logic and thresholds must be re-evaluated and revised to ensure earlier and more decisive isolation of bleed air following indications of severe engine damage, high vibration, or LRD activation.
