**Association of Flight Attendants (AFA)  
Party Submission  
Alaska Airlines Flight 1282 Accident January 5, 2024**

Seth Heiple - AFA Party Coordinator, Alaska Airlines Flight 1282 Investigation

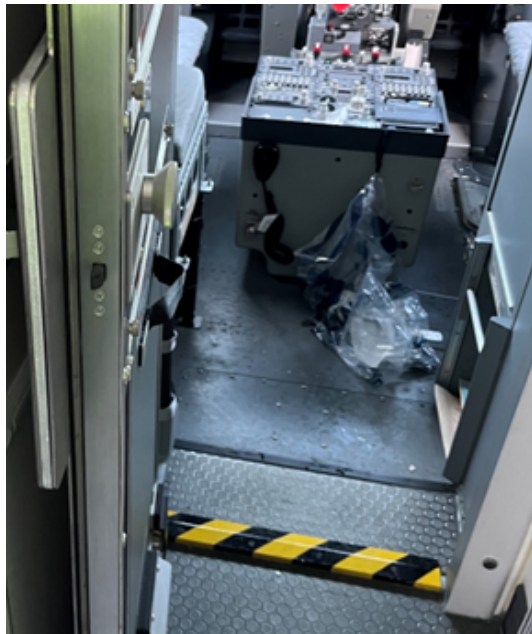
On the floor threshold of the 737 MAX flight deck, there is a plate mounted inside the door sill that appears to be about 1 cm in height and runs the entire width of the flight deck door opening.

The plate on the floor may have interrupted the airflow under the door from the flight deck into the cabin, possibly increasing the force sufficiently to cause a violent opening of the flight deck door, the impact of which caused the forward lavatory door (LAV A) to jam into its frame. This floor plate is not installed on the B737 NG aircraft and may be an enhanced security item added to the 737 MAX. AFA questions whether any analysis or testing has been done to verify that its presence did not create a safety risk by the reduction of airflow following a decompression.

**Figure 2.** Photograph of entry to flight deck from cabin looking into the flight deck. The striped metal plate was added to the 737 MAX but is not present on the 737 NG.

The FAA should review and revise its standards to ensure the flight deck and lavatory doors do not sustain damage in a decompression. A door stop or snubber on the flight deck frame/door could be installed to prevent the flight deck door from striking the lavatory door with such force. Analyses should also be conducted to determine whether the floor plate mounted inside the flight deck door significantly restricts air movement from the flight deck to the cabin during a cabin decompression.

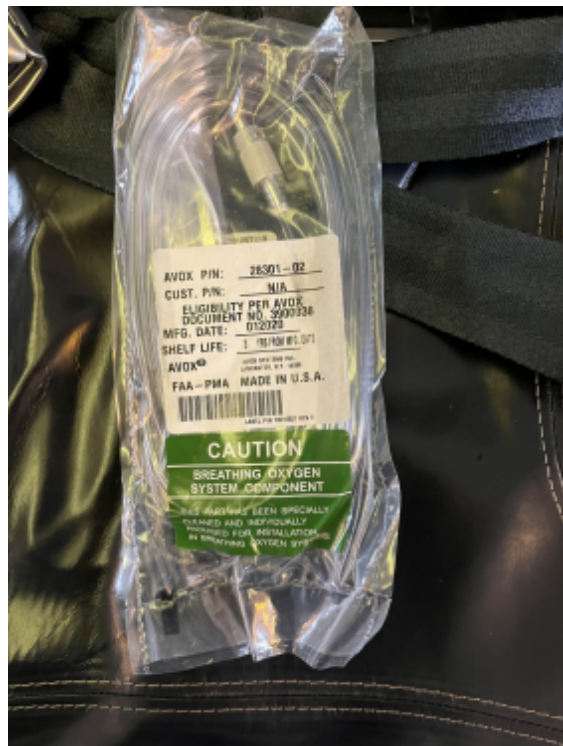
Use of the disposable masks provisioned by Alaska Airlines on the Portable Oxygen Bottles (POBs) is not intuitive, and they are difficult to access and don. Flight Attendants depend on quick access and use of the POBs to perform required emergency procedures, including ensuring pilot consciousness. As of the date of this submission Alaska Airlines had not replaced these masks with the alternate “cup” design used for the passenger oxygen system.

Figure 3. POB mask in sealed package

The FAA should review and revise its standards to ensure POB masks for Flight Attendant use are designed and tested for ease of use and quick donning.

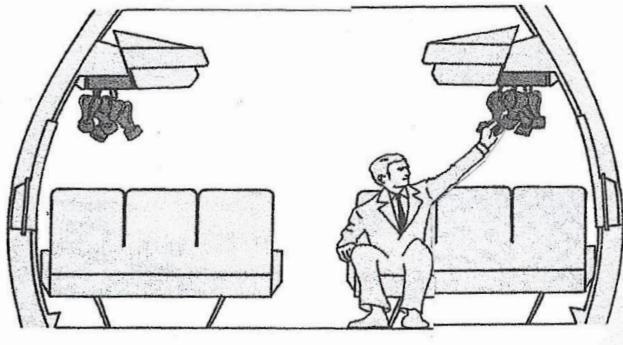
However, Boeing introduced the “Boeing Sky Interior” for the 737 NG with push-up bins; these were also installed on 737 MAX aircraft. The push-up bin design on single-aisle aircraft required the oxygen mask compartment to be moved outboard closer to the window seat, increasing its distance from the aisle. In 737 aircraft with push-up bins, the distance from the aisle armrest to the center of the oxygen compartment is 43 inches in most of the main cabin. This is 10” farther from the aisle than in 737s with shelf-style bins. Crew and passengers in the aisle now have to reach over two seats to obtain the spare oxygen mask above the window seat. This design change did not result in a change to airline procedures even though the distance increased such that most individuals would no longer be able to reach an oxygen mask when standing in the aisle.

**Figure 5.** Oxygen mask location on single-aisle aircraft with push-up bins.

On Alaska 1282, both the B and C Flight Attendants reported they could not reach the deployed oxygen masks from the passenger’s PSU due to excessive distance. The C Flight Attendant reported she mimed to the passengers in one row to give her a mask as she held the mask from the row behind on her nose and mouth. They could not understand her request even though she was shouting through the mask she held to her face. She gave up and dashed several rows forward to an available mask.

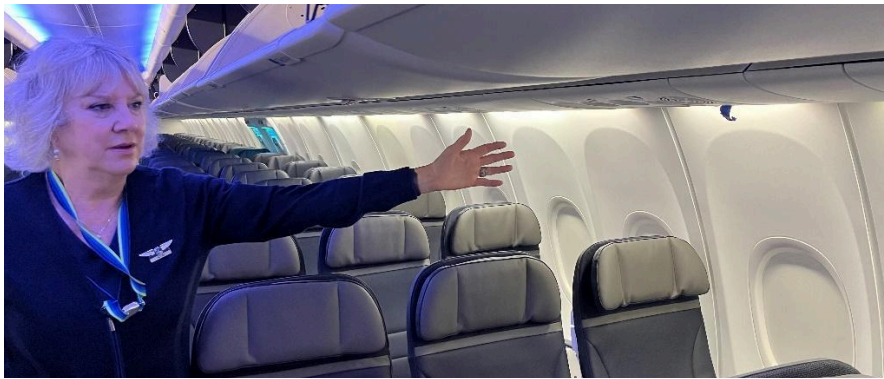
**Figure 7.** Reach from the aisle in premium class located in the main cabin of a 737 with push-up bins (a piece of blue tape marks the center of the oxygen compartment). Distance from the aisle armrest to the center of the oxygen mask compartment in the main cabin is 43", and the average measured Flight Attendant reach is 22".

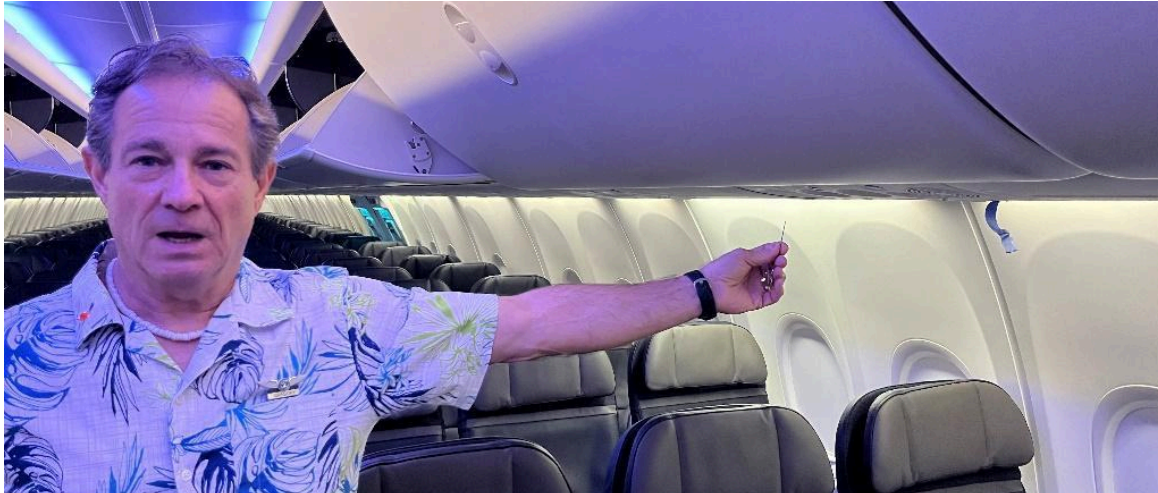
The inability of a person standing in the aisle to reach and manually deploy the oxygen masks on 737s with the push-up bins is an additional concern when conducting post-decompression checks. We have also observed that even on aircraft with shelf-style overhead bins, where the oxygen masks are 10" closer to the aisle, it is difficult to reach and manually deploy the oxygen masks.

**Figure 11.** Actual reach to the manual release pinhole used to release the oxygen mask in a 737 with push-up bins (pinhole indicated by blue tape).

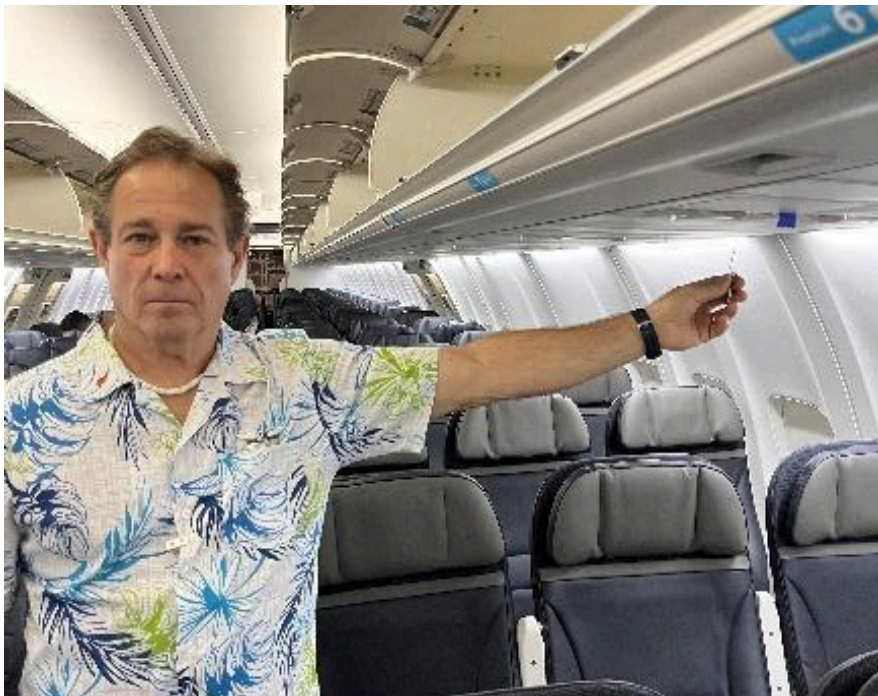
**Figure 12.** Actual reach to the manual release pinhole used to release the oxygen mask in a 737 with shelf-style bins (pinhole indicated by blue tape).

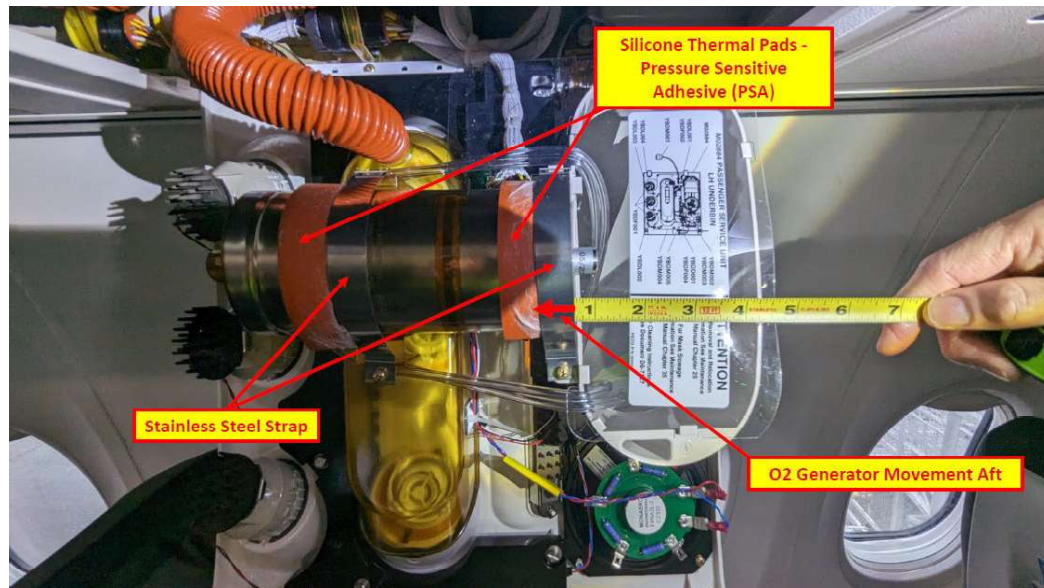
In the case of Alaska 1282, most oxygen canisters had migrated out of the front stainless-steel strap, and a few canisters were barely held by the aft stainless-steel strap. The tension of the device's firing pin could have caused premature activation. Most firing systems allow very little play; instead of a passenger or crew member pulling the mask to remove the firing pin from the canister, migration out of the strap could have activated the generator. This would have resulted in no oxygen being available in a decompression.

**Figure 1.** PSU Oxygen Generator Canister Migration Example<sup>25</sup>

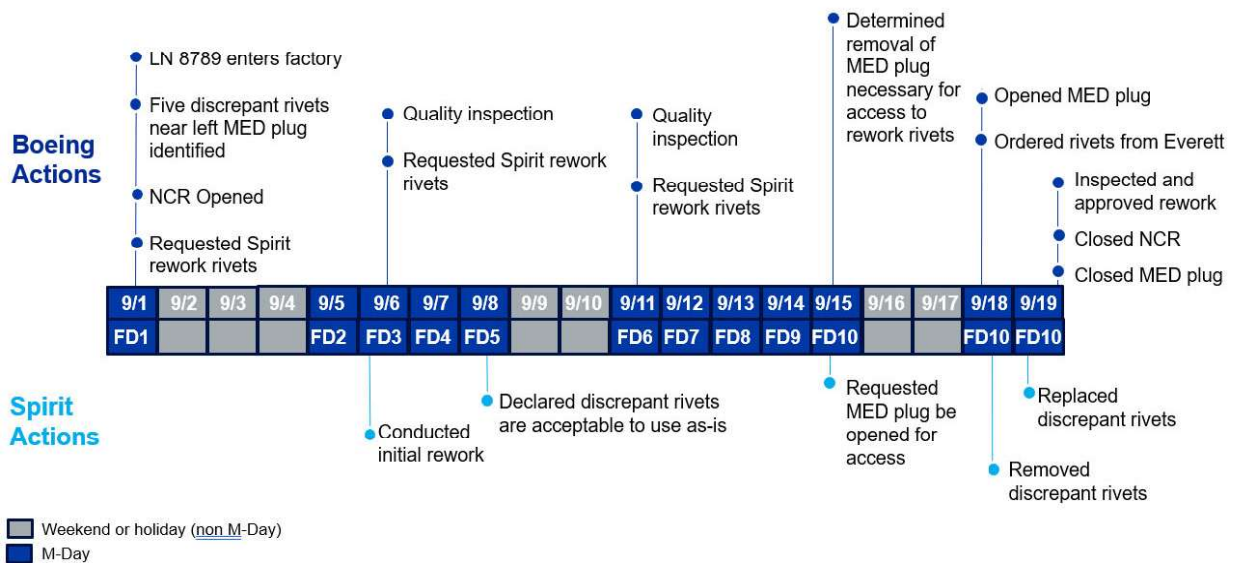
As a removal record was not available, the timeline in Figure 8 was developed to determine the approximate times the Left MED plug was opened and closed. Different types of data were used to construct the timeline, including the Shippside Action Tracker (SAT), Installation Plans, NCRs, NCOs, Shop and Quality Signoffs, computer time stamps, Boeing employee communication records (i.e., email, text), employee airplane entry and exit time records (Barge Log), employee timecards, written statements and interviews of Boeing and Spirit AeroSystems employees, and photographs from both Spirit AeroSystems and Boeing employees.<sup>67</sup> The timeline indicates the MED plug was likely opened on September 18 or 19 and closed on September 19.

**Figure 8.** Sequence of event for the opening and closing of LEFT MED plug (Image Copyright © Boeing).<sup>68</sup>
