737-9/-900ER MED Plug Enhancements  
Subject to final certification

Six Additional Safety Features Added

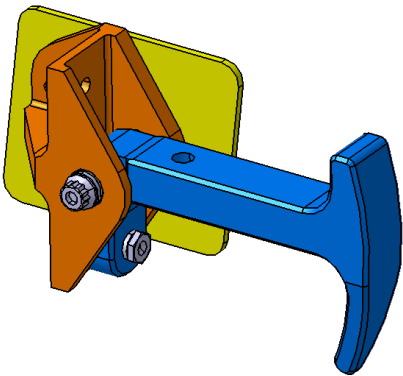
New Retention Arm Assemblies

- Two assemblies prevent the plug from translating upward and becoming misaligned from fuselage stop fittings.
- If Retention Arm is not in the properly stowed position, it interferes with the installation of the interior sidewall panel

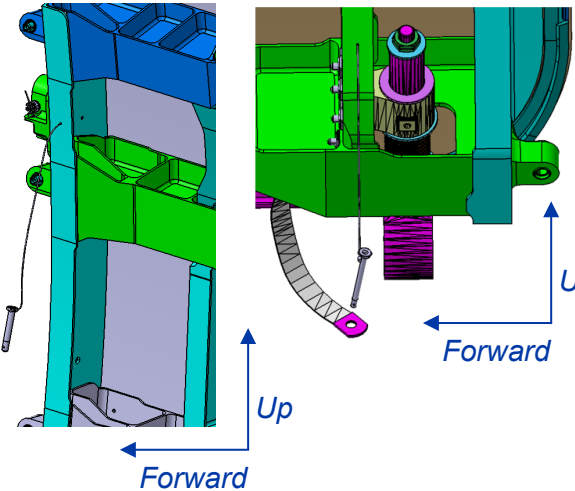
Enhanced Primary Retention Features

- Four existing bolts securing plug to fuselage now permanently attached to plug via safety wire 'lanyard'
- Lanyards allow for plug installation and removal, but provide visual indications if bolts are not re-installed.
