National  
Transportation  
Safety Board

# In-Flight Separation of Left Mid Exit Door Plug Alaska Airlines Flight 1282 Boeing 737-9 Portland, OR January 5, 2024

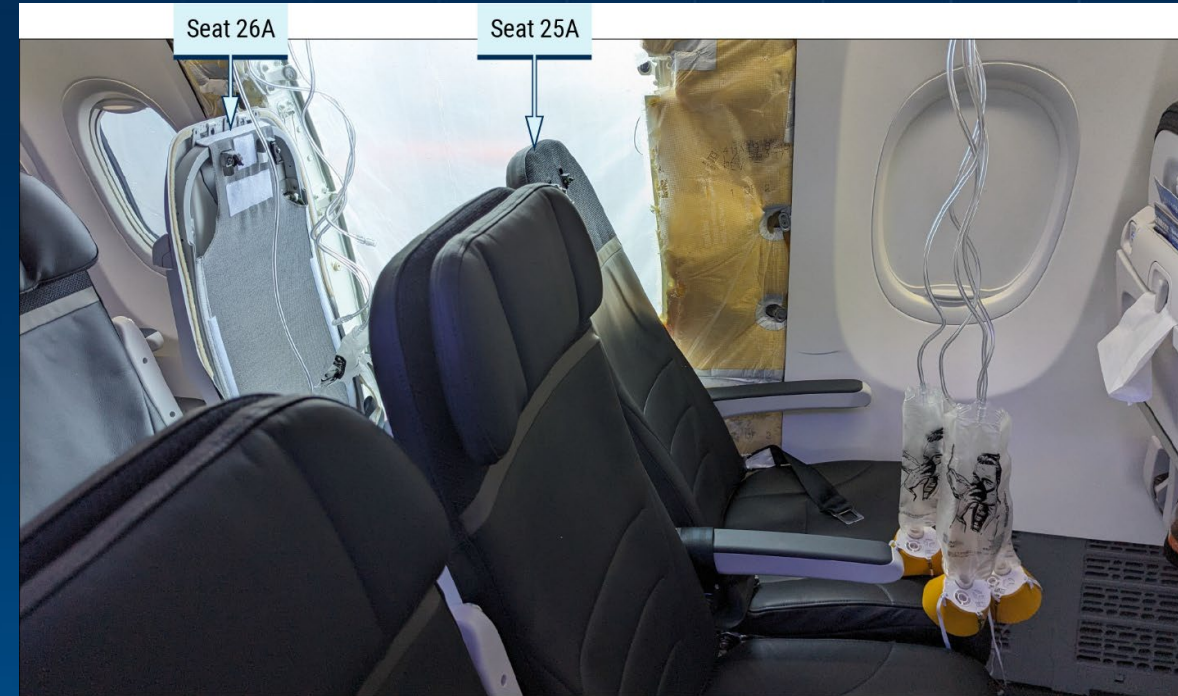
- Returned to Portland
- Near rows 25 and 26
- Airplane had a hole in fuselage where left MED plug had been

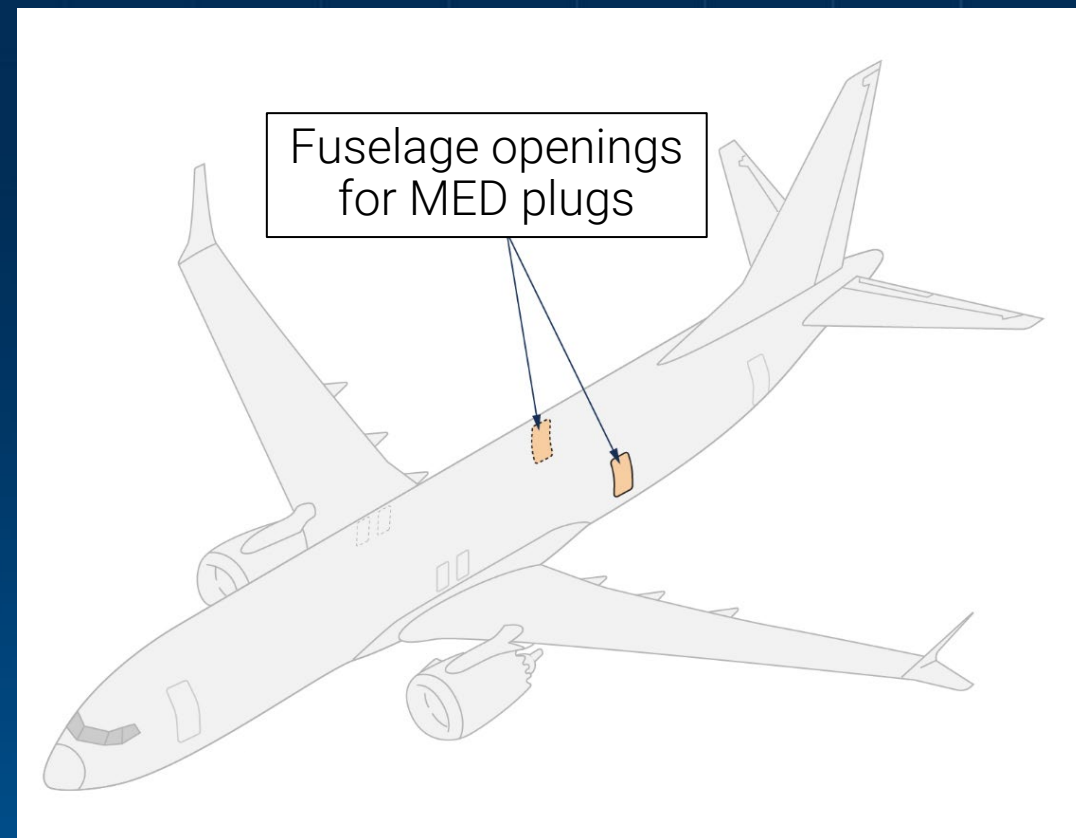
- MED plug is a customer option
- Saves weight
- Not intended to be opened during operations
- Not normally opened during production
- Left MED plug was opened during final assembly in Renton
- Left MED plug was missing four retaining bolts

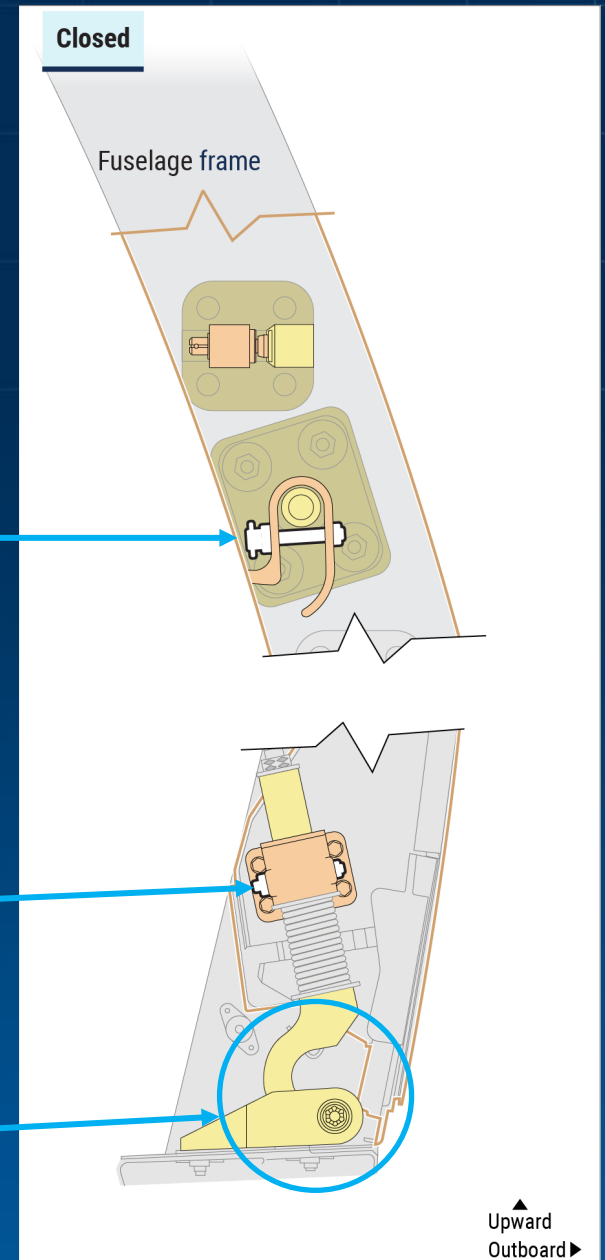
Upper guide track bolt

Vertical movement arrestor bolt

Lower hinge

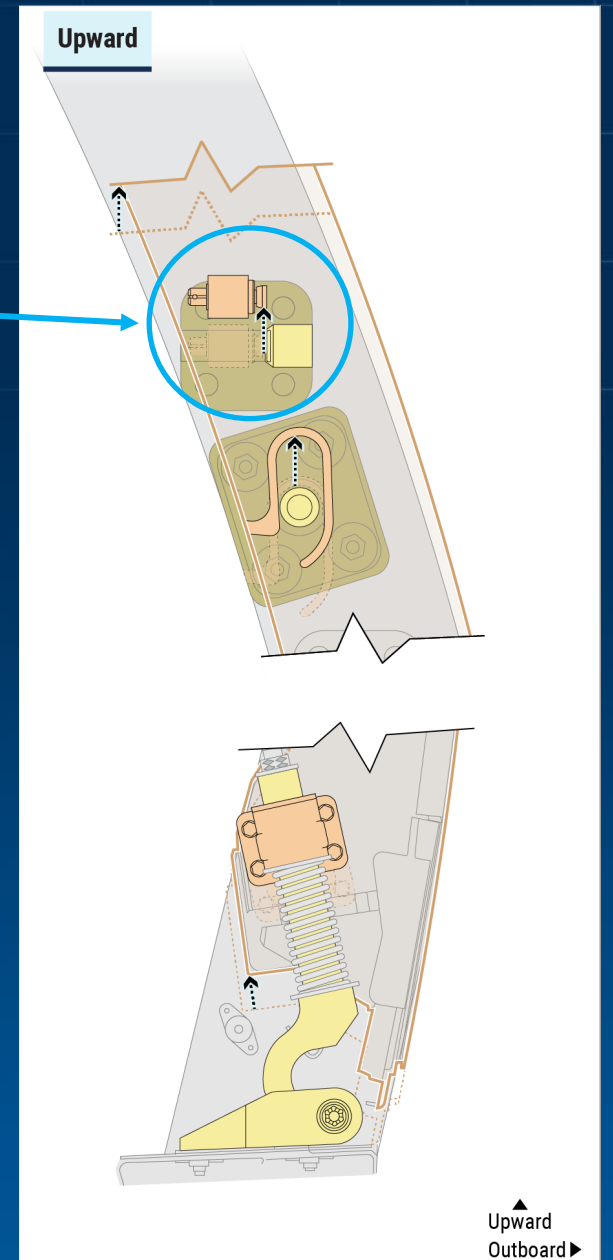
Upward

Stop fittings disengaged

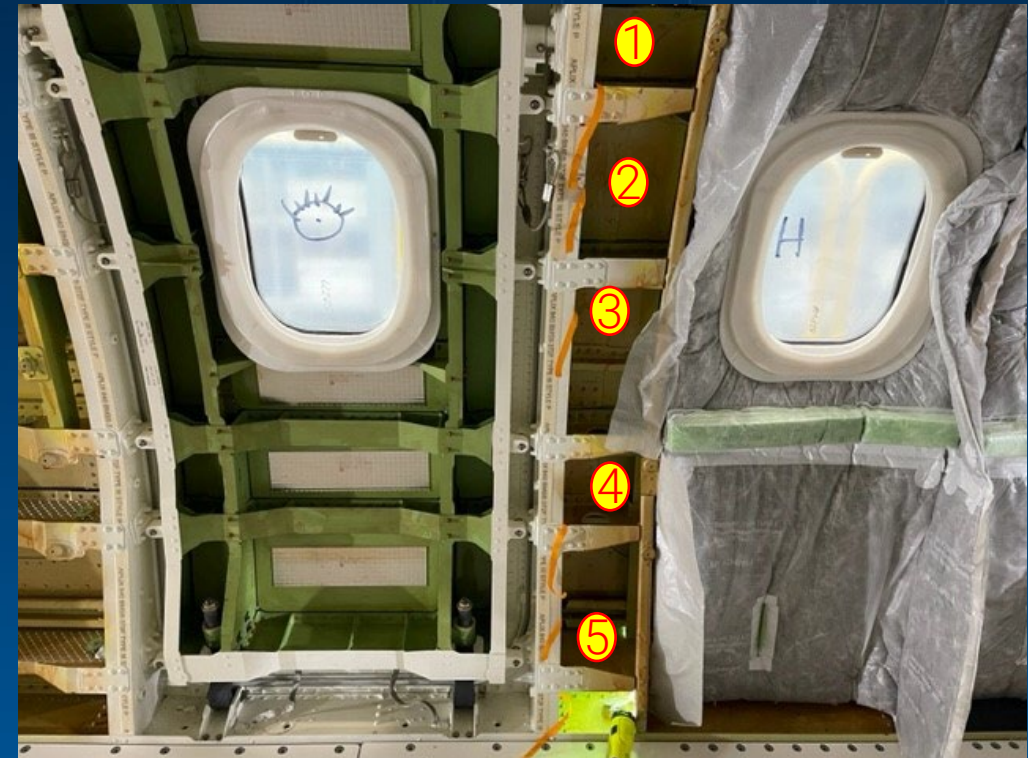
- Line 8789 manufacturing
  - Received and entered production line August 31, 2023
  - September 1, 2023, quality inspectors wrote up a discrepancy on five rivets on the forward edge frame common to the left MED plug
- Spirit AeroSystems in Boeing Renton
- Tasked to replace rivets
