# National Transportation Safety Board

DCA25LA061

## STRUCTURES

Group Chair's Factual Report

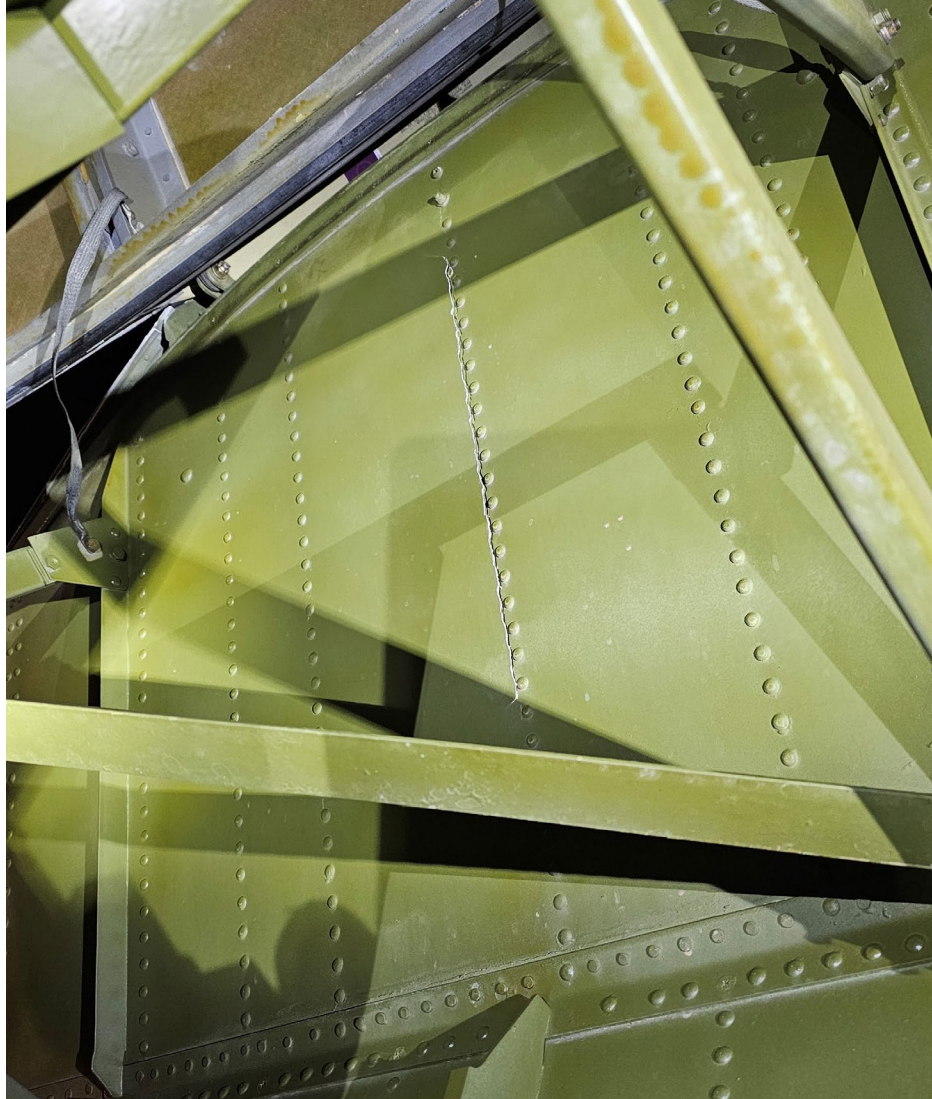
Lynden reported the airplane was climbing through flight level (FL) 220 when the crew “heard a loud bang and experienced a rapid depressurization”. The crew descended to 13,000 feet and continued to their destination where they landed safely. Post flight inspection of the fuselage station (FS) 93 forward pressure bulkhead behind the radome (Figure 1) found a fracture, about 14 inches long, in the canted web area adjacent to the fasteners along the centerline of the airplane at buttock line (BL) 0 (Figure 2).

**Figure 2.** Fracture in forward pressure bulkhead near BL 0, N403LC (Lynden photo).

Lynden excised the fractured area of the canted web and shipped it to the NTSB Materials Lab for examination. See the NTSB Materials Laboratory Factual Report 25-056 in the public docket for the details of the exam. Lynden repaired the canted web by installing a patch repair where the fracture was removed (Figure 3).

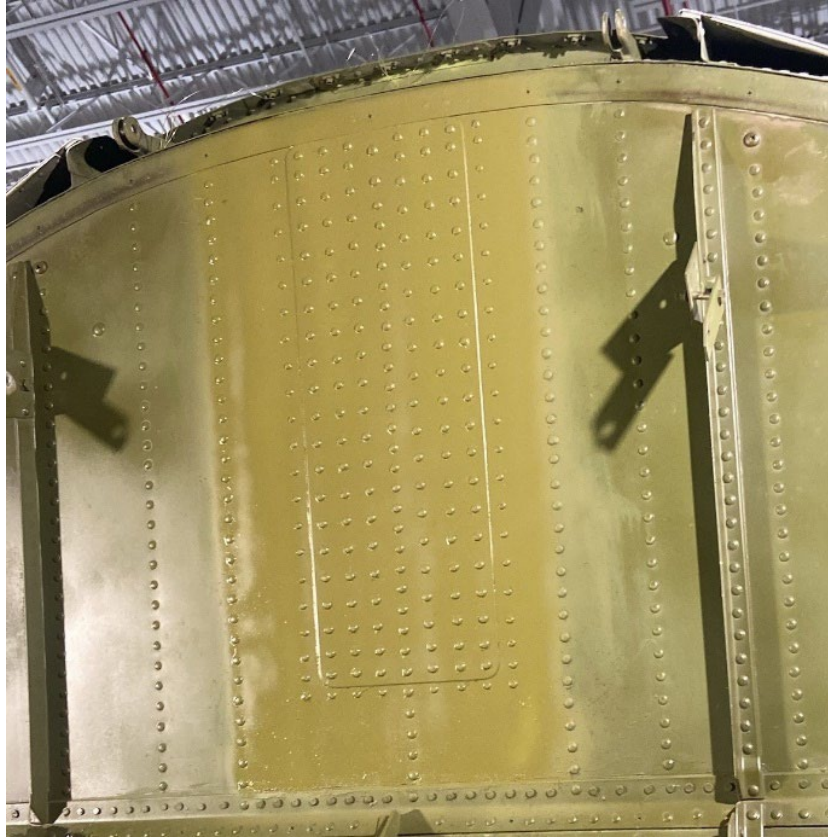
**Figure 3.** N403LC patch repair of FS 93 canted bulkhead (Lynden photo).
