# National Transportation Safety Board

Office of Research and Engineering

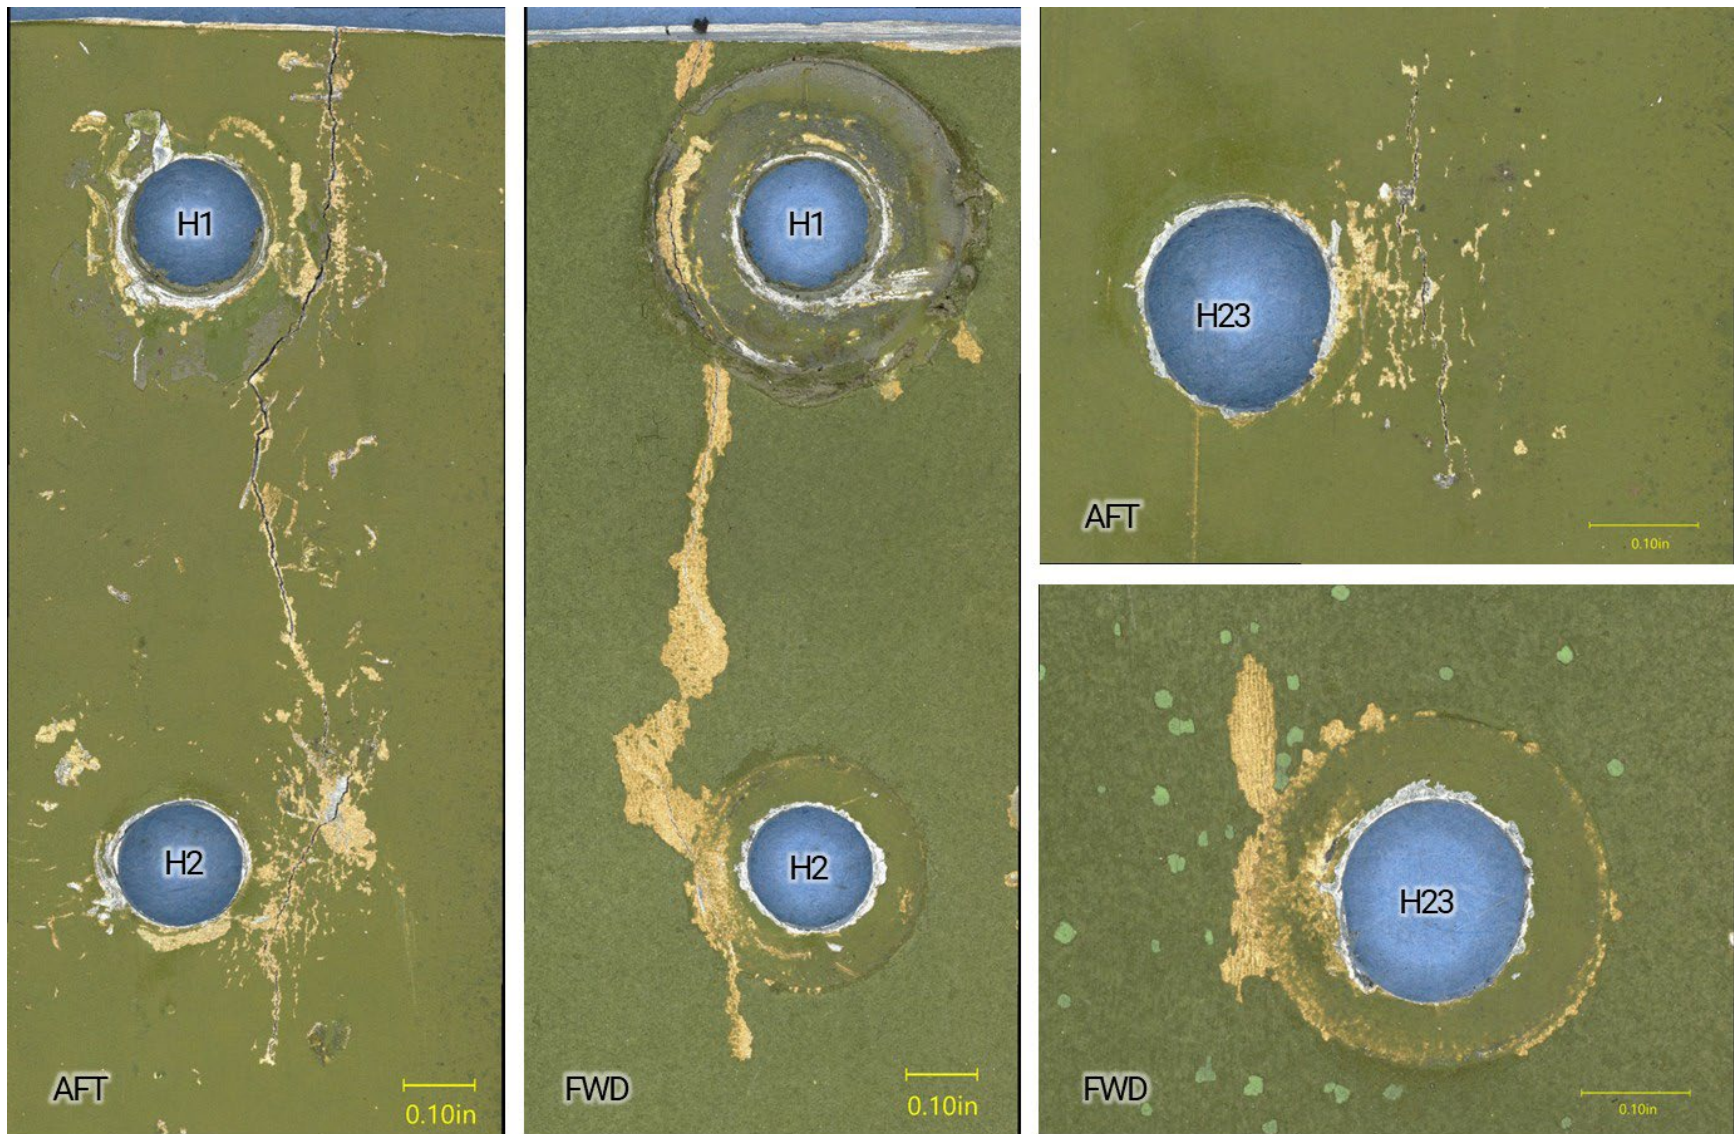
**Figure 2.** Closer views of the aft and forward surfaces of the bulkhead web near holes 1, 2, and 23 where vertically oriented cracks were observed adjacent to the holes.

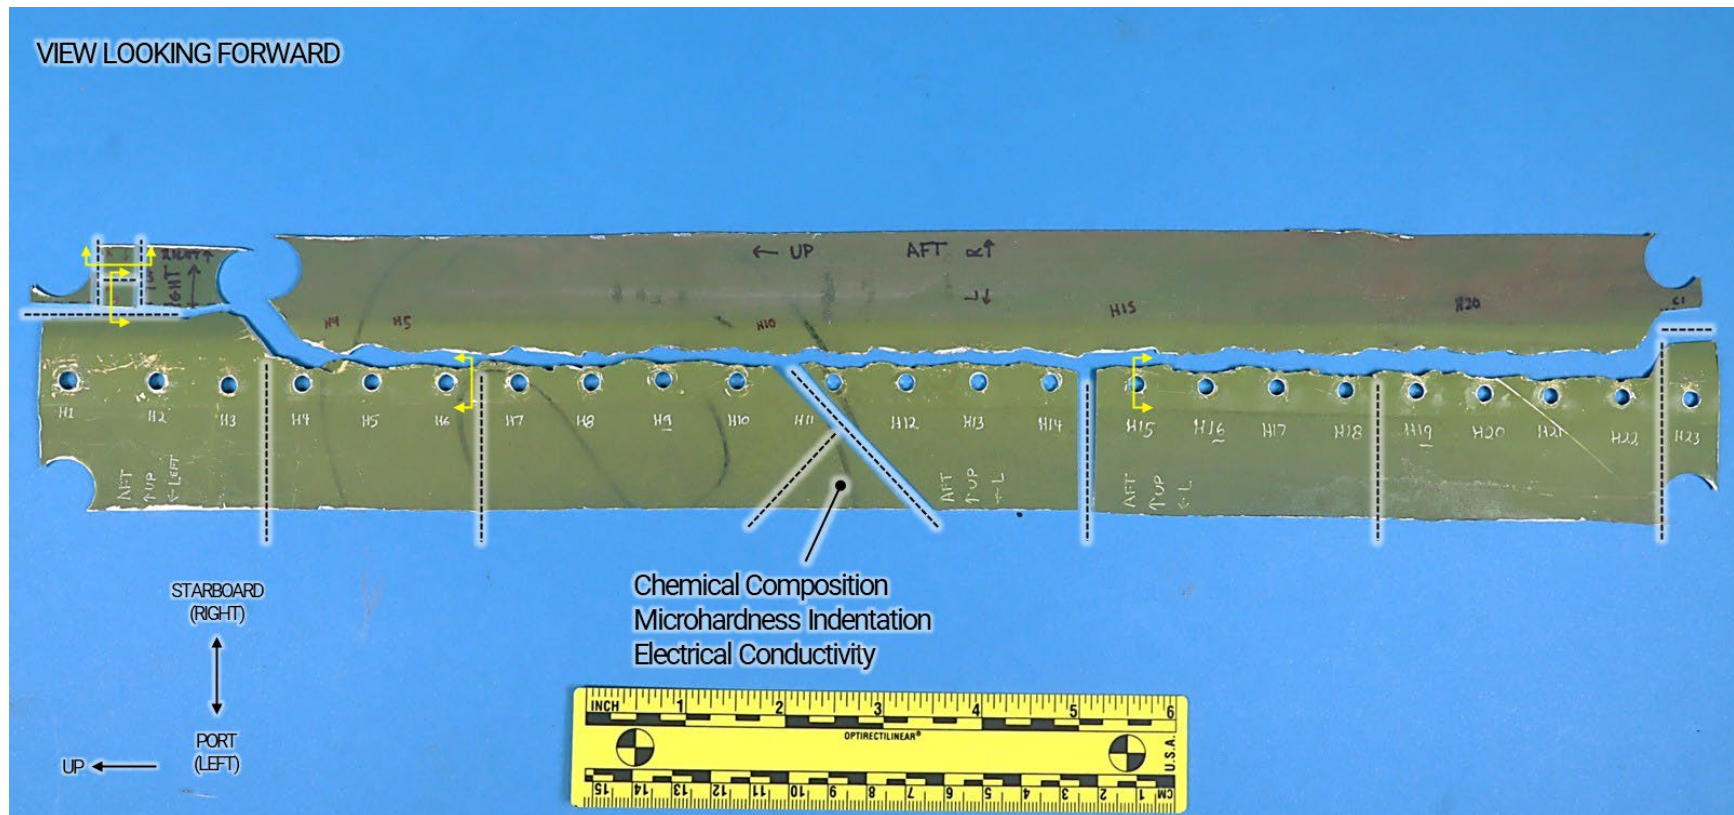
**Figure 3.** A specimen map of the bulkhead web showing locations where cuts were made in the laboratory (dashed lines) to facilitate handling, closer examination, and testing. Metallurgical cross-sections were excised from locations indicated by yellow brackets.

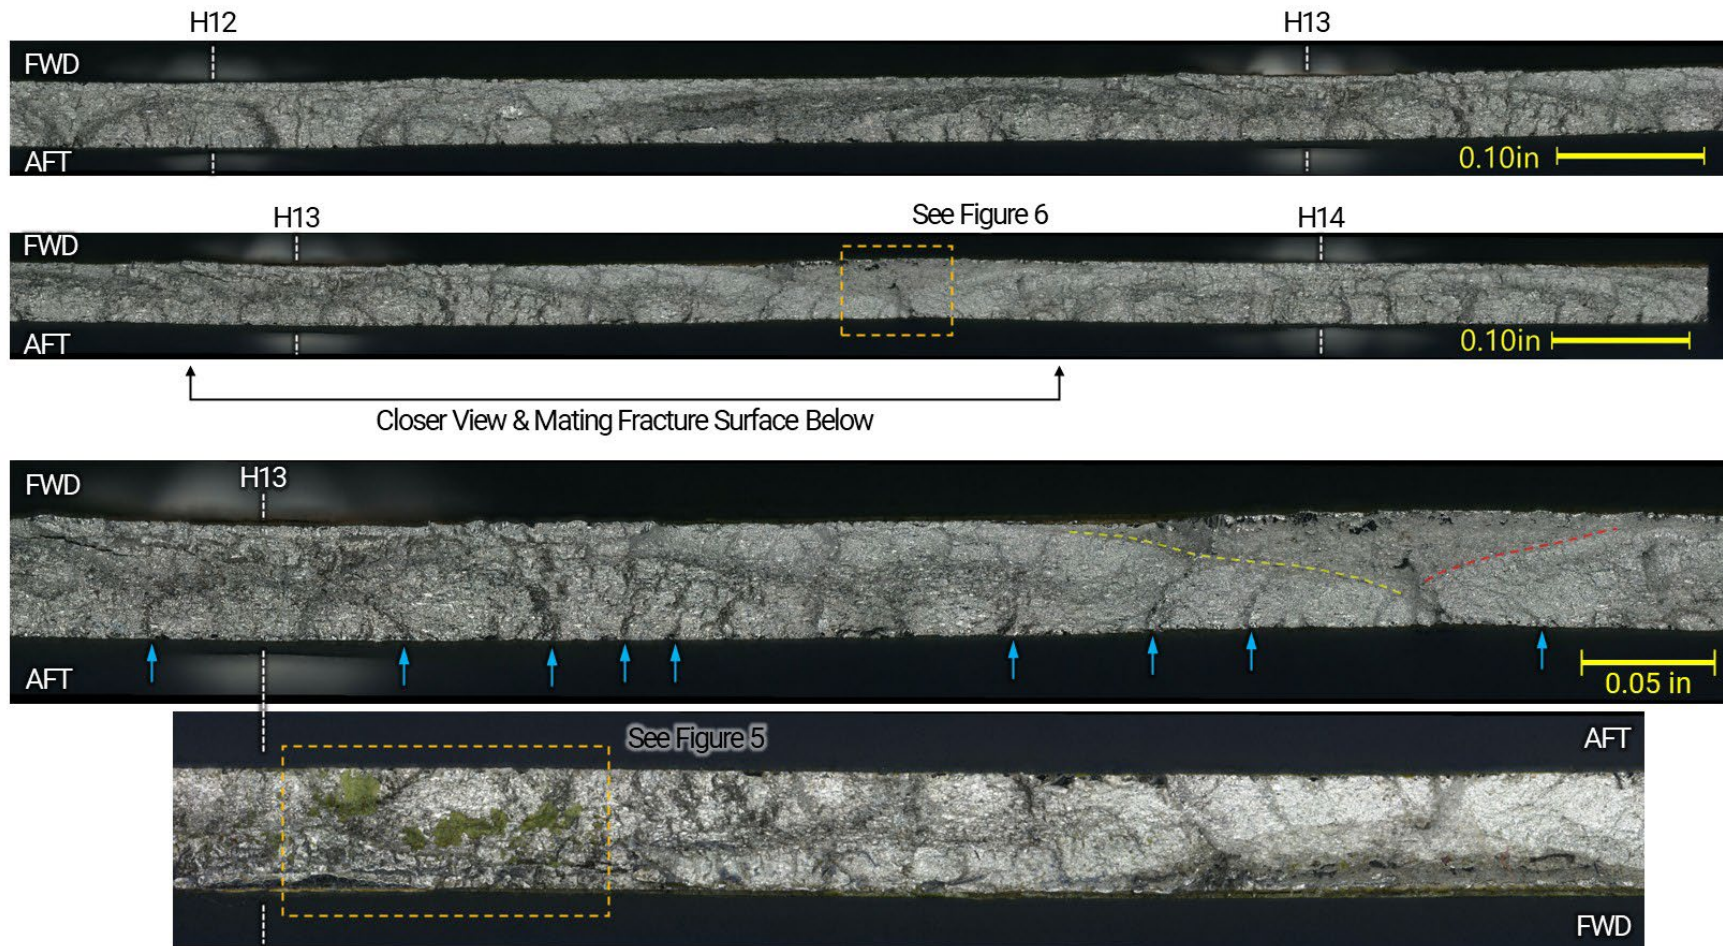
**Figure 4.** Closer views of the fracture surface between H12 - H14 shown above with a zoomed in view between H13 and H14 below. Curved crack arrest marks emanating from H13 and H14 are indicated by yellow and red dashed lines, respectively. Typical ratchet mark features observed along the aft surface are indicated by blue arrows. The bottom image shows the mating (right side) fracture surface between H13 and H14 showing green deposits on the fracture surface.

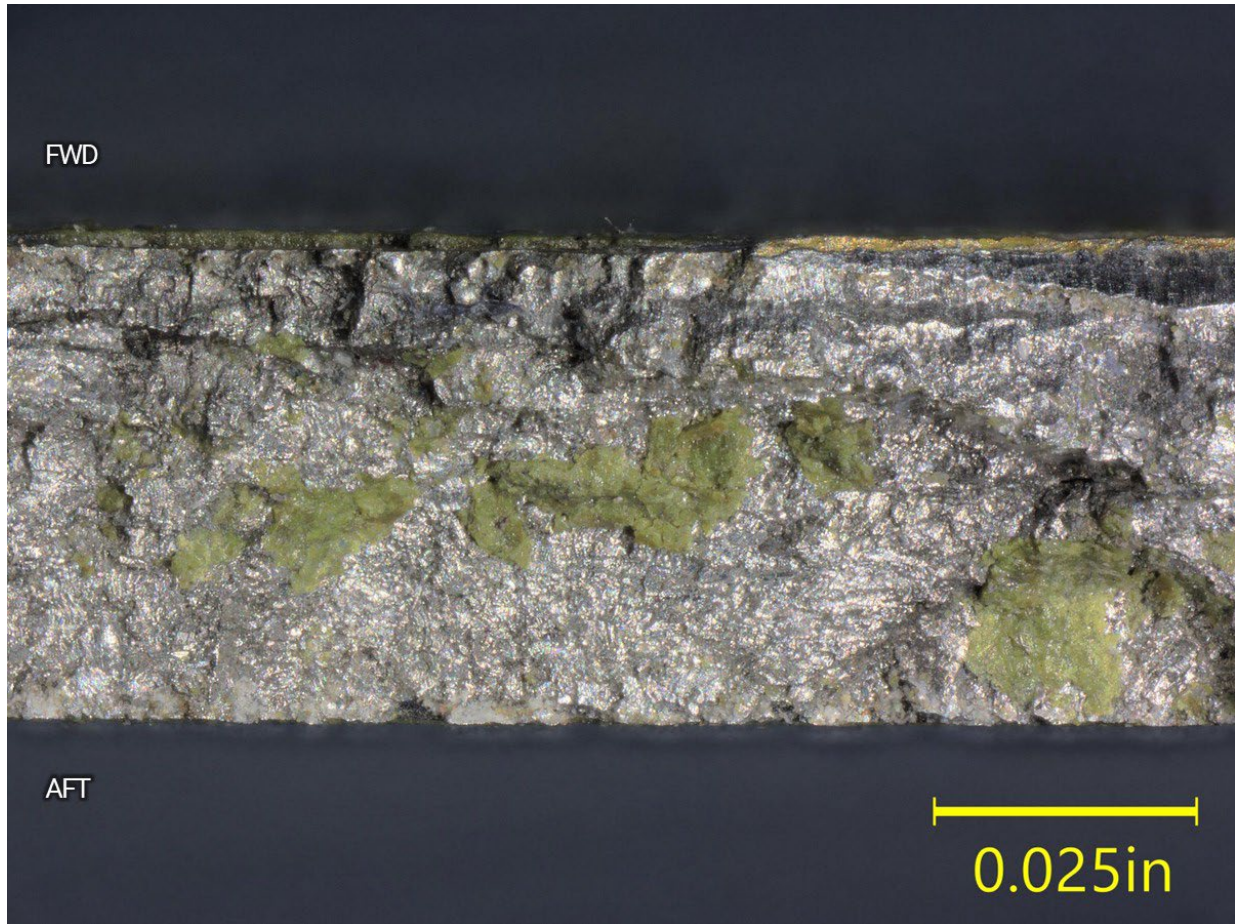
**Figure 5.** A closer view of the right fracture surface indicated in the previous figure showing green deposits embedded on the fracture surface.

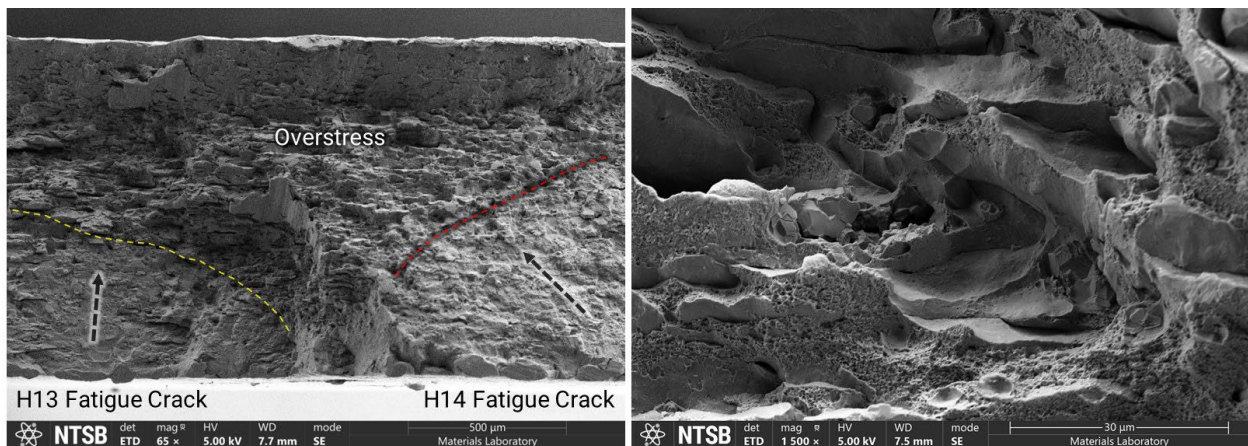
**Figure 6.** SEM images of the region identified in figure 4. The extent of fatigue cracking from the aft surface (growth direction indicated by arrows) from H13 and H14 is indicated by yellow and red dashed lines, respectively. The right image shows a closer view of the overstress region where dimpled fracture features were observed.

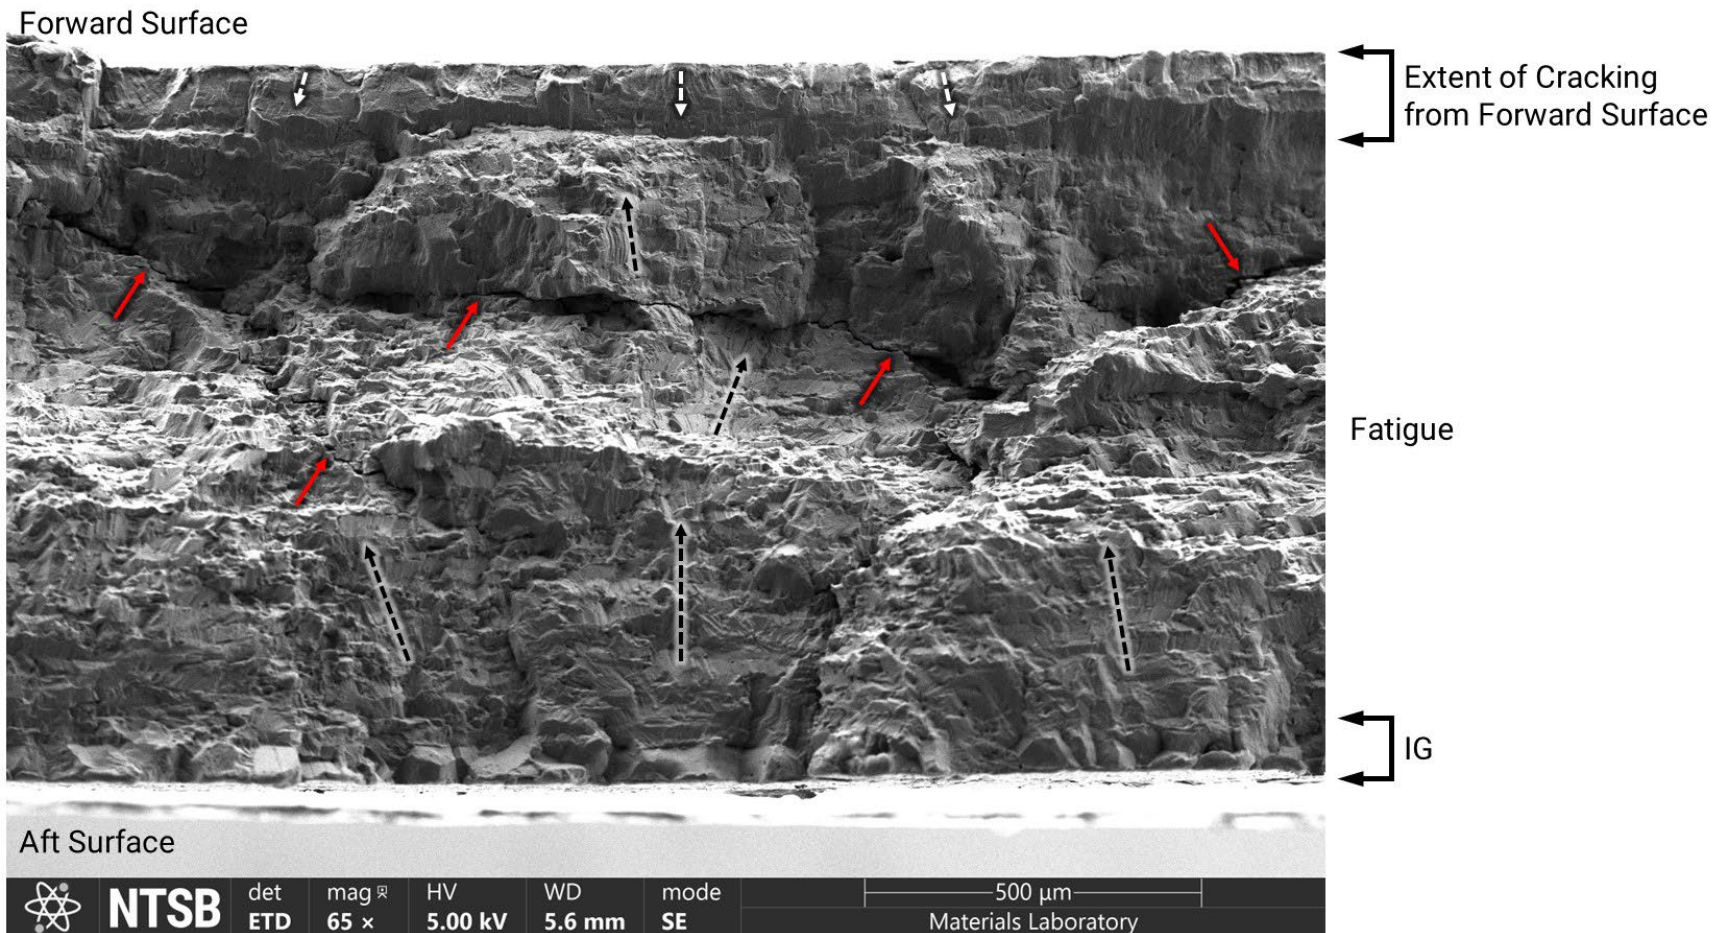
**Figure 7.** An overall SEM image of the left fracture surface at H13 showing an intergranular (IG) region at the aft surface from which fatigue cracking extended through the material thickness as indicated by black arrows. Curved thumbnail shaped crack regions extended from the forward surface as indicated by white arrows. Secondary cracks were observed branching from the primary fracture surface with typical examples indicated by red arrows.

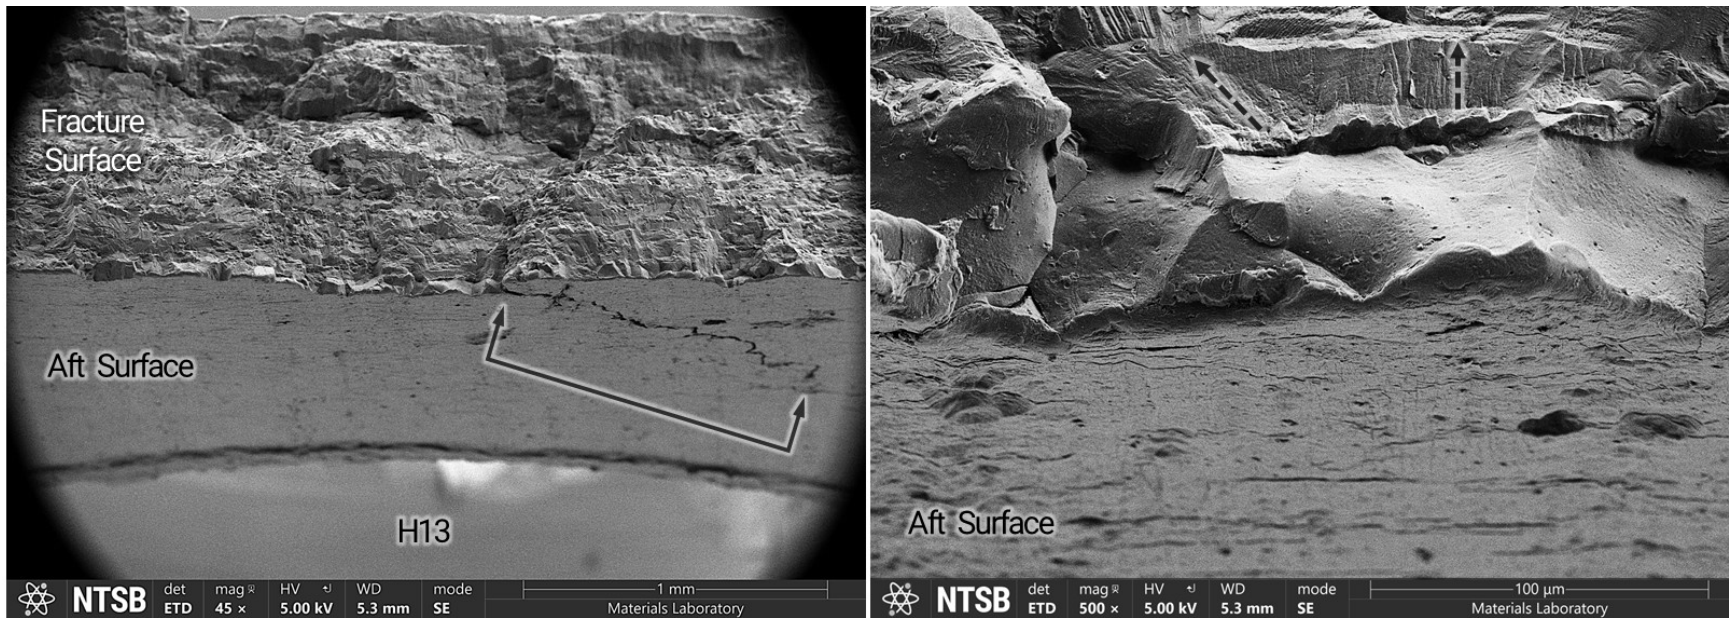
**Figure 8.** Tilted SEM images of the same region in the previous figure showing the adjacent aft surface. The bracket in the left image indicates a crack in the aft surface undercutting the adjacent fracture surface. The right image shows a closer view of intergranular features at the aft surface from which fatigue cracking progressed from as indicated by black arrows.

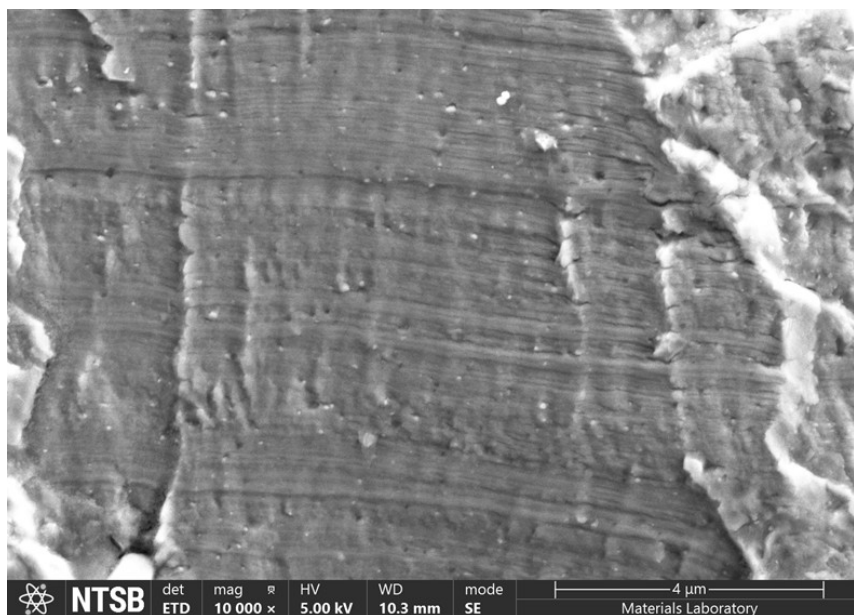
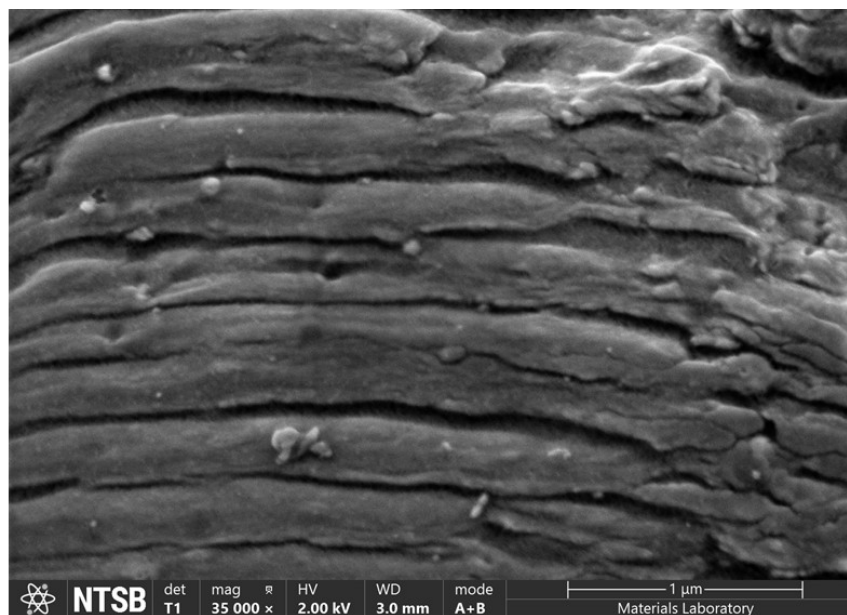
**Figure 9.** SEM images at different magnification levels of typical fatigue striations observed along the H13 fatigue crack growing from the aft surface. The crack growth direction is upwards in these images.

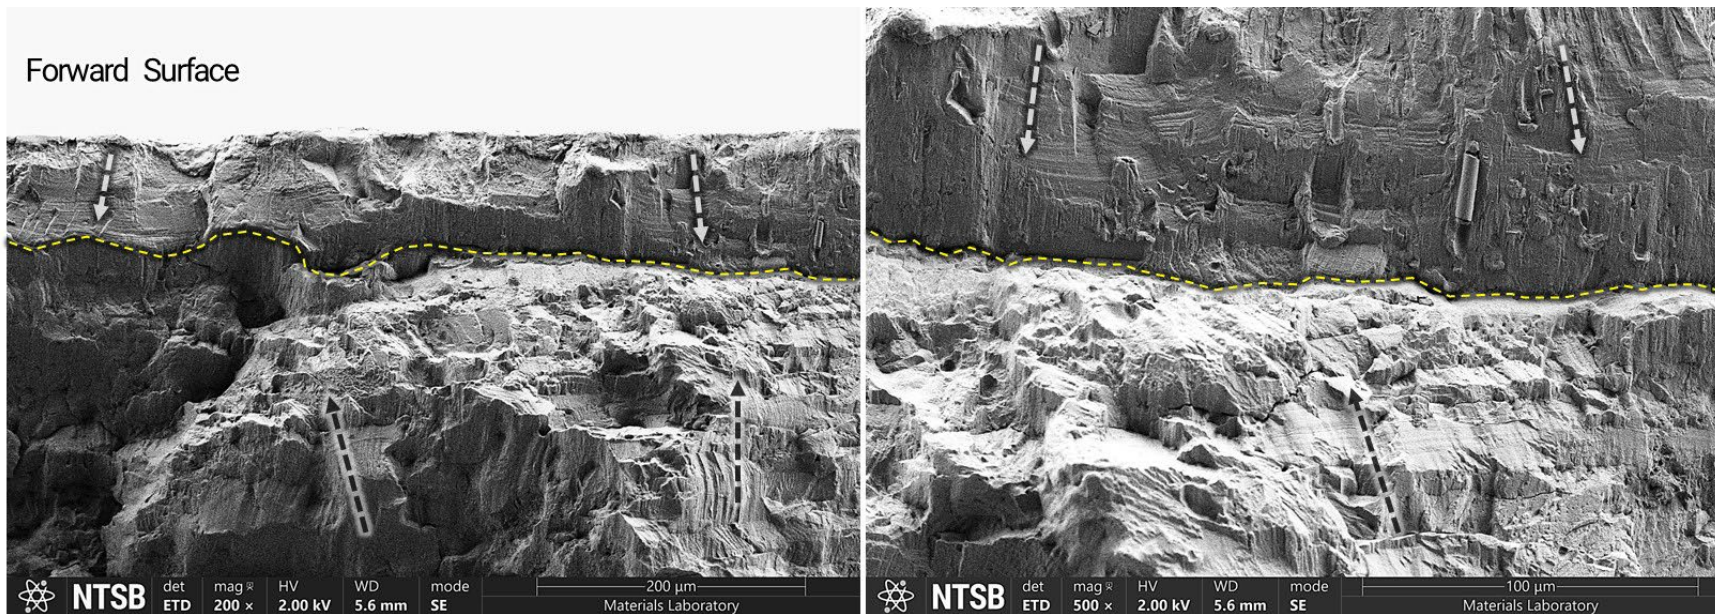
**Figure 10.** SEM images showing closer views of fatigue cracking extending from the forward surface at H13 (in the direction of the white arrows). The boundary between fatigue cracking extending from the aft surface (in the direction of the black arrows) is indicated by a yellow dashed line.

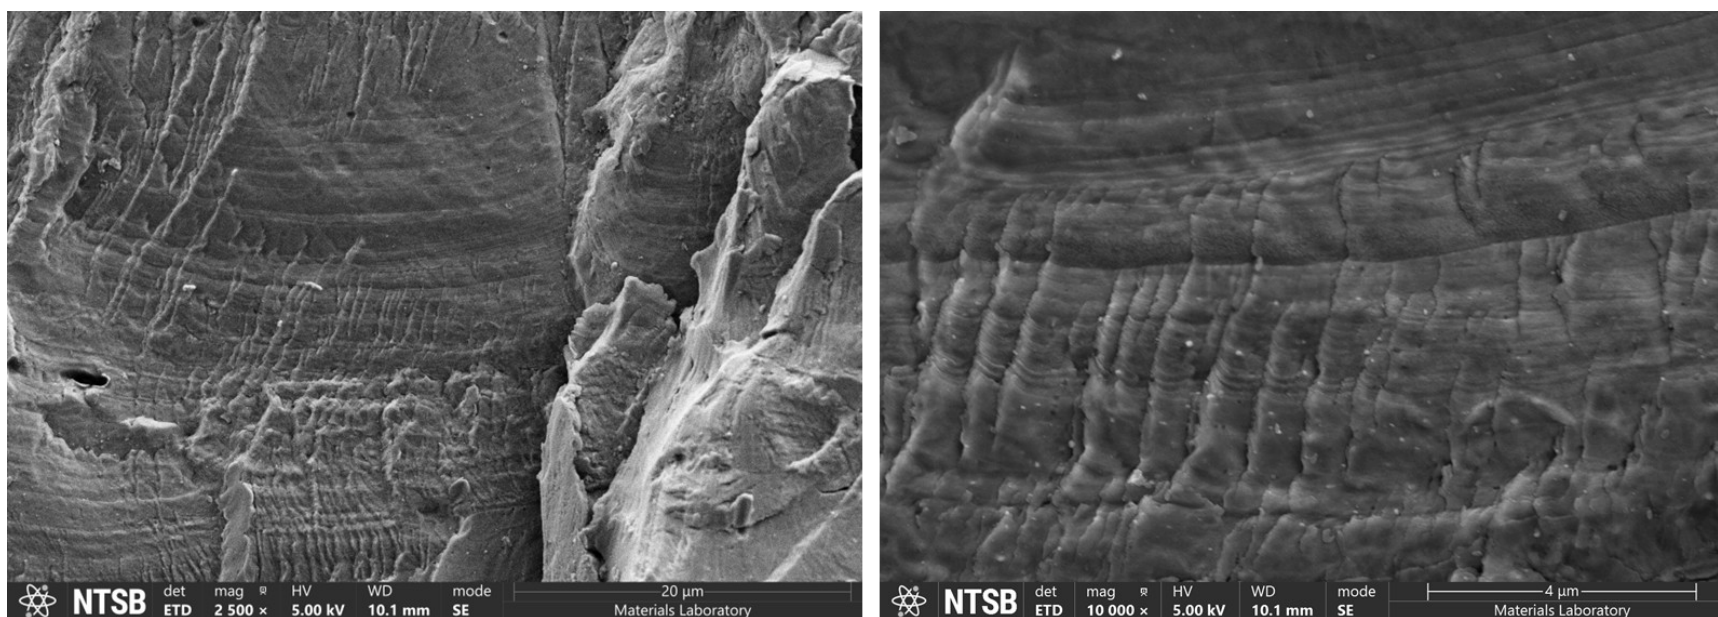
**Figure 11.** SEM images at different magnification levels of typical fatigue striations observed along the H13 fatigue crack growing from the forward surface. The crack growth direction is downwards in these images.

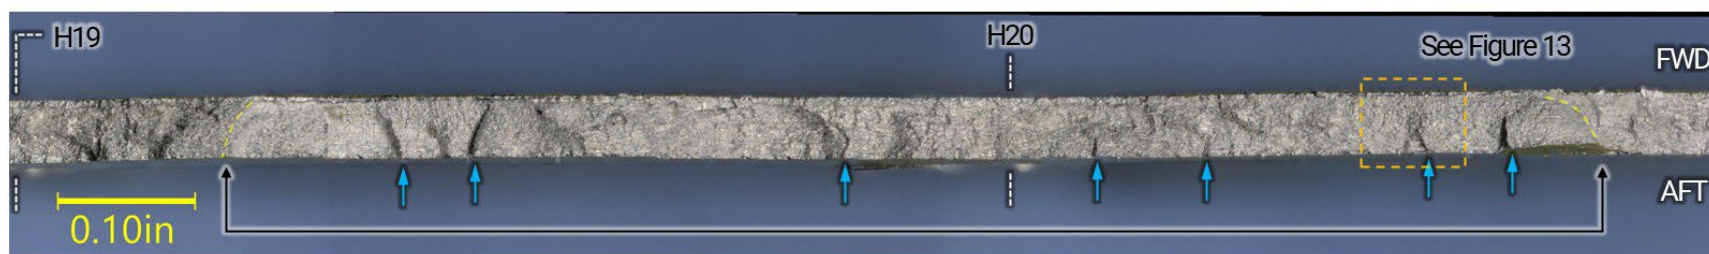
**Figure 12.** Closer view of the fracture surface between H19 - H21. Curved crack arrest marks emanating from H20 (bracketed region) are indicated by yellow dashed lines. Typical ratchet mark features observed along the aft surface are indicated by blue arrows.

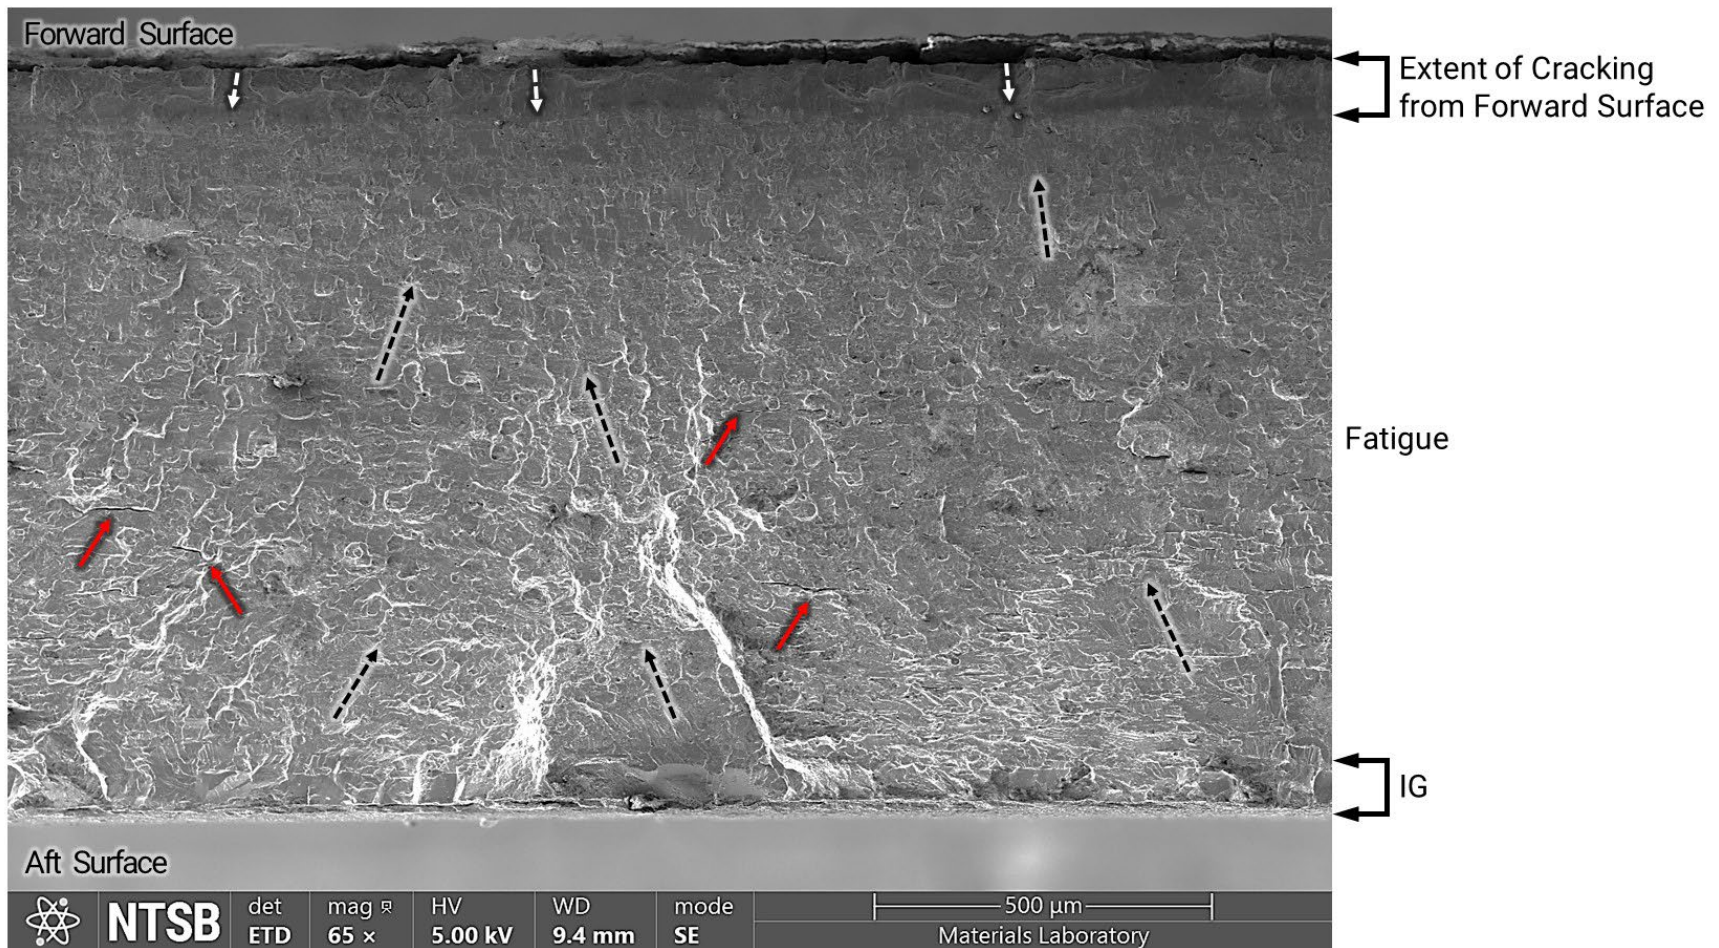
**Figure 13.** An overall SEM image of the left fracture surface at H20 showing a region with intergranular (IG) features at the aft surface from which fatigue cracking extended through the material thickness as indicated by black arrows. Curved thumbnail shaped crack regions extended from the forward surface as indicated by white arrows. Secondary cracks were observed branching from the primary fracture surface with typical examples indicated by red arrows.

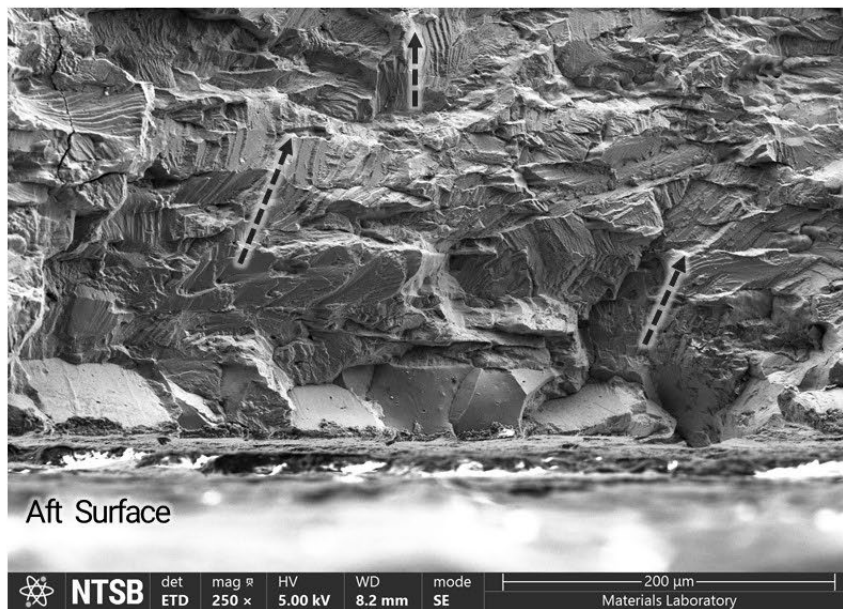
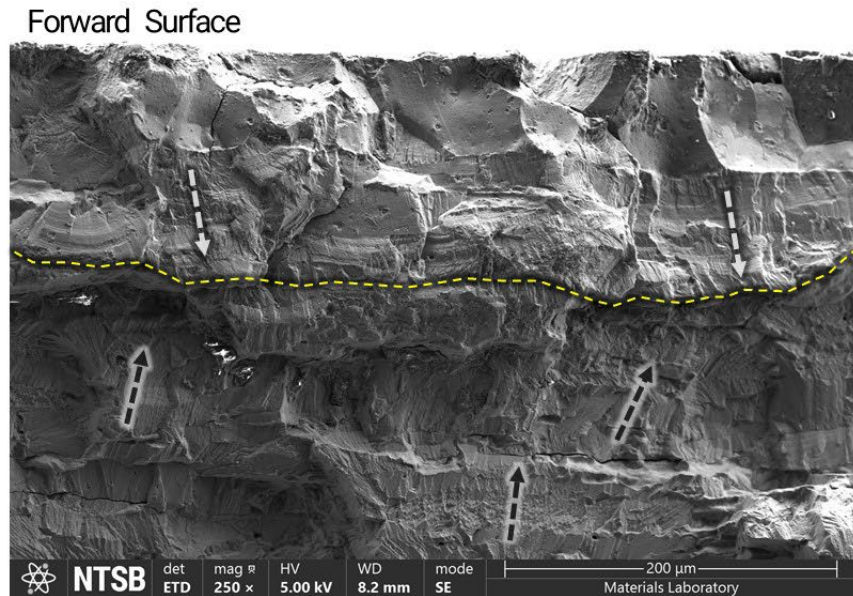
**Figure 14.** Closer SEM images of fracture initiation sites at the aft surface (left) and forward surface (right). Intergranular features with fatigue cracking features emanating from them were observed at both surfaces with black arrows indicating crack growth direction from the aft surface and white arrows indicating crack growth direction from the forward surface. The right image shows the boundary between the aft and forward fatigue cracks indicated by a yellow dashed line.

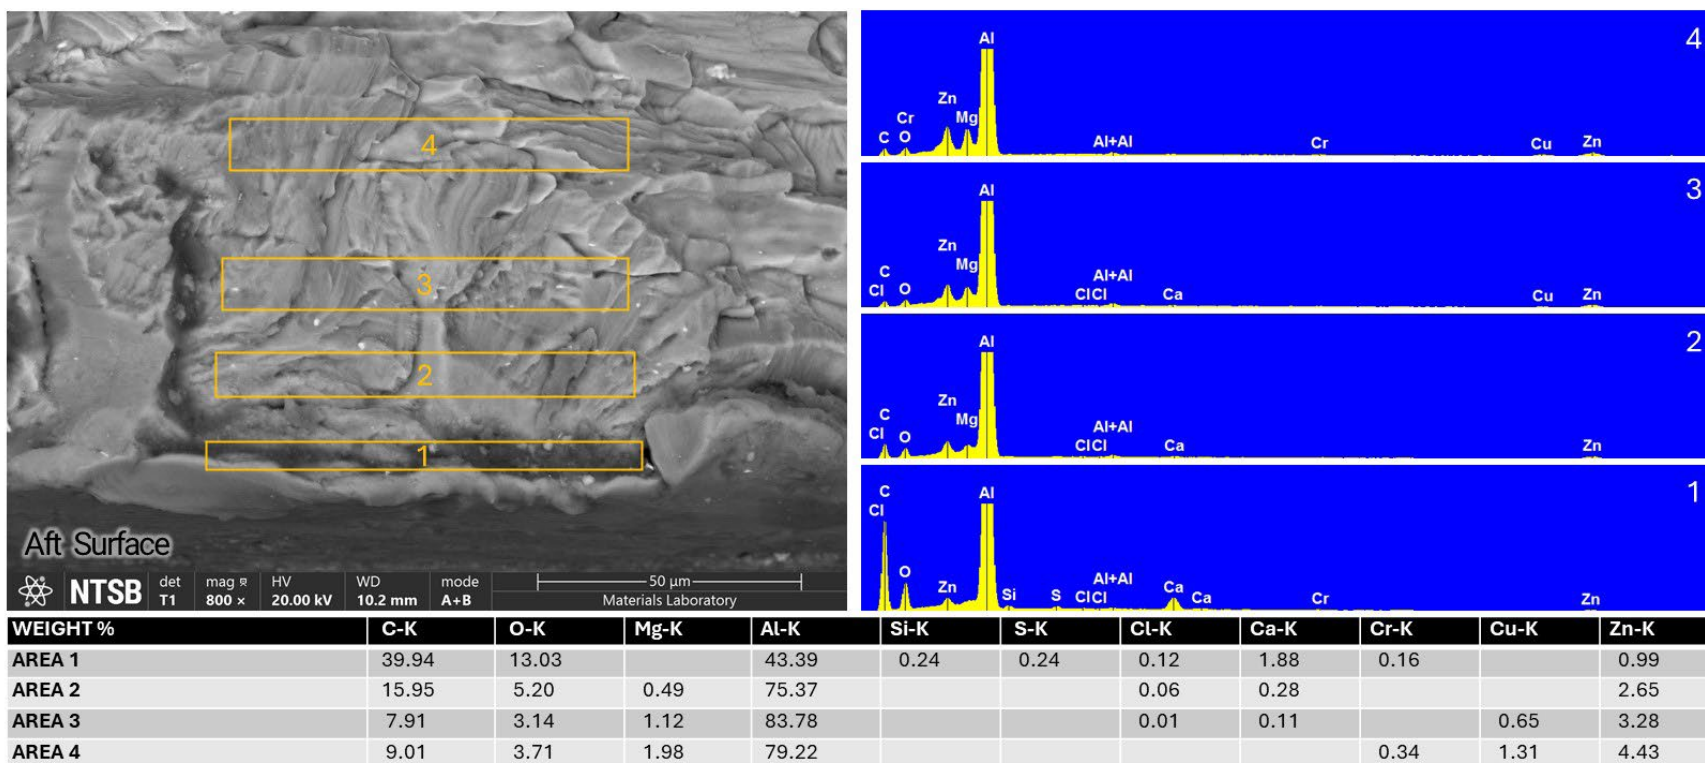
**Figure 15.** Energy dispersive spectroscopy (EDS) results at several regions near a fracture initiation site at the aft surface. The presence of chlorine (Cl) was detected near the surface.

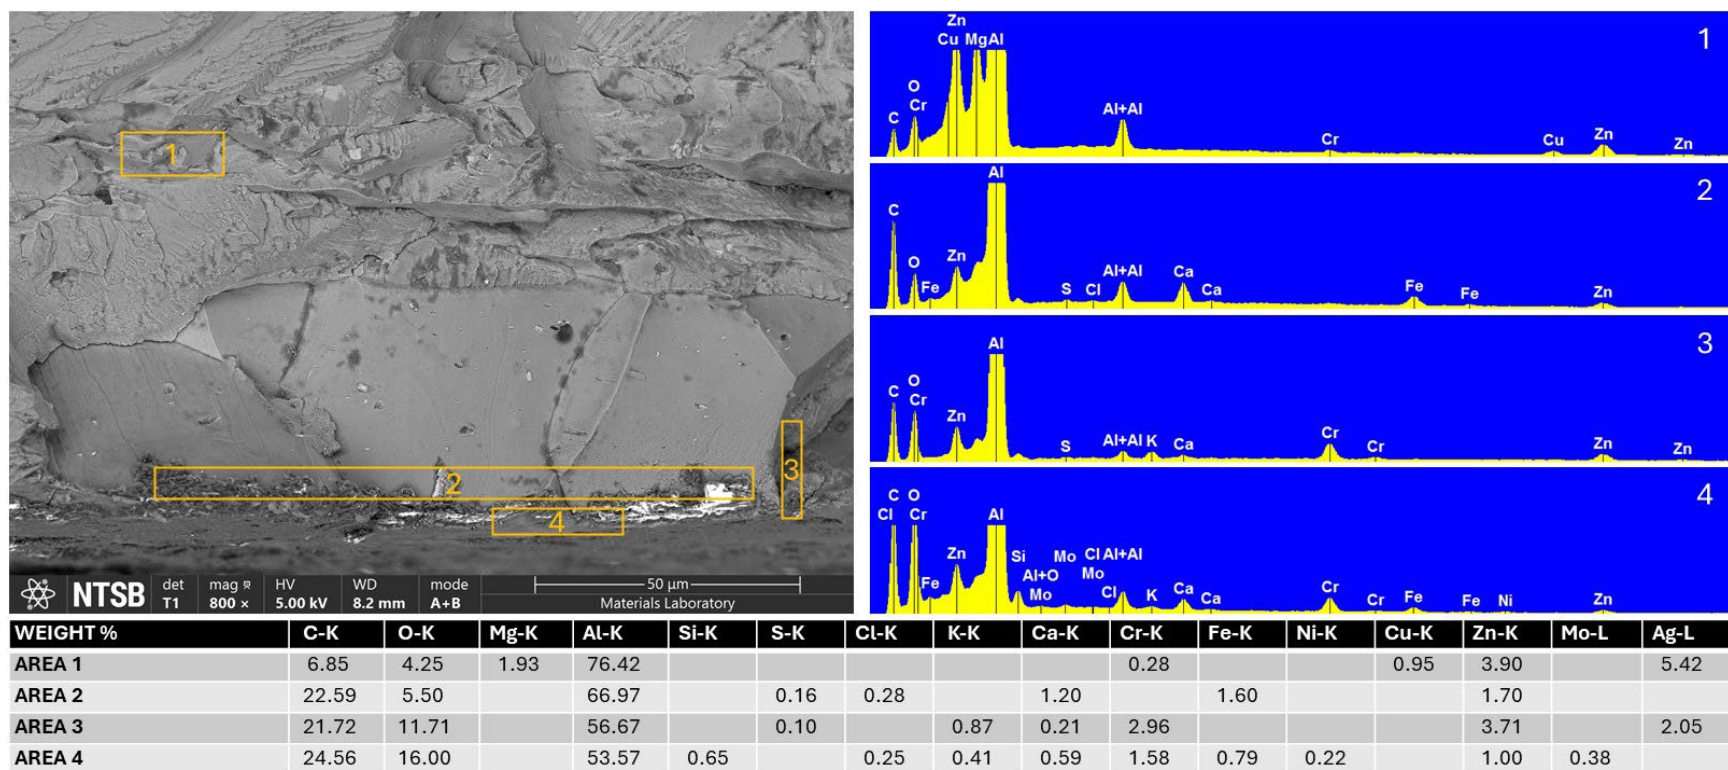
**Figure 16.** Energy dispersive spectroscopy (EDS) results at several regions near an intergranular fracture initiation site at the aft surface. The presence of chlorine (Cl) was detected near the surface.

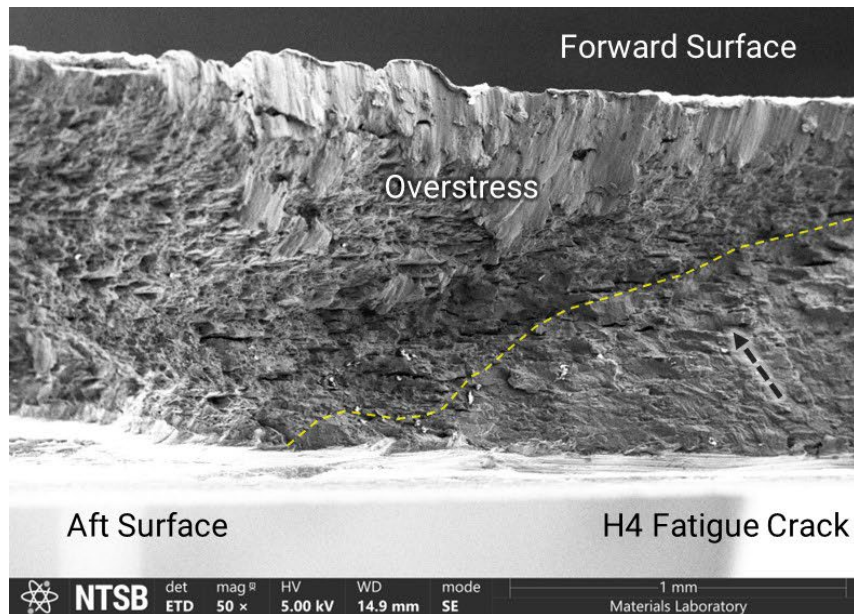
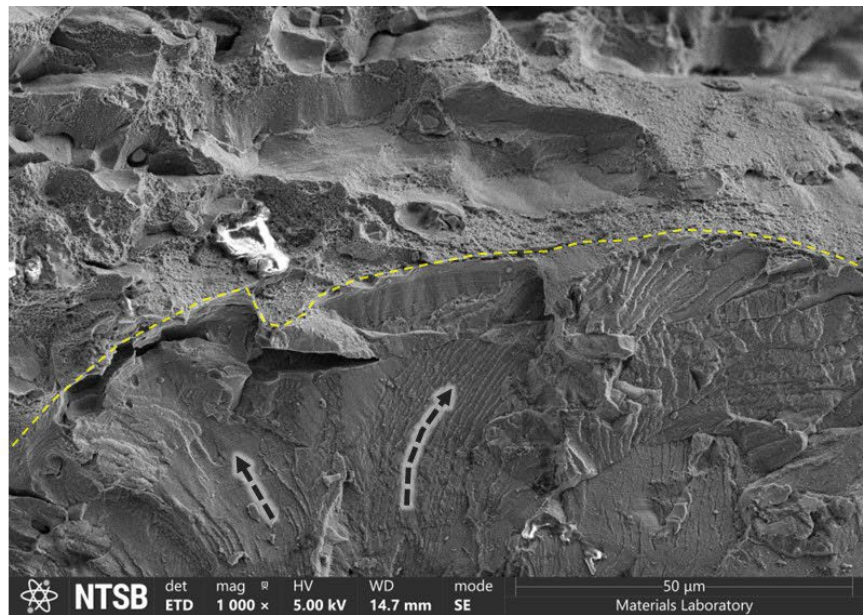
**Figure 17.** SEM images at different magnification levels of the upper end of the bulkhead web fracture surface near H4 showing the edge of the fatigue cracking (yellow dashed line) growing from the aft surface in the direction of the black arrows. The region above and to the left of the yellow dashed line was consistent with overstress fracture.

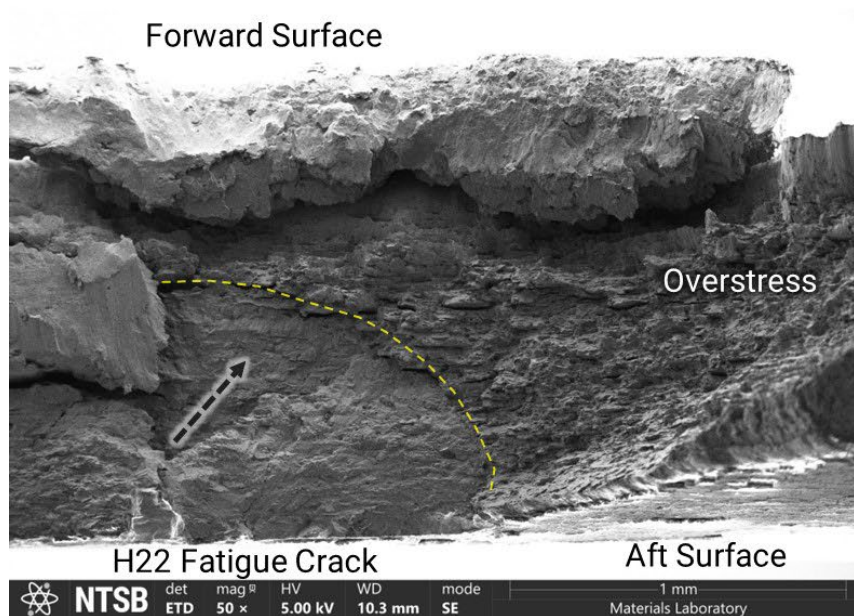
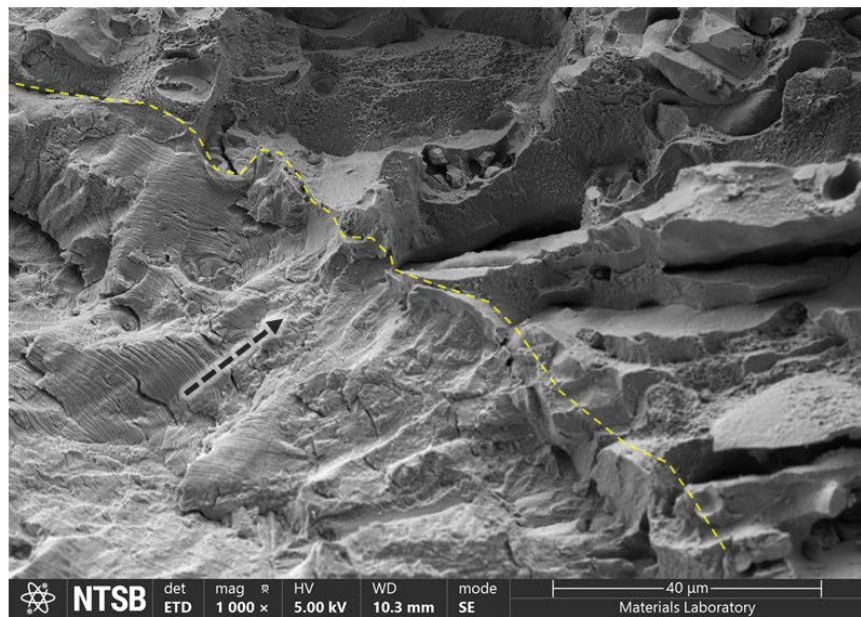
**Figure 18.** SEM images at different magnification levels of the lower end of the bulkhead web fracture surface near H22 showing the edge of the fatigue cracking (yellow dashed line) growing from the aft surface in the direction of the black arrows. The region above and to the right of the yellow dashed line was consistent with overstress fracture.

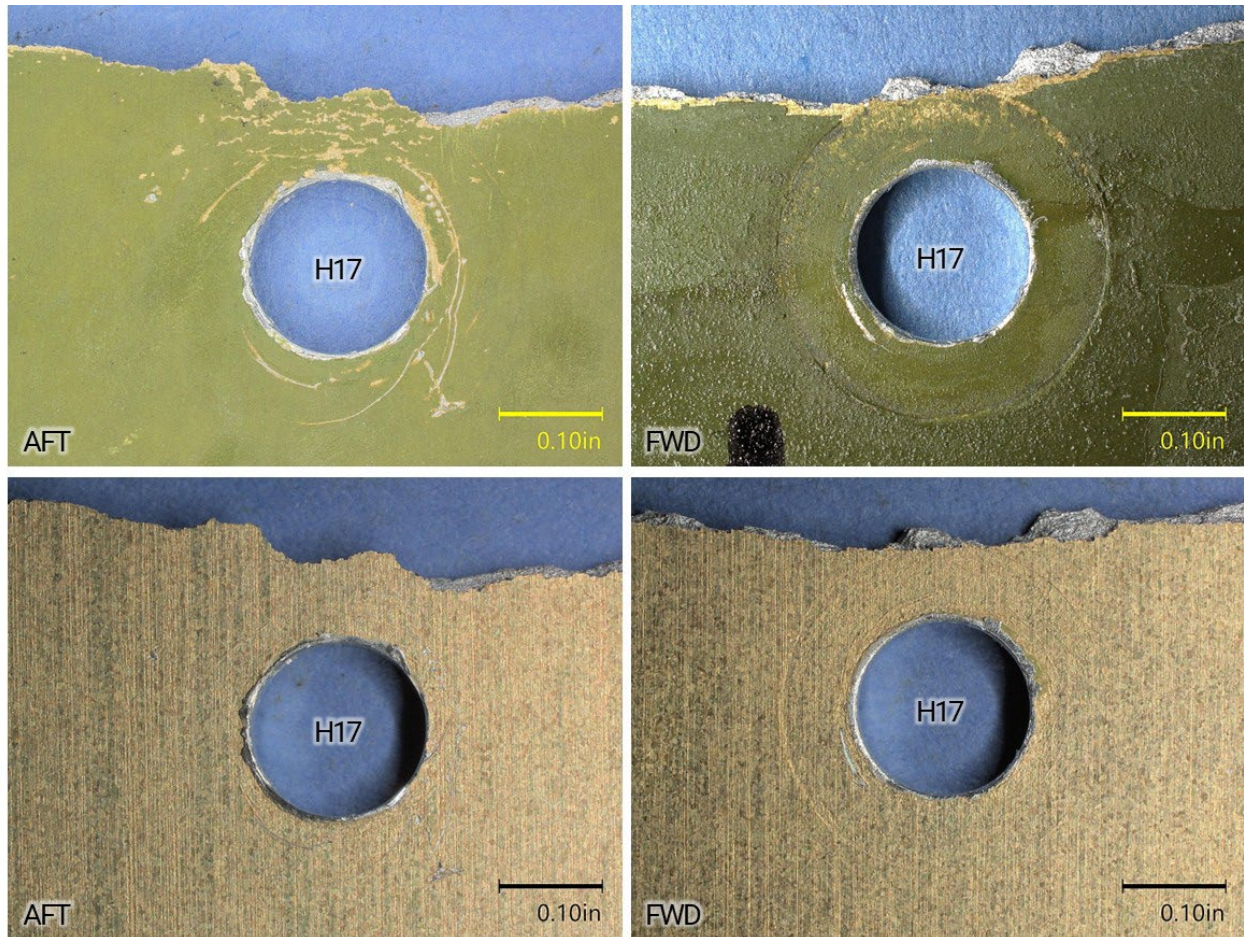
**Figure 19.** Digital microscope images of both surfaces of the bulkhead web at H17 before (above) and after (below) coating removal (chemical stripping).
