# National Transportation Safety Board

Office of Research and Engineering

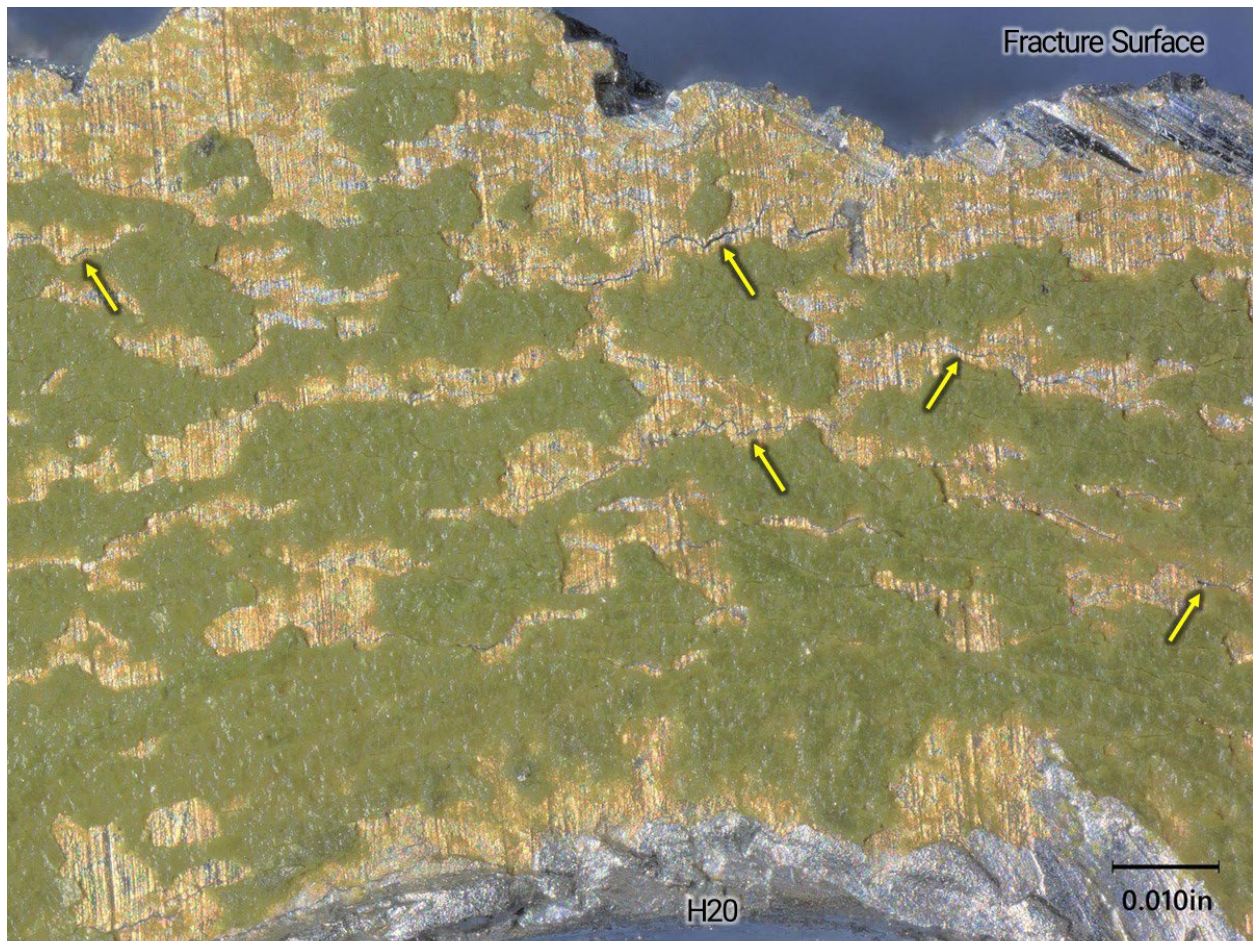
**Figure 20.** A representative view of the aft surface (prior to coating removal) between a fastener hole edge and the fracture surface. Small cracks oriented parallel to the primary fracture surface were observed in the vicinity of the fastener holes with typical examples indicated by yellow arrows.

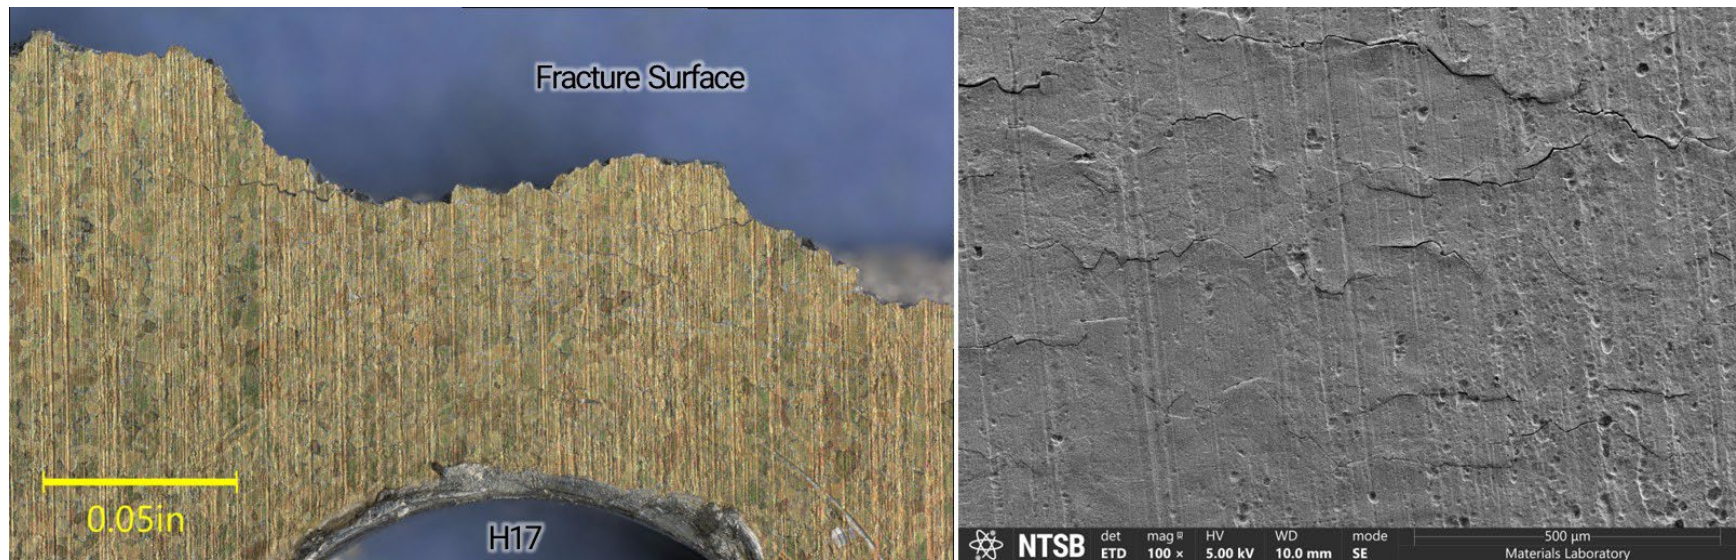
**Figure 21.** Representative views of the aft surface (after coating removal) between a fastener hole edge and the fracture surface. A digital/optical image is shown on the left and a higher magnification SEM image on the right. Small cracks oriented parallel to the primary fracture surface were observed in the vicinity of the fastener hole. Scratch-like features (oriented vertically in these images) running perpendicular to the fracture plane and some surface pits were also observed.

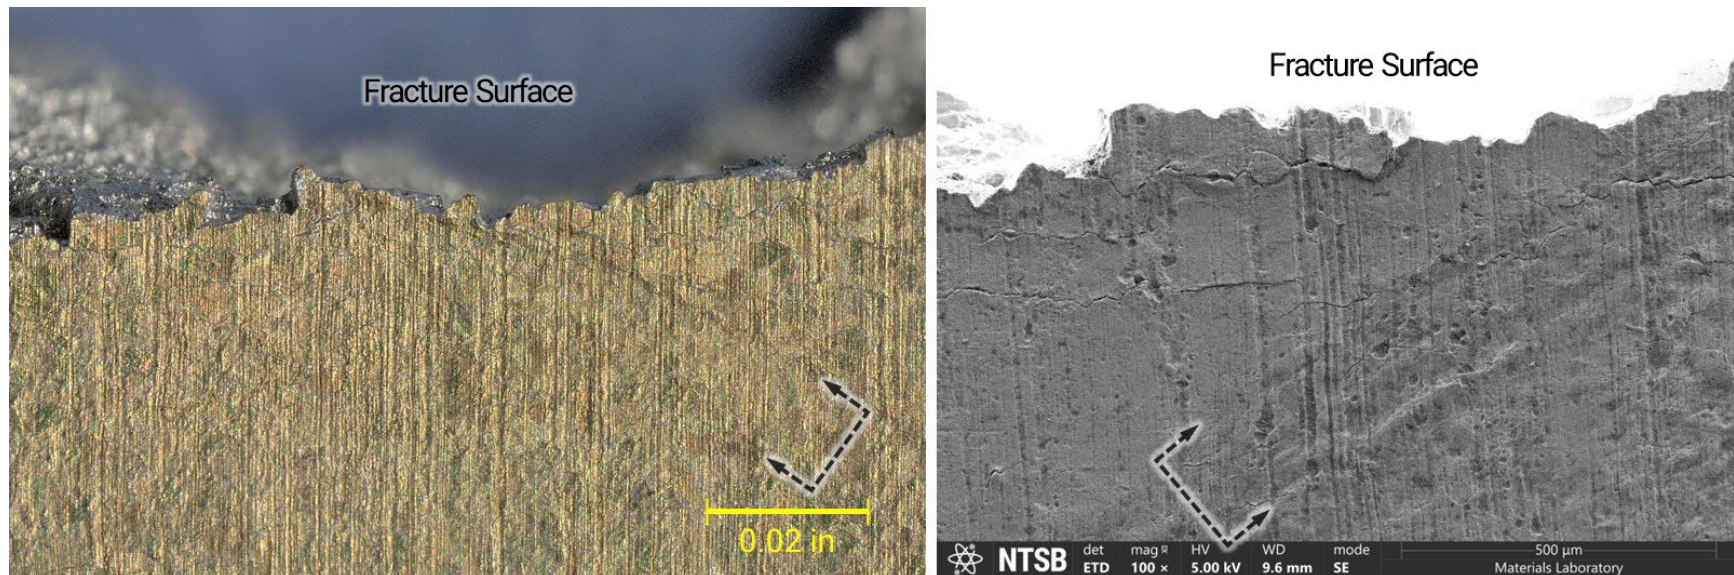
**Figure 22.** Representative views of the forward surface (after coating removal) between a fastener hole edge and the fracture surface. A digital/optical image is shown on the left and a higher magnification SEM image on the right. Small cracks oriented parallel to the primary fracture surface were observed in the vicinity of the fastener hole. Scratch-like features (oriented vertically in these images) running perpendicular to the fracture plane and some surface pits were also observed. The bracketed region indicates a circular witness mark consistent with the presence of a fastener head.

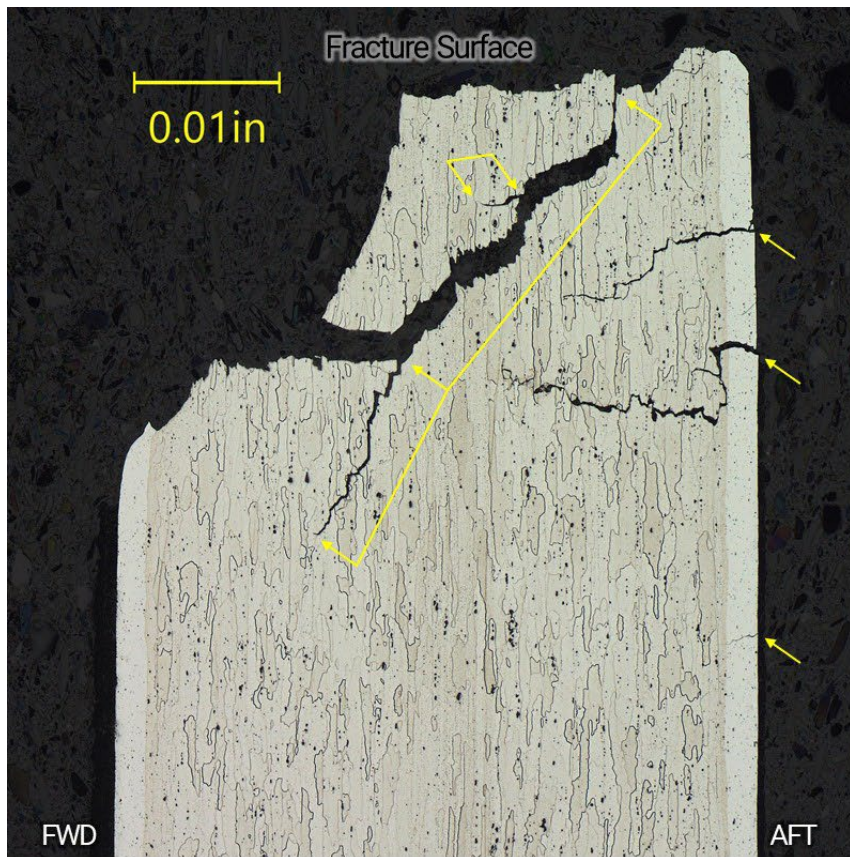
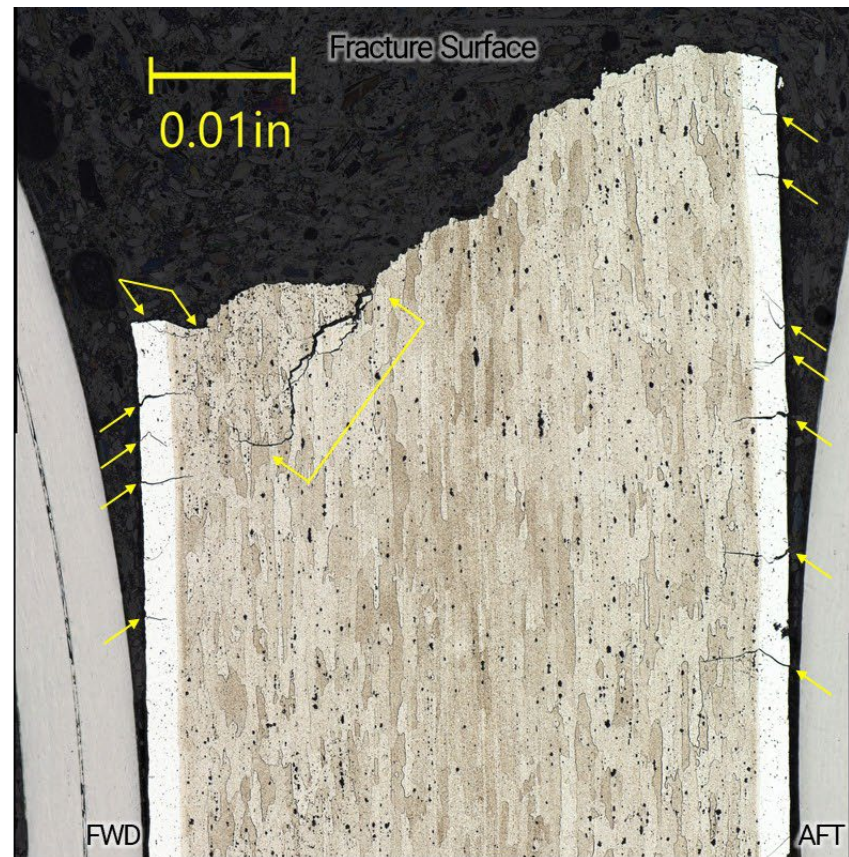
**Figure 23.** Metallurgical cross section views taken between H6 - H7 (left) and through H15 (right). Surface cracks were observed extending through the lighter etched clad layer and into the base metal as indicated by arrows. Bracketed regions indicate branching cracks. Bright Field Images, Keller's Etch.

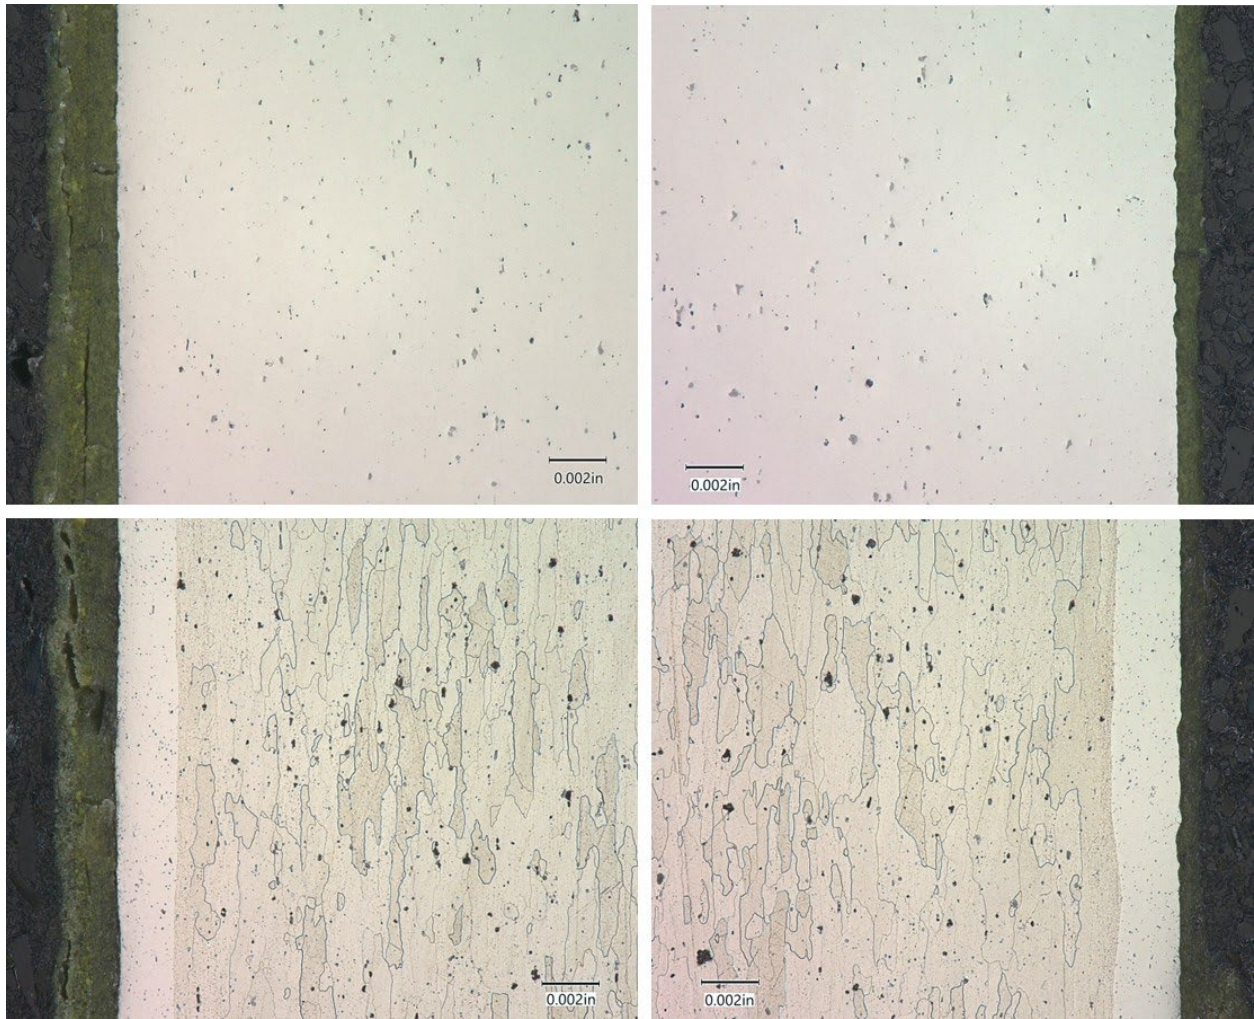
**Figure 24.** Metallurgical cross section views near the forward surface (left) and aft surface (right) taken from bulkhead web material away from the fracture surface. The as-polished condition is shown above, and the etched condition is shown below. Bright Field Images, Keller's Etch.
