# National Transportation Safety Board

DCA25LA065

## **OPERATIONAL FACTORS**

Location: Orlando, Florida  
Date: December 21, 2024  
Time: 18:30 EST  
23:30 UTC  
UAS/Drone: Uvify IFO

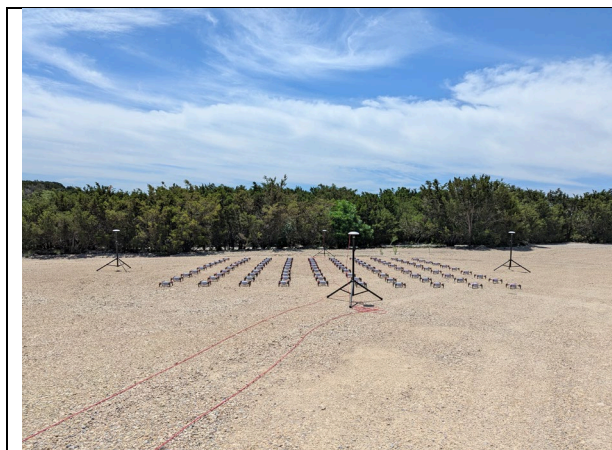
On May 21, 2025, a test drone show was performed by SkyElements in Weatherford, Texas. The test show utilized the same laptops, Wi-Fi network, Wi-Fi access points, 915 MHz radio, and RTK unit that were used during the accident flight. The test show used 100 sUASs that had not been part of the accident flight. After completing the preflight checks and calibrations, the test show was activated. All of the sUASs operated normally during the initial takeoff. Shortly after takeoff, one of the sUASs, suddenly left formation while the motors made a loud buzzing sound. The sUAS’s motors can then be heard shutting off, and the sUAS then began to flip over multiple times before impacting the ground at the border of the programmed hard fence. The remaining sUASs remained in formation, and the test show continued. The remaining sUASs flew the programmed test show without any anomalies that would have precluded normal operation. The laptops, Wi-Fi network, access points, 915 MHz radio, and the RTK all operated normally during the test show.

Figure 1: Test Drone Setup

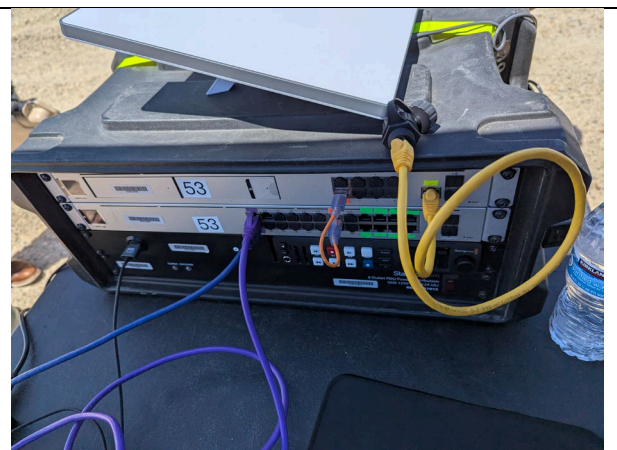
Figure 2: Show Network Switch

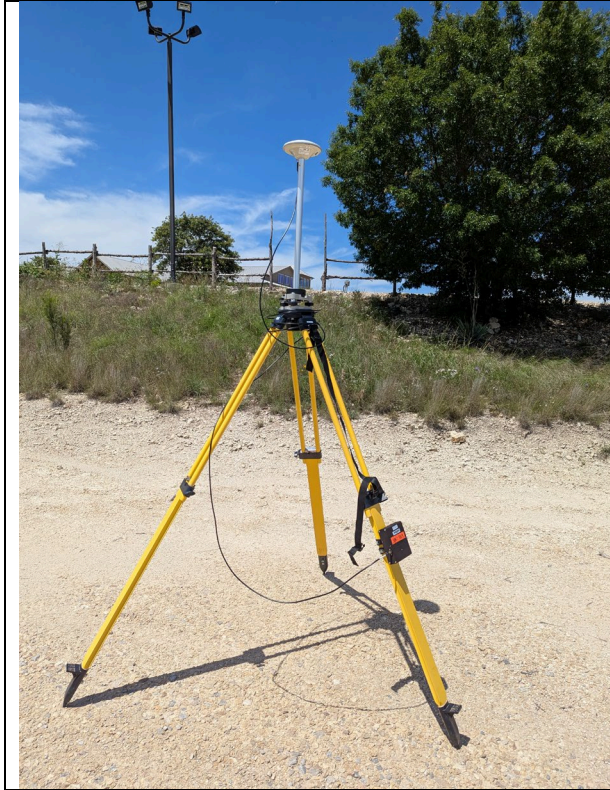
Figure 3: RTK Unit

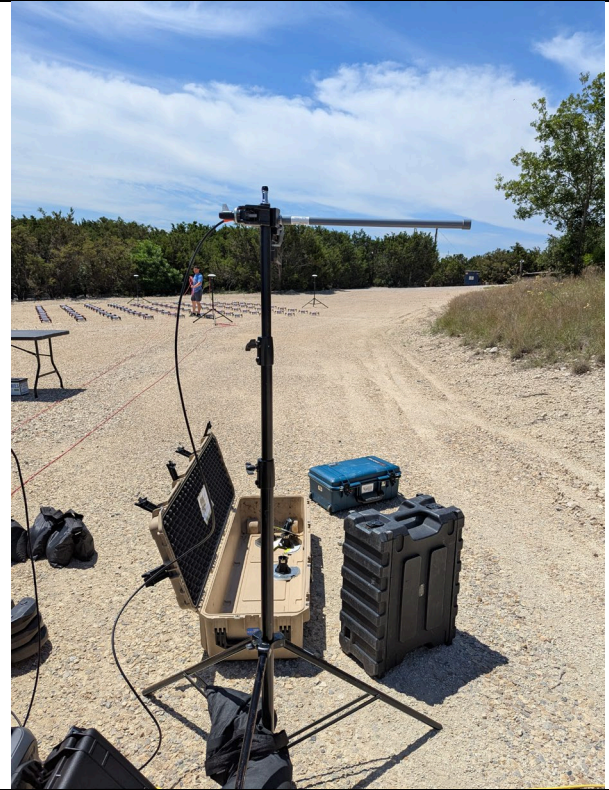
Figure 4: 915 MHz Antenna

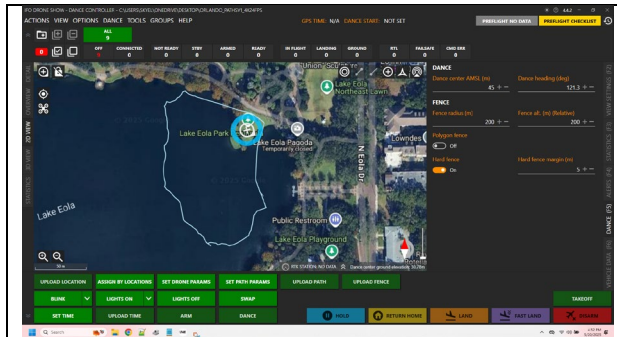
Figure 5: Drone show as designed (except for hard fence margin)

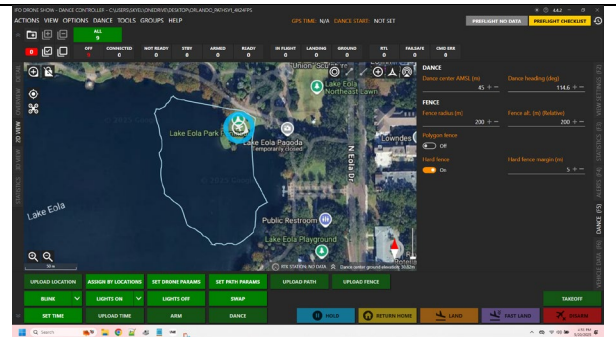
The command laptop maintained log files from the accident drone show, which the operator and the NTSB examined. The examination of the files revealed that the drone show center position was not oriented over the physical location of the sUASs. The operator reported the center of the sUAS physical location was 28.5449938997792, -81.371134865313; however, the RPIC had programmed and uploaded to the sUASs position to be 28.5449583471286, -81.3711627772998. This equated to a deviation of approximately 16.5 ft between the physical show center and the RPIC-programmed show center. The operator reported that this shift also moved the show closer to where the spectators would be located. Additionally, the log files showed only 498 sUAS were selected for the show location, meaning two of the sUAS were programmed with a different show center location than the rest of the sUAS. The data further showed that all 500 sUAS were launched for the show.

Further review of the show location data revealed that the drone show heading was different than what the show was initially programmed to be. The operator reported that the RPIC was provided a show heading of 121.3°; however, the data log revealed that the show was set to be 114.6°. The deviation in show heading resulted in the flight position being off by about 60 ft from the planned position. The heading adjustment moved the show even closer to the expected location of the spectators.

Figure 6: Drone show as flown

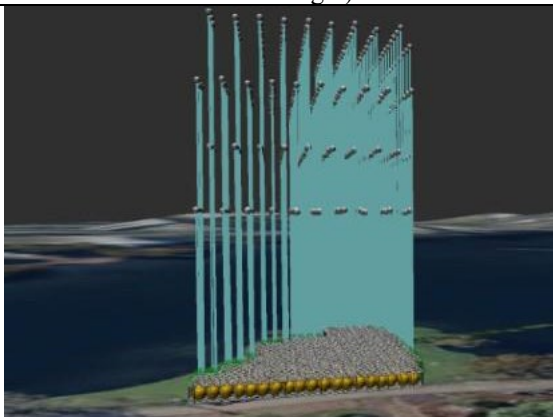
Figure 6: Drone show as designed with no crossing paths

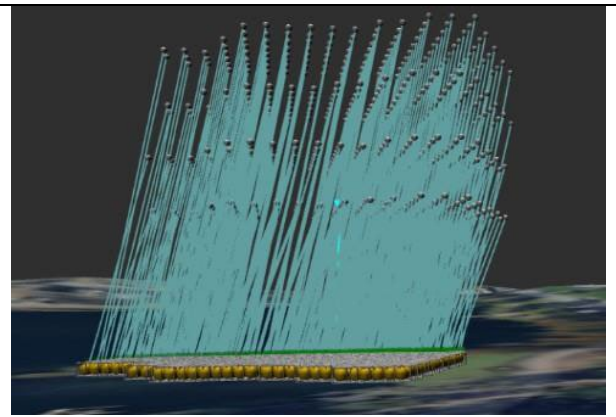
According to the operator, it was critical that the RPIC positioned the show center correctly over the center of the starting grid, as the software used algorithms to assign the correct path to the correct drone based on this position. The operator reported that when the position is not accurate, the software will map incorrect drones to the flight paths, which could result in collisions during takeoff and during the move to position. The software allowed the RPIC to view and confirm the correct position on a 2D map. Additionally, the software allowed the RPIC to view the flight paths in a 3-dimensional map to verify that the paths are accurate and that there are no crossing paths between the sUASs.

Figure 7: Drone show as flown with crossing paths

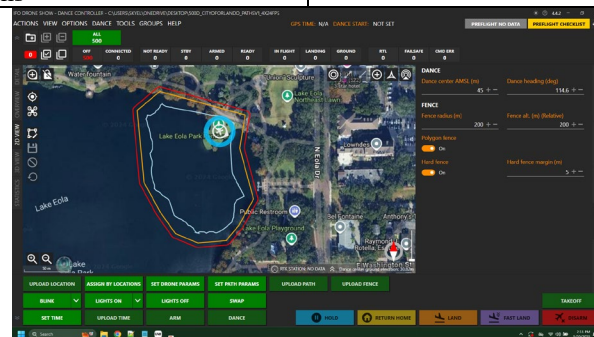
The drone show software had options to adjust the geofences around the drone show. The software had two different geofences. The soft geofence is the first geofence, which is set to send a sUAS back to its home point to land. The hard geofence is the second geofence and is programmed to disarm the sUAS's motors immediately upon reaching the geofence. Both of these geofences required the sUAS to have GPS positioning to determine where the programmed geofences are. According to the operator, at the time of the accident, the policy for margin between the two geofences was 1 meter (about 3.28 ft); however, the data showed that the RPIC had the geofence margin set to 5 meters (16.4 ft). According to the operator, the 5-meter geofence margin used to be the standard; however, on December 9, 2024 (12 days before the accident), the policy had been changed to adjust the geofence margin to 1 meter. The operator further reported that it was up to RPIC to update the command laptops with the new margin default setting as they were being used for shows. The operator also stated, that it was up to the RPIC to "draw" the geofences around the show, and that it was policy to put the fences as close to the

edges of the show as possible. A review of the data revealed that the geofences were drawn in several locations farther from the edge of the show than the operator stated would be normal. The resulting geofences were near where the spectators were expected to be stationed.

Figure 8: Drone show as flown with soft and hard fences shown

6. SkyElements' updated the operation handbook for procedures when an accident occurs.
7. The safety buffer was adjusted for 155 ft between the edge of the hard geofence and the spectators.
