DCA25LA085

## INVESTIGATION PHOTOGRAPHS

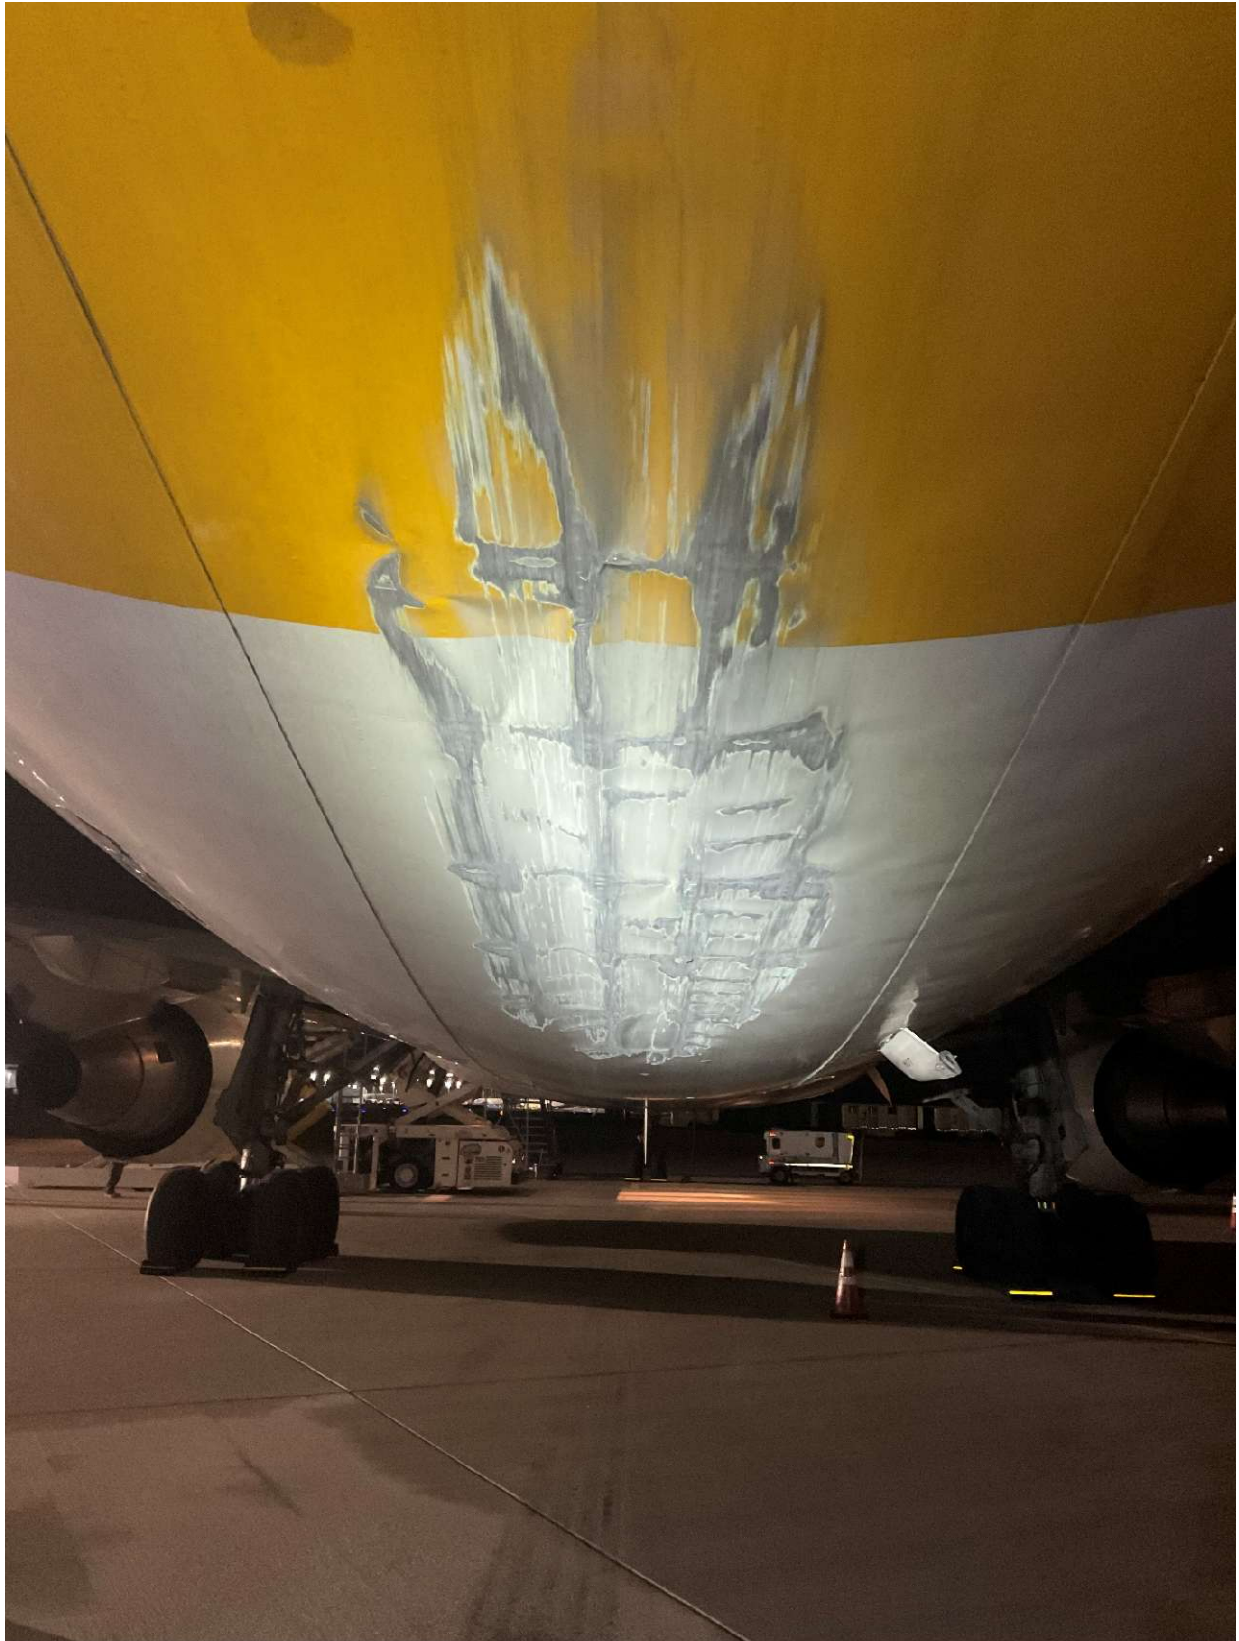
**Photograph 1 - Lower fuselage damage near tail.**

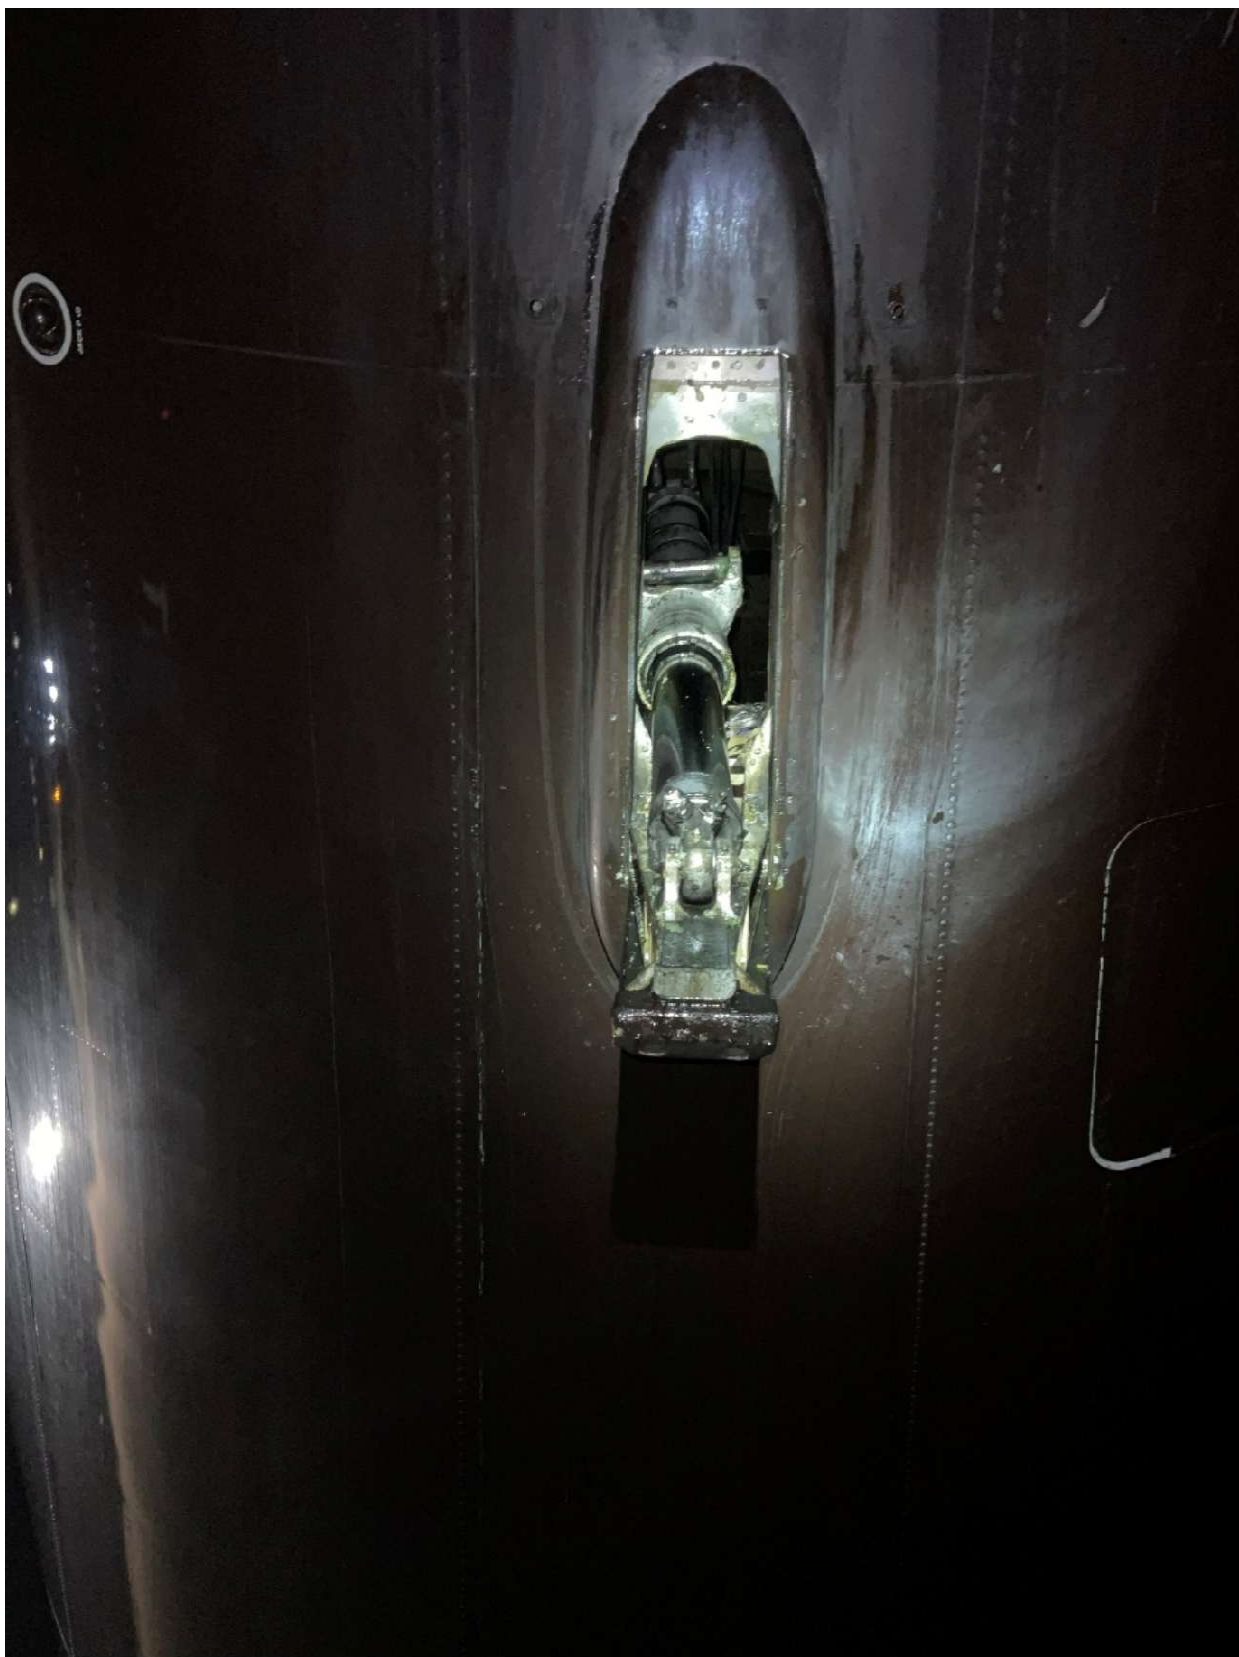
**Photograph 2 - Tail skid.**

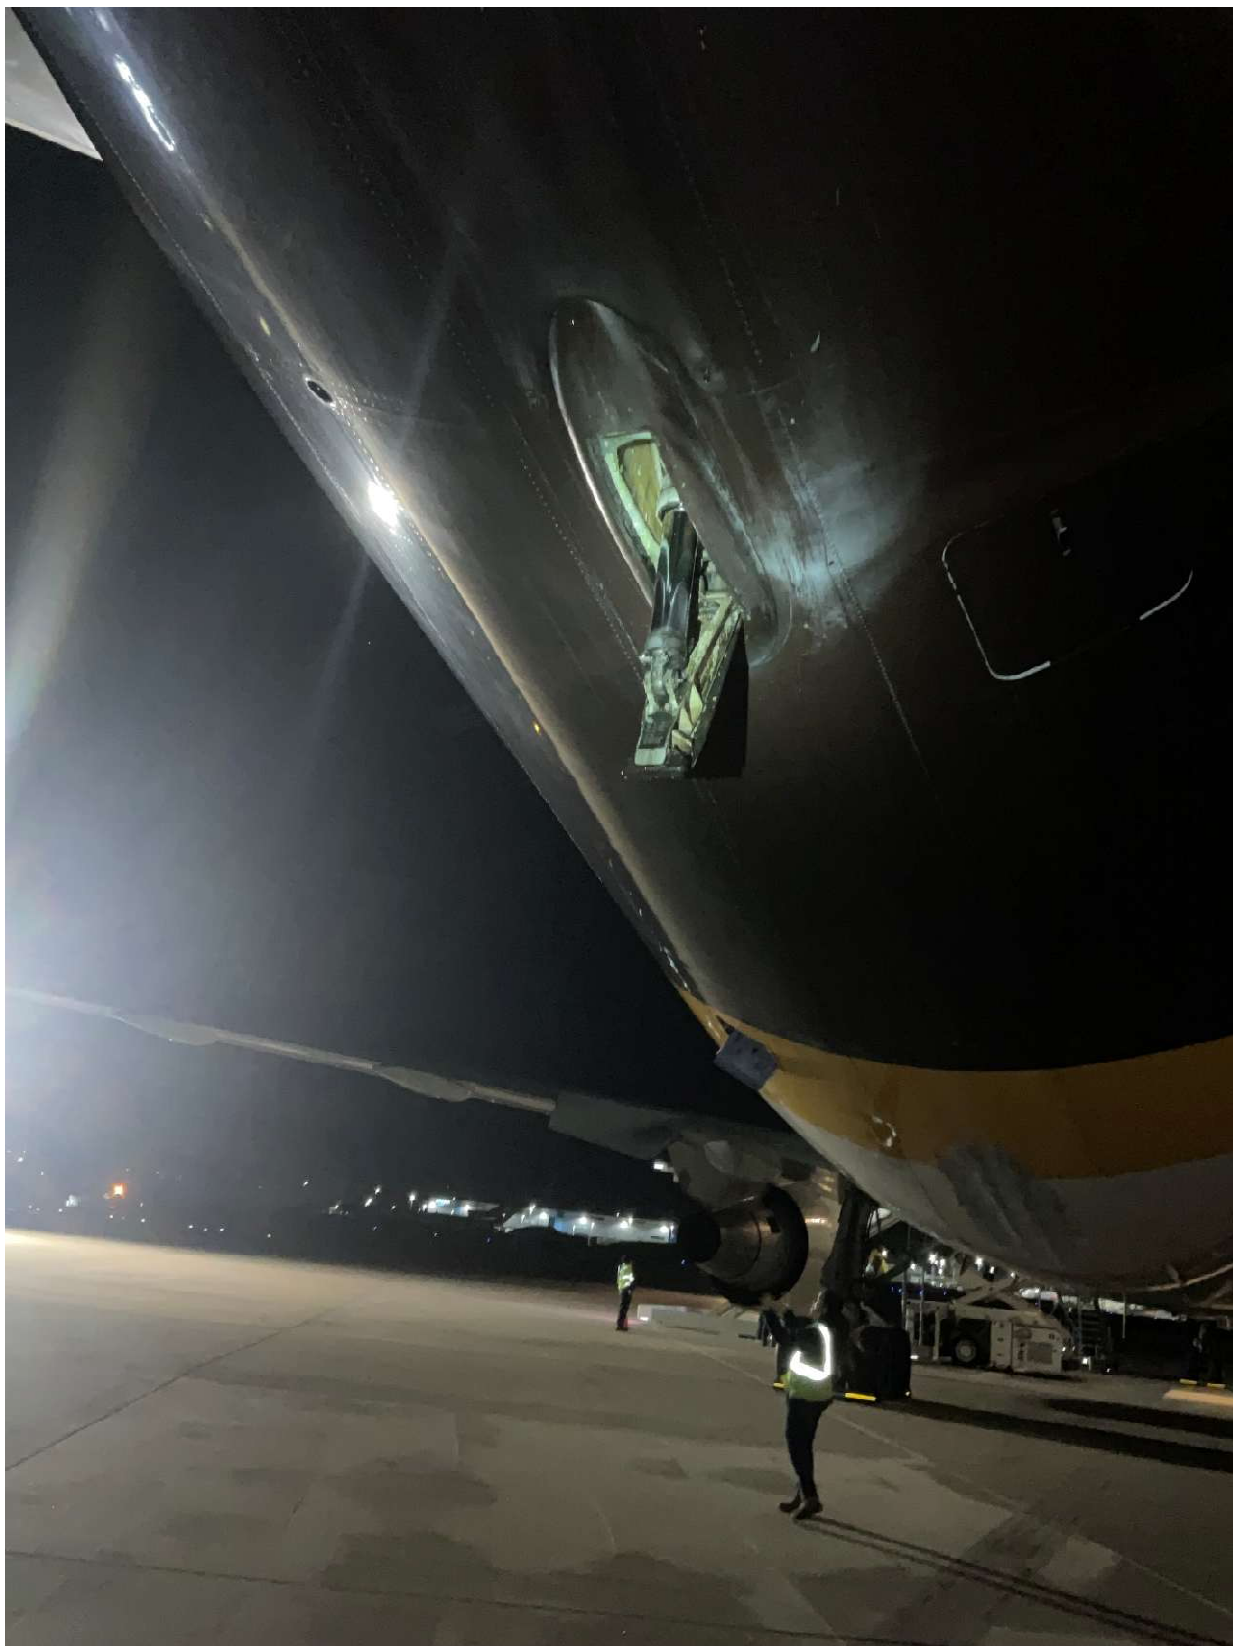
**Photograph 3 - Tail skid.**

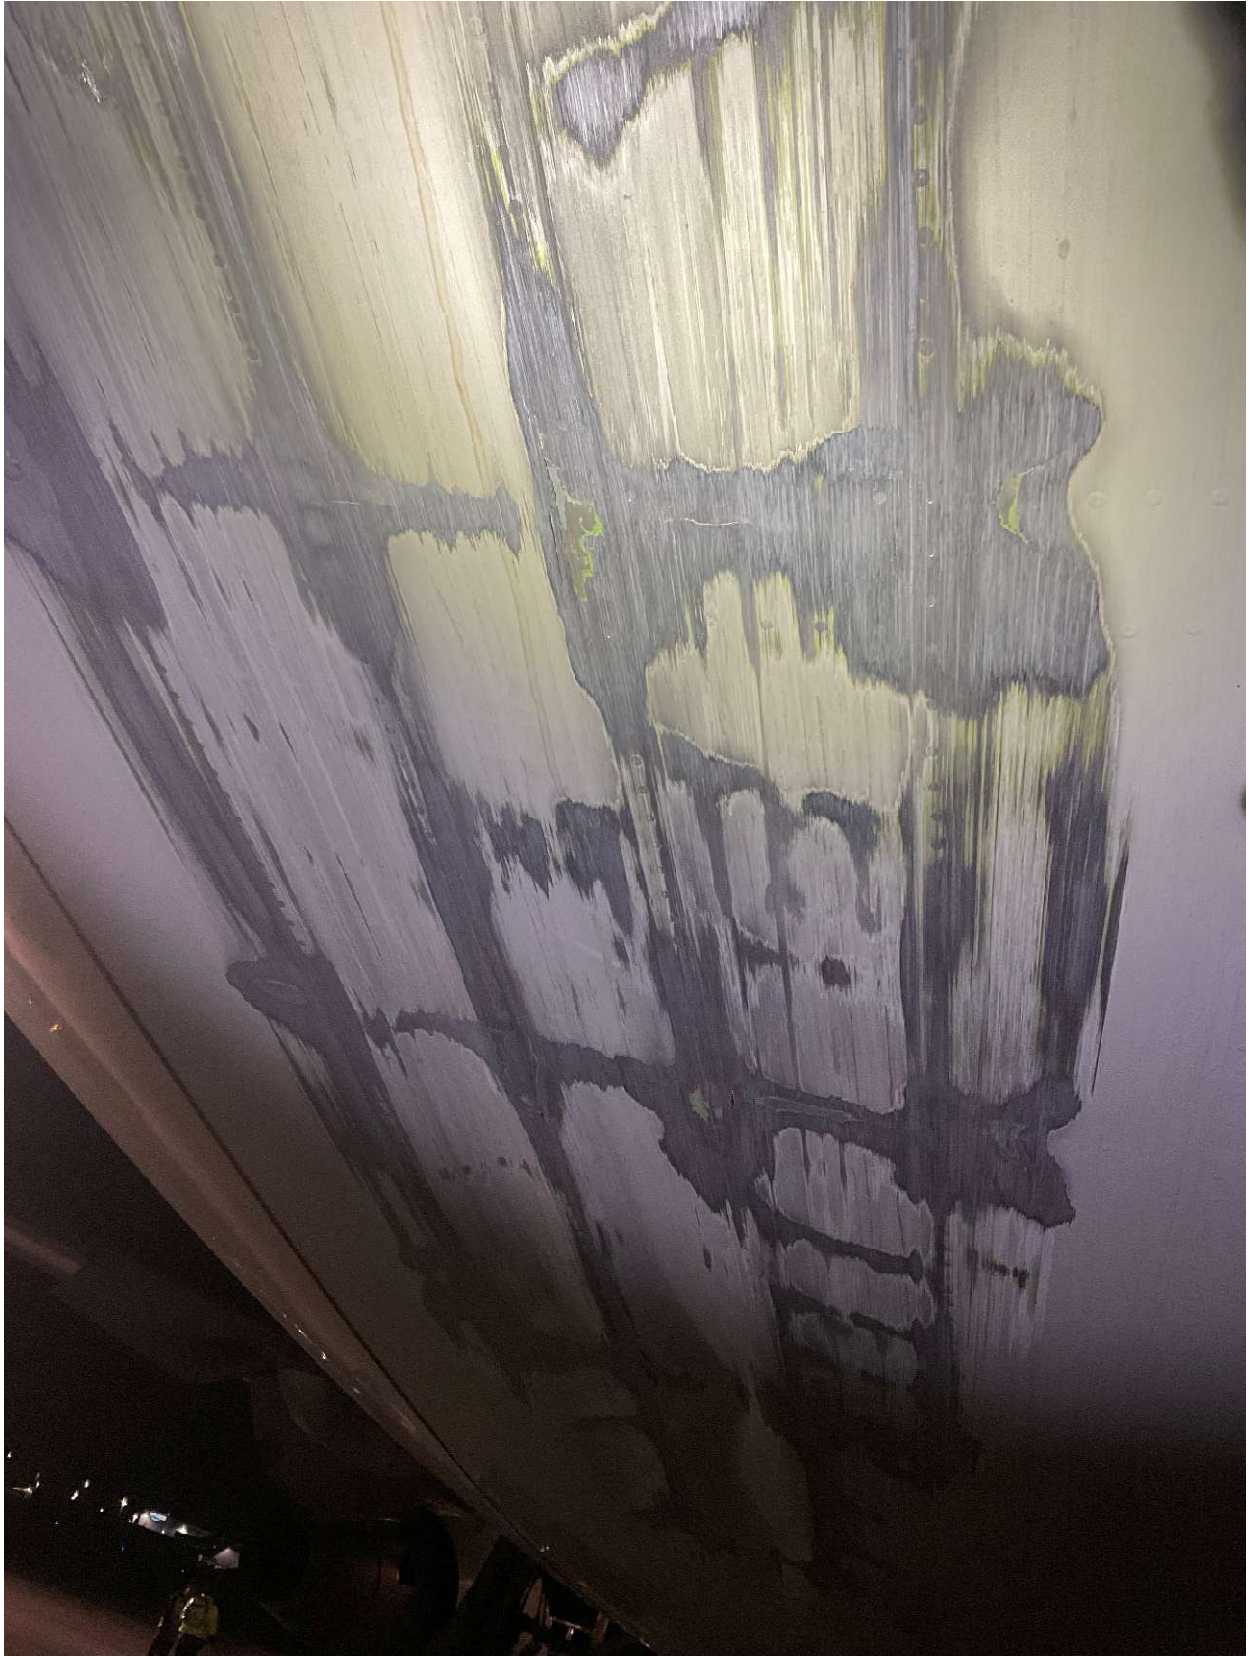
**Photograph 4 - Lower fuselage damage near tail.**

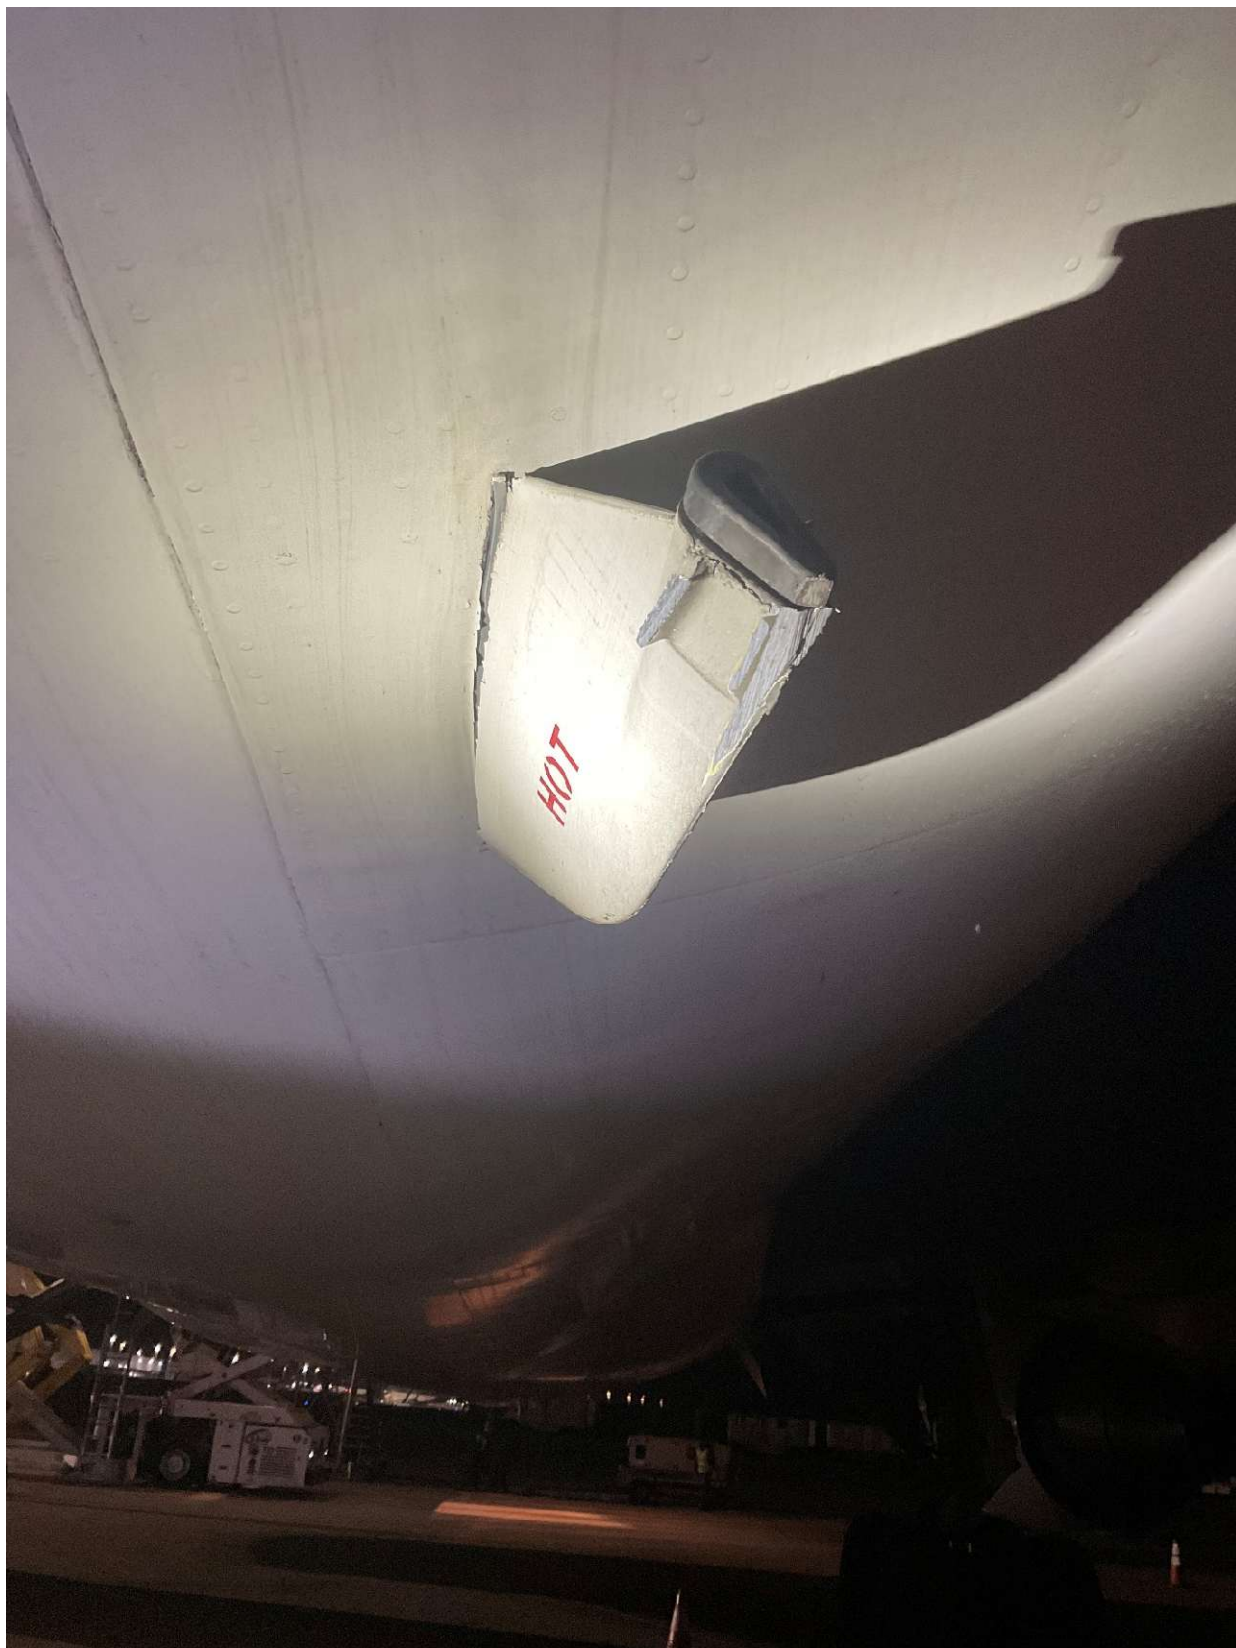
**Photograph 5 - Drain mast damage.**
