# National Transportation Safety Board

DCA25LA163

## **OPERATIONAL FACTORS/HUMAN PERFORMANCE**

Group Chairs' Factual Report

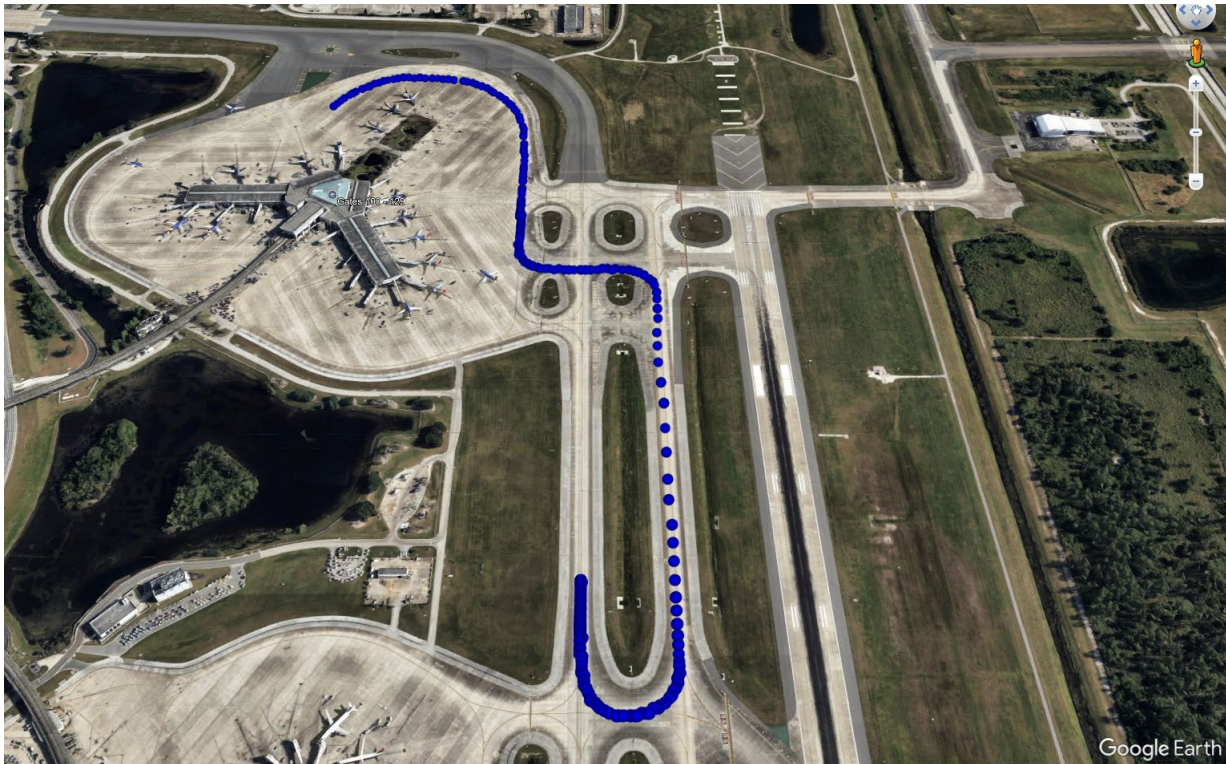
About 0930, the event flight approached taxiway "H" on taxiway "H2," subsequently made a right turn onto taxiway "H," the recorded ground speed was 14 kts, the engine N1 speed increased about 90.6%, and the flight began the takeoff roll. According to the captain's statement *"After taxiing past taxiway G, I mistakenly turned right onto taxiway H, thinking that it was the runway. With the engine spooled from taxi power and before I finished the right turn, I announced that I was setting takeoff thrust and selected TOGA<sup>7</sup>, while advancing the thrust levers."*<sup>8</sup> According to

**Figure 1:** Incident Flight's Taxi and Attempted Takeoff Route

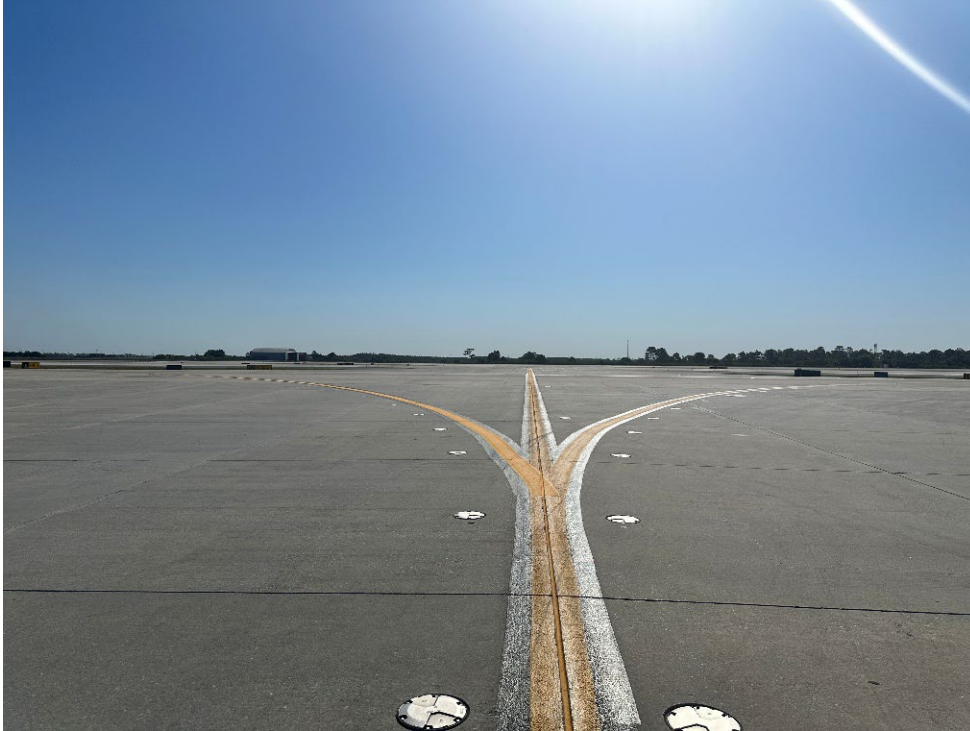
**Figure 5:** View towards the East on Taxiway H2 (Source: Human Performance Group Chairman)

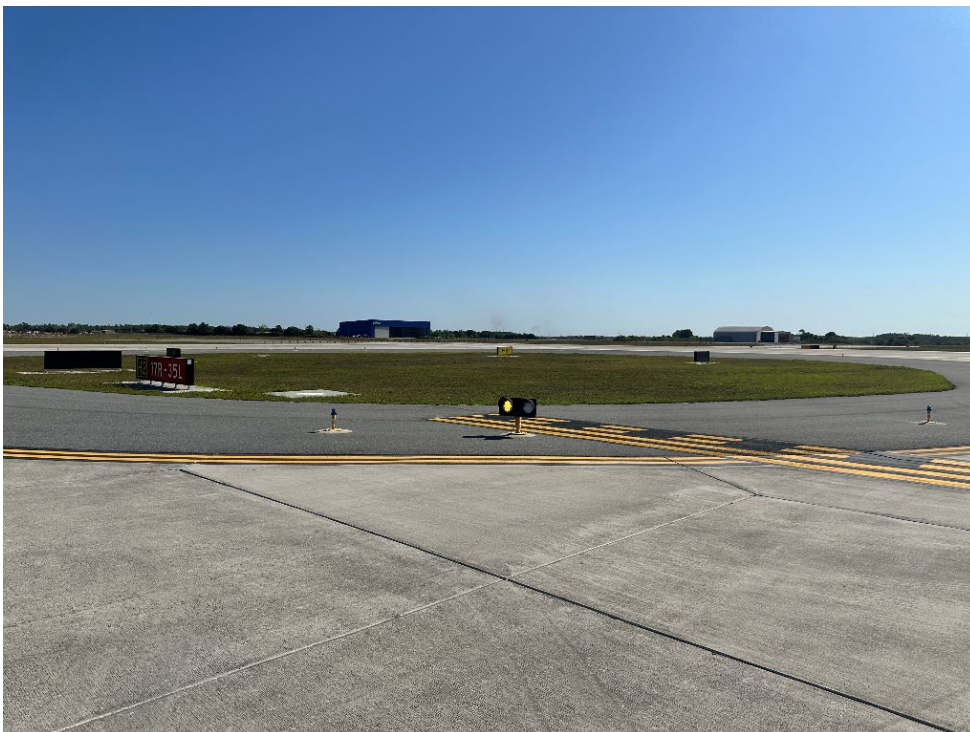
**Figure 6:** View of Hold-short Line and Runway Sign for Runway 17R/35L (Source: Human Performance Group Chairman)

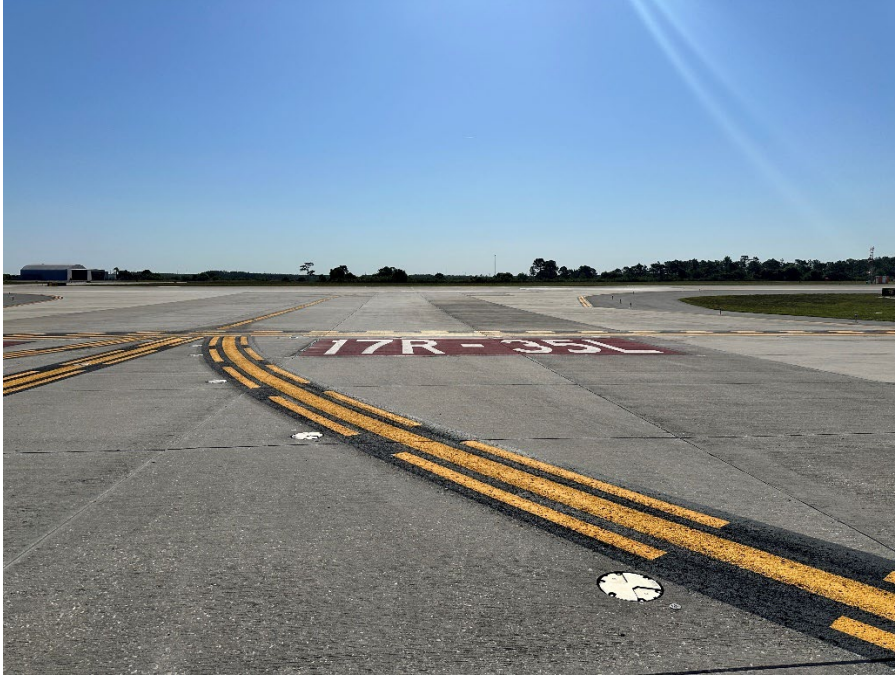
**Figure 7:** View of Runway 17R/35L Hold-short Line and Taxiway Markings on Taxiway H2 (Source: Human Performance Group Chairman)

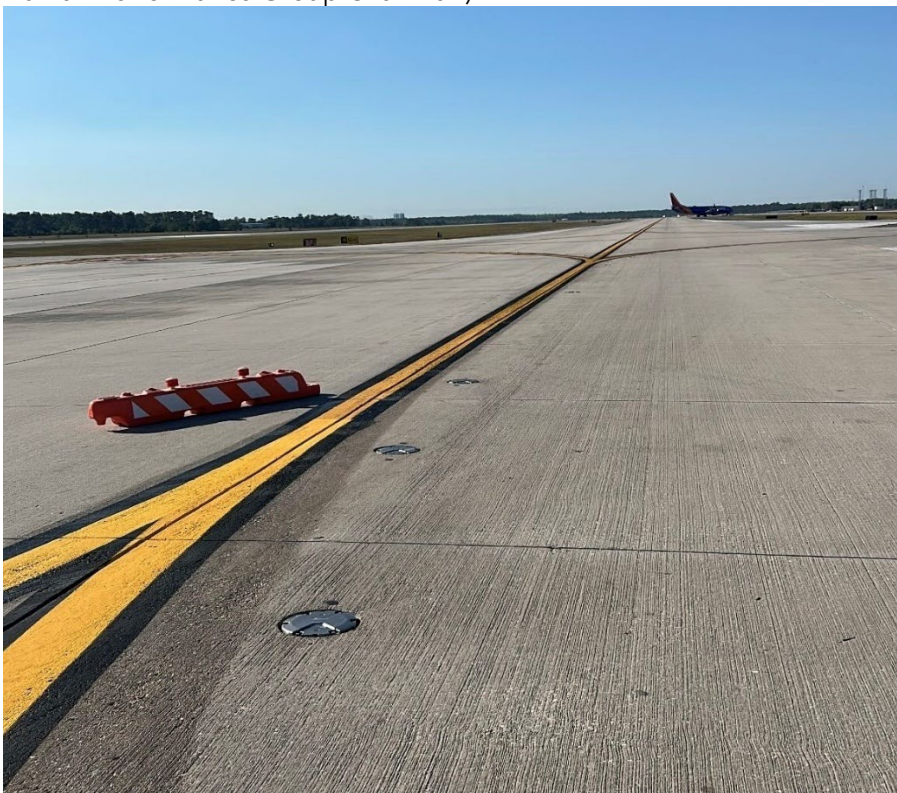
**Figure 8:** Displaced Construction Barricade (Postincident) on Taxiway H. Incident Airplane in Background (Source: Greater Orlando Airport Authority)

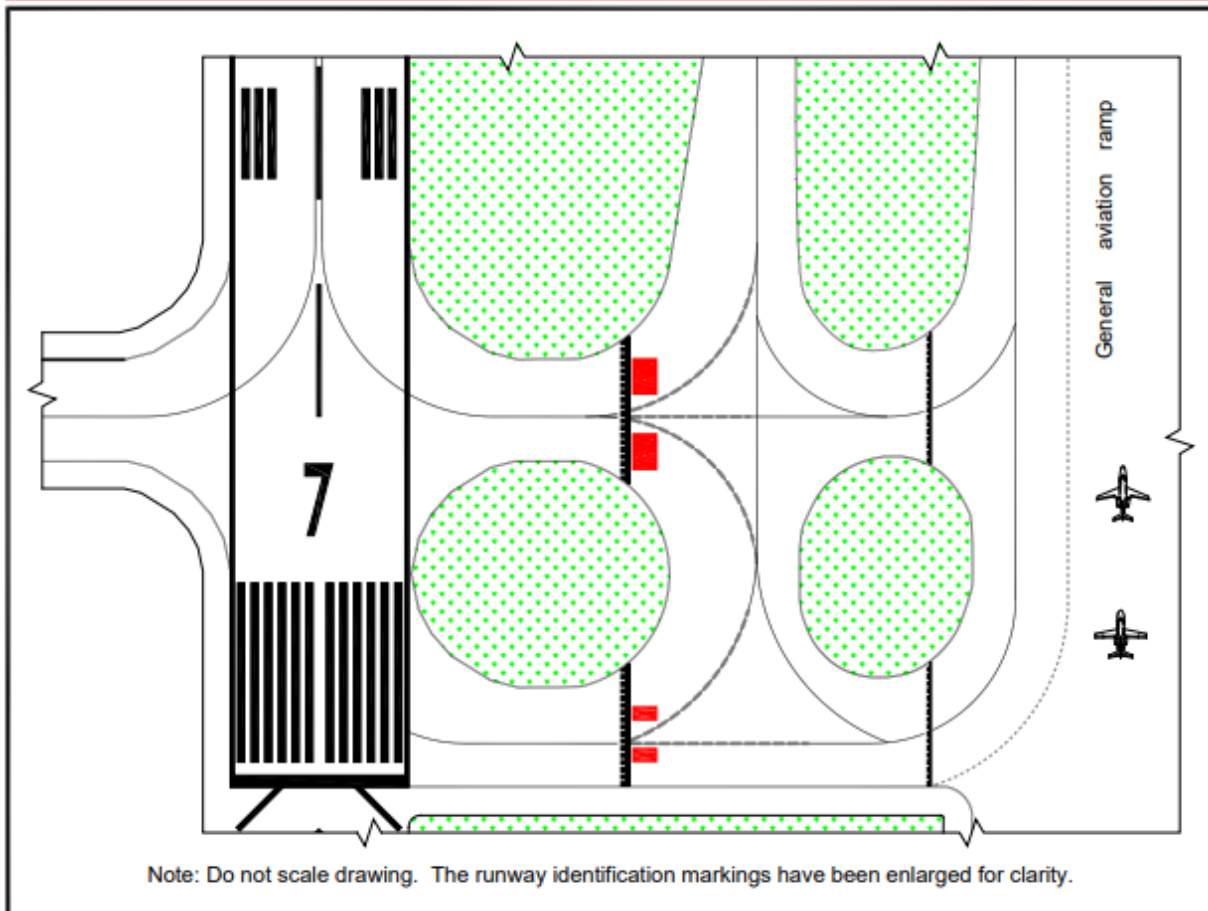
**Figure 12:** Surface Marking Depiction for Parallel Taxiways (Source: FAA)

Precaution should be taken not to paint a non-movement area boundary marking on the outer edges of an apron that is transitioning into a taxiway that leads directly to a runway. Under certain runway/taxiway geometries, such as shown in Figure 5-1, placement of this surface marking where dual parallel taxiways support a runway have resulted in pilots taking off on a parallel taxiway. The concern of such usage is that pilots who expect a nearby runway holding position marking after leaving an apron will confuse these two markings because of their visual similarities, i.e., single dash/single line versus dual dashes/dual lines. It is recommended that the non-movement boundary marking not be located on or just prior to a taxiway that leads directly to a runway.

*Note: The location of movement area markings at these locations may cause pilots errors. For example, to mistake this marking for a runway holding position marking (Pattern A), resulting in a takeoff from the parallel taxiway*
