# Damage Report

Aircraft Type: 787-10

Tail No.: JA986A

## JA986A LH Wing Tip Damage

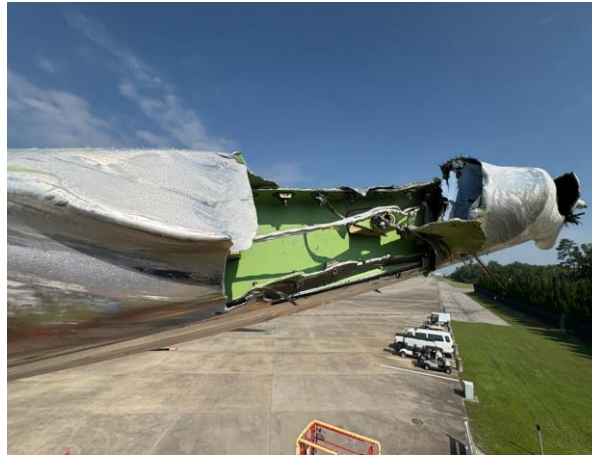
## #1 Removable Wing Tip Assy

The removable tip is severed on the outboard edge.

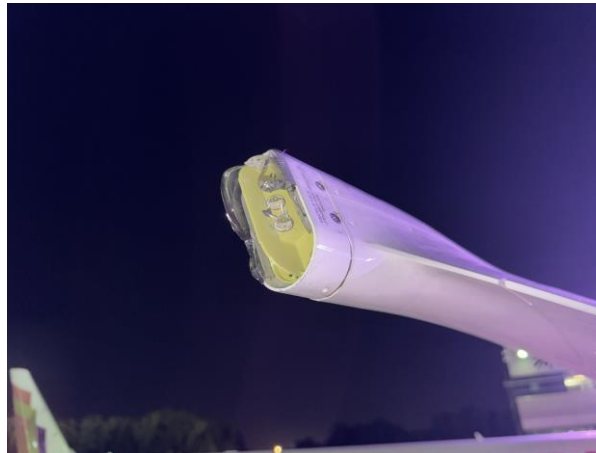
## #2 Aft Position Light

The Aft Position Light Assembly is severed.

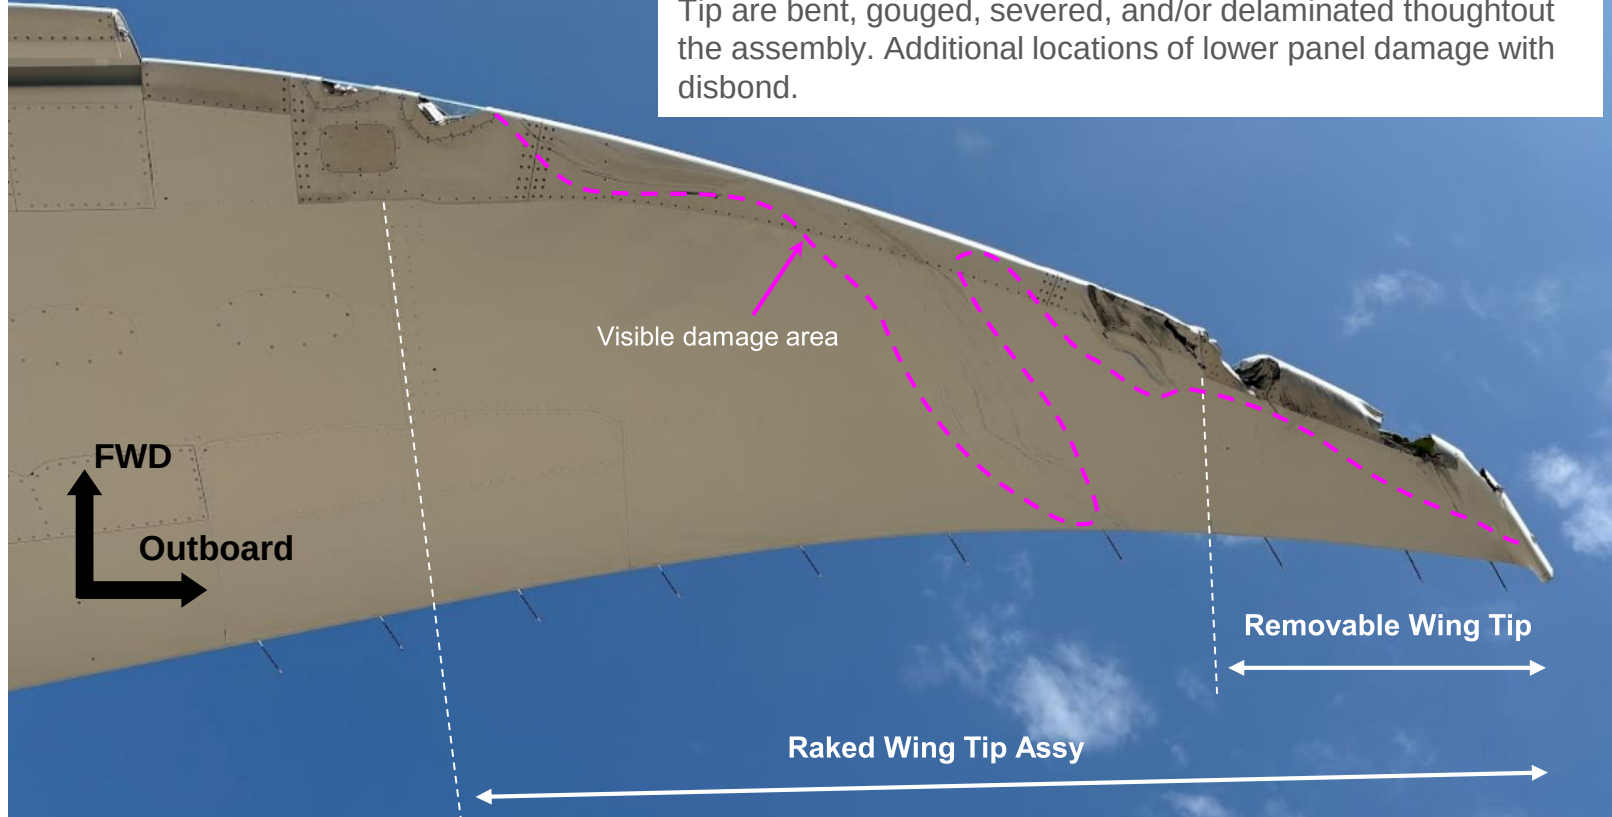
### #3 Raked Wing Tip Assembly

All components common to the leading edge of the Raked Wing Tip are bent, gouged, severed, and/or delaminated throughout the assembly. Additional locations of lower panel damage with disbond.

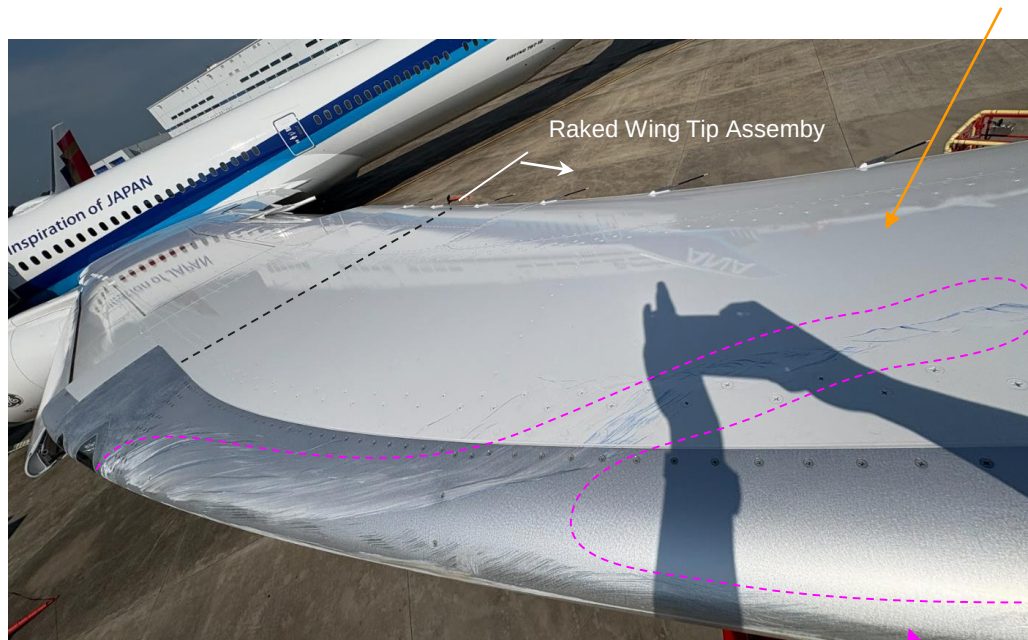
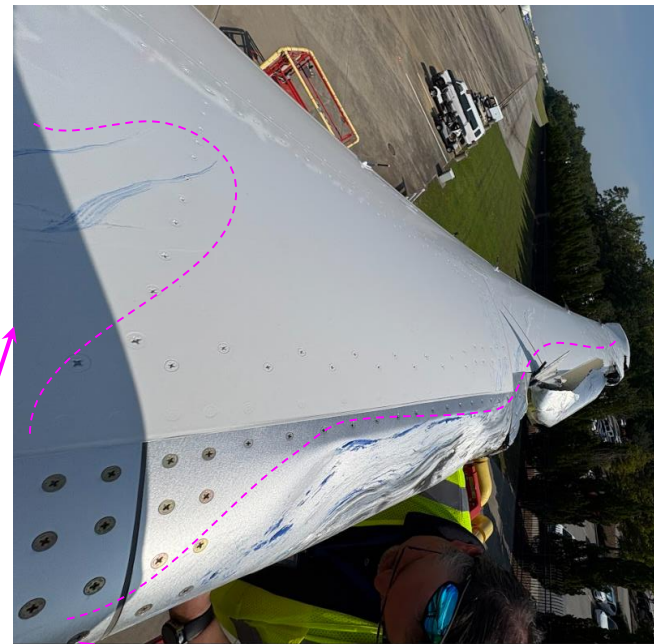
Wing Lower Shown

Visible damage area

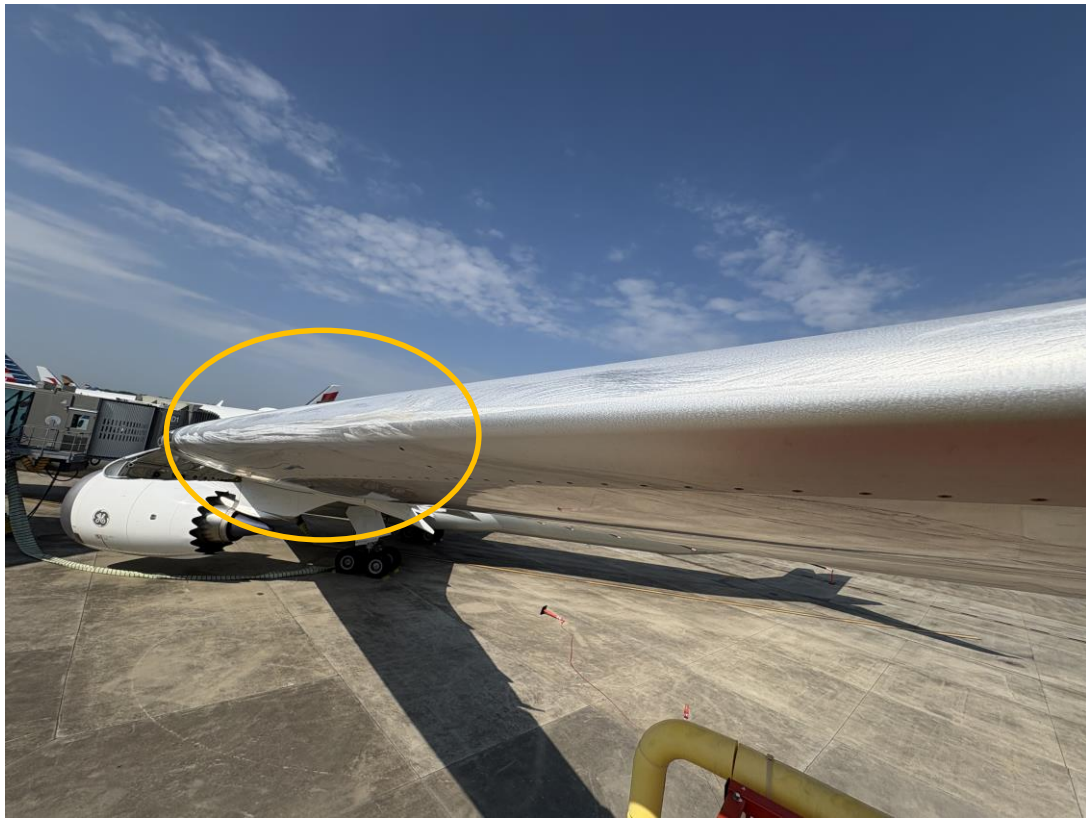
#### #4 Wing Tip FWD Position Light Assembly

The bullnose has multiple areas of scratches and the lense covers are cracked and gouged.

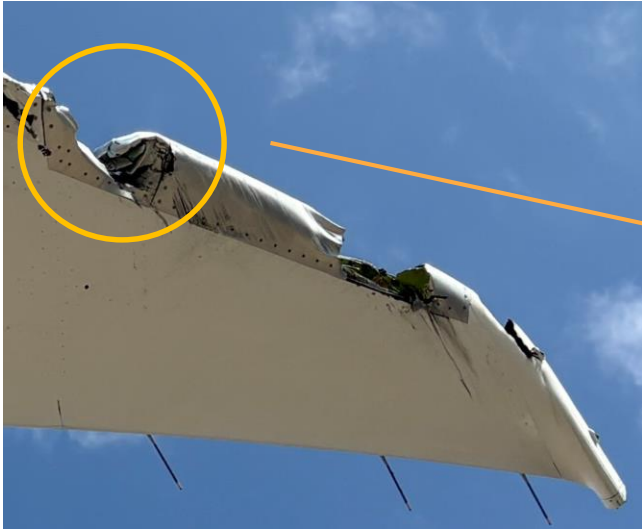
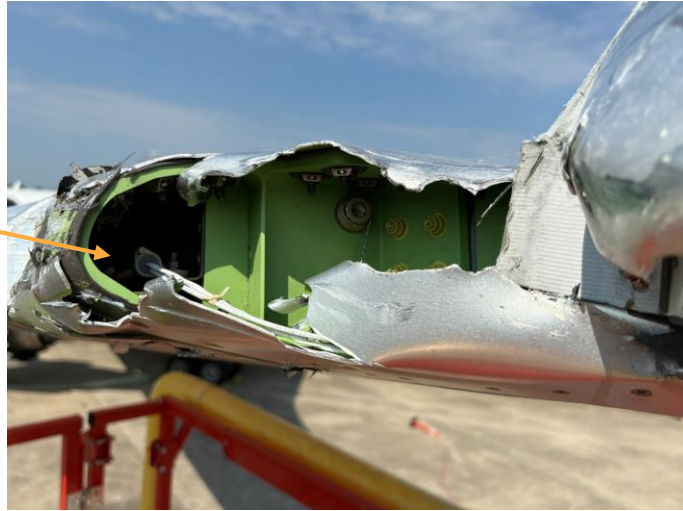
## #5 Wire Harness - Aft Position Light

Damage of Aft position light wire harness is suspect.
