## **Preliminary Event Summary**

### **N247BZ / ANA JA986A Ground Collision CHS**

**Event Type:** Aircraft Ground Damage

**Event Date:** 7/18/2025

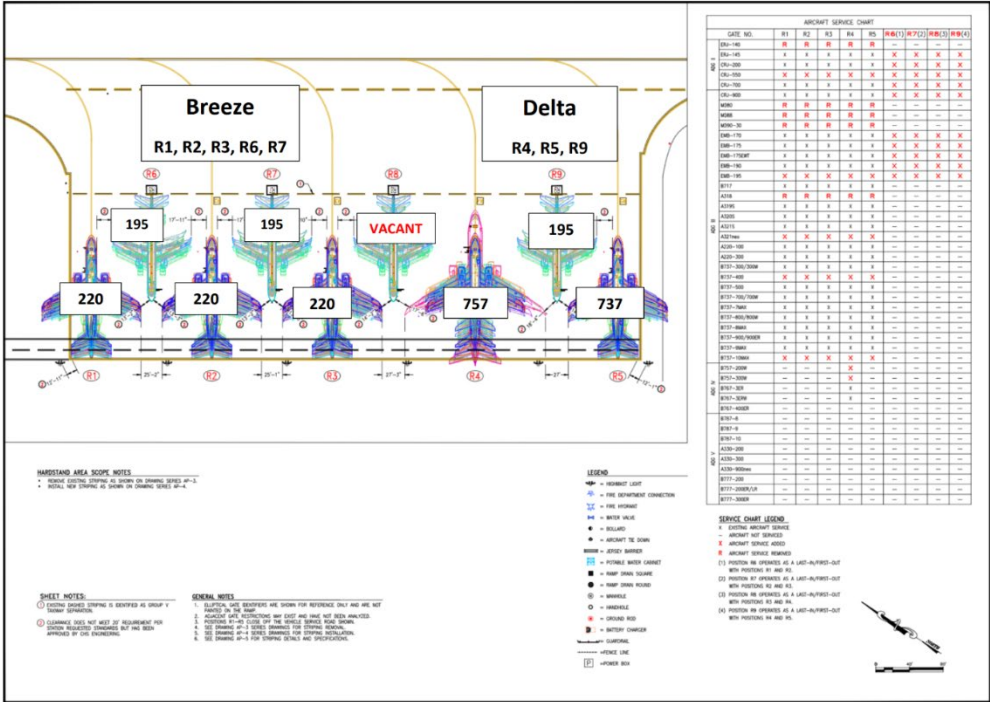
Figure 1 – CHS RON Parking Plan

2. **Parking Spot R6 is not intended for use by A220 type aircraft** – The only approved A220 parking spots in CHS (reference Figure 1) are “tail-in” spots such as R1. The stop bar painted for spot R6 only depicts a parking position for CRJ and ERJ type aircraft. Further, Unifi indicated that R6 has been previously used on multiple occasions for “gas and go” diversion type operations of A220 type aircraft without incident so its usage had become accepted as common practice.

- Brief expectations on use of rated RON parking space with all team members. Only R1, R2 and R3 shall be used.
- Unifi CHS STM Document failures by the supervisor in the employee file (use of nonapproved RON spot, performing a task without the minimum team size, failure to complete huddle and failure to move equipment out of equipment restraint area).

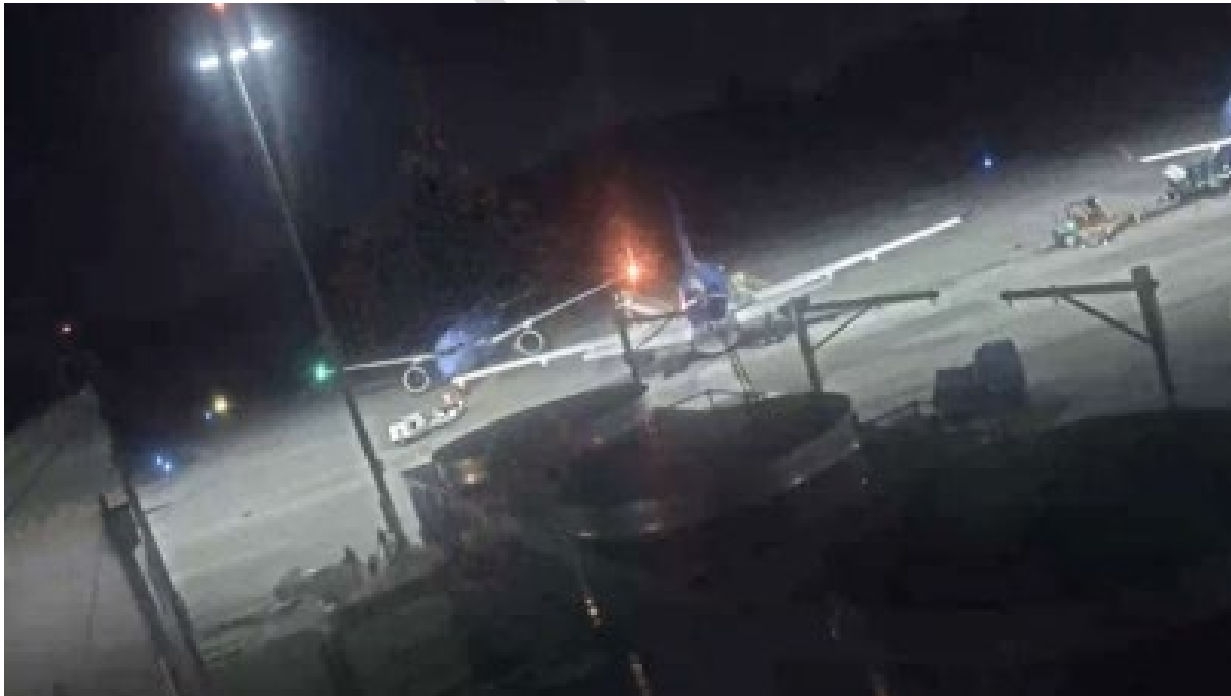
Figure 2a – CHS Fuel Farm Camera Ramp View: Time of Parking

Breeze flight 509 landed in CHS at 0130z based upon ACARS transmitted aircraft data. The aircraft was met and marshalled into spot R6 by one Unifi agent (Figure 2a). The marshaller indicated for the aircraft to stop short of the "stop bar" on the J-line for spot R6 and the pilots complied with his signals. The aircraft was parked at 0136z and remained in this position through the remainder of the event (confirmed by Figure 3). Approximately one minute later, at 0137z, a CHS Airport Ops vehicle approached the aircraft from the opposite side of the ramp and verbally

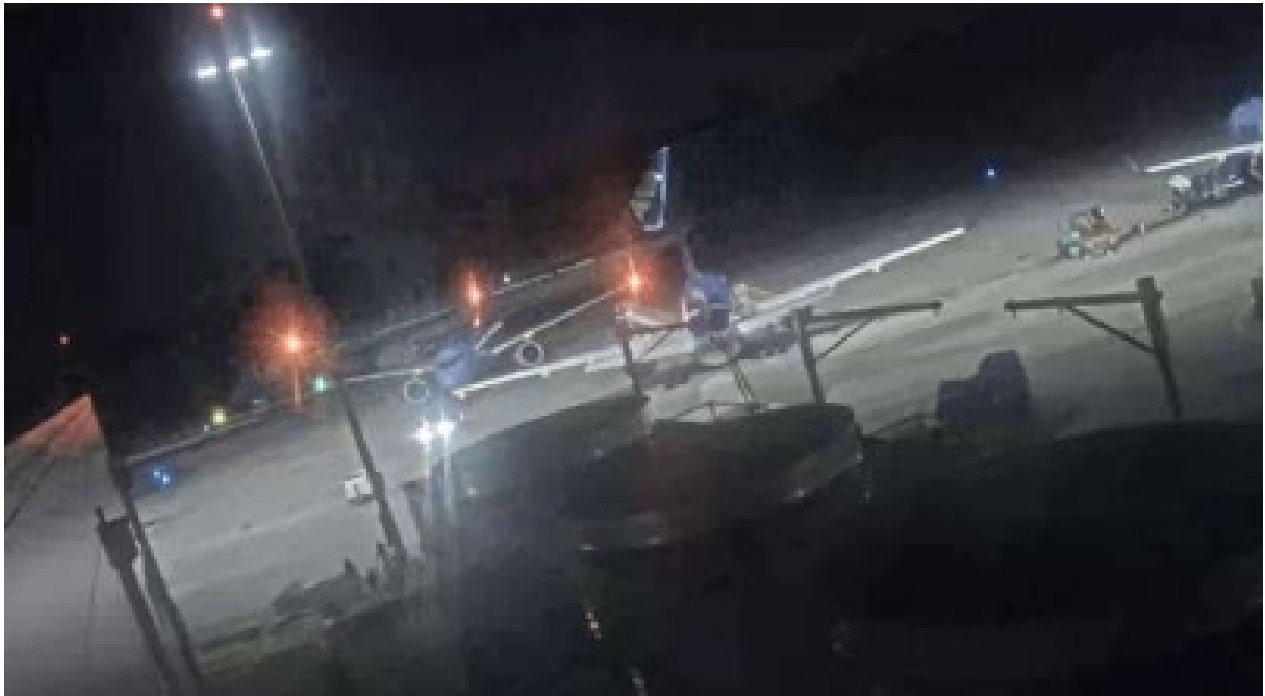
Figure 2b – CHS Fuel Farm Camera Ramp View: Time of Collision

After the conversation with Airport Ops, the Unifi agent reapproached the aircraft and repositioned out of the immediate area a GPU cart that had been pre-staged in front of the aircraft and in the vicinity of the stop bar for spot R6. The agent then connected via headset to the aircraft to discuss repositioning options with the pilots (whether to re-start engines and taxi or connect the tug and tow forward). The joint decision was made to have the tug connected and the aircraft towed forward. The crew reactivated the seat belt sign and the PIC monitored the aisle to ensure that all passengers retook their seats. The Unifi agent began making preparations to connect the aircraft to the tug (the tug was a “towbar-less” type). At 0141z, as the Unifi agent was in the process of connecting to the aircraft, the crew felt a sudden impact, heard unusual noises, and perceived sounds resembling tires screeching. The PIC believed the tug may have been engaged improperly, causing unintentional aircraft movement. The UNIFI agent then used the headset and informed the crew that the aircraft had been struck by a Boeing aircraft. Post-event video and picture review confirmed that an ANA B787-10 on taxiway M made contact with the Breeze aircraft when taxiing through the area (taxiway located immediately adjacent to the RON pad) and its left wing impacted the rudder/tail section of N247BZ at approximately 21:41 EDT when attempting to pass behind the aircraft, (refer to visual aids for impact areas). Approximately five (5) minutes elapsed from time of parking to the time that the collision occurred.

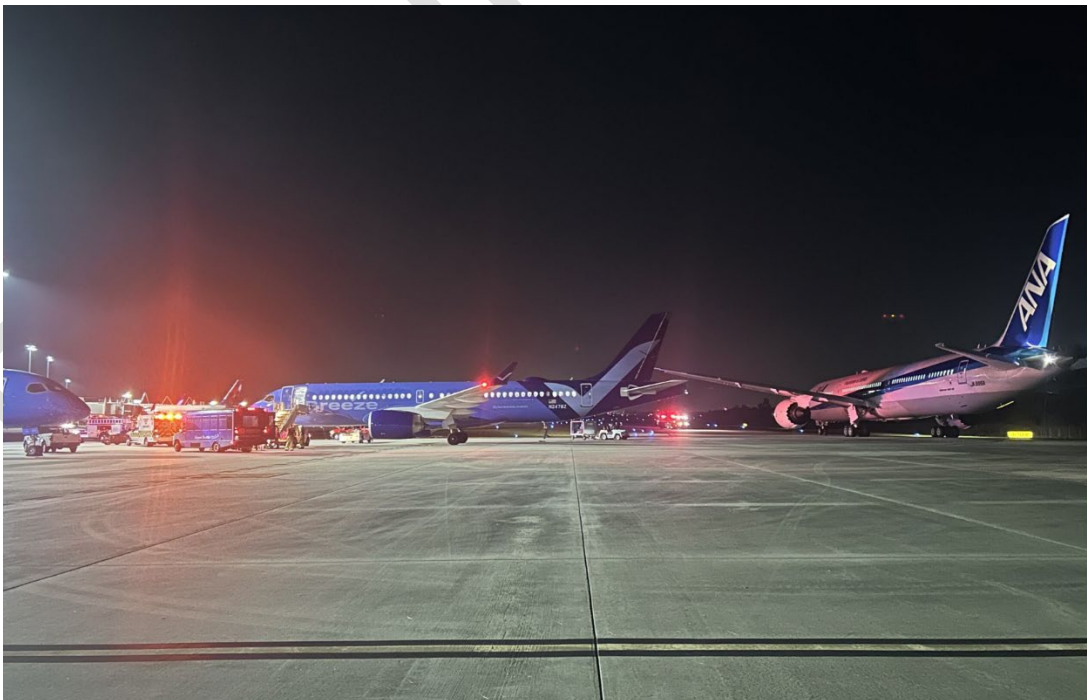
Figure 3 – Ramp/Taxiway Wide View

3. **N247BZ was parked using non-standard procedures and with its tail protruding into Taxiway M** – No wing walkers were used during parking, a pre-arrival huddle was not conducted, and an equipment restraint area (ERA) was not setup prior to aircraft arrival. Additionally, a GPU was located near the J-line of spot R6 which prevented the aircraft from being parked fully forward. The aircraft was parked approximately 40-feet short of the stop bar painted for spot R6 and the tail was protruding approximately 10-feet over a “clearance line” on the RON ramp. For background, this clearance line exists to provide visibility on where parked aircraft must clear to ensure adequate taxiway separation.

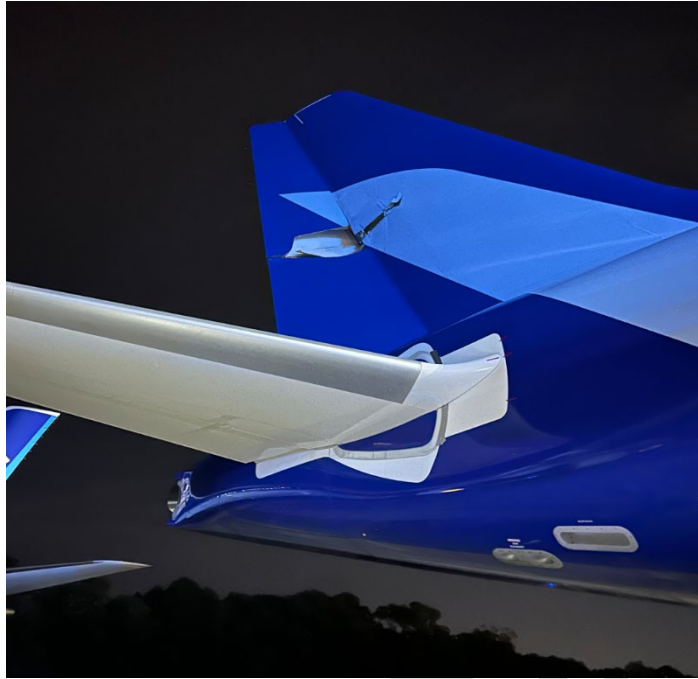
Figure 4a – 247BZ RH Tail

On the evening of July 18, 2025, the tail of aircraft N247BZ that was parked at CHS RON pad spot R6 following the weather diversion of Breeze flight 509 was struck by the lefthand wing of an ANA Boeing 787-10 (JA986A) as it taxied behind and past on taxiway M. N247BZ sustained substantial damage to the vertical stabilizer, rudder, and rear cone (see reference photos). The ANA B787-10 sustained damage to the outer section of the left-wing (see reference photos).
