**Charleston Regional Aviation Authority**  
**Incident Report – Boeing 787/Breeze A220**  
**Date of Occurrence:** July 18, 2025  
**Location:** RON Ramp/TWY M at CHS Airport

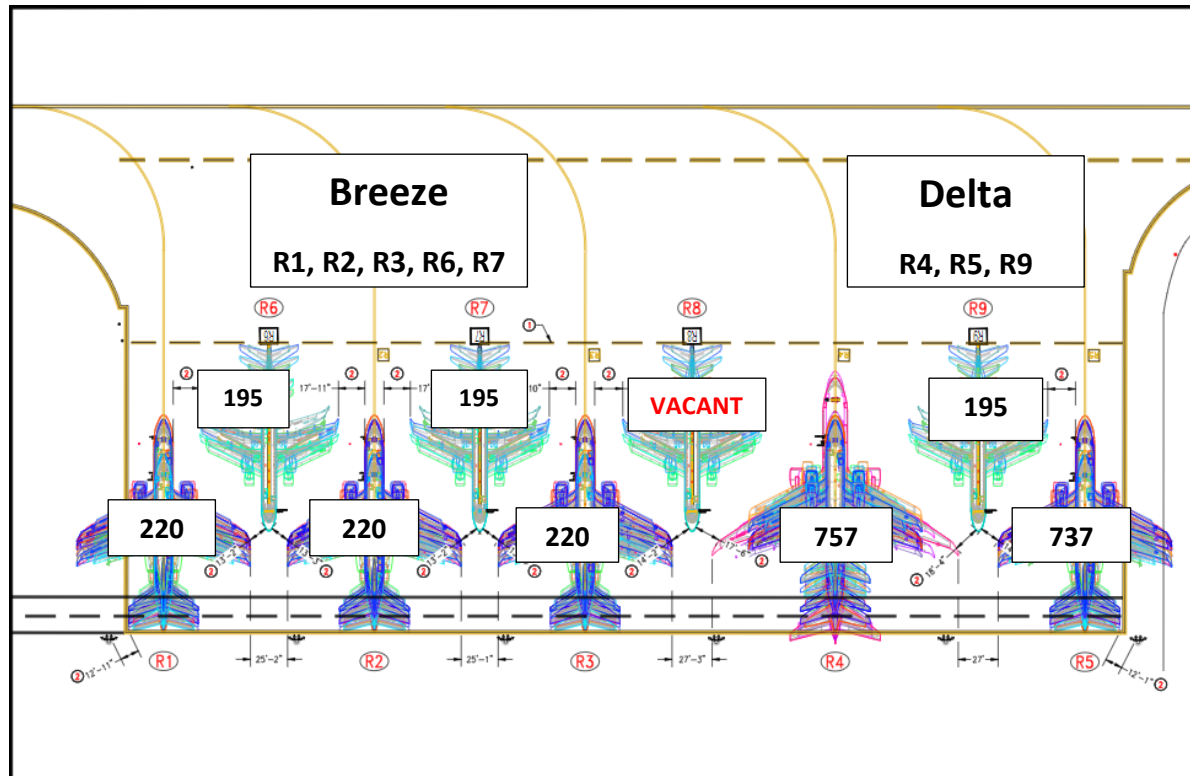
# Zipper Parking RON Ramp

Upon arrival at approximately 2130L, the aircraft proceeded to the RON ramp. Unifi personnel Neal Dennis, Jr. was present to marshal the aircraft. However, the A220 was parked nose-in on Spot R6 instead of the assigned R1. CRAA Airport Operations (Kidd) requested that the aircraft be repositioned to R1. The carrier acknowledged the request.

- EXISTING DASHED STRIPING IS IDENTIFIED AS GROUP V TAXIWAY SEPARATION.
- CLEARANCE DOES NOT MEET 30' REQUIREMENT PER STATION REQUESTED STANDARDS BUT HAS BEEN APPROVED BY CHS ENGINEERING.

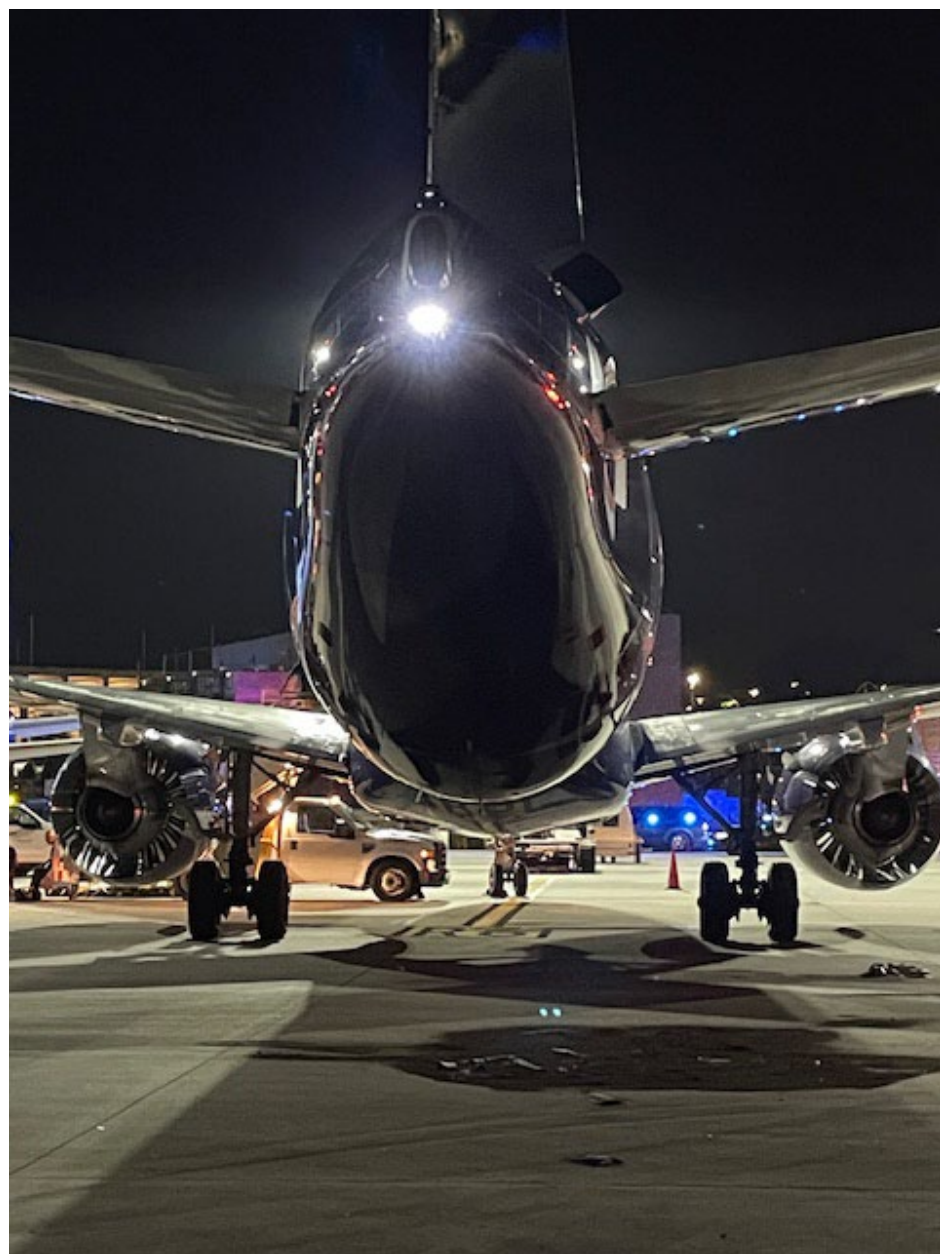
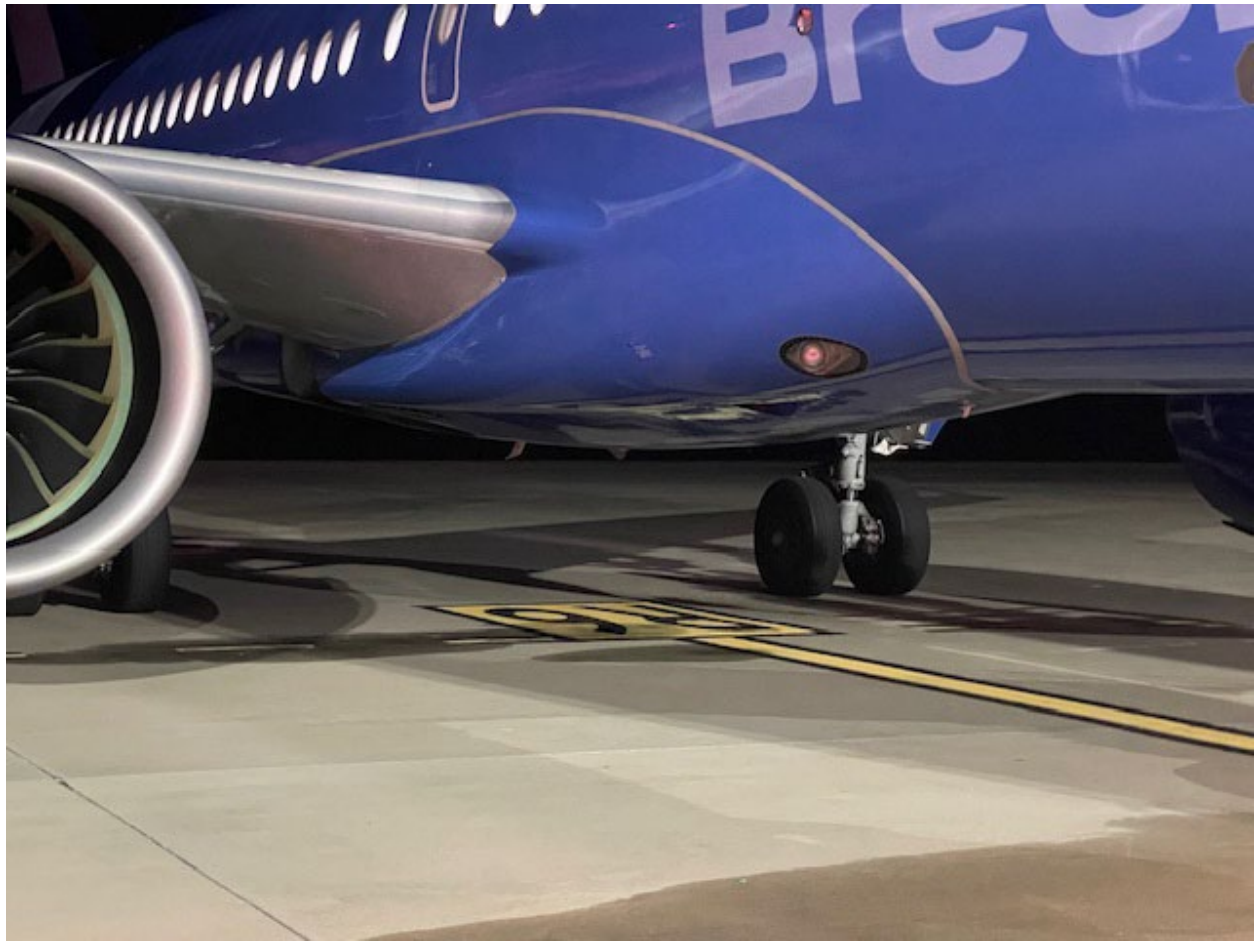
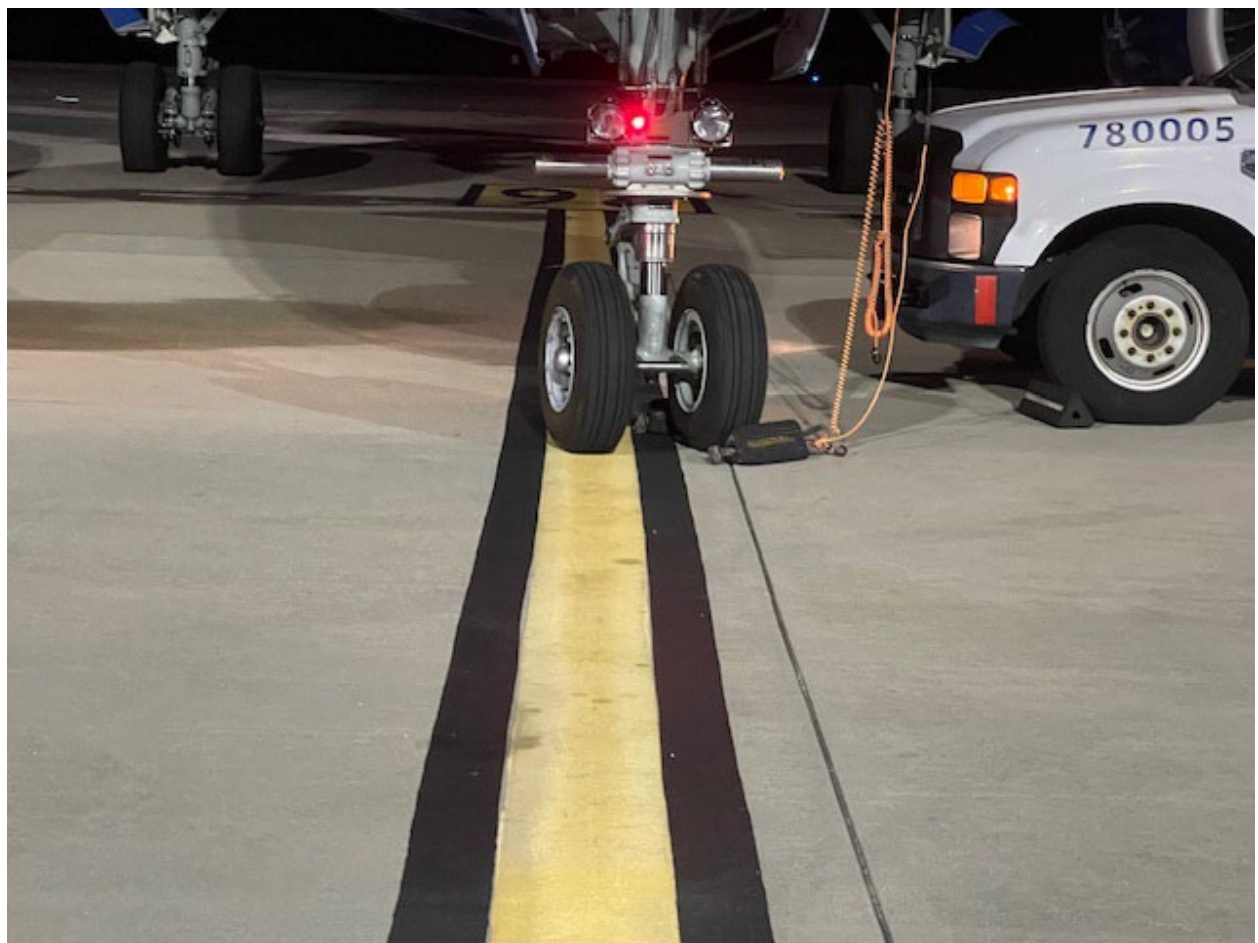
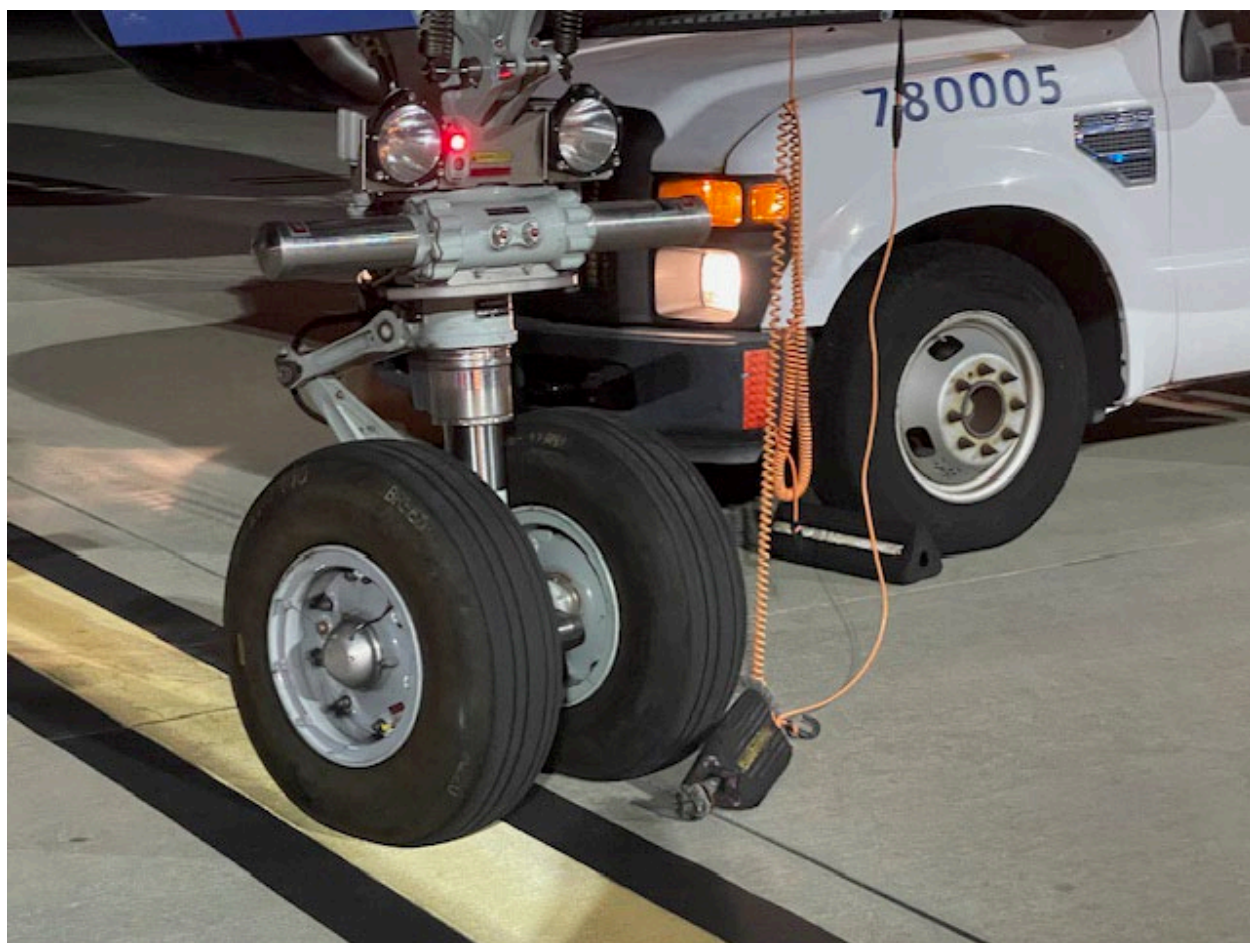
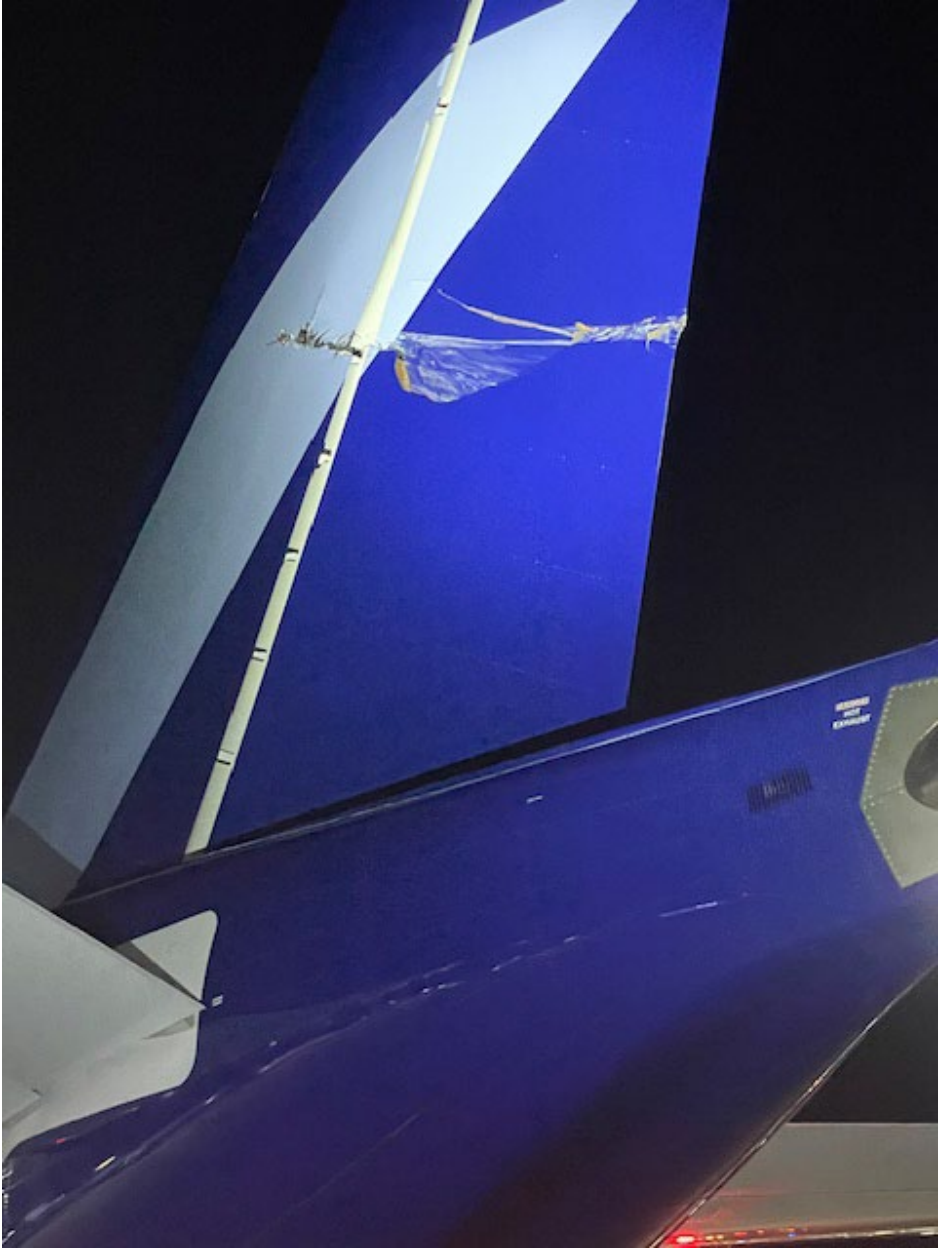
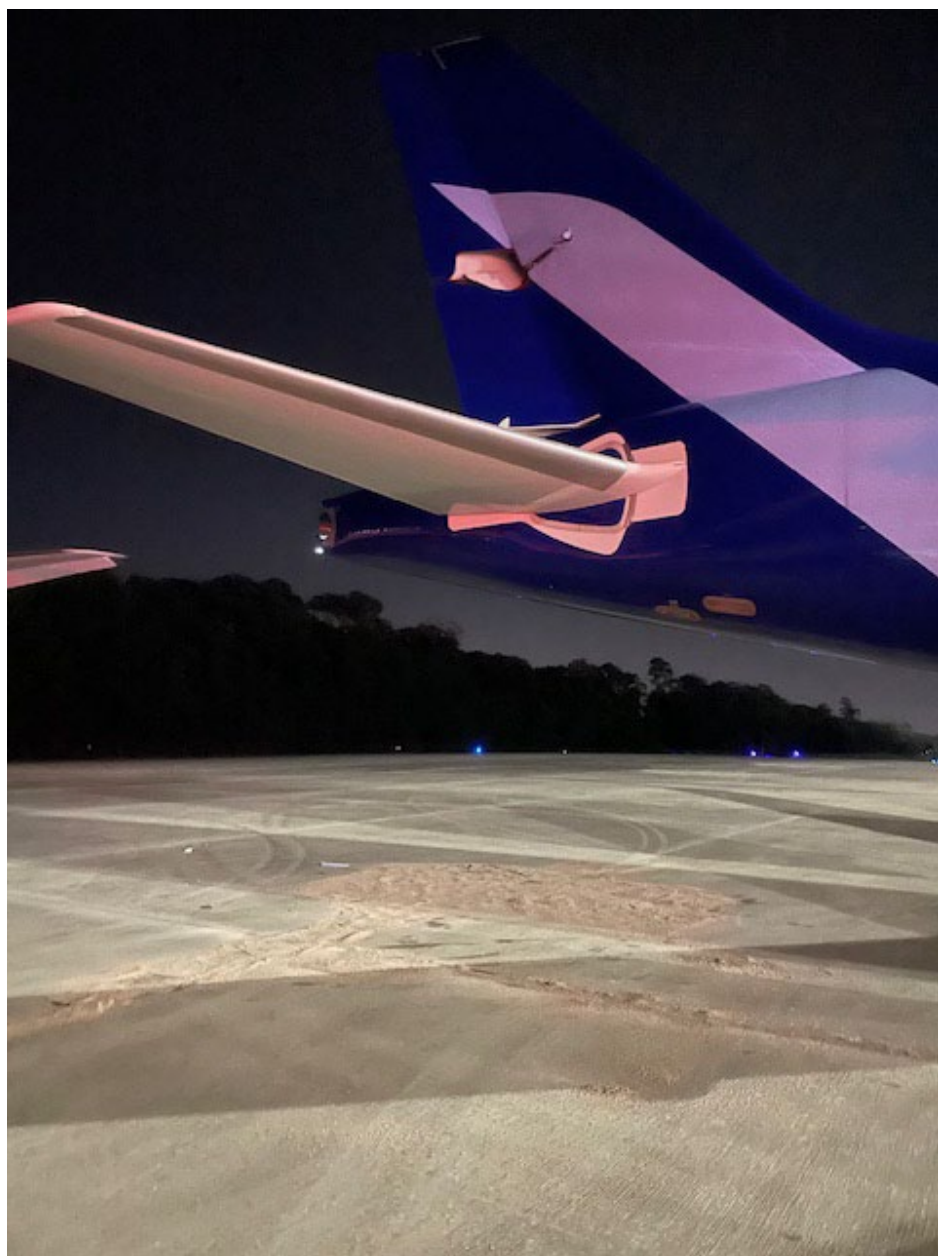
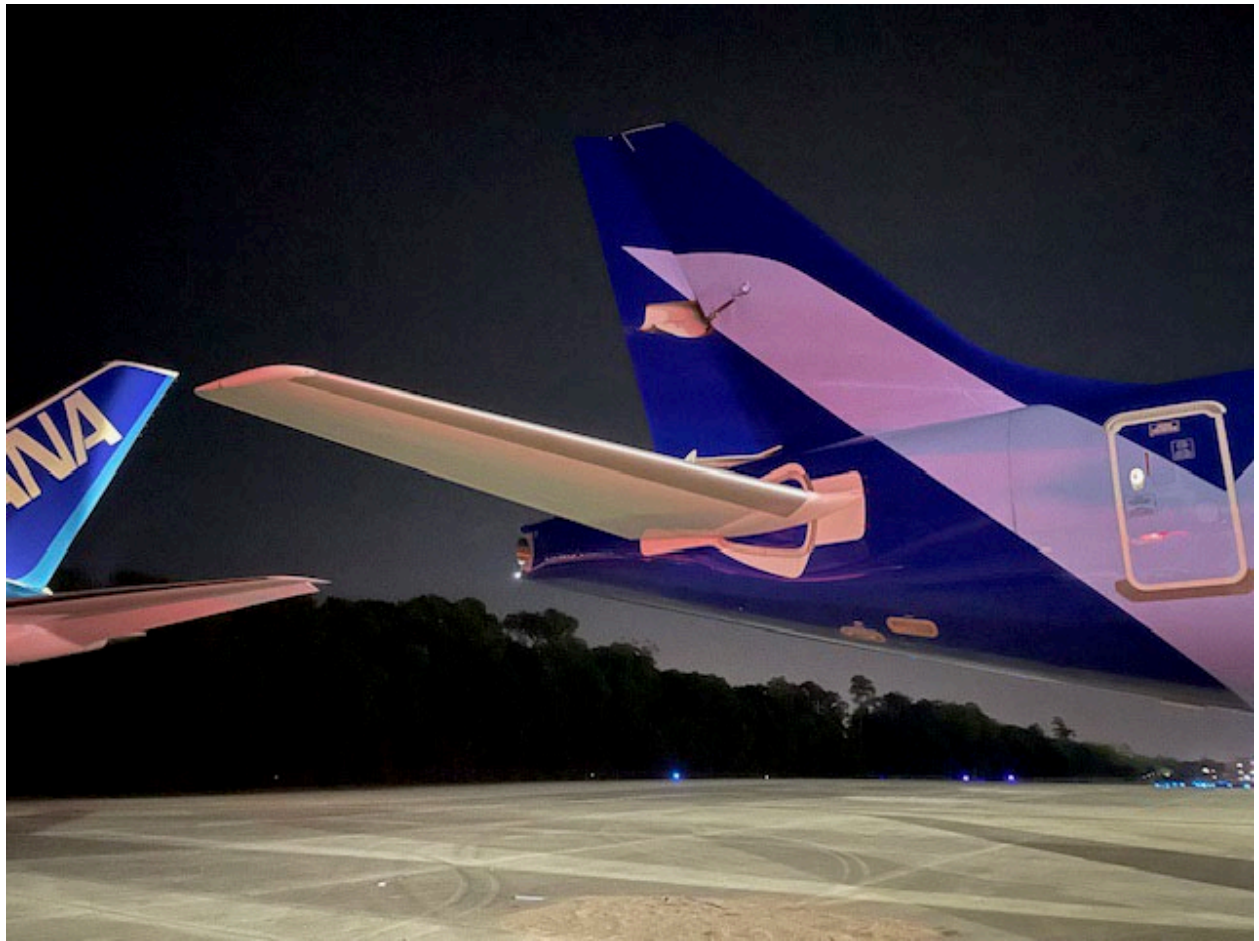
Subsequently, a Boeing 787 aircraft (tail number **JA986A**) taxied on Taxiway M from the Boeing ramp came into contact with the Breeze Airways aircraft. The 787's left wing struck the tail section of the A220. The aircraft stopped on Taxiway M following the contact.

A hydraulic leak from the Breeze A220 was contained with absorbent material by USAF CFR. FAA clearance was obtained to move both aircraft after assessment. Boeing's tow team, led by Josh Maynard, towed the 787 back to the Boeing ramp. The Breeze aircraft was also repositioned off Taxiway M's safety area.

*Photos documenting the aircraft damage are attached to this report.*
