# DCA25LA275 – American Airlines 3023 Boeing 737-8, N306SW

Denver, Colorado

July 26, 2025

# LMLG Tire and Wheel Failure

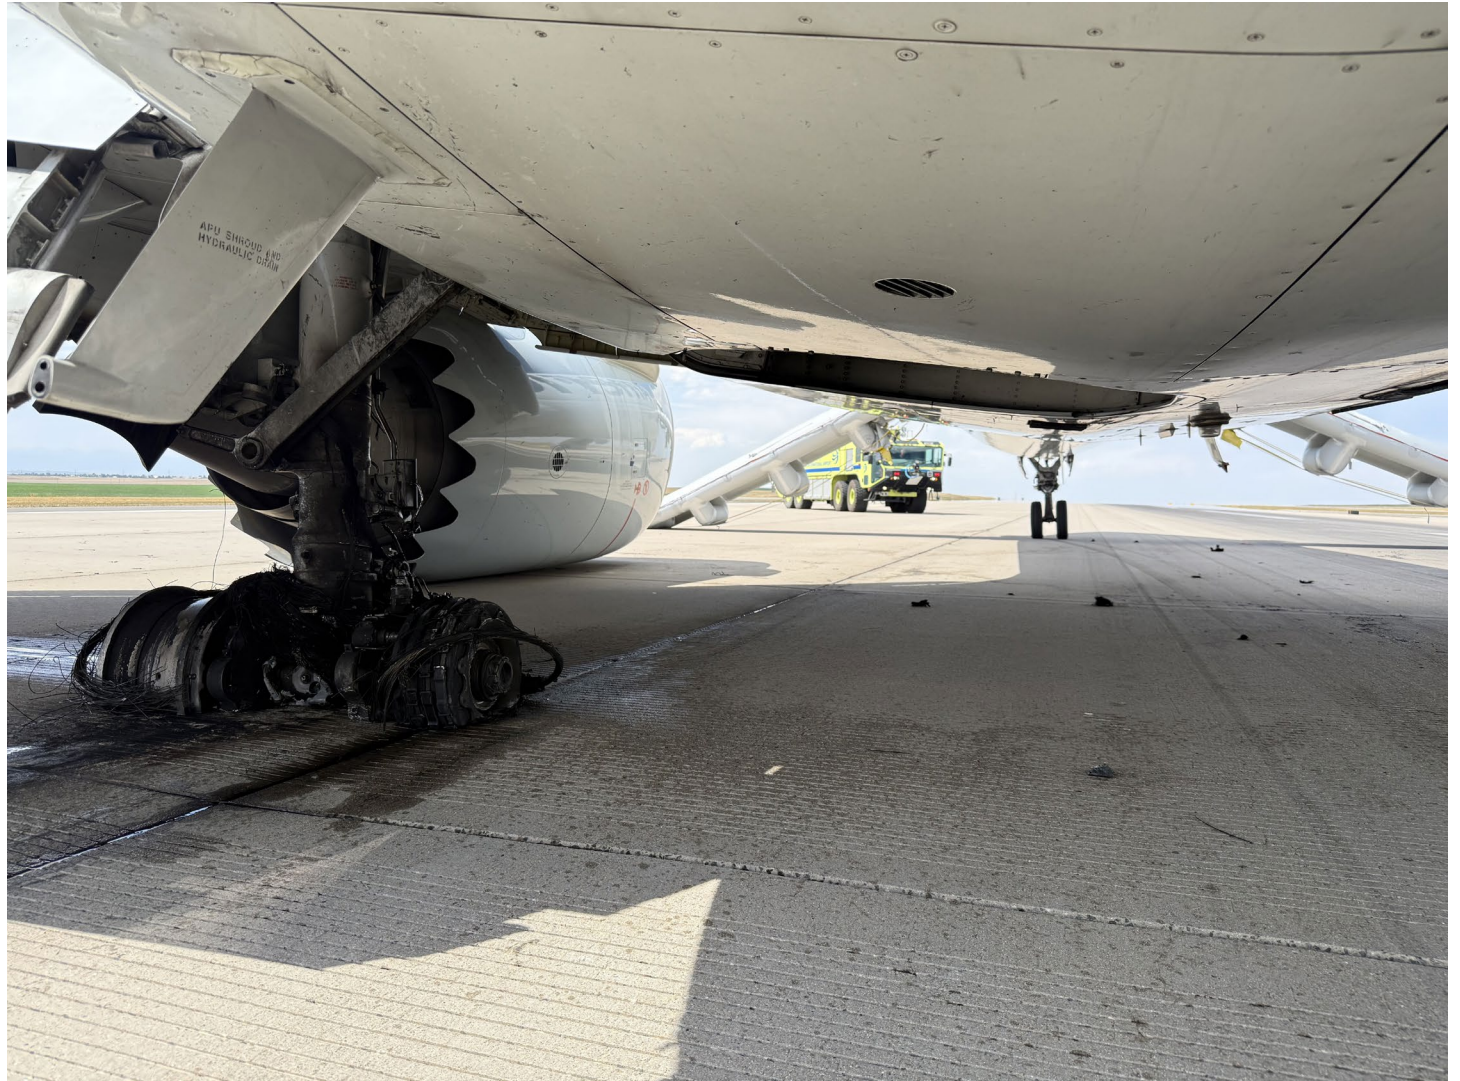
- View looking forward
- Both tires separated
- Left OB wheel partially intact
- Left IB wheel fractured and separated

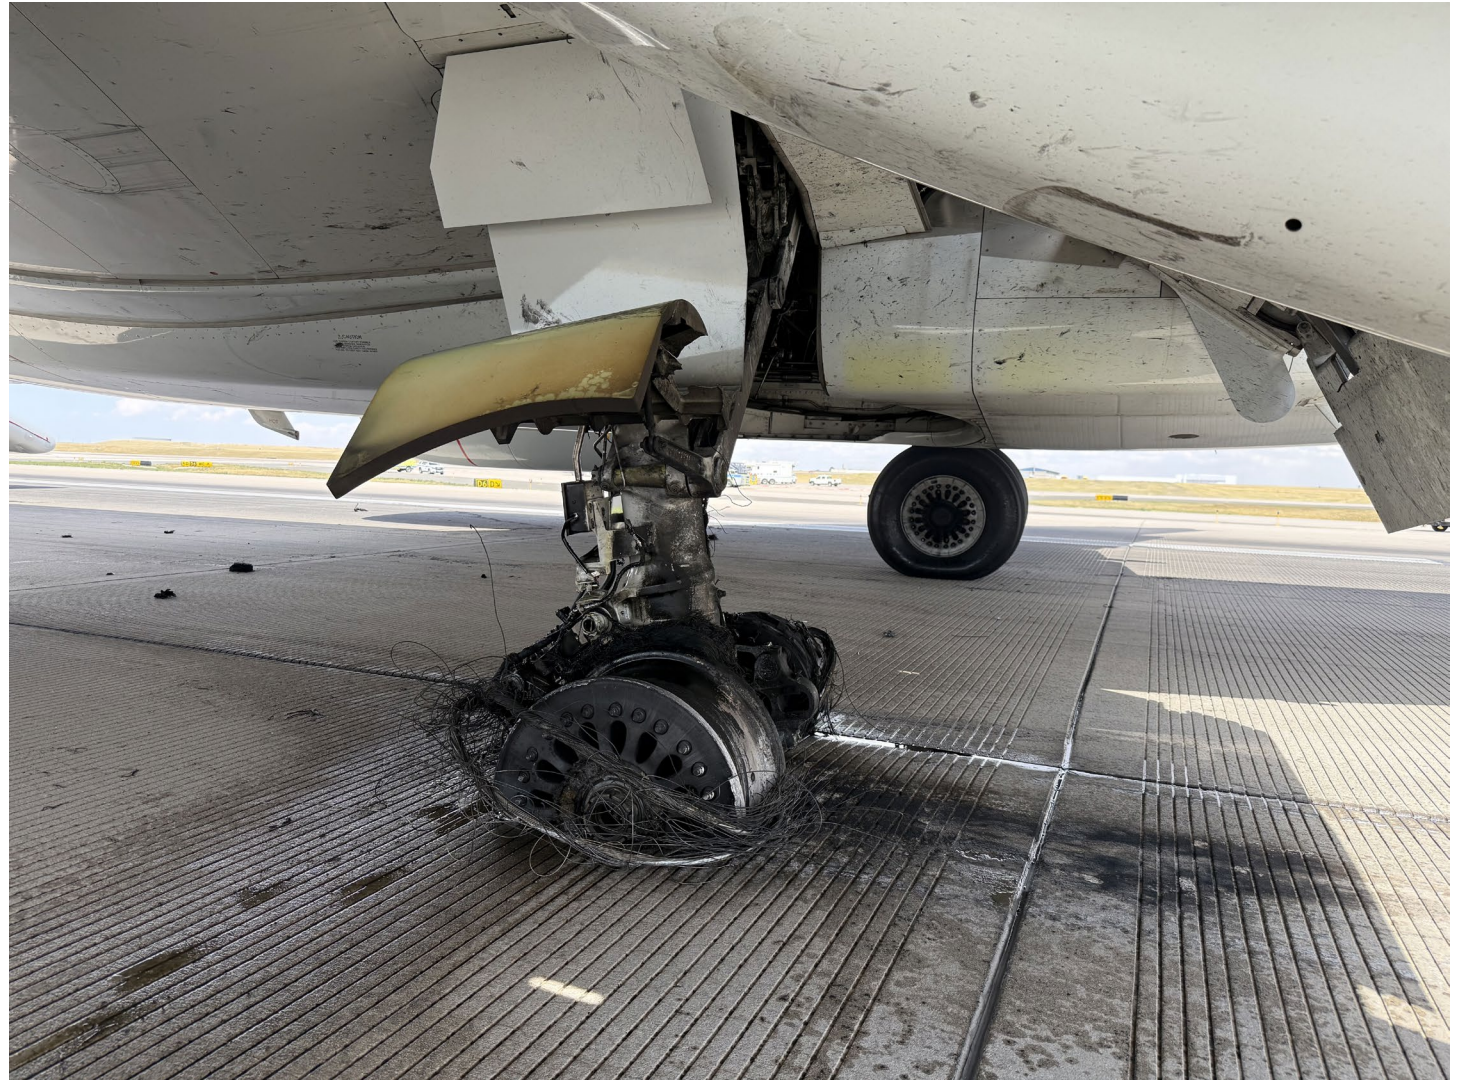
# LMLG Tire and Wheel Failure

- View looking inboard
- Left OB wheel partially intact

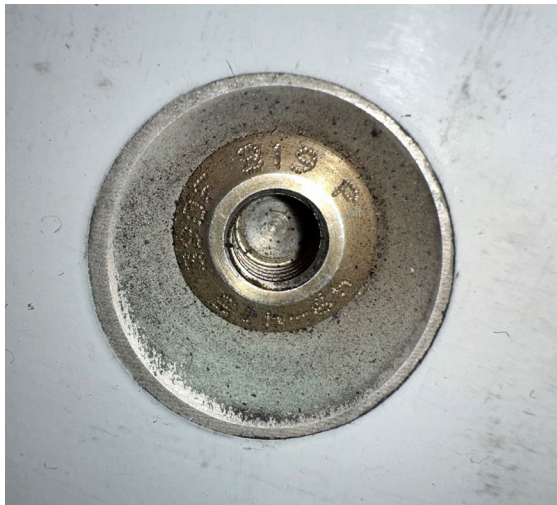
# 737-8 Wheel

- Equipped with 4 Thermal Relief Plugs per wheel
- Relieve tire pressure in overheat condition
- Press fit in wheel with o-ring

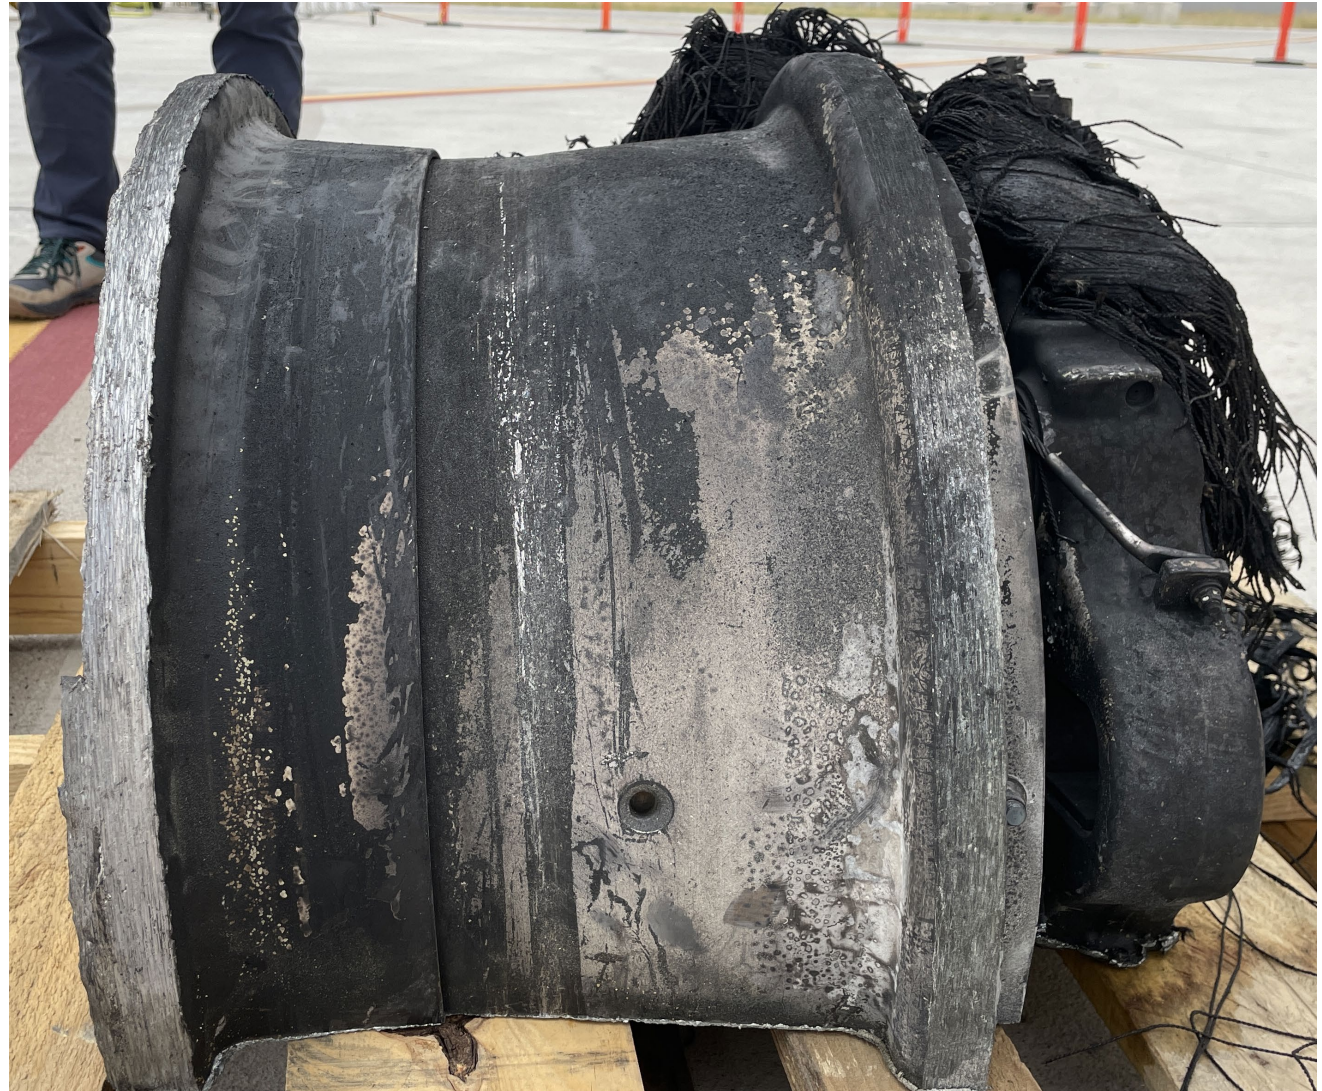
## Left OB Wheel

- View looking forward

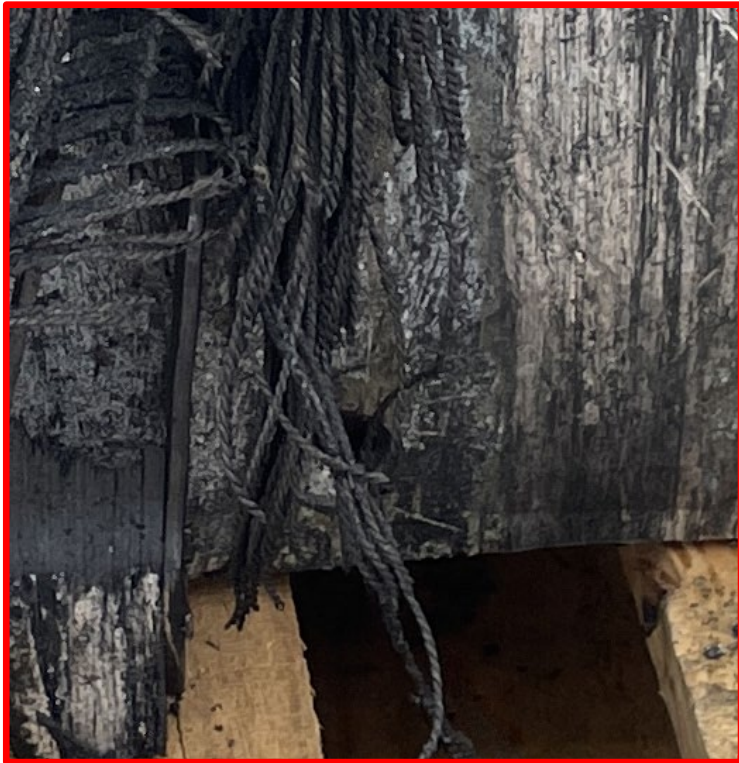
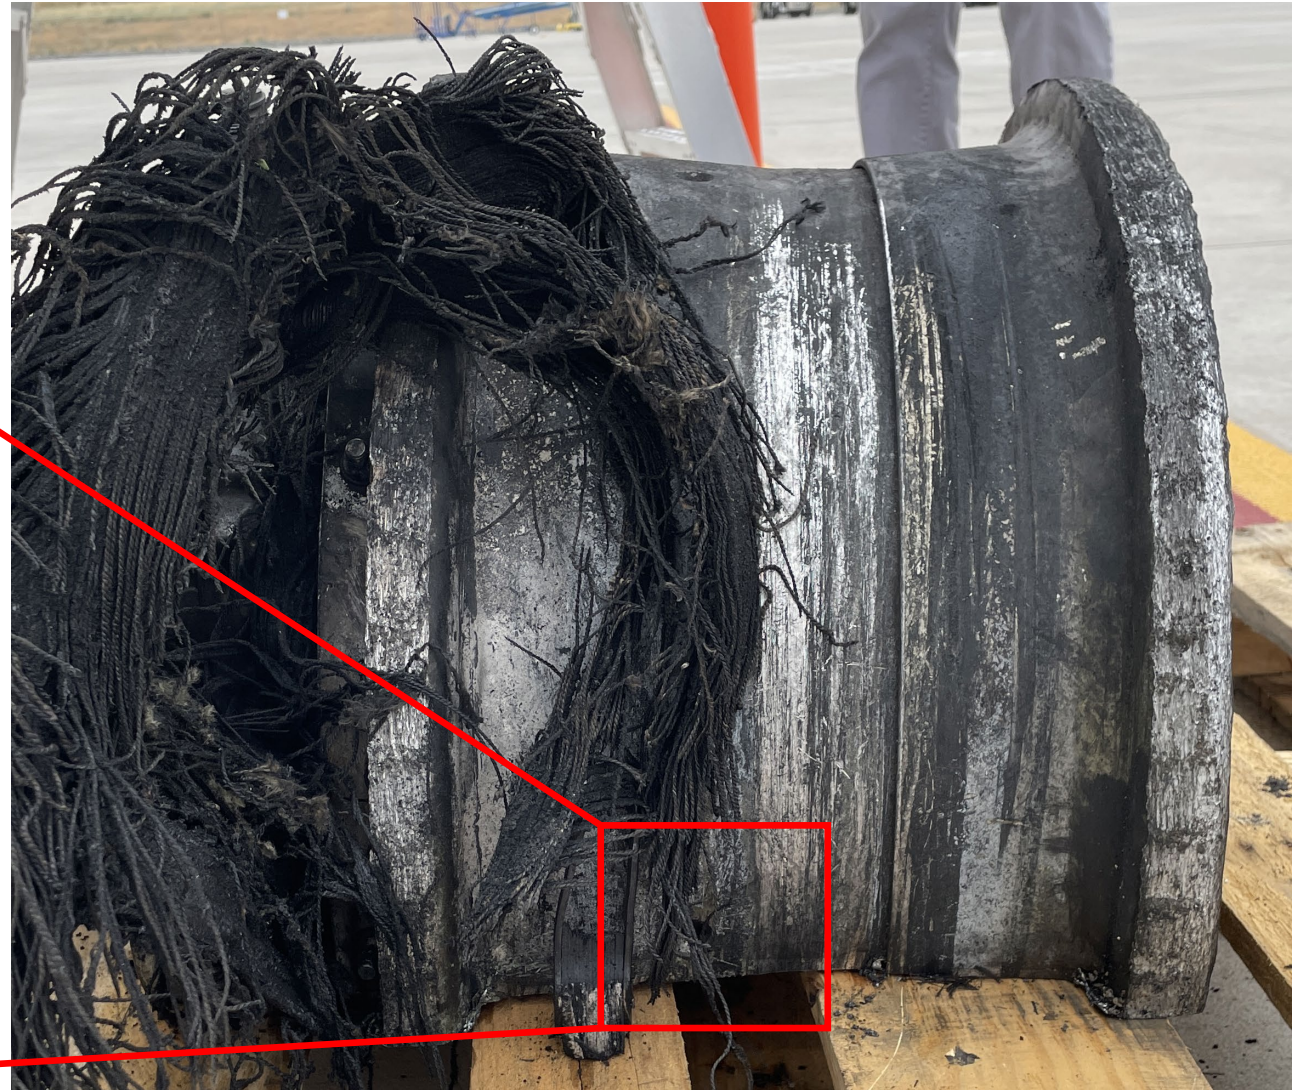
## Left OB Wheel

- View looking aft

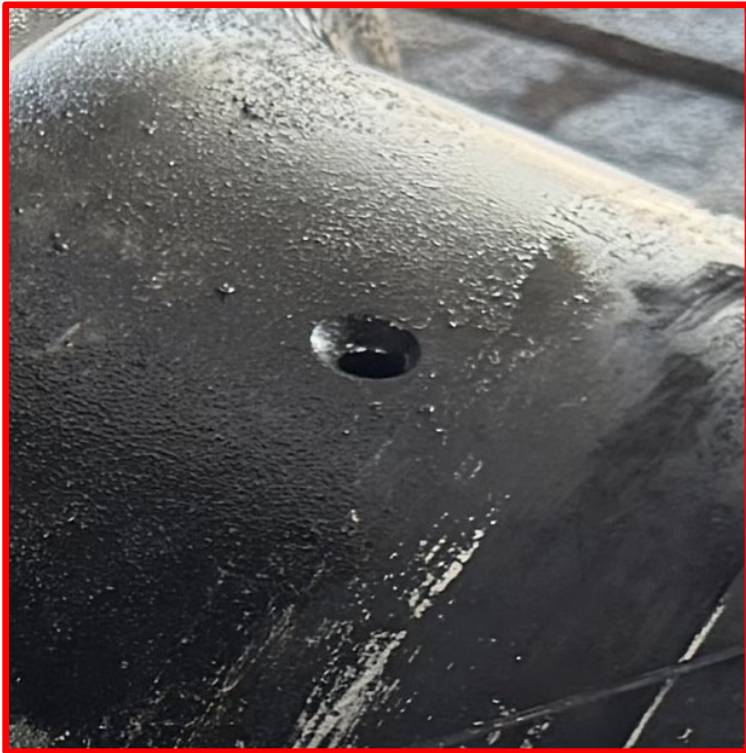
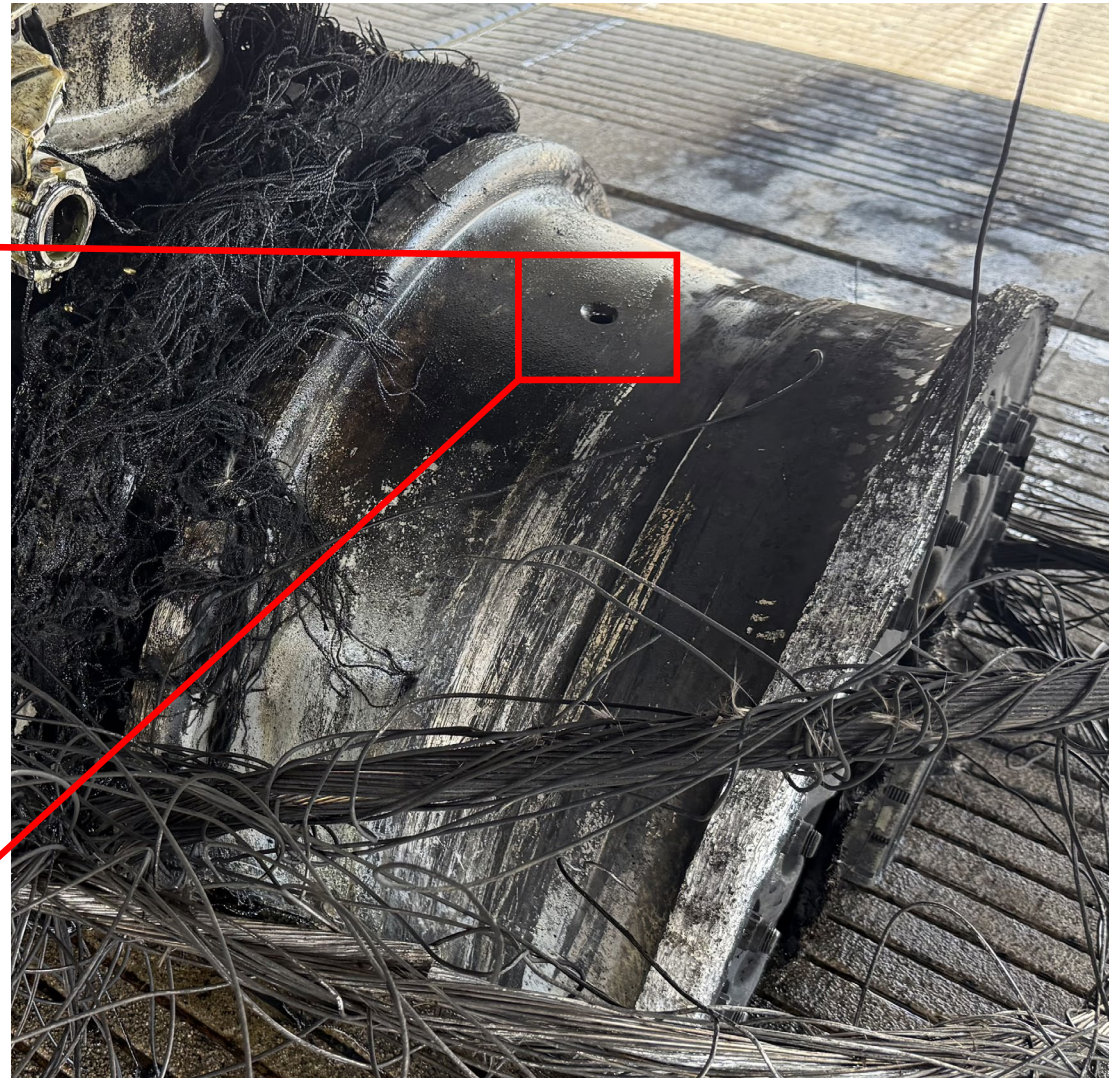
# Left OB Wheel

- View looking down and aft

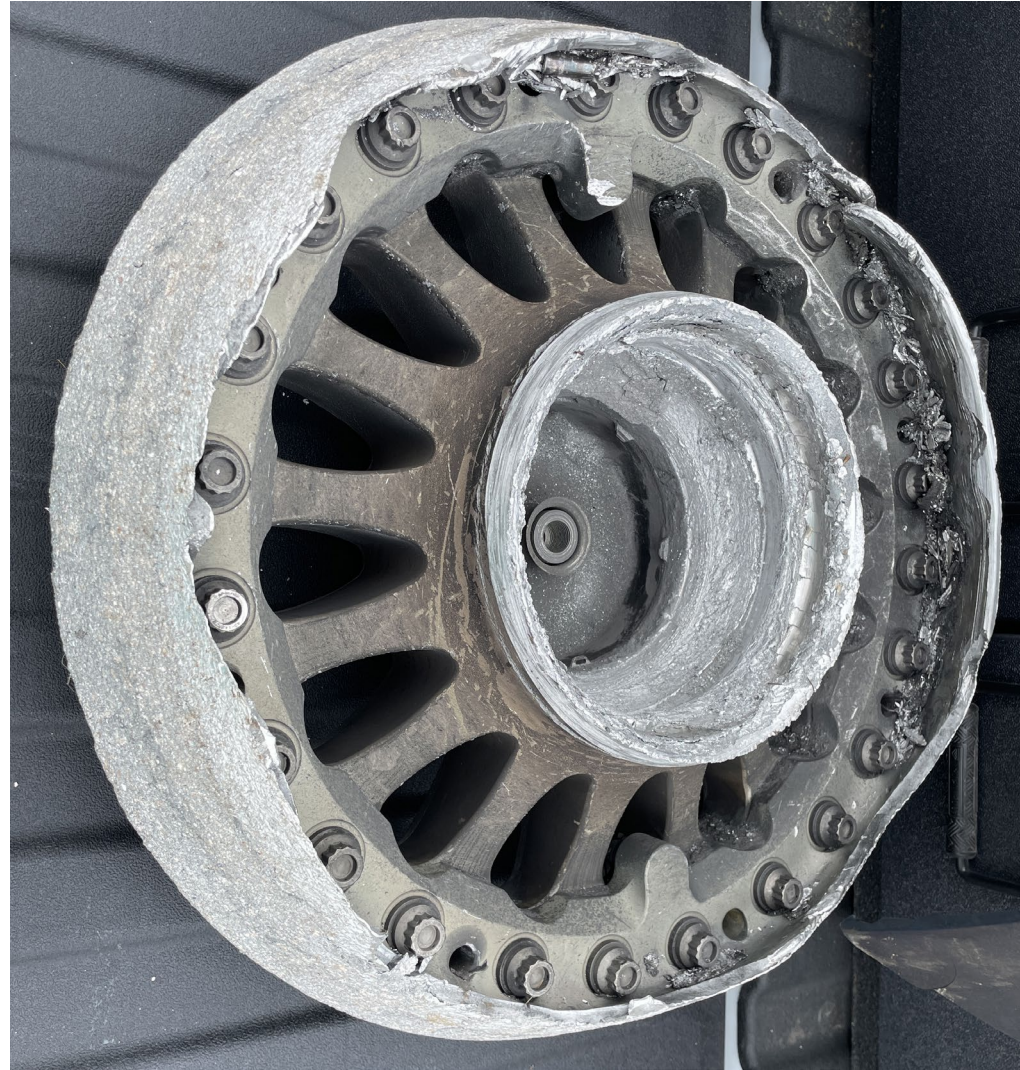
## Left IB Wheel

- Outer wheel half
- Severe rolling abrasion

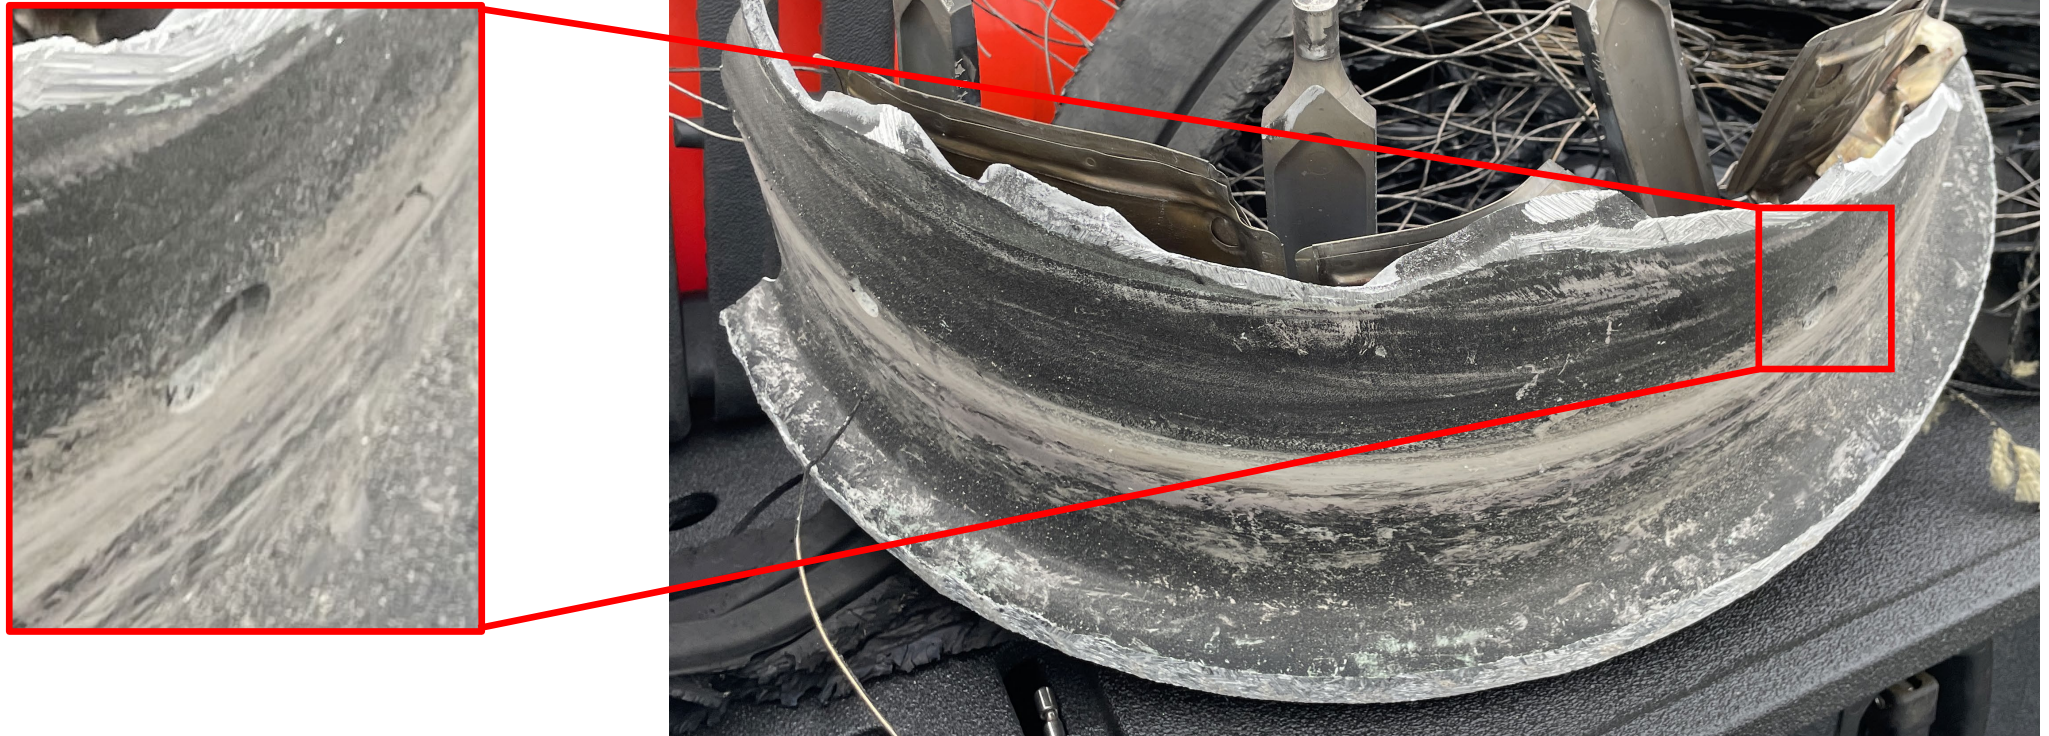
## Left IB Wheel

- Inner wheel half fragment
- Recovered on/near runway

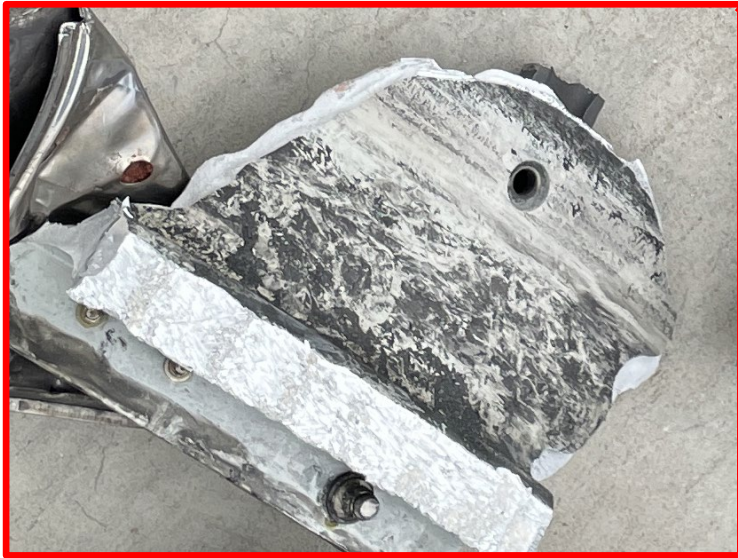
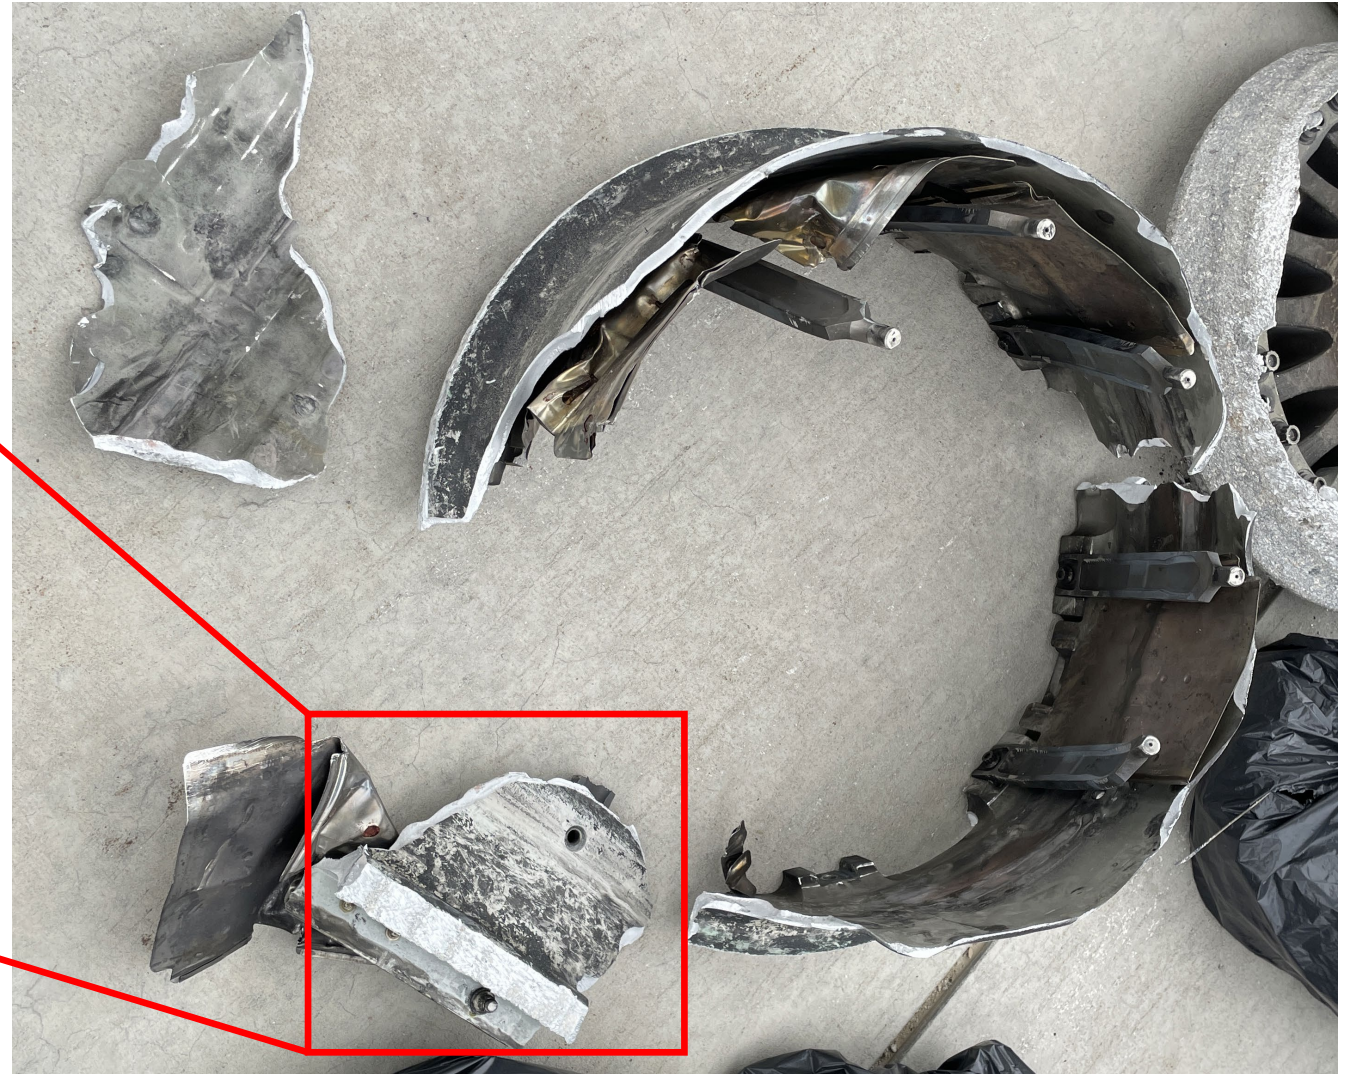
## Left IB Wheel

- Inner wheel half fragments
- Recovered on/near runway

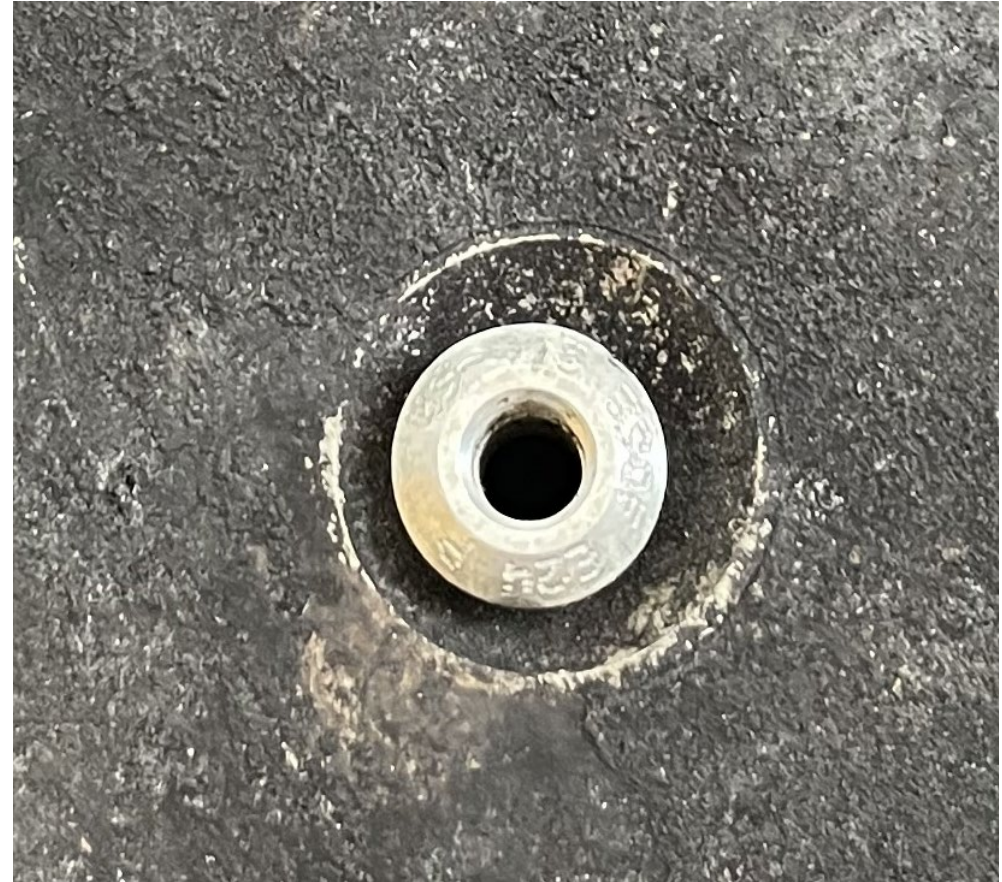
# Thermal Relief Plug

- Recovered from runway
- Unknown original location
- Placed in left OB wheel fragment at unknown time after NTSB examination
