DCA26LA102

## INVESTIGATION PHOTOGRAPHS

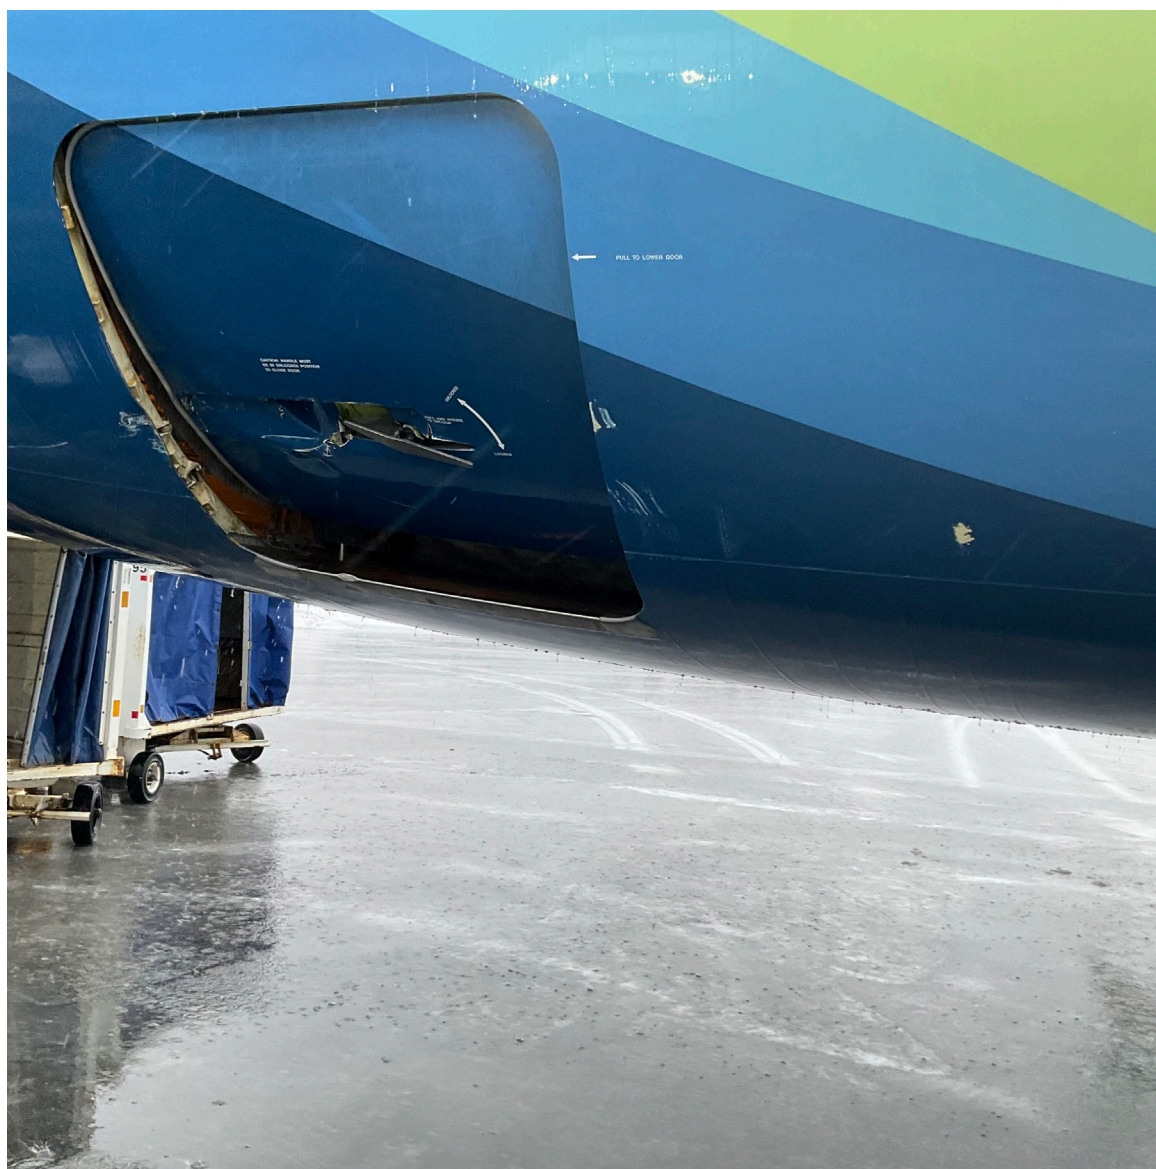
**Photograph 1 - Damage to AFT Right Cargo Door and Frame (Courtesy of Alaska Airlines)**

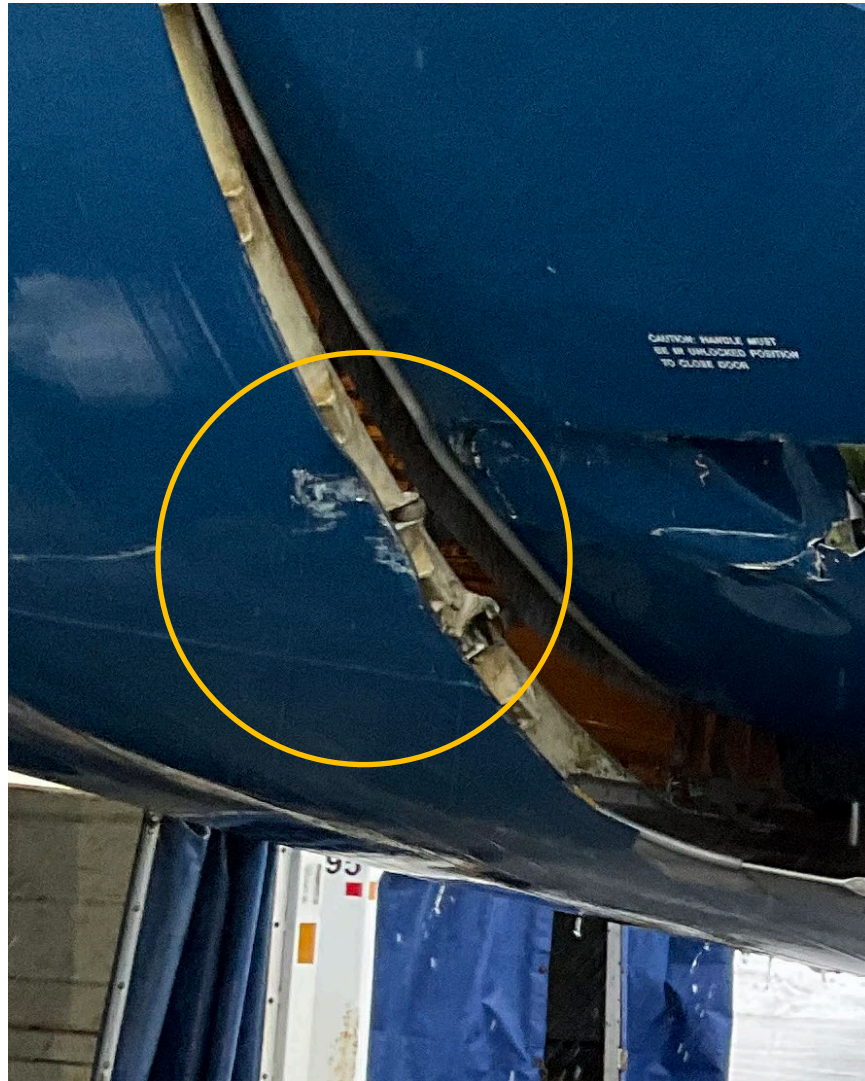
**Photograph 2 - Damage to Door Frame (Courtesy of Alaska Airlines)**

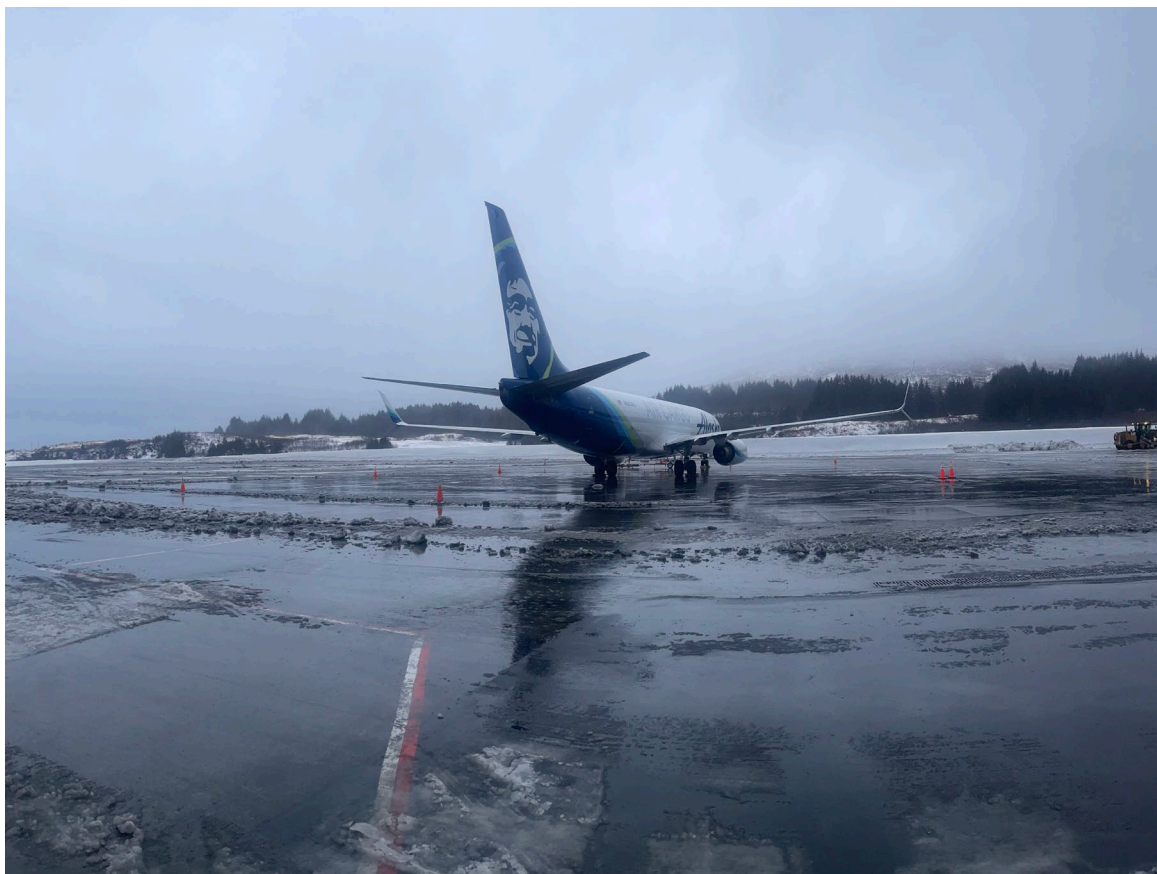
**Photograph 3 - View of Airplane on Ramp (Courtesy of Alaska Airlines)**
