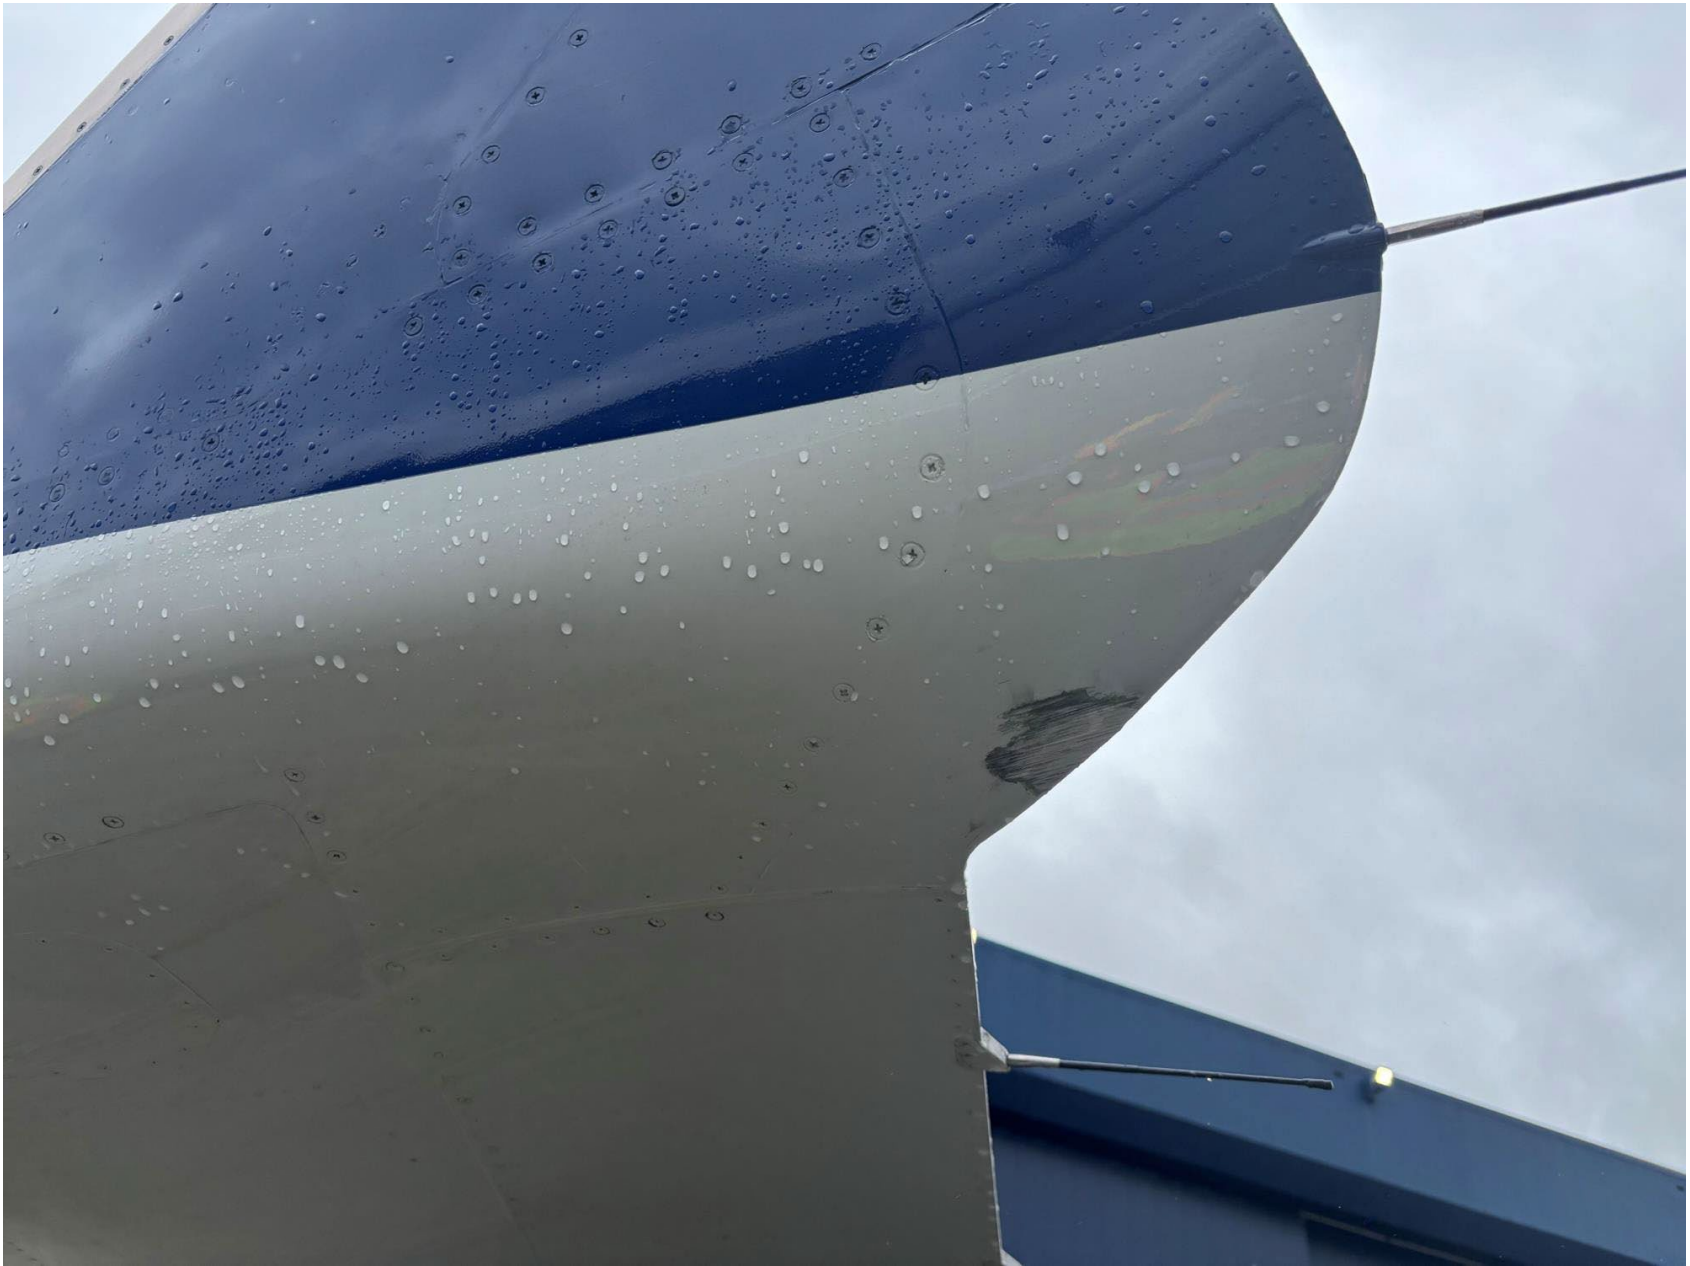
**Photo 1 – Minor damage to right wing. (Source Endeavor Air)**

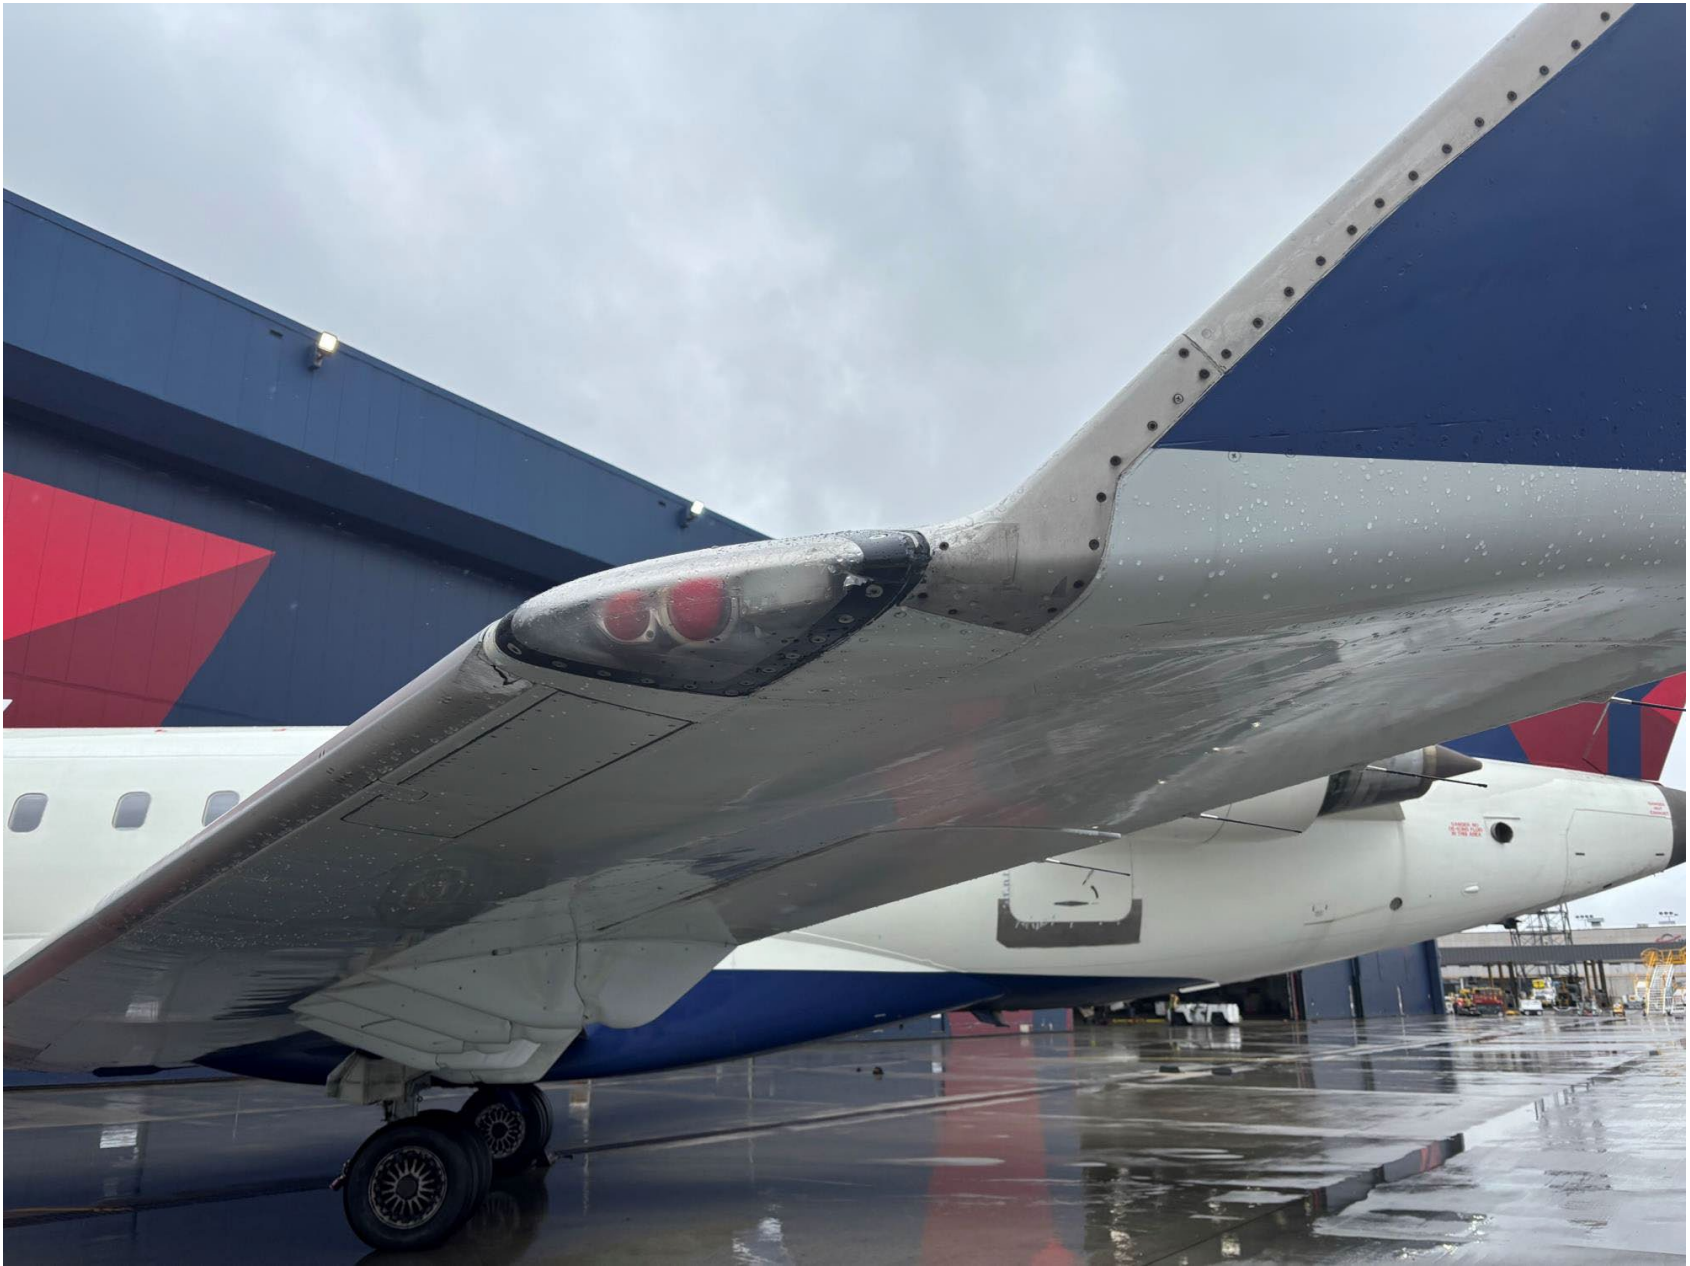
**Photo 2 – Right-wing leading-edge slat damage. (Source Endeavor Air)**

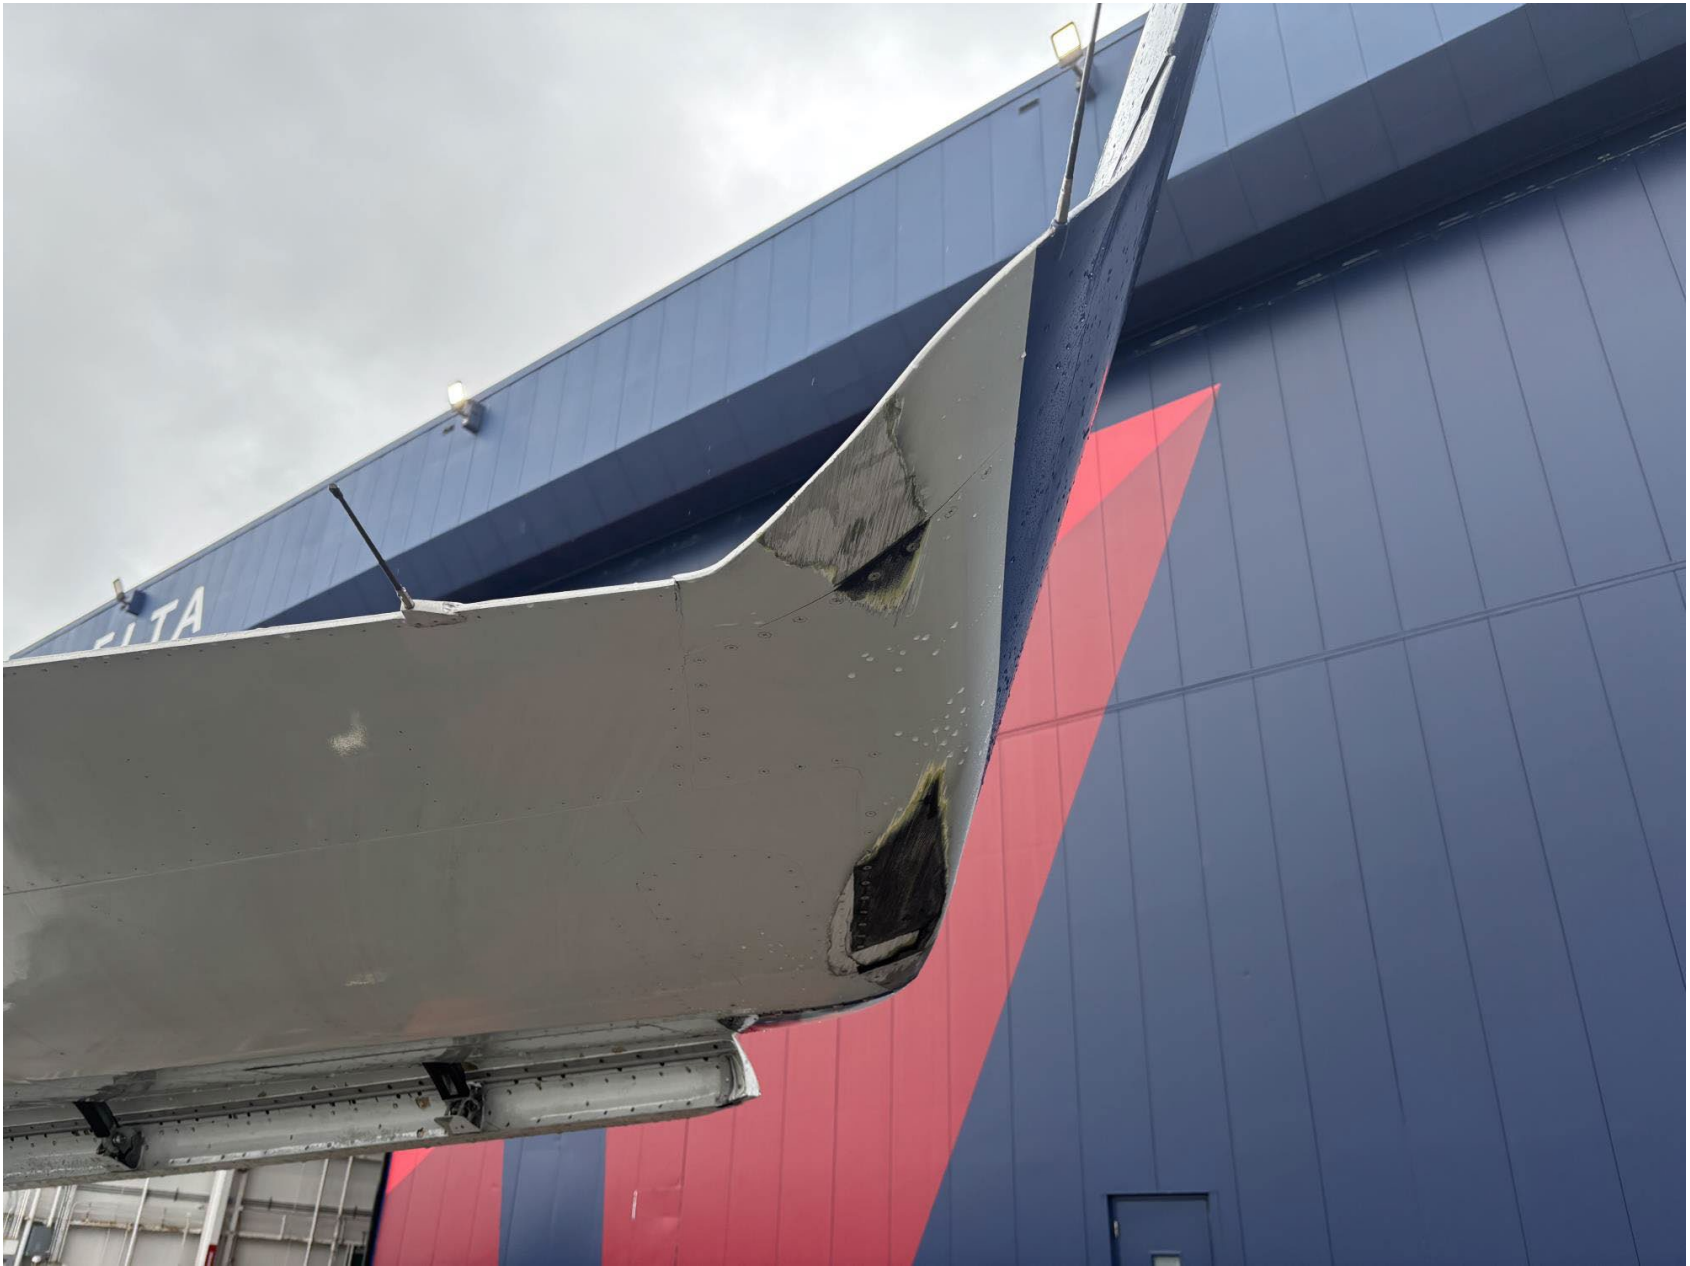
**Photo 3 – Minor damage to left wing. (Source Endeavor Air)**

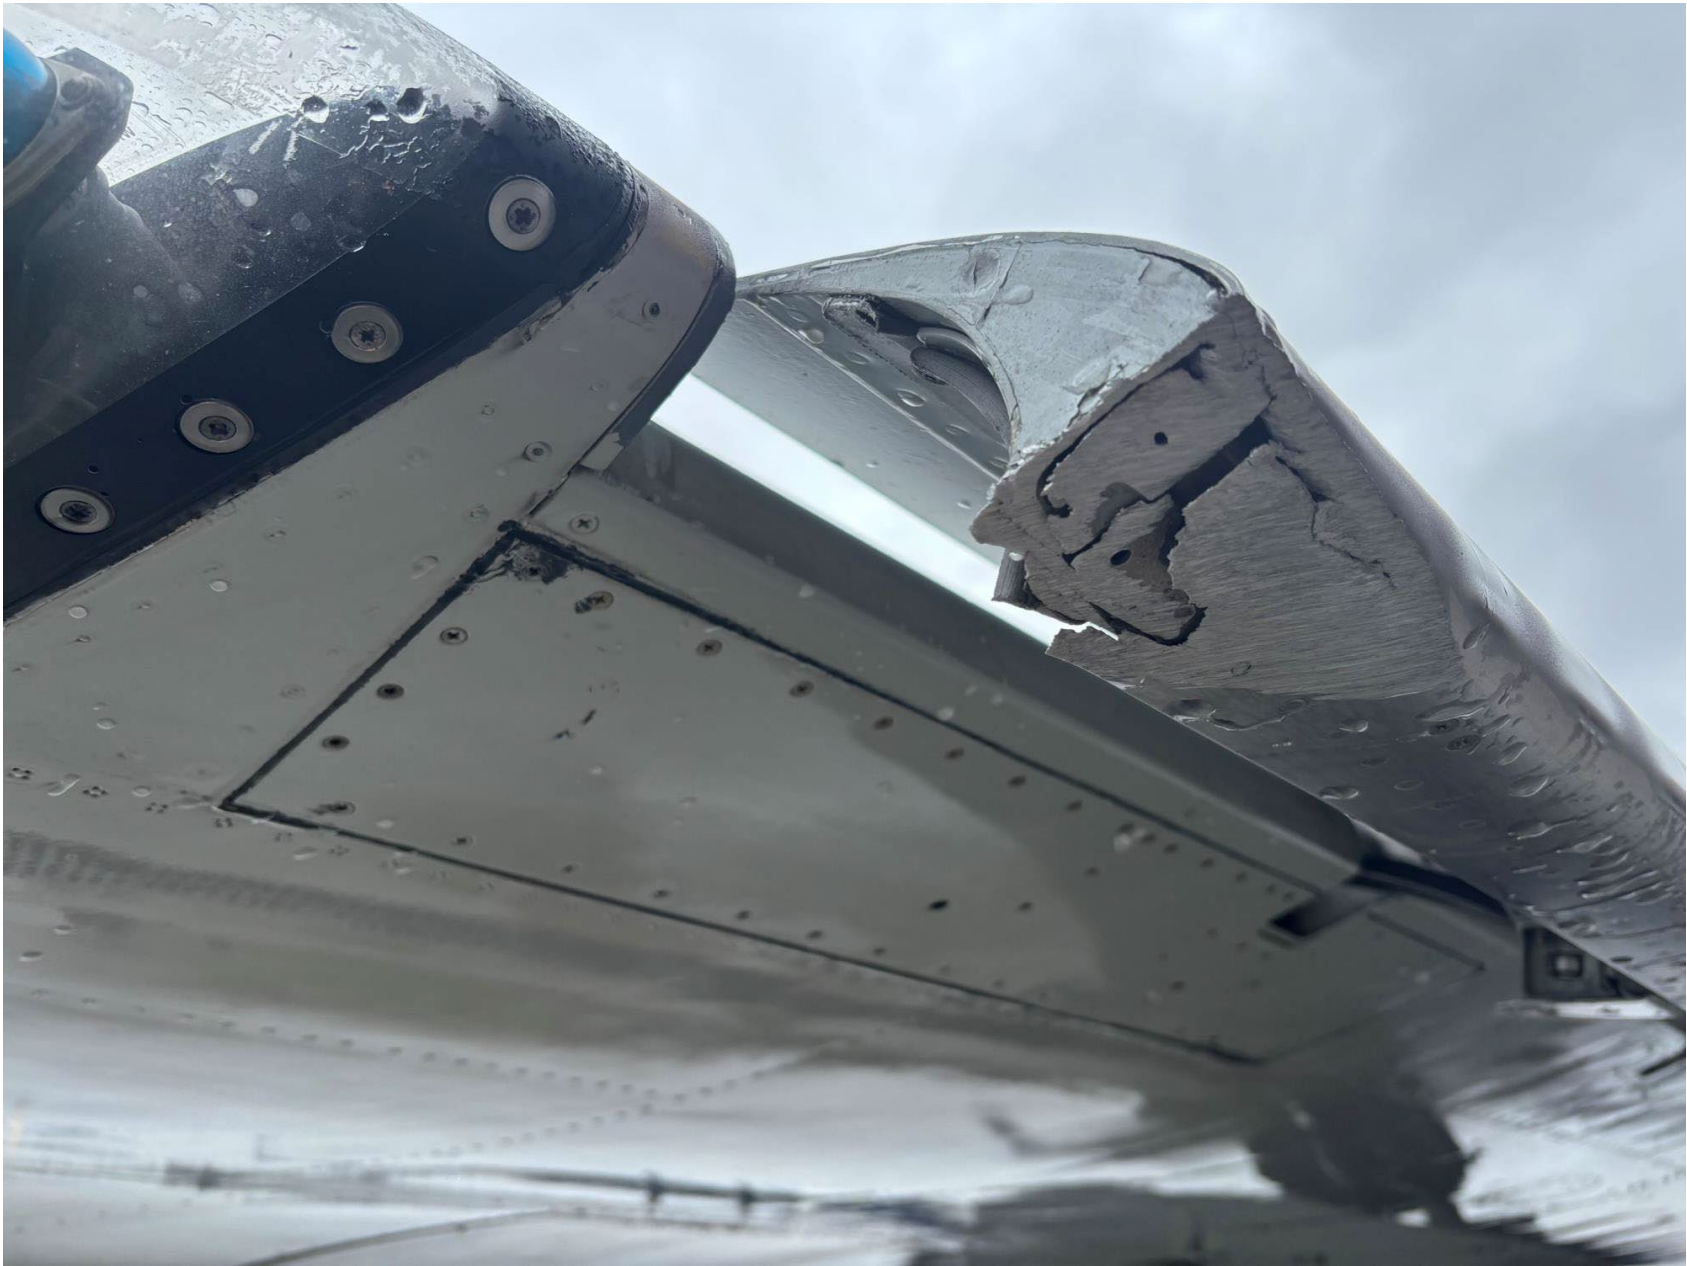
**Photo 4 – Left-wing leading-edge slat damage. (Source Endeavor Air)**
