NATIONAL TRANSPORTATION SAFETY BOARD  
OFFICE OF AVIATION SAFETY  
WASHINGTON, D.C. 20594

**POWERPLANTS GROUP CHAIRMAN'S FACTUAL REPORT**

NTSB ID No.: ENG16IA001

Location: Russian airspace on Airway B241 near GITRU fix  
Date: October 2, 2015  
Time: About 0500 UTC  
Aircraft: Boeing 747-451, N662US, Delta Air Lines flight 158

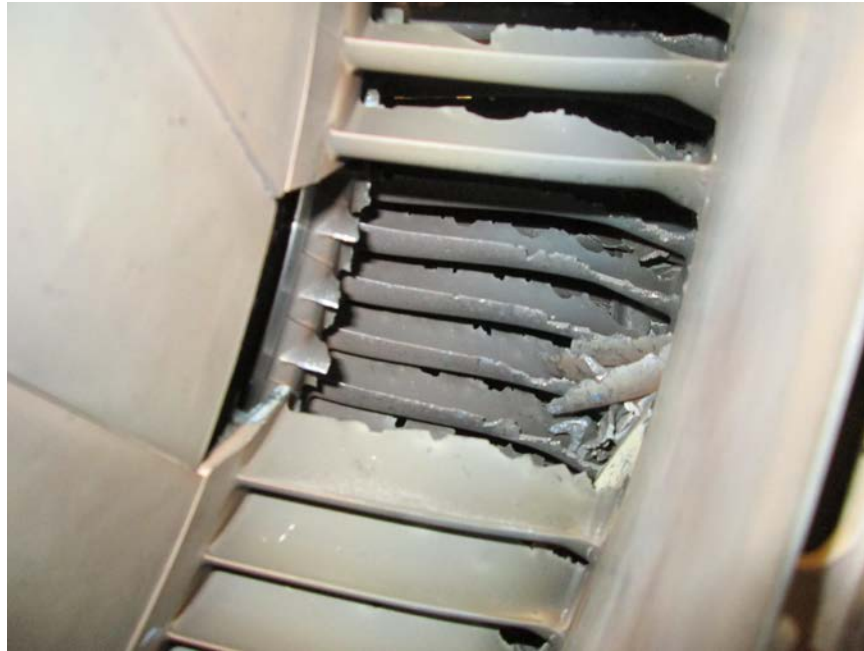
The No. 29<sup>6</sup> 3rd stage turbine vane cluster was missing from the turbine case at about 8:30 o'clock.<sup>7</sup> (Photo No. 1) The bolt hole tab from the missing cluster remained attached to the inner transition duct support. The fractured end of the bolt hole tab and the adjacent side of the nut were burnished. (Photo No. 2)

Photo No. 1: View from the front of the location of the missing 3rd stage turbine vane cluster. (Delta)

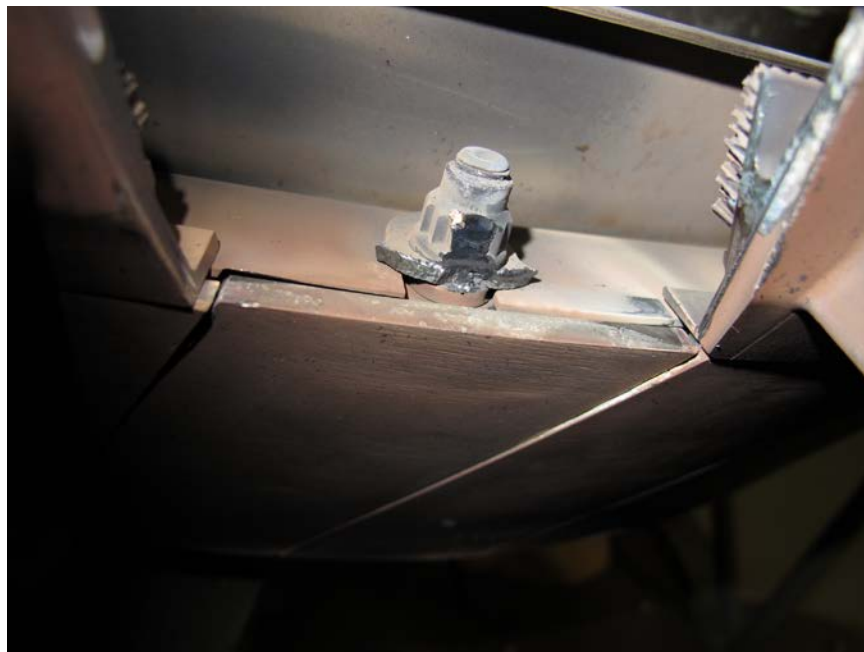
Photo No. 2: Close-up view of bolt hole tab and retaining nut that remained attached to the inner transition duct. (P&W)

The examination of the No. 29 3rd stage turbine vane cluster bolt hole tab that remained attached to the inner transition duct revealed wear that was consistent with fretting, a high frequency low amplitude relative motion. The fretting wear that was observed on the fractured tab was similar to that observed on the other 3rd stage turbine vane cluster bolt hole tabs. The fracture surface on the tab was smeared and there were no resolvable features.

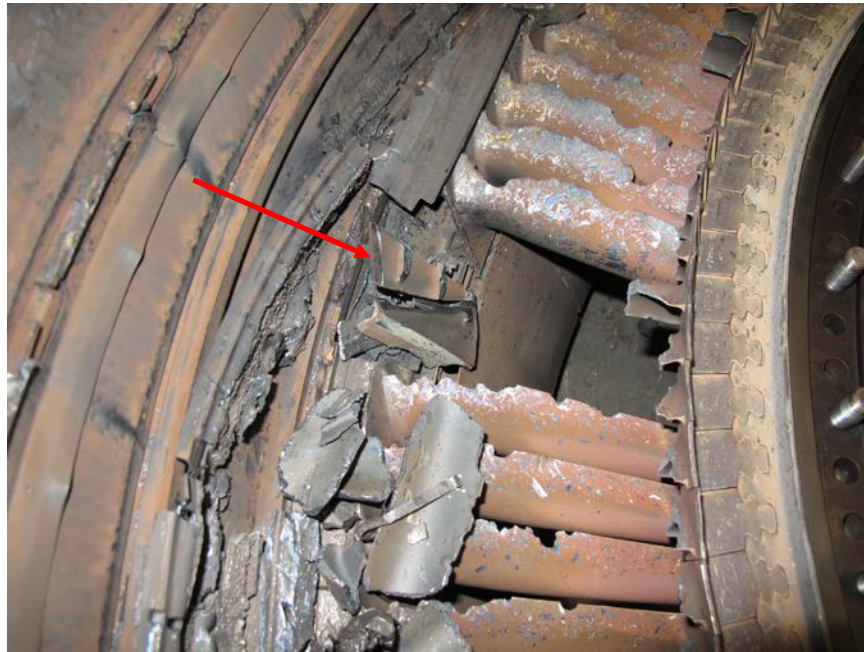
A piece of a 3rd stage turbine vane cluster inner shroud was recovered from the debris in the LPT case's 3rd stage turbine rotor's plane of rotation at about 8 o'clock, near the location of

the missing cluster. (Photo No. 3) The piece was about 1.5-inches wide from the front face or the inner shroud and included the leading edges of three airfoils that were about 0.62-inches long. The piece had three distinct circumferential grooves that were worn into the inner shroud. There was a circumferential groove across the underside of the shroud just forward of the honeycomb and the normal operating position of the shroud that corresponded to the 3rd stage rotating air seal knife edge. (Photo No. 4) There was a circumferential groove worn into the rear of the inner shroud and airfoils that corresponded to the leading edge of the rim of the 3rd stage rotating air seal. (Photo No. 5) And there was a groove on the flow path side of the inner shroud that cut across three airfoils on the forward side of the fragment that corresponded to the rim of the 3rd stage rotating air seal. (Photo No. 6) There was no heat discoloration or any cracking around any of the grooves cut in the piece of the 3rd stage turbine vane inner shroud.

Photo No. 3: View from the rear of the location of the missing 3rd stage vane cluster with an arrow pointing to the piece of 3<sup>rd</sup> stage vane cluster inner shroud. (P&W)

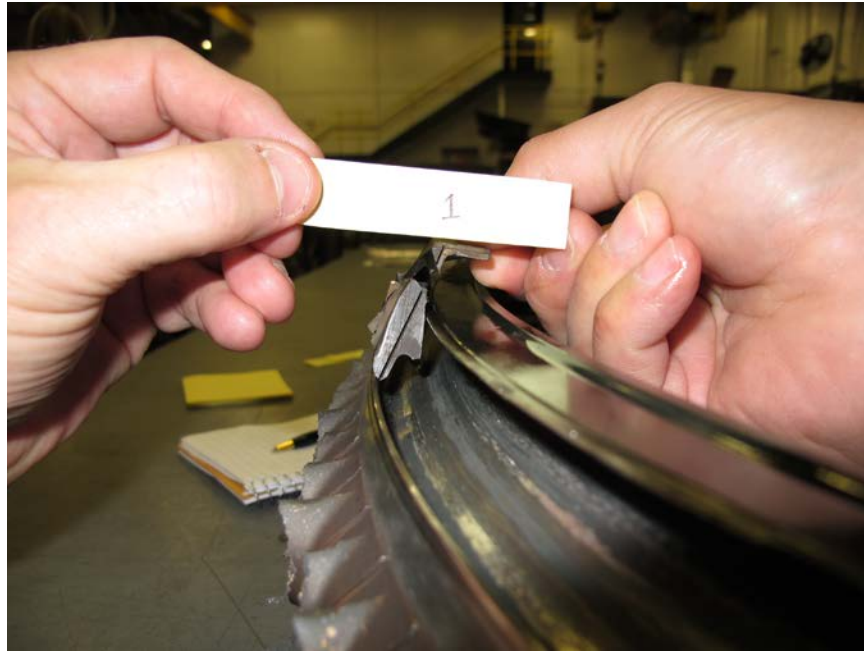
Photo No. 4: Side view of piece of 3rd stage turbine vane cluster inner shroud showing relation of circumferential rub mark on underside of shroud to 3rd stage rotating air seal knife edge.  
(P&W)

The examination of the fragment of the inner shroud that was recovered revealed remnants of fatigue on the counterclockwise (CCW) side of the forward flange. The fatigue had progressed forward from multiple origins along the aft surface of the flange. The fatigue had progressed to a maximum depth of 0.026 inches. However, the fracture surface beyond the fatigue was smeared and it could not be determined if the fatigue had progressed further. The examination of the inner shroud fragment also revealed two wear patterns on the CCW mating face consistent with contact with the No. 28 3rd stage turbine vane cluster. There was one wear pattern that was indicative of the normal installed position of the vane cluster and there was a second wear pattern that was indicative of the vane cluster having moved out of position. There were no wear patterns on the clockwise (CW) side of the inner shroud fragment.

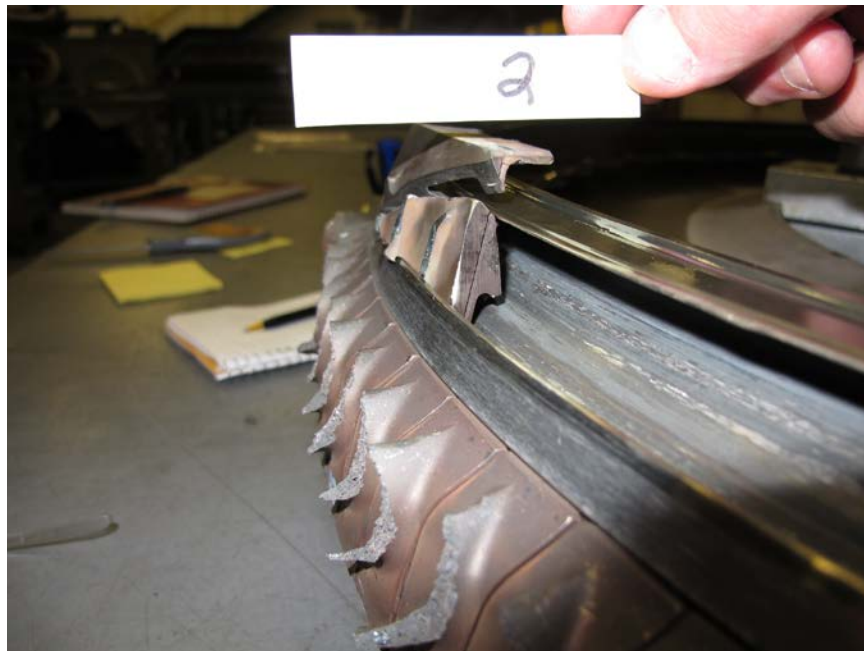
Photo No. 5: Side view of 3rd stage vane cluster inner shroud showing the circumferential rub mark on the rear of shroud in relation to the edge of the rim of the 3rd stage rotating air seal.  
(P&W)

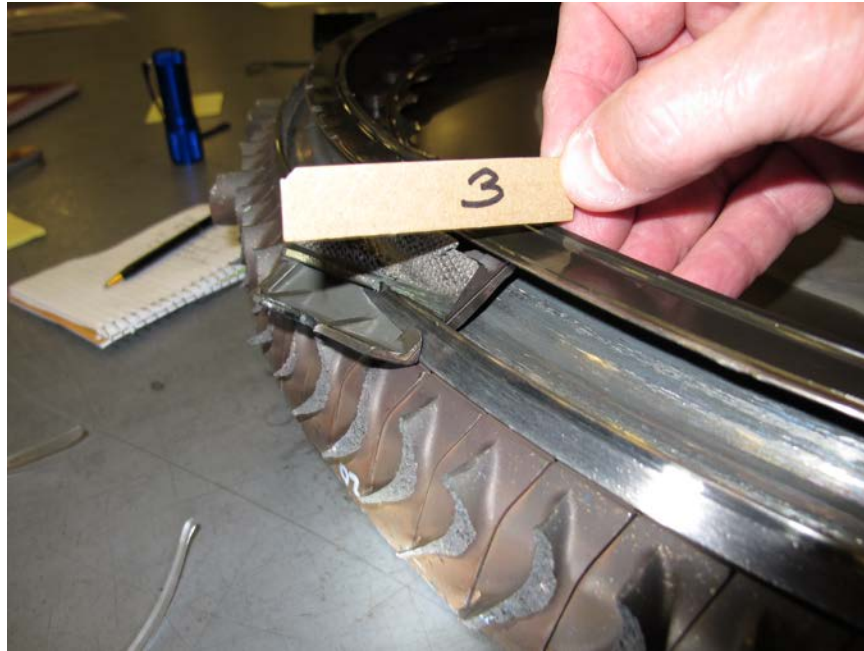
Photo No. 6: View of 3rd stage turbine vane cluster inner shroud showing relation between rub mark across the airfoils in relation to the 3rd stage rotating air seal. (P&W)

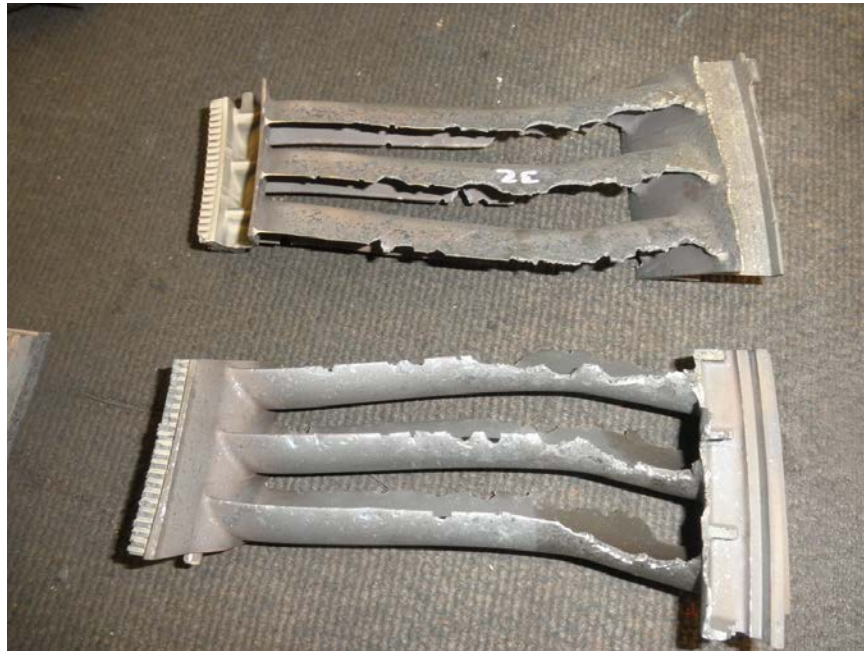
All of the remaining 3rd stage turbine vane clusters remained in place secured to the LPT case and the inner transition duct assembly. The inner transition duct tabs on the 3rd stage turbine vane clusters were the rounded configuration. The No. 26 3rd stage turbine vane cluster had heavy tapered wear on the aft foot that engages with the LPT case rail. The 3rd stage turbine vane clusters that remained in the LPT case did not have any circumferential rub marks on the aft face or the undersides of the inner shrouds. The 3rd stage turbine vane clusters' airfoils had nicks and dents along the leading and trailing edges and there was material missing from the trailing edges up to about 2.27-inches long radially and about 0.5-inches axially. (Photos No. 7) The circumferential face of the outer shroud of 3rd stage turbine vane cluster No. 30 was heavily battered.

Photo No. 7: Other 3rd stage turbine vane clusters, trailing edge on the top and leading edge on the bottom.

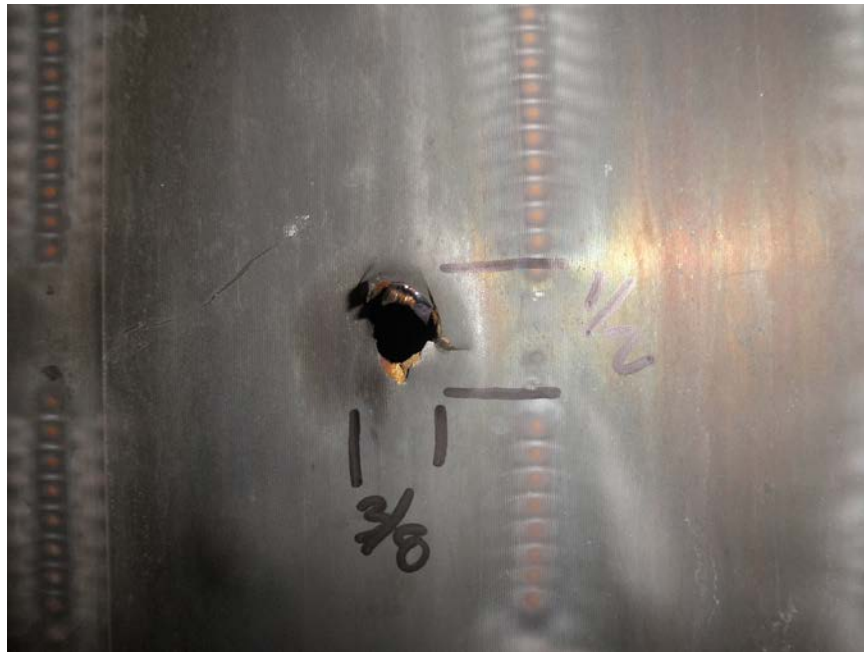
The LPT case was PN 50N348-003, SN VZ7299. The LPT case was intact, but had two small holes on the left side and one on the right side of the case. There was an approximately 0.5-inch long circumferential by 0.38-inch axial hole at about 9:15 o'clock (Photo No. 8) and an approximately 0.62-inch long circumferential by 0.56-inch wide axial hole at about 10:30 o'clock (Photo No. 9) in the plane of the 3rd stage turbine rotor. There was an approximately 0.69-inch long axial by 0.44-inch wide circumferential hole at about 2:45 o'clock in the plane of the 5th stage turbine rotor. (Photo No. 10) There were lifted tabs of metal adjacent to all three holes on the clockwise side of each hole. There were several bulges, some with splits in the metal, around the circumference of the LPT case in the planes of the 3rd, 4th, and 5th stage rotors. The exterior of the LPT case had seven rows of light-colored marks that were coincident with the impingement holes in the cooling air tubes.

Photo No. 8: Hole in LPT case in place of 3rd stage turbine rotor at 9:15 o'clock.

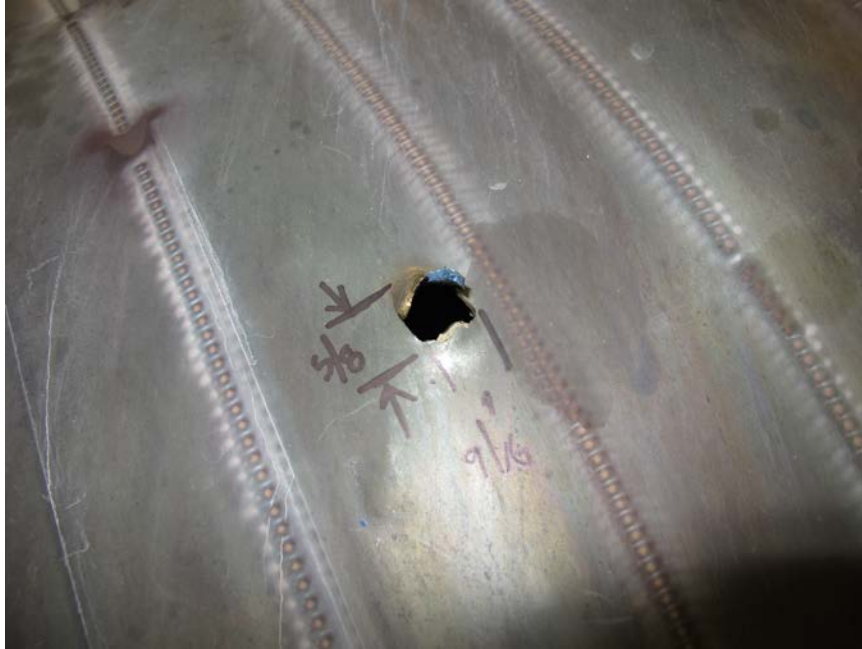
Photo No. 9: Hole in LPT case in plane of 3rd stage turbine rotor at 10:30 o'clock. (P&W)

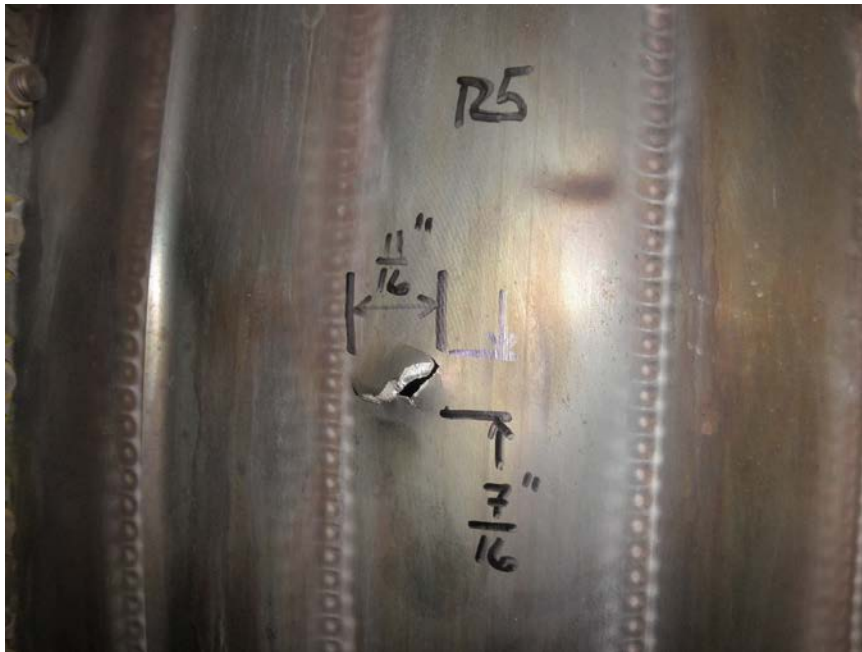
Photo No. 10: Hole in LPT case in plane of 5th stage turbine rotor at 2:45 o'clock.

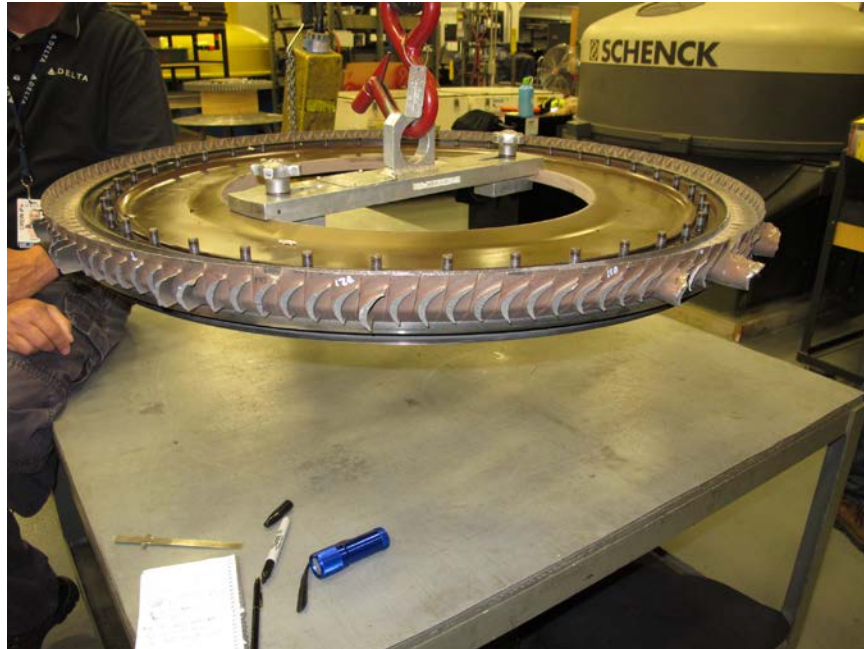
All of the 3rd stage turbine blade roots were in place in the disk. All of the 3rd stage turbine blades were fractured. Most of the 3rd stage turbine blades were fractured transversely across the airfoil adjacent to the blade root platform. (Photo No. 11) There were 16 3rd stage turbine blades that were fractured across the airfoil between about 0.5 and 1.5 inches above the blade root platform. The fracture surfaces on all of the 3rd stage turbine blades were coarse and grainy. (Photo No. 12) All of the 3rd stage turbine blades that had a partial airfoil were rubbed along the leading edges that remained. The 3rd stage turbine blade roots' rear face had circumferential scuff marks. There were four 3rd stage turbine blades, two adjacent, blades Nos. 8 and 9,<sup>8</sup> and two randomly located, blades Nos. 102 and 123, that had portions of the inner or outer aft blade root flow guides broken off.

Photo No. 11: View of 3rd stage turbine disk showing it is intact and all of the blades were in the disk, but the airfoils are fractured. (P&W)

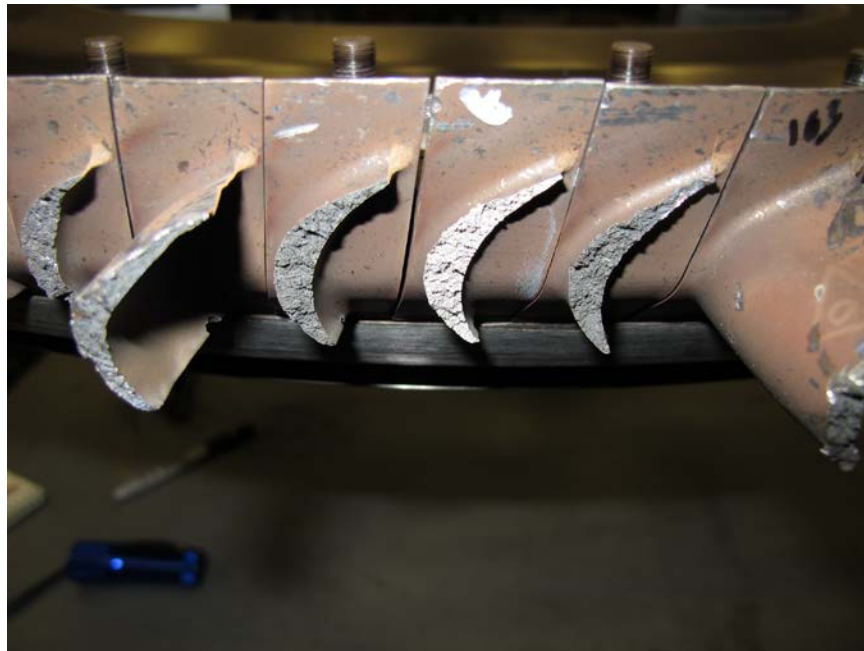
Photo No. 12: Close up view of fractured 3rd stage turbine blades showing coarse fracture surface. (P&W)

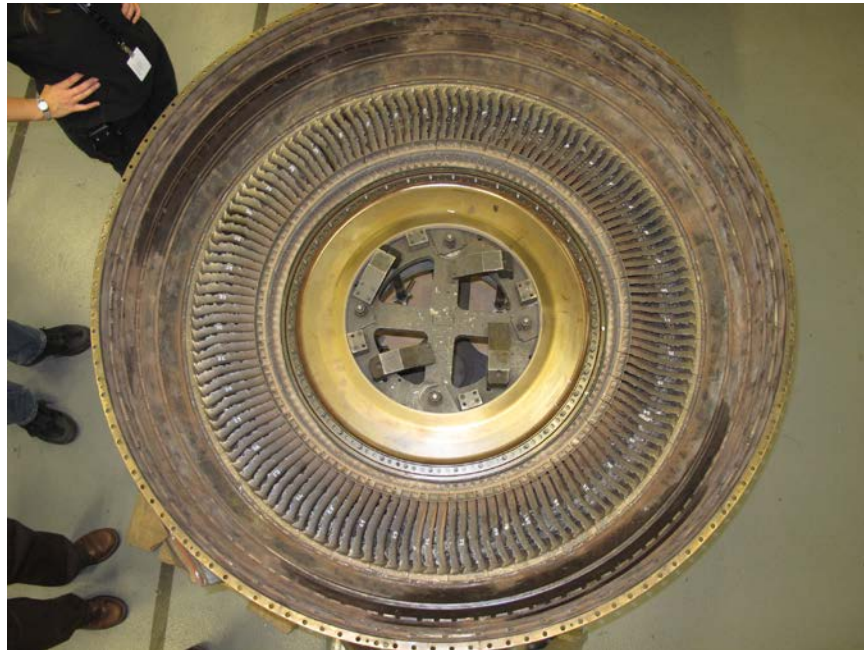
The 4th stage turbine vane clusters were all in place in the LPT case. (Photo No. 13)  
The 4th stage turbine vane clusters did not have any fractured airfoils. The 4th stage vane cluster's inner shrouds were all aligned with the adjacent shrouds. The gussets and hooks did not have any cracking. There was no apparent clashing between the inner shrouds. The 4th stage turbine vane inner shrouds did not have any apparent wear in the pin pocket areas. There was no wear on the honeycomb. There were nicks and dents on the rear face of the clusters' rear foot. There were several vane clusters that had wear on the inner shroud contact surfaces. There was one cluster that had light wear on the pin pocket and a vane cluster had wear on the pin itself. There were a pair of adjacent clusters that had wear on the ends of the honeycomb. There were a pair of adjacent clusters that had galling on the inner shroud contact surfaces. The 4th stage turbine vane cluster airfoils had nicks and dents on the leading edges and were missing material from the leading edge up to about 2.75-inches long radial and 0.5-inches wide axial. (Photo No. 14)

Photo No. 13: View of 4th stage turbine vane clusters showing all are in place in the LPT case. (P&W)

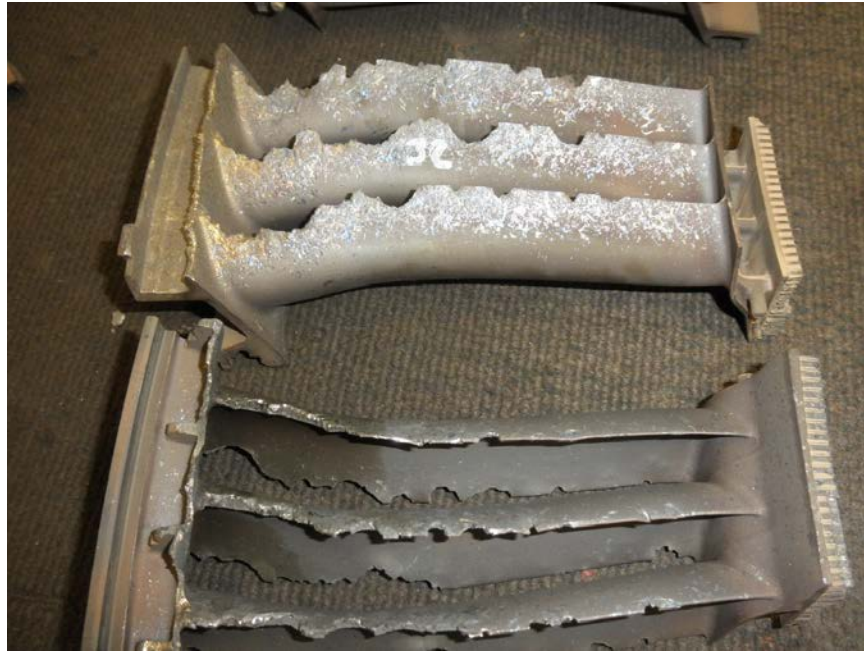
Photo No. 14: Close up view of 4th stage turbine vane clusters showing damage to the leading and trailing edges of airfoils.

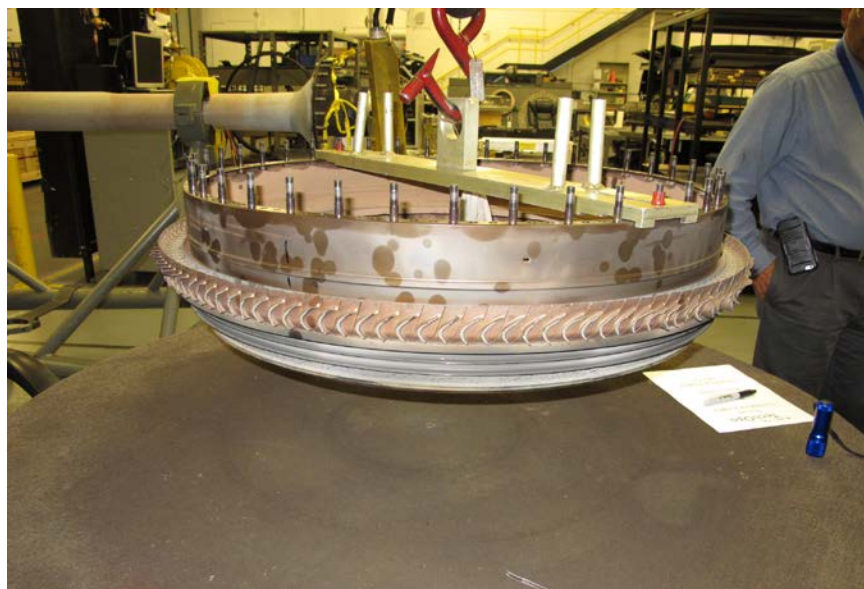
The 4th stage turbine disk and the integral spacers were intact. The 4th stage turbine disk had some circumferential scuff marks on the rear face of the rim. All of the 4th stage turbine blade roots were in place in the disk. All of the 4th stage turbine blades were fractured transversely across the airfoil adjacent to the blade root platform. (Photo No. 15) The fracture surfaces on all of the 4th stage turbine blades were coarse and grainy. (Photo No. 16) There were no circumferential rub marks on what remained of the blades' leading edges.

Photo No. 15: View of 4th stage turbine disk showing it is intact and all of the blades are in the disk, but are fractured across the airfoils. (P&W)

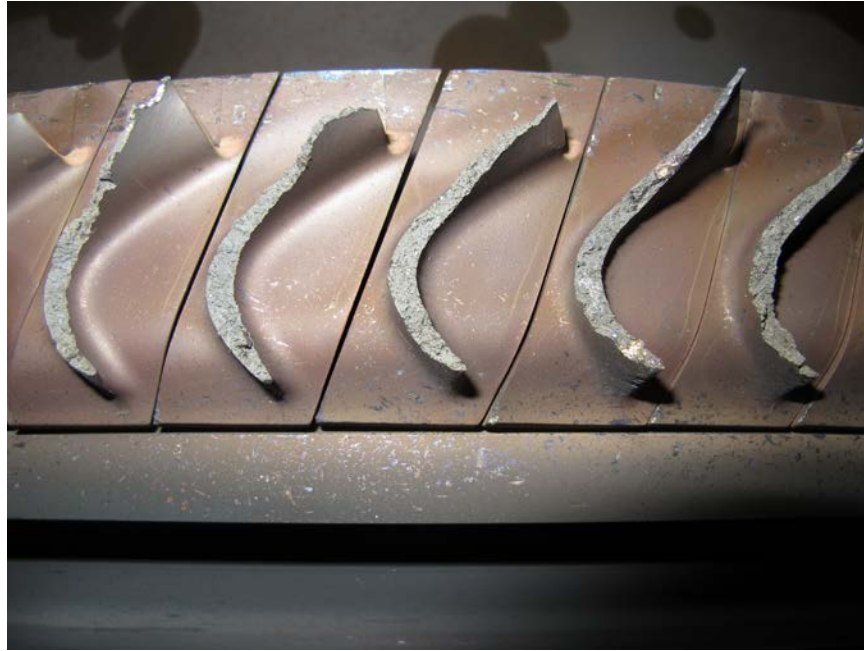
Photo No. 16: Close up view of fractured 4th stage turbine blades showing coarse fracture surface. (P&W)

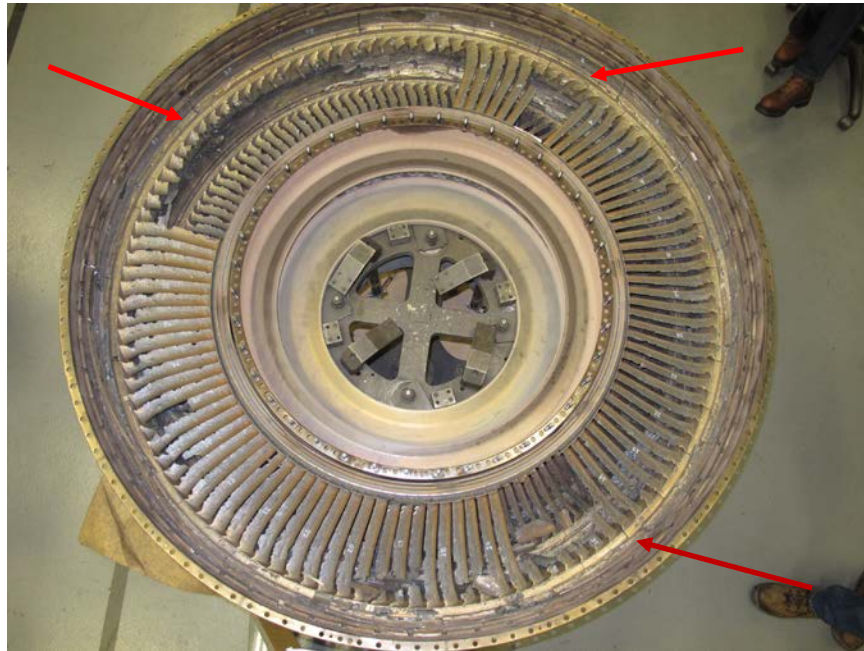
The 5th stage turbine vane clusters were all in place. (Photo No. 17) The Nos. 1, 2, 4 through 14, 17, 18, and 20 through 29 5th stage turbine vane clusters were full length with the inner and outer shrouds in place and engaged. The No. 3 cluster at about 12:30 o'clock and No. 19 cluster at about 7 o'clock had all three airfoils in the cluster broken at the outer end adjacent to the shroud and canted forward while the inner shroud remained engaged. The Nos. 3 and 17 5th stage turbine vane clusters were rubbed on the inner shroud aft face. The No. 17 5th stage turbine vane cluster had approximately 0.37- by 0.25-inch notches rubbed into the airfoils adjacent to the inner shroud. The Nos. 15, 16, and 30 through 36 5th stage turbine vane clusters consisted of only the outer shroud with the airfoils and inner shrouds missing. The 5th stage turbine vane cluster airfoil leading edges had nicks and dents and were missing sections up to about 2.5-inches long radial by 1-inch deep axial adjacent to the outer shroud. (Photo No. 18)

Photo No. 17: View of 5th stage turbine vane clusters showing all of the clusters or the clusters' outer shrouds remained in place. Arrows point to where only the outer shroud remained. (P&W)

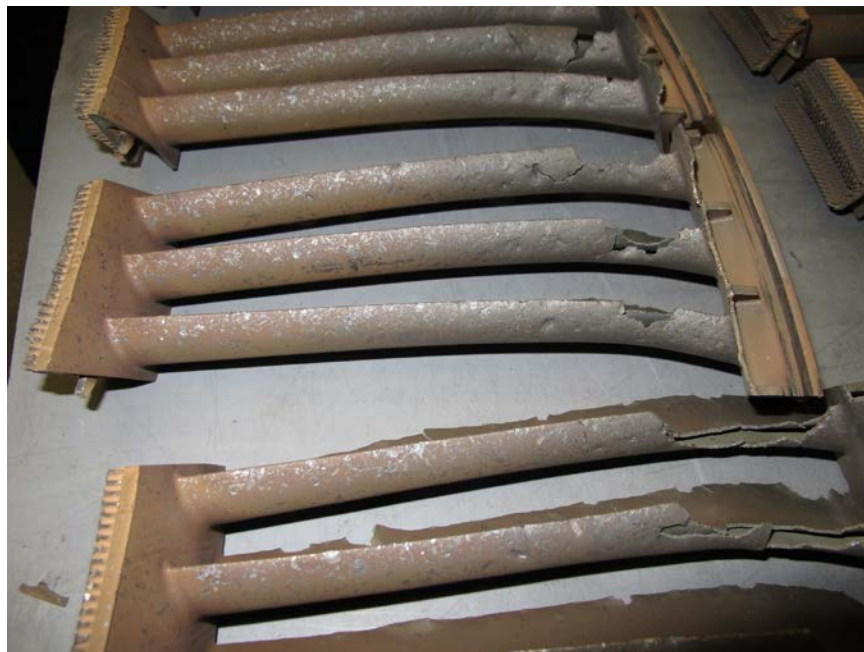
Photo No. 18: Close up view of damage to leading edges of 5th stage turbine vane clusters. (P&W)

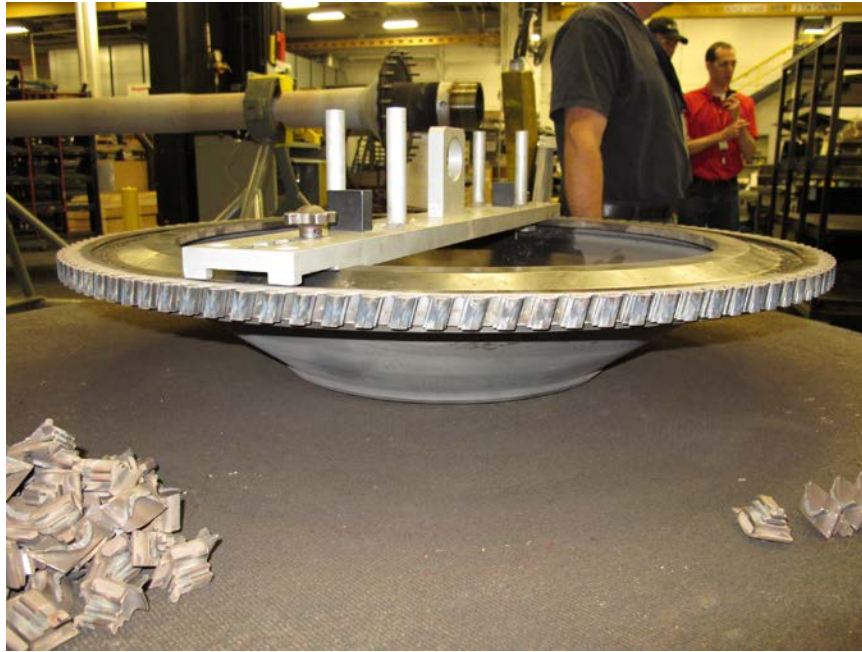
The 5th stage turbine disk and the drive cone were intact. (Photo No. 19) There were circumferential scuff marks on the rear face of the disk rim. All of the 5th stage turbine blade roots were in place in the disk. All of the 5th stage turbine blades were fractured transversely

across the airfoil adjacent to the blade root platform. On those 5th stage turbine blades that had part of the airfoil trailing edge remaining, all of them had an impact mark on the convex side of the airfoil. The fracture surfaces on all of the 5th stage turbine blades were coarse and grainy. (Photo No. 20) There were no circumferential rub marks on what remained of the blades' leading edges.

Photo No. 19: View of 5th stage turbine disk showing that it was intact. (P&W)

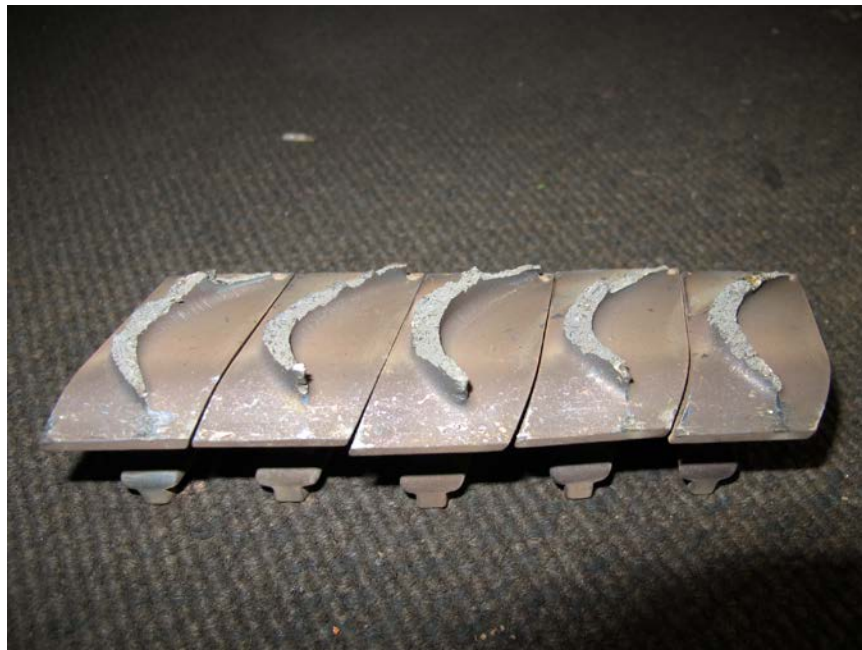
Photo No. 20: Close up view of 5th stage turbine blades showing coarse and grainy fracture surfaces. (P&W)

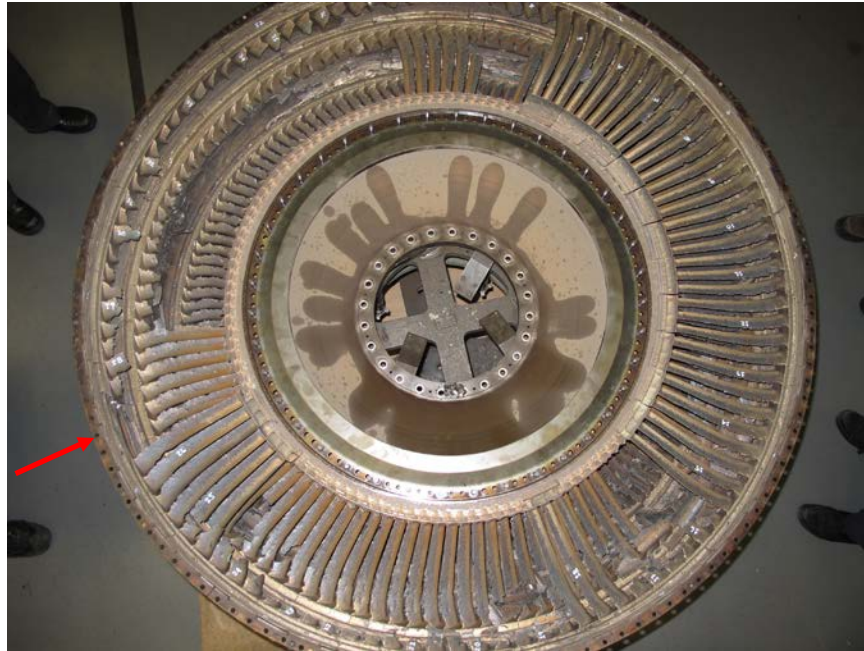
The 6th stage turbine vane clusters or the outer shroud of the cluster were all in place except for one cluster at about 8:30 o'clock that was missing. (Photo No. 21) The 6th stage vane clusters that were still intact were Nos. 5 through 15 between about 1 and 4 o'clock, No. 18 at about 5 o'clock, and No. 25 and 26 at about 8 o'clock. The complete vanes were heavily battered on the leading edges and convex surface of the airfoil at the trailing edge. The 6th stage turbine vane clusters had nicks and dents on the leading edges and large sections up to about 3.5-inches radial by 1-inch deep axial of the leading edge adjacent to the outer shrouds missing. The trailing edges and adjacent convex surfaces of the remaining airfoils had nicks, dents, and sections missing along their full length. (Photo No. 22) The remaining 6th stage turbine vane clusters were missing the airfoils and the inner shroud with only the outer foot remaining in the case. The sheet metal insulation blanket under where the missing vane cluster was located did not have any impact damage.

Photo No. 21: View of 6th stage turbine vane clusters with an arrow showing the location of the missing cluster. (P&W)

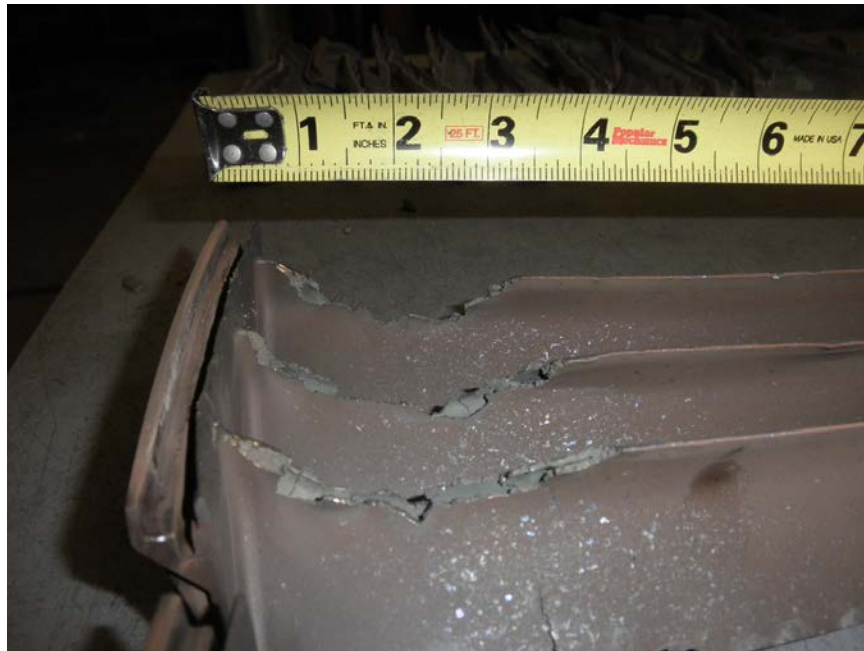
Photo No. 22: Close up view showing damage to 6th stage turbine vane cluster airfoil leading edges.

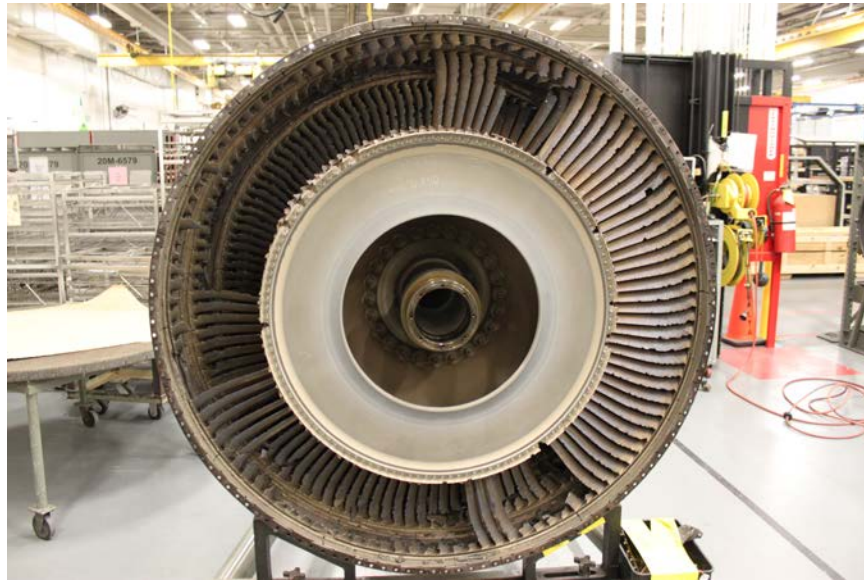
The 6th stage turbine disk and integral spacer were intact. (Photo No. 23) The 6th stage turbine disk's integral spacer knife edges were in place. The tips of the knife edges had a very light uniform fresh rub around their entire circumference. The hard face coating on both of the knife edges was chipped on the edge around the entire circumference. The rear face of the 6th

stage turbine disk and the outer diameter of the integral spacer had some random scuff marks. All of the 6th stage turbine blade roots were in the slots except for 12 randomly located blade roots that were missing. There were 10 6th stage blade roots recovered from the debris at the bottom of the LPT case. All of the 6th stage turbine blades, including those found at the bottom of the LPT case, were fractured transversely across the airfoil adjacent to the blade root platforms. All of the 6th stage turbine blades had the leading edge flow guides broken off except for an approximately 30 degree sector where the flow guides were intact. The fracture surfaces on all of the 6th stage turbine blades were coarse and grainy. (Photo No. 24) There were no circumferential rub marks on what remained of the blades' leading edges.

Photo No. 23: View of 6th stage turbine disk showing that it was intact. (Delta)

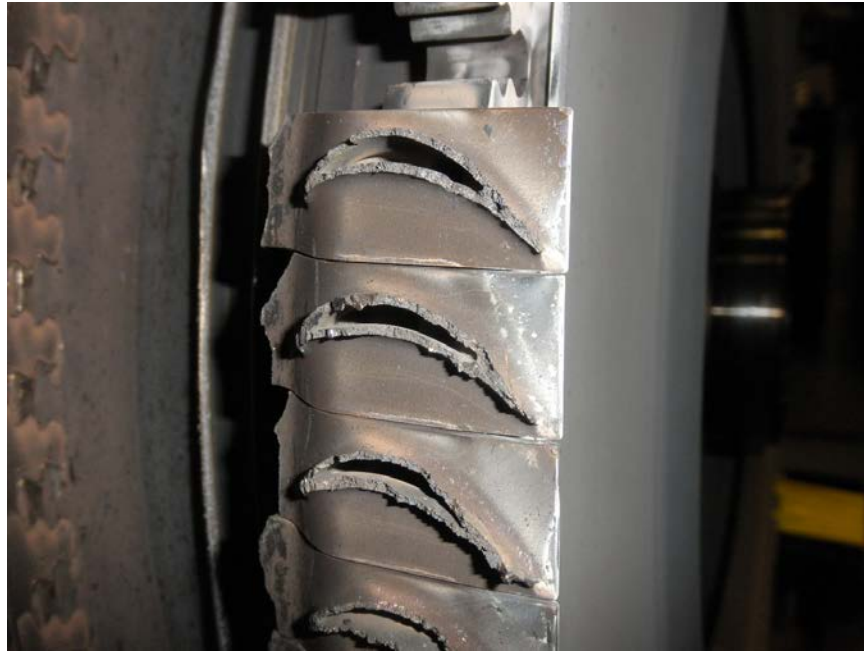
Photo No. 24: Close-up view of 5th stage turbine blades showing coarse and grainy fracture surfaces.

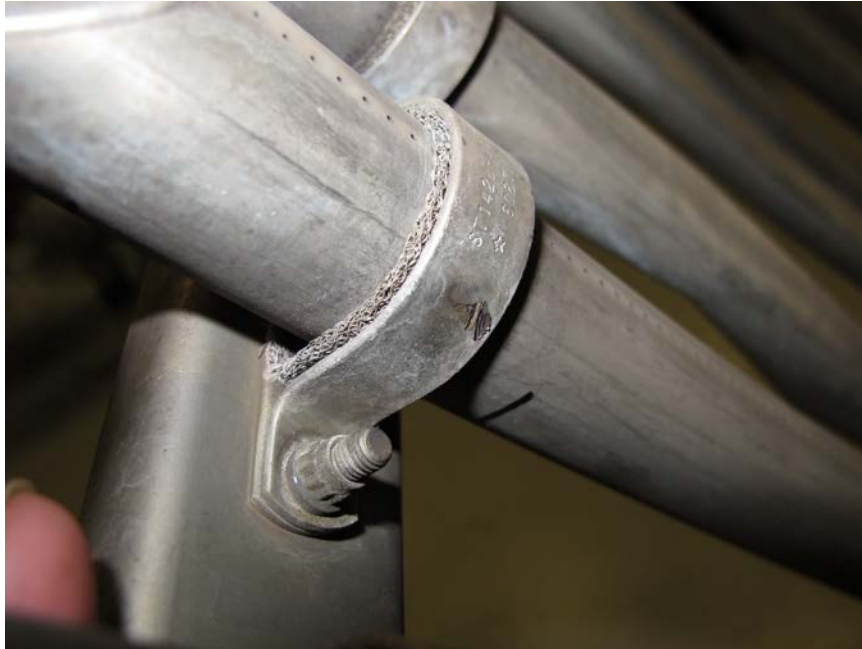
Photo No. 25: Close-up view of dent on turbine cooling air manifold clamp. (P&W)

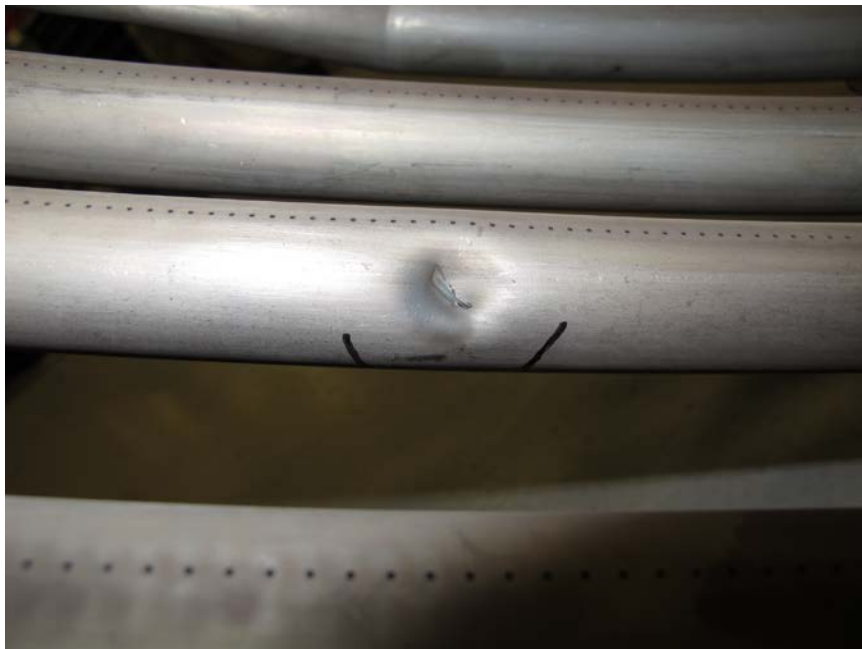
Photo No. 26: Close-up view of dent on inner surface of turbine cooling air manifold. (P&W)

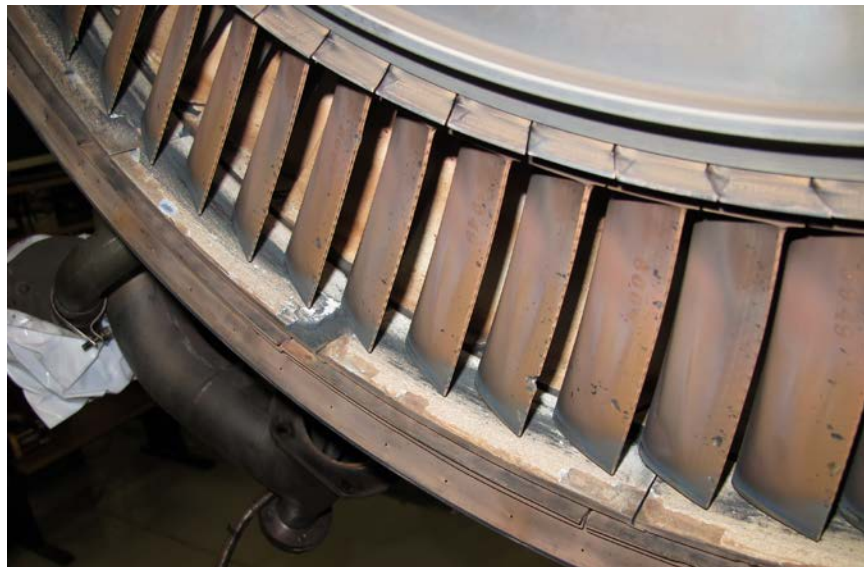
The 1st and 2nd stage turbine disks were intact. The 1st and 2nd stage turbine blades were all in place in their respective disks. The 1st stage turbine blades did not have any damage. There were randomly located 2nd stage turbine blades that had nicks and dents on the airfoil and pieces up to approximately 0.25 by 0.25-inch missing from the trailing edges. (Photo No. 27) The 1st and 2nd stage turbine blade radial tip clearance with their respective BOAS was about 0.12 and 0.18-inches, respectively.

Photo No. 27: Close up view of 2nd stage turbine blades showing damage to trailing edges and the erosion to the blade outer air seals. (P&W)

The 1st and 2nd stage BOAS segments were all in place. The 1st stage BOAS had several segments that had the thermal barrier coating on the ends, either one or both, partially eroded and missing that exposed the base metal. There were two 2nd stage BOAS at about 3 and 7 o'clock that had the thermal barrier coating on the counter-clockwise edge of the BOAS segment partially eroded and missing that exposed the base metal. (Refer to Photo No. 27)
