**NATIONAL TRANSPORTATION SAFETY BOARD  
OFFICE OF AVIATION SAFETY  
WASHINGTON, D.C. 20594**

**POWERPLANT GROUP CHAIRMAN'S FACTUAL REPORT  
NTSB ID: ENG16IA027**

Location: Jamaica, New York  
Date: July 7, 2016  
Time: 1307 UTC  
Aircraft: Boeing 757-200, N706TW, MSN 6804

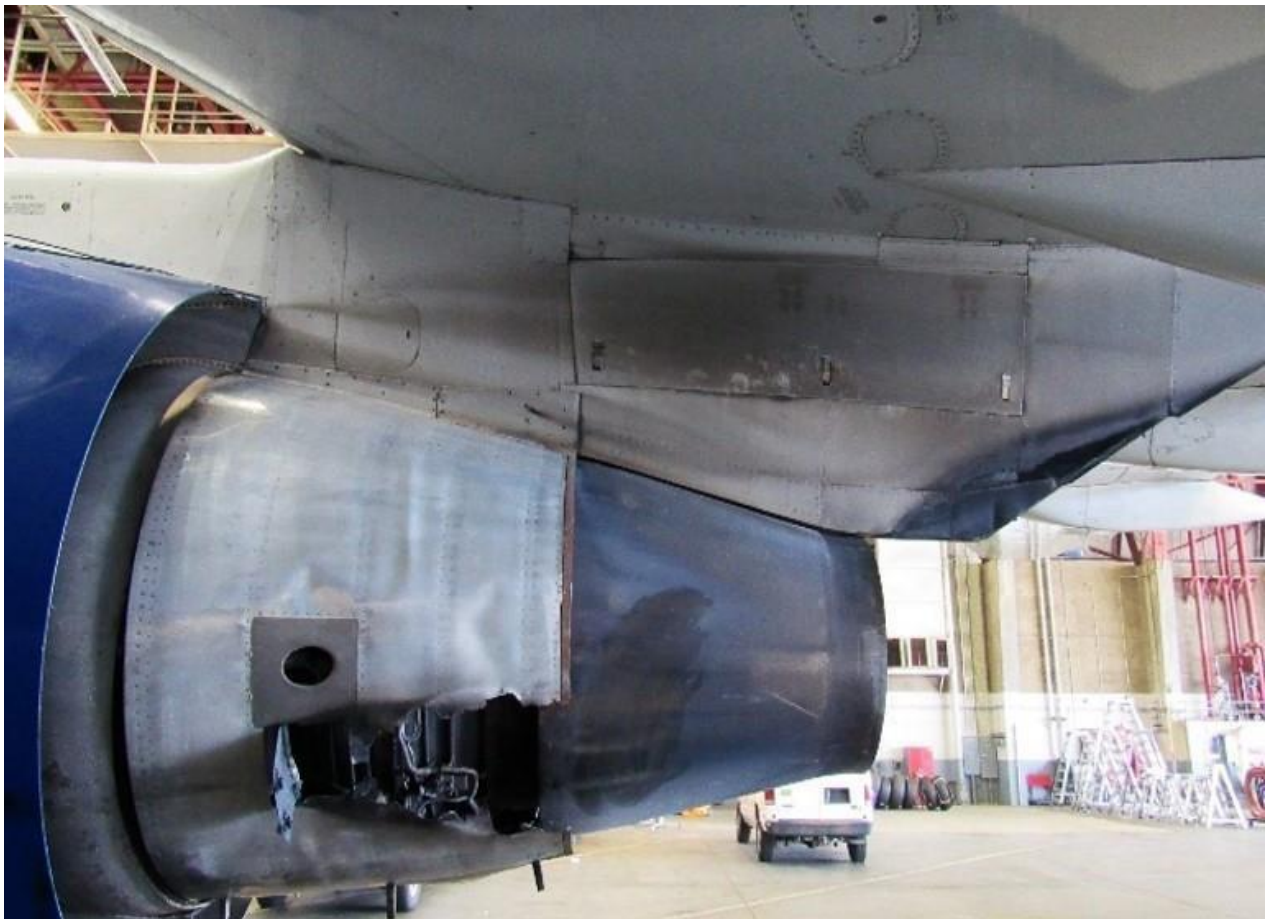
On July 07, 2016, about 1307 UTC, a Delta Air Lines (DAL) Boeing B752, N706TW, experienced a right<sup>1</sup> engine under cowl fire shortly after takeoff from John F. Kennedy International Airport at Jamaica, NY (JFK). The flight declared an emergency after receiving a right engine fire warning at approximately 400 feet agl. The flight crew reported that they shut down the right engine and that the fire warning extinguished following shutdown. Neither fire bottle was discharged. The flight returned to JFK and landed without incident. An airport rescue and firefighting unit met the airplane and determined that there was no active fire. The airplane damage was minor, and no injuries were reported. The airplane was being operated as a 14 CFR Part 121 scheduled flight from JFK to San Diego International Airport Lindbergh Field, San Diego, California (SAN). A post-incident airplane inspection found a hole in the right nacelle inboard core cowl consistent with a burn through. See Figure 1.

Figure 1. Right nacelle, showing cowling burn-through

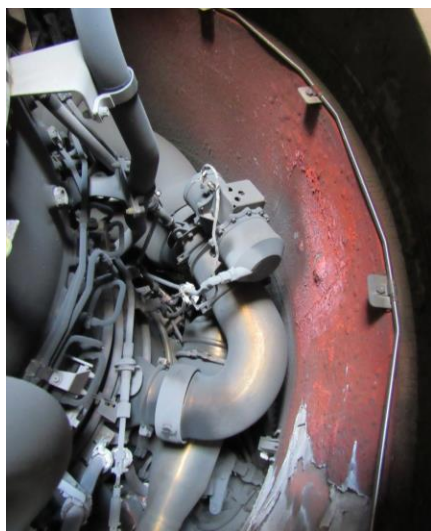
No thermal damage was noted to the inlet cowl or the fan cowls. The paint was blistered on the aft 11 inches of the thrust reverser cowl inner fan duct flowpath. The ablative coating on the inner surfaces of the thrust reverser cowl was intact between 12 and 3 o'clock<sup>3</sup> and charred and fractured with some exposure of the underlying honeycomb structure between 3 and 12 o'clock. See Figures 2 and 3.

Figure 2. Thrust reverser cowl inner surface, 12 to 4 o'clock

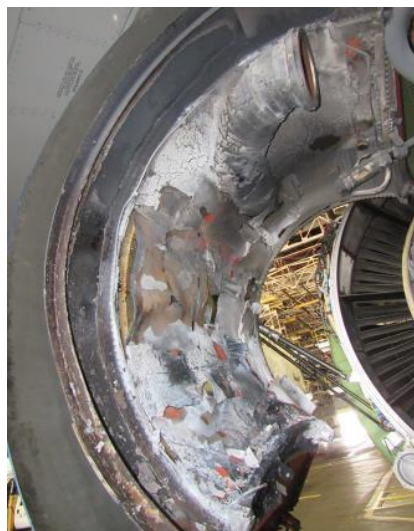
Figure 3. Thrust reverser cowl inner 7 to 11 o'clock

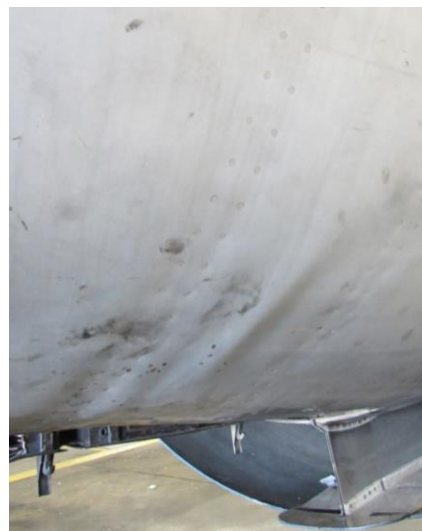
Figure 4. Outboard core cowl

The skin at the aft end of the outboard core cowl was buckled between 4 and 6 o'clock. See Figure 4.

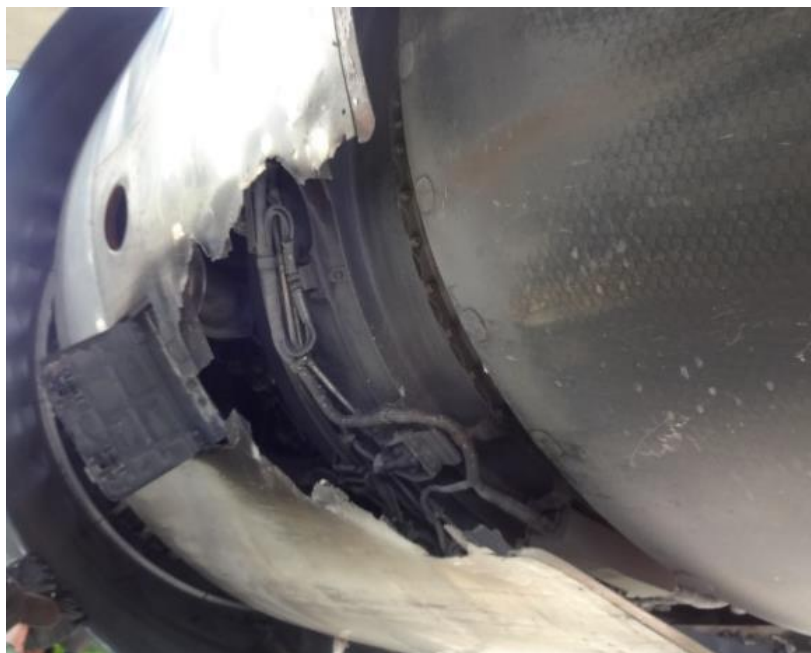
The inboard core cowl was deformed and was missing a 25-inch long (axial) section at 7 o'clock. The missing section measured 3.5 inches wide at the forward end and 14.5 inches wide at the aft end and included the aft edge of the pressure relief door (PRD) cut-out. The edges of the hole were thinned and irregular. A pattern of discoloration and soot surrounded the PRD cut-out and missing cowl section and extended aft. See Figure 5. There were rough, matte-gray deposits adhering to the aft end of the exhaust nozzle outer surface between 4 and 10 o'clock. See Figure 6.

Figure 5. Right engine inboard core cowl burn-through

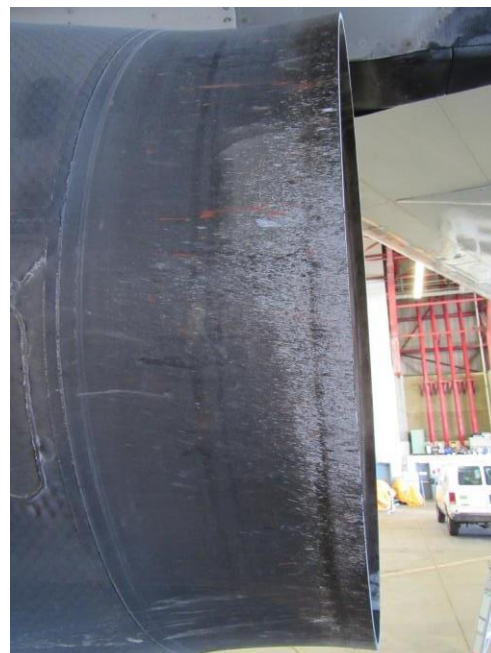
Figure 6. Exhaust nozzle deposits

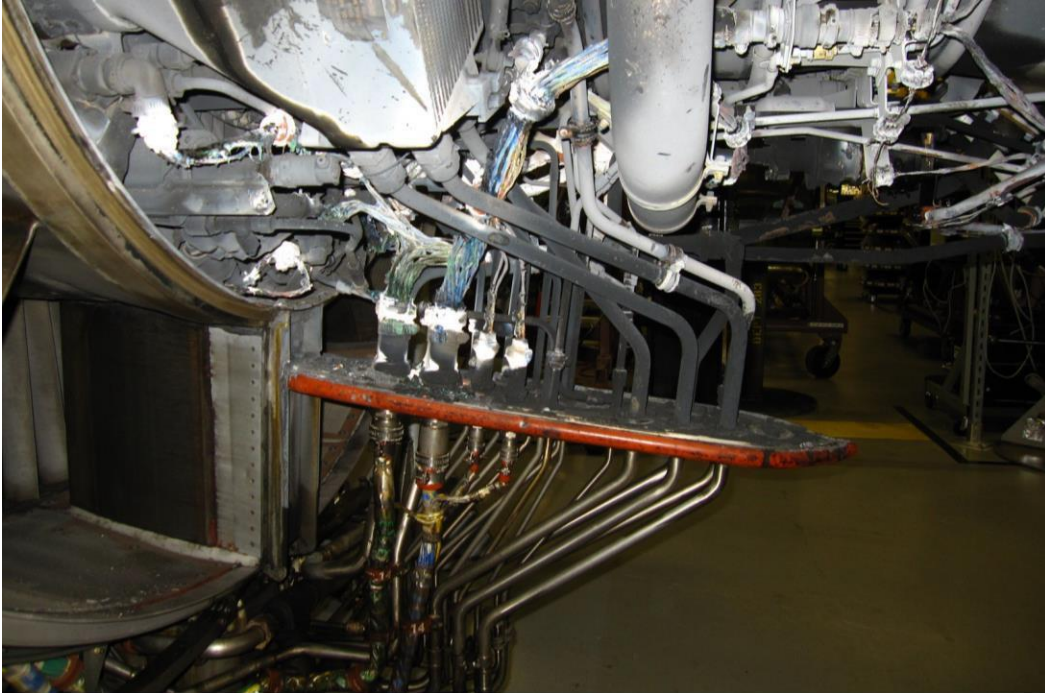
The engine fan section was in good condition, with no evidence of thermal damage. On the core compartment side of the bifurcation panel, tubes and components were sooted and the wiring, insulation and attachment hardware were thermally damaged. On the outboard side of the bifurcation panel, the tubes and wiring showed no evidence of thermal distress. See Figure 7. The panel bulb seal was in good condition. See Figure 7.

Figure 7. Bifurcation panel, showing isolation of the fire damage to the core compartment

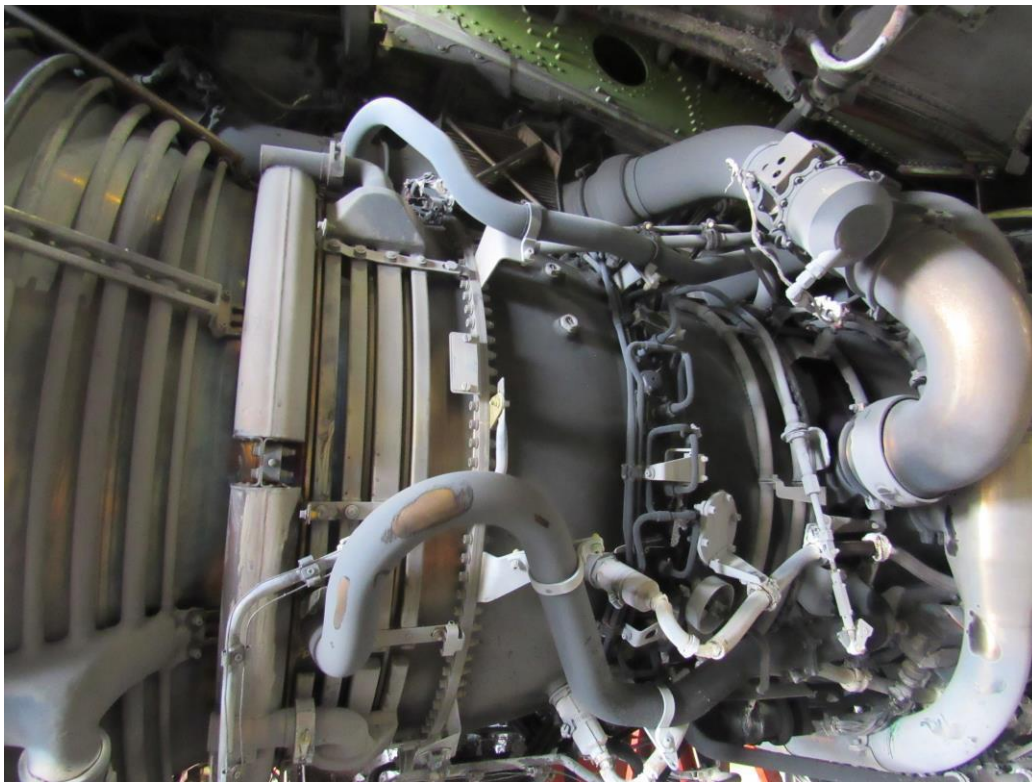
The engine thermal distress was limited to the core compartment fire zone. Soot was deposited over the entire core. The HPC between 1 and 4 o'clock showed the least thermal damage. See Figure 8.

Figure 8. Upper right side of engine

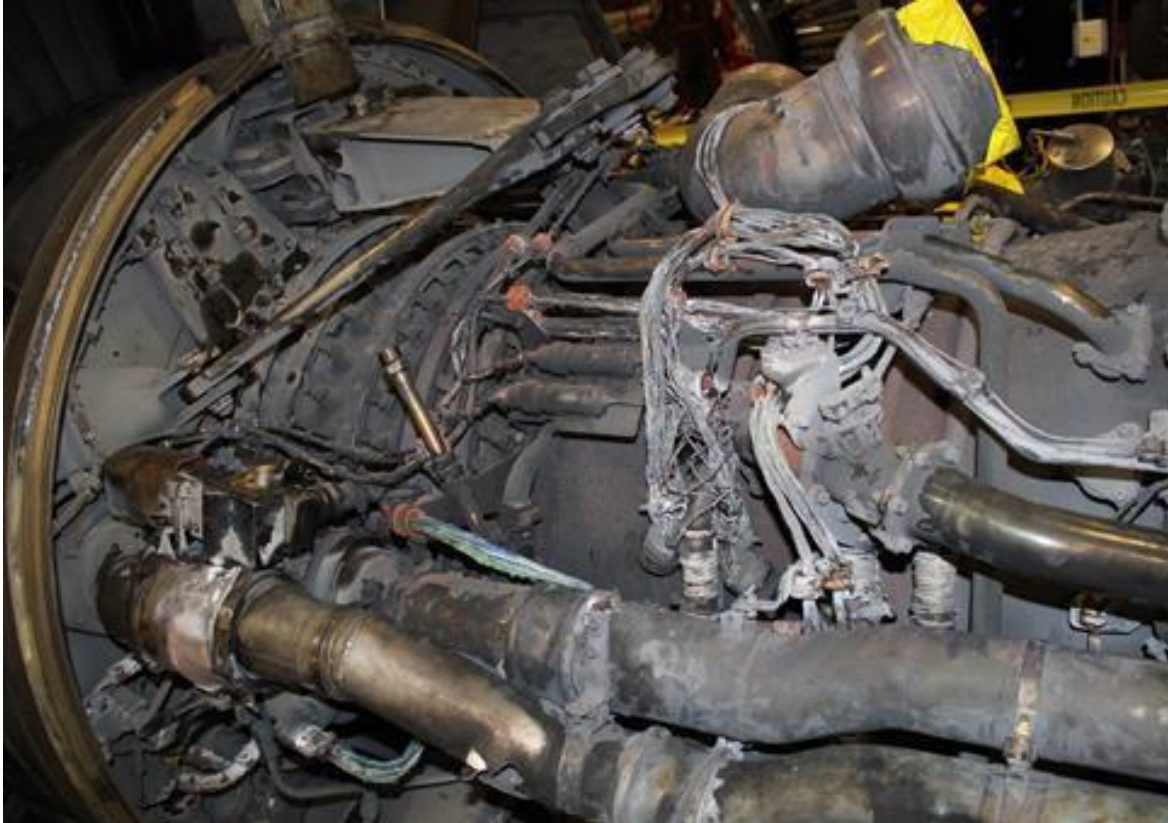
Most of the engine electrical harnesses, insulation material and attachment hardware between 4 and 1 o'clock were thermally distressed. The damage included melted wiring harness insulation, eroded P-clamp cushions, whitened and flaking flexible fuel line fire sleeves and melted or missing fire loop grommets. The turbine case cooling line (TCC line) was ruptured 21.5 inches aft of the V-groove at 9 o'clock. The rupture was approximately 2 inches across and the fractured edges were petalled outward. The fan air valve actuator housing was heat deformed and was partially consumed. See Figures 9 – 11.

Figure 9. General thermal distress, engine externals on left side of the engine

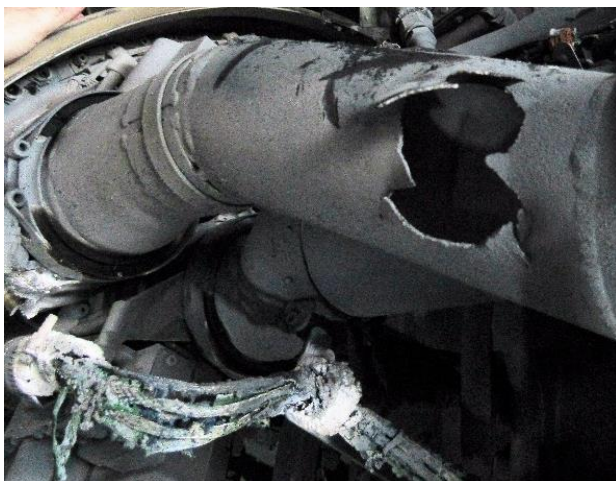
Figure 10. Ruptured TCC line

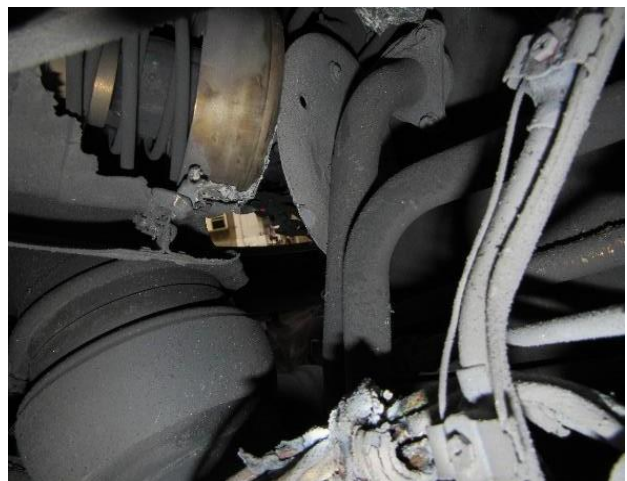
Figure 11. Partially-consumed fan air valve

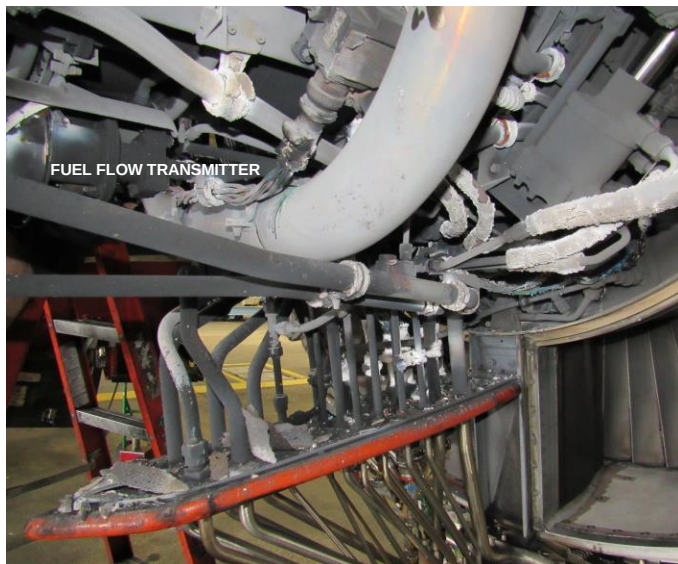
The most pronounced thermal damage was to the diffuser/HPT area between 6 and 9 o'clock where bare and separated wires were noted, including burner temperature, turbine cooling air and EGT signal wires, and both aft lower fire loops. The sooting had the darkest appearance between 6 and 7 o'clock where the FFT assembly shell and identification plate assembly was partially consumed by fire. See Figure 12. A rubbery blue-colored substance consistent with fuel-resistant O-ring material<sup>5</sup> protruded from the top and left sides of the FFT-to-fuel OUT tube joint. See Figure 13.

Figure 12. Right side of the FFT showing heavy sooting

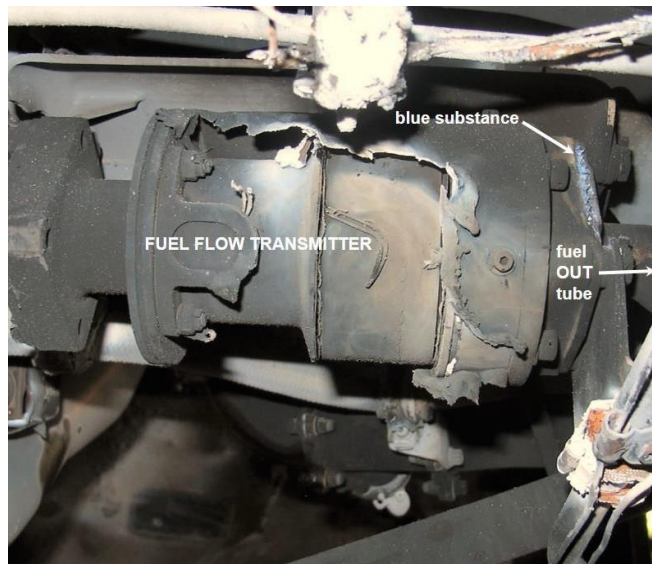
Figure 13. FFT thermal damage and blue substance at the FFT-to-fuel OUT joint

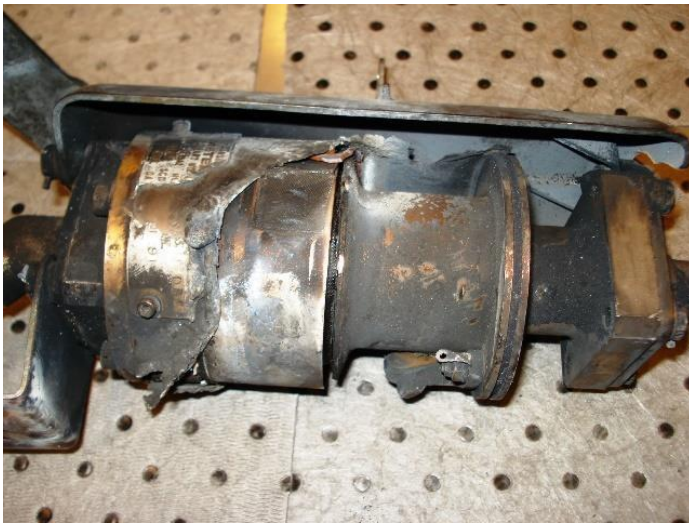
The FFT was heavily sooted and fire damaged. The damage was concentrated at the fuel inlet end. Approximately 65% of the FFT assembly shell and identification plate assembly, including the electrical connector housing and lead wires, was missing/thermally destroyed.<sup>7</sup> See Figure 15. The edges of the remaining assembly shell at the fuel OUT end were deformed and drooping at 6 o'clock. The coil electromagnetic interference shield had separated at its braze points, exposing the start signal coil/stator

assembly. The exposed area of coil and silicone shrink sleeve was thermally consumed. Silicone shrink sleeve remnants observed under the shell appeared dry and brittle. The ground strap was partially consumed. There was no obvious thermal damage to the main and end housings. Material consistent with oil- and fuel-resistant fluorosilicone protruded from the FFT-to-fuel OUT tube joint and was adhered to attachment bolt threads.

Figure 15. FFT receiving inspection

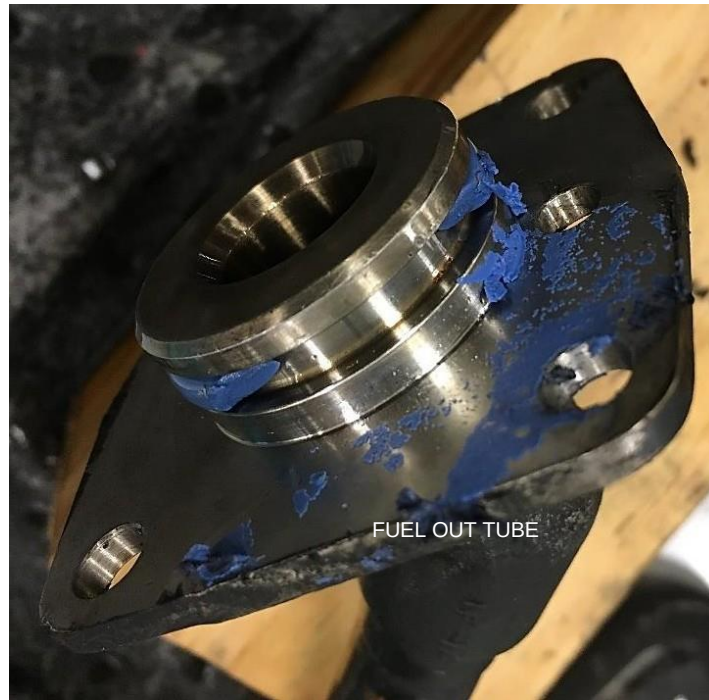
The fuel OUT tube O-ring was seated in the gland but was missing a 90° arc of material. The separated O-ring ends were shallowly angled. See Figure 17.

Figure 17. Fuel OUT tube showing damaged O-ring in tube gland and O-ring material deposited on flange surface

Parker Aerospace, a globally recognized manufacturer of seals and O-rings, was asked to assess the fuel OUT O-ring damage. Parker reported that the similar angle/plane cuts on both O-ring ends is commonly observed and is a typical result of installation error.

A new O-ring was lubricated and installed in the fuel OUT tube gland. The tube was reassembled to the FFT and the retaining bolts were torqued to the minimum required torque per the engine manual (65 lb in).

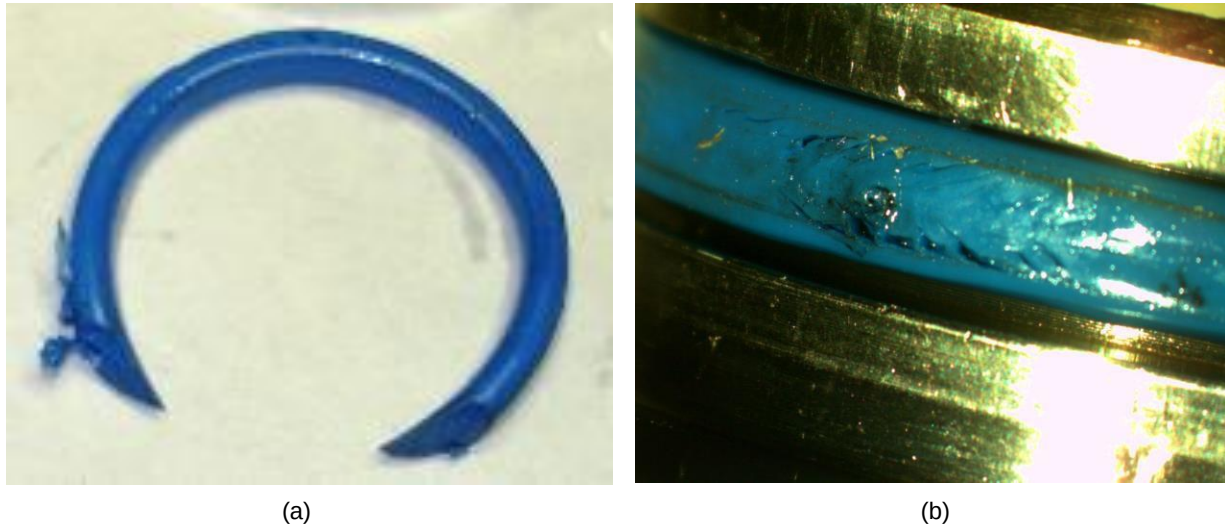
The surface of the O-ring was rough and eroded. Deteriorated O-ring material was found between 9 and 12 o'clock, on the tube flange along the rim of the flow path outlet between 8 and 1 o'clock, and at the No. 4 attachment bolt hole and the dowel pin. There was an approximately 0.25-inch longitudinal cut at 8 o'clock adjacent to bolt hole 3. There was a longitudinal tear at 5 o'clock. There were parallel longitudinal abrasion marks and axial gouges. See Figure 18.

Figure 18. FFT fuel OUT tube O-ring showing (a) missing arc of material and (b) O-ring surface damage

The fuel IN and fuel OUT O-rings were submitted to the NTSB Materials Lab for evaluation. A Fourier transform infrared spectrometry analysis found spectra consistent with Type 1 Class 1 Grade 60 rubber fluorosilicone/ elastomer, which conformed to the drawing specification. The surface texture of both O-rings was gummy and easily deformed and the outer surface of the fuel OUT tube O-ring also exhibited flaking and delamination. These conditions are consistent with polymer reversion.<sup>9</sup>

- Boeing B757 AMM Task 73-31-01-404-018-P00, *Install the Fuel Flow Transmitter*, did not include an instruction to lubricate O-rings prior to installation<sup>10</sup> or specify a torque value for the tube attachment bolts. It incorrectly directed that the fuel tube O-rings be installed on the FFT rather than into the fuel tube O-ring glands.
- Boeing B757 AMM Task 73-31-01-004-010-P00, *Remove the Fuel Flow Transmitter*, referred to the fuel IN and fuel OUT tube O-rings as installed on the FFT rather than in the fuel tube glands.

Boeing has revised these instructions.
