# NATIONAL TRANSPORTATION SAFETY BOARD

MATERIALS LABORATORY FACTUAL REPORT

Report No. 17-002

Place : Miami, Florida  
Date : September 19, 2016  
Vehicle : Airbus A320-232, P4-AAA  
NTSB No. : ENG16IA037  
Investigator : Pocholo Cruz, AS-40

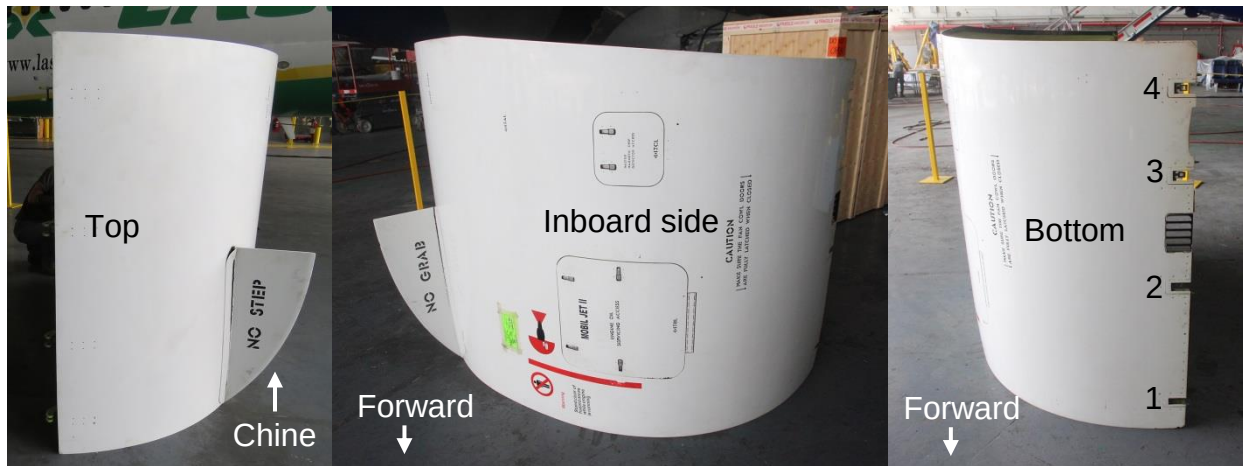
**Figure 1:** Views of left side of No. 2 engine fan cowl from the top to the bottom.

Views of the left side of the fan cowl are shown in figure 1 starting at the top of the cowl and proceeding to the bottom. Visual examination revealed cracks in the outer skin at the aft root end of a chine attached to the cowl approximately one-third of the way from the top. For convenience, the latches and keepers were numbered 1 through 4 starting at the forward end of the cowl. The keepers were examined for indications of wear or deformation but no apparent indication of either were found, as shown in figure 2. All of the keepers exhibited some play when moved by hand. There were alignment pins on the left side of the cowl that mated with guide holes on the right side. All of the pins were present and there were no apparent signs of damage.

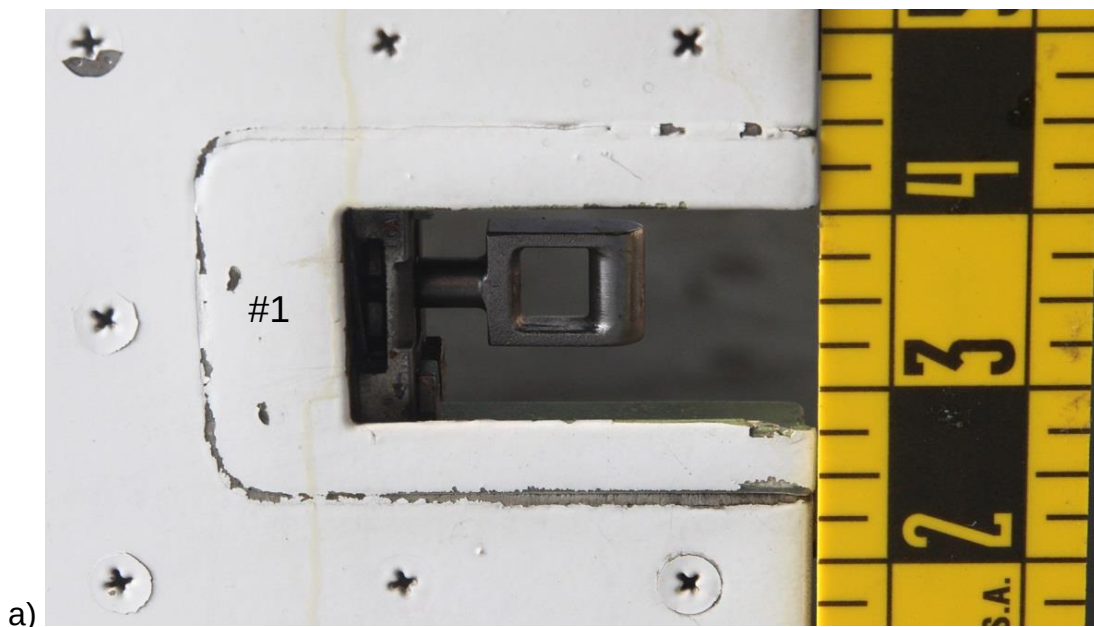
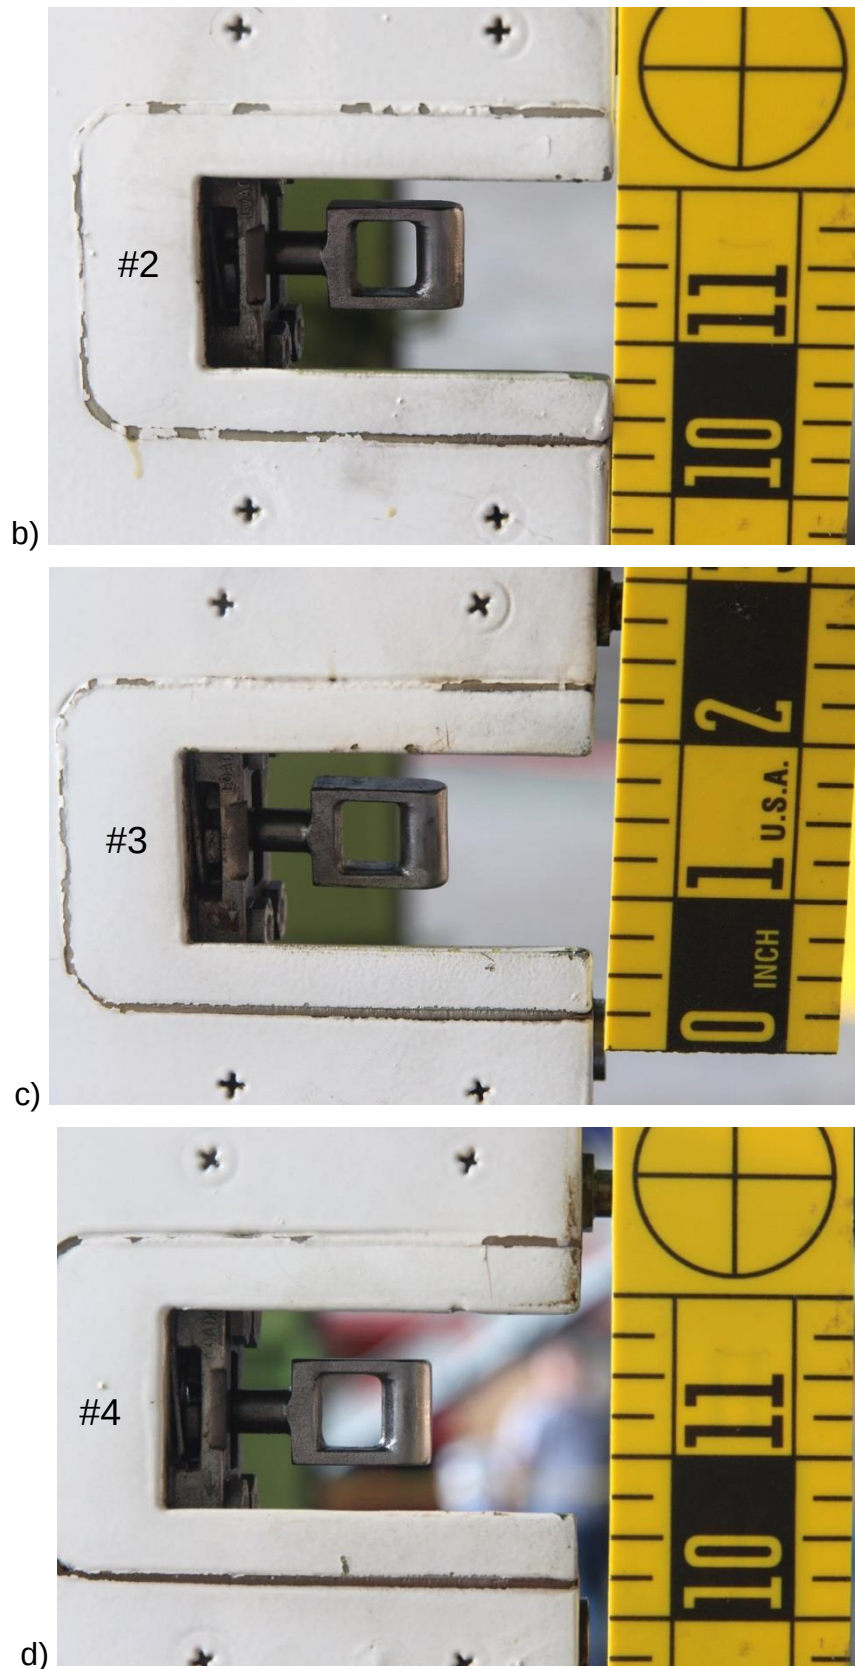
**Figure 2:** Images of keepers on left side of fan cowl: a) keeper for latch #1;

**Figure 2 (cont.):** b) – d) keepers for latches #2 through #4, respectively.

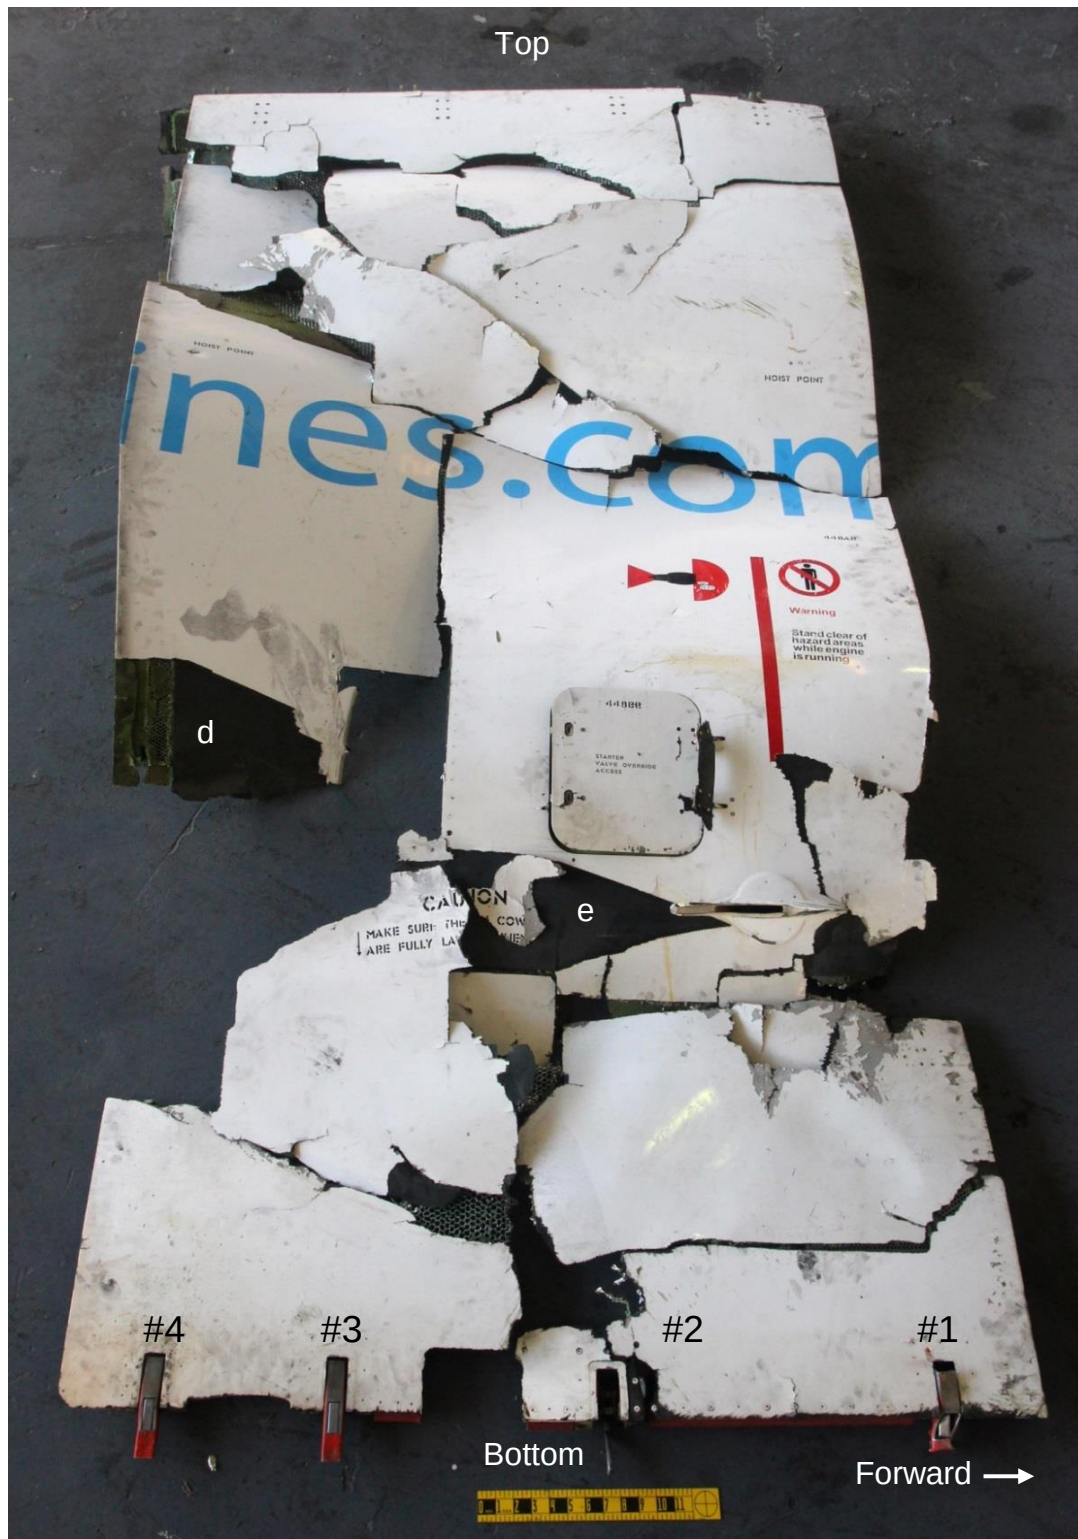
The cowl was a composite construction consisting of an aluminum honeycomb core and carbon fiber composite skins adhesively bonded to the inner and outer faces of the core. The right side of the No. 2 engine fan cowl was fractured into multiple pieces. The fracture and delamination patterns were used to reconstruct the cowl where possible. Outer and inner views of the reconstructed cowl are shown in figures 3 and 4, respectively.

**Figure 3:** Outer view of the reconstructed right side fan cowl.

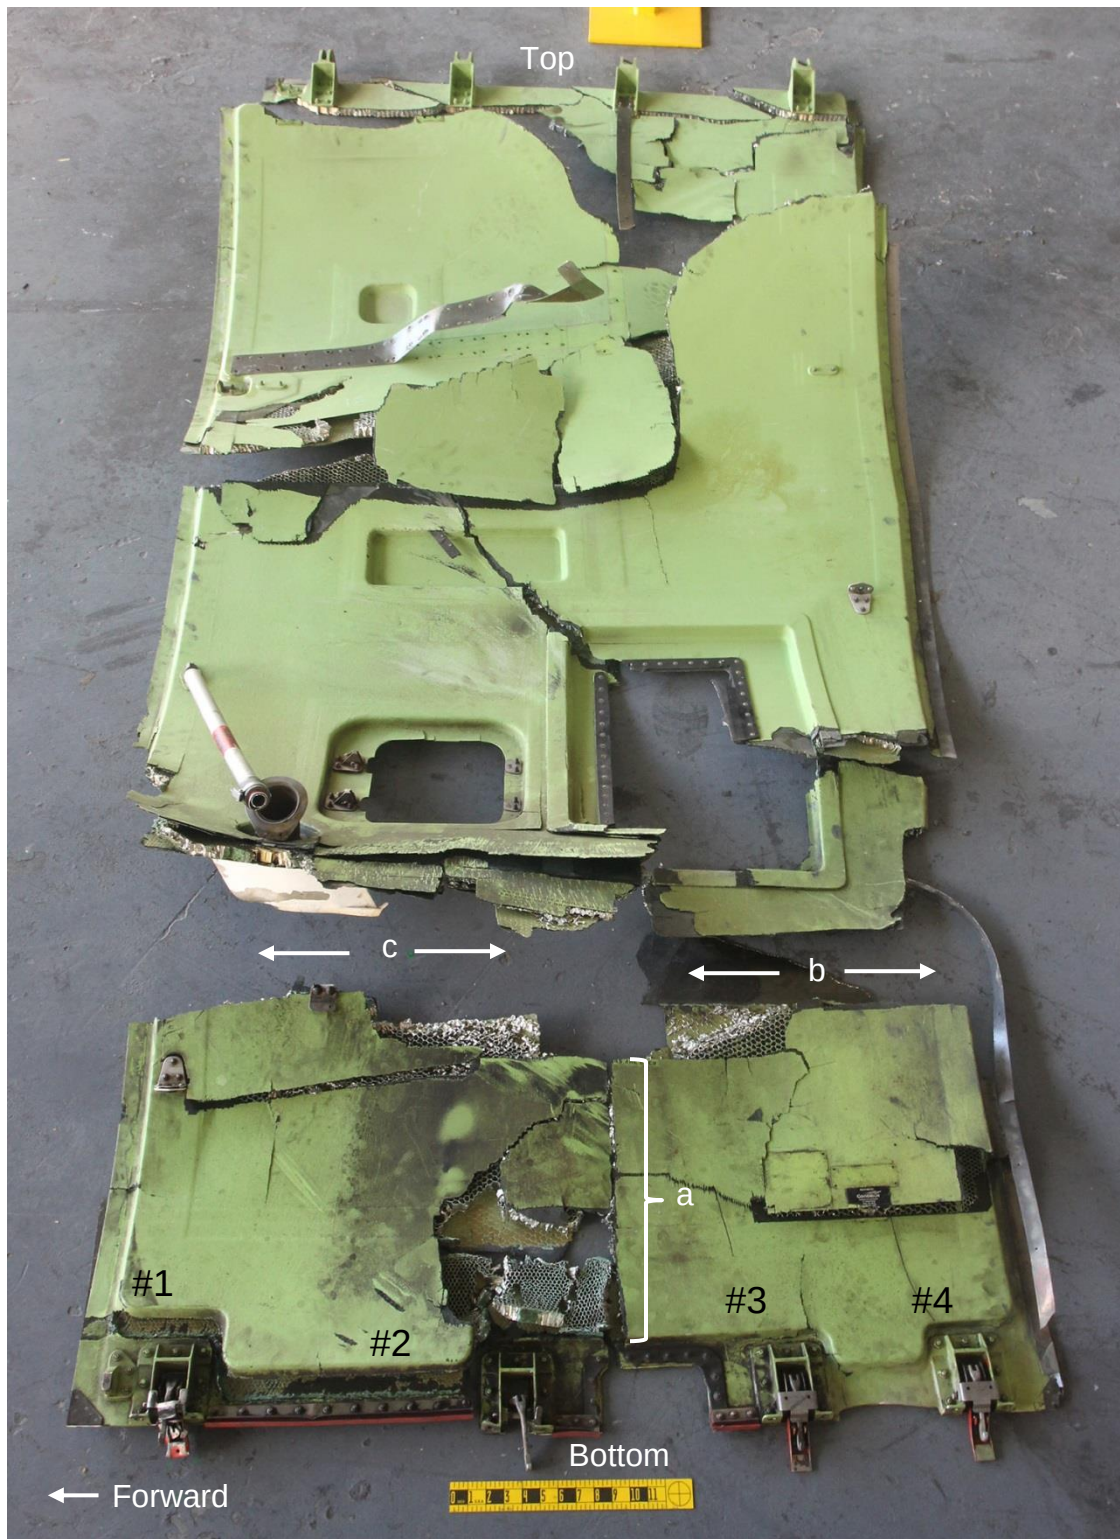
**Figure 4:** Inner view of the reconstructed right side fan cowl.

The inner skin and core were fractured along the axial direction below two cutouts in the cowl, as shown in figure 4, near the upper end of the 16-inch circumferential/radial fracture. Along the aft portion of the fracture, labelled “b”, the outer skin was delaminated from the core or missing. As seen in the outer view of the cowl in figure 3, the outermost white ply of the outer skin had delaminated from the underlying carbon fiber plies in two locations toward the aft end of the cowl, labelled “d” and “e”. The outermost ply had torn in a chevron or partial chevron pattern consistent with the delaminations proceeding in the aft to forward direction.

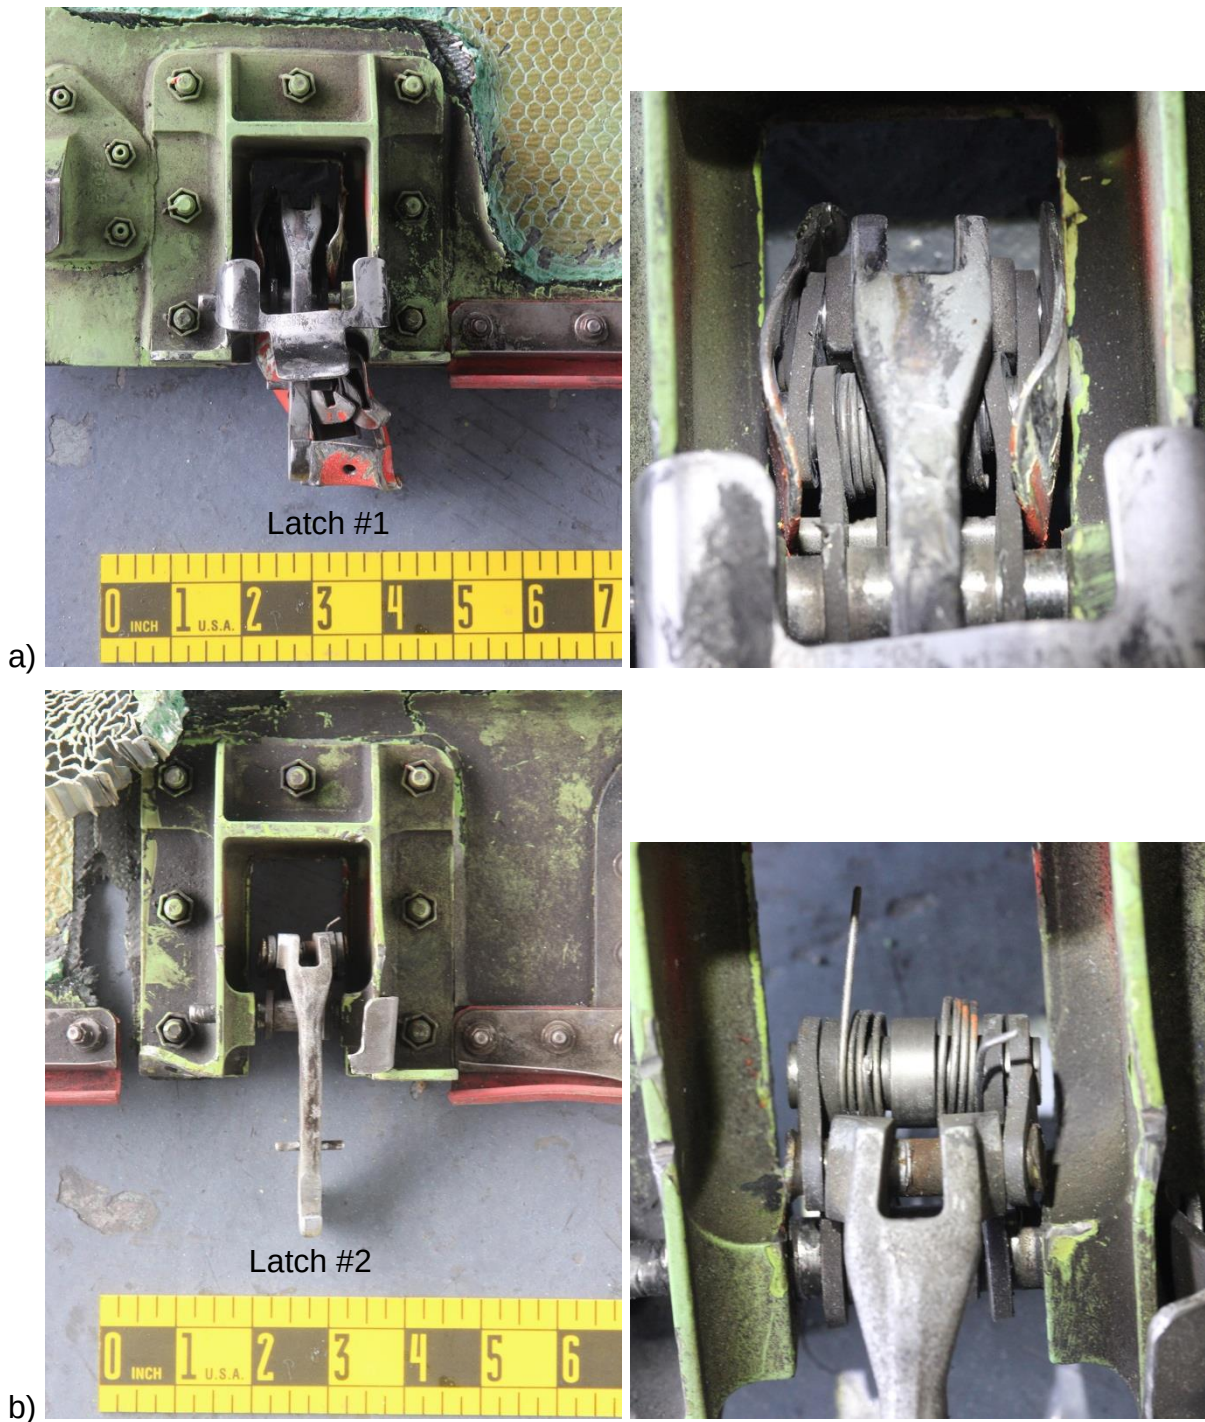
Images of the right fan cowl latches are shown in figures 6a through 6d for latches 1 through 4, respectively. The handle for latch #1 (Figure 6a) was deformed. The catches were not engaged with the posts but were flattened against the underside of the handle. The posts and the slots in the catches did not exhibit any contact or deformation marks indicative of forced disengagement of the catches due to an external load. The links for latch #1 were deformed as shown in the right photo of figure 6a.

Images of latch #2 are shown in figure 6b. The plate that limits latch travel was fractured and the handle was missing. The base of the latch and the links in the latch mechanism were deformed as shown in the right photo of figure 6b.

**Figure 6:** Photos of the fan cowl handles/latches and link mechanisms. Latches are numbered 1 through 4 starting at the forward end of the cowl; a) latch #1; b) latch #2;

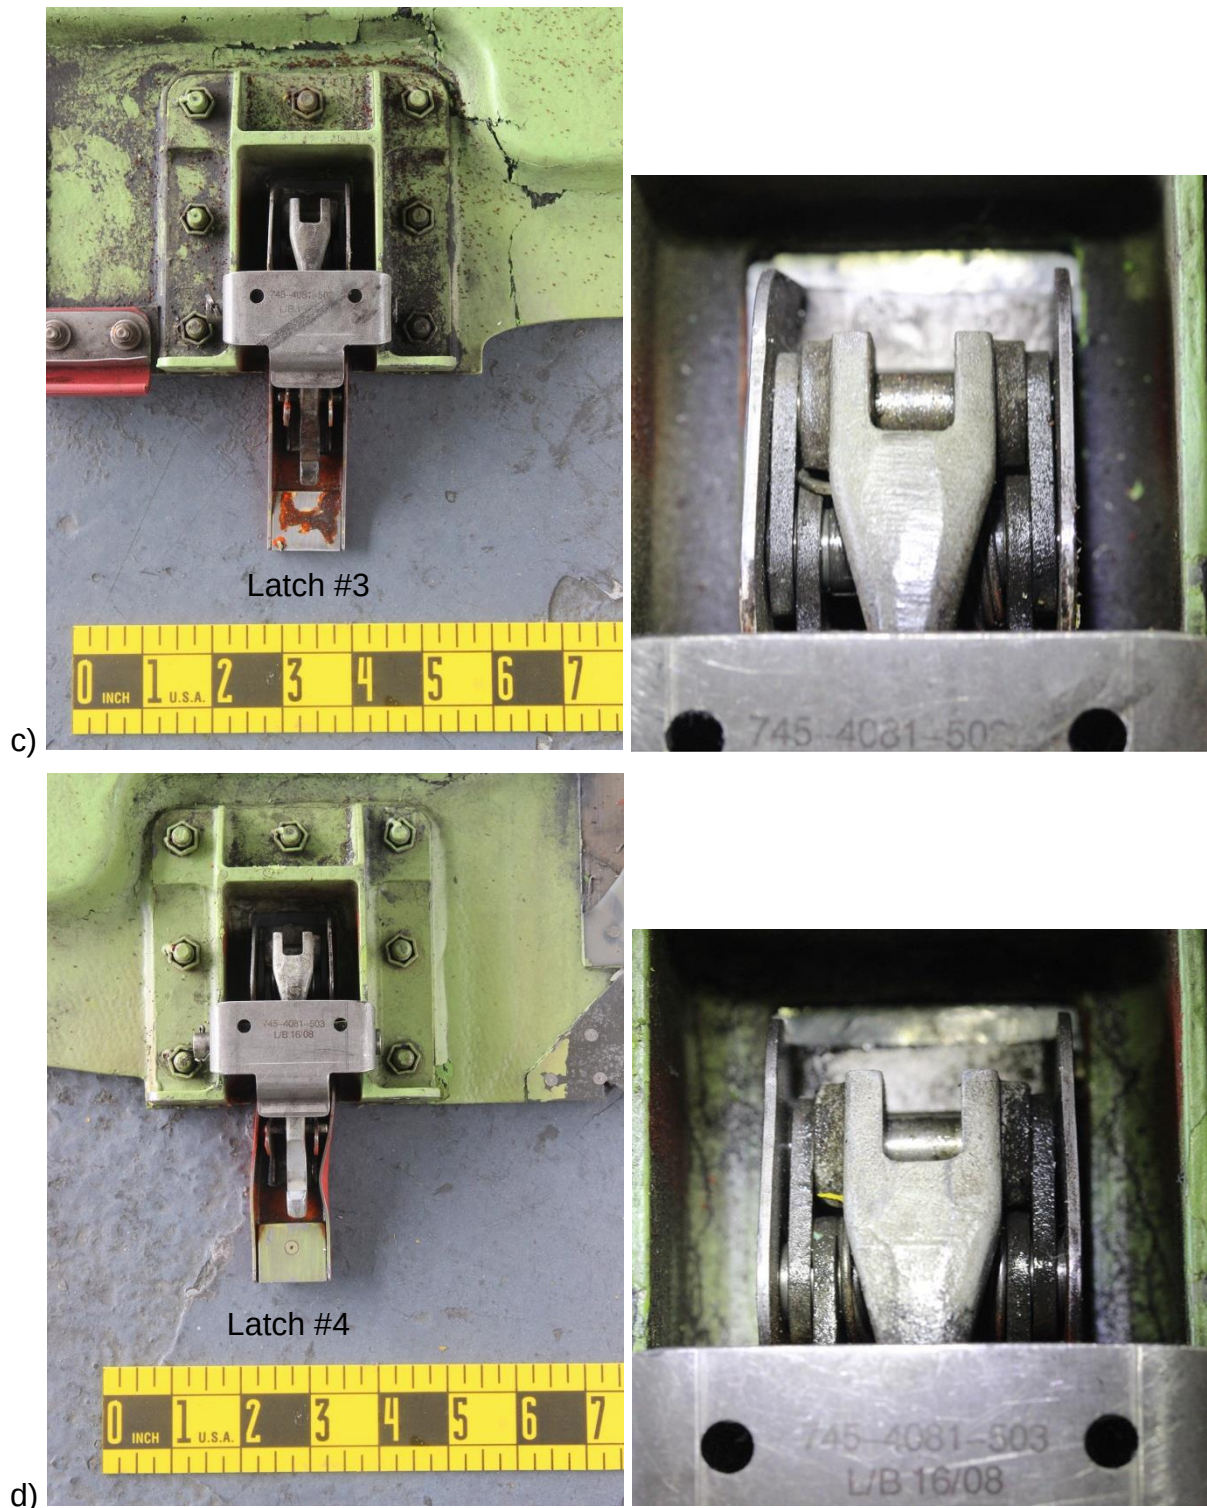
Images of latches #3 and #4 are shown in figures 6c and 6d, respectively. In their as-examined condition, the catches were engaged with the posts on latches #3 and #4. The lower portion of the #4 latch handle was deformed in the forward direction by approximately 1/8". There were no apparent indications of deformation to the #3 latch handle or to the links in the latch mechanism for either latch, as shown in the right photos of figures 6c and 6d.

Figure 6 (cont.): latch #3 and d) latch #4.

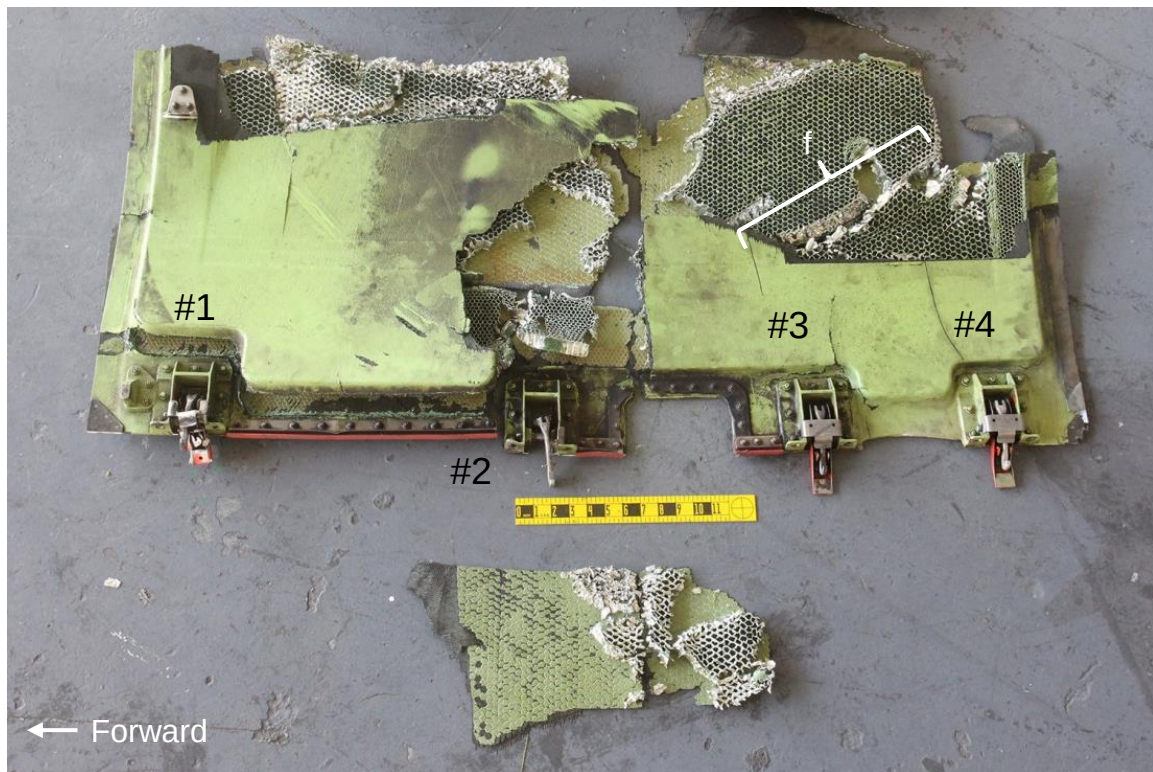
A plastic grill between latches 2 and 3 was fractured along the edge of its mounting flange as shown in figures 4, 5 (example of intact grill), and 7. The flange was also fractured near the forward end of the grill through two adjacent bolt holes. The cowl was fractured along the forward and the top edges of the number 2 latch fitting (adjacent to the grill cutout). The fracture along the top edge of the fitting extended to the forward edge of the grill cutout, separating the number 2 latch fitting from the rest of the cowl. The core, inner skin and outer skin were fractured in the circumferential/radial plane over an approximately 16-inch length, labelled “a” in figure 4, from the forward edge of the grill cutout to a rectangular patch on the outer skin. The core was delaminated from the outer skin in certain locations on either side of the fracture as shown in figure 7.

**Figure 7:** Inner view of lower portion of the fan cowl with inner skin pieces set aside.

The inner skin was disbonded from the core along the lower portion of the cowl as shown in figures 7 and 8. Along the aft portion there was a longitudinal fracture through the outer skin and core in the delaminated region, labelled “f” in figure 7. Along the forward

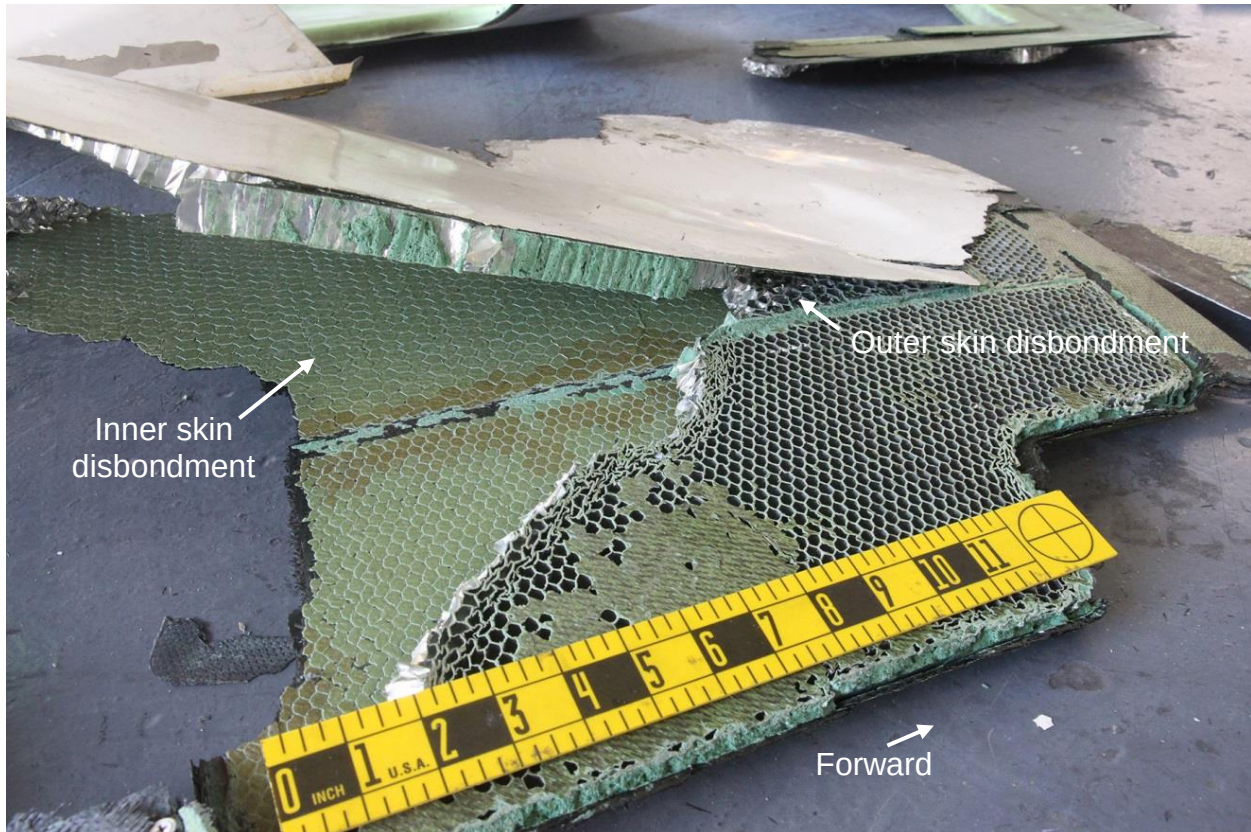
portion, the delamination extended from the previously noted axial fracture, labelled “c”, toward the bottom of the cowl crossing a bond line between different core density materials as seen in figures 8 and 9.

**Figure 8:** Image of the lower forward portion of the fan cowl showing the delamination of the inner skin from the core and the separation of the lower portion of the outer skin with doubler from the core.

The forward lower portion of the outer skin had disbonded from the core and a piece of the skin had separated from the rest of the outer skin along with the number 1 latch, as shown in figures 8 and 9. The skin tore along the edge of a doubler that ran along the lower edge of the cowl. Near the forward edge of the cowl, the tear intersected another doubler that ran along the forward edge of the cowl after which the tear proceeded at an approximately 45° angle to the edges of the cowl.

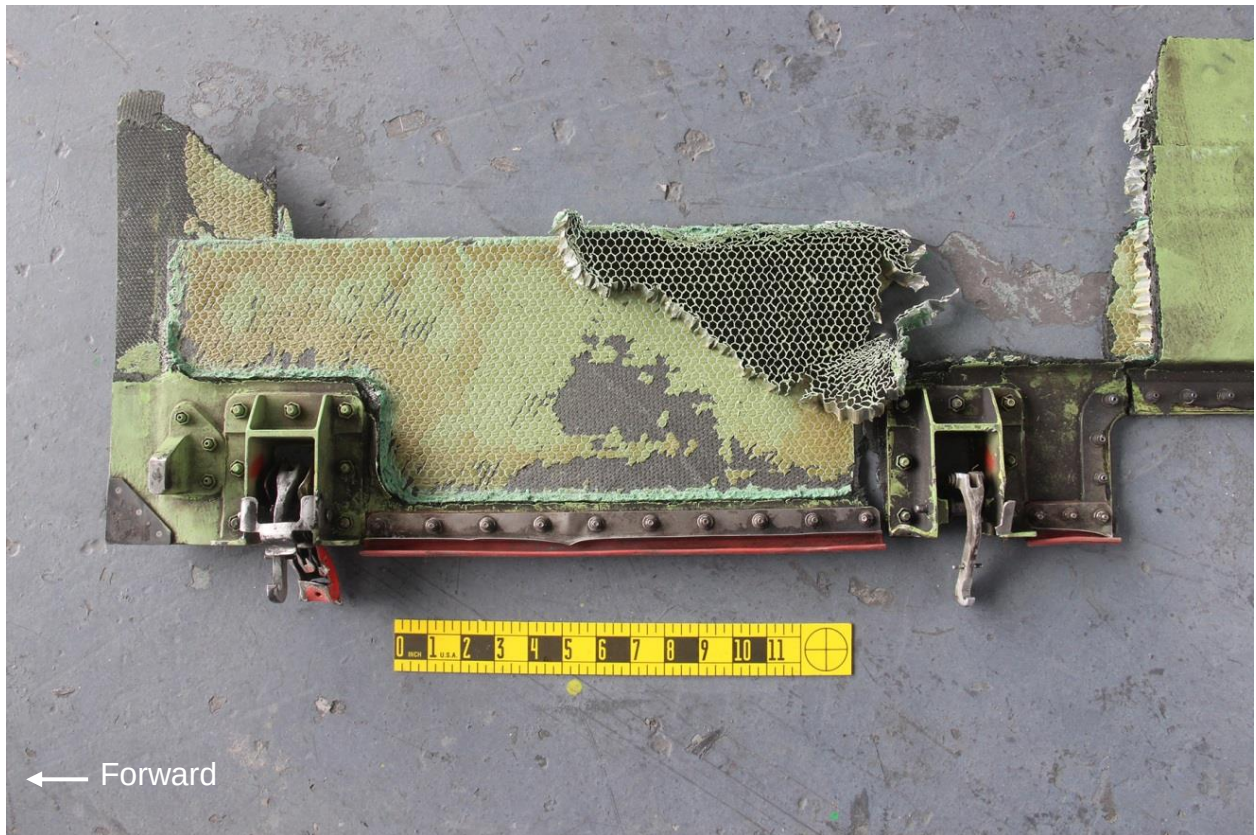
**Figure 9:** Forward lower portion of outer skin with number 1 latch still attached. The inner skin was disbonded from the core at the upper aft corner of the piece. The outer skin was disbonded from the core over the remainder of the piece. The skin separated along the edge of a doubler along the lower edge of the cowl.

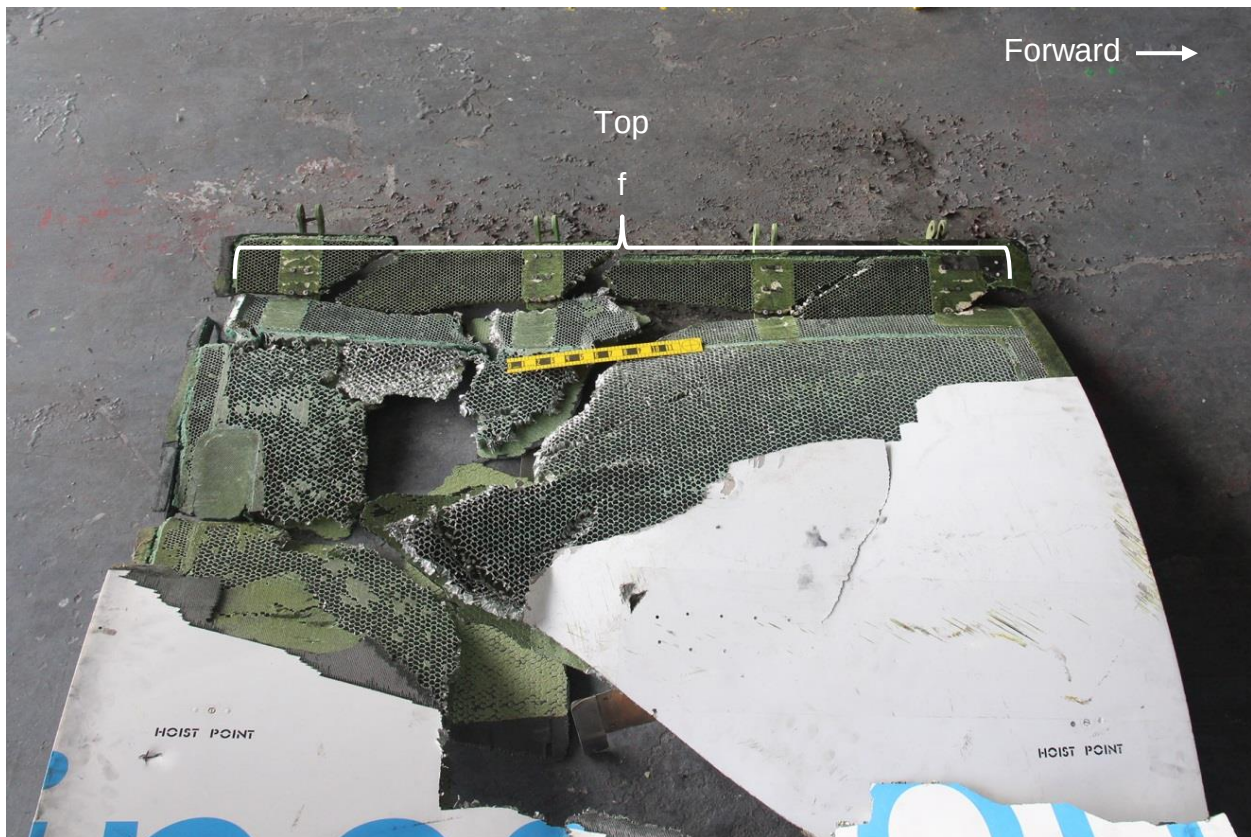
At the top of the cowl, the outer skin had disbonded from the core from the forward edge to the aft edge as shown in figure 10. At the forward edge, the disbonded region extended from the top edge down to approximately 24 inch from the top. At the aft edge, the disbonded region extended from the top edge down to approximately 30 inch from the top. In between, the edge of the disbonded region followed an irregular profile.

There was a series of longitudinal fractures through the inner skin and core that coincided with the lowermost row of attachment bolts that attached the hinge fittings to the cowl, indicated as "f" in figure 10 and also shown in figures 11a and b.

**Figure 10:** Outer side of the top of the cowl showing delamination of the outer skin and a series of longitudinal fractures at the root of the hinge fittings.

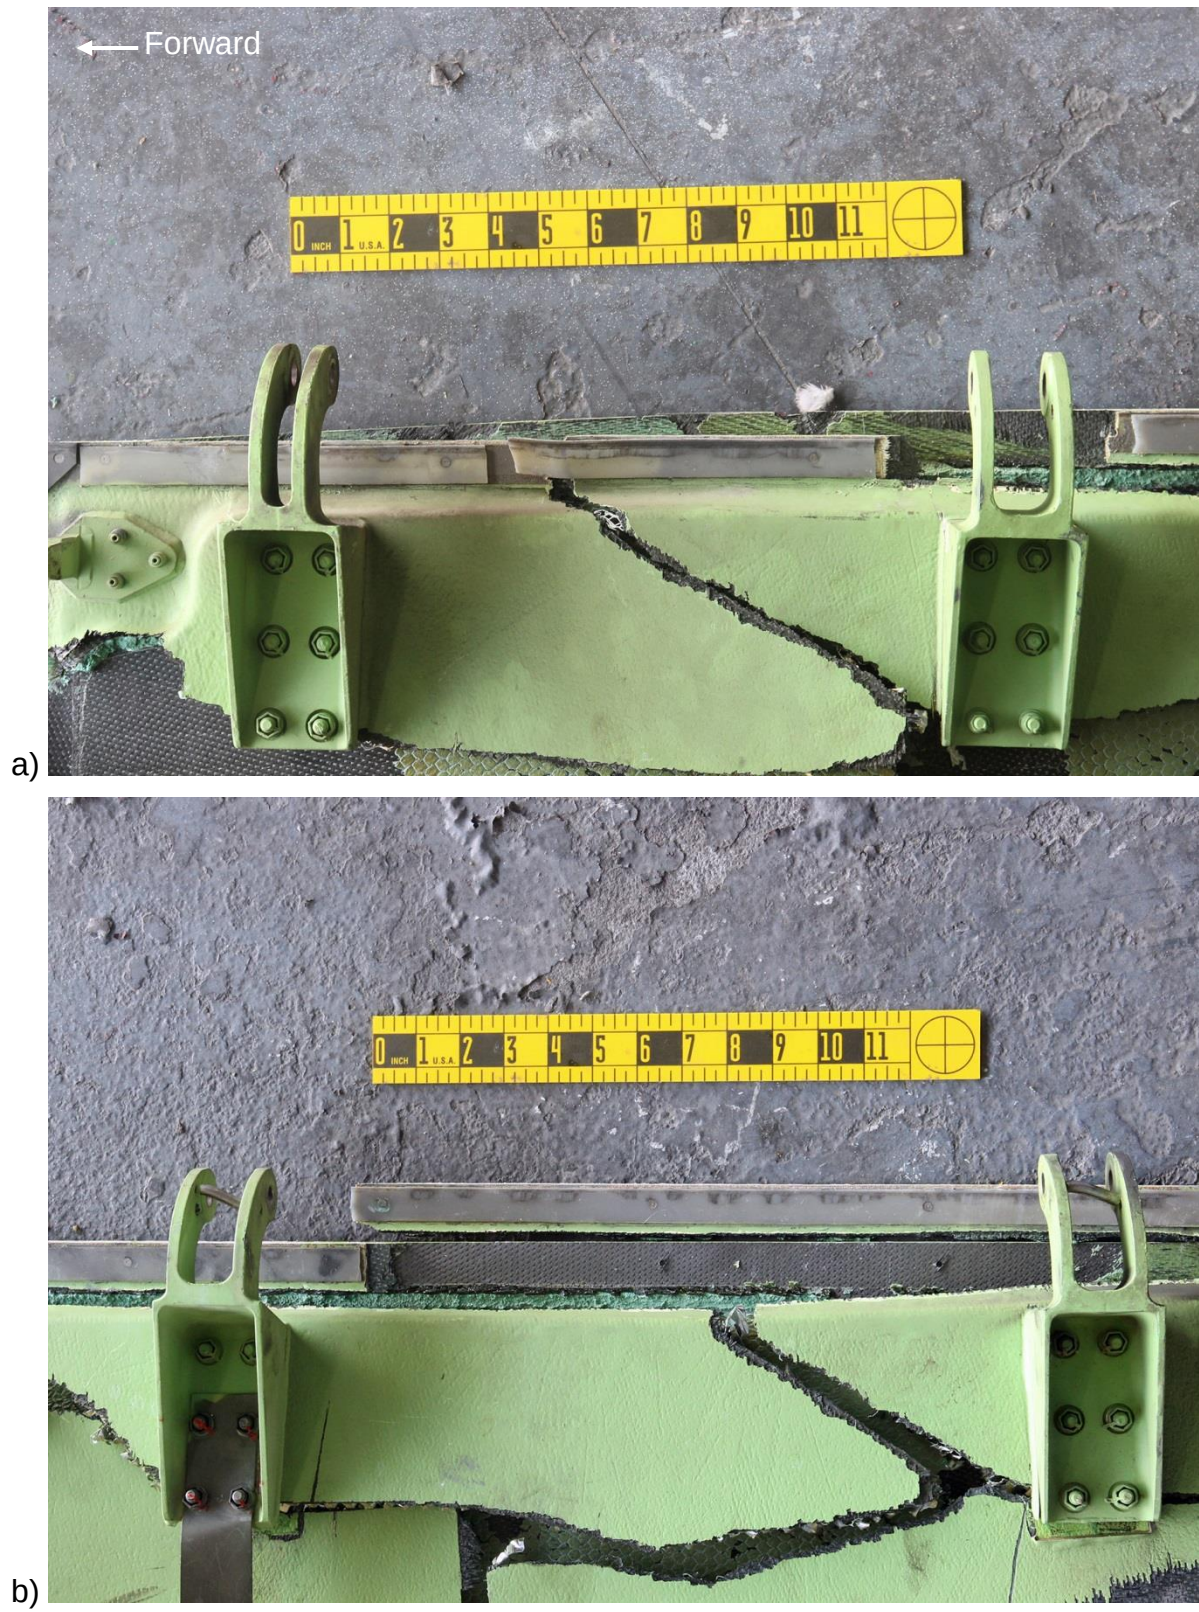
Three of four hinges (toward the aft end of the cowl) were equipped with a metal rod that was designed to contact a stop when the cowl was opened, thereby limiting its travel. The rods were fractured and/or deformed as shown in figures 11a and b. The first hinge from the forward end of the cowl was not equipped with a travel limiting rod. The second hinge was equipped with a rod whose center section was missing. Examination of the hinge indicated that the rod had been sheared at its forward and aft ends. The rods on the third and fourth hinges were deformed and had been sheared at the forward end but were still attached at the aft end. The rod on the third hinge was deformed approximated 0.5 inch center to center and the rod on the fourth hinge was deformed approximately 0.25 inch center to center.

**Figure 11:** Images of the hinge fittings at the top of the right fan cowl: a) two fittings at forward end of cowl and b) two fittings at aft end of cowl.
