**NATIONAL TRANSPORTATION SAFETY BOARD**  
**Office of Aviation Safety**  
**Washington, D.C. 20594**

**POWERPLANT GROUP CHAIRMAN'S FACTUAL REPORT**  
**NTSB No: ENG17IA003**

Aircraft: Airbus A330-223, N855NW, Delta Air Lines Flight 17

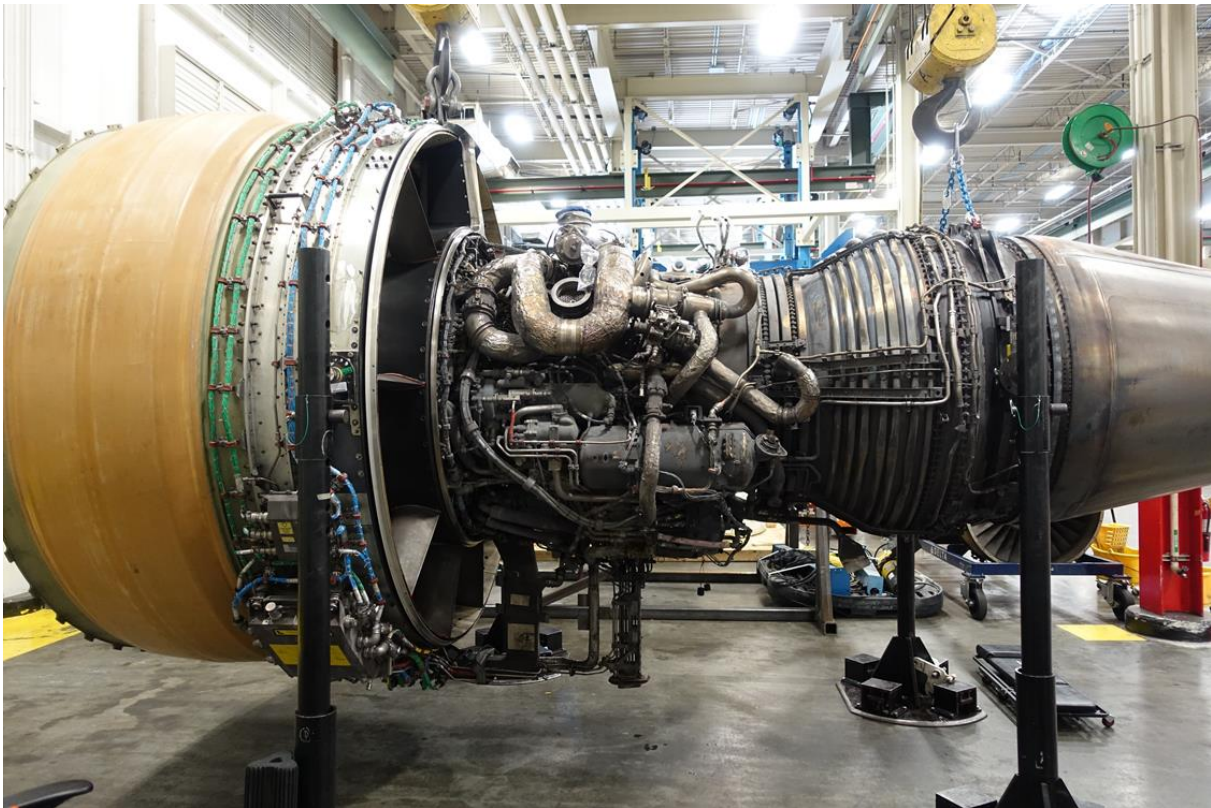
**Photo 1- Left Side of Engine, As Received**

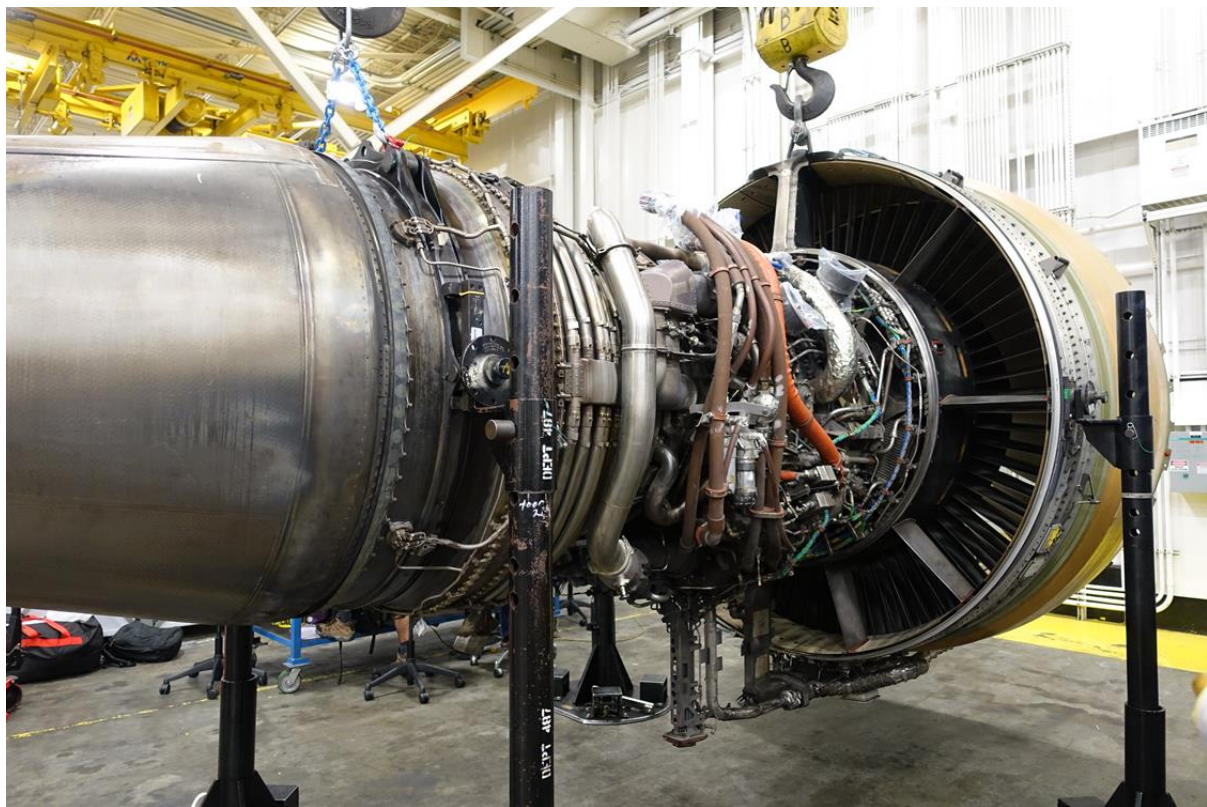
**Photo 2- Right Side of Engine, As Received**

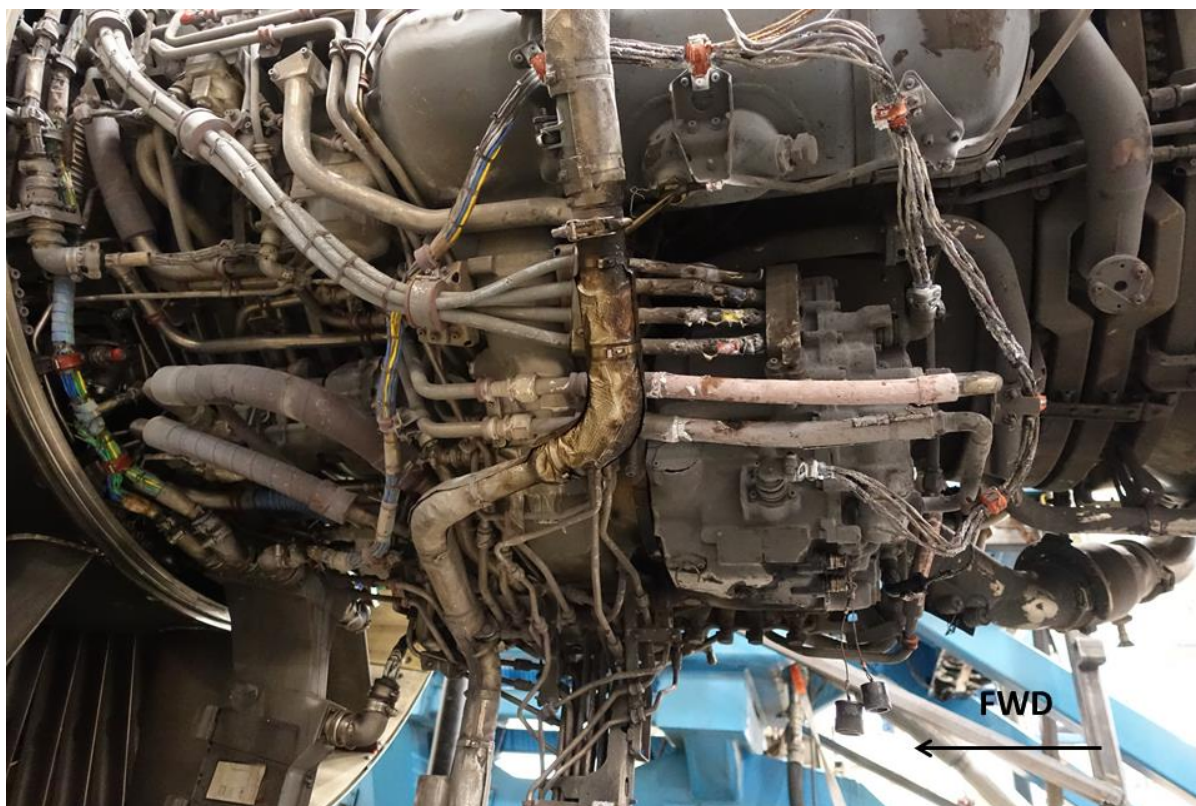
The No. 1 engine was removed from the airplane at SEA and prepared for shipment to Delta TechOps in Atlanta, Georgia for examination. The engine was received at Delta TechOps in an engine shipping stand and was held in the NTSB quarantine cage until the investigation team arrived. The engine was then transferred onto work pedestals to facilitate inspection and removal of external components (**Photos 1, 2, and 3**). The engine was sooted/discolored from the 5 o'clock to 12:30 positions, between the fan case and exhaust case. The soot/discoloration was most concentrated from the 6 to 9 o'clock positions from the forward flange of the HPT case to the aft flange of the diffuser case. Clamps, wiring harness cables, and the electrical power cables (feeder cables) in the area of greatest soot concentration exhibited thermal damage including charred and melted material (**Photos 4 and 5**). At the 12 o'clock position an additional area of localized soot/discoloration was noted on the diffuser case near fuel nozzle No. 1. Directly above the discoloration, the middle of three pressure regulating valve pneumatic lines had braided metal sleeve burn through and discoloration above the collar (**Photos 6 and 7**).

**Photo 4- Soot/Discoloration and Thermal, 6 to 9 o'clock**

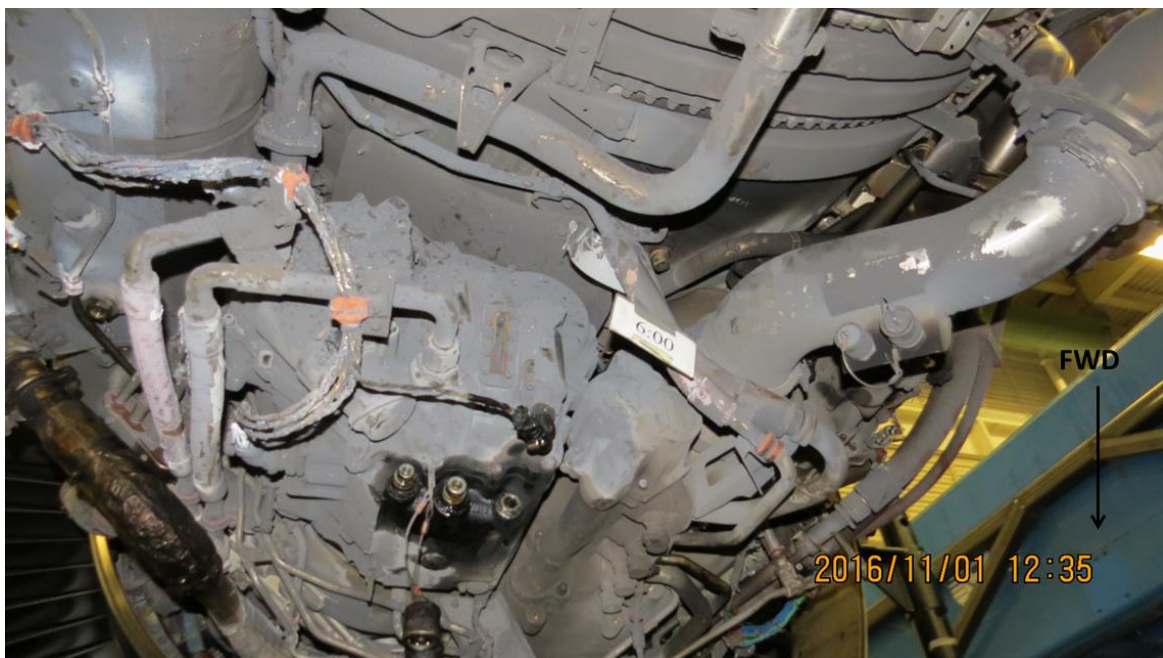
**Photo 5- Soot/Discoloration and Thermal Damage, 6 o'clock**

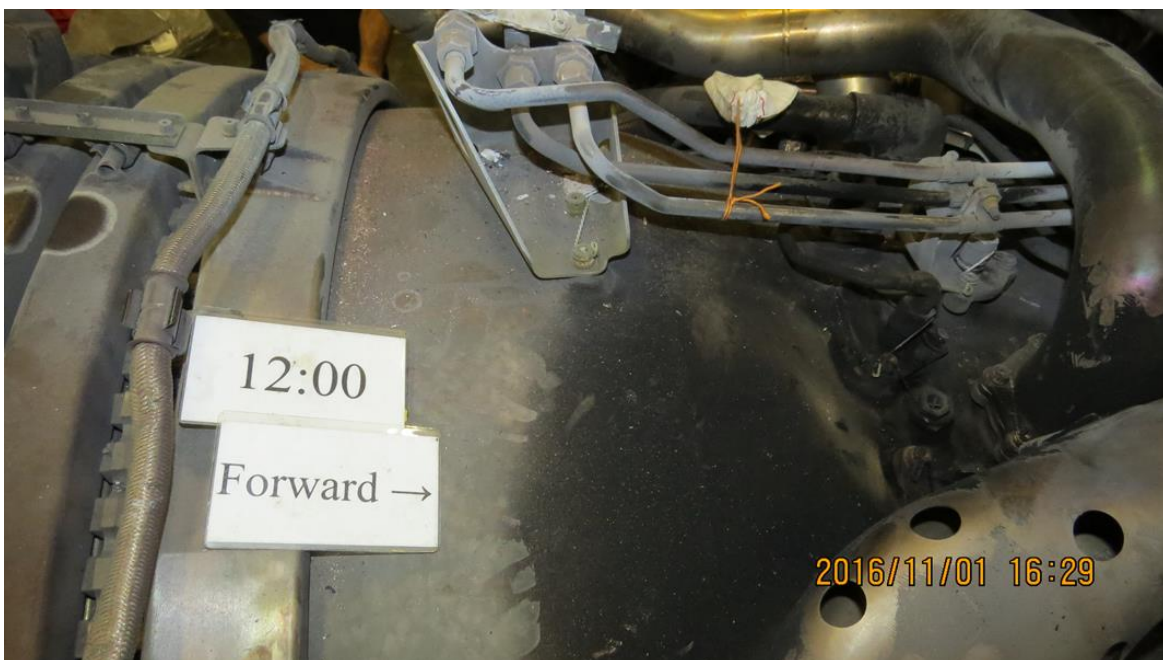
**Photo 6- Localized Soot/Discoloration, 12 o'clock**

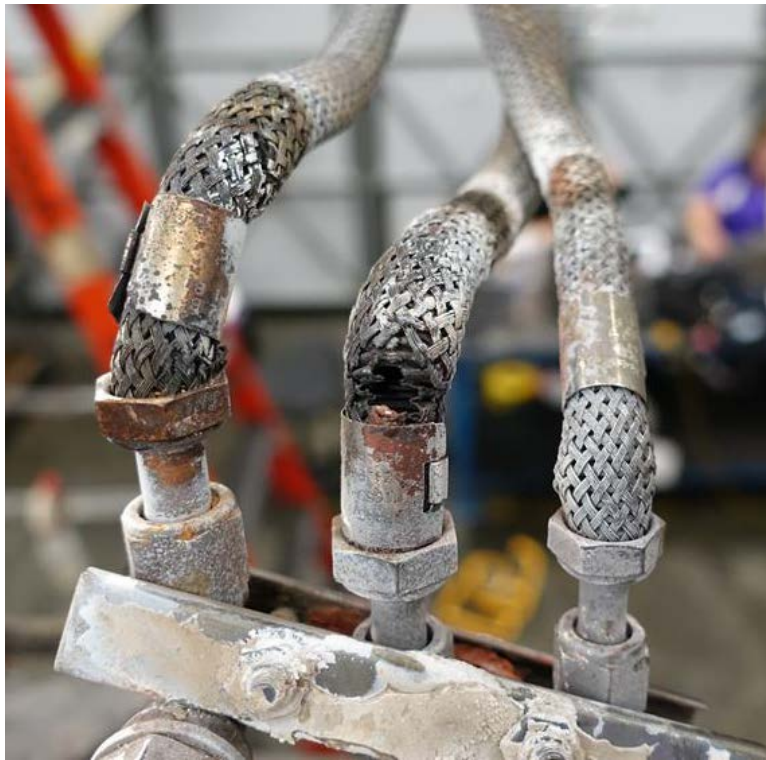
**Photo 7- Pressure Regulating Line Thermal Damage, 12 o'clock as Viewed from the Right Side**

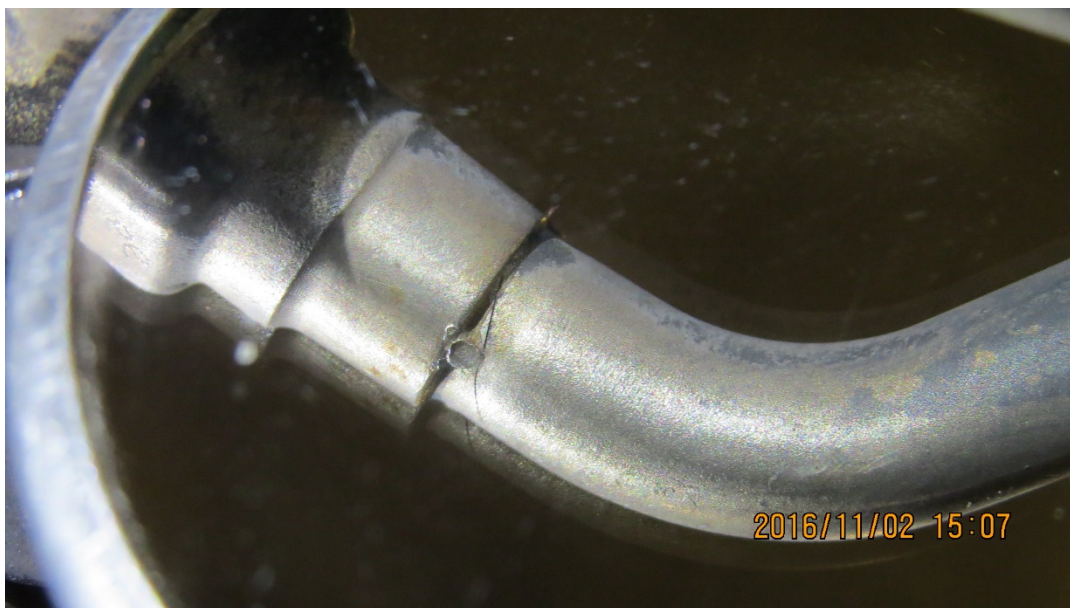
Each fuel nozzle was individually numbered and photographed. All engine case openings that were exposed during removal of external engine components were covered with tape. The FFT was removed and pressurized shop air (~120 pounds per square inch (psi)) was ported into the supply side of the FDV valve in accordance with the engine maintenance manual (EMM). The fuel manifold system was pressurized, and an air leak was detected coming from the fuel manifold supply line that feeds fuel nozzle No. 1, located at the 12 o'clock position. Fuel nozzle No. 1 and the attached fuel manifold supply line were cleaned, and a fine crack was observed on the manifold supply line near the nozzle braze joint (**Photos 8 and 9**). A second pressure check was completed after each fuel manifold and nozzle assembly was cleaned with isopropyl alcohol with no additional findings.

**Photo 8- Manifold Supply Line Crack, 12 o'clock as Viewed With Inspection Mirror**

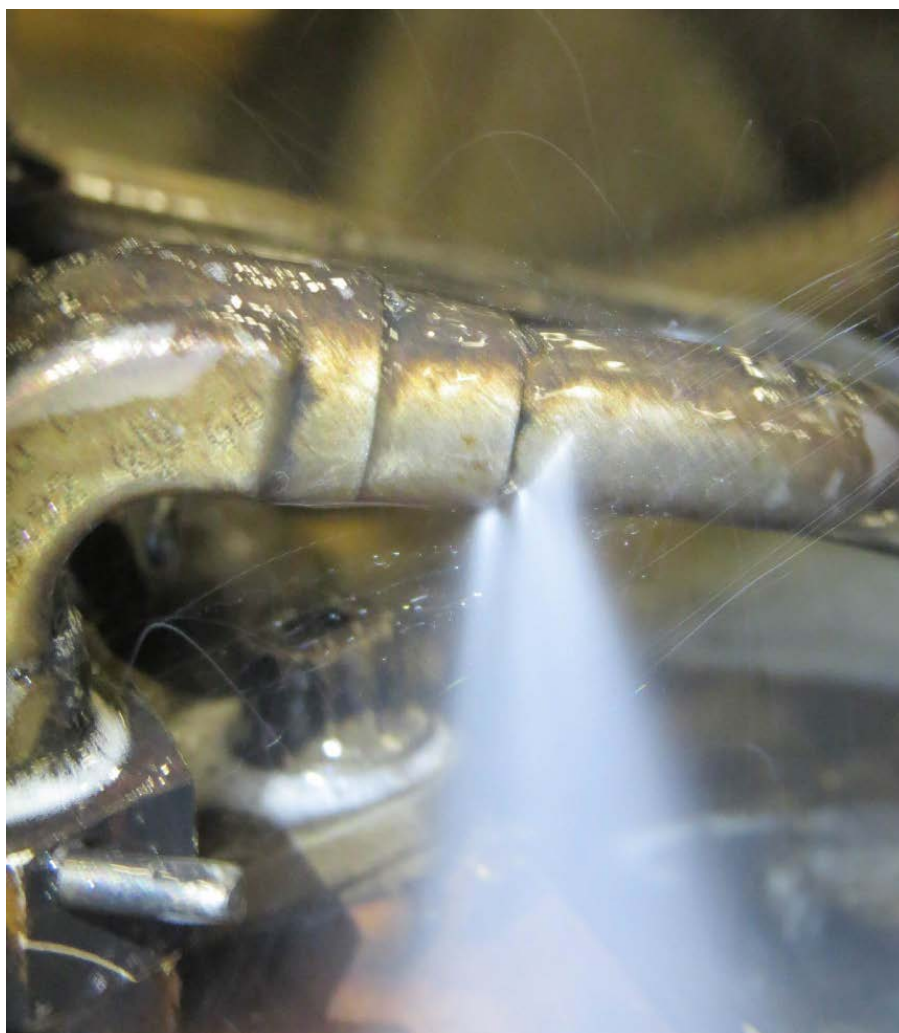
**Photo 9- Manifold Supply Line Leak During Pressure Test**

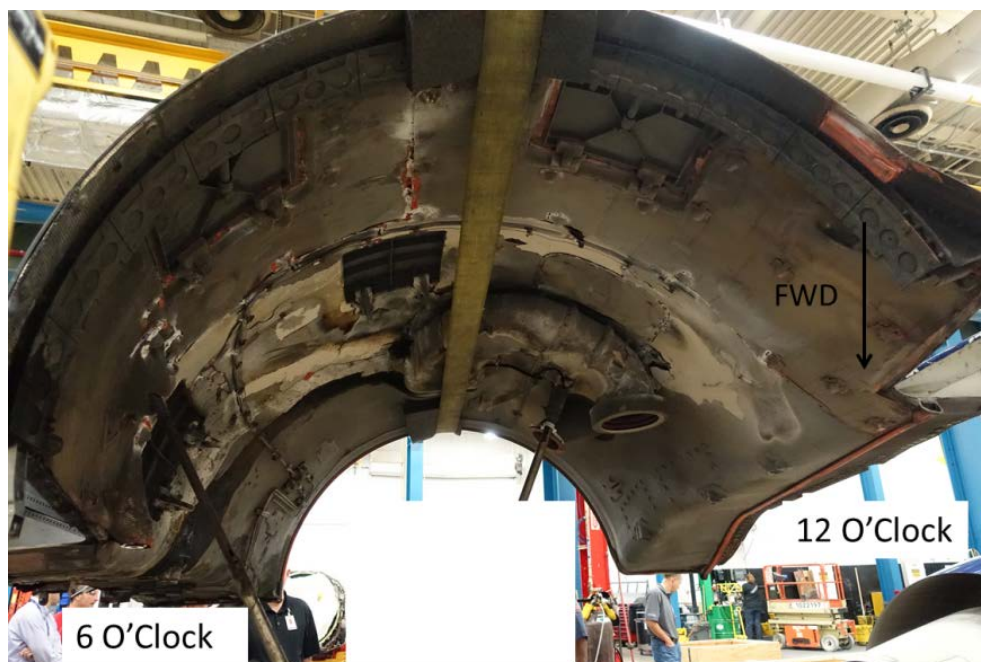
The outboard thrust reverser (TR) cowl half exhibited thermal damage including charring of the ablative material and discoloration of the thermal blanket from the 6 to 12 o'clock positions, mostly concentrated on the forward half (**Photos 10 and 11**). No burn through was observed. The damage observed was coincident with the soot/discoloration and thermal damage documented on the engine cases. The fire loop rubber grommets were thermally consumed across a majority of the loop. A small area of thermal damage was observed on the inboard side of the TR cowl at the lower split line (6 o'clock).

**Photo 10- Outboard Thrust Reverser Cowl Damage**

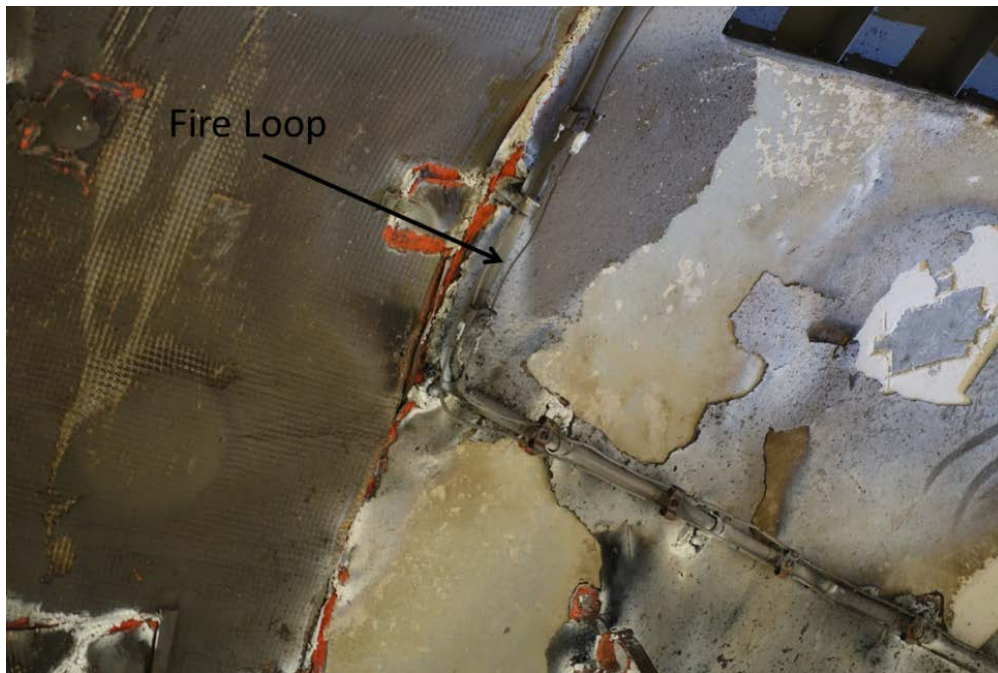
**Photo 11- Thrust Reverser Ablative Coating and Fire Loop Damage, 8 o'clock**

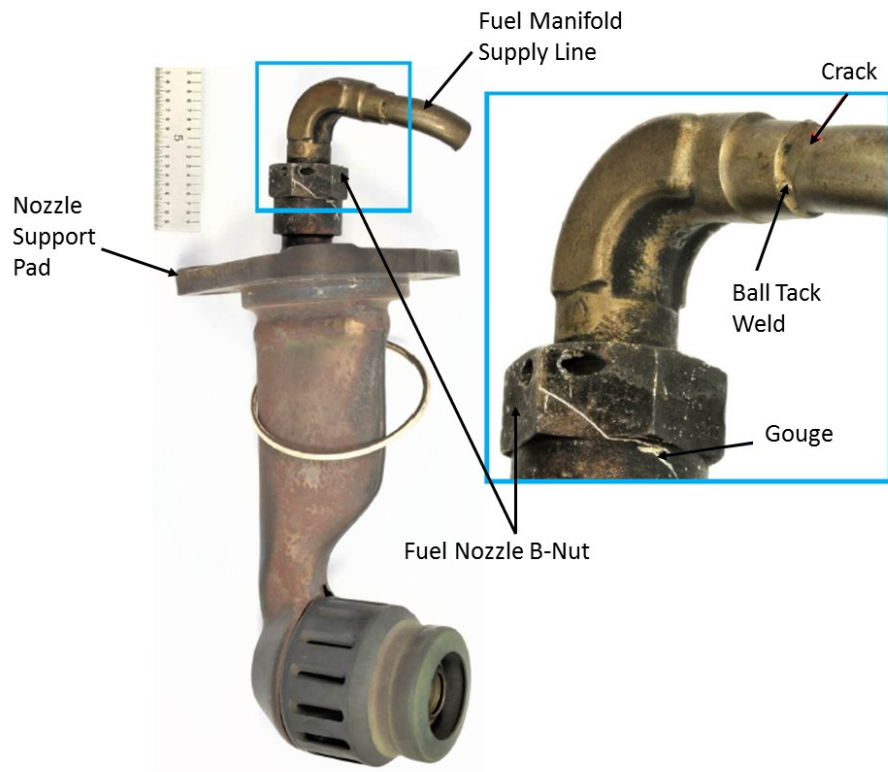
**Photo 12- Fuel Nozzle No. 1 Assembly, as Removed from Engine**

A visual and binocular examination identified a crack that originated from the run out of the braze fillet around the toe of a ball tack weld. Scanning electron microscopy (SEM) was used to examine the crack surface features and they were consistent with high cycle fatigue (HCF). There were no defects or material damage on the manifold supply line near the crack origin. A test of the manifold supply line material confirmed the material met drawing specification. The braze joint where the manifold supply line joins the elbow fitting had sufficient coverage and no voids in the braze material were observed. A complete copy of the materials laboratory report is available in the docket under the title “Pratt & Whitney Materials & Processes Engineering Metallurgical Investigation of Fuel Triplet and Fuel Nozzle from PW4168 Engine P733619.”

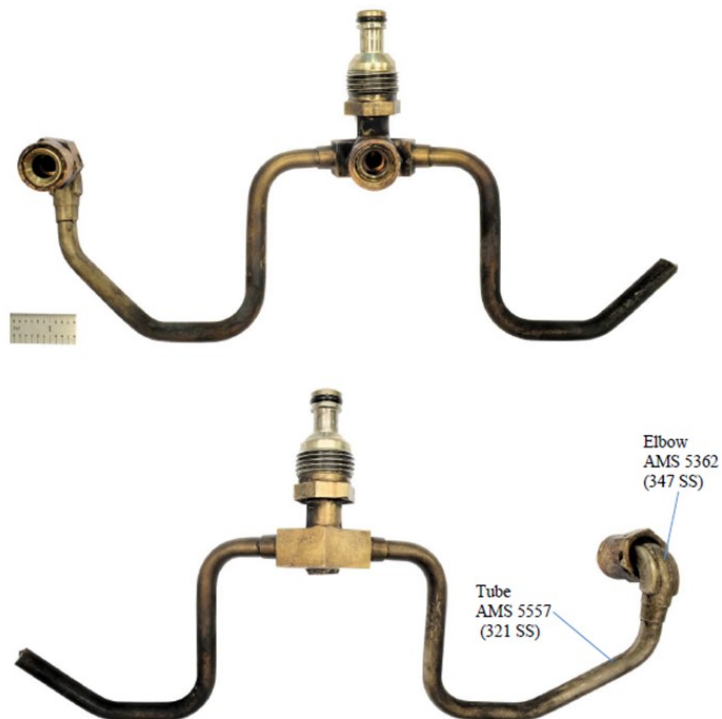
**Photo 13- Fuel Manifold Triplet Assembly, Fuel Nozzles Removed**

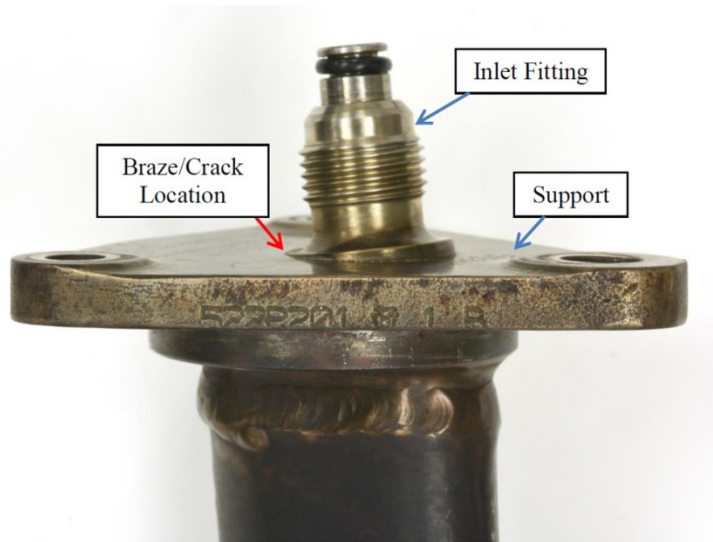
The NTSB has investigated or acted as an accredited representative<sup>8</sup> on multiple PW4000-94 inch and -100 inch fan fuel manifold/fuel nozzle leaks that have resulted in engine fires. The findings from these investigations have been supplemented with P&W field service reports from non-reportable<sup>9</sup> fuel leaks to compile a summary of failure modes and an occurrence count to date. The NTSB is aware of three separate fuel manifold/fuel nozzle failure points: the fuel nozzle-to-fuel manifold interface, the fuel nozzle fitting-to-nozzle support pad braze joint, and the fuel manifold supply line (**Photos 12 and 14**).

**Photo 14- Fuel Nozzle Braze Crack Location**

The fuel nozzle fitting-to-nozzle support braze cracks were also attributed to thermal gradients driven by TALON II combustors. The thermal gradients cause thermal fatigue cracks to develop and propagate until they result in a fuel leak from the braze joint. Several fuel leaks that were originally reported as b-nut related leaks were later reclassified as fuel nozzle braze cracks after the parts were retroactively examined. In addition to the thermal gradients, a tack weld that was applied during manufacture to stabilize the assembly during brazing is thought to potentially also play a role by creating stress risers that may contribute to crack formation. P&W engineering studies have not conclusively determined if the resonant combustor tone discussed in the vibration testing section of this report factors into loss of b-nut clamping or fuel nozzle braze joint crack growth. There have been 58 total fuel leaks reported due to the loss of b-nut clamping force or fuel nozzle braze cracks in the PW4000-100 inch fan
