# Metallurgical Investigation Final Report

**Subject:** Metallurgical Investigation of Fuel Triplet and Fuel Nozzle from PW4168 Engine P733619

**Date:** December 1, 2016

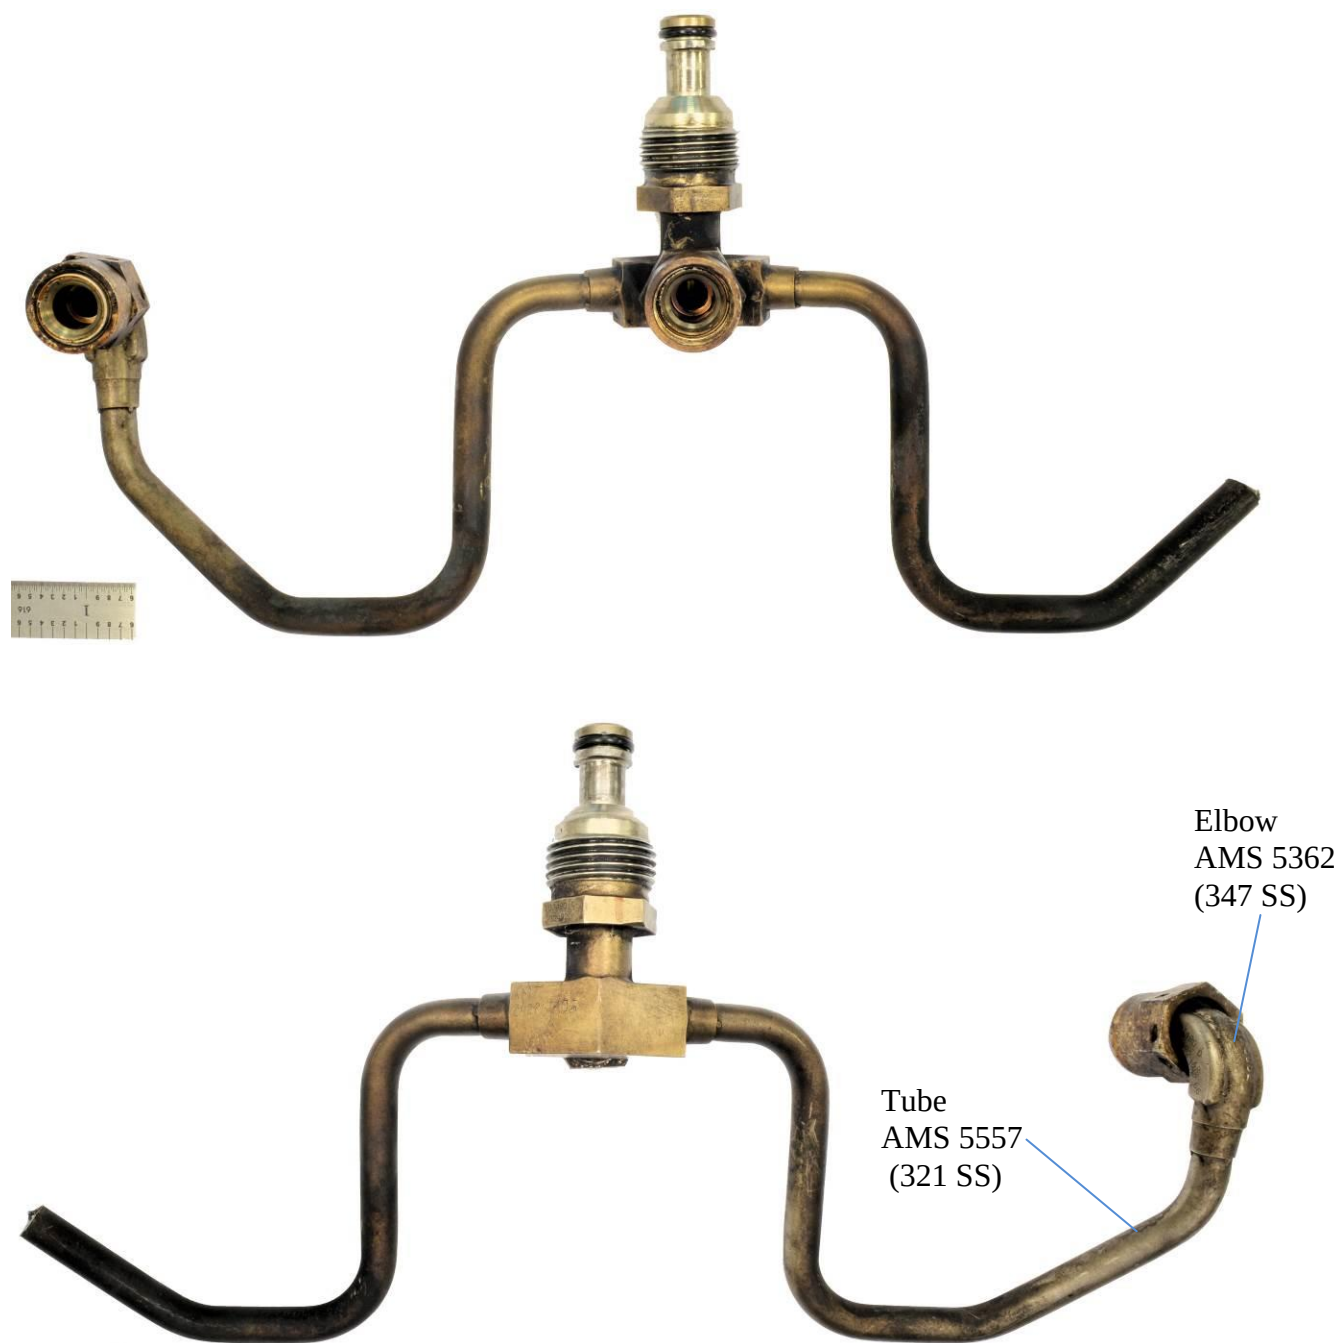
The fuel triplet and fuel nozzle were received in well-packed shipping containers that did not exhibit any handling damage. An installation schematic showing the relative positions of the fuel triplet component in an engine is shown in Figure 2. The fuel triplet was received with one end cut off and the fuel nozzle still attached as it was at the time of the event. It was reported that it had been cut to facilitate disassembly from the engine without disturbing the b-nut connection to the fuel nozzle. Images of the triplet hardware as-received are shown in Figure 2. The remainder of the triplet attached to the fuel nozzle is shown in Figure 3. A close examination of the tube at the brazed joint to the fitting revealed a crack. The crack was approximately aligned with the center of a tack weld, but not in the tack weld. A gouge was apparent on the nut, however, the source of this damage could not be determined.

**Figure 2: Condition of the fuel triplet as-received. Note that it was cut prior to submission for this investigation to facilitate disassembly.**

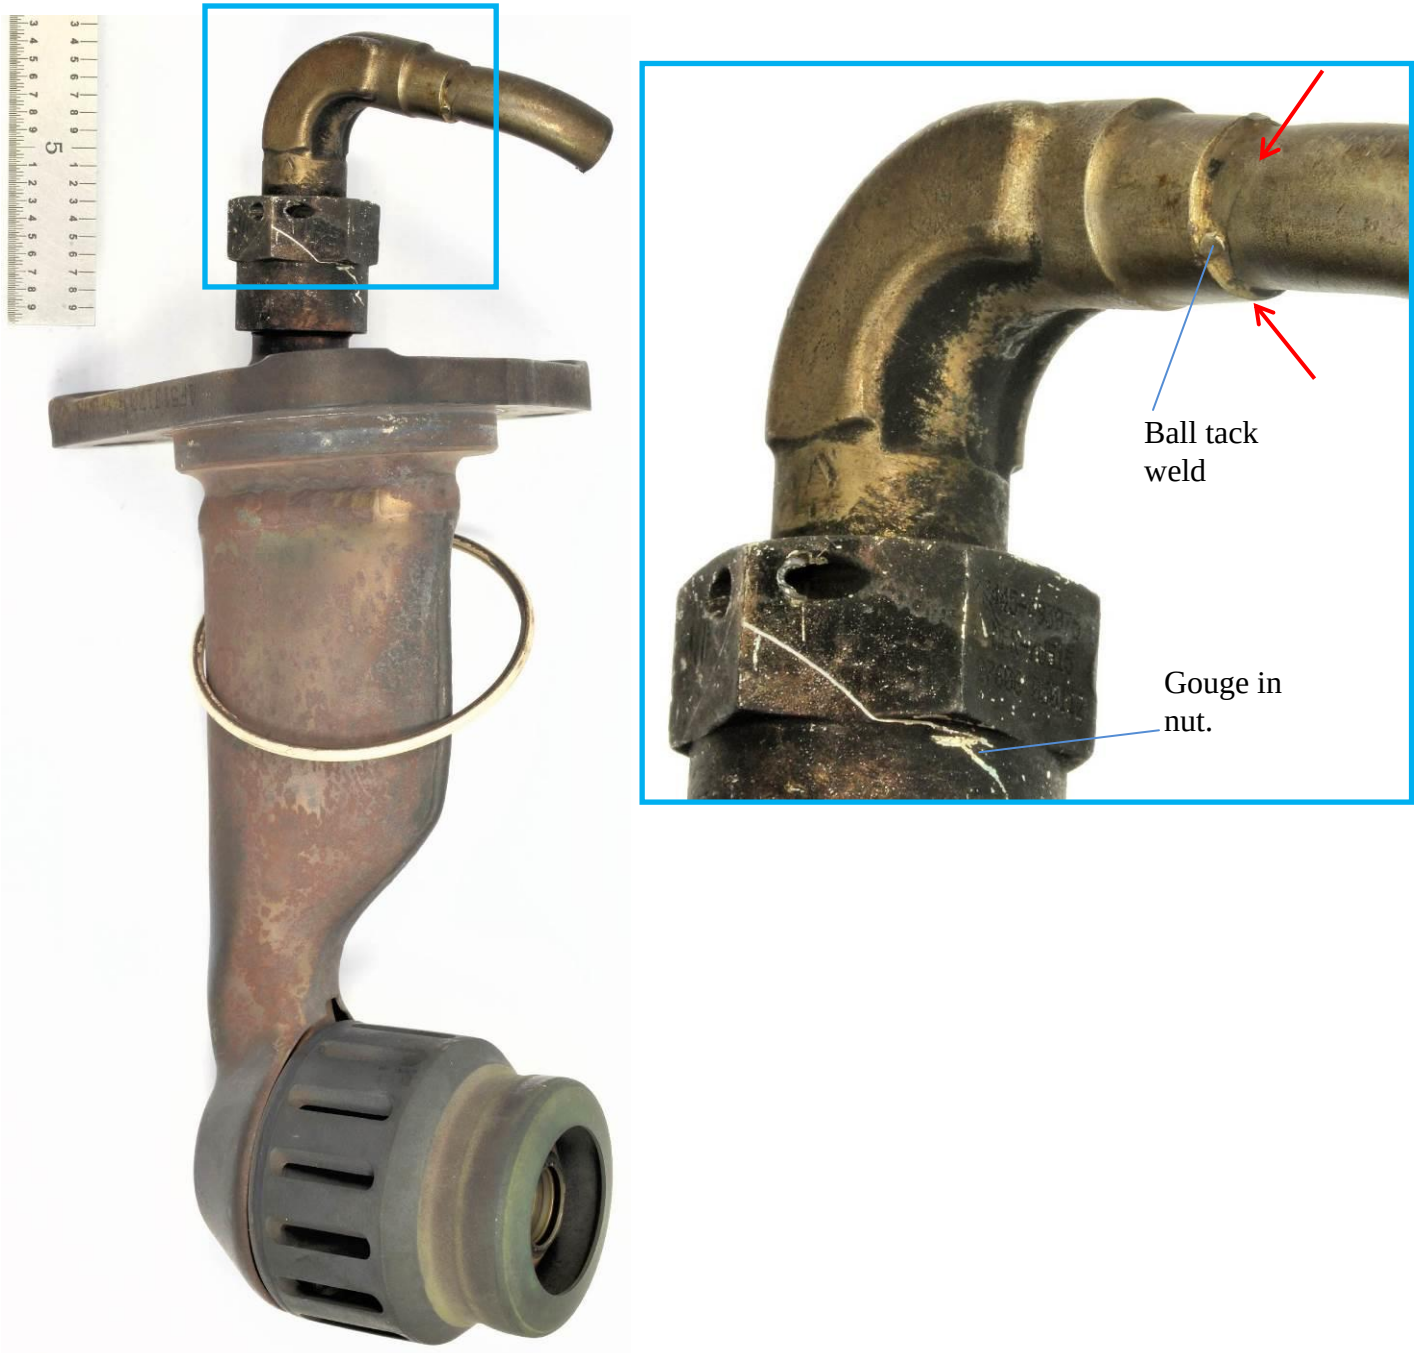
An undercowl fire was attributed to a fuel leak from a crack in the fuel triplet that originated from the run out of the braze fillet around the toe of a ball tack weld. Analysis of the fracture surface revealed that the cracks were due to high cycle fatigue. No defects or anomalies were found to be associated with the crack. X-ray examination as well as a metallographic cross-section through the fatigue origin found full braze coverage with very little porosity. The tube, braze and elbow were confirmed to be similar in composition to the applicable material specifications. The tube thickness near the crack surface conformed to drawing requirements.

**Figure 3: Sectioned piece of fuel triplet attached to fuel nozzle. The cracked location was at a brazed joint between an elbow and a tube, as indicated.**

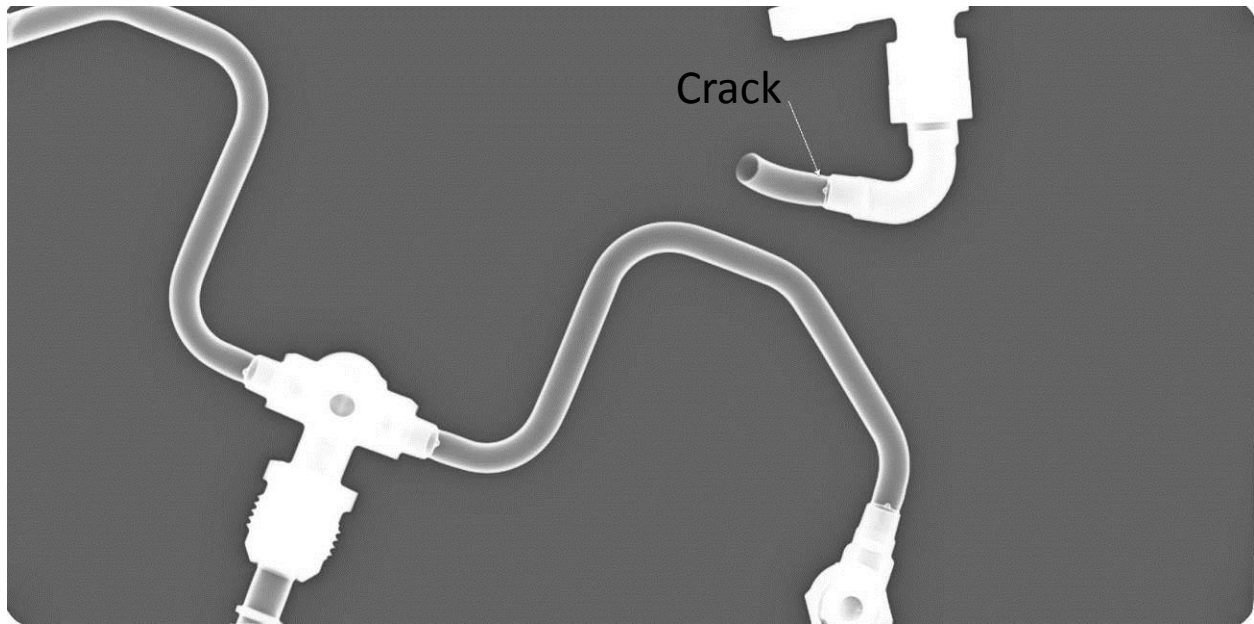
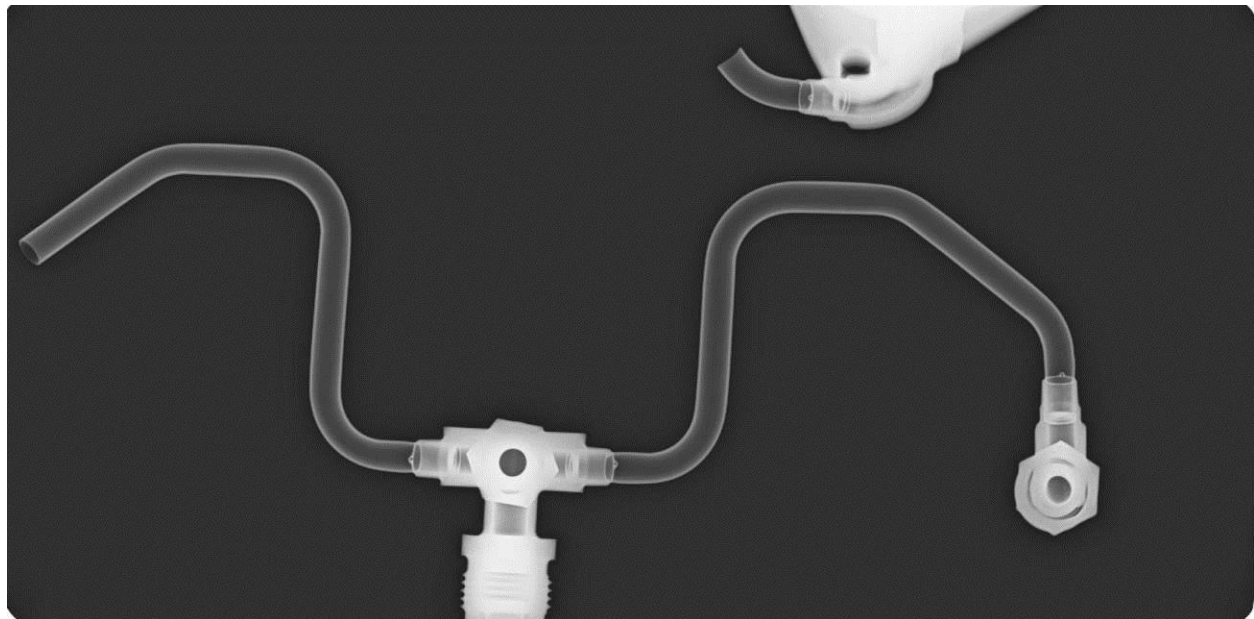
The fuel triplet was ultrasonically cleaned in a mild solution of *BLUE GOLD*<sup>1</sup>. After cleaning, part markings were documented as shown in Figures 4-6. The part was then submitted for radiographic inspection. X-ray of the brazed joints on the fuel triplet found full braze coverage (Figure 7). The only crack observed was the crack previously shown in Figure 3.

**Figure 7: X-ray inspection found full braze coverage at all brazed joints.**

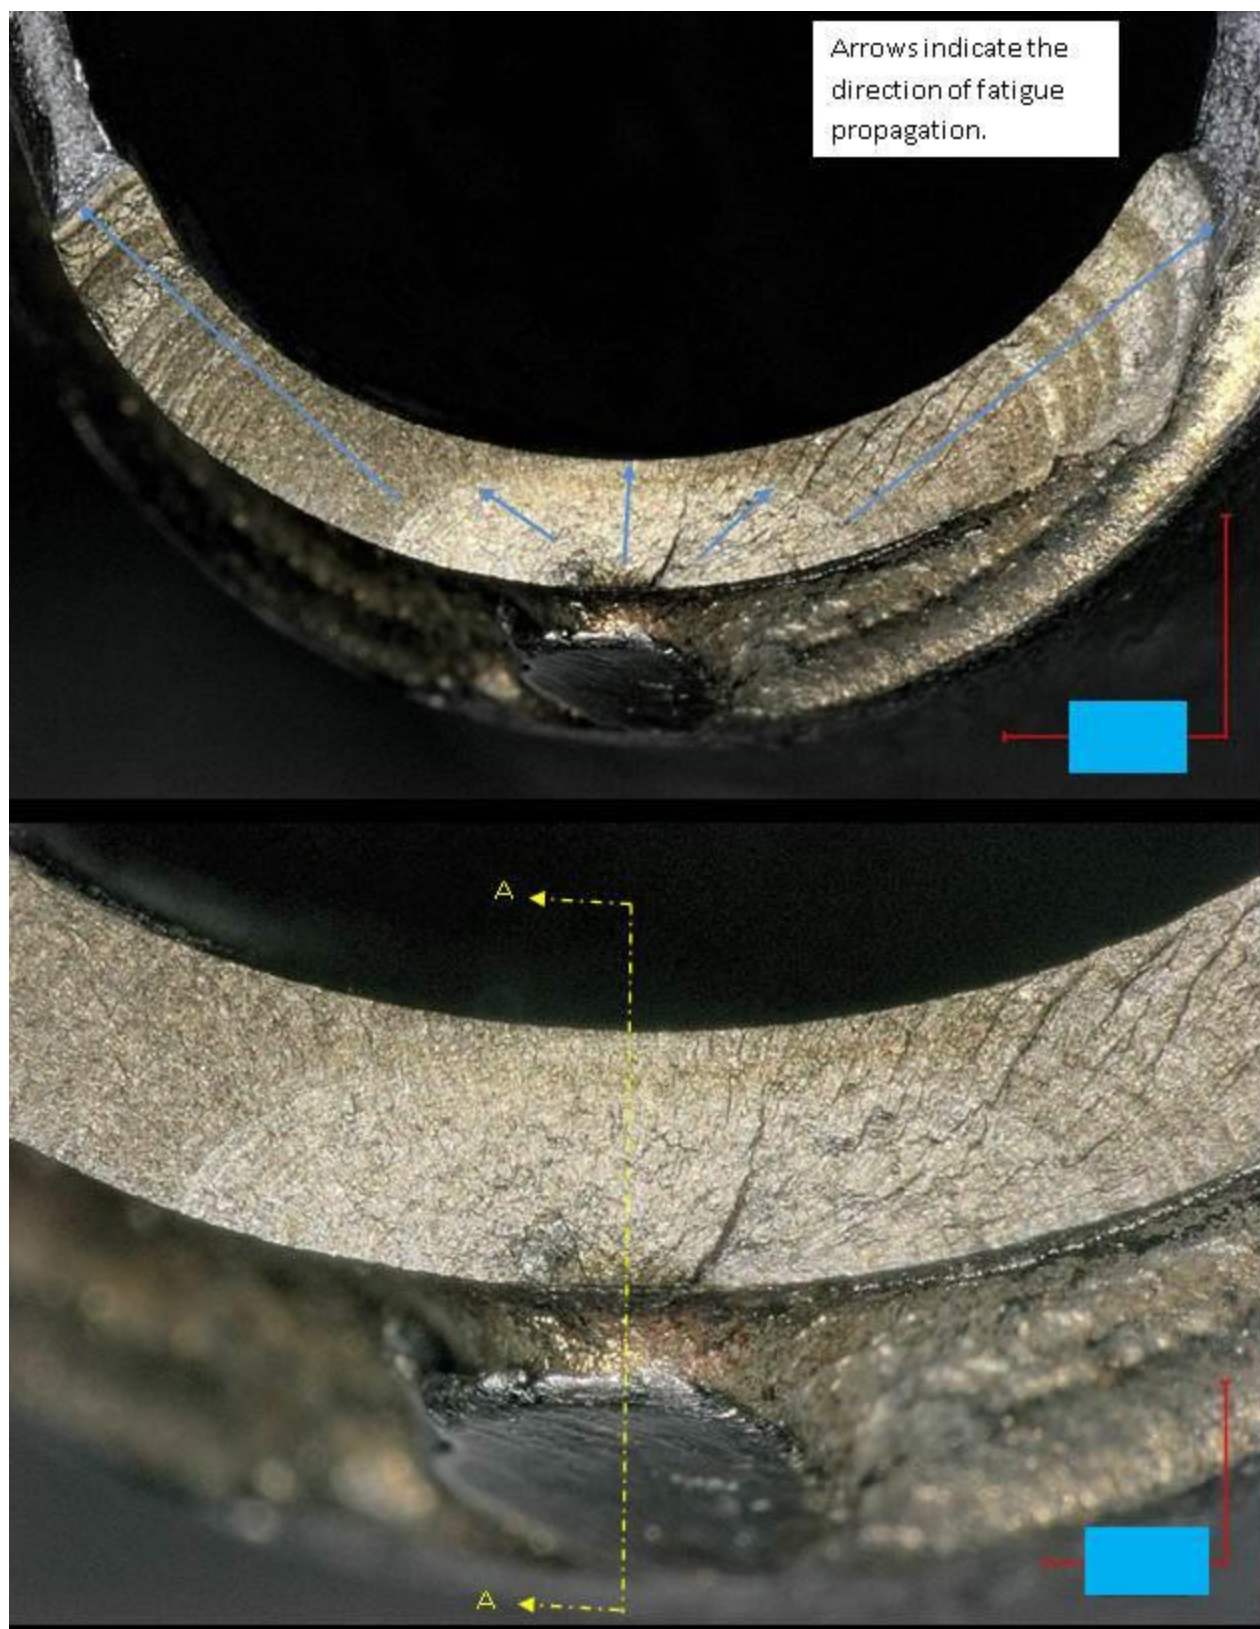
The crack was fractured open and examined using a binocular microscope. Examination found a thumbnail shaped region of fatigue that progressed through wall from an origin on the outer diameter surface of the tube, approximately in line with the toe of a ball tack weld. This region was approximately 0.1” along the circumference, and fatigue in this region progressed predominantly toward the center of the tube. Outside of this region, the fatigue progressed circumferentially (Figure 8). The total fatigue crack is shown in Figure 9.

**Figure 8: Fatigue origin was aligned with a tack weld.**

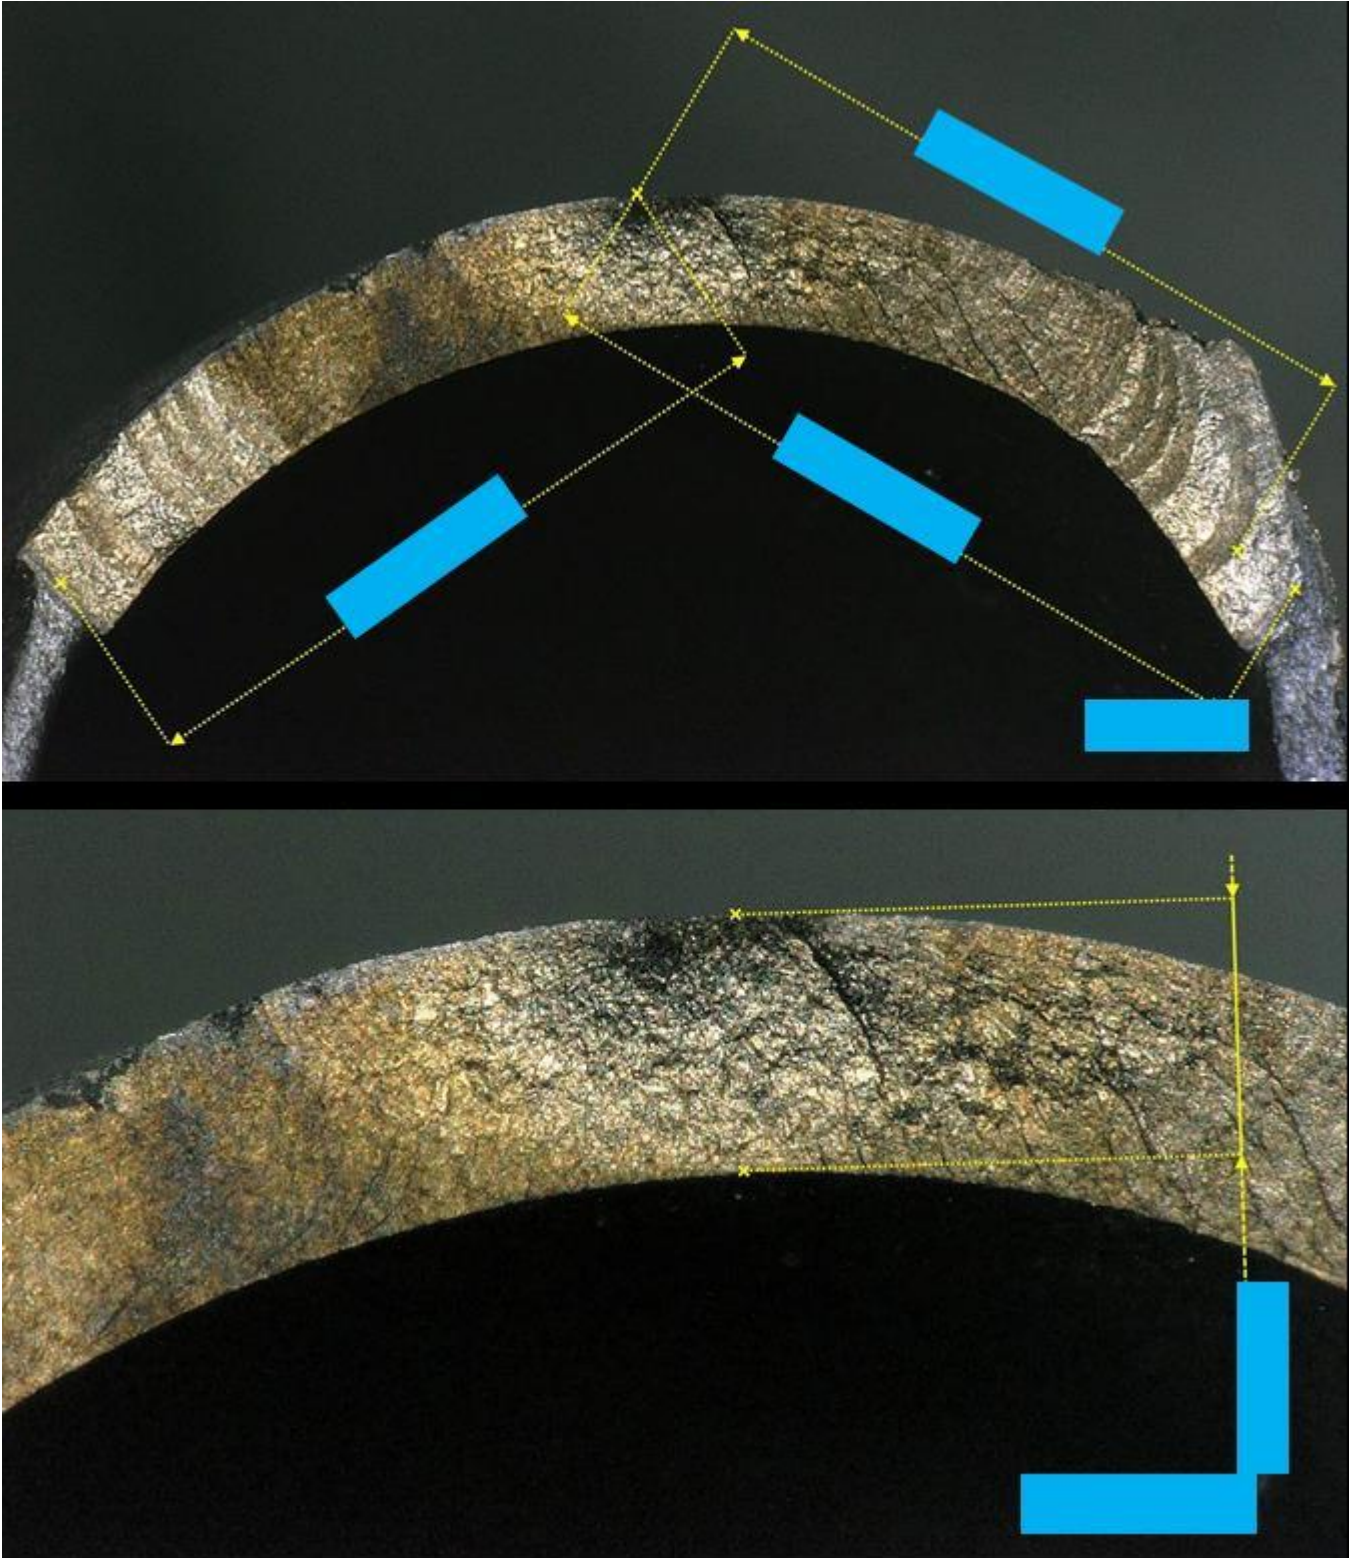
Figure 9: Opposite side of the crack surface. Fatigue progression was [REDACTED] along the circumference and the tube wall was [REDACTED] thick at the fatigue origin.

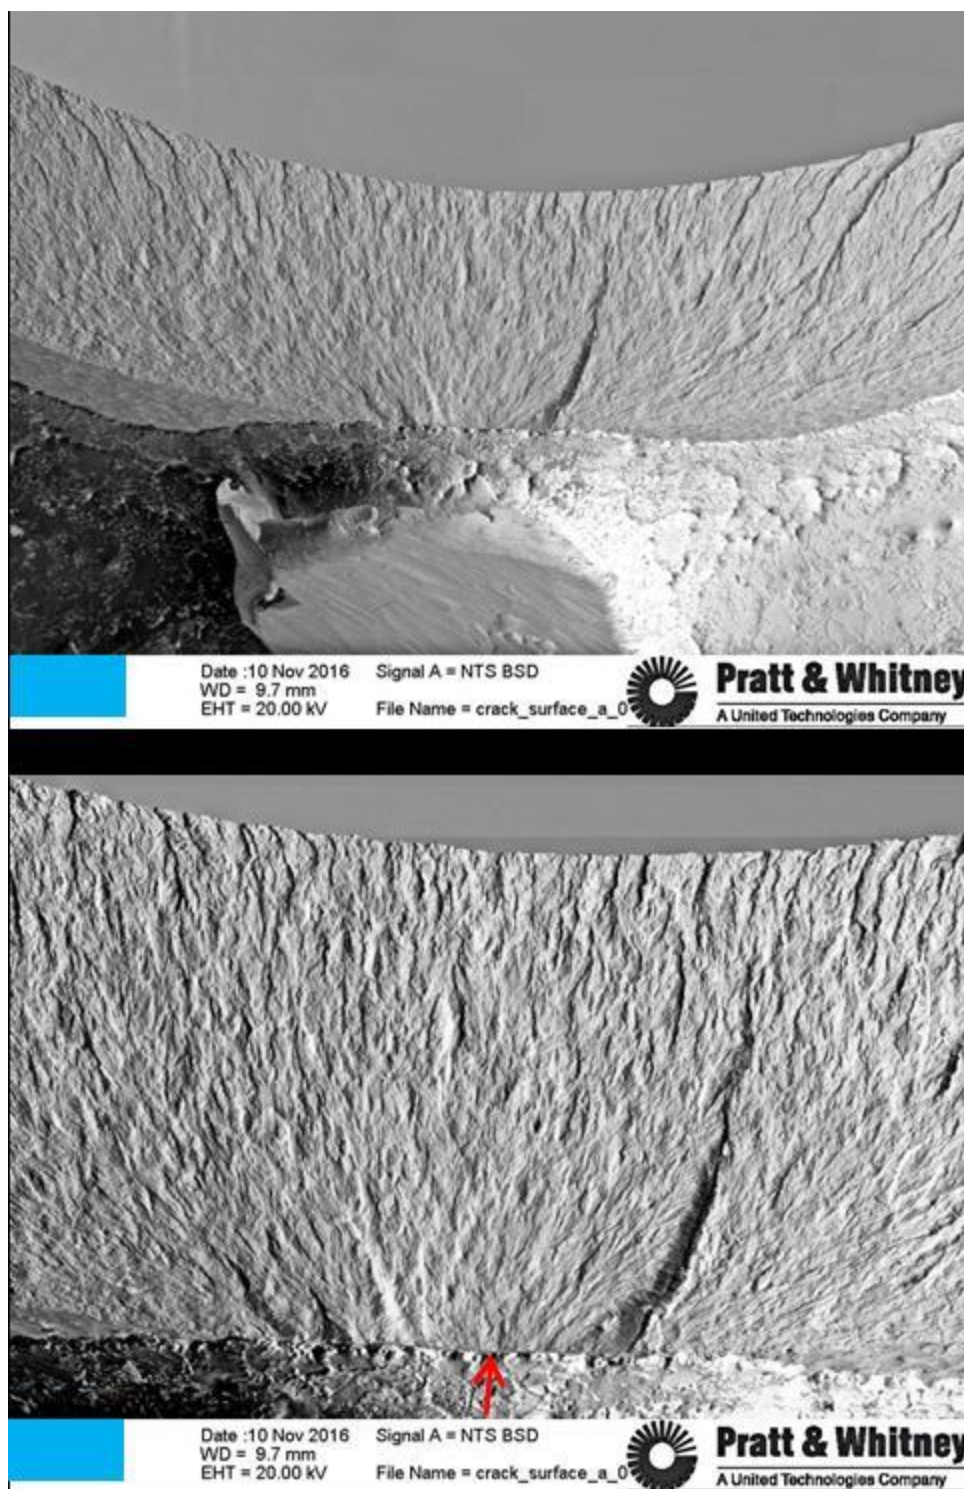
The crack surface was examined using a field emission scanning electron microscope (FESEM). Examination of the origin region revealed no defects or anomalies (Figure 10). Also, no overstress features were apparent (Figure 11). Examination of the surface at higher magnification found finely spaced, difficult to resolve striations indicative of HCF (Figures 12-14). It was noted that the fatigue features became increasingly banded toward the extremities of the progression.

**Figure 10: Backscatter SEM images of the fatigue origin, which is indicated with an arrow. No defects or anomalies were apparent at low magnification.**

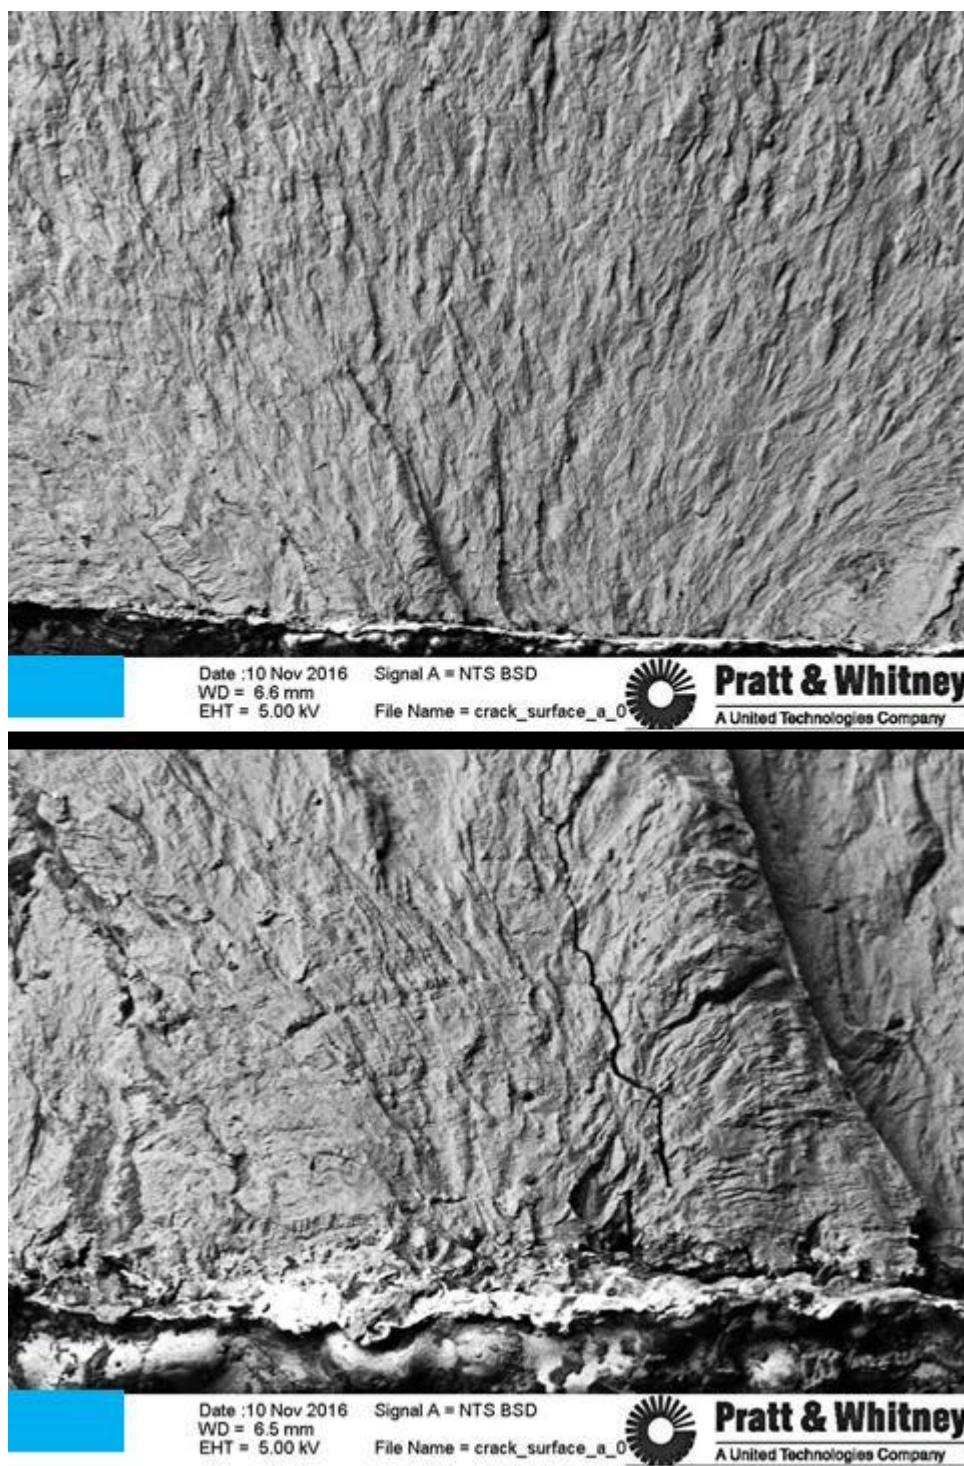
**Figure 11: Backscatter SEM images of origin region at higher magnification. No overstress region was apparent at the surface and no defects were observed.**

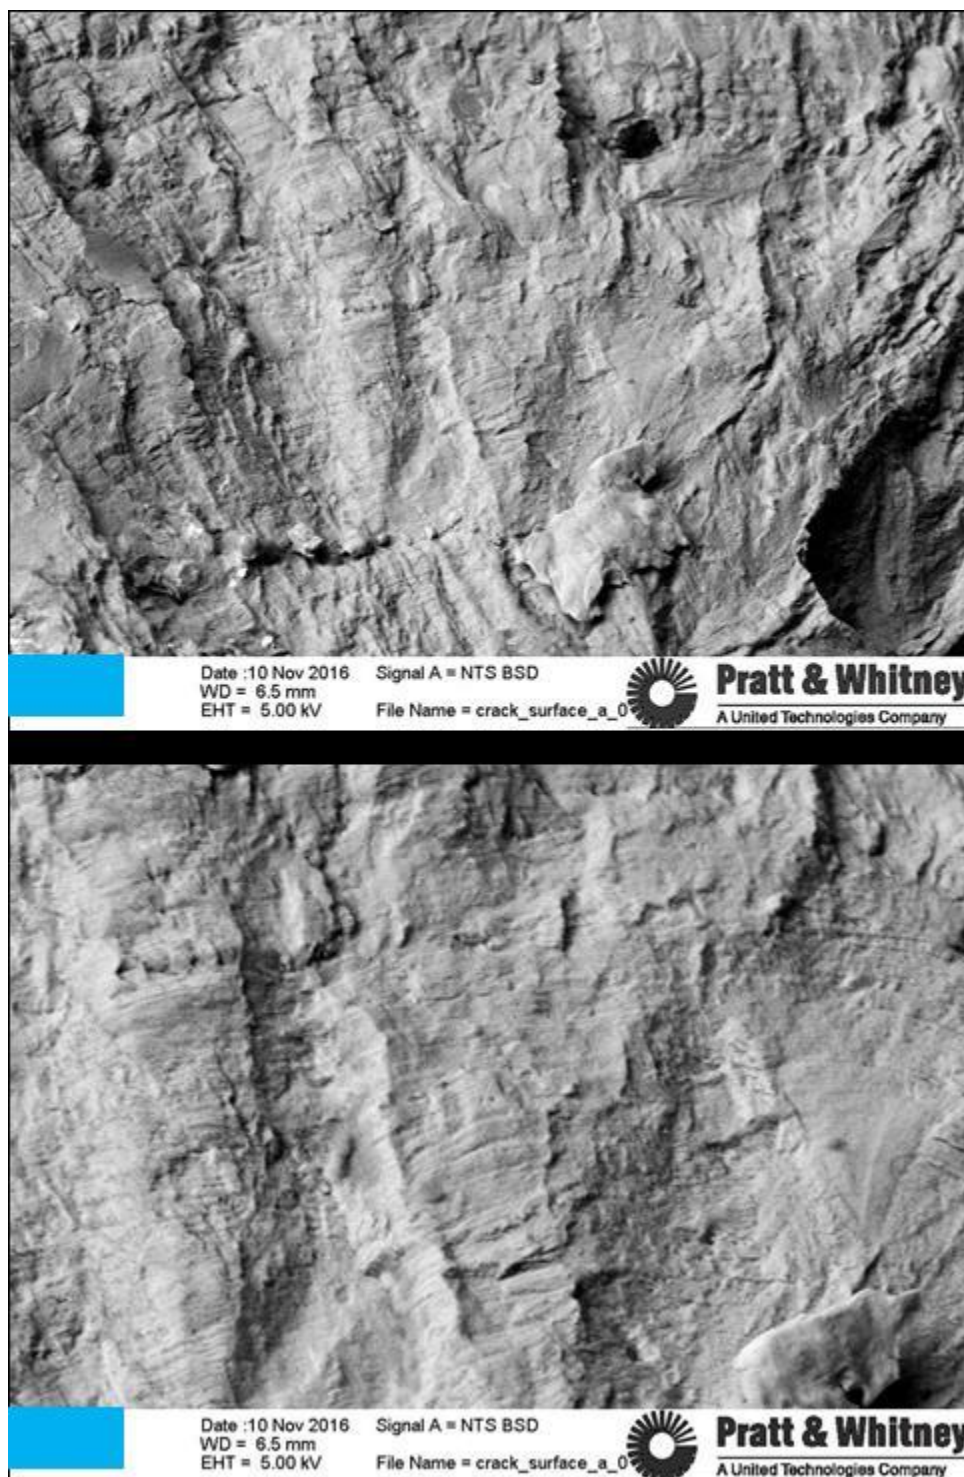
**Figure 12: Finely spaced fatigue striations indicative of High Cycle Fatigue progression.**

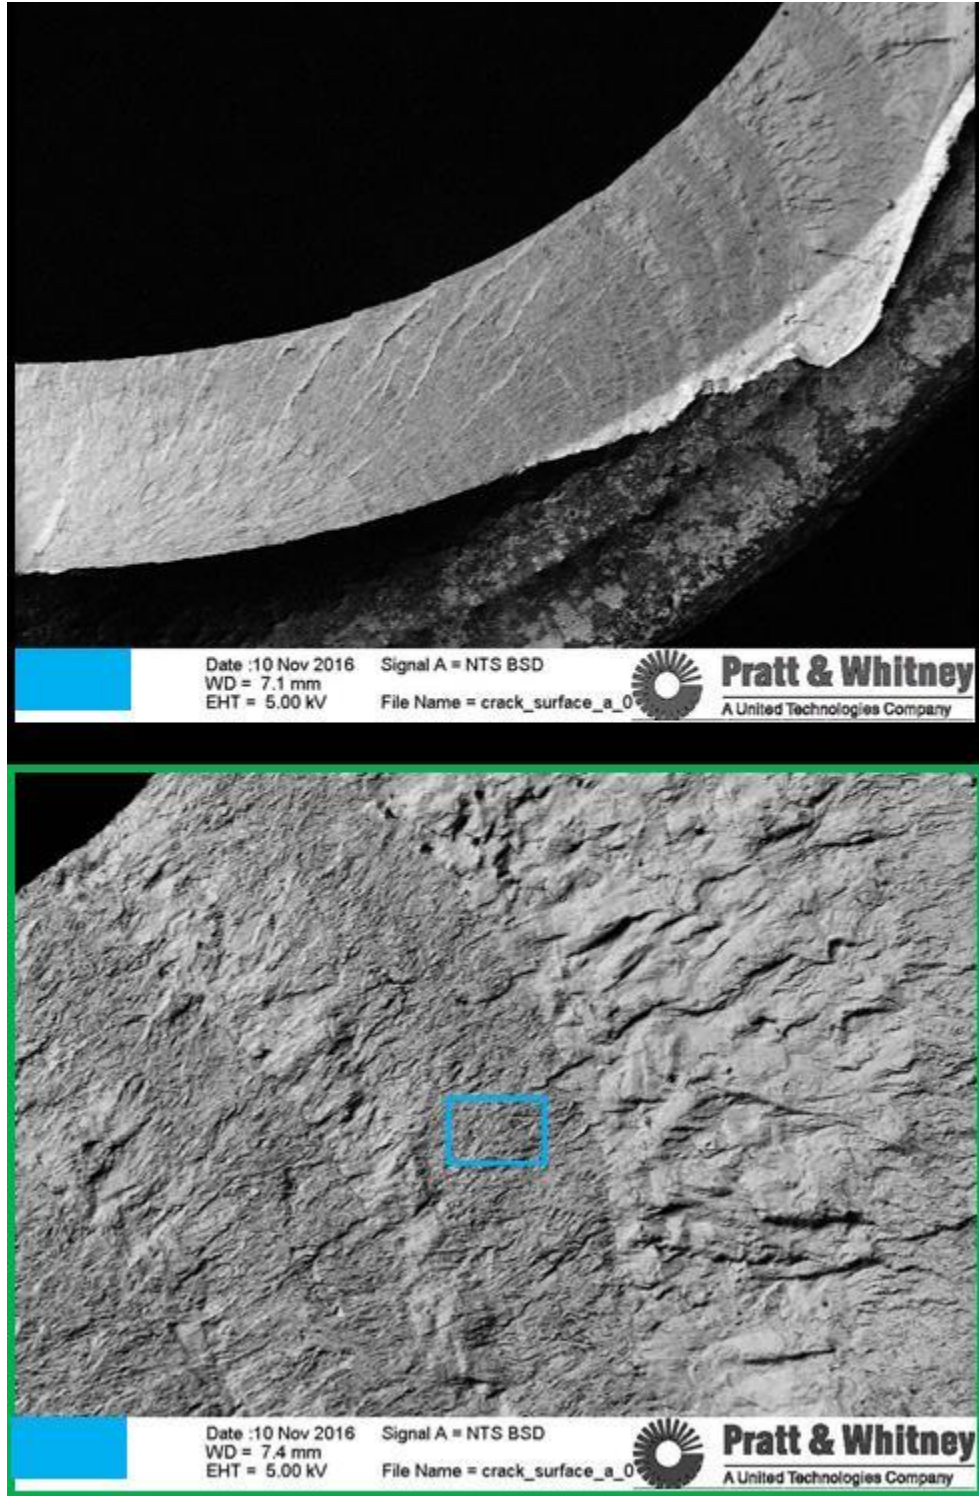
Figure 13: Banded HCF progression moving circumferentially away from the fatigue origin.

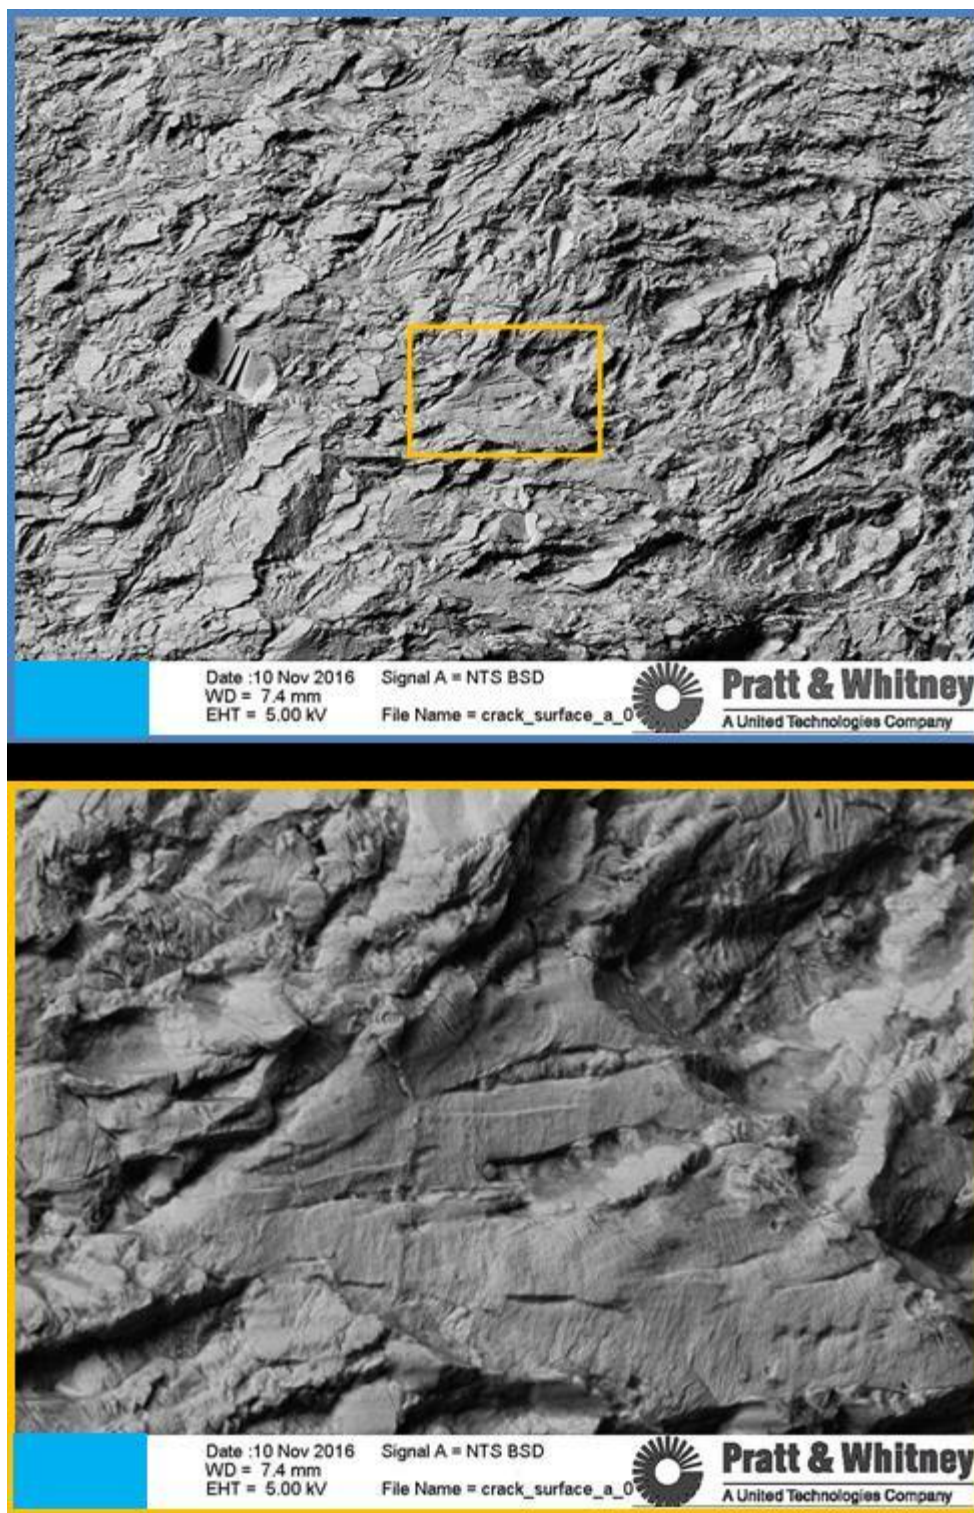
Figure 14: Finely Spaced HCF striations near extremity of crack progression.

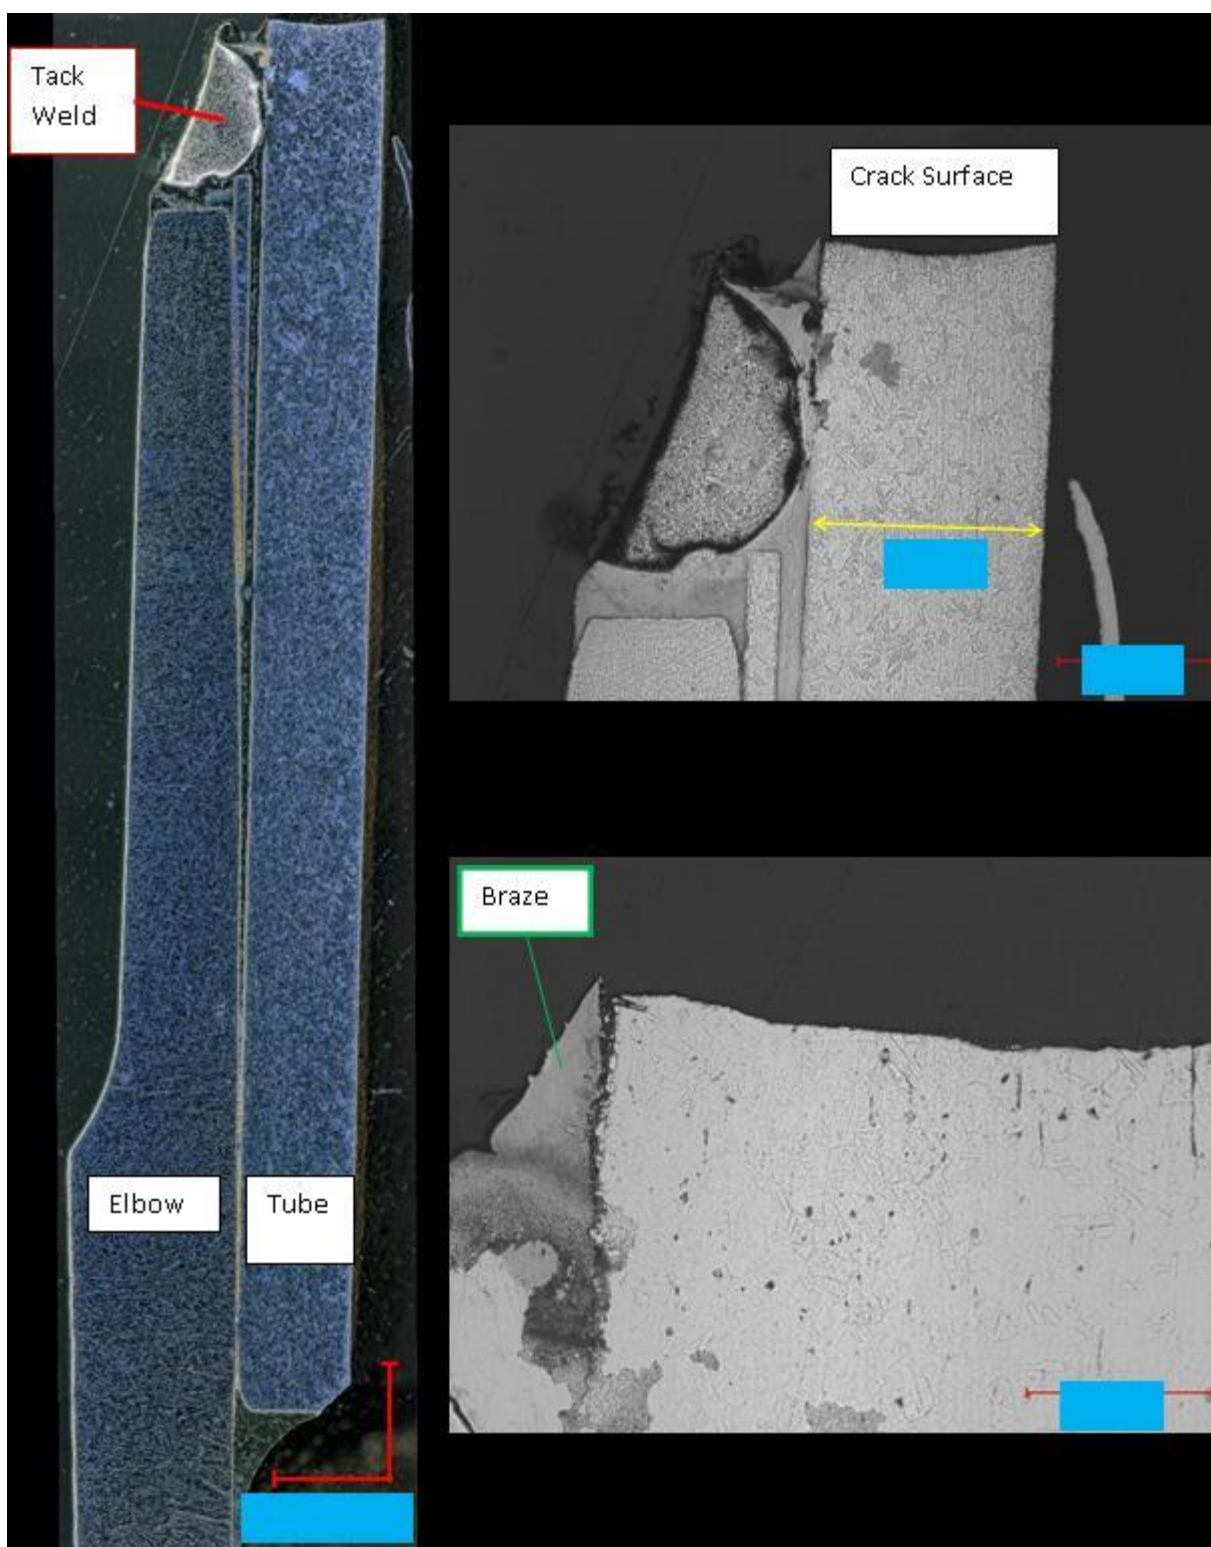
Metallographic section A-A was prepared transversely through the half of the crack that also had the tack weld, as sketched in Figure 8. Review of the section in the as-polished condition revealed full braze coverage with minimal porosity. The section was then etched with a solution of 10% oxalic acid, which revealed a tube microstructure that was typical of properly processed 321 stainless steel. The tube thickness at this location conformed to drawing requirements (Figure 15).

Figure 15: Optical metallographic examination of section A-A (reference Figure 8).

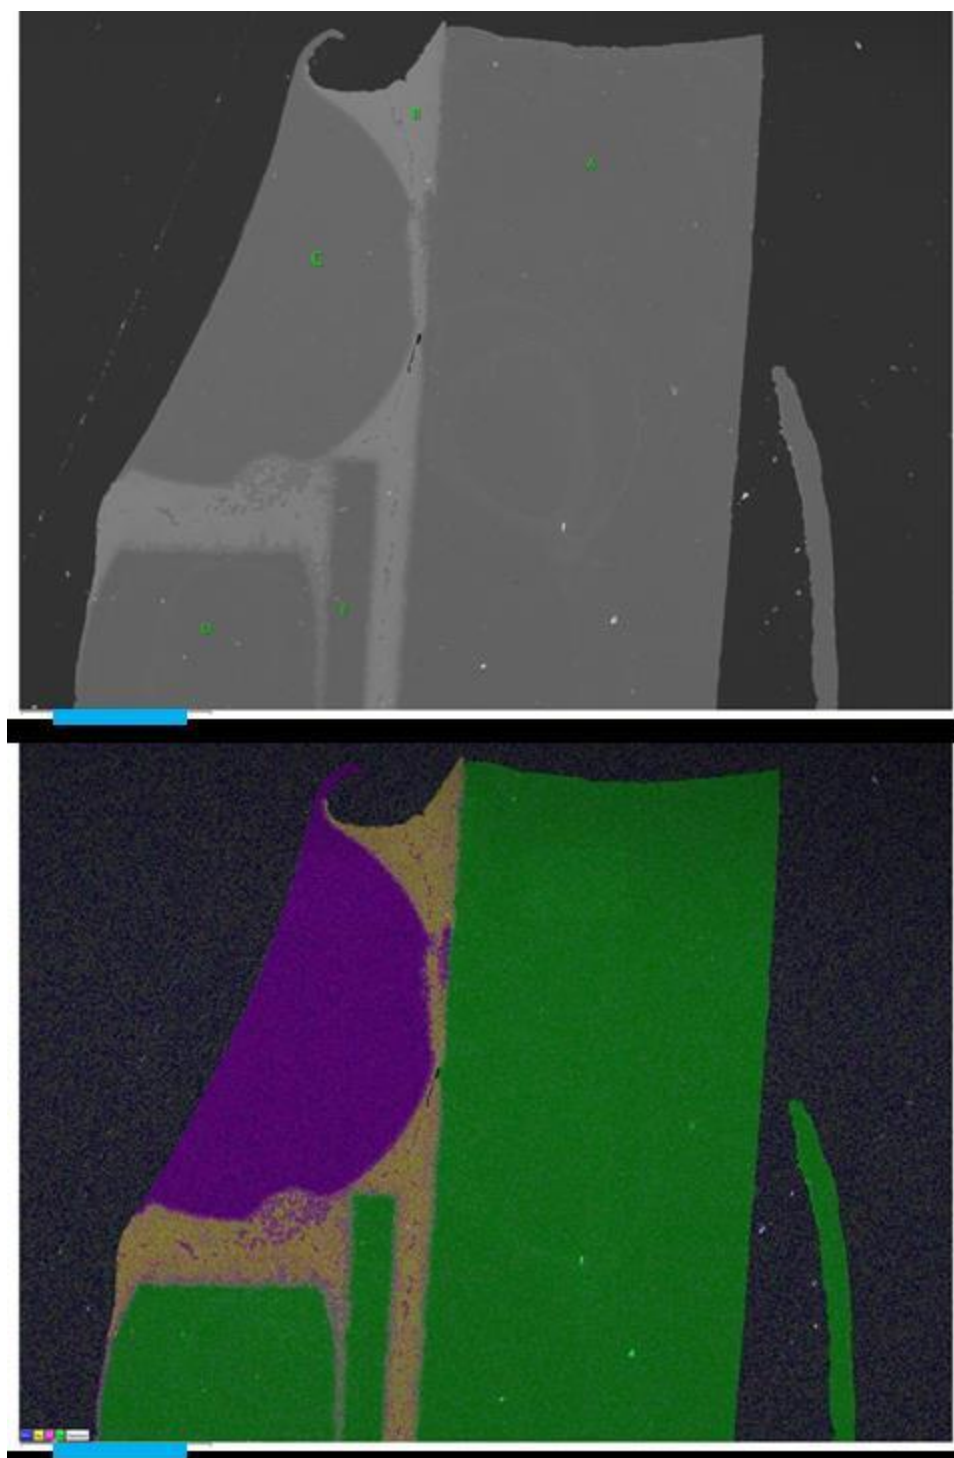
Section A-A was re-polished to remove the etched affect. It was then carbon coated for enhanced conductivity and examined using a FESEM. As with the optical review, no defects or anomalies were found. Energy dispersive spectrometry (EDS) was used to examine the composition of the mounted section. An x-ray map showed that the tube and elbow were similar materials, with the braze and the tack weld having significantly different compositions. Quantitative EDS analysis found the tube composition to conform to AMS 5557 (321 stainless steel). The elbow was similar to 347 stainless, the tack weld was similar to Inconel 625, and the braze was gold nickel.

**Figure 16: SEM image of section A-A (top) and layered x-ray map (bottom) showing compositional differences.**
