# Metallurgical Investigation Final Report

**Subject:** Metallurgical Investigation of Fuel Triplet and Fuel Nozzle from PW4168 Engine P733619

**Date:** December 1, 2016

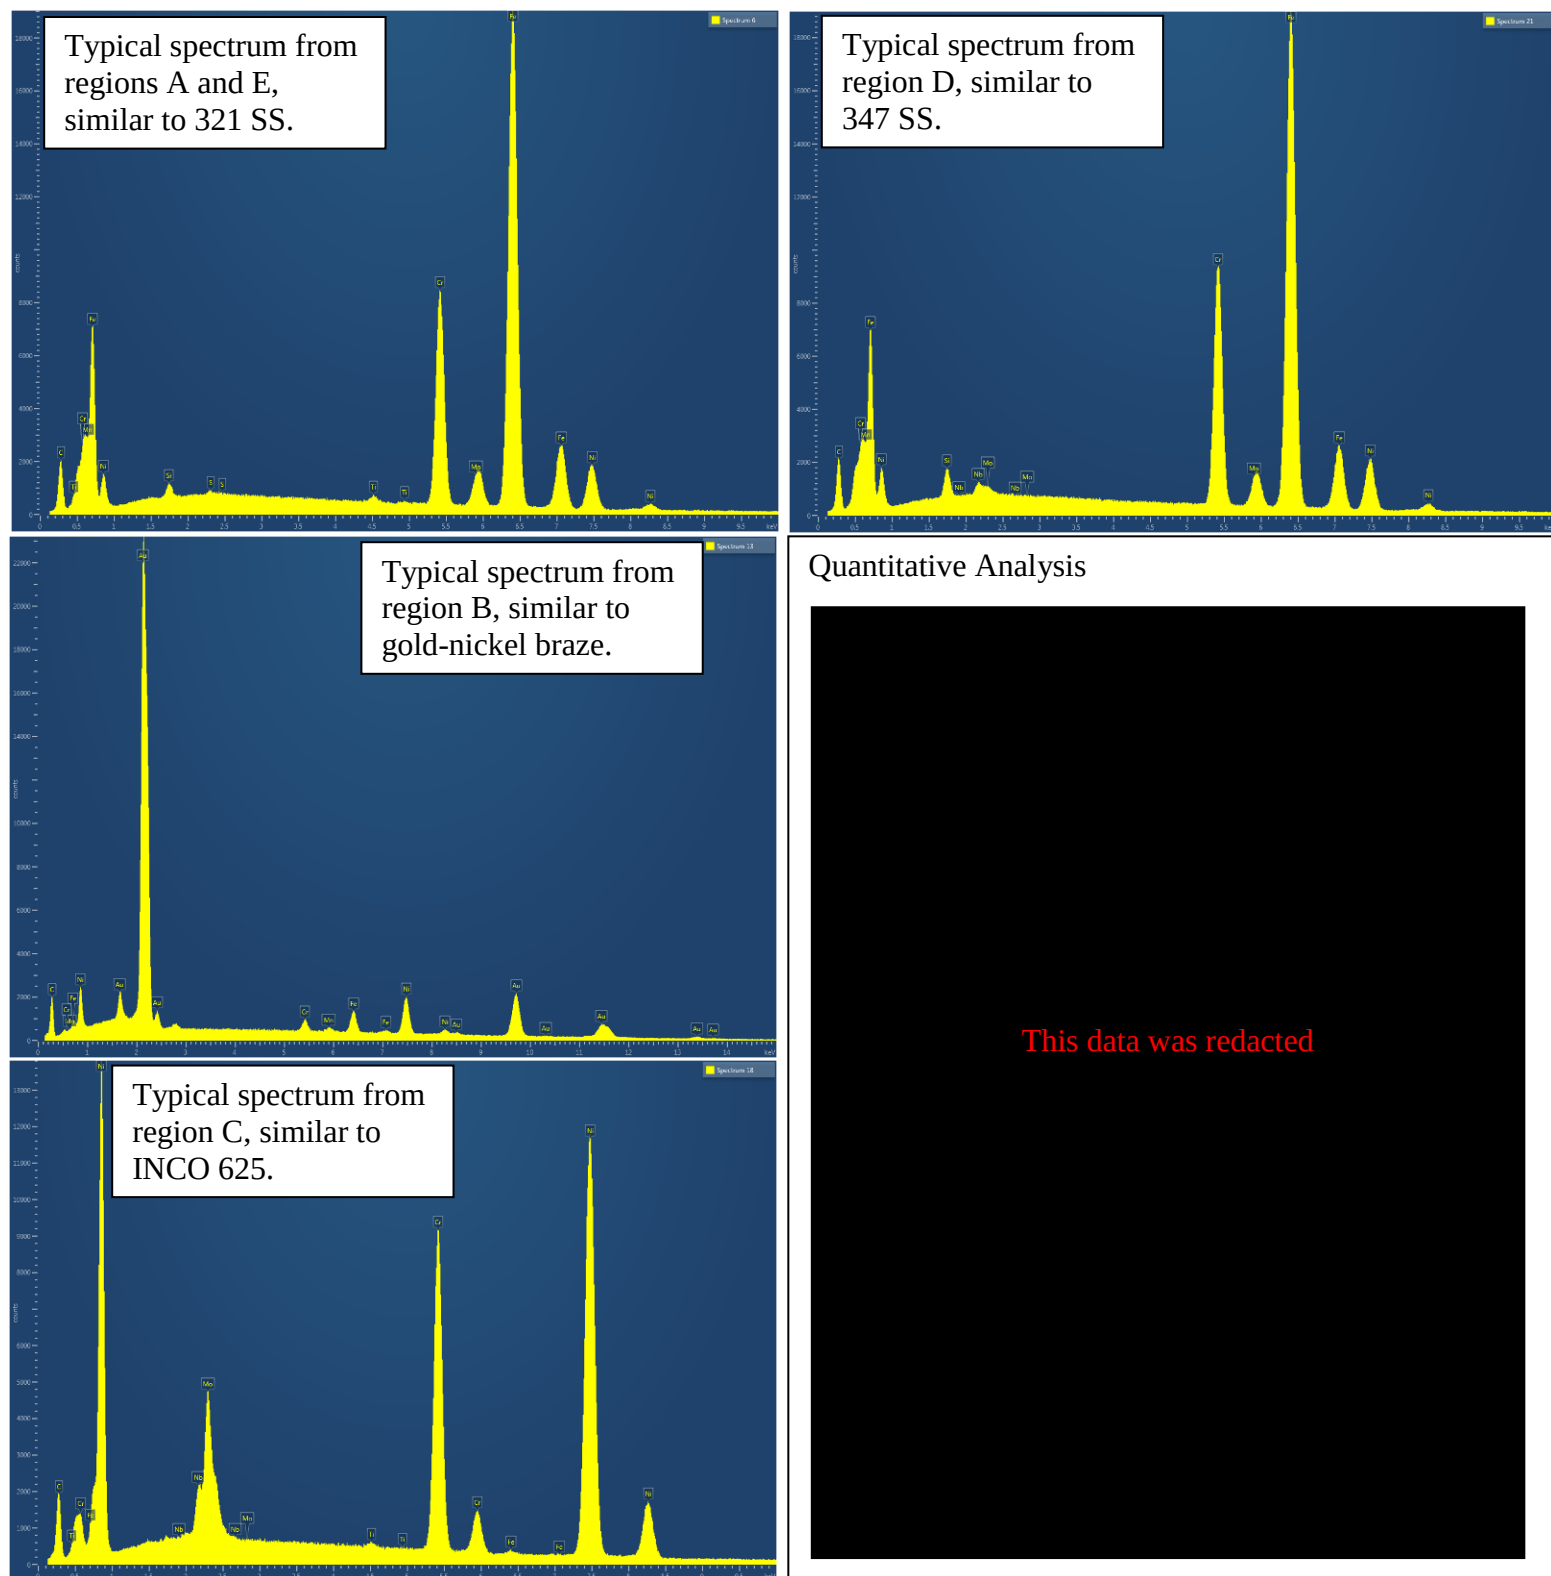
Section A-A was re-polished to remove the etched affect. It was then carbon coated for enhanced conductivity and examined using a FESEM. As with the optical review, no defects or anomalies were found. Energy dispersive spectrometry (EDS) was used to examine the composition of the mounted section. An x-ray map showed that the tube and elbow were similar materials, with the braze and the tack weld having significantly different compositions. Quantitative EDS analysis found the tube composition to conform to AMS 5557 (321 stainless steel). The elbow was similar to 347 stainless, the tack weld was similar to Inconel 625, and the braze was gold nickel.

Figure 17: EDS analysis of elemental composition of materials in section A-A.
