**NATIONAL TRANSPORTATION SAFETY BOARD  
Office of Aviation Safety  
Washington, D.C. 20594**

**POWERPLANT GROUP CHAIRMAN'S FACTUAL REPORT  
NTSB No: ENG17IA006**

Aircraft: Bombardier CRJ700, N367CA, GoJet Airlines LLC, Flight 6210

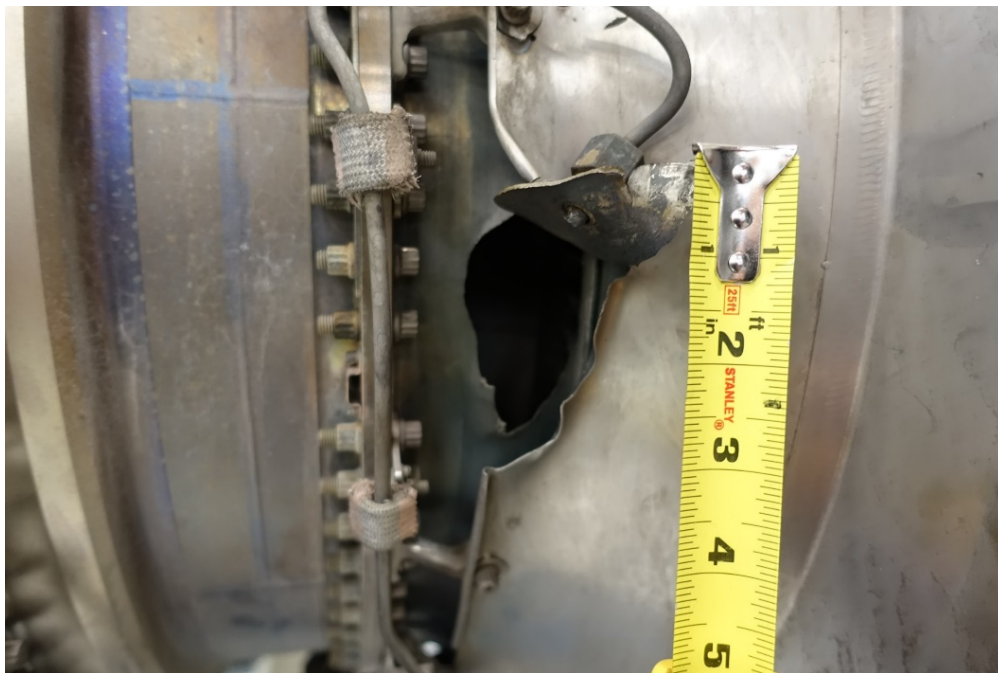
The LPT case had a 3 inch circumferential by 1.5 inch axial penetration located 1 inch aft of the LPT flange at the 8 o'clock position (**Photo 4**). The LPT case and baffle material around the penetration was curled radially outward, away from the engine. The exhaust gas temperature (EGT) thermocouple and thermocouple harness adjacent to the penetration were damaged. Fine metal debris was resting on the exhaust case struts. The remainder of the engine exterior was intact and in good condition.

**Photo 4- LPT Case Penetration, 8 o'clock Position**

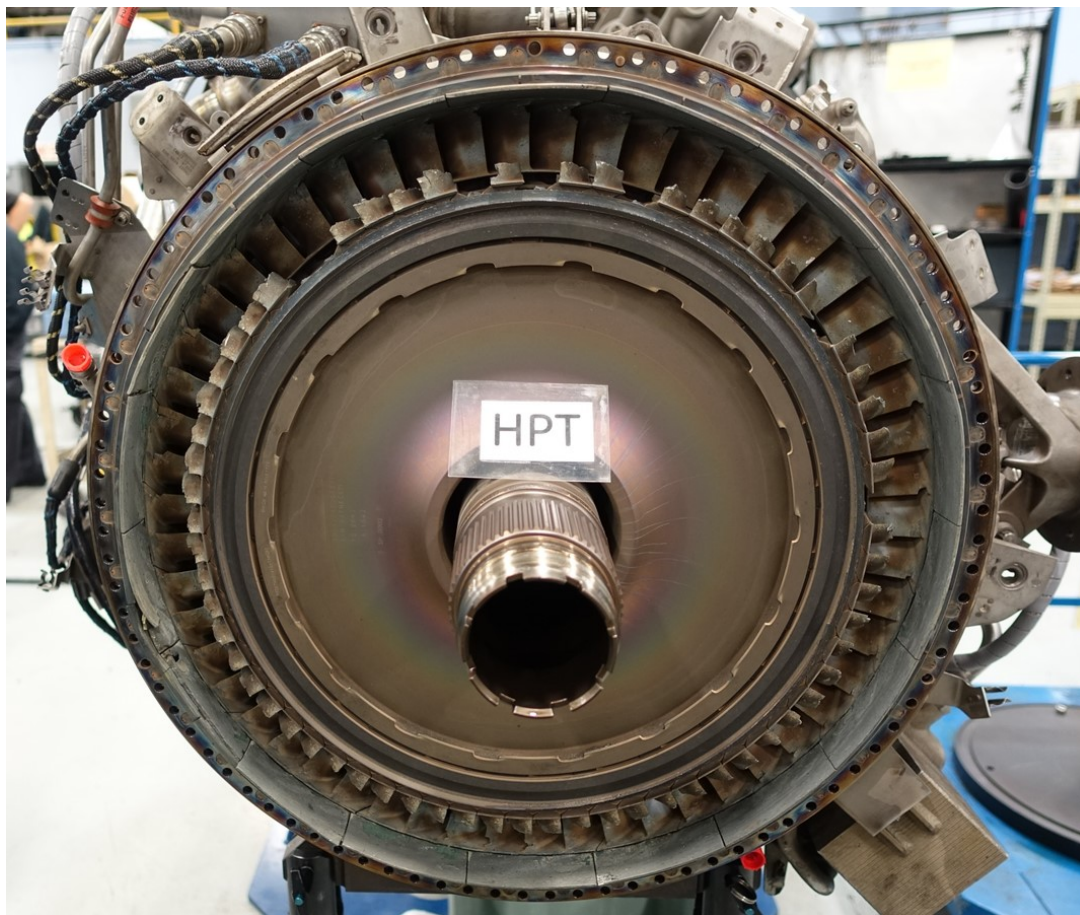
All HPT 2<sup>nd</sup> stage disk blades were fractured and separated but the blade dovetails all remained secure within the disk blade slots (**Photo 6**). Sixty one of the 68 blades were fractured between  $\frac{1}{4}$  to  $\frac{1}{2}$  inch above the blade platform and the remaining seven blades were fractured below the blade platform. The blade stubs exhibited both impact and thermal damage (**Photo 7**). The HPT 2<sup>nd</sup> stage disk shroud was heavily rubbed and had an area of localized deformation at the 8 o'clock position, coincident with the location of the penetration observed in the LPT case (**Photo 8**). The HPT 2<sup>nd</sup> stage nozzle was intact but had thermal damage including flaked TBC on the leading edge of multiple vanes. A single vane at the 6 o'clock position had

**Photo 6- HPT 2<sup>nd</sup> Stage (ALF)**

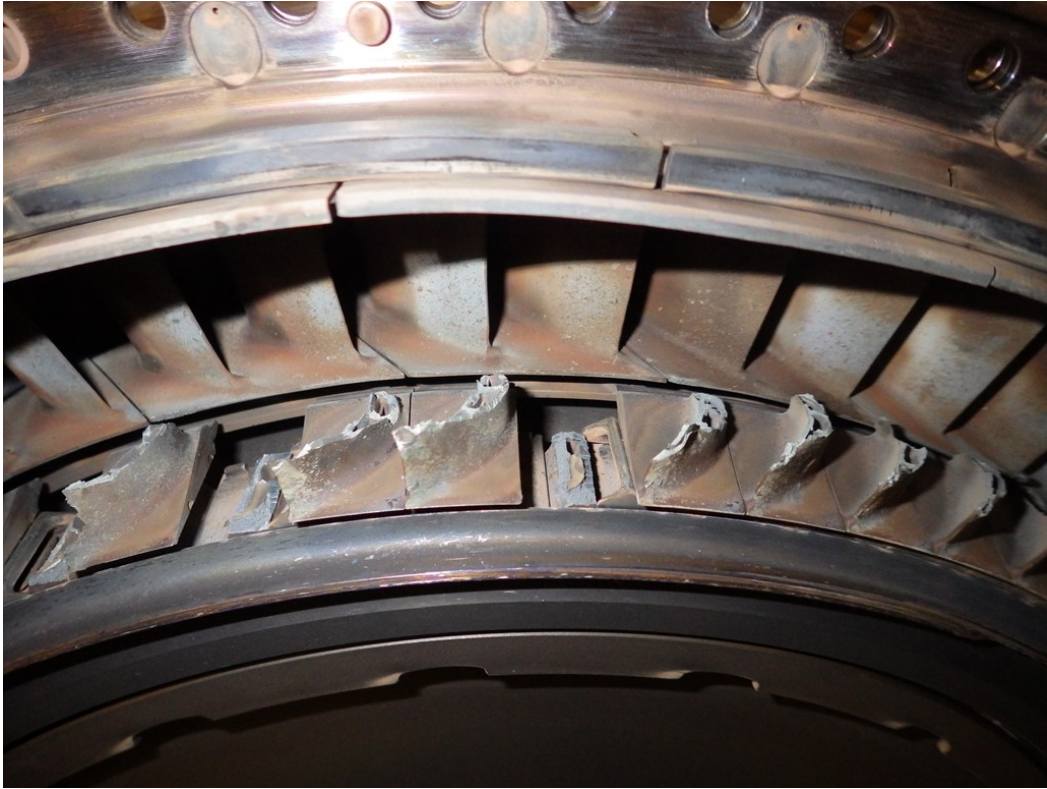
**Photo 7- HPT 2<sup>nd</sup> Stage Blade Damage**

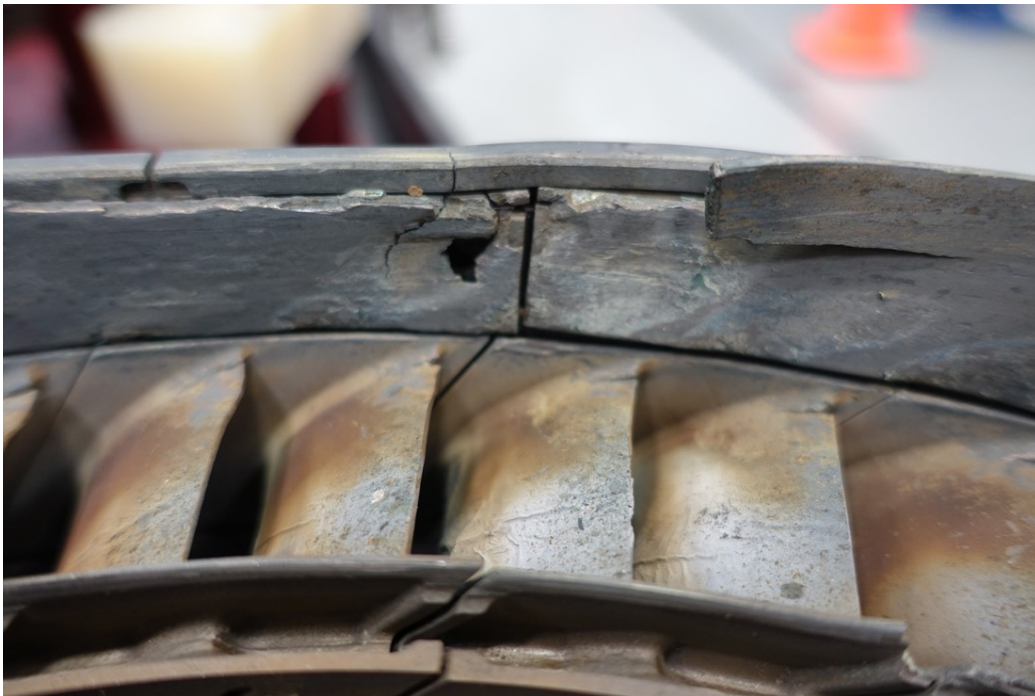
**Photo 8- HPT 2<sup>nd</sup> Stage Blade Shroud**

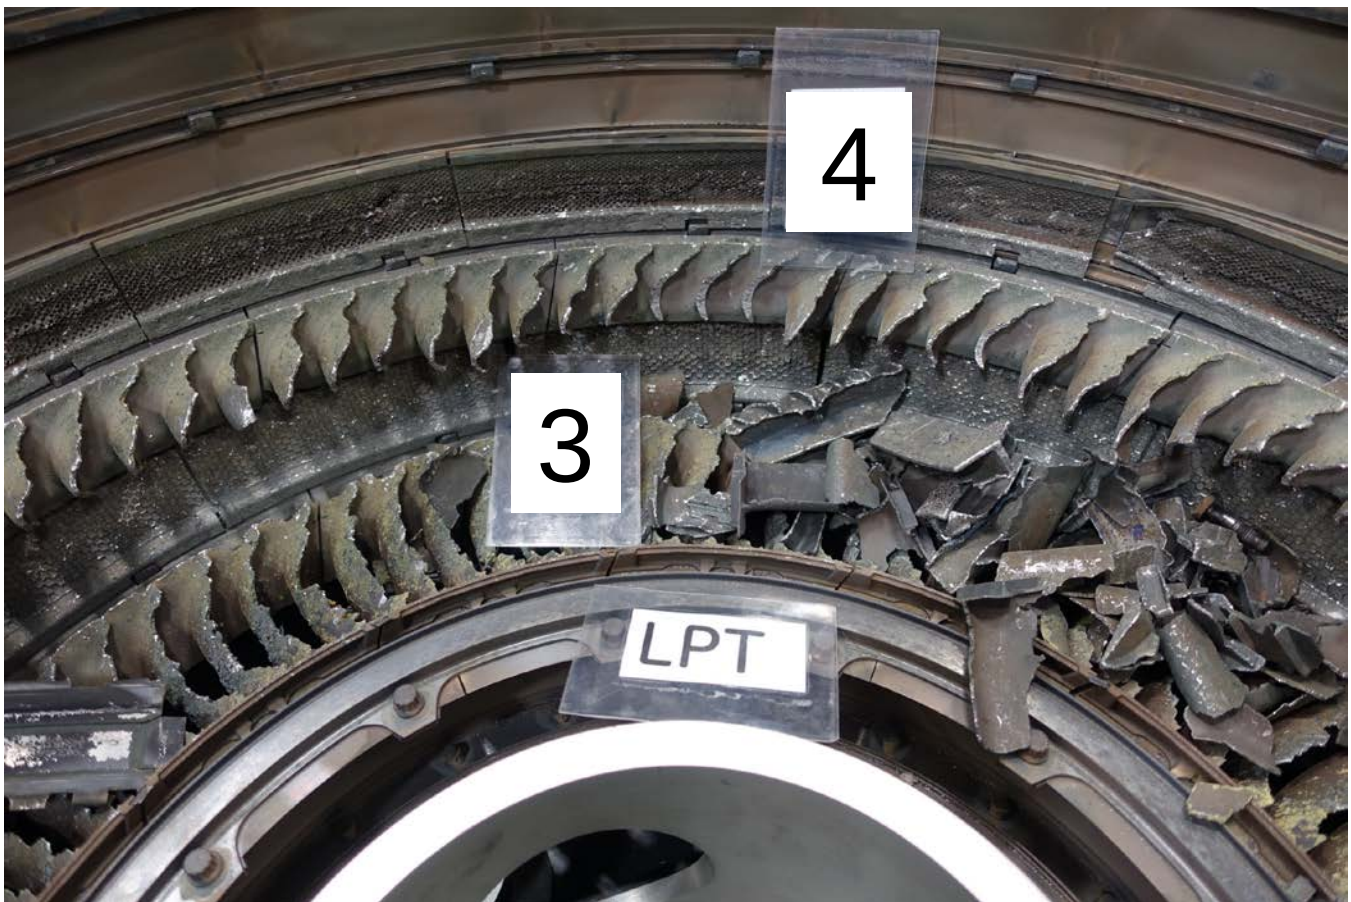
The LPT 3<sup>rd</sup> stage nozzle exhibited extensive impact damage on the trailing edge of all vanes (**Photo 9**). The midspan of eight consecutive vanes were thermally consumed at the 8 o'clock position, leaving small sections of the vane in place at the inner and outer platforms (**Photo 10**). An unidentified yellow substance was noted on several vanes. The LPT 3<sup>rd</sup> stage blades were all fractured near the blade platform and the remaining blade stubs had impact damage, including material tearing and smearing (**Photo 11**). The outer transition liner (OTL) segments were fractured and missing from the LPT case. One complete segment of the OTL was still present at the 12 o'clock position. A fragment of one of the OTL segments was adhered to the forward side of the 3<sup>rd</sup> stage nozzle at the 2 o'clock position. To remove the LPT baffle, the deformed metal around the LPT case penetration was broken off with a hammer. The piece was collected for shipment to the GE Materials Laboratory with the LPT case.

Photo 9- LPT 3<sup>rd</sup> and 4<sup>th</sup> Stage Nozzle Vanes

The LPT 4<sup>th</sup> stage nozzle inner diameter platform was fragmented into pieces and all nozzle vanes were separated near the outer diameter platform. All LPT 4<sup>th</sup> stage blades were fractured near the blade platform and the remaining blade stubs exhibited impact damage including material tearing and smearing (**Photos 9 and 11**).

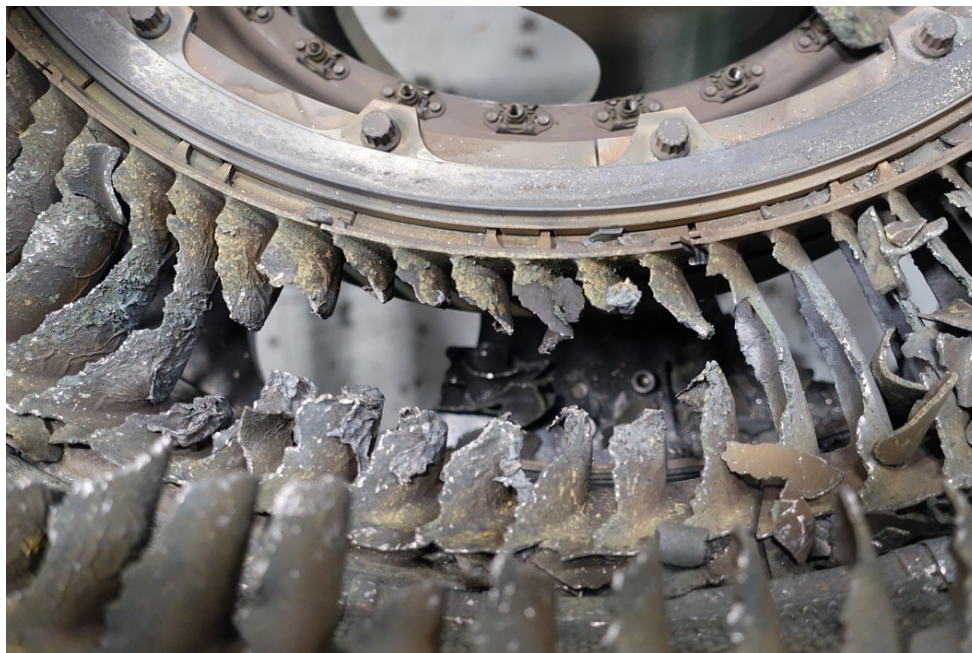
**Photo 10- LPT 3<sup>rd</sup> Stage Nozzle Vane Thermal Damage**

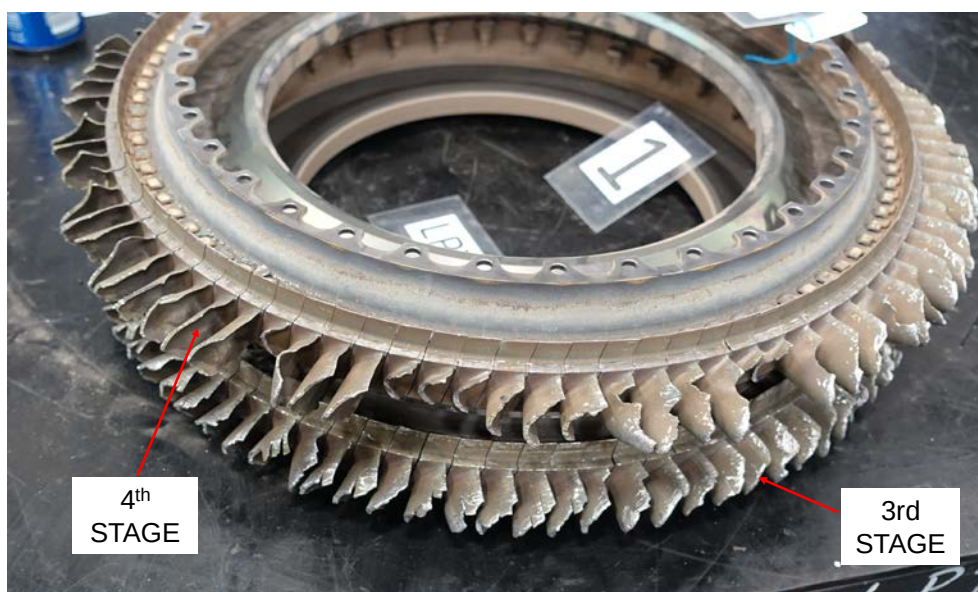
**Photo 11- LPT 3<sup>rd</sup> and 4<sup>th</sup> Stage Rotor Blade Damage**

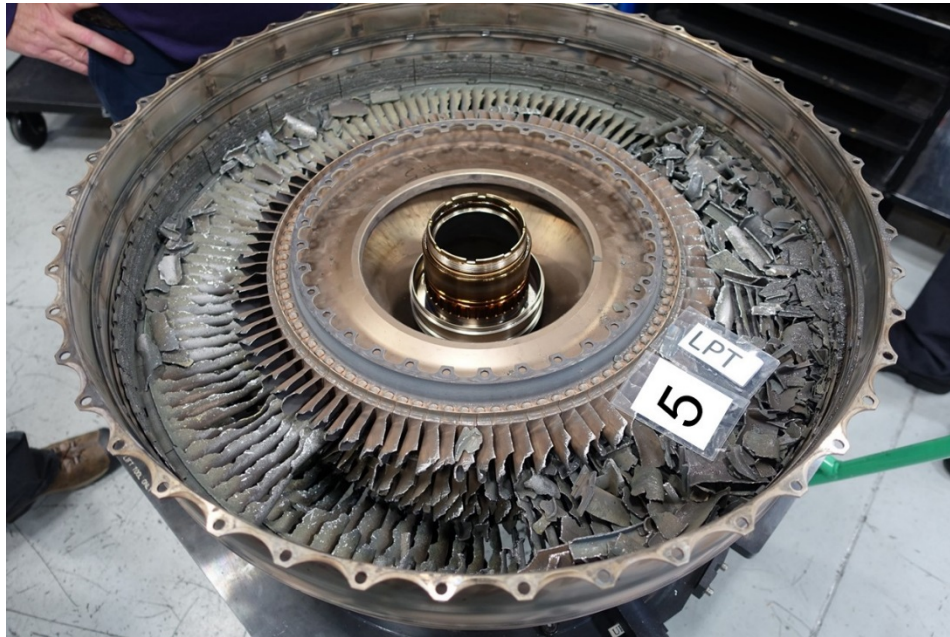
The LPT 5<sup>th</sup> stage nozzle vanes were all fractured, with small pieces of each vane airfoil remaining on the inner and outer diameter platforms. Two vane segments were separated

completely from the case at the 8 o'clock position. A large quantity of metal debris was trapped between the LPT 5<sup>th</sup> and 6<sup>th</sup> stages (**Photo 12**).

**Photo 12- LPT 5th Stage Damage**

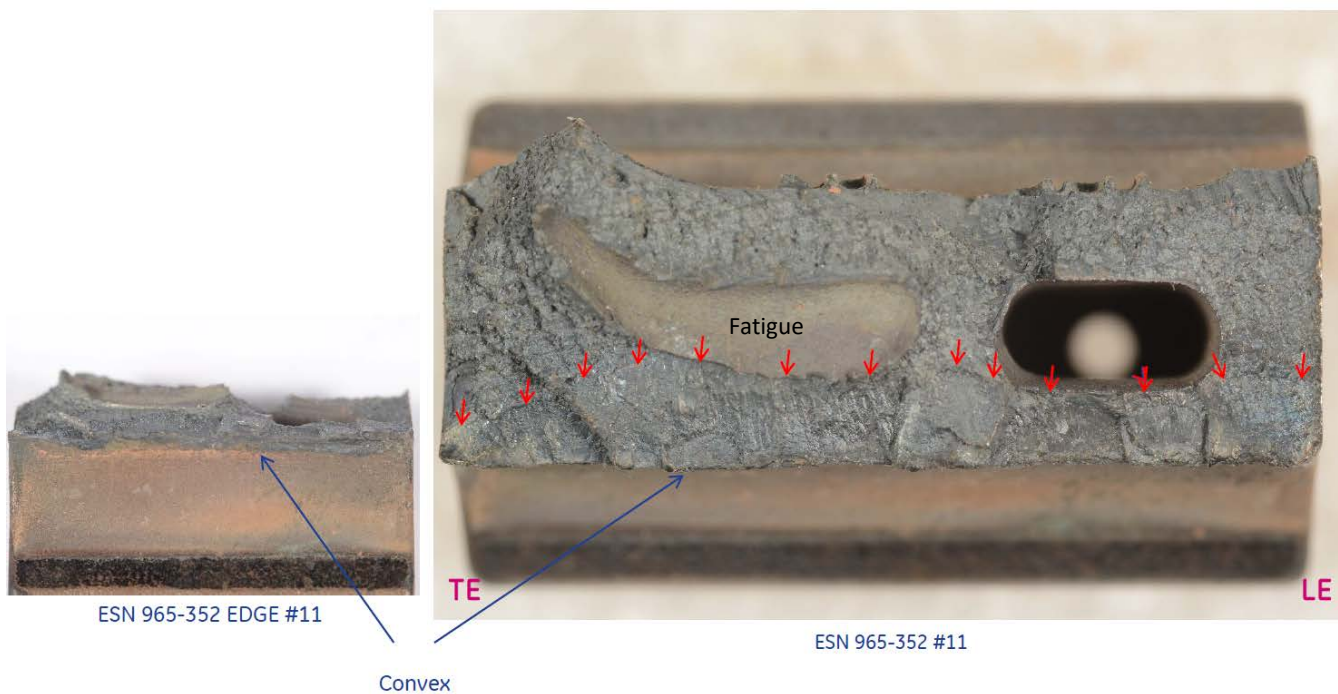
The remaining stubs of all 68 HPT 2<sup>nd</sup> stage rotor blades were removed from the disk and shipped to the GE materials laboratory in Lynn, Massachusetts for analysis. The laboratory confirmed that seven HPT 2<sup>nd</sup> stage blades, part number 4125T01, separated under the platform at the shank upper radius, and each fracture surface exhibited visual evidence of fatigue on the convex side originating from an area of corrosion (**Photo 13**). Multiple blades that were separated above the blade platform also had cracks originating from areas of corrosion below the platform in the same general location as the seven blades that separated below the platform. The 61 blades that were separated above the platform failed due to overload consistent with secondary damage. It could not be determined which blade separated first.

**Photo 13- HPT 2<sup>nd</sup> Stage Blade Under Platform Fracture Surface**

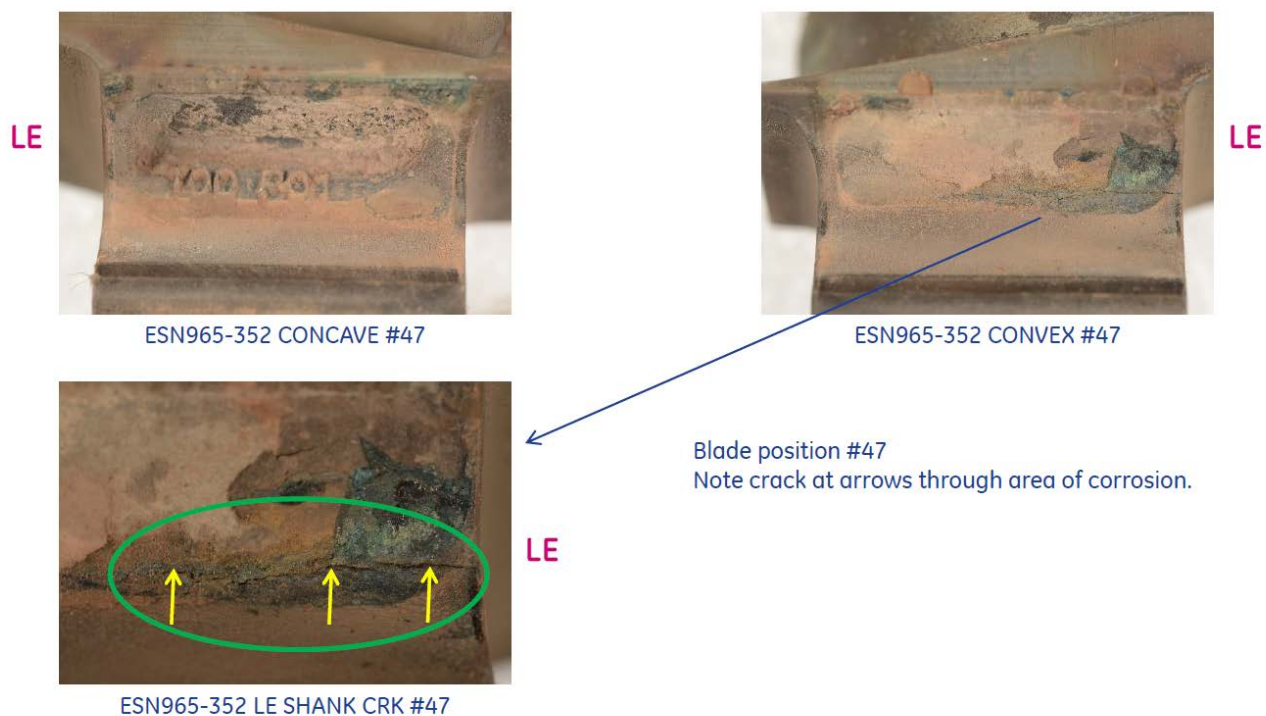
**Photo 14- Below Platform Crack on a Blade Separated Above the Platform**
