# GE Aviation

*CF34-8 ESN 965-352*  
*HPT S2B Under-Platform*  
*Separations*

TL-17-013

TL-17-026 update

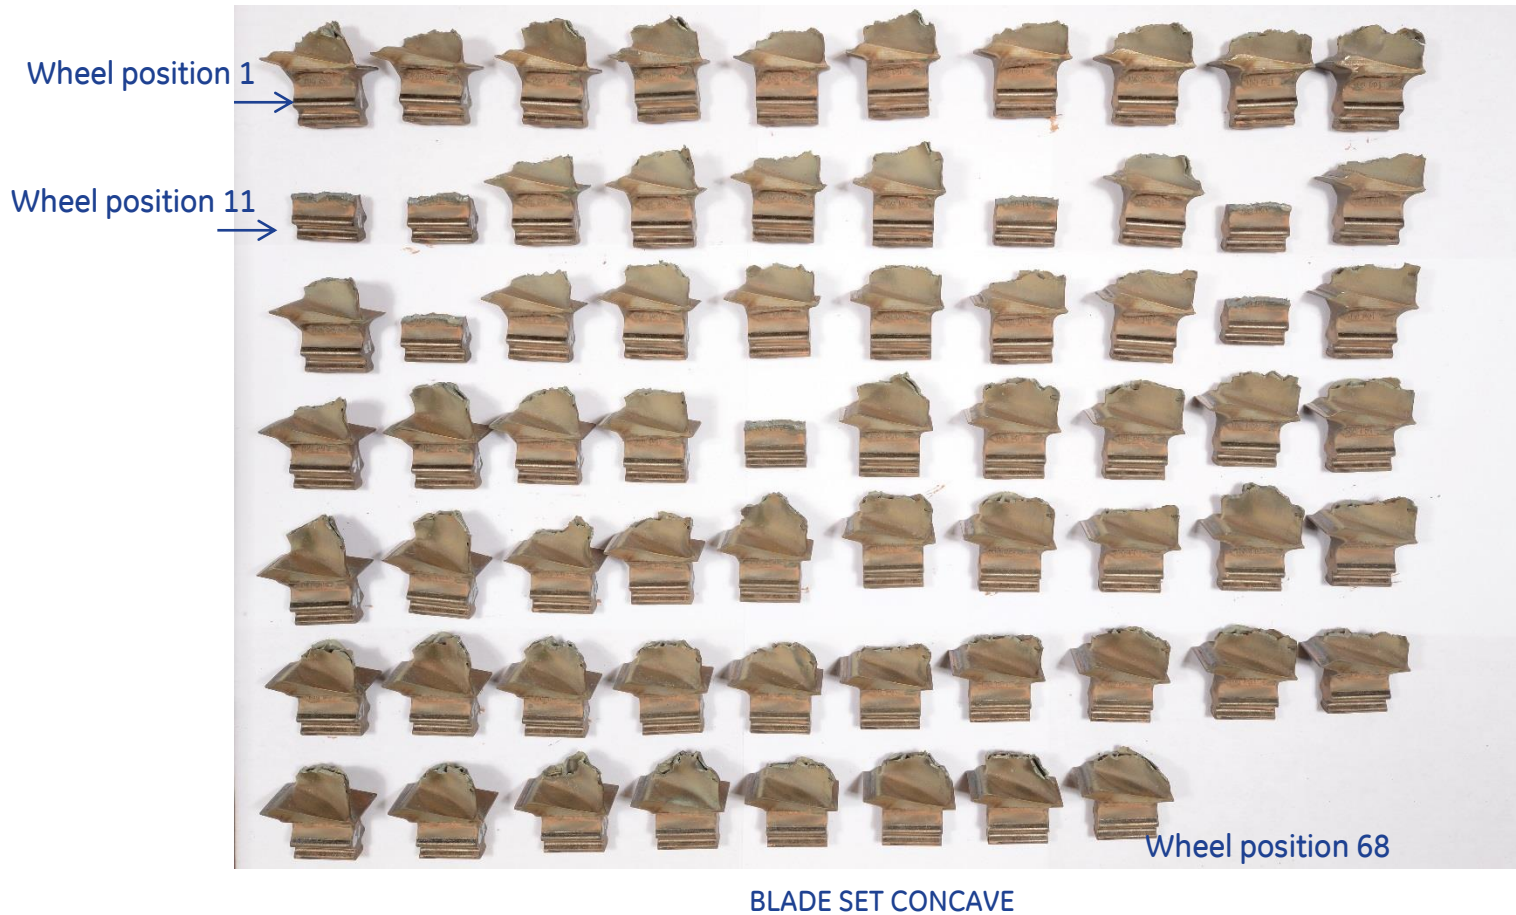
Figure 1

- The full set of sixty-eight HPT S2 blades (4125T01G01, N5/PtAl on airfoil) from ESN 965-352 operated by GoJet was submitted for metallurgical evaluation after an HPT stage 2 blade liberation event, which fractured all the blades in the set (see Figure 1) and punctured the LPT case locally. During teardown all stage 2 blades were found fractured, but 7 were fractured below the platform. The blades accumulated 20710 hrs ETSV/14839 cycles ECSV.
- Since the event was classified as “uncontained” the NTSB is involved in the investigation.

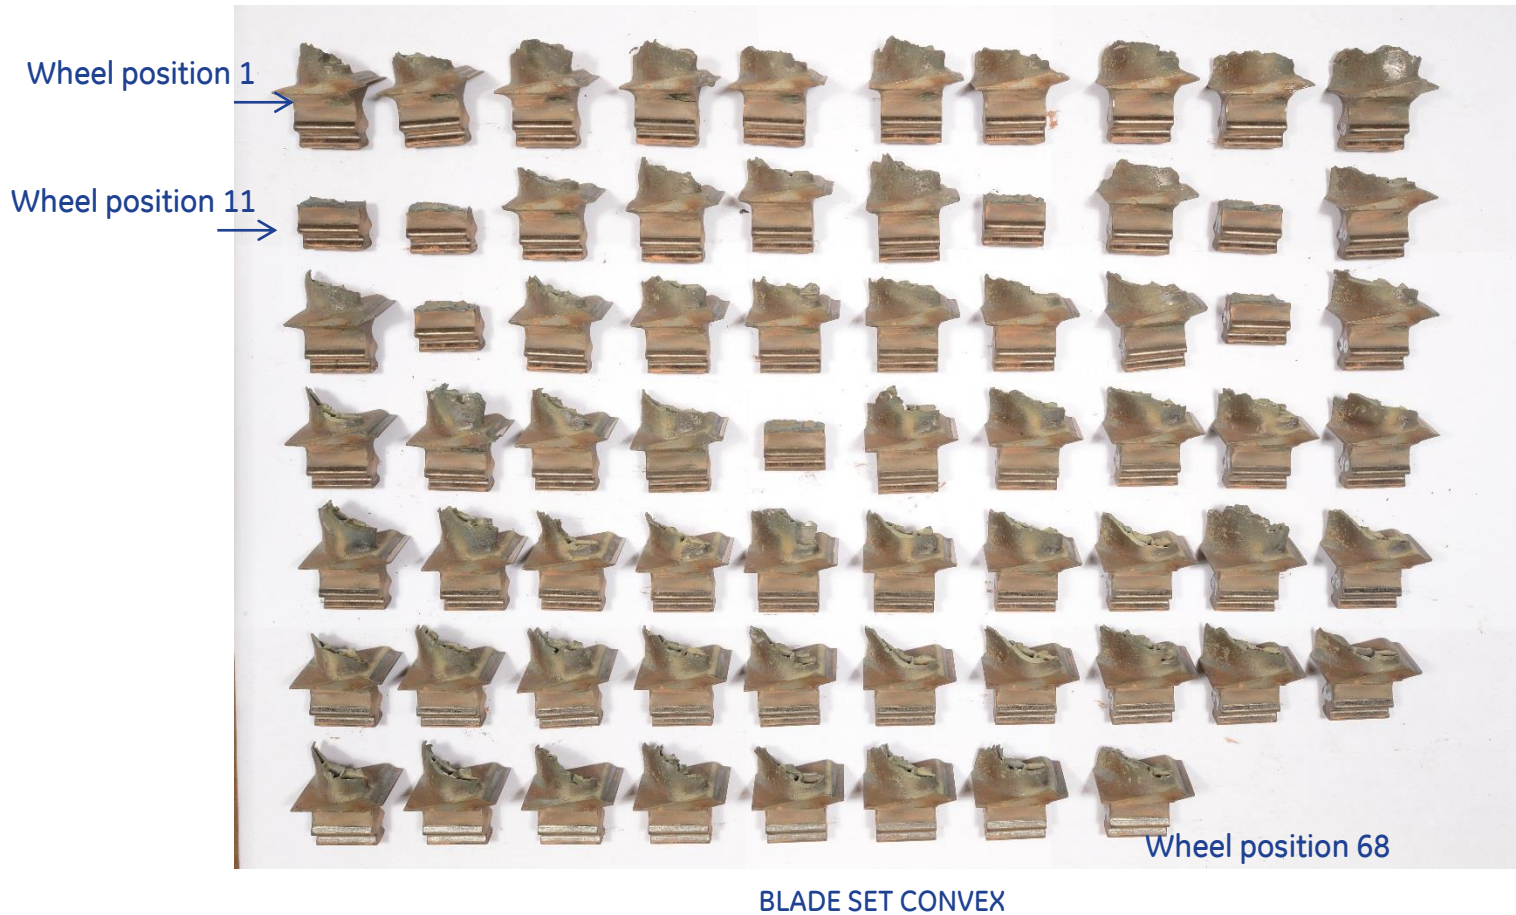
Figure 2

- Only non-destructive examination was performed.
- The full set of HPT S2 blades (Figures 1-2) were examined with the binocular microscope (up to 45X)
  - Seven blades separated under the platform in the shank upper radius.

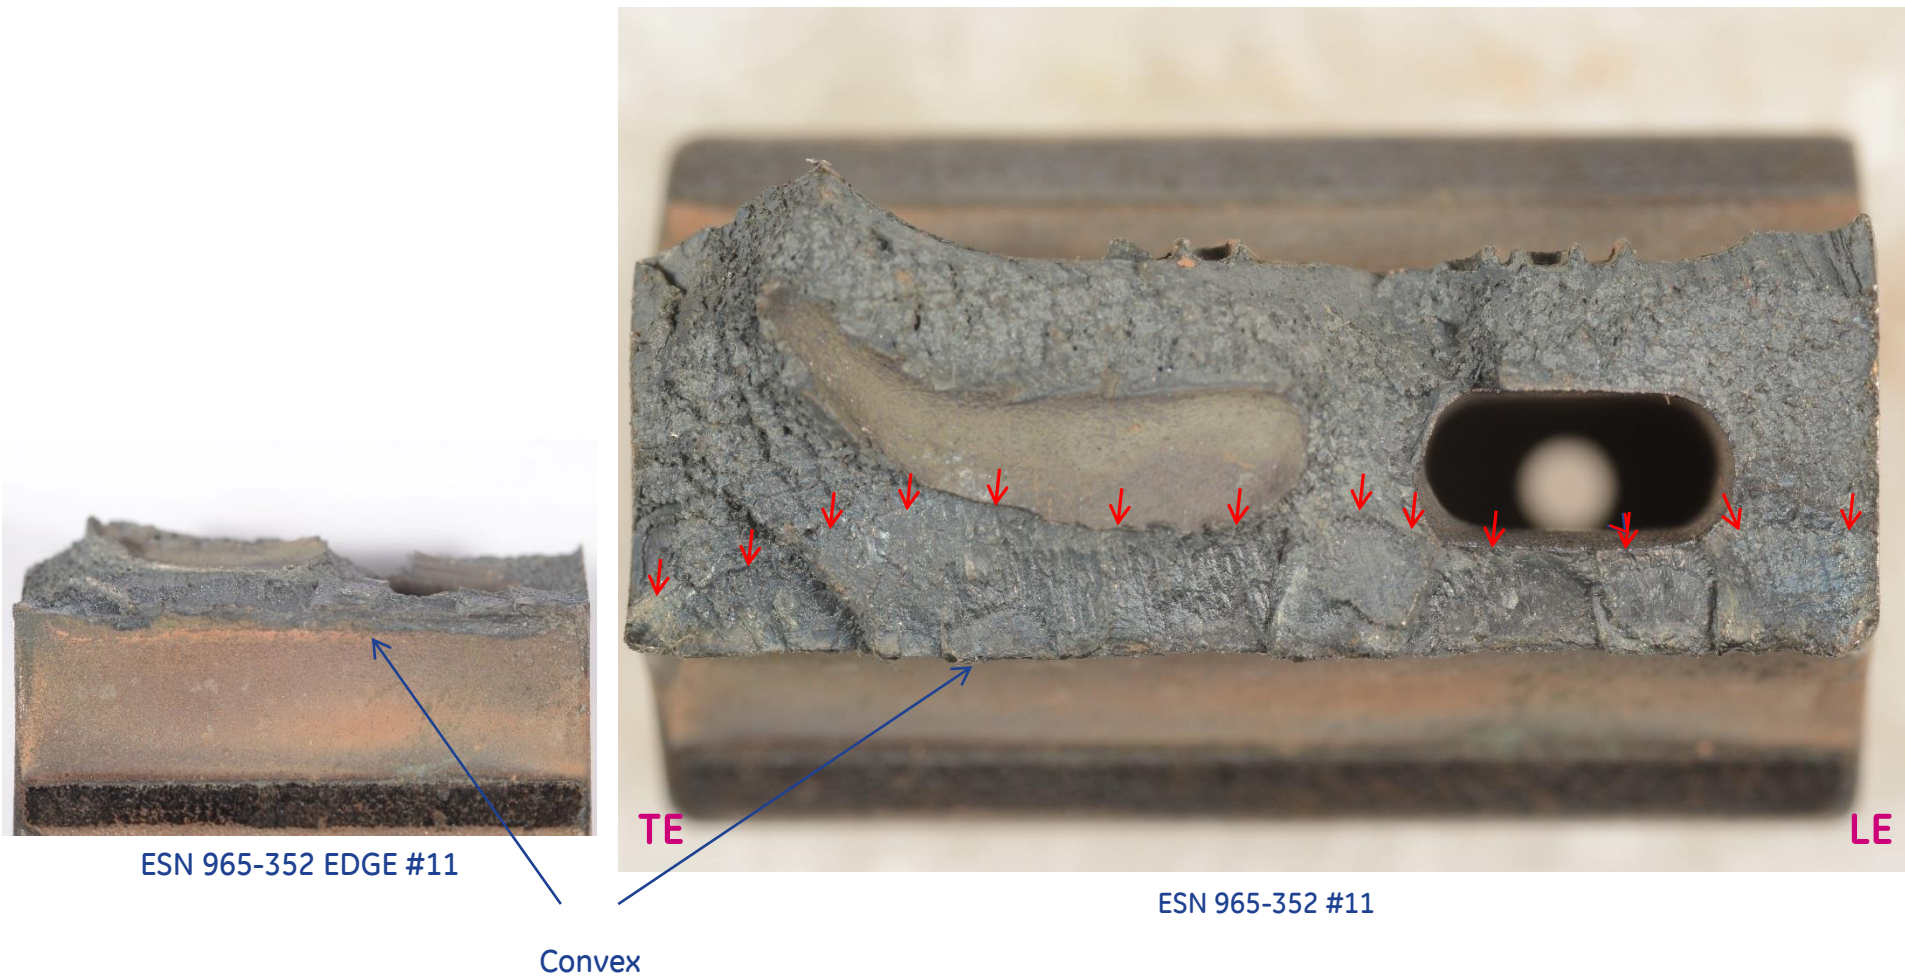
Figure 3

- The fracture surface of each of the seven blades separated under the platform exhibited visual evidence of fatigue initiating on the convex side in an area of corrosion. Mapping of the fatigue based on binocular examination is presented in Figures 3-9.

Red arrows denote extent of fatigue based on binocular examination (up to 45X)

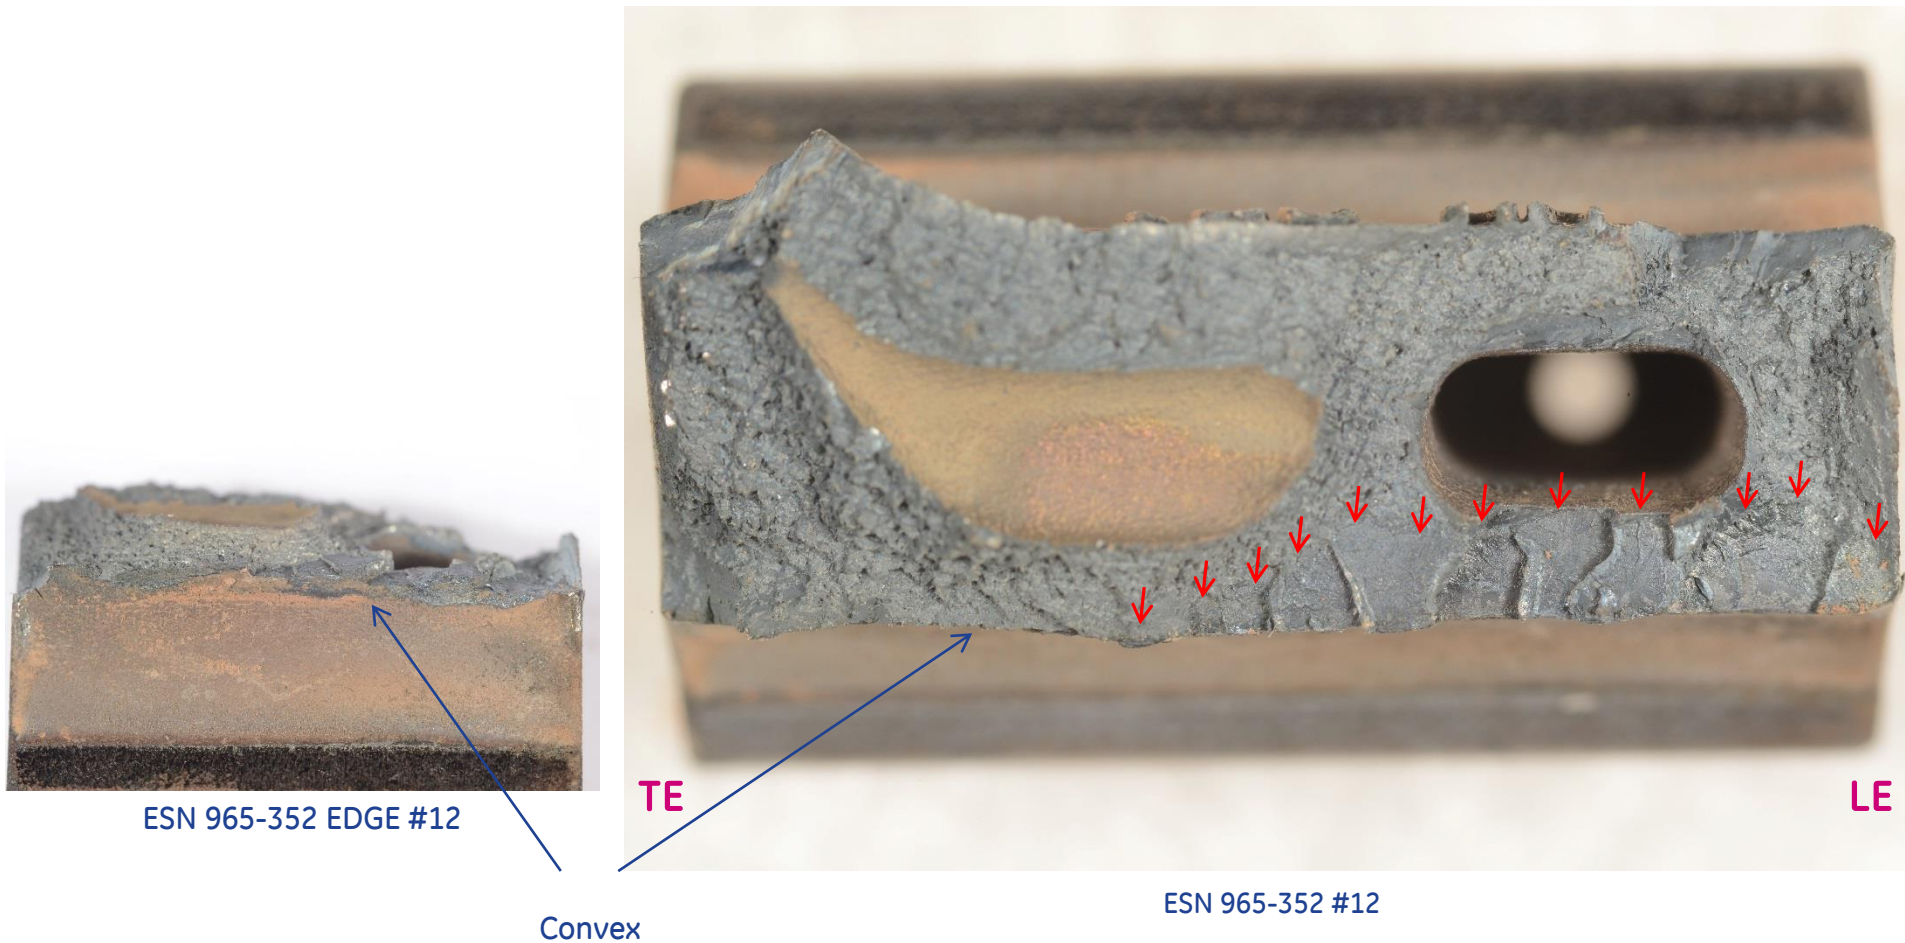
Figure 4

Red arrows denote extent of fatigue based on binocular examination (up to 45X)

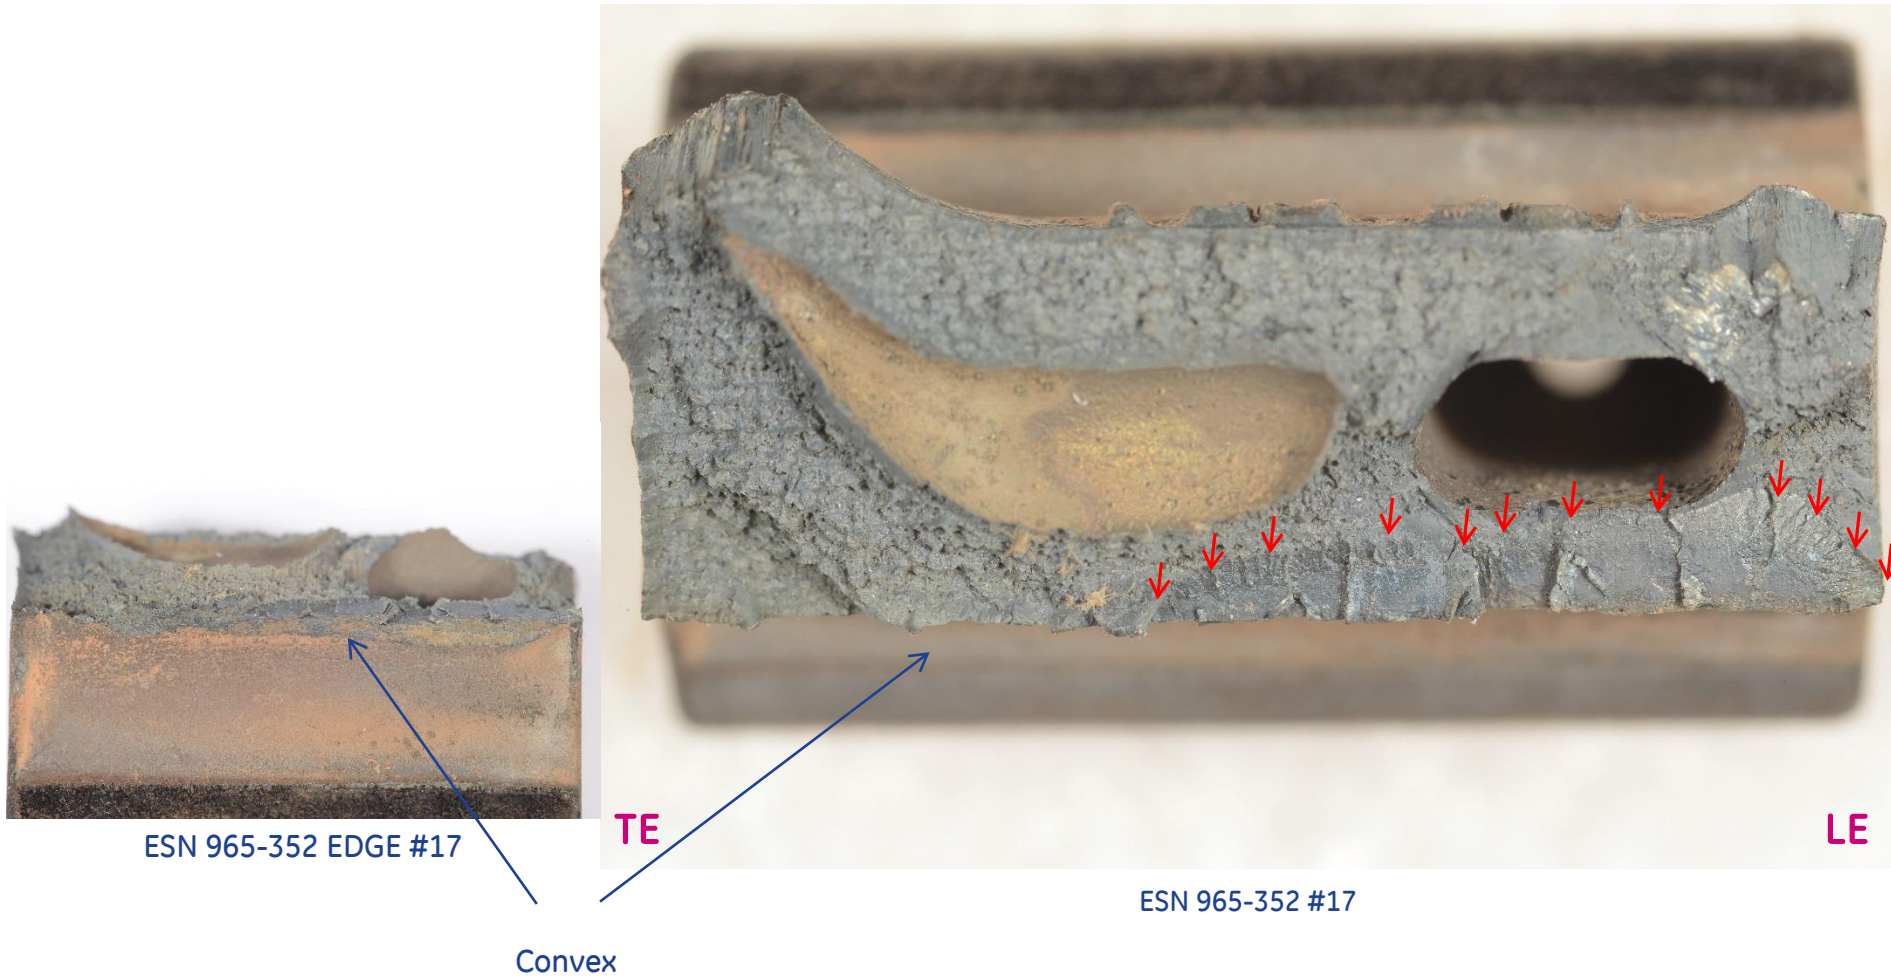
Figure 5

Red arrows denote extent of fatigue based on binocular examination (up to 45X)

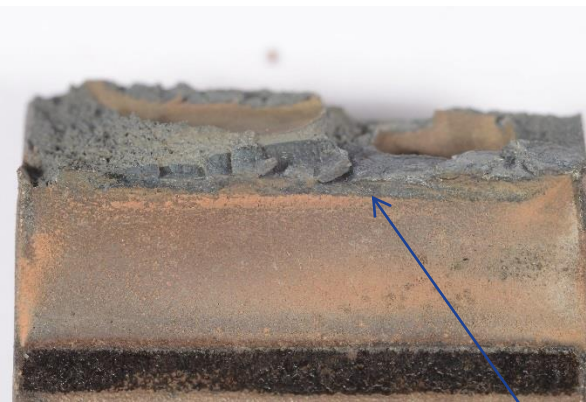
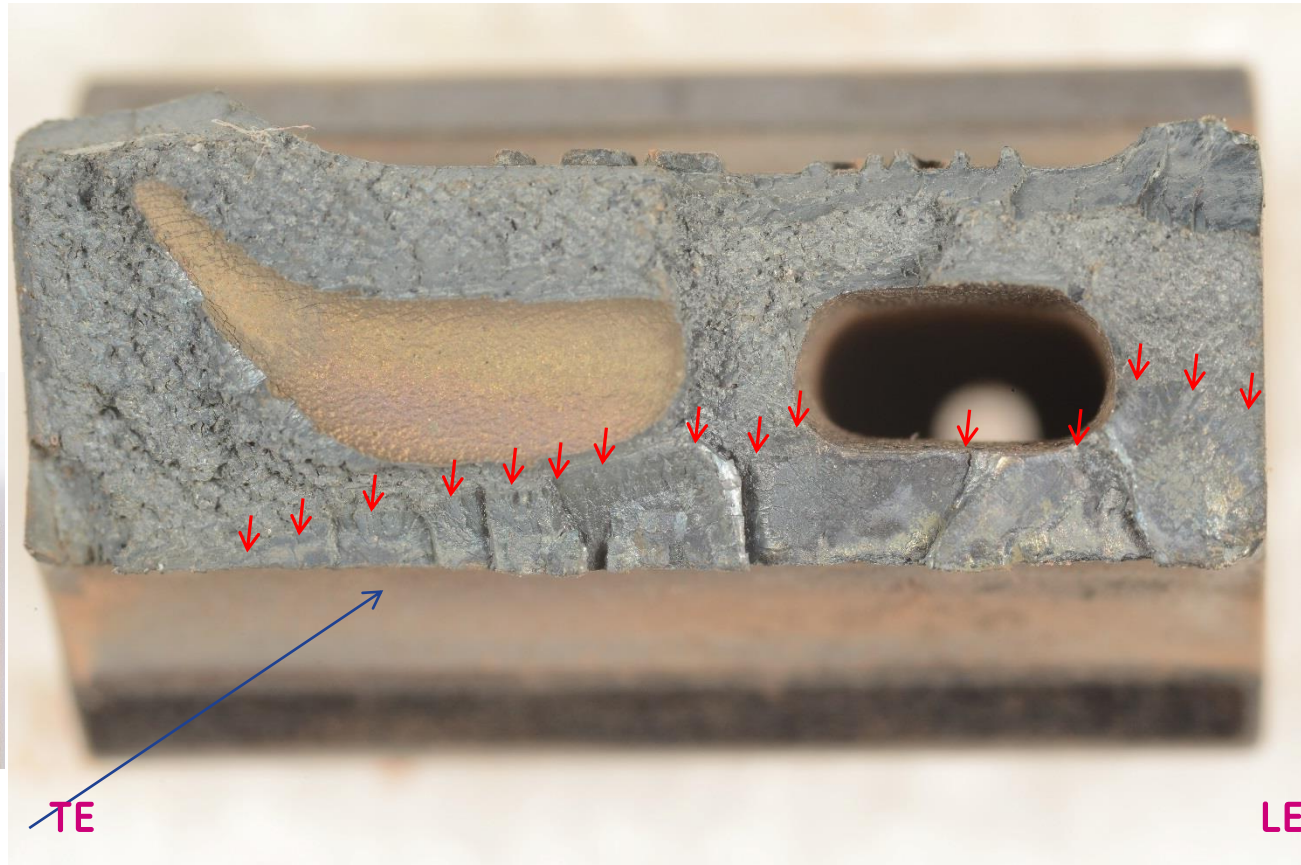
Figure 6

Red arrows denote extent of fatigue based on binocular examination (up to 45X)

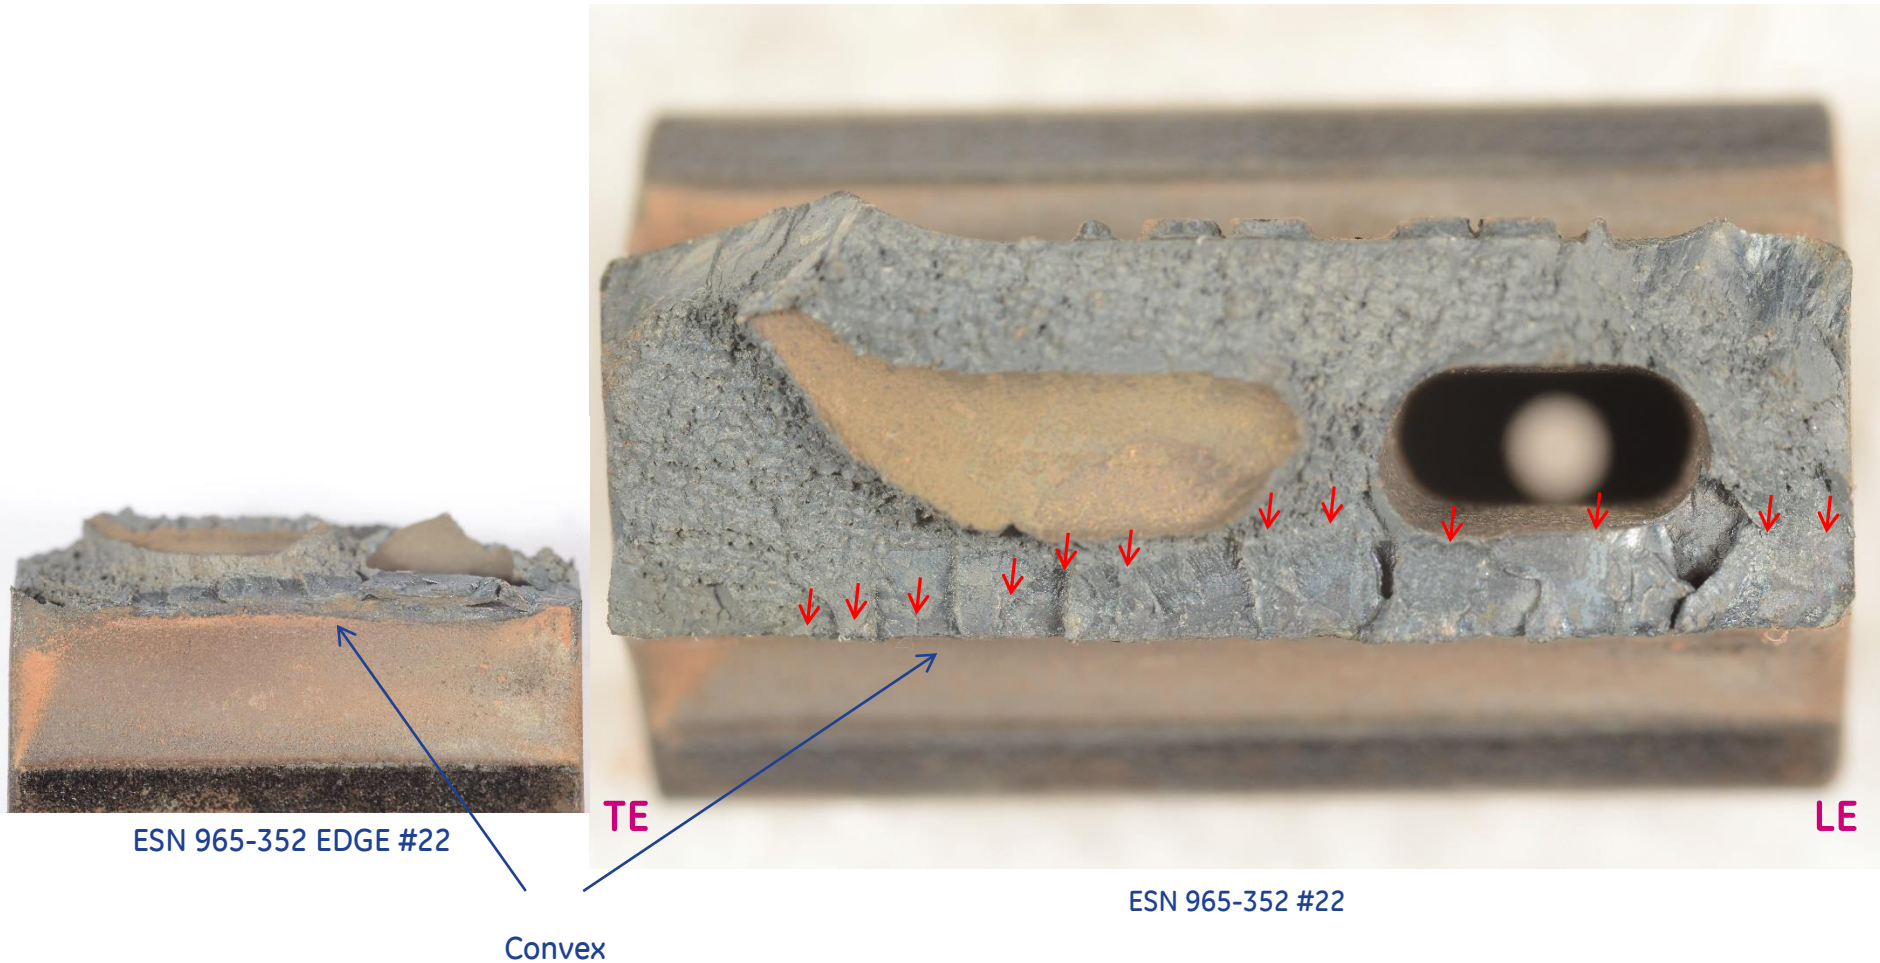
Figure 7

Red arrows denote extent of fatigue based on binocular examination (up to 45X)

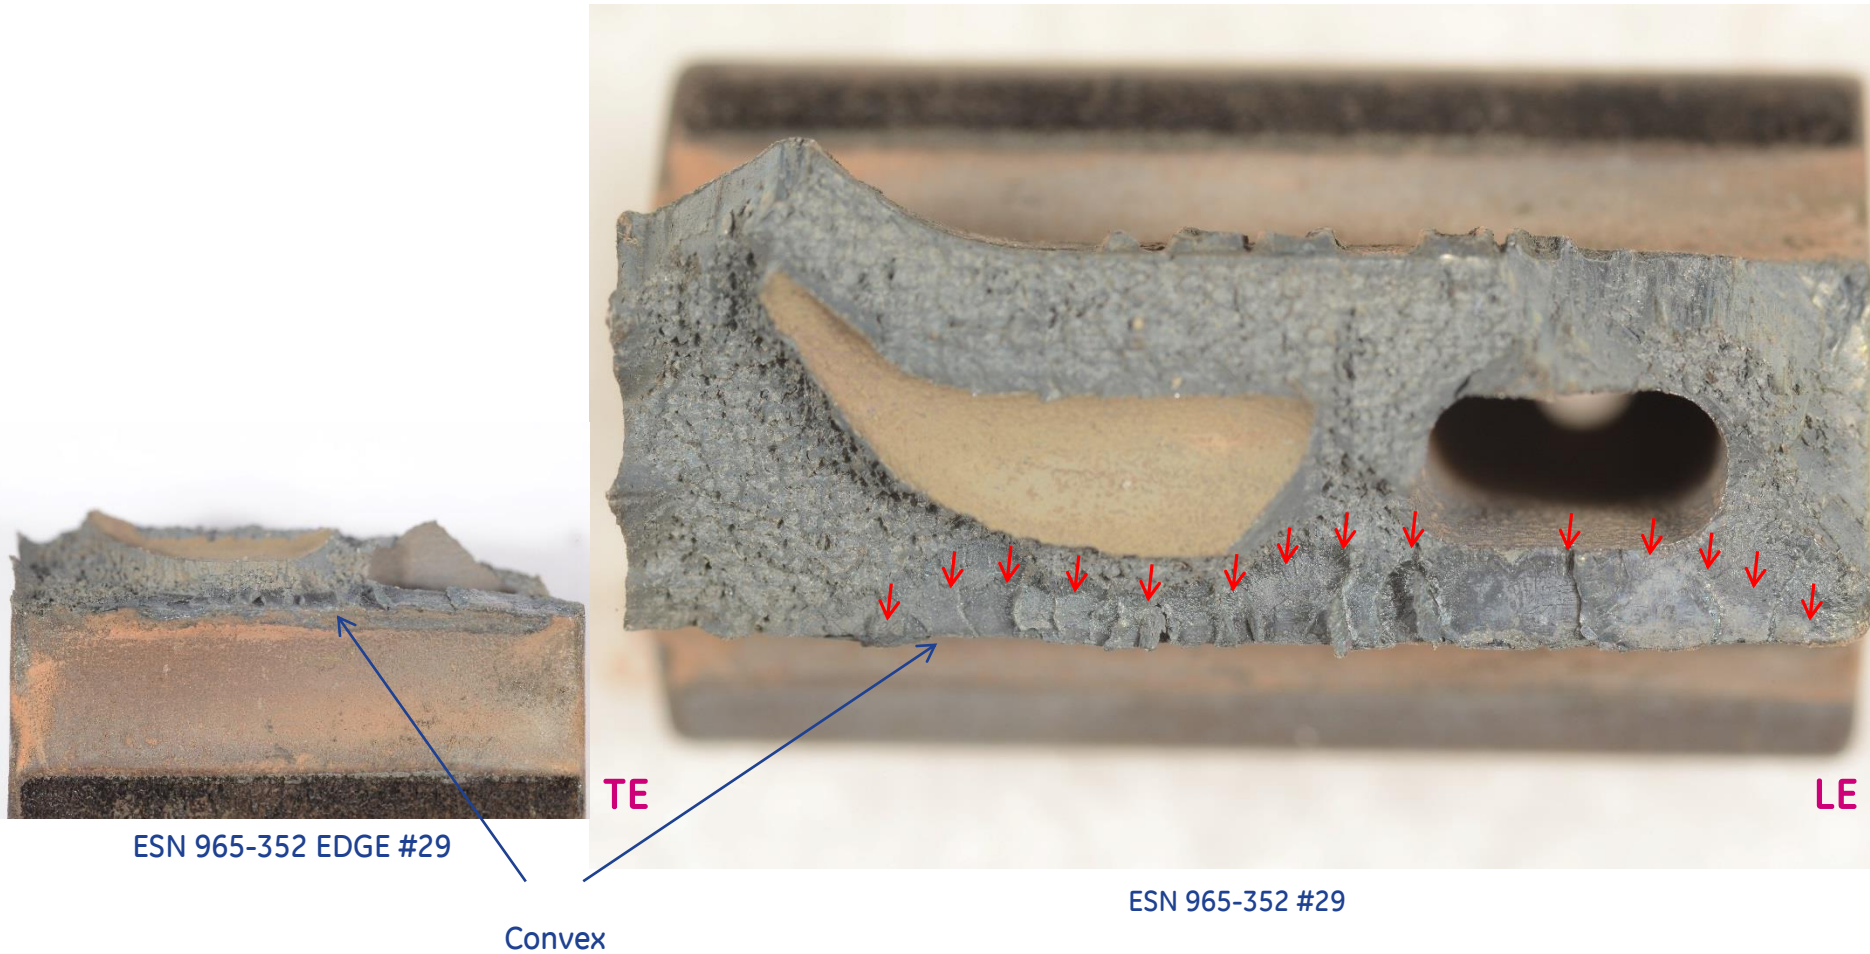
Figure 8

Red arrows denote extent of fatigue based on binocular examination (up to 45X)

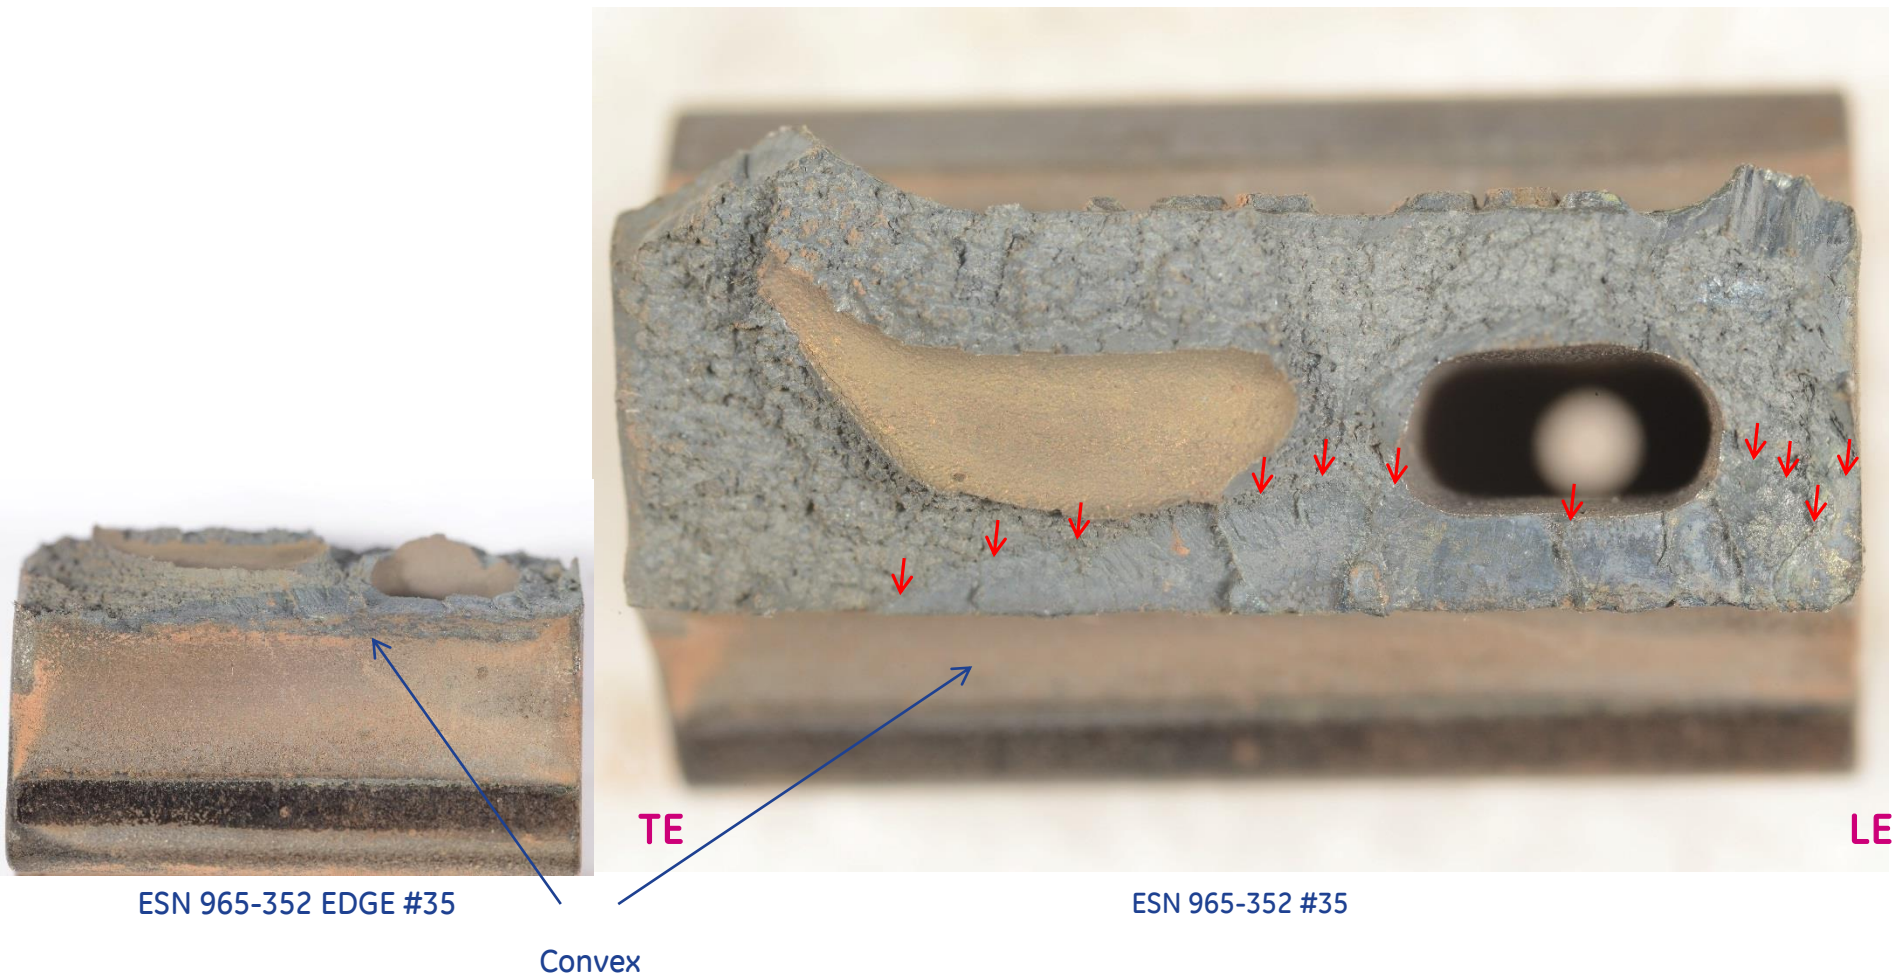
Figure 9

Red arrows denote extent of fatigue based on binocular examination (up to 45X)

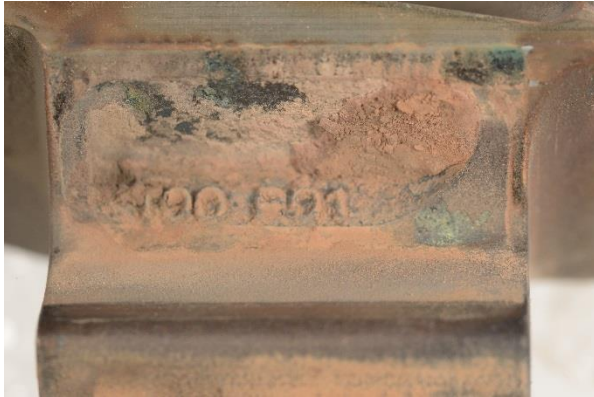
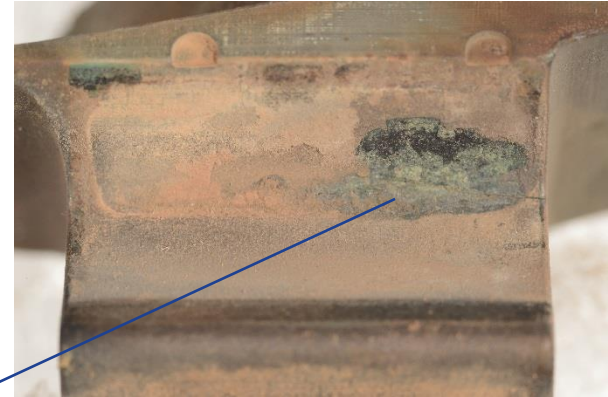
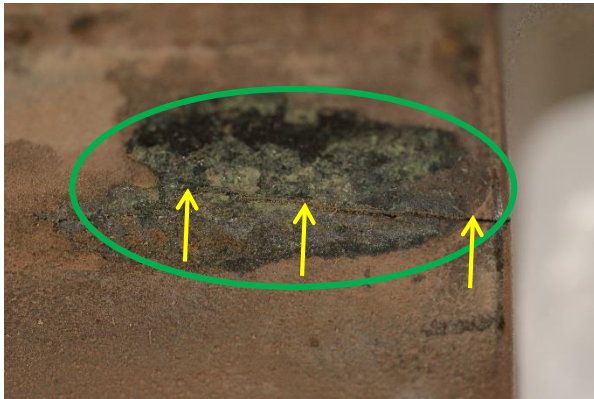
Figure 10

- Cracks were present in the convex shank under the platform of a number of the blades at a comparable location to the fatigue identified on the separated blades. Table 1 documents the crack size and location for each of the blades. Photomacrographs of representative blades with under-platform cracks are presented in Figures 10-13.

Blade position #2  
Note crack at arrows through area of corrosion.

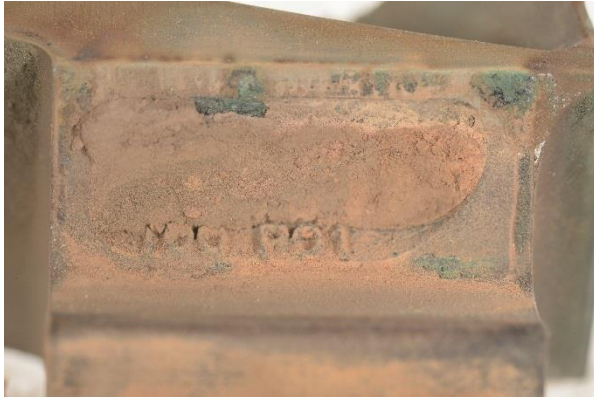
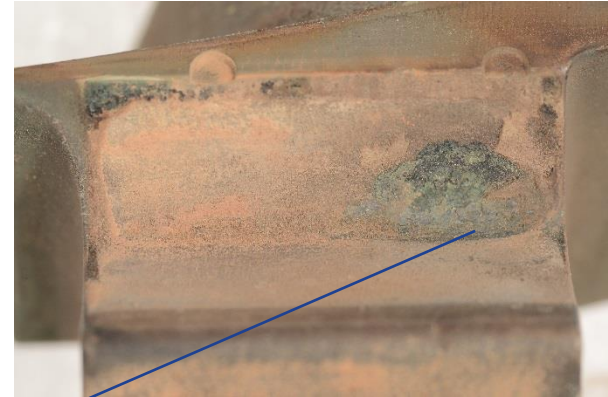
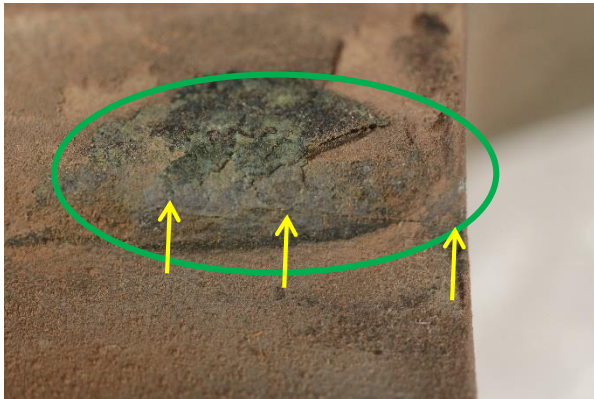
Figure 11

Blade position #6  
Note crack at arrows through area of corrosion.

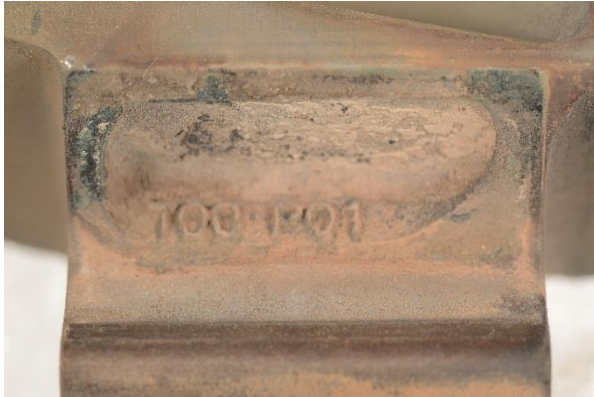
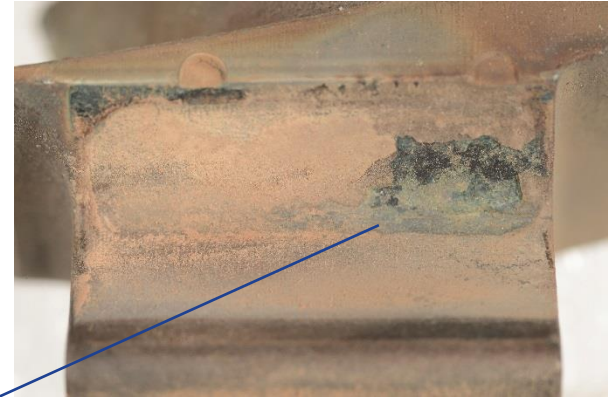
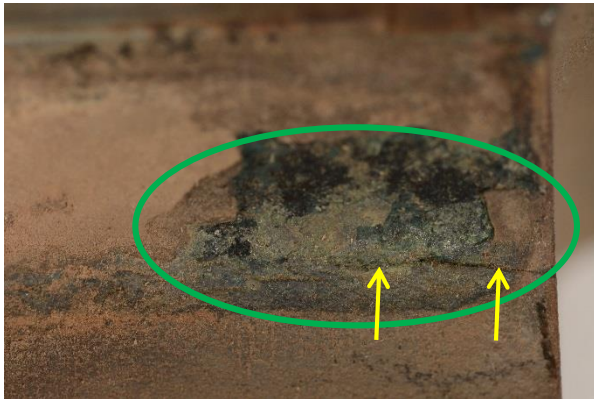
Figure 12

Blade position #30  
Note crack at arrows through area of corrosion.

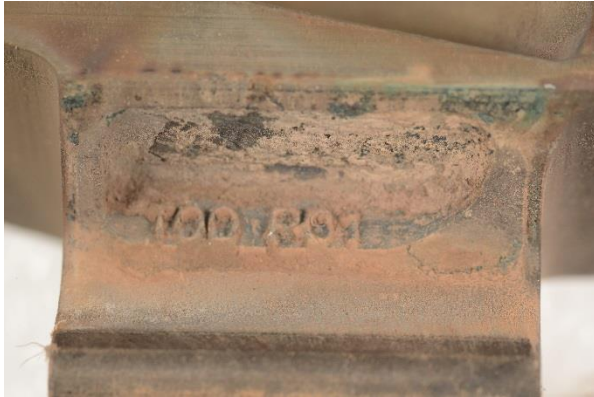
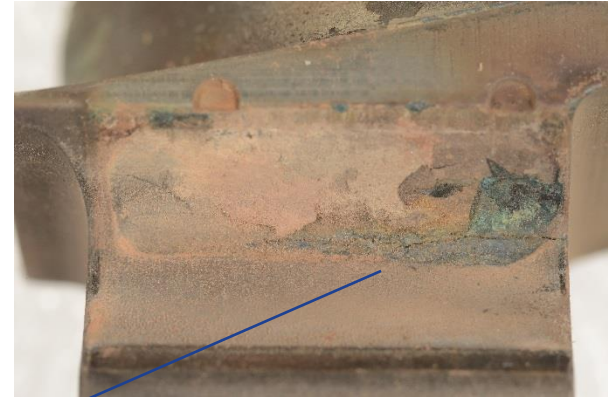
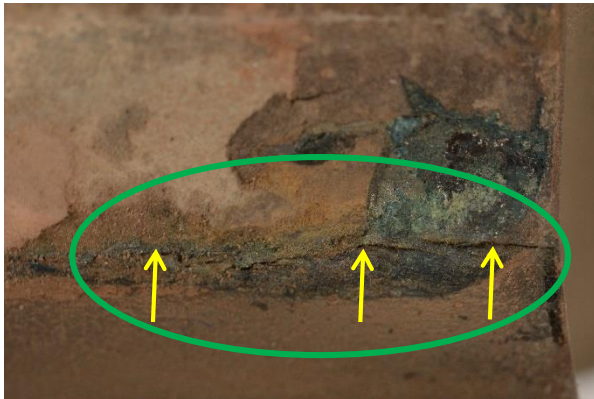
Figure 13

Blade position #47  
Note crack at arrows through area of corrosion.

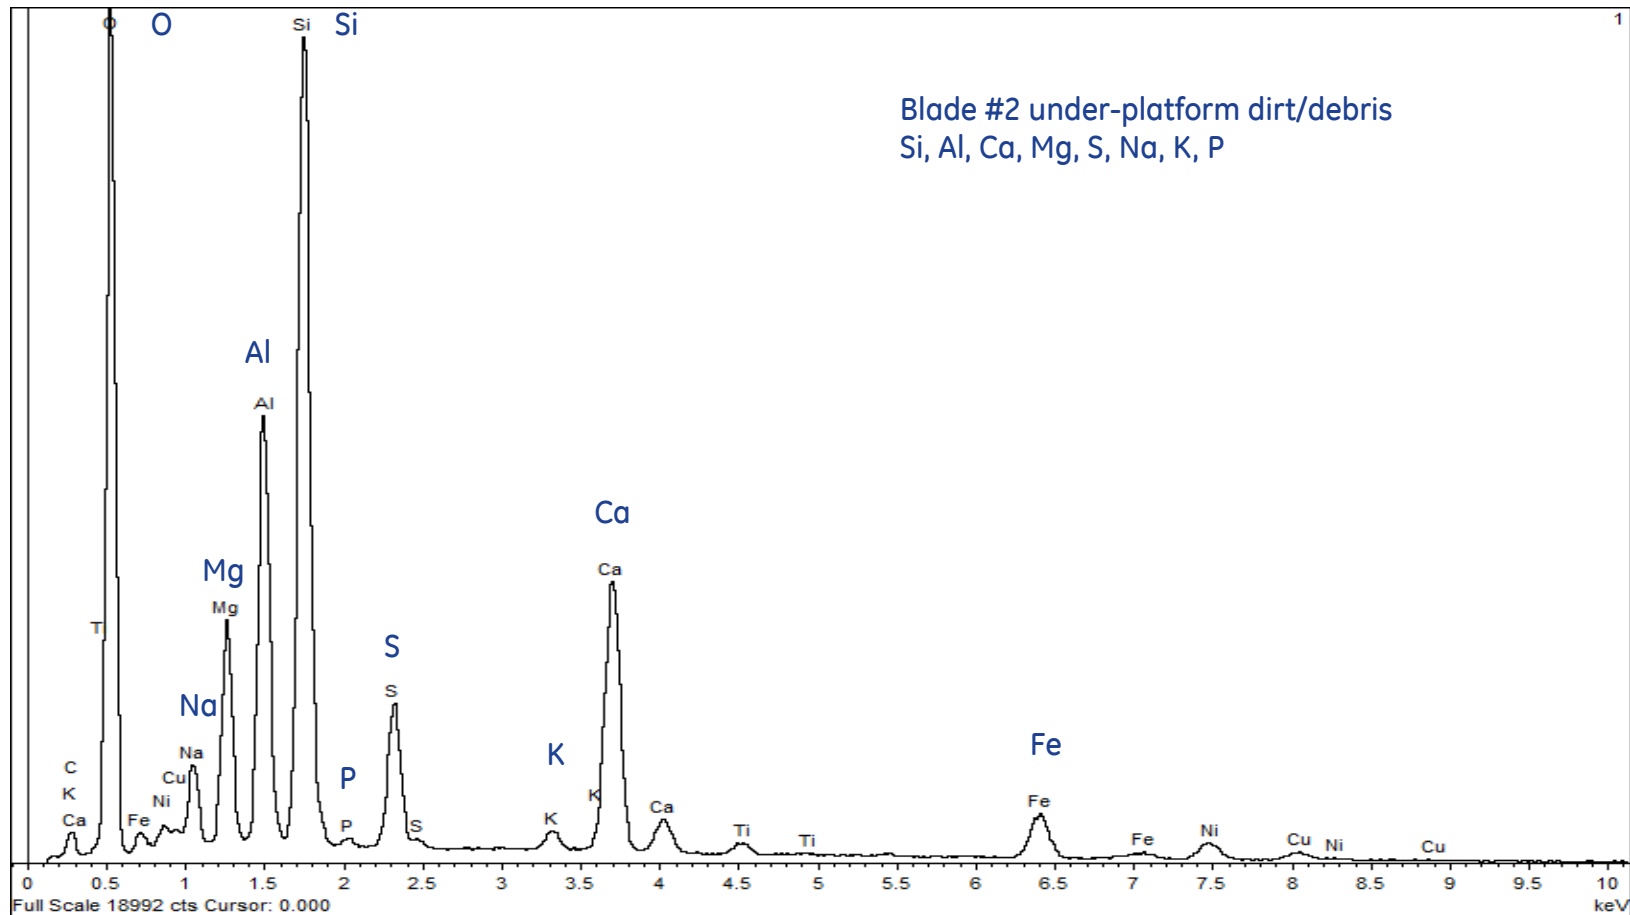
Figure 18

EDX analysis of the dirt/debris under the platform of cracked blade #2 identified the presence of Si, Al, Ca, Mg, S, Na, K, P. The presence of S, Na, K and P are consistent with corrosion. Figure 18.

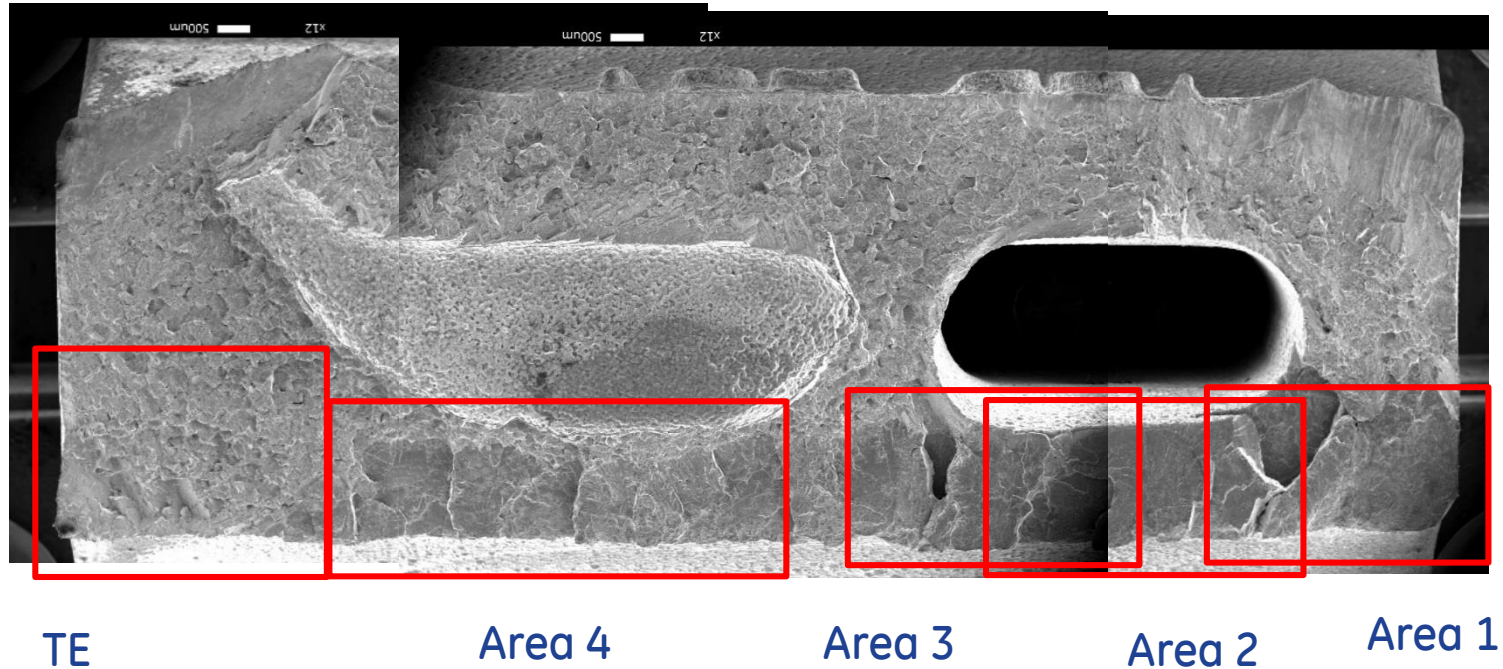
Figure 19

While corrosion products on the fracture surface often obscured fine details of the fracture surface, it was evident based on river lines and beach marks that fatigue had initiated at multiple origins along the convex surface of the shank upper radius and progressed toward the concave side. Figures 19-24.

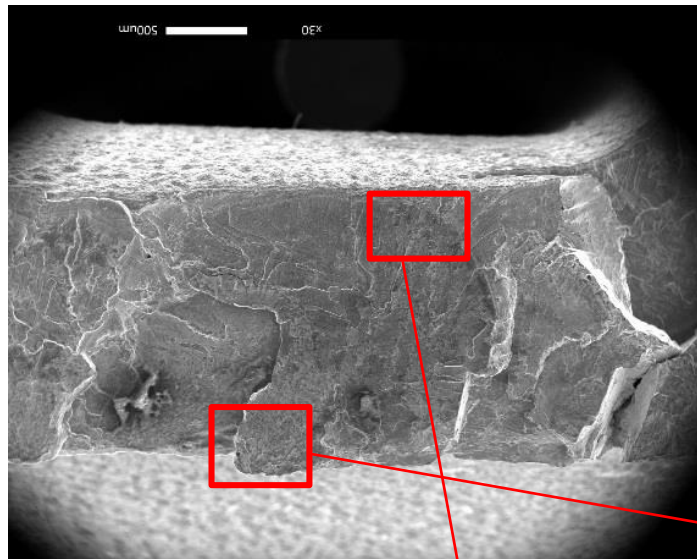
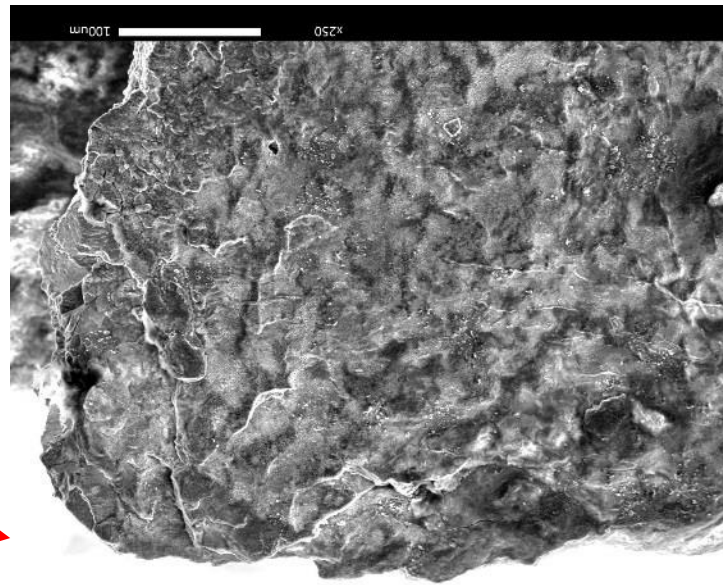
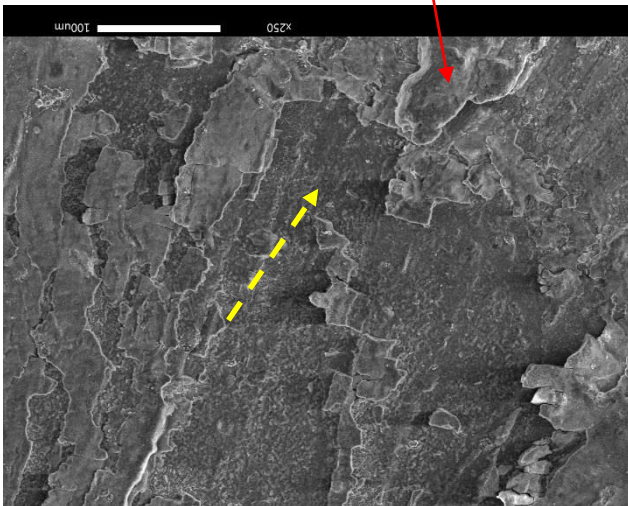
Figure 21

Corrosion product present on fracture surface

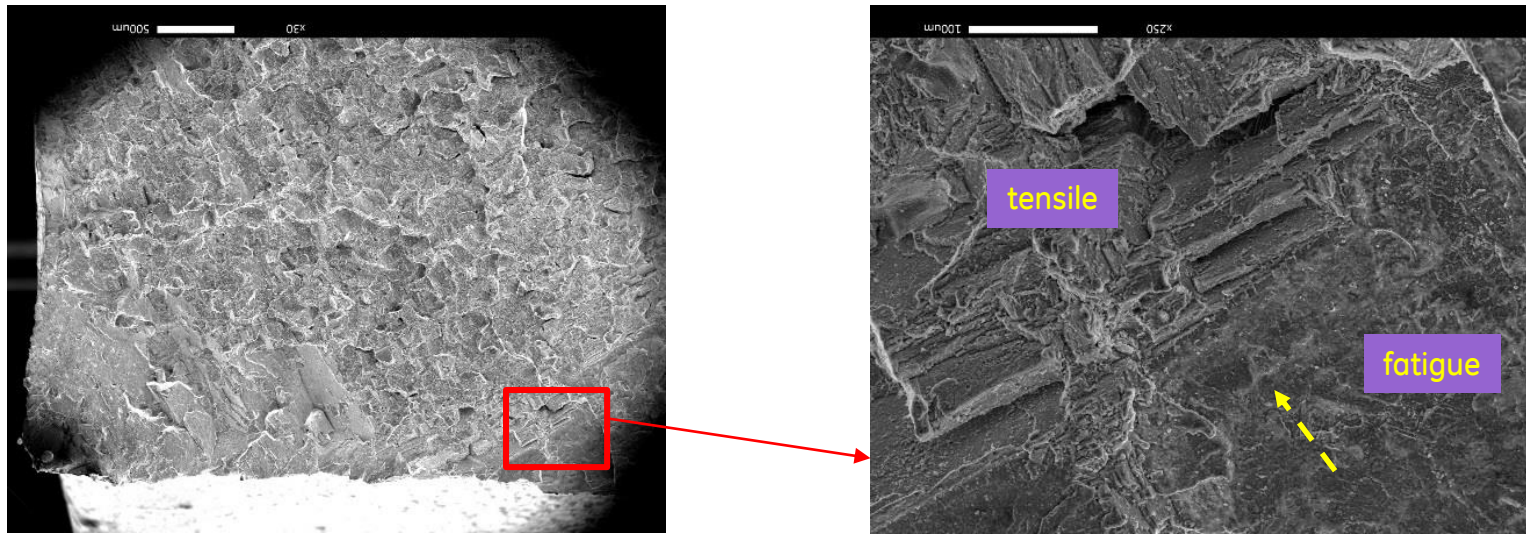
Figure 24

### Transition to tensile
