# GE Aviation

*CF34-8 ESN 965-352*  
*HPT S2B Under-Platform*  
*Separations*

TL-17-013

TL-17-026 update

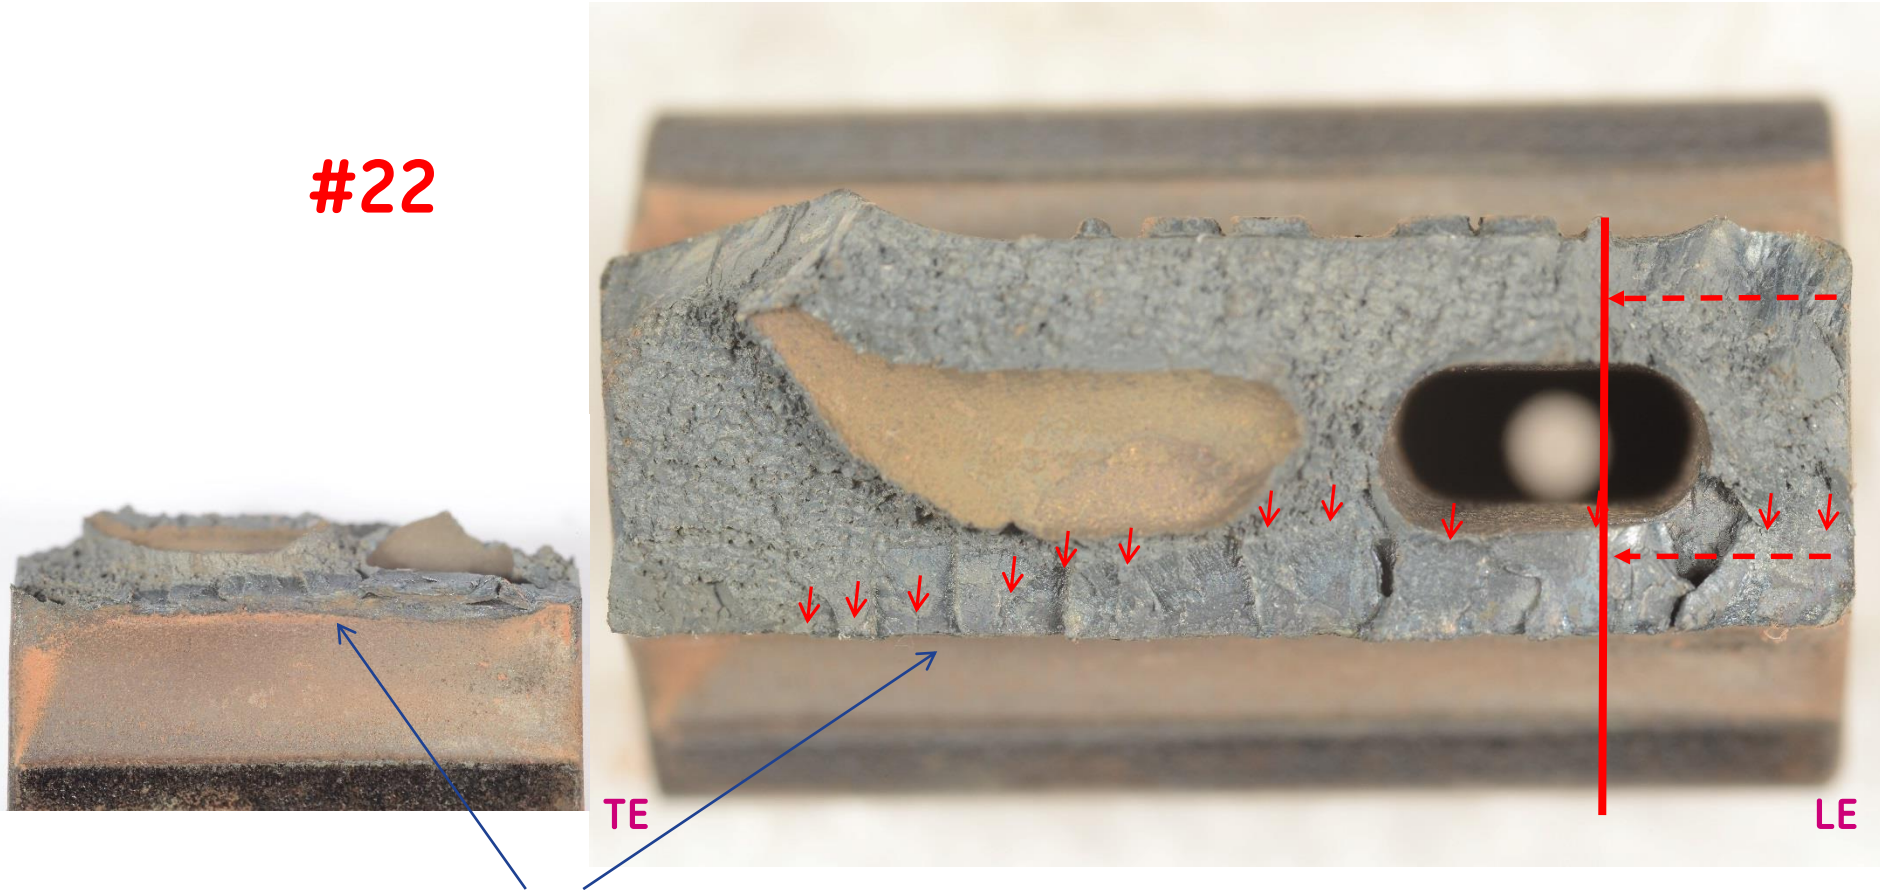
A radial section through the fracture surface of separated blade #22 as marked in Figure 25 was prepared for metallographic evaluation.

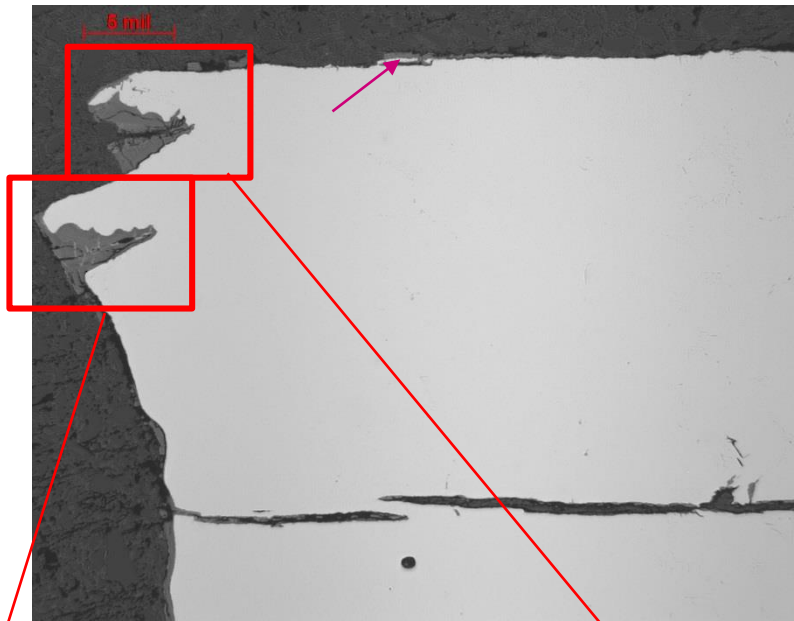
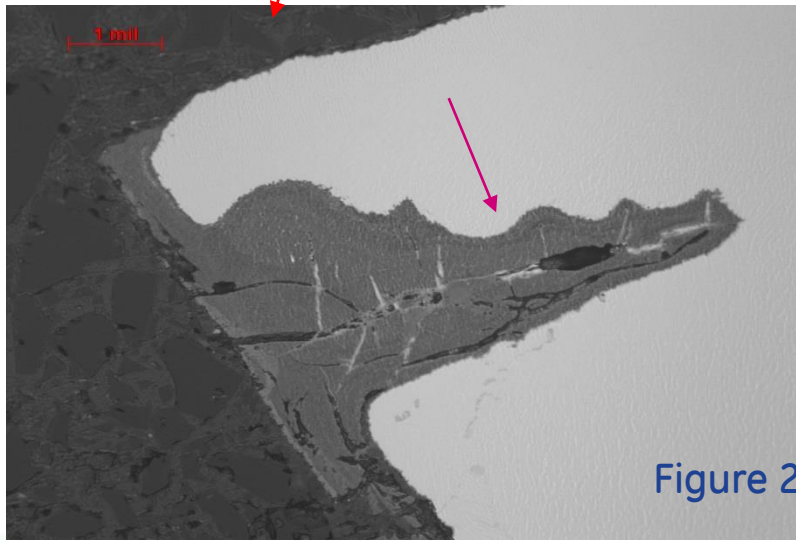
Figure 26

- Corrosion product was present on the fracture surface.
- Two “wedges” of corrosion were present just below the fracture surface. Figure 26.
- A secondary crack was present further below the fracture surface.
- Corrosion product was present in the secondary crack. Figure 27.

Corrosion product on fracture surface  
and in "wedges" below fracture  
surface.

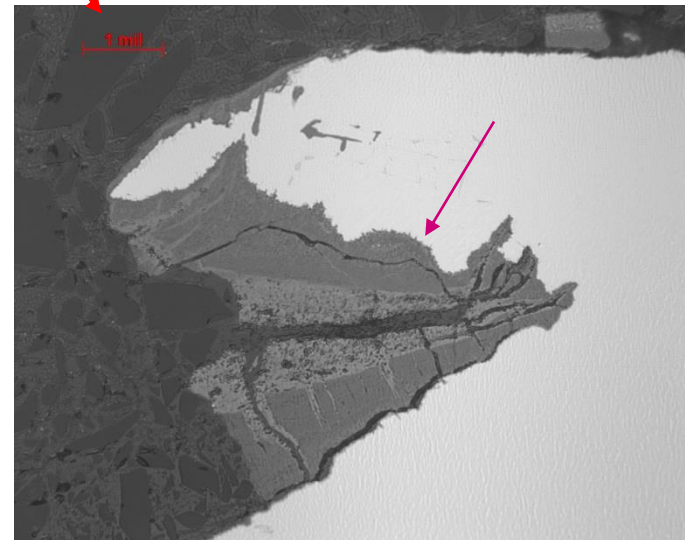
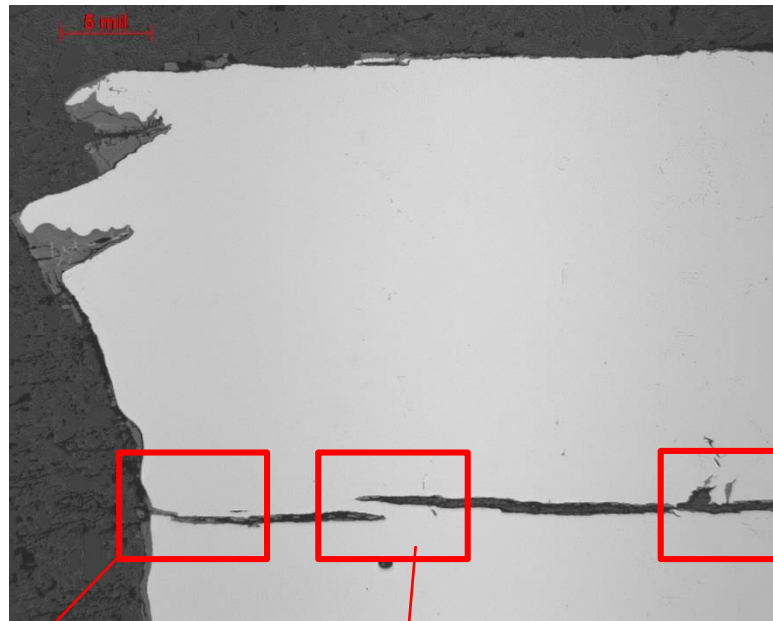
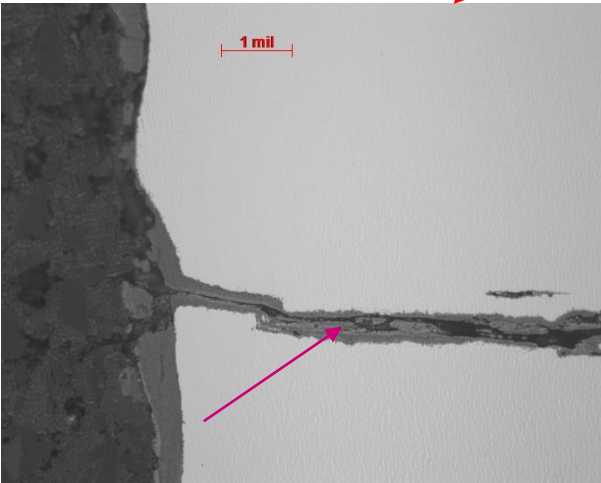
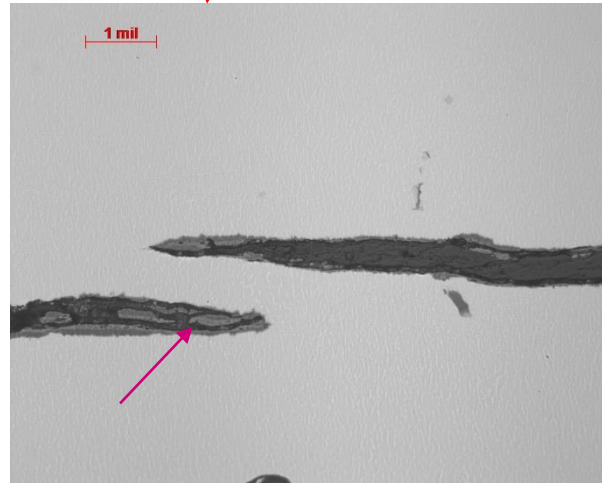
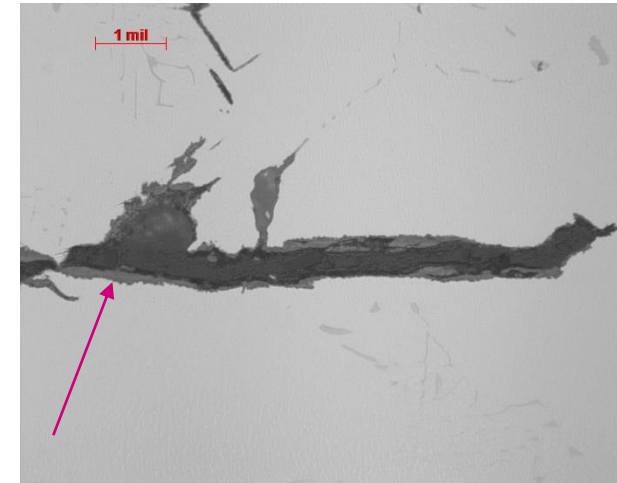
Figure 27

Corrosion product in secondary crack  
below the fracture surface.

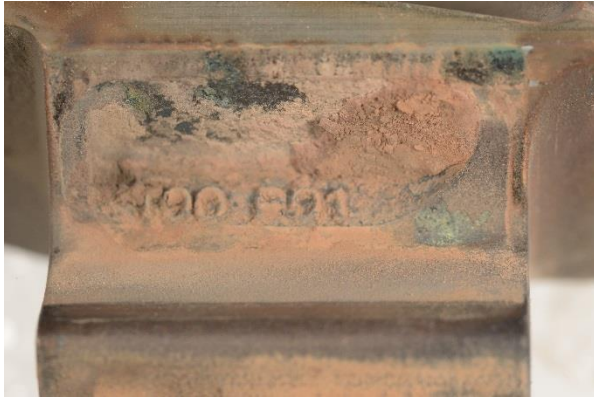
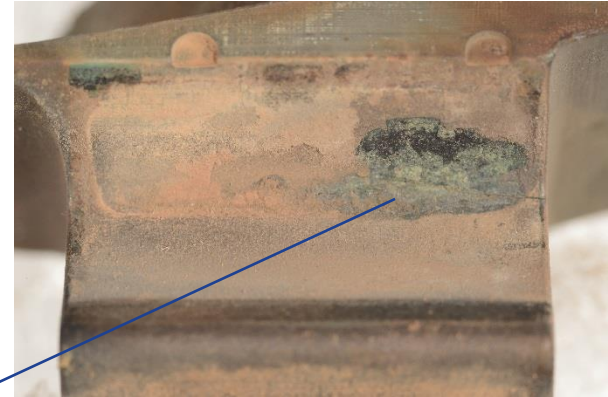
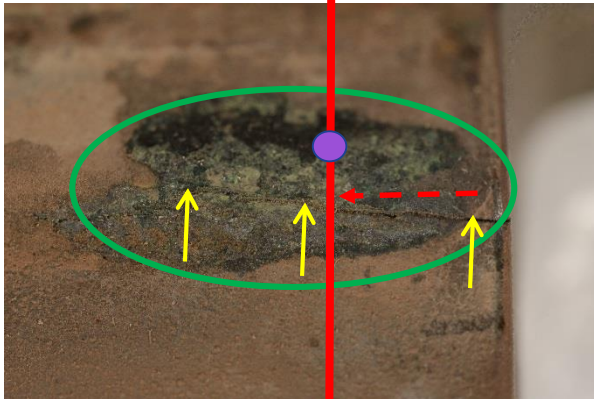
A radial section through the crack of blade #2 as marked in Figure 28 was also prepared for metallographic evaluation.

Note crack at yellow arrows through area of corrosion.

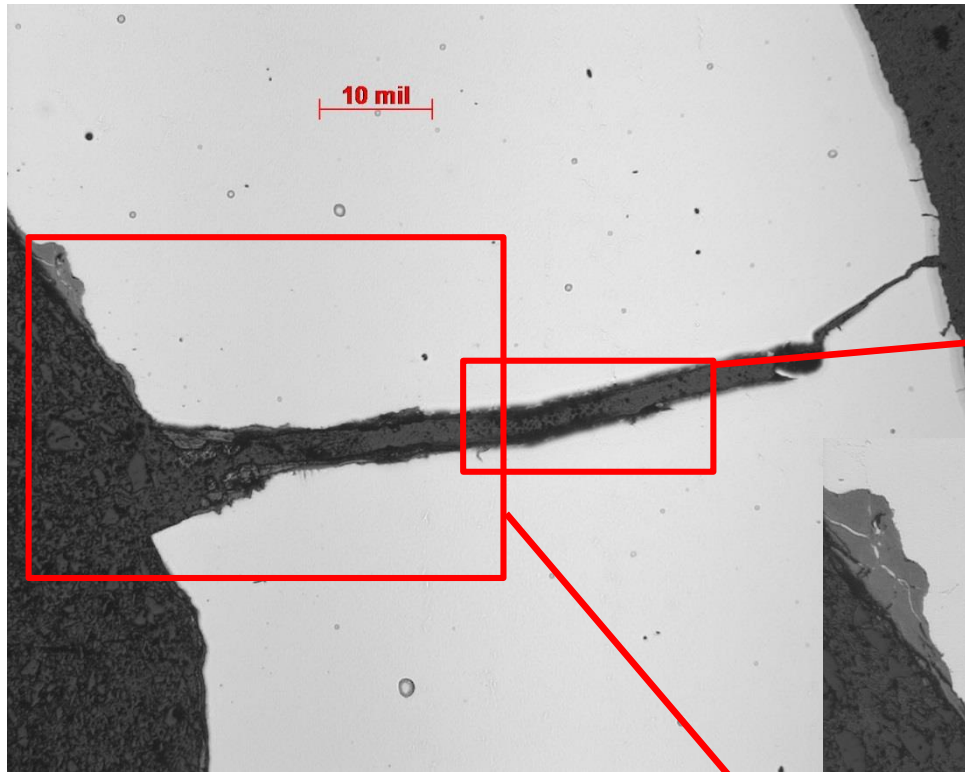
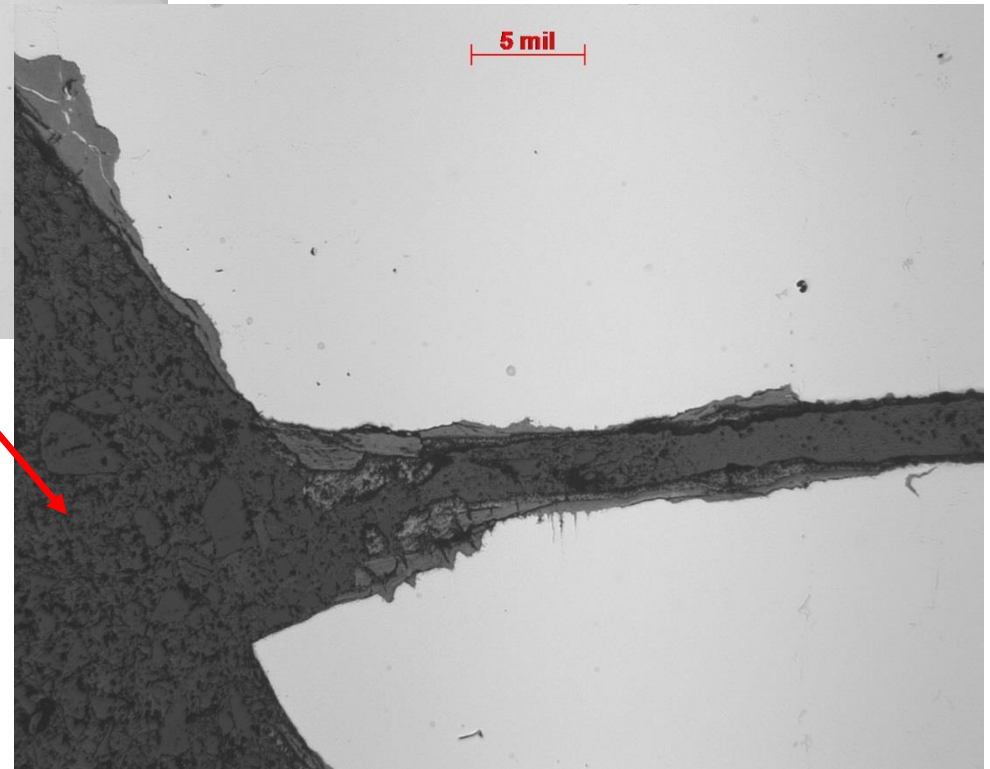
Figure 29

- Sulfides were identified to be present in the crack and on the external convex surface outward of the crack in the area of visible corrosion. Figures 29-30.
