# Metallurgical Investigation Report

## Log No. FAL2017-17956

### METALLURGICAL EVALUATION OF A CF34-8C LPT CASE FROM ESN 965-352 OPERATED BY GOJET

P/N 4117T50G02  
S/N IHI355DA

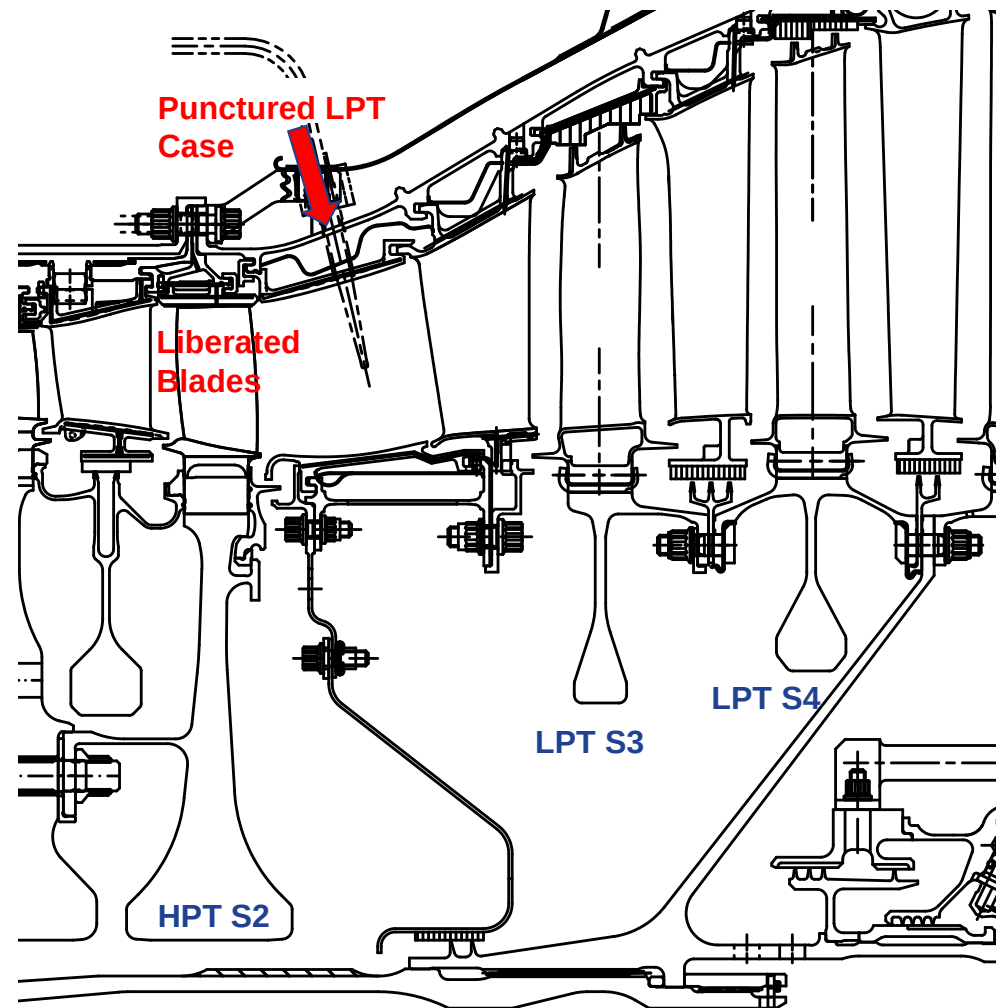
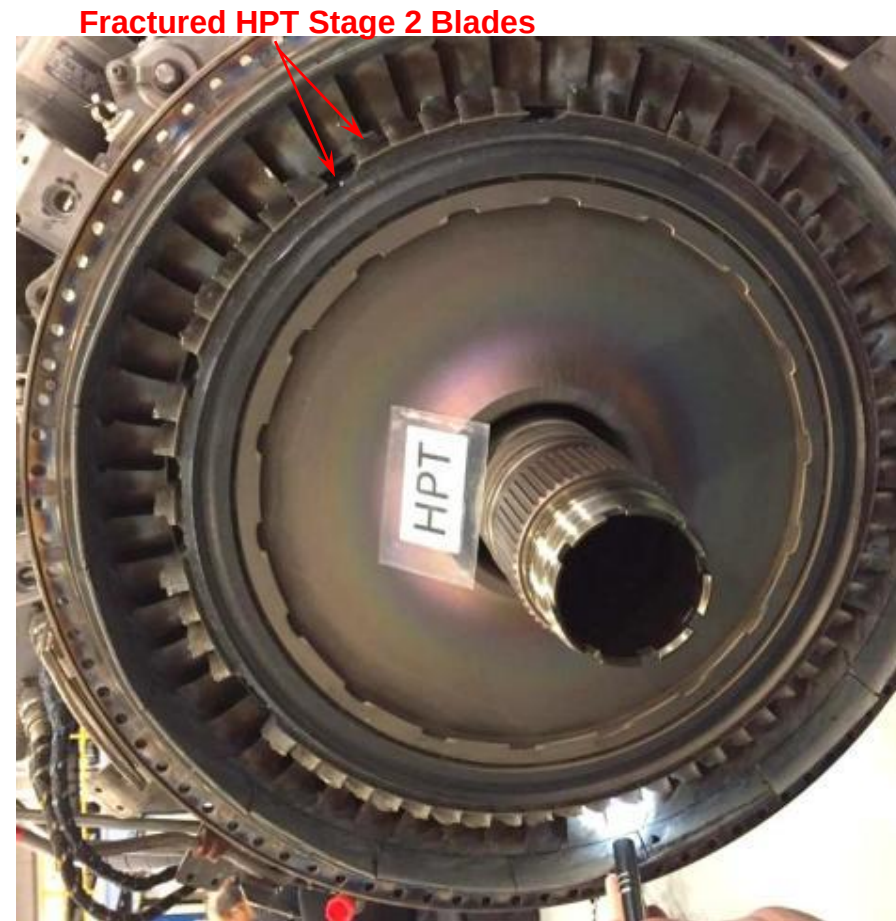
- A section of a CF34-8C LPT case (P/N 4117T50G02, S/N IHI355DA) from ESN 965-352 operated by GoJet was submitted for metallurgical evaluation after an HPT stage 2 blade liberation event, which fractured all the blades in the set (see Figure 1) and punctured the LPT case locally. During teardown all stage 2 blades were found fractured, but 7 were fractured below the platform. Reportedly the stage 2 blades are made of N5 with platinum-aluminide coating. The blades accumulated 33,207 hours / 23,814 cycles since new. Since the event was classified as “uncontained” the NTSB is involved in the investigation.

- A cross-sectional view of the turbine section showing the location of the punctured case can be seen in Figure 1, along with a view from the tear-down of the fractured HPT stage 2 blades.

**Figure 1:** Schematic of the CF34-8 turbine cross-section showing the location of the liberated HPT stage 2 blades and LPT case puncture. The right image is a view of the stage 2 blades during teardown, showing that they were all fractured (7 below the platform).

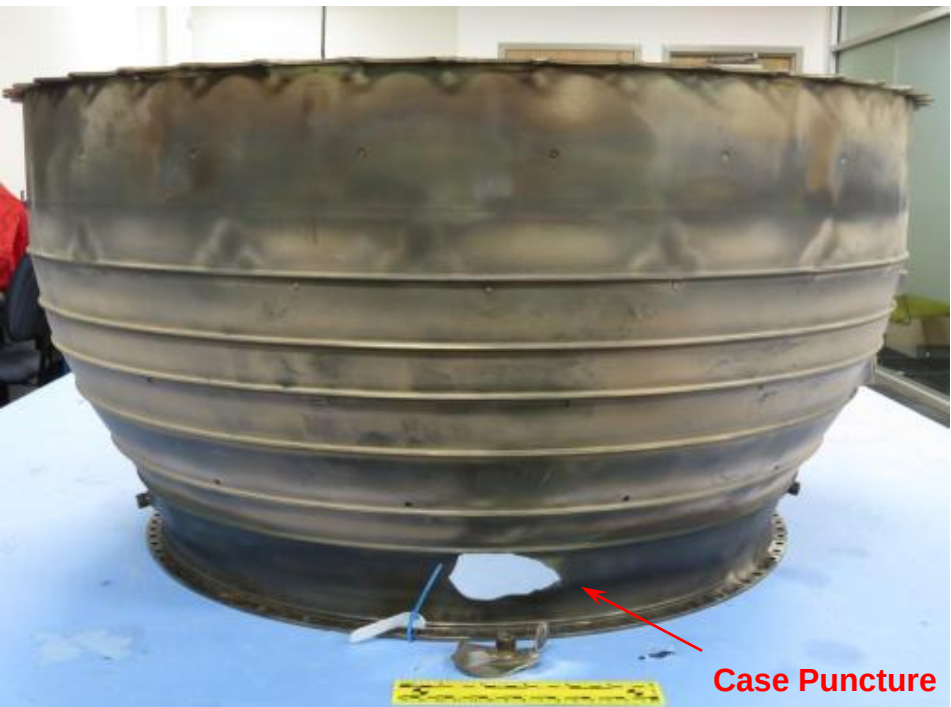
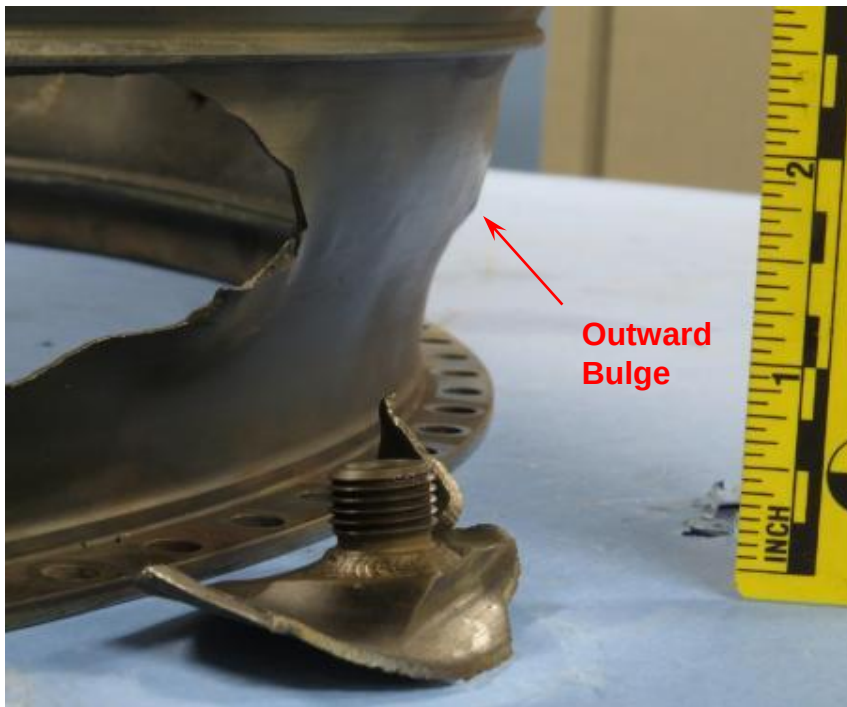
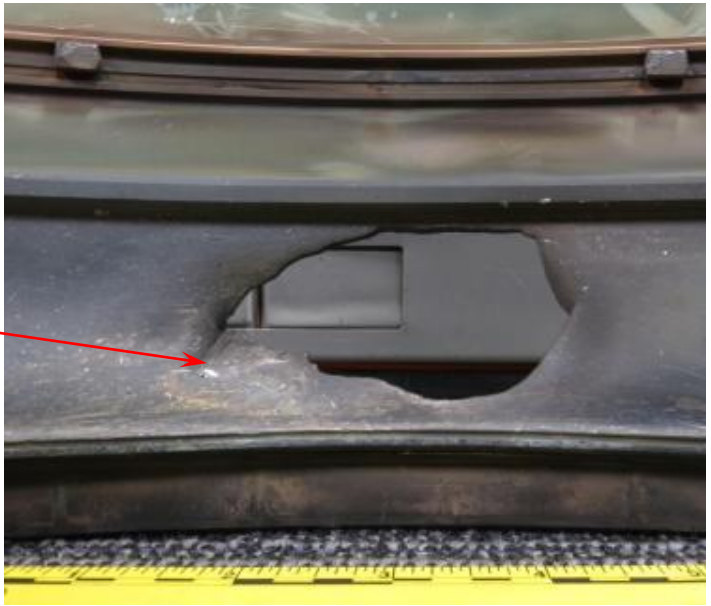
- Visual examination showed that the case had bulk outward deformation/impacts at other circumferential locations in the same plane as the puncture, but at the puncture location a more defined impact area was observed (Figure 2).

**Figure 2:** Optical views of the case inner and outer diameter surfaces showing an approximate 3 inch long puncture in a plane aft of the liberated stage 2 blades. Also visible was the bulk deformation in the same circumferential plane, consistent with a build-up/impacts from liberated debris.

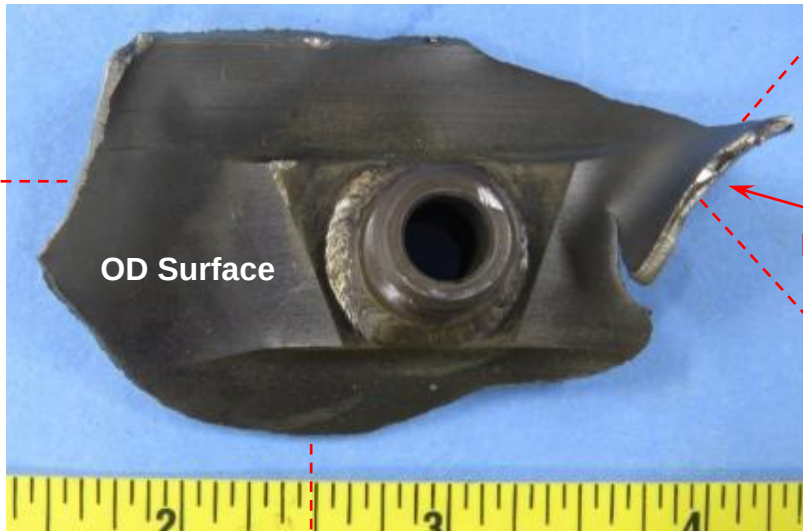
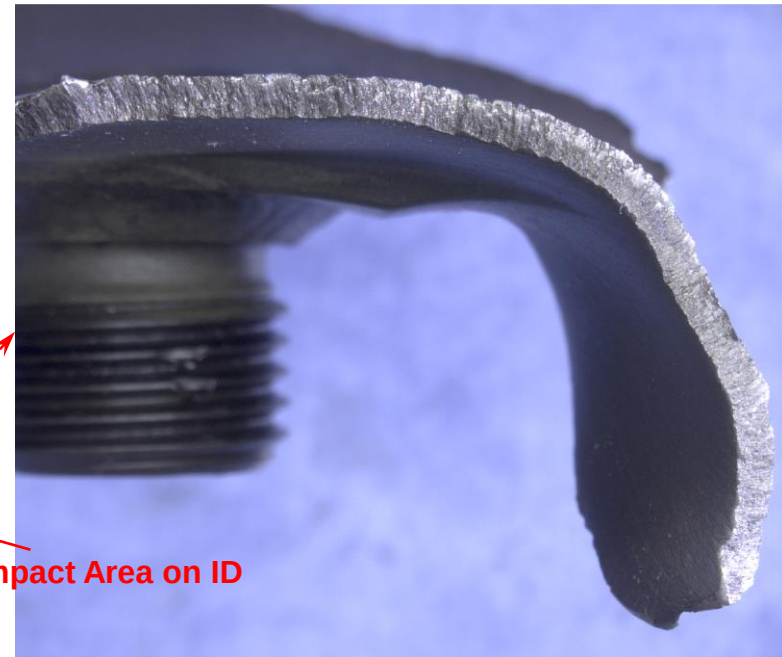
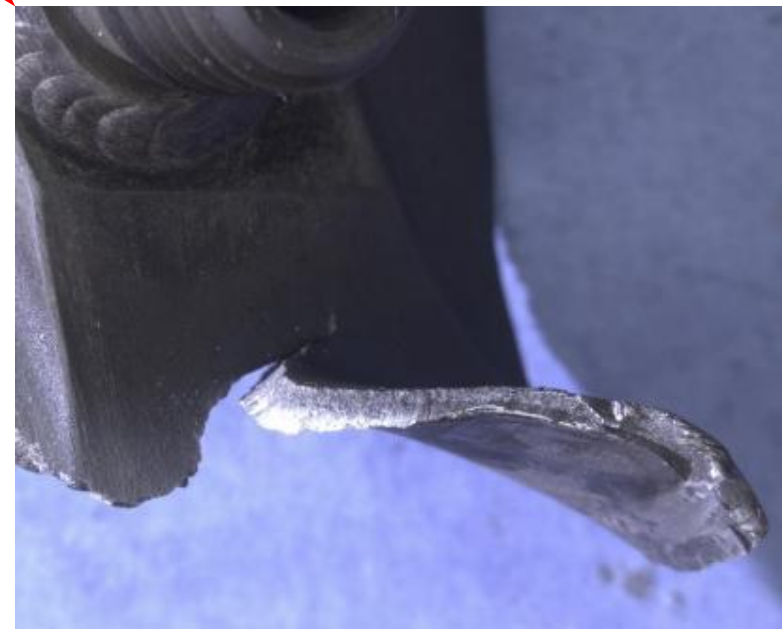
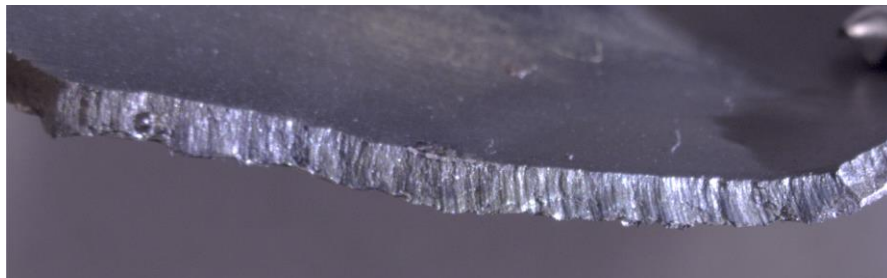
- Optical examination showed that the fracture features had bulk deformation, often fractured on slant planes, and in one area examined in the scanning electron microscope (SEM) had ductile dimples, all features consistent with event-related shear/overstress (Figures 2-4). No evidence of progressive/fatigue growth was observed.

**Figure 3:** Optical views of the fracture surfaces of the liberated piece showing bulk deformation and rough/sheared fracture features consistent with instantaneous overstress/shear fracture.

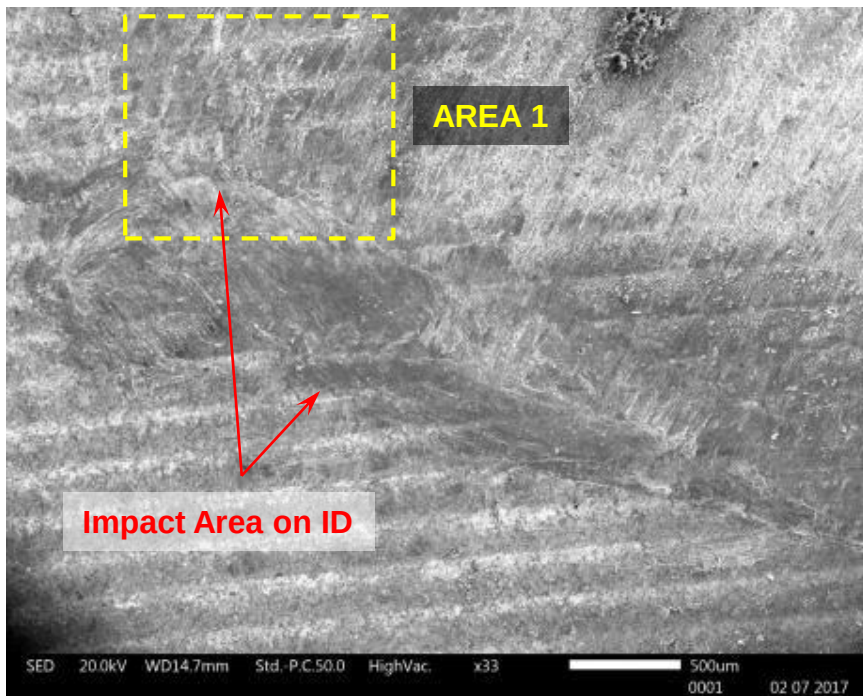
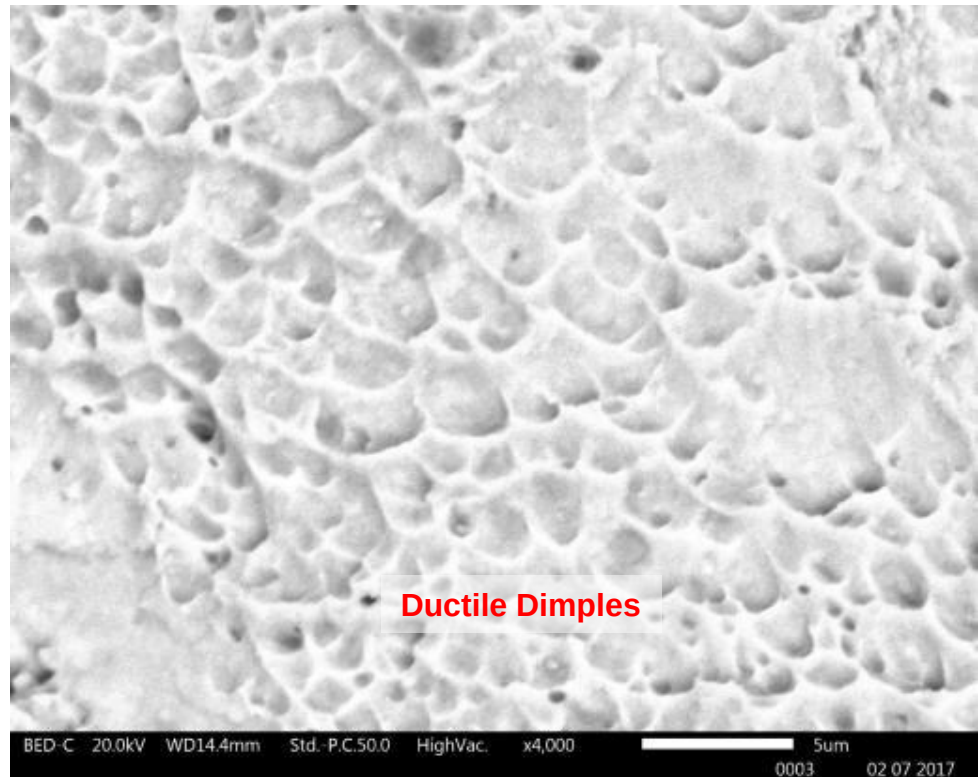
**Figure 4 :** SEM view of an impact area on the inner diameter surface that was analyzed further (top image) and a representative view of a fracture surface area showing ductile dimples, consistent with overstress (bottom image).

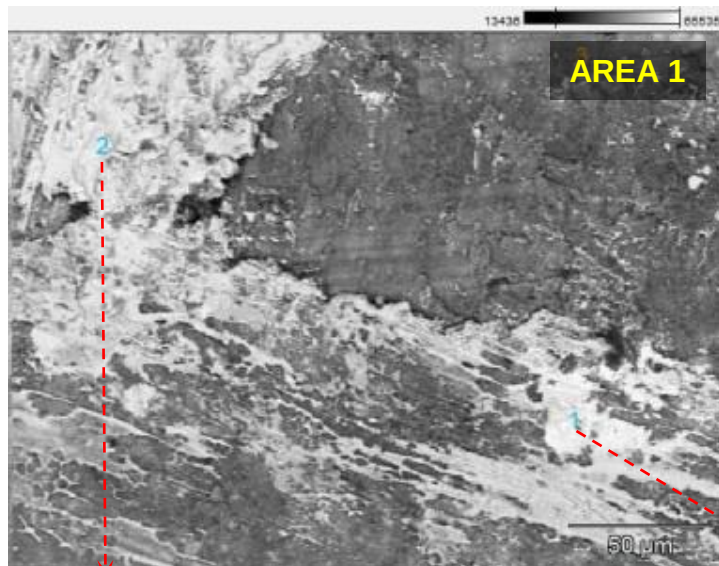
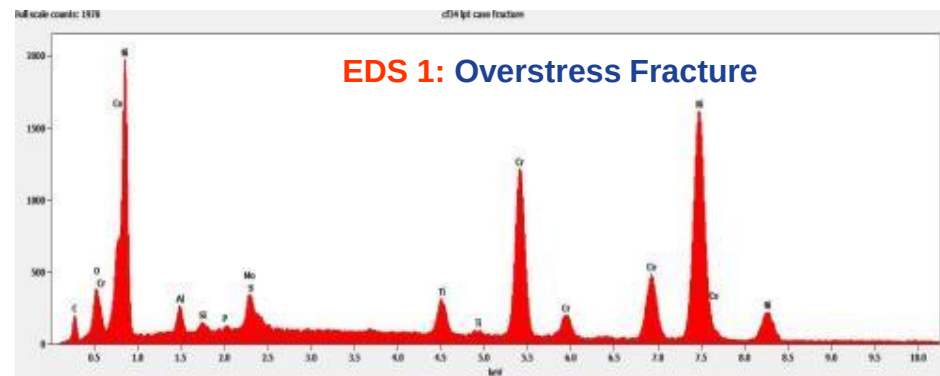
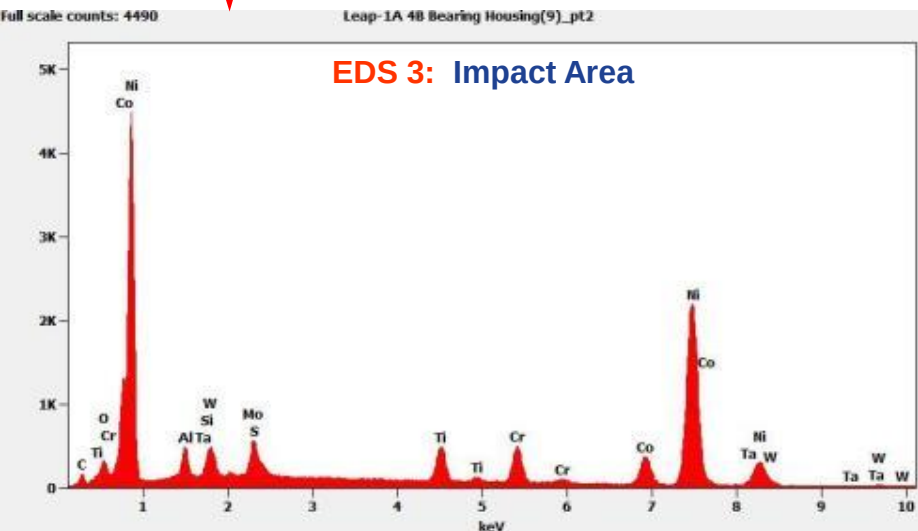
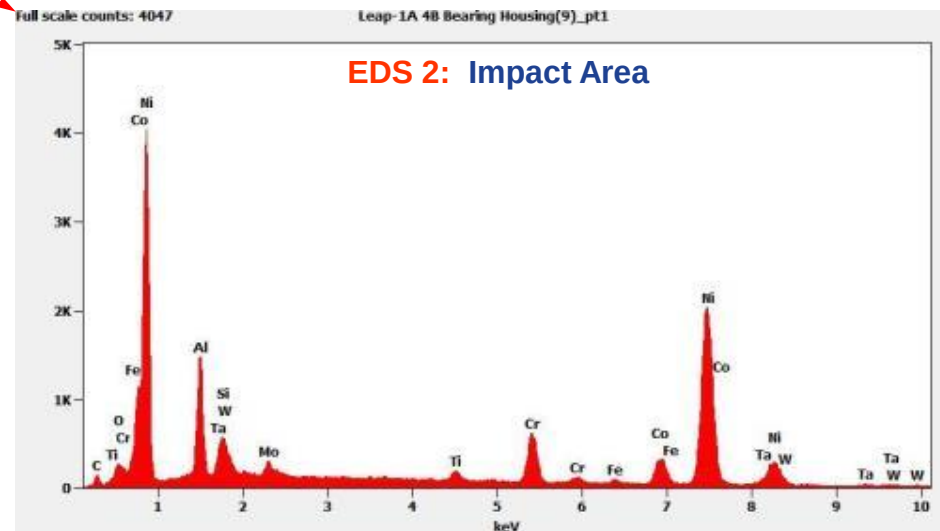
- Energy dispersive spectroscopy (EDS) analysis of the overstress showed a spectrum consistent with the requirement of Waspaloy per AMS 5707 (EDS 1). In the impacted areas was transferred debris containing altered Waspaloy peaks and Ta/W/Hf, consistent with a mixing of base alloy and liberated N5 HPT blade material (EDS 2 and 3- Figures 4 and 5).

**Figure 5 :** EDS analysis of the overstress region showed a spectrum consistent with the requirement of Waspaloy (EDS 1), with spectra taken in the impact regions showing altered peak heights and the addition of Ta/W/Hf, consistent with a mixing of base metal and liberated N5 HPT blade material (EDS 2 and 3).

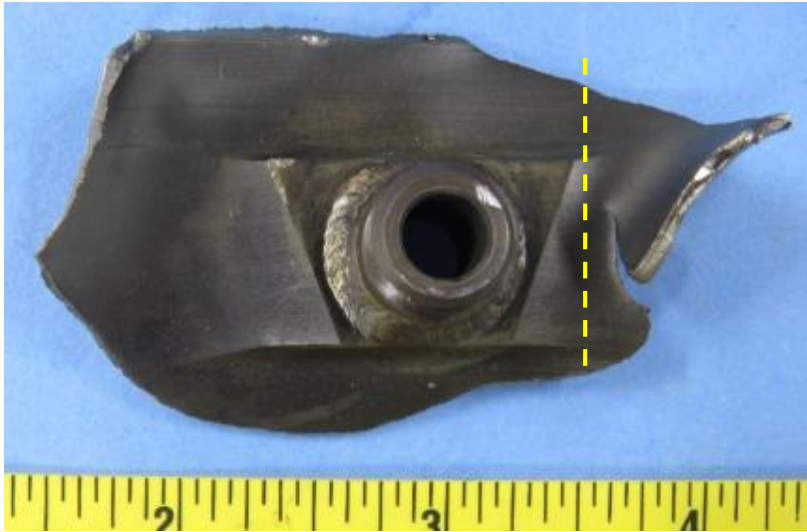
- A metallographic mount showed a wrought microstructure consistent with properly processed Waspaloy with an average grain size of approximately ASTM 5, conforming to the requirement of AMS 5707.

**Figure 6 :** A cross-sectional metallographic mount was made near the impact area showing a wrought structure with an average grain size of approximately ASTM 5, conforming to the requirement of AMS 5707. At the fracture (lower left) the wall was distorted and the grains were locally deformed consistent with a shear region.
