# NATIONAL TRANSPORTATION SAFETY BOARD

MATERIALS LABORATORY FACTUAL REPORT

Report No. 17-039

Place : Baltimore, Maryland  
Date : January 23, 2017  
Vehicle : Bombardier CRJ200, N8986B  
NTSB No. : ENG17IA008  
Investigator : Robert Hunsberger, AS-40

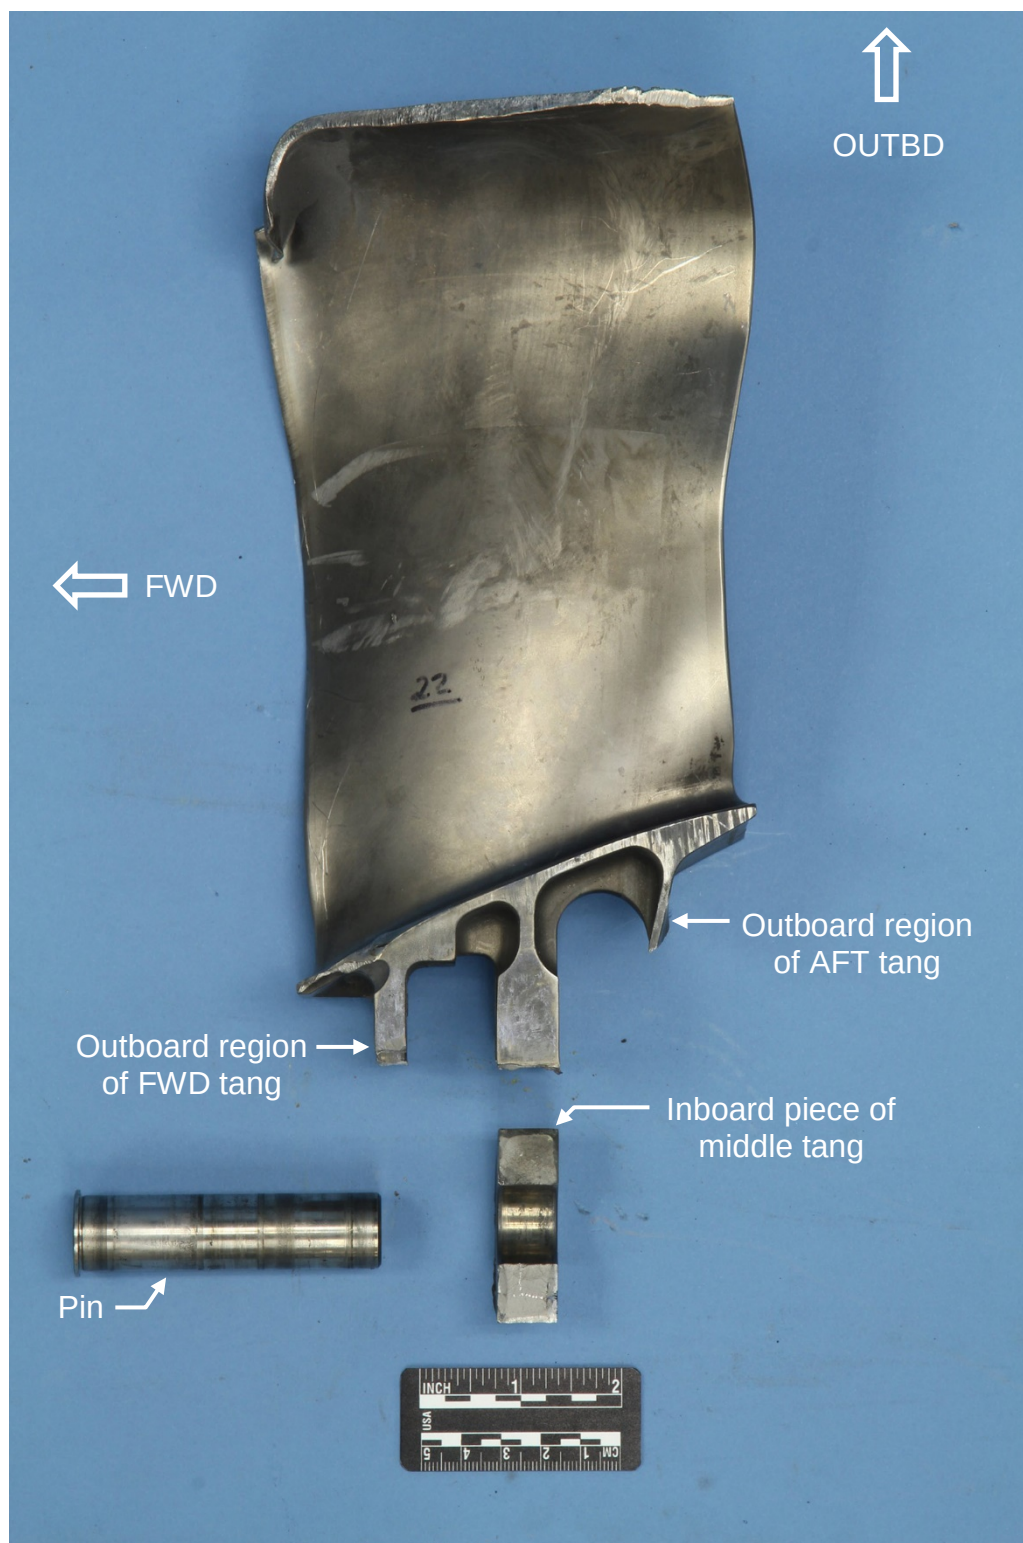
**Figure 1:** The outboard portion of the fan blade, inboard portion of the middle tang, and the retention pin, as received.

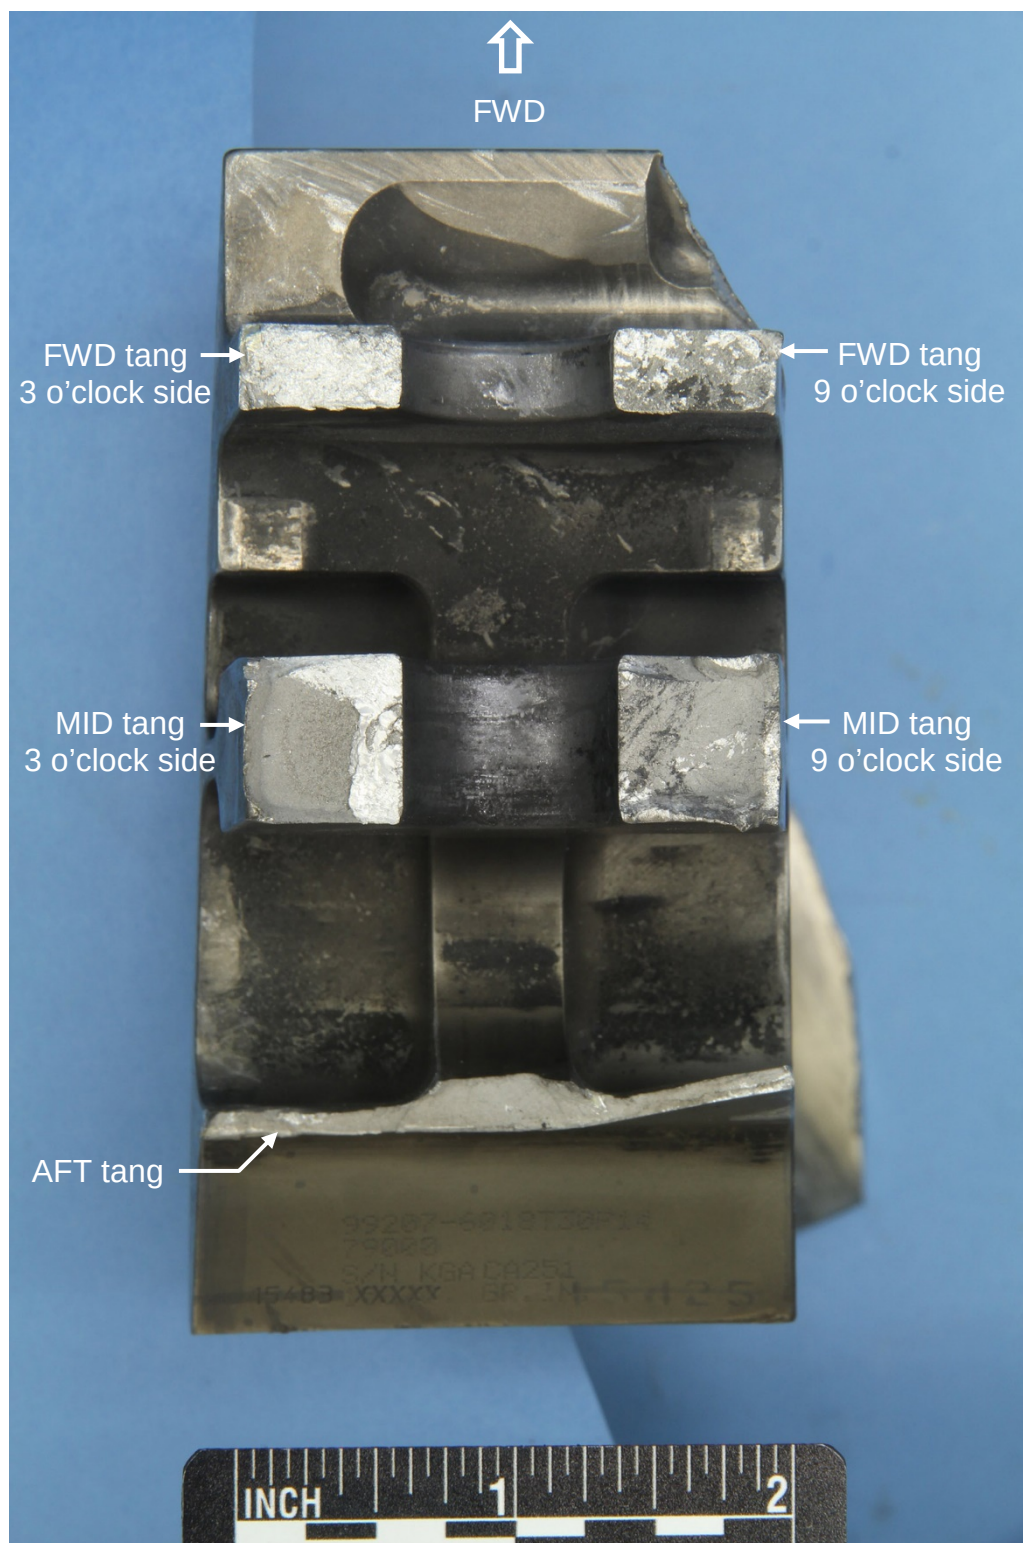
The CF34-3B1 fan blade has three tangs below the platform with a hole in the center of each tang to accommodate insertion of a retention pin. The retention pin also inserts through holes on the rim of the fan disk, thereby coupling the blades to the disk. On the accident fan blade, the forward and middle tangs were fractured through the pin holes at approximately the 3 o'clock and 9 o'clock positions, while the aft tang was fractured radially outboard of the pin hole, but below the platform, as shown in figures 1 – 3.<sup>2</sup> The forward tang fracture surfaces were generally oriented in the axial/circumferential plane and exhibited smeared metal deposits that were identified as aluminum using x-ray fluorescence spectroscopy. The middle tang fracture surfaces exhibited a similar appearance with the addition of 45° shear lips that were observed along the forward, aft, and outer edges of both the 3 o'clock and 9 o'clock positions. The aft tang exhibited torsion deformation and a 45° inclined fracture surface that was consistent with a ductile overstress fracture. The forward and aft faces of the tangs exhibited a dimpled appearance, consistent with applied shot peening. The pin hole surfaces adjacent to the fractures occasionally exhibited a burnished appearance consistent with pin contact.

**Figure 2:** Image of the fractured fan blade tangs viewed looking radially outward. Smeared aluminum deposits were observed on the forward and middle tangs.

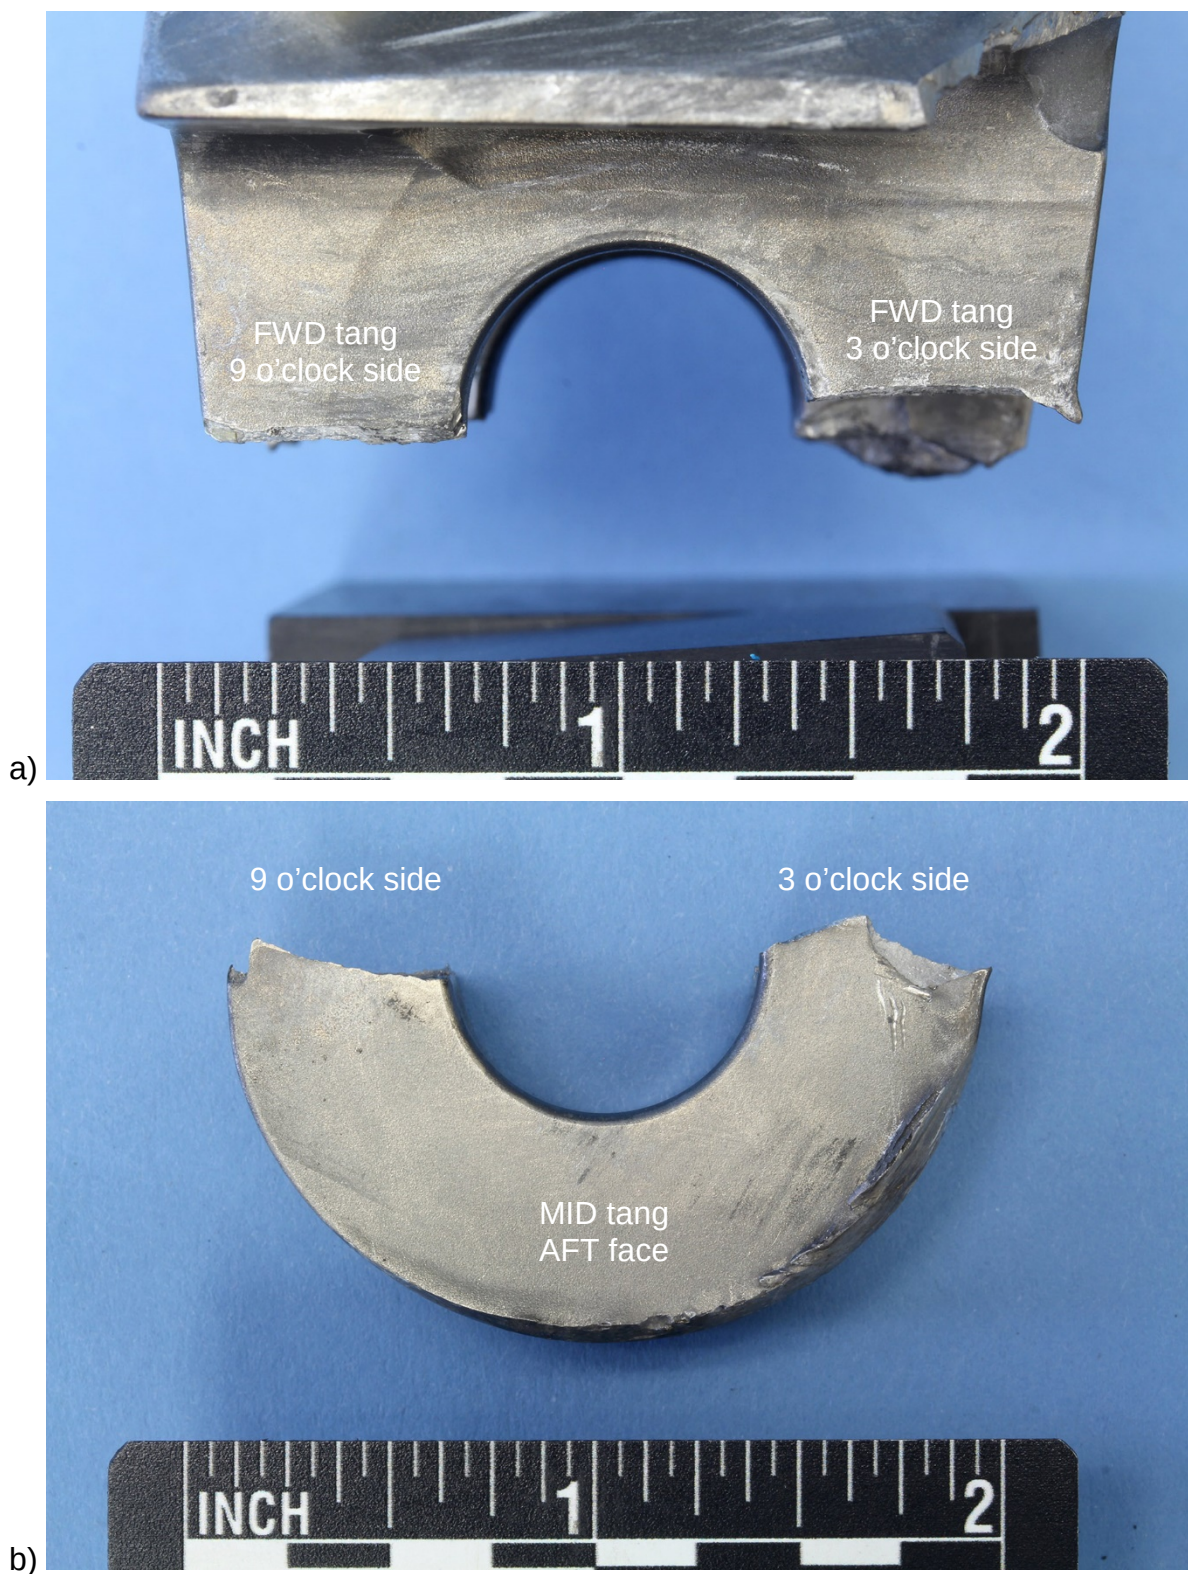
**Figure 3:** a) Image of the outboard portion of the fractured forward tang, viewed forward looking aft and b) image of the inboard portion of the fractured middle tang, viewed aft looking forward.

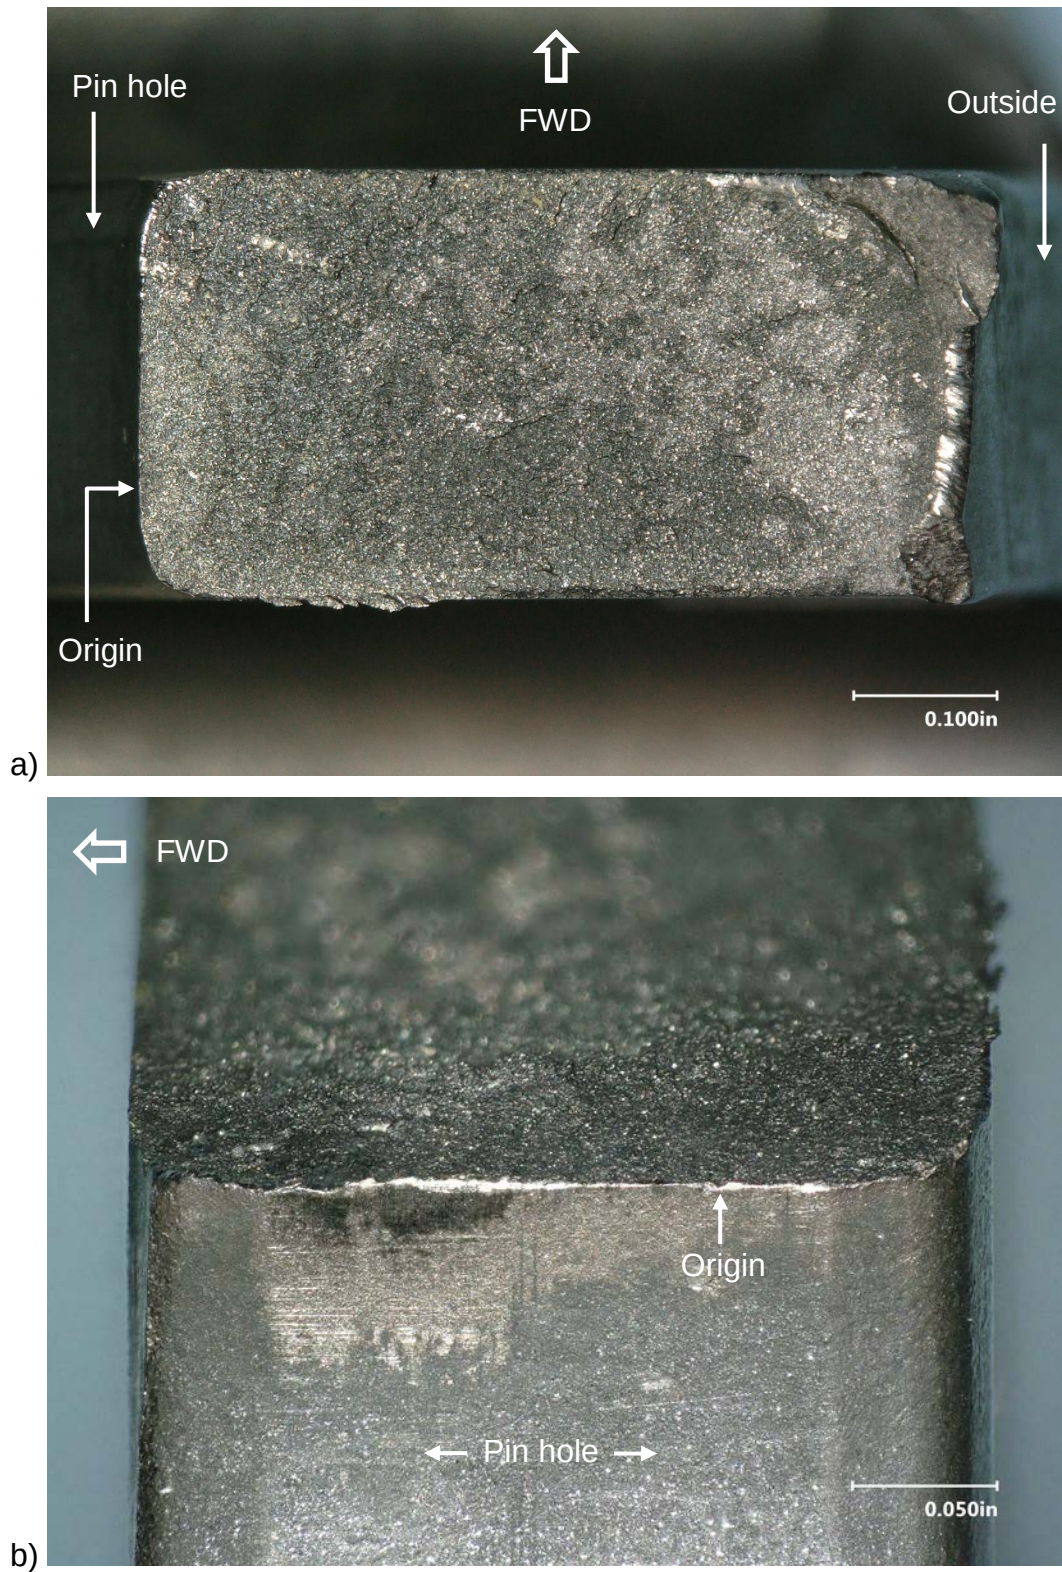
All of the fracture surfaces exhibited curved crack arrest lines near the pin hole surface that were consistent with crack initiation at the pin hole. The arrest lines at the forward tang 9 o'clock position originated from a single origin located approximately 0.090 inch from the aft face of the tang. In contrast, at the other positions (figures 5 – 7), ratchet marks were observed along the pin hole edge, consistent with multiple initiation sites.

**Figure 4:** Images of the forward tang 9 o'clock position fracture surface after cleaning: a) image of the fracture surface, viewed looking radially outward and b) inclined view showing the intersection of the fracture with the pin hole.

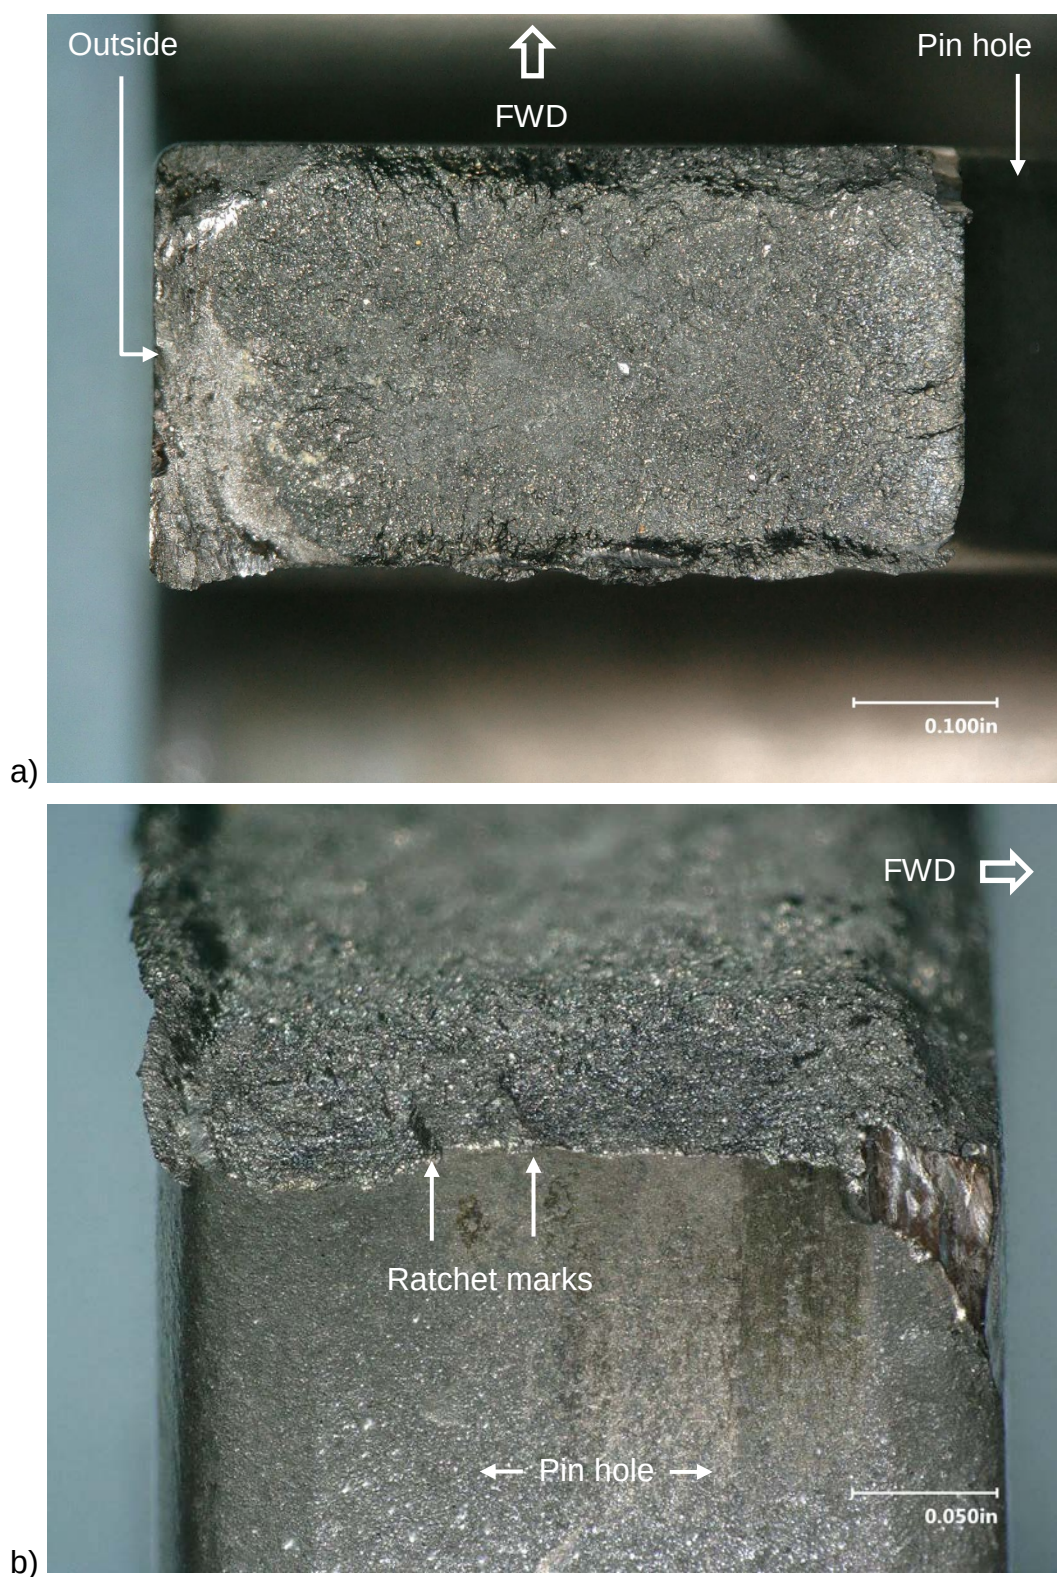
**Figure 5:** Images of the forward tang 3 o'clock position fracture surface after cleaning: a) image of the fracture surface, viewed looking radially outward and b) inclined view showing the intersection of the fracture with the pin hole.

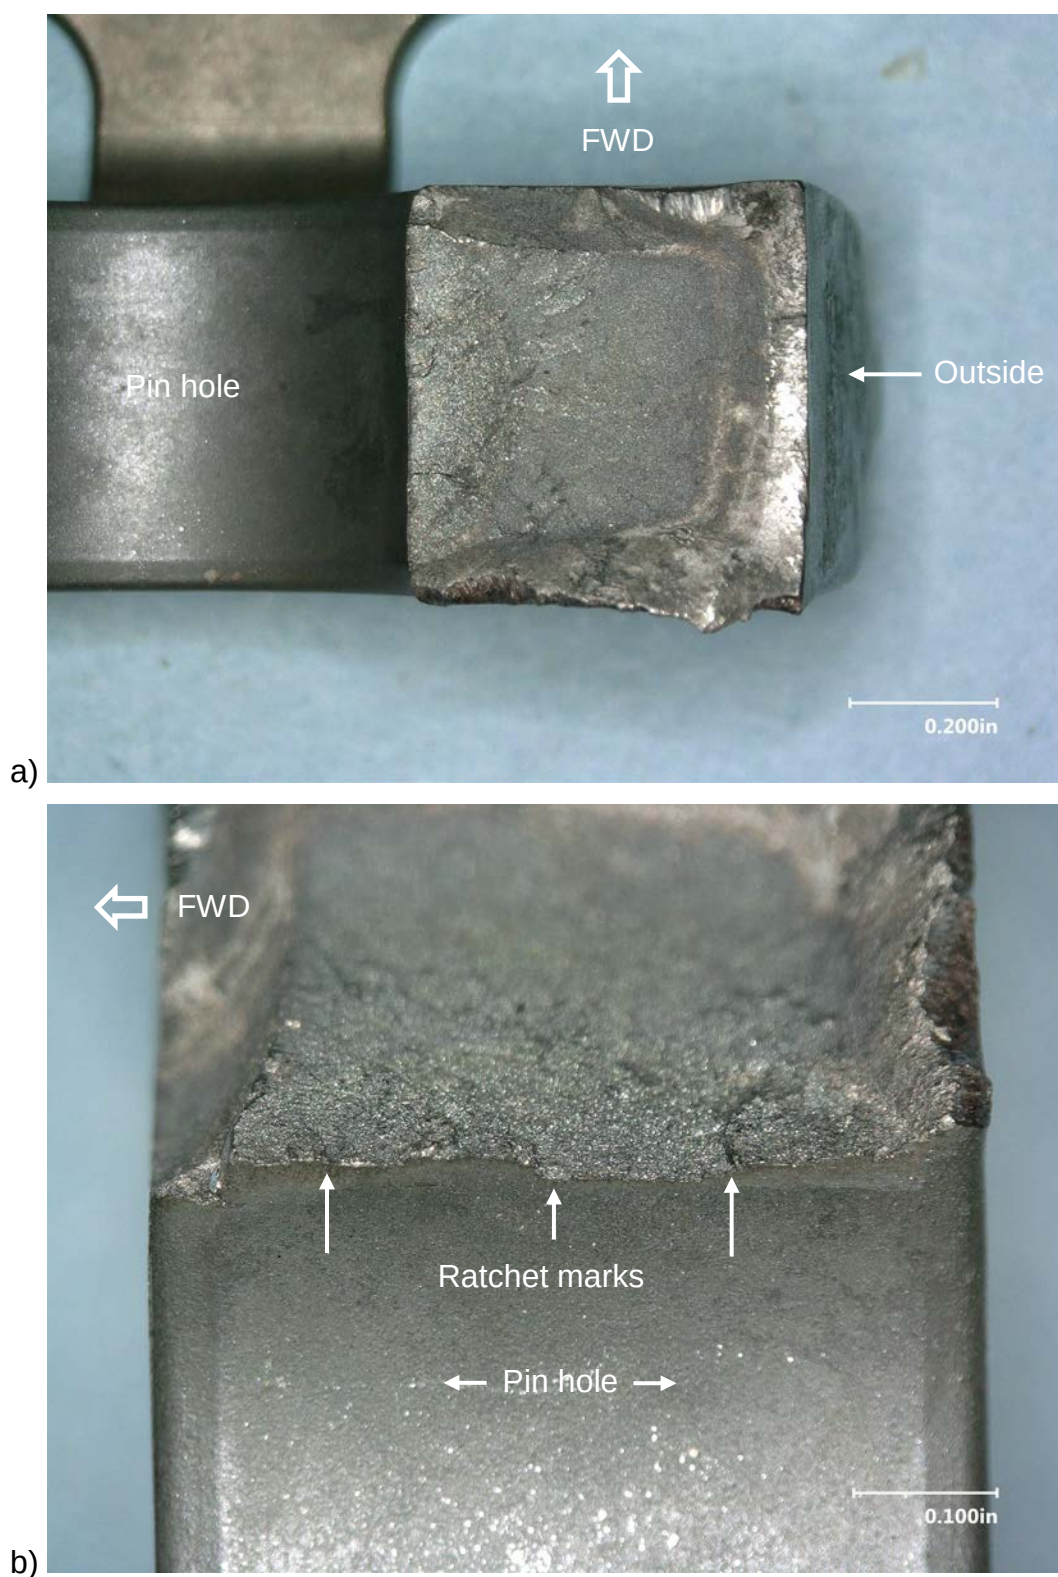
**Figure 6:** Images of the middle tang 9 o'clock position fracture surface after cleaning: a) image of the fracture surface, viewed looking radially outward and b) inclined view showing the intersection of the fracture with the pin hole.

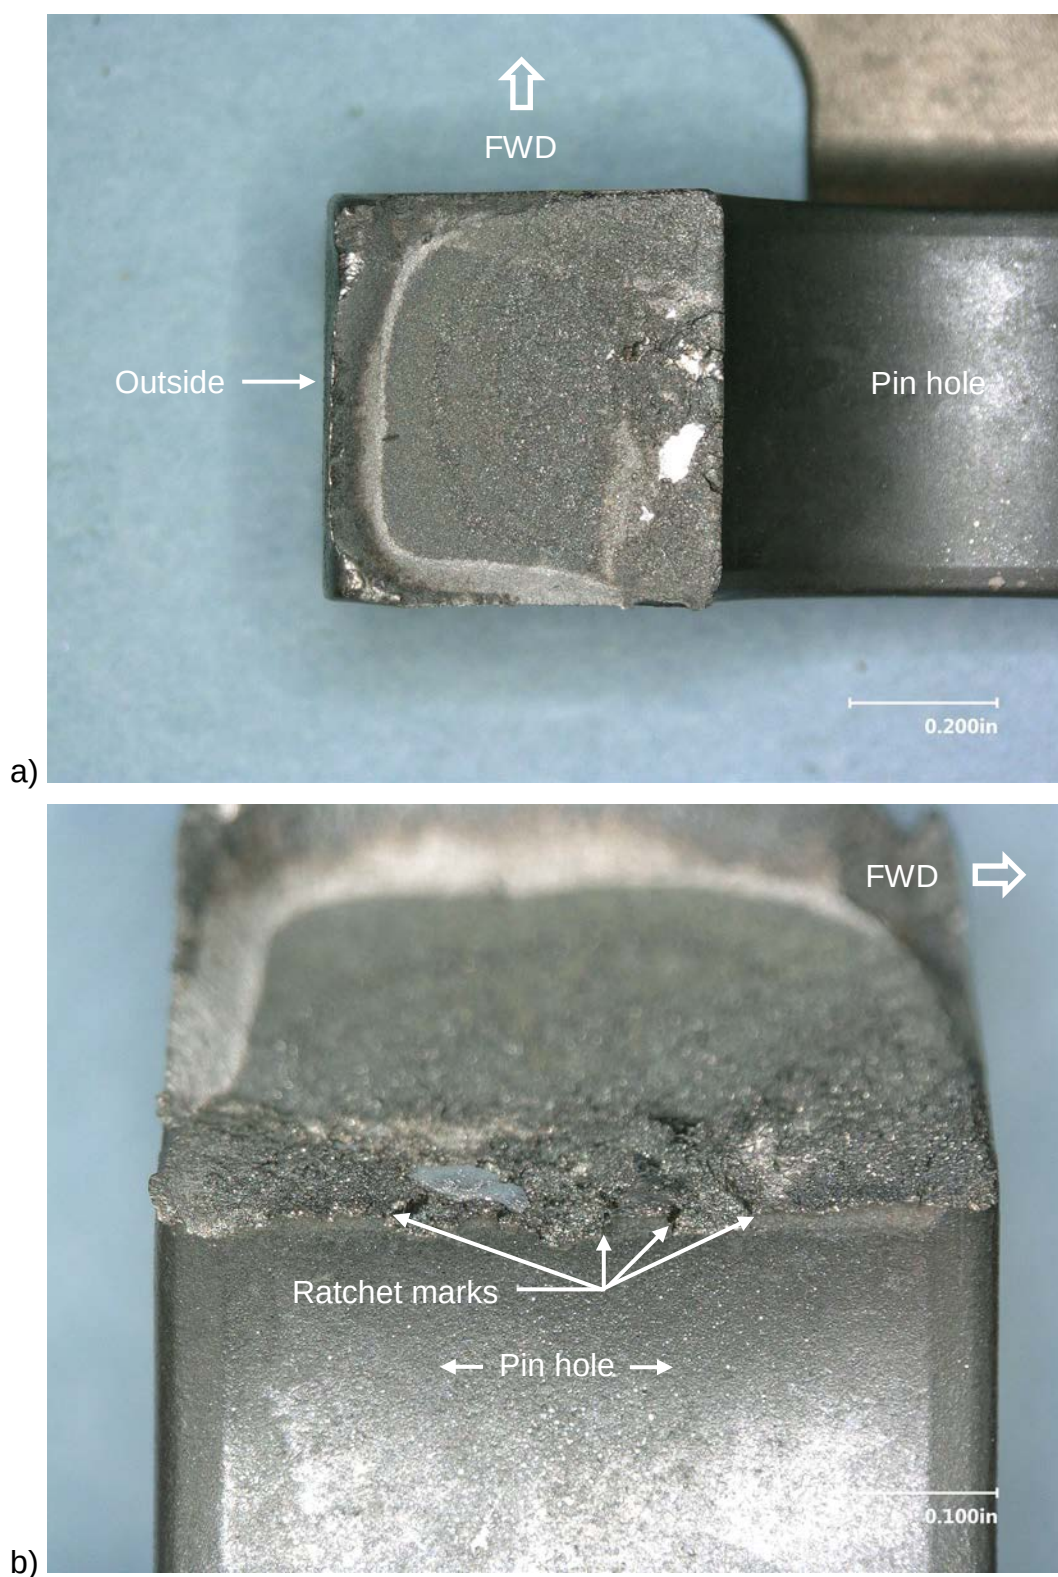
**Figure 7:** Images of the middle tang 3 o'clock position fracture surface after cleaning: a) image of the fracture surface, viewed looking radially outward and b) inclined view showing the intersection of the fracture with the pin hole.

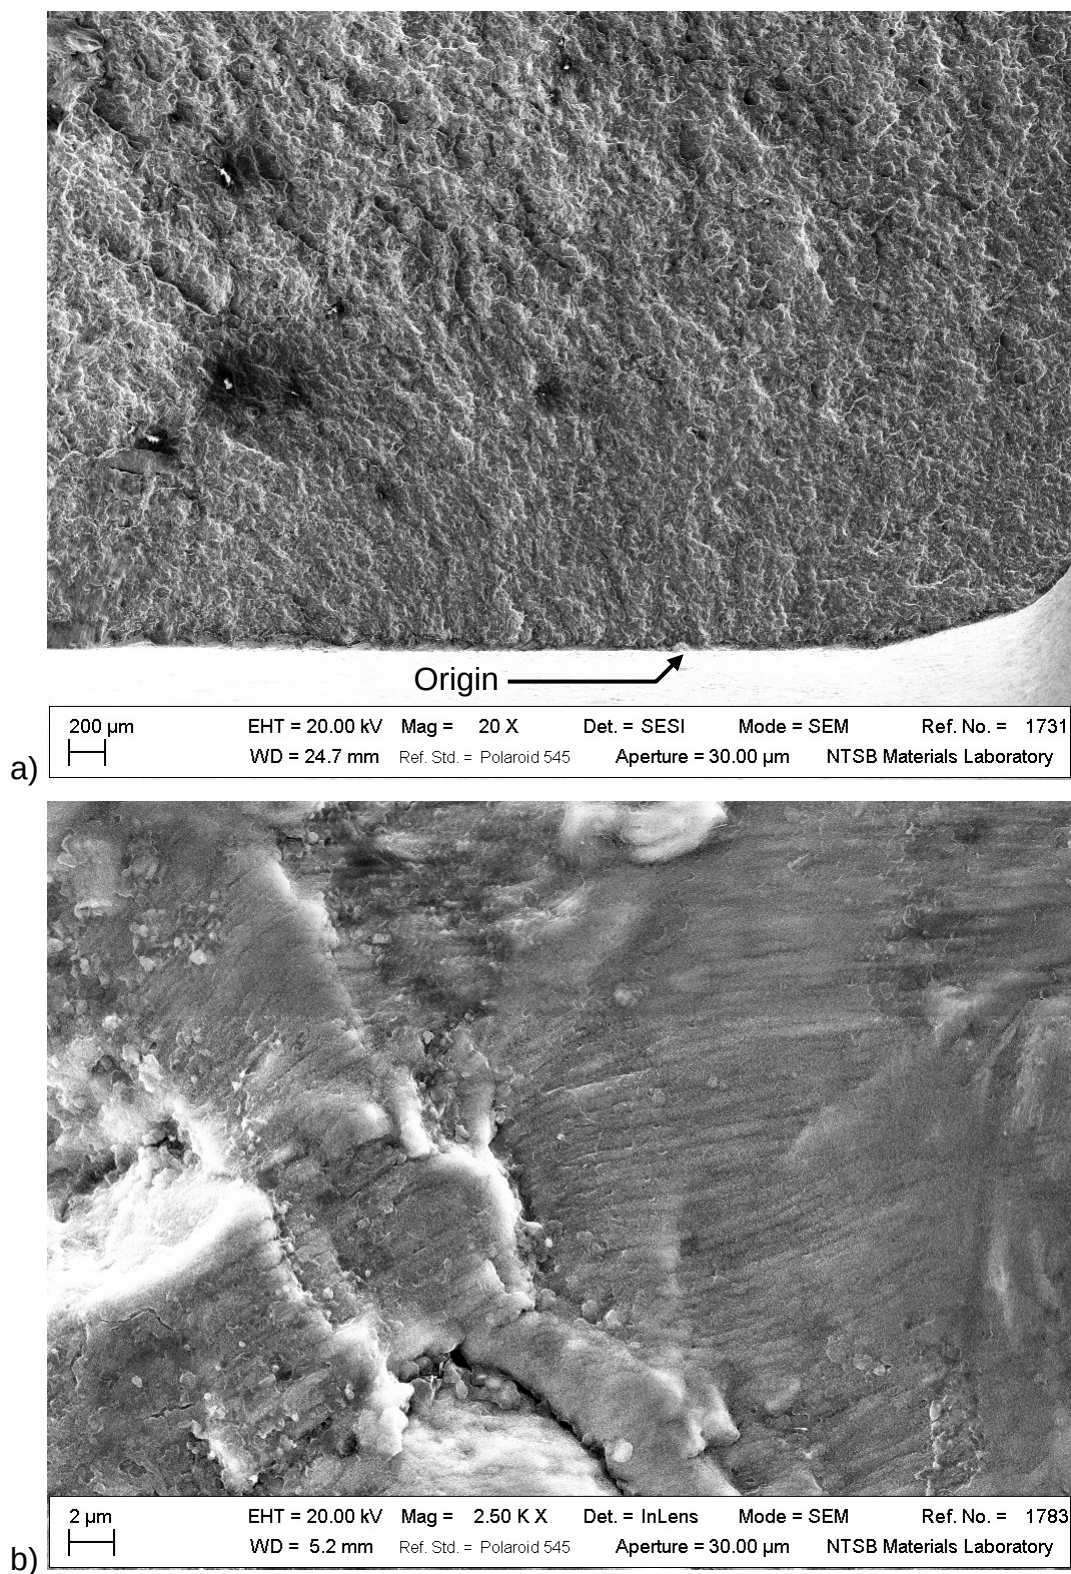
The forward and middle tang fracture surfaces were examined by SEM. Each fracture surface exhibited regularly spaced striated features close to the pin hole surface that progressed away from the hole and toward the outer edge at their respective position, consistent with low cycle fatigue (LCF) (see figure 8 for an example of striations observed on the forward tang 9 o'clock position fracture surface). At increasing distance from the pin hole, the fracture surfaces transitioned to a smeared appearance where striations

**Figure 8:** Scanning electron microscope images of the forward tang 9 o'clock position fracture surface: a) Image of the origin area and b) image taken 0.023 inch from the pin hole surface showing fatigue striations.

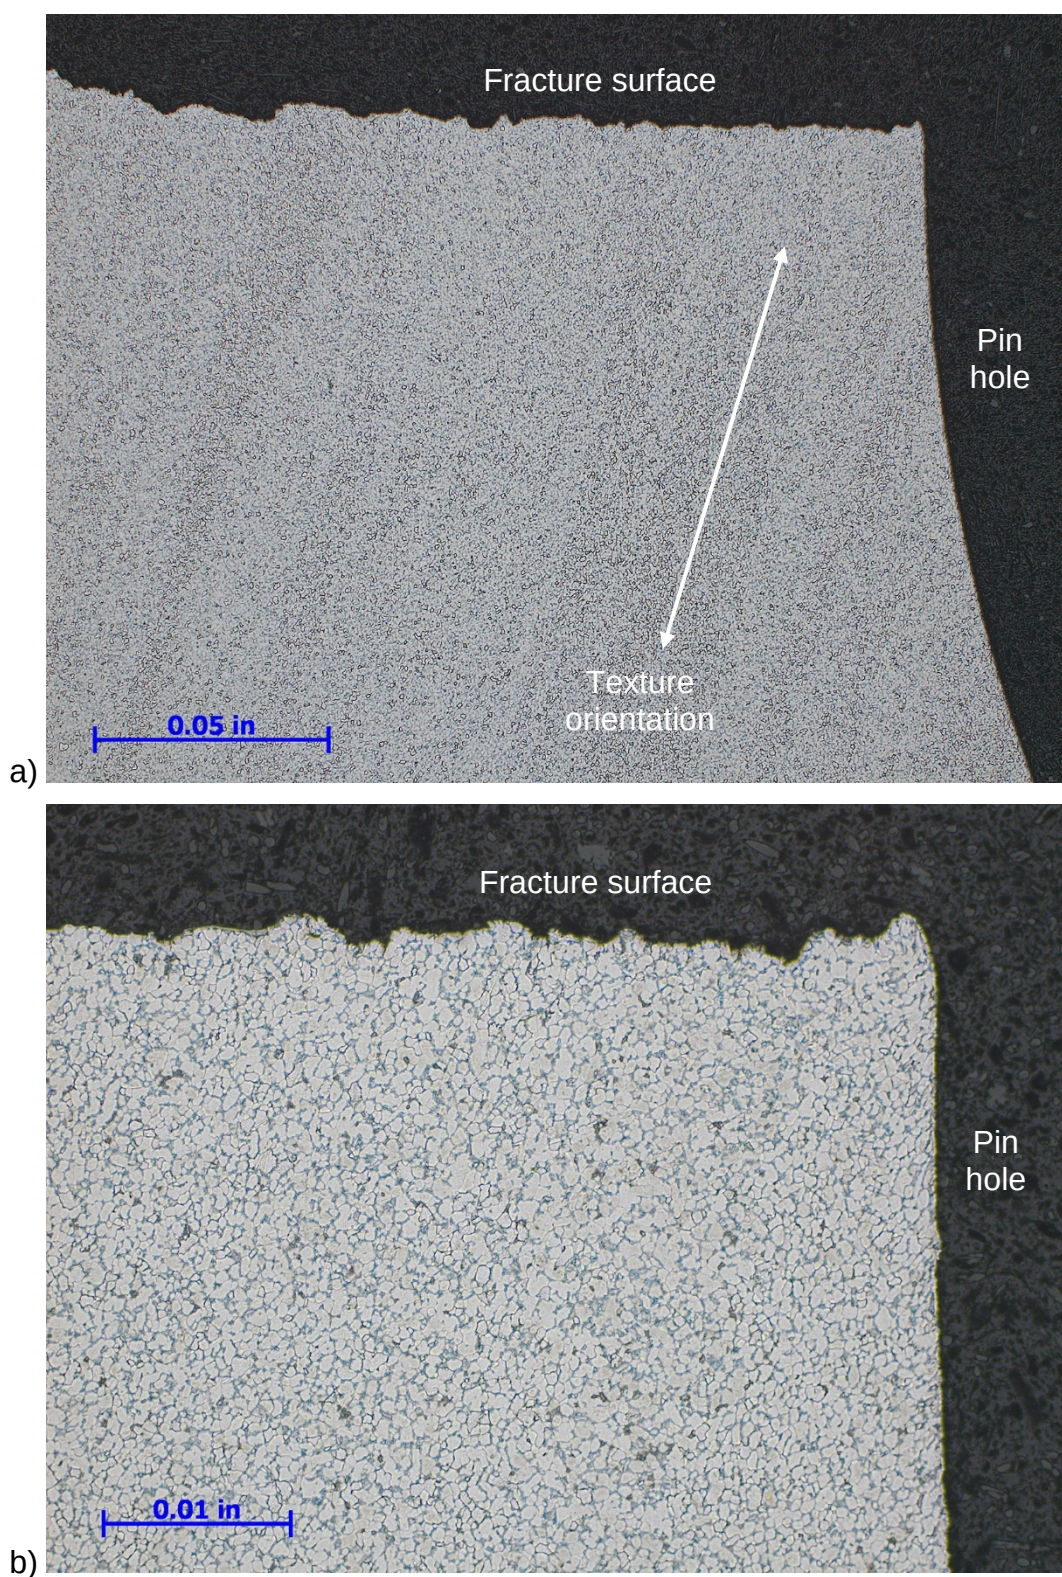
1. There was visually apparent microstructural texture at the forward tang 9 o'clock position as indicated in figure 9a;
2. There was one apparent surface crack at the middle tang 9 o'clock position pin hole as indicated in figure 11a;
3. There were multiple surface cracks at the middle tang 3 o'clock position pin hole as indicated in figure 12a;

**Figure 9:** Polished and etched metallographic cross sections at the forward tang 9 o'clock position (Kroll's reagent): a) 25X objective image showing texture orientation and b) 100X objective image showing material condition along pin hole.

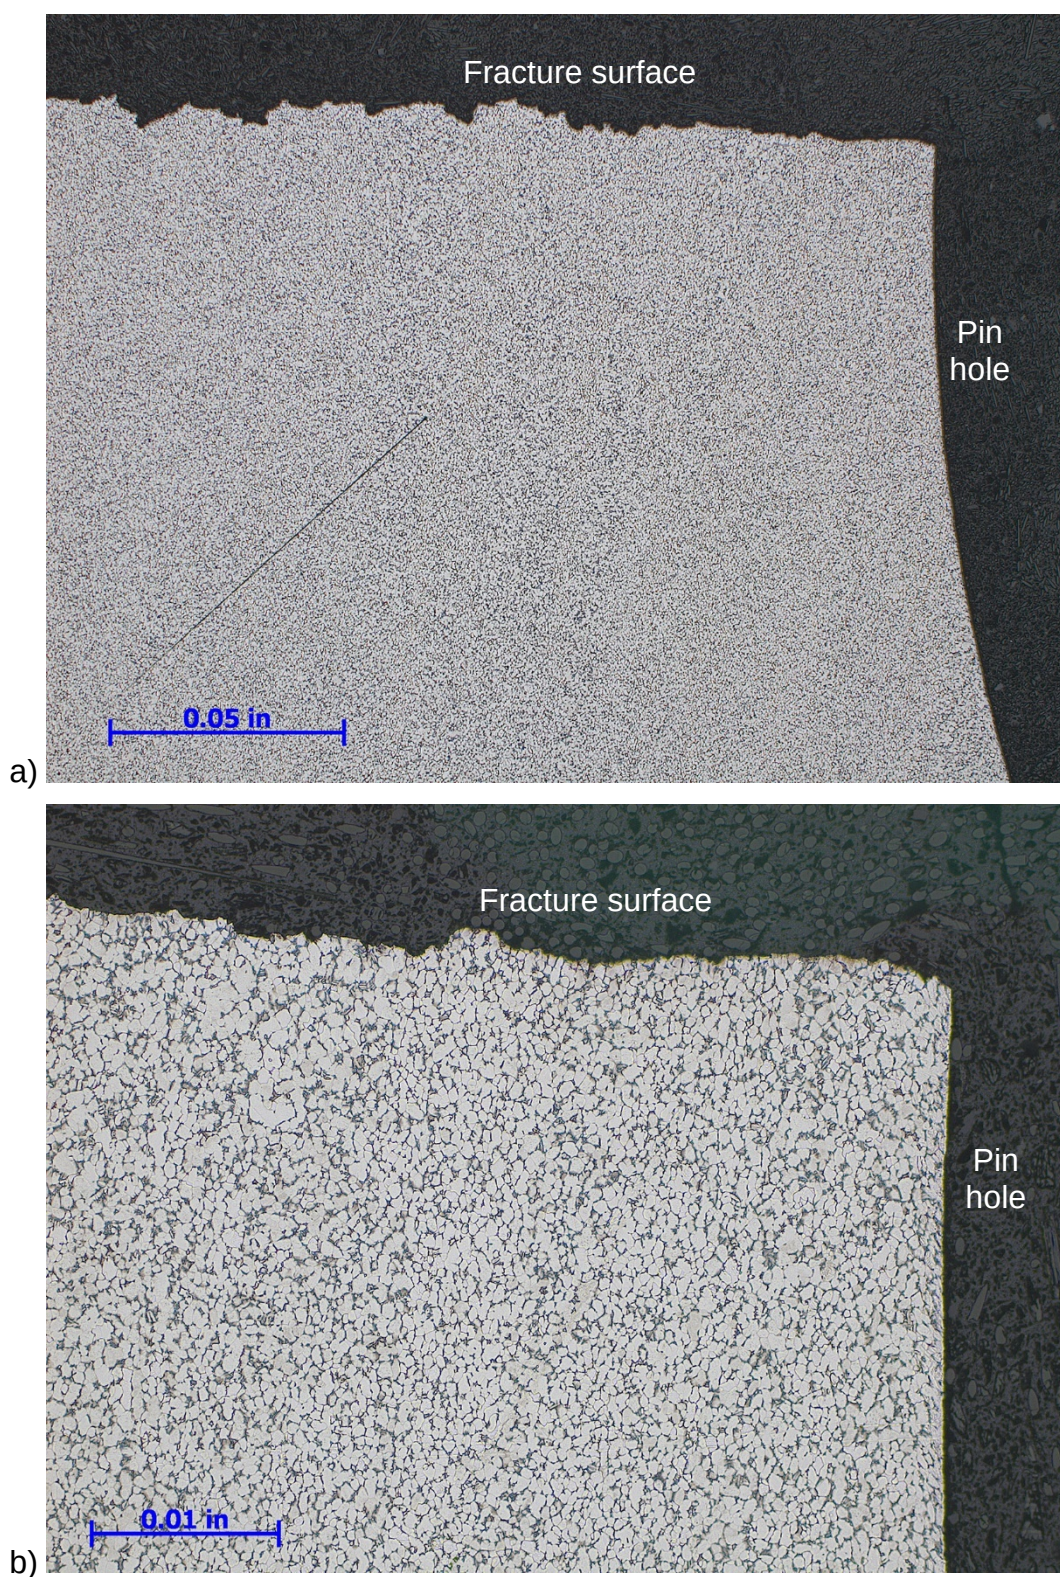
- 
4. There were no indications of heavily deformed microstructure along the pin hole surfaces as seen in figures 9b, 10b, 11b, and 12b.

**Figure 10:** Polished and etched metallographic cross sections at the forward tang 3 o'clock position (Kroll's reagent): a) 25X objective image showing no apparent texture and b) 100X objective image showing material condition along pin hole.

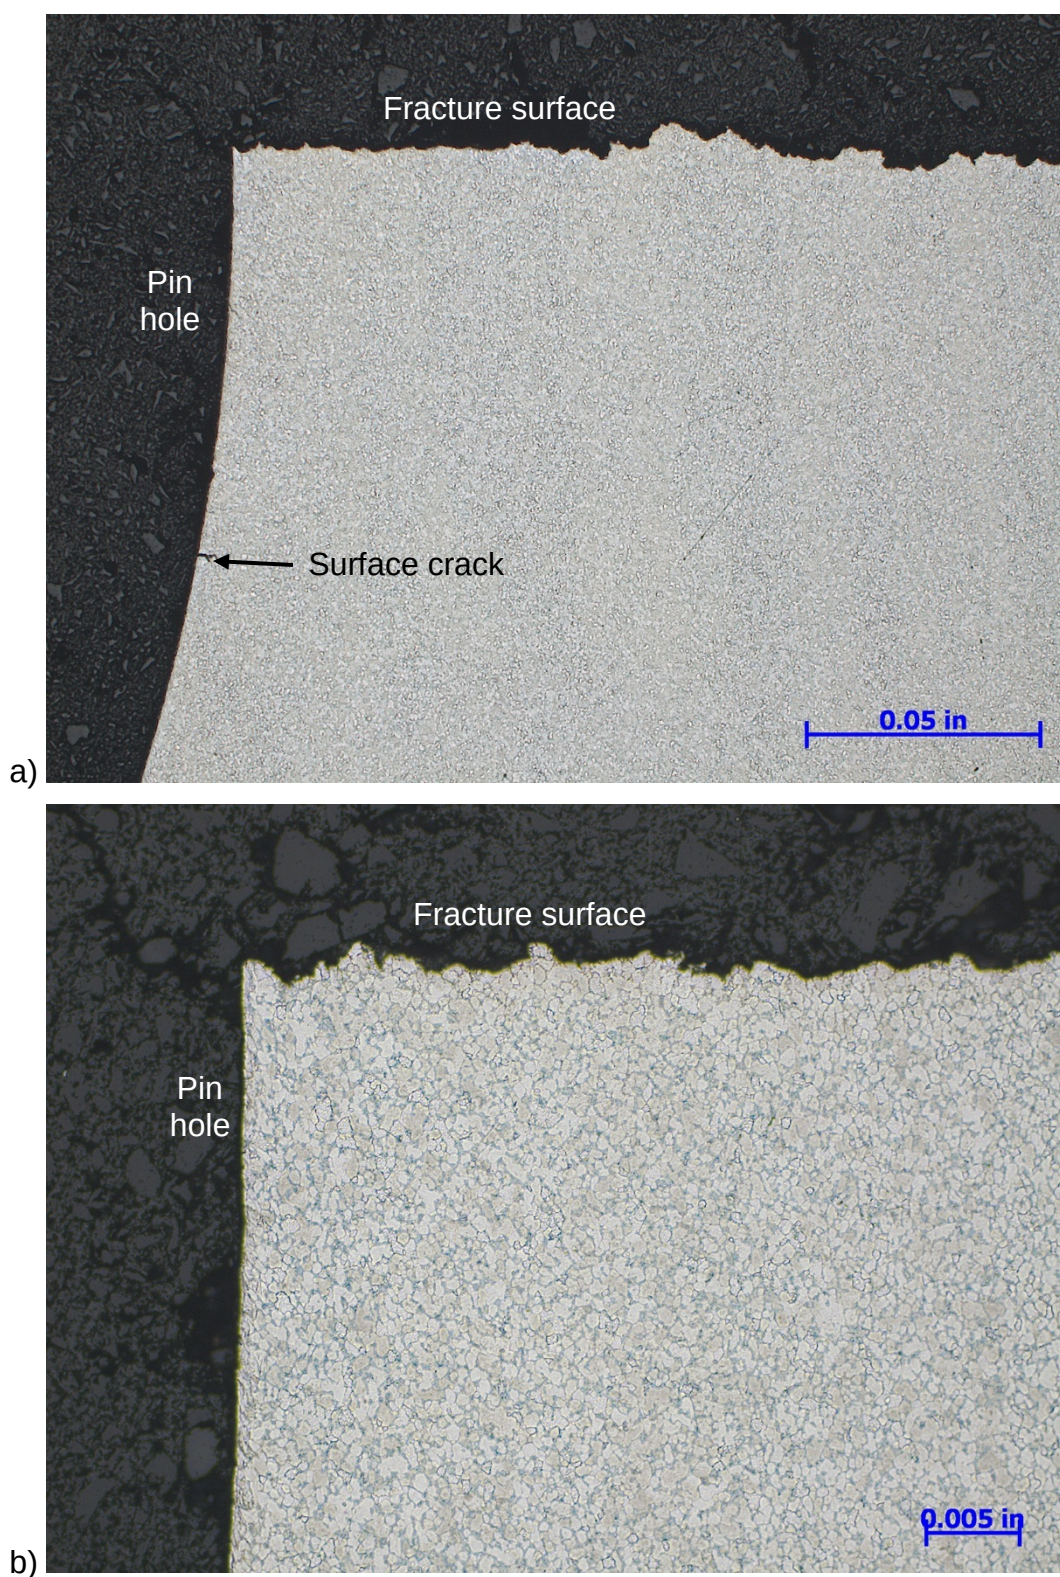
**Figure 11:** Polished and etched metallographic cross sections at the middle tang 9 o'clock position (Kroll's reagent): a) 25X objective image showing no apparent texture and one surface crack and b) 100X objective image showing material condition along pin hole.

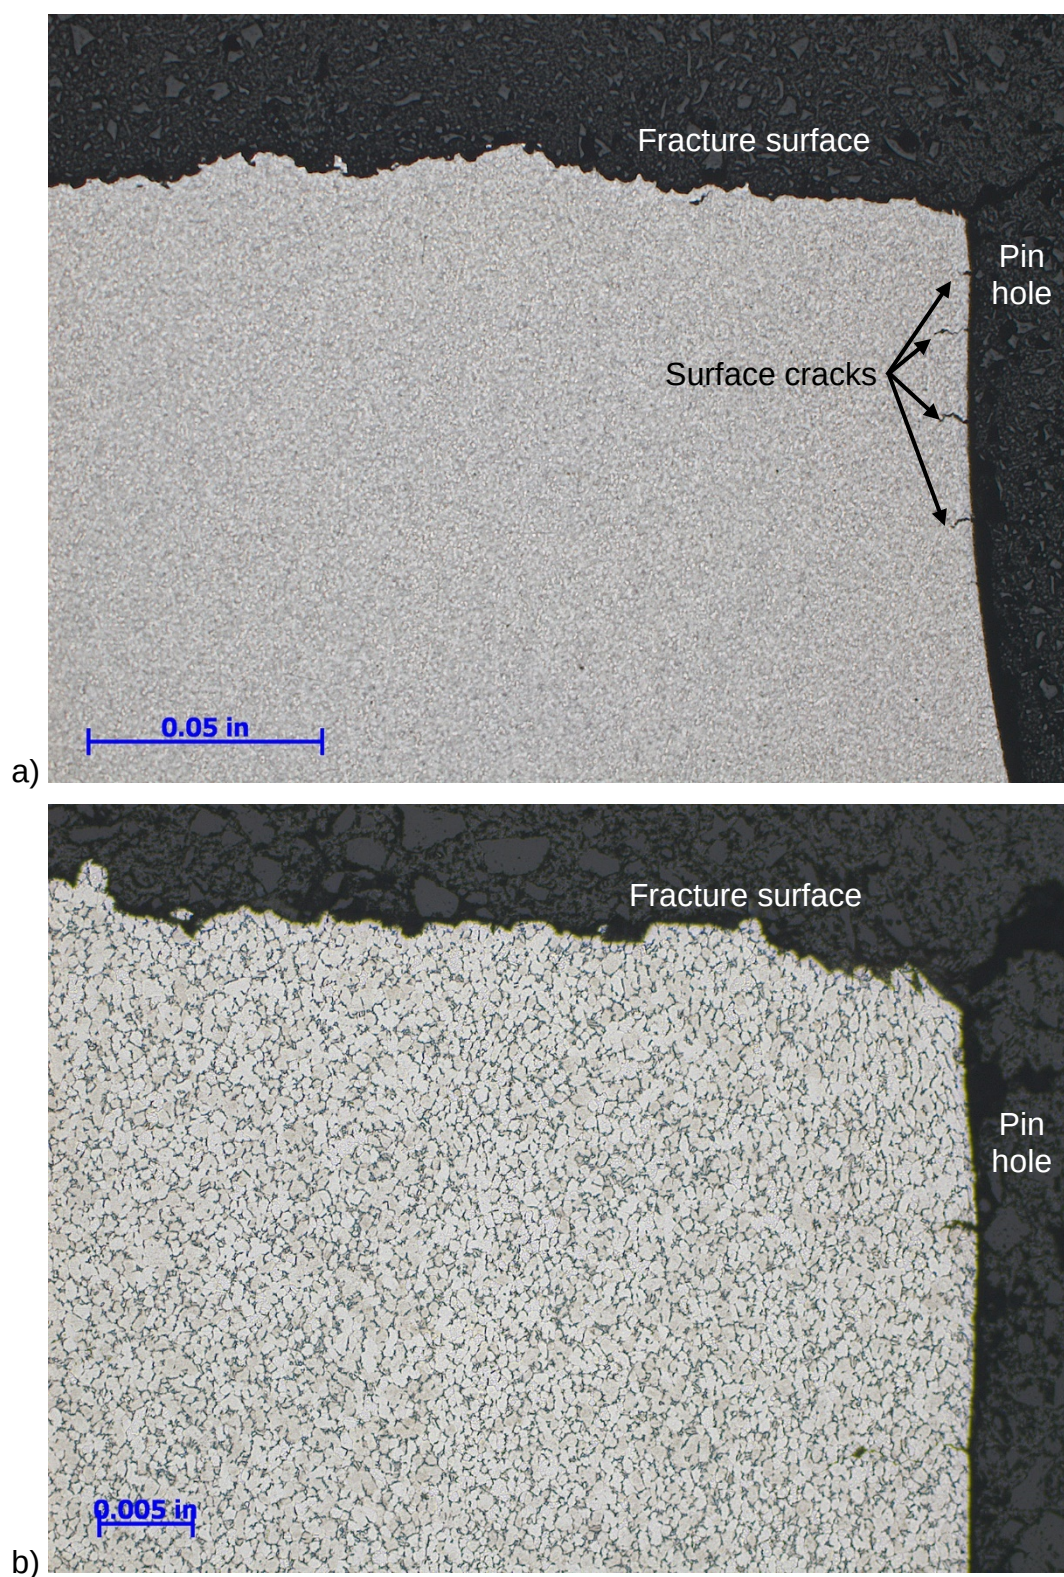
**Figure 12:** Polished and etched metallographic cross sections at the middle tang 3 o'clock position (Kroll's reagent): a) 25X objective image showing no apparent texture and multiple surface cracks and b) 100X objective image showing material condition along pin hole.
