# Metallurgical Investigation Report

## FA Log No. 2017- 18137

### **METALLURGICAL EVALUATION OF A RELEASED FAN BLADE FROM ENDEAVOR AIRLINES CF34-3B1**

ESN 873-642  
S/N KGACA251  
P/N 6018T30P14

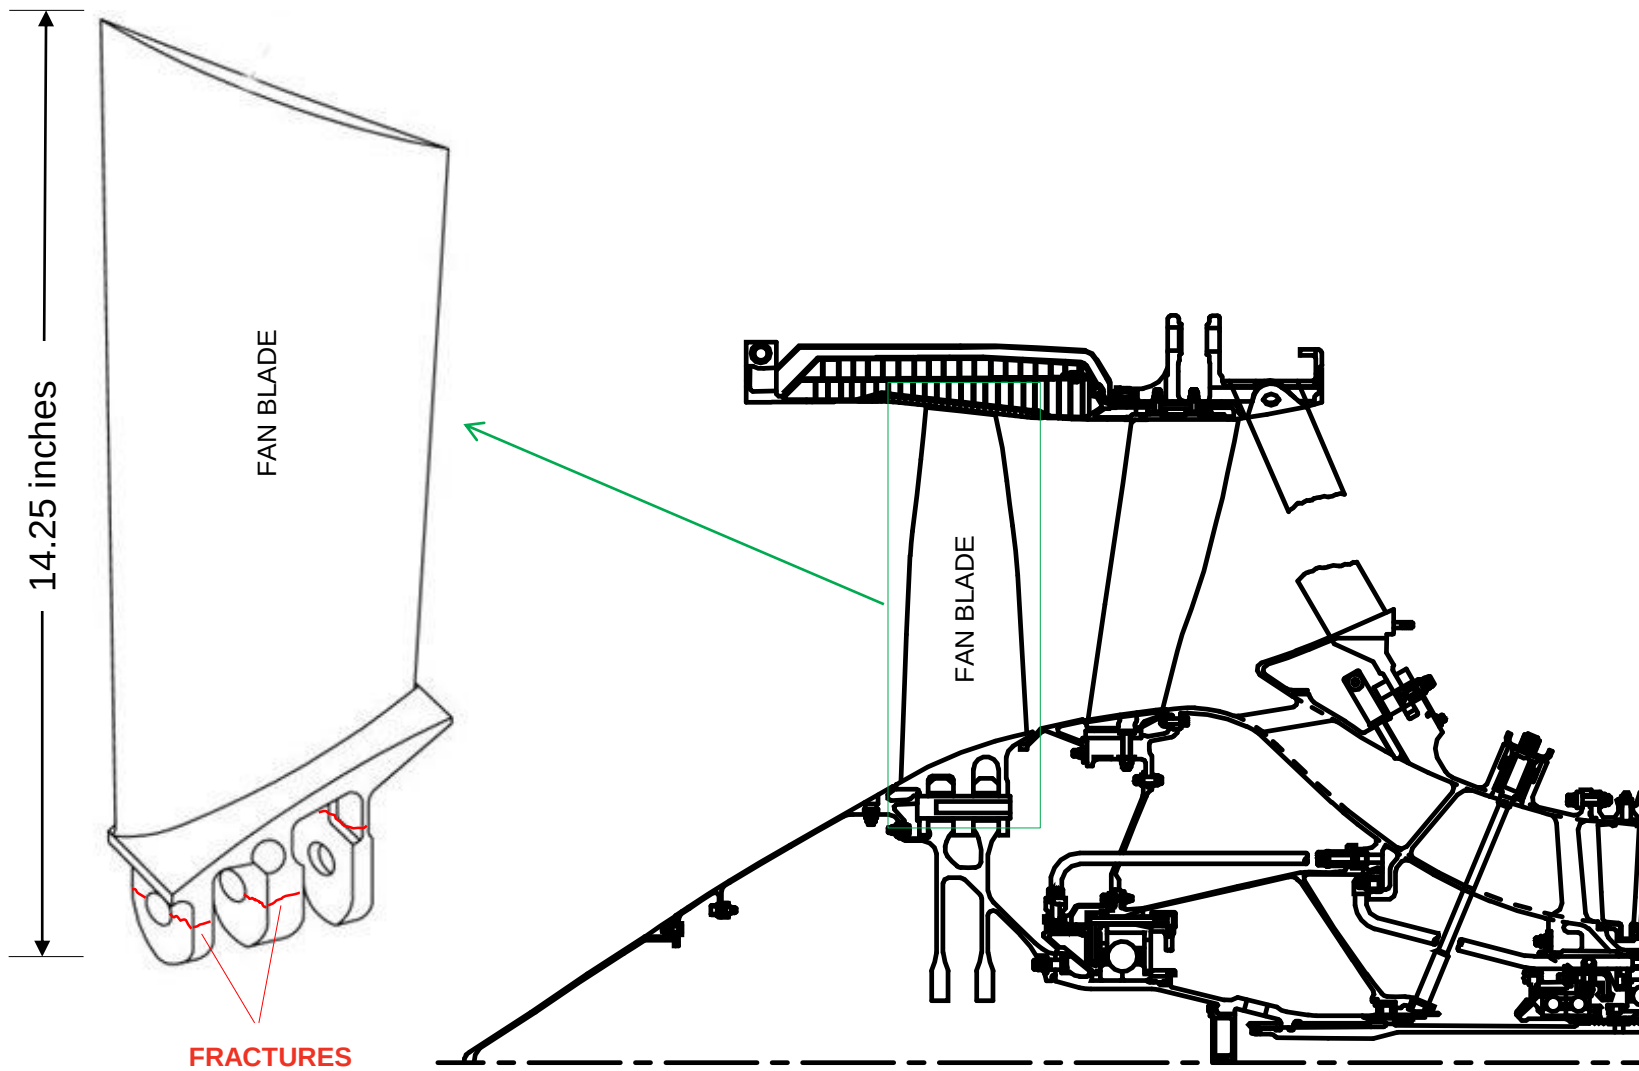
The illustration above shows the location of the fan blade in the CF34 engine. The fracture occurred through the mid point of the forward and mid pin tangs as depicted by the red lines.

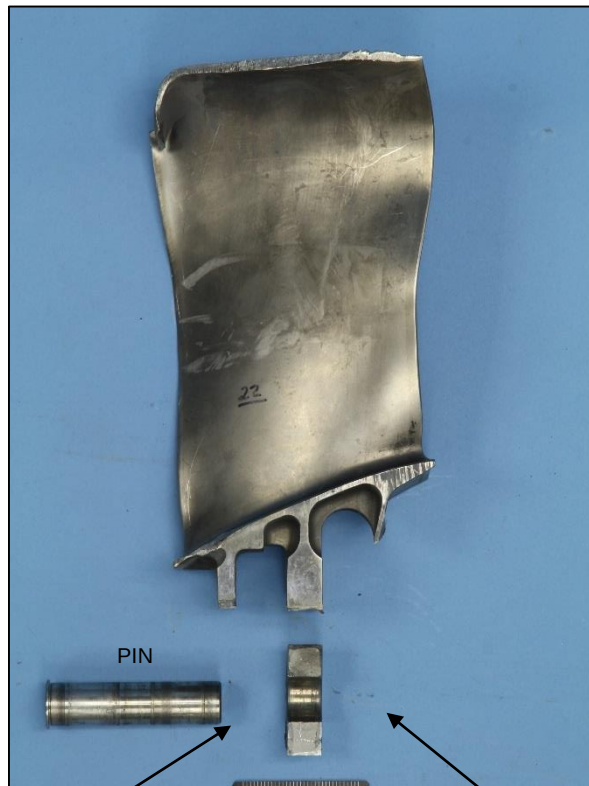
UNRECOVERED  
INBOARD FWD TANG  
FRACTURE

UNRECOVERED  
INBOARD AFT TANG  
FRACTURE

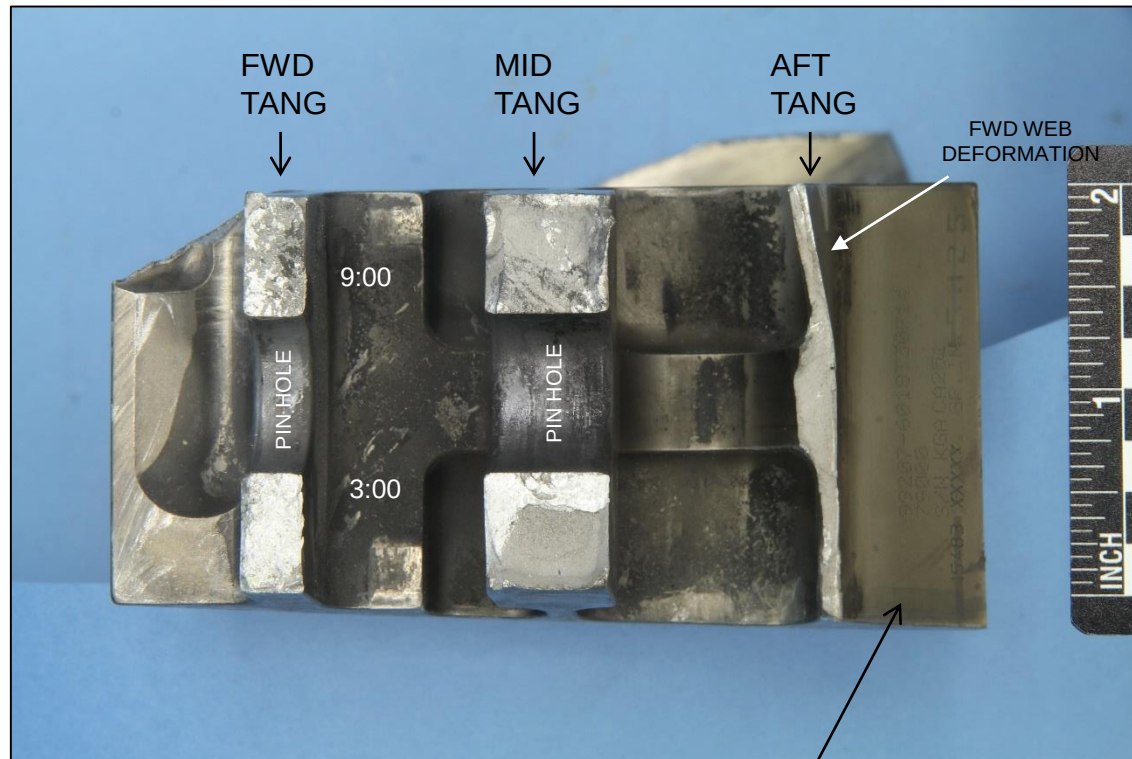
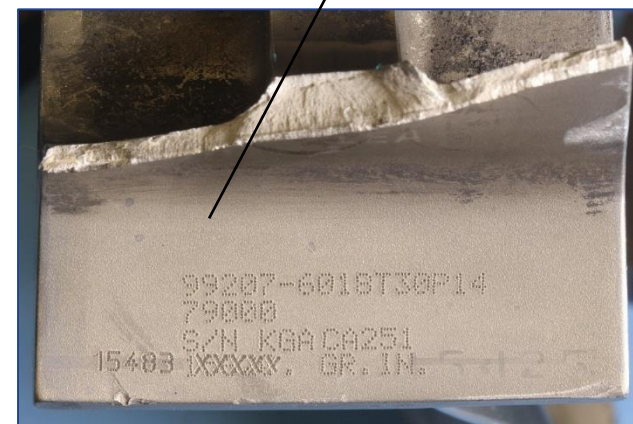
Views of the 6018T30P14 fan blade from ESN 873-642 which was identified as S/N KGACA251 per the part markings on the platform. The fracture surfaces were designated as 3 o'clock and 9 o'clock aft looking forward for reference in this report. The fracture of the aft tang was secondary as the fracture occurred outboard of the pin hole and the remaining portion of the web was plastically deformed forward consistent with the final separation of the fan blade.

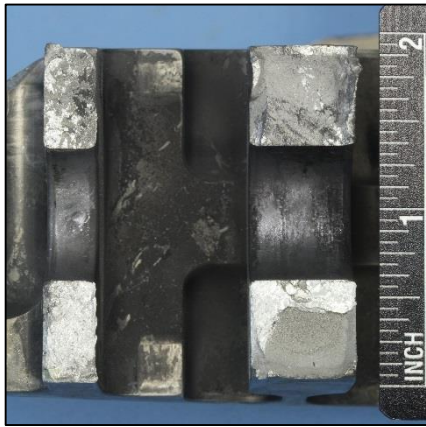
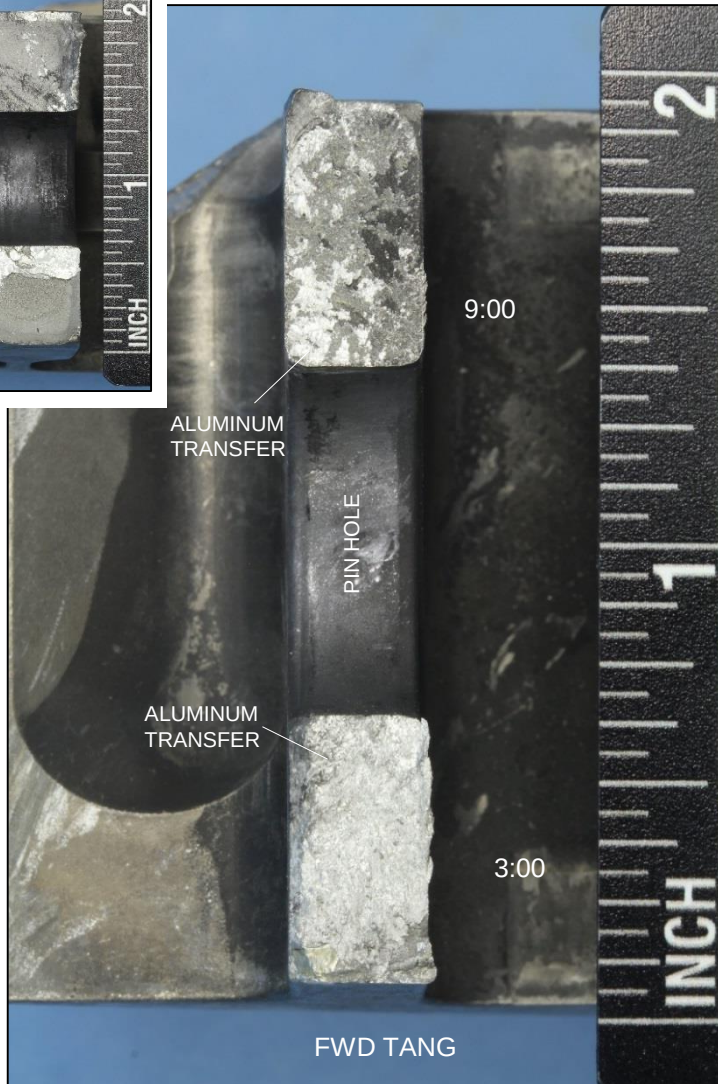
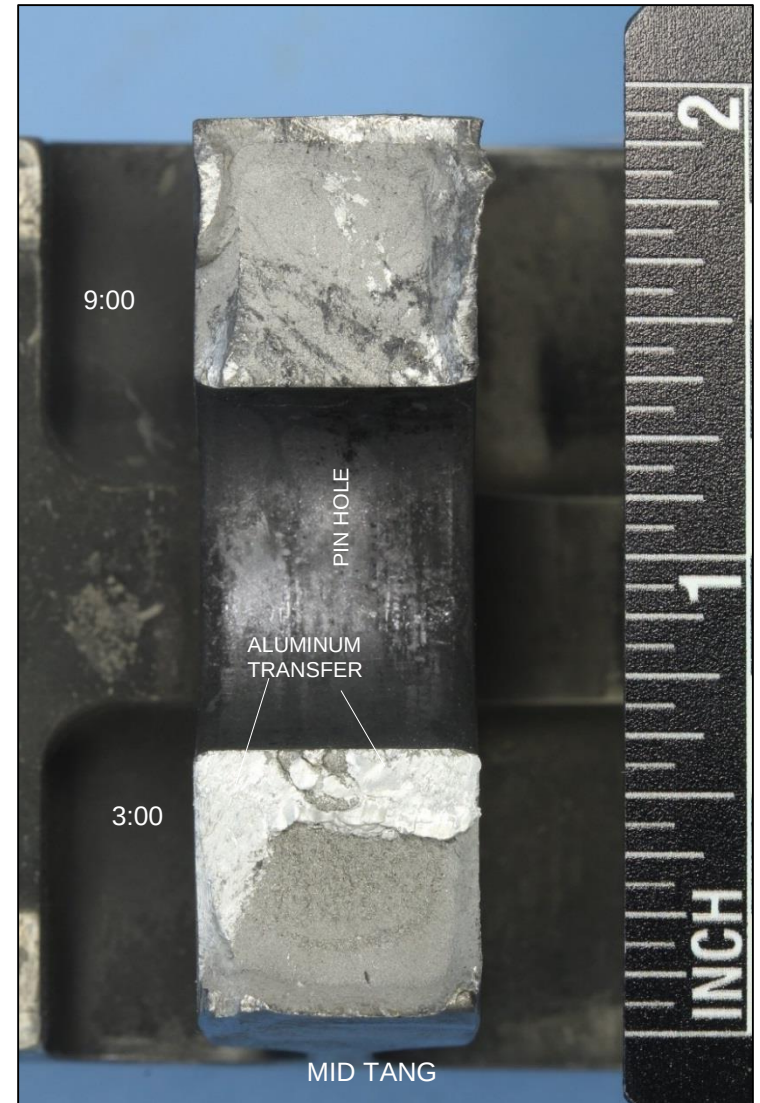
Additional views of the 6018T30P14 fan blade from ESN 873-642 which was identified as S/N KGACA251 per the part markings on the platform. The fracture surfaces exhibited transferred aluminum from the separation event. The aluminum was subsequently removed by chemical immersion.

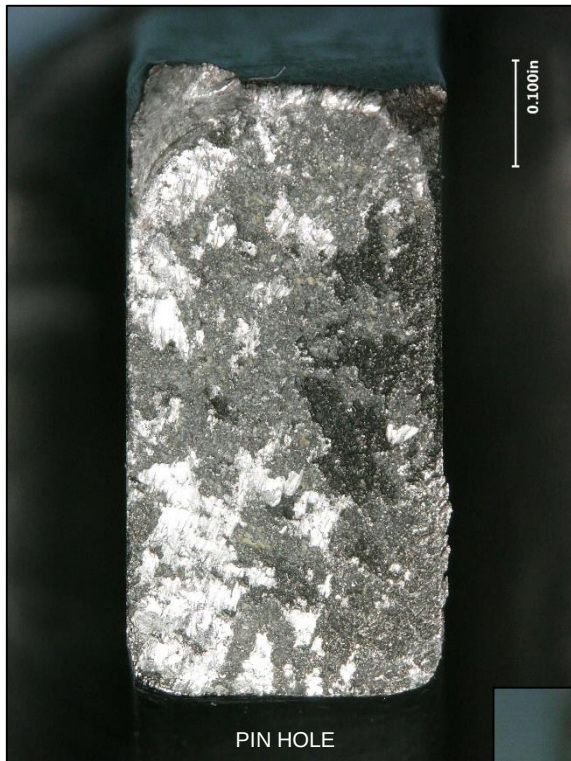
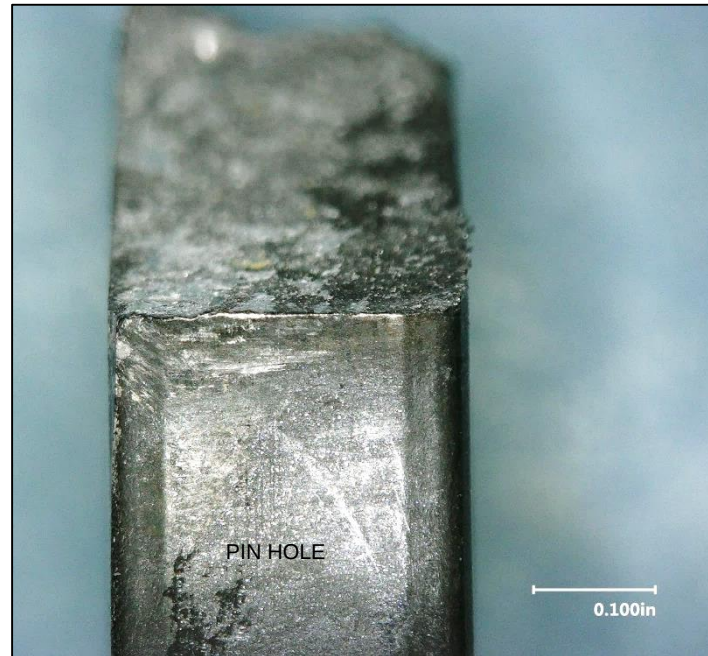
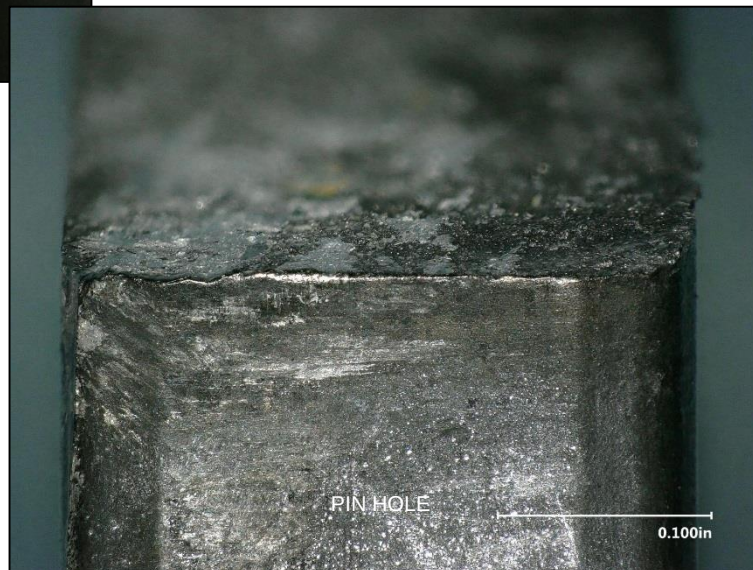
FWD TANG  
9 O'CLOCK

Views of the forward tang fracture at the 9 o'clock (ALF) position. Visual examination found no evidence of blending from a repair operation.

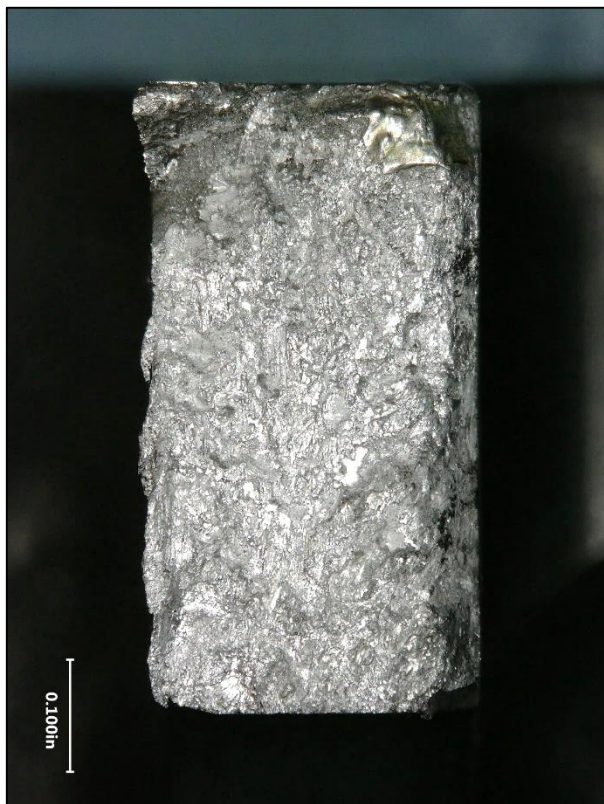
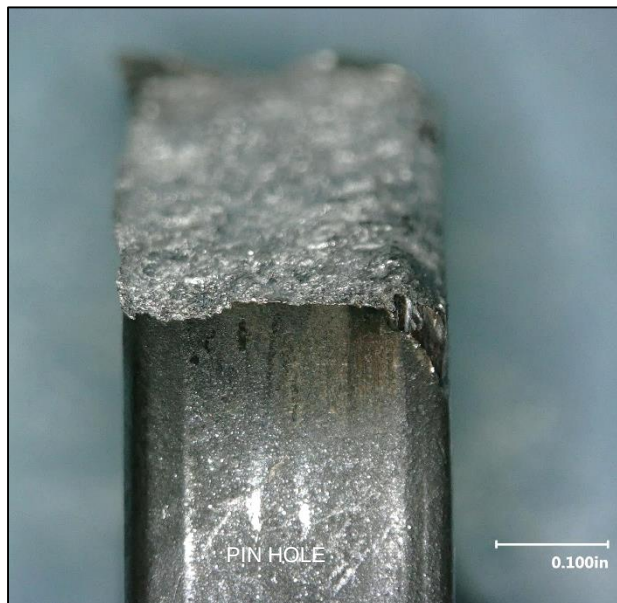
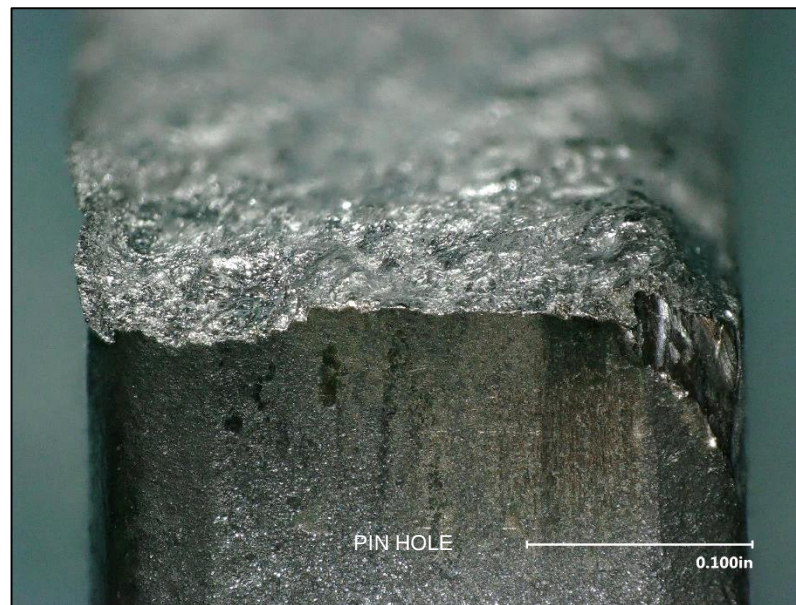
FWD TANG  
3 O'CLOCK

Views of the forward tang fracture at the 3 o'clock (ALF) position. Visual examination found no evidence of blending from a repair operation. The fracture surface was obscured by transferred aluminum.

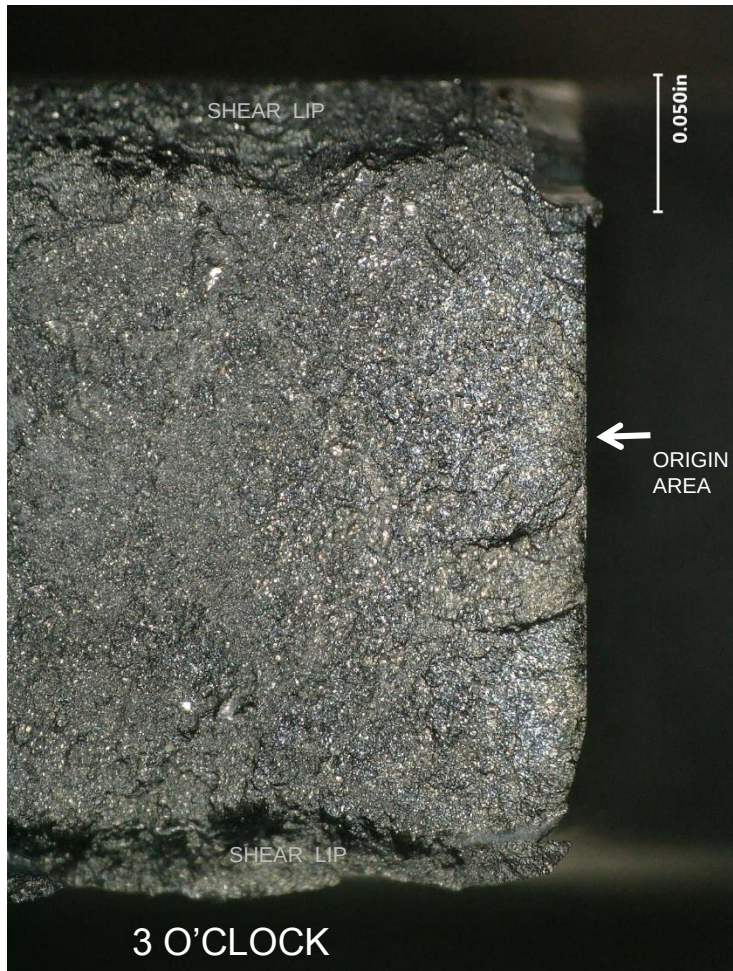
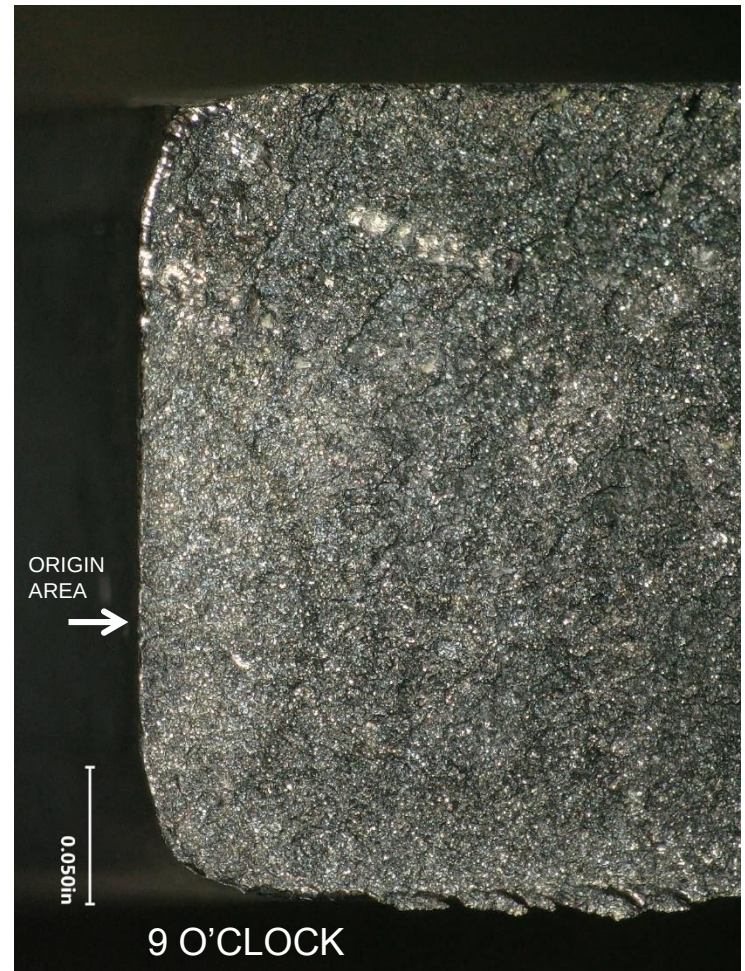
FWD TANG

Additional views of the fracture surface on the forward tang after chemically removing the transferred aluminum. The white arrows indicate the location of the fatigue origins on the pin hole surface.

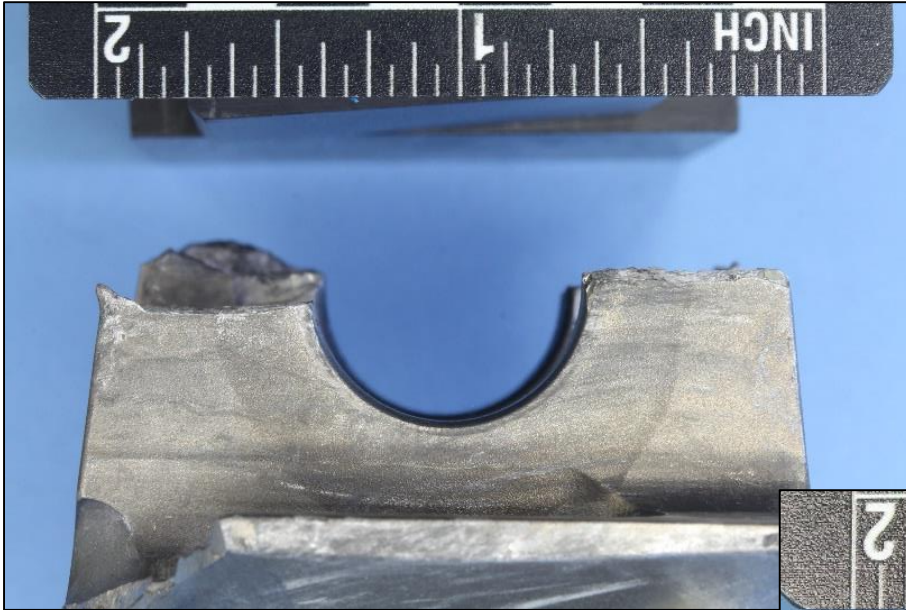
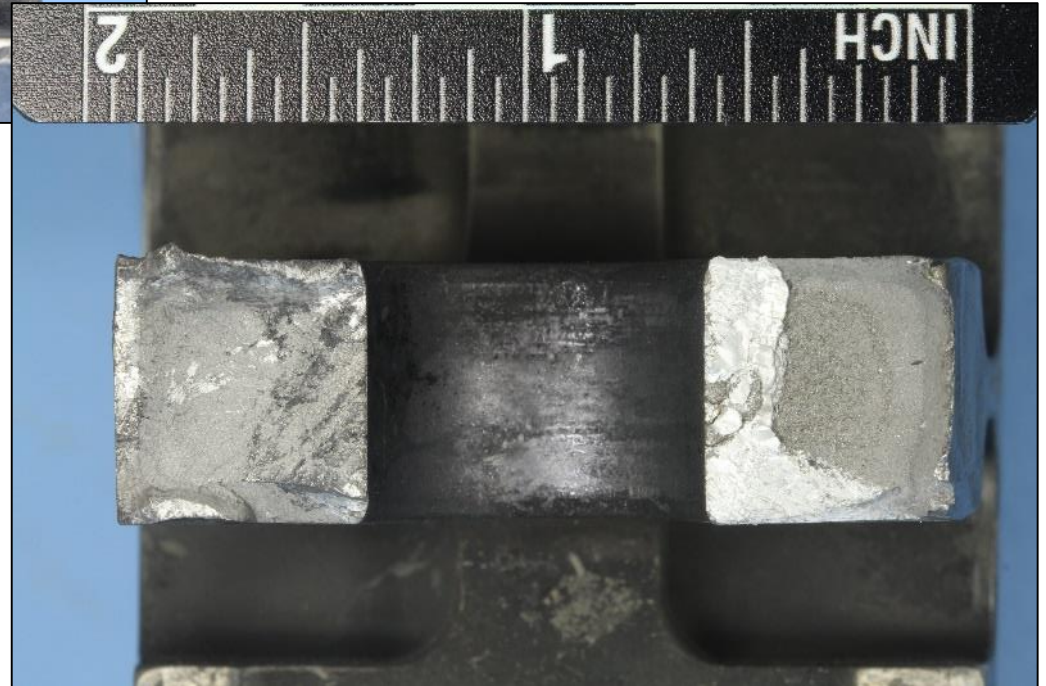
## MID TANG

Views of the fractures on the mid tang. Visual examination found no evidence of blending from a repair operation.

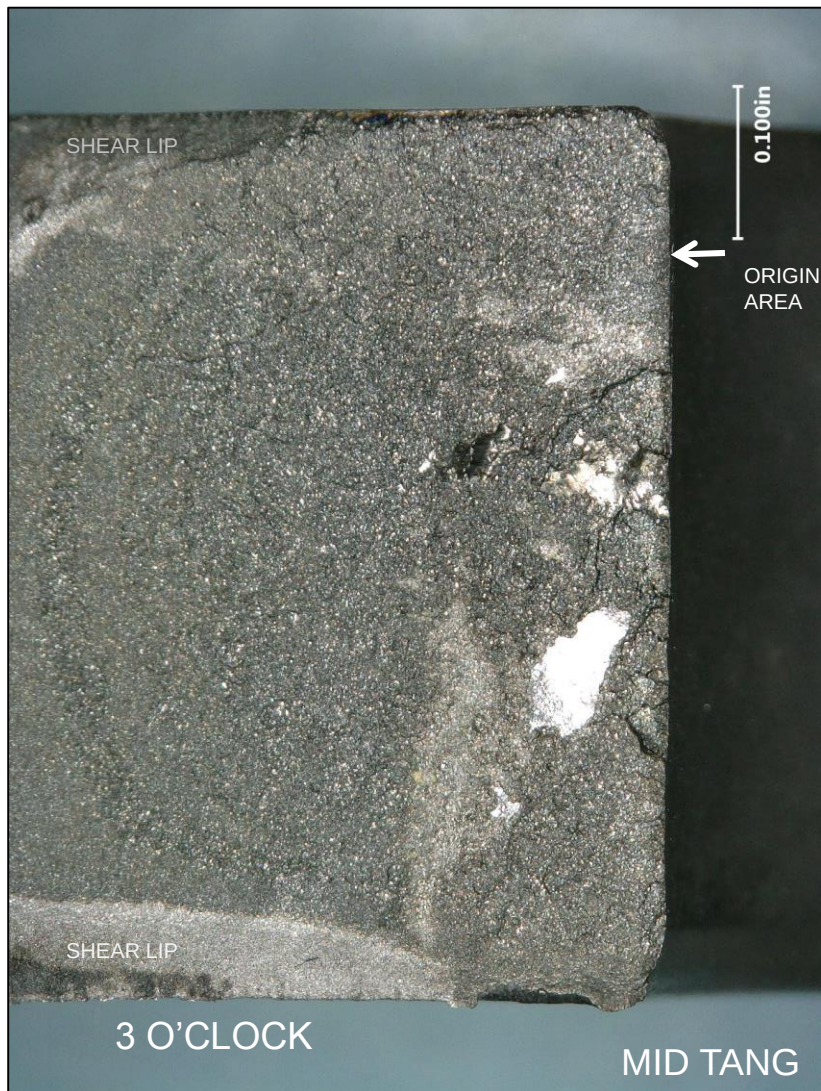
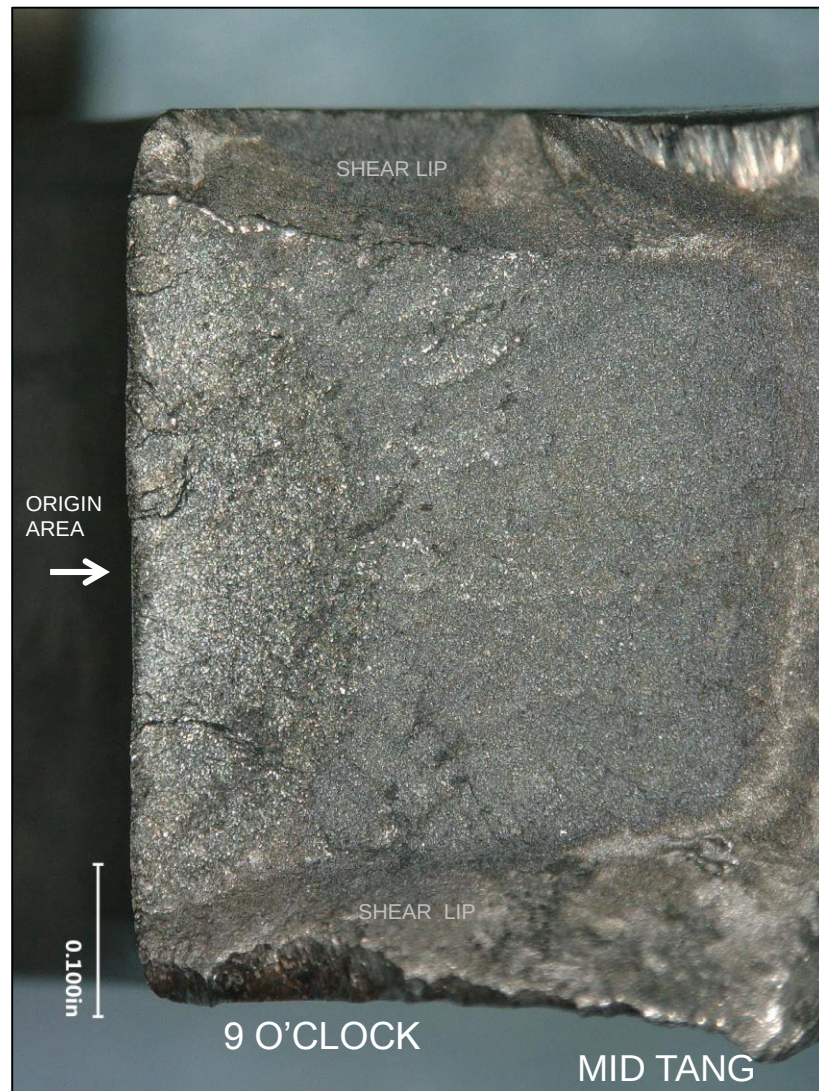
Views of the fracture surface on the mid tang after chemically removing the transferred aluminum. The white arrows indicate the location of the fatigue origins on the pin hole surface.

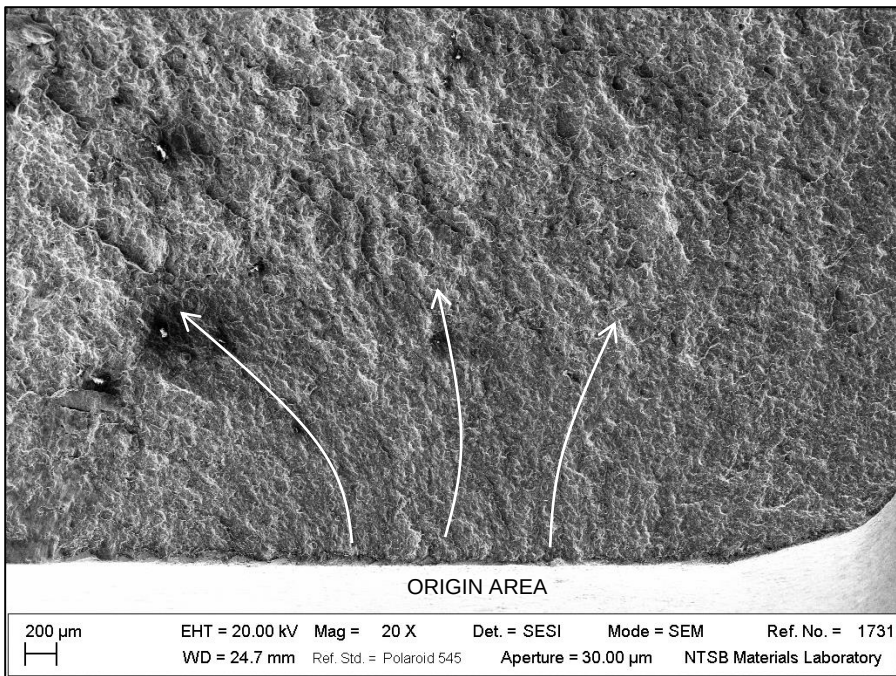
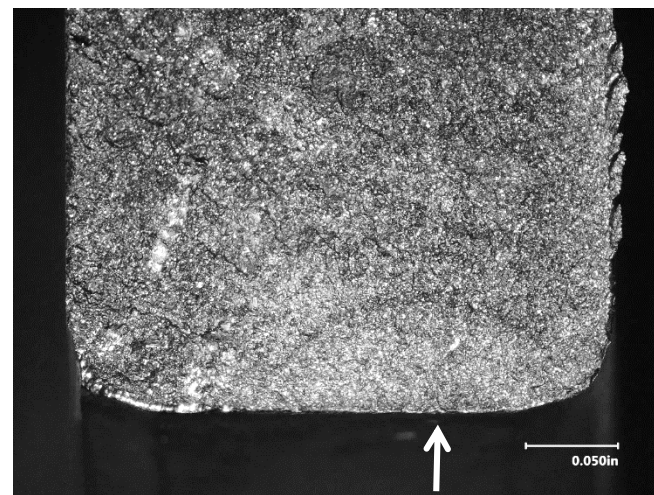
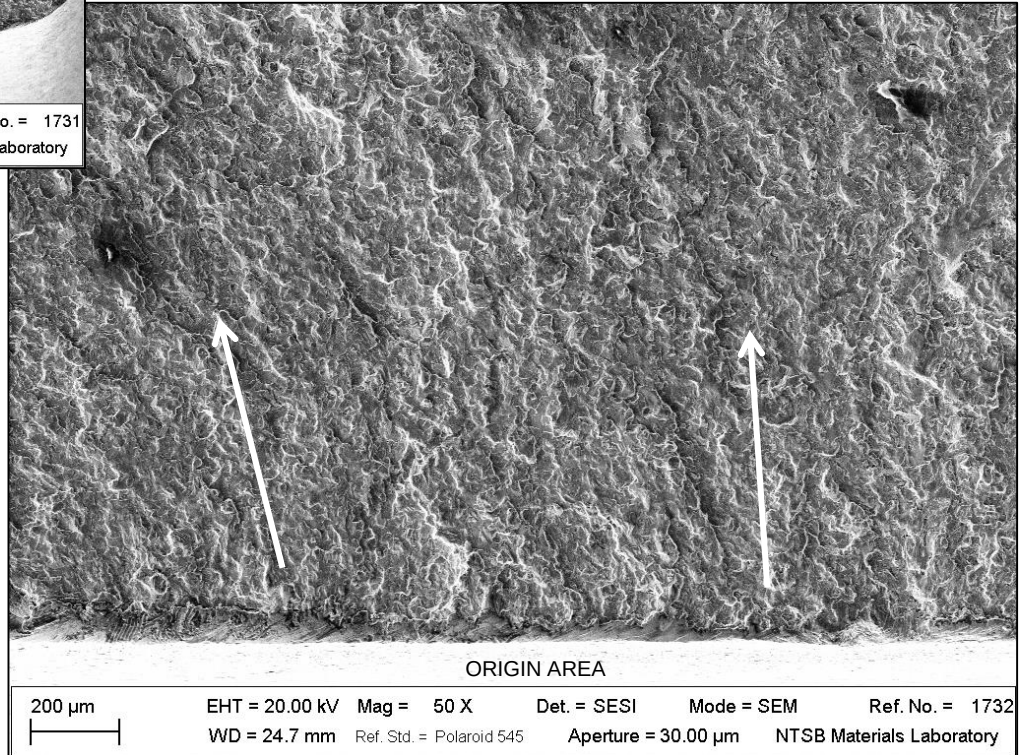
## FWD TANG 9 O'CLOCK

SEM evaluation of the fracture surface on the forward tang 9 o'clock location confirmed the origin to be at the surface of the pin hole. No evidence of material anomalies or damage was observed.

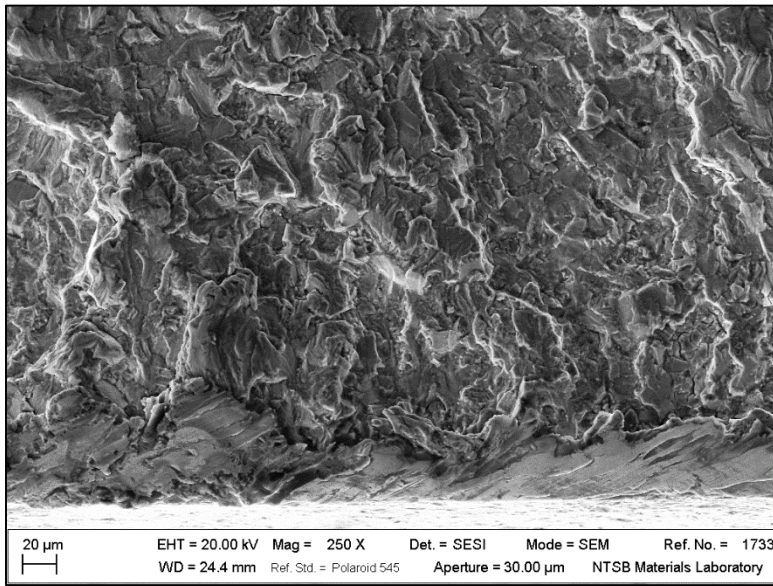
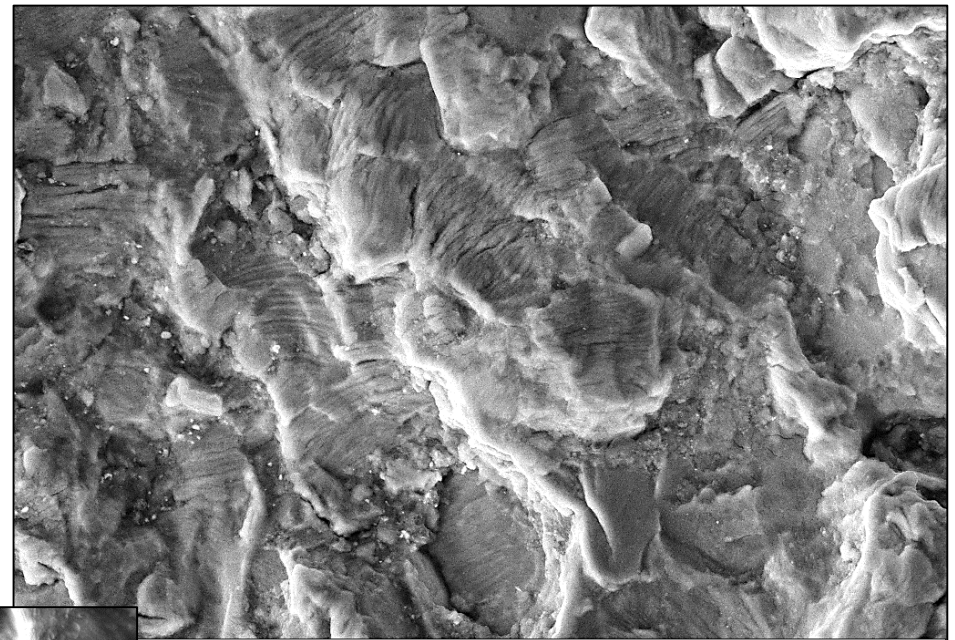
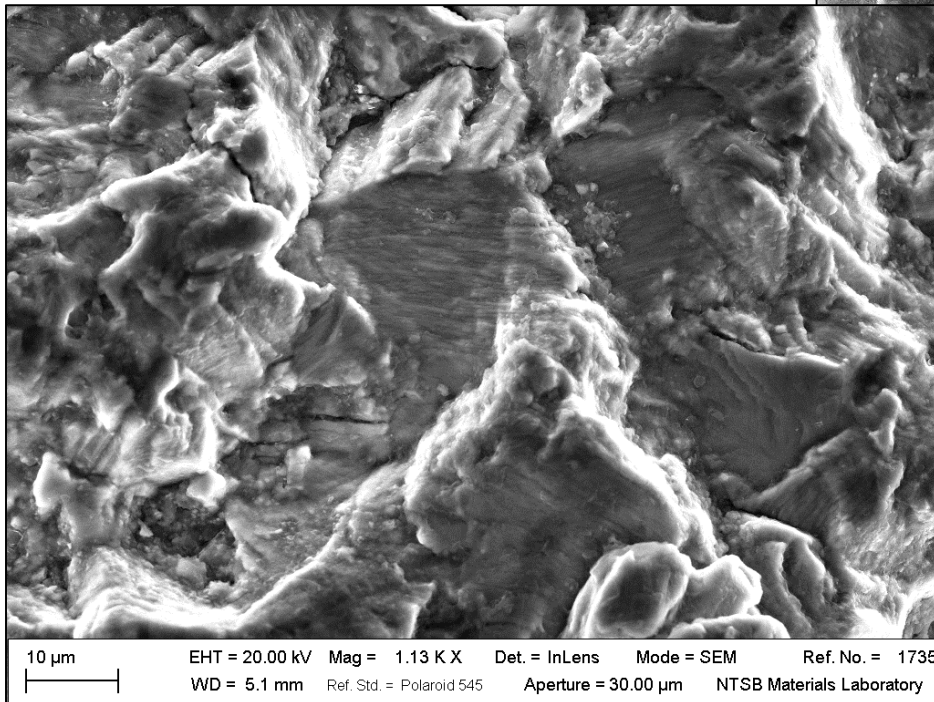
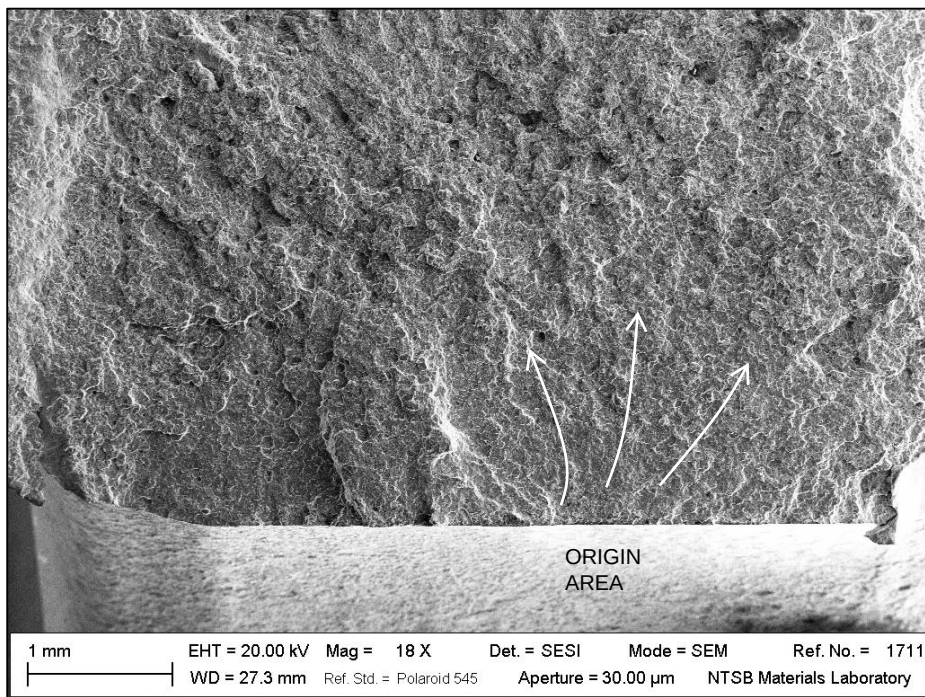
## FWD TANG 9 O'CLOCK

SEM views of the fracture surface at the origin area at the 9 o'clock position on the forward tang. Striated fatigue features were observed consistent with crack initiation and propagation by low cycle fatigue. No evidence of material anomalies or damage was observed.

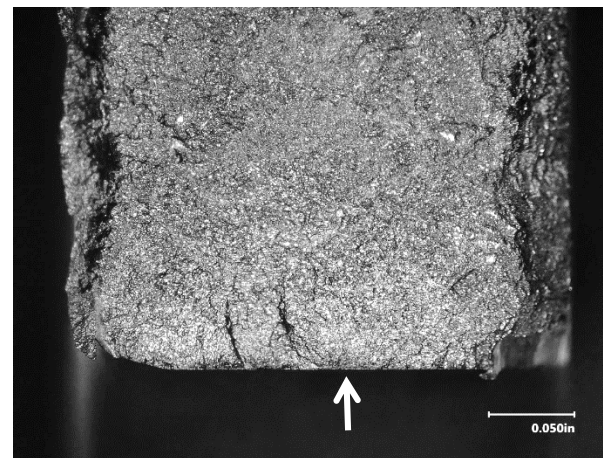
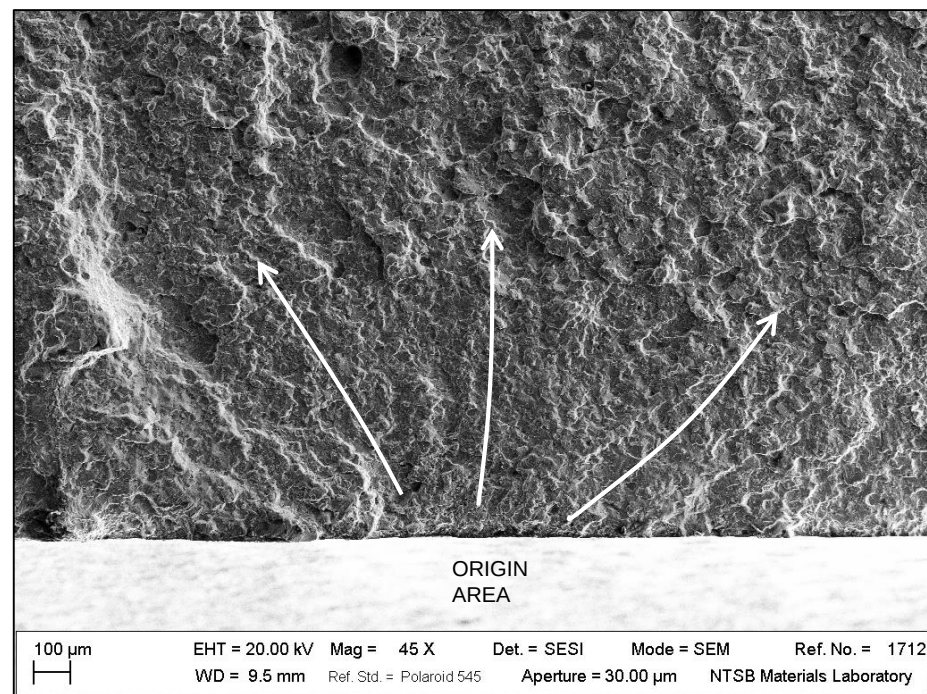
## FWD TANG 3 O'CLOCK

SEM evaluation of the fracture surface on the forward tang 3 o'clock location confirmed the origin to be at the surface of the pin hole. No evidence of material anomalies or damage was observed.

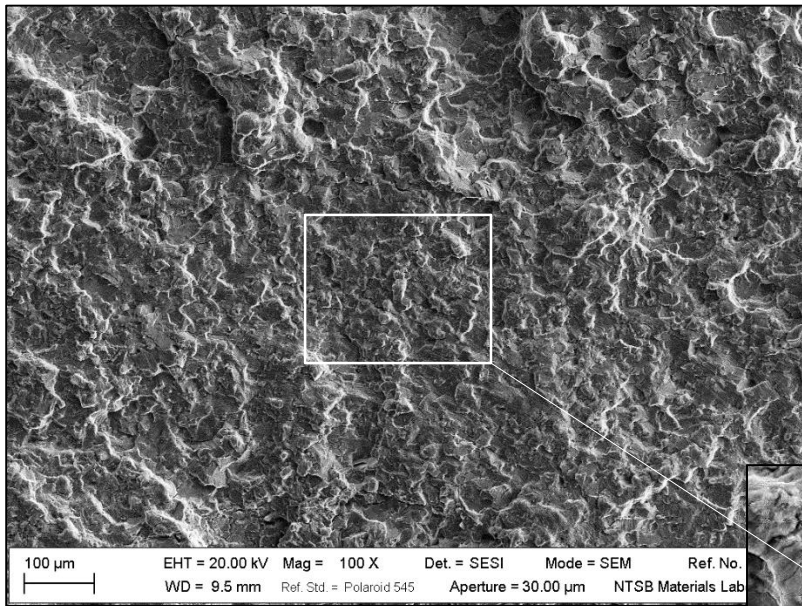
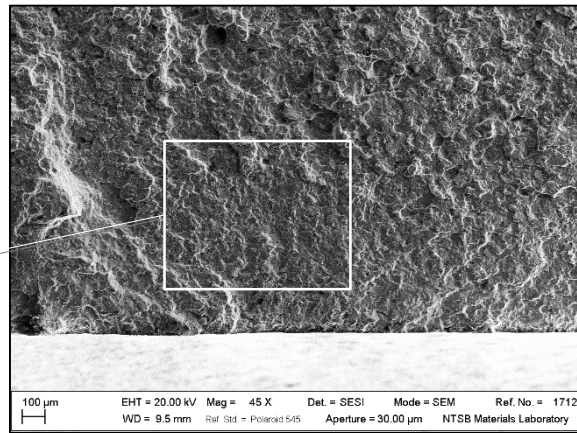
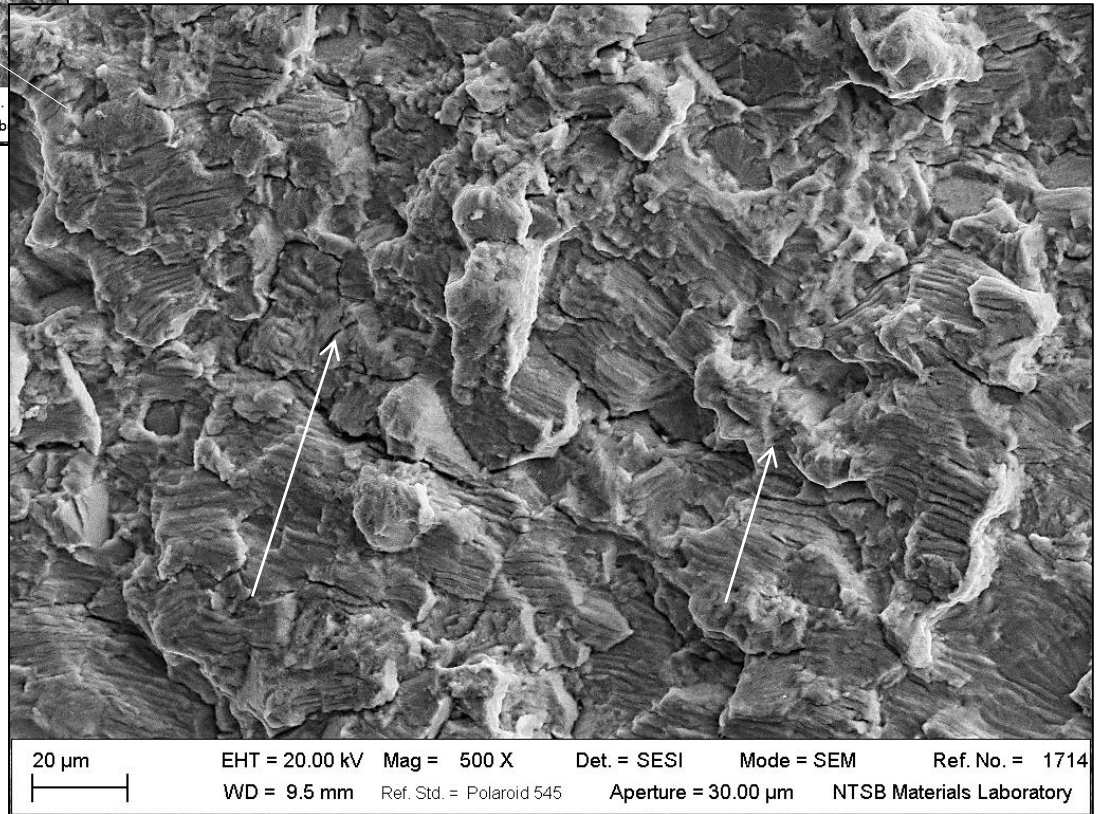
## FWD TANG 3 O'CLOCK

SEM views of the fracture surface at the origin area at the 3 o'clock position on the forward tang. Striated fatigue features were observed consistent with crack initiation and propagation by low cycle fatigue. No evidence of material anomalies or damage was observed.

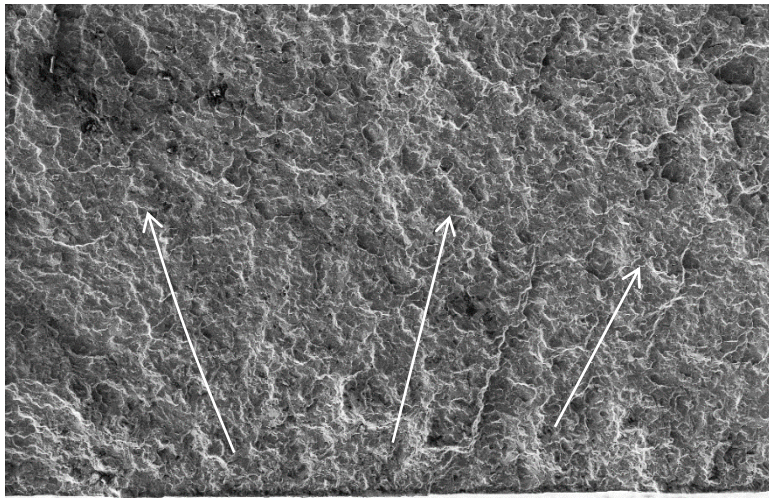
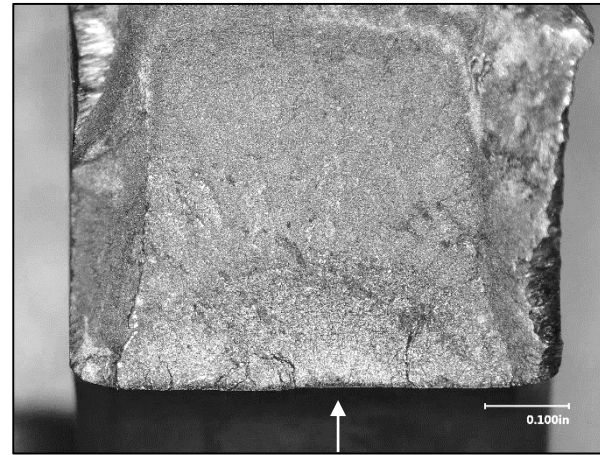
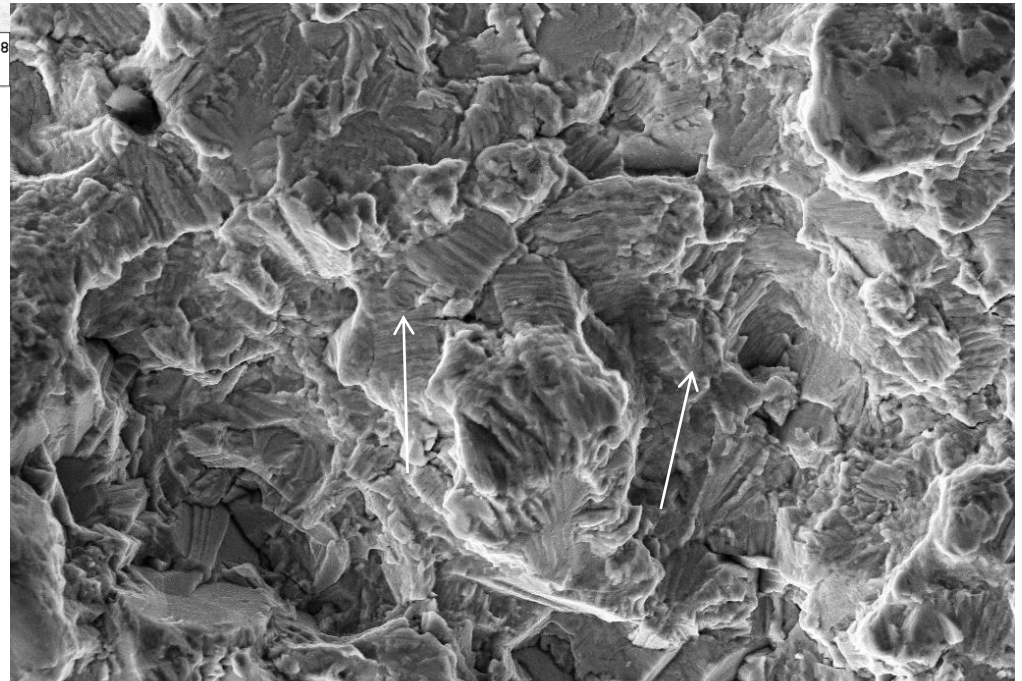
## MID TANG 9 O'CLOCK

SEM evaluation of the fracture surface on the mid tang 9 o'clock location confirmed the origin to be at the surface of the pin hole. Striated fatigue features were observed consistent with crack initiation and propagation by low cycle fatigue. No evidence of material anomalies or damage was observed.

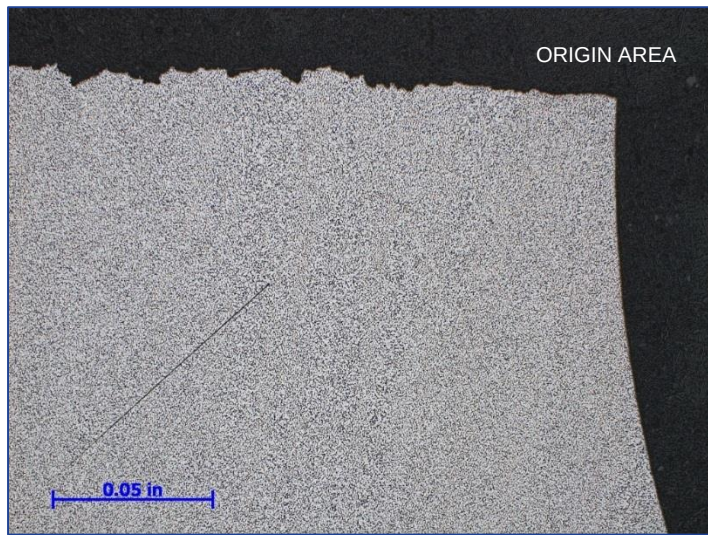
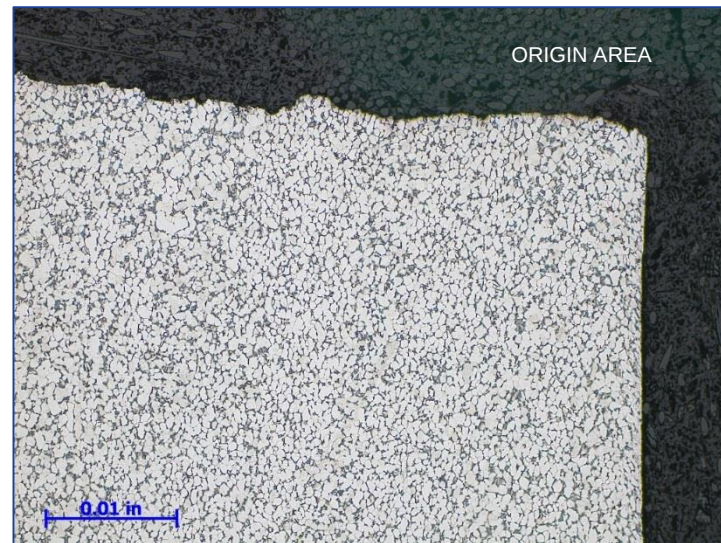
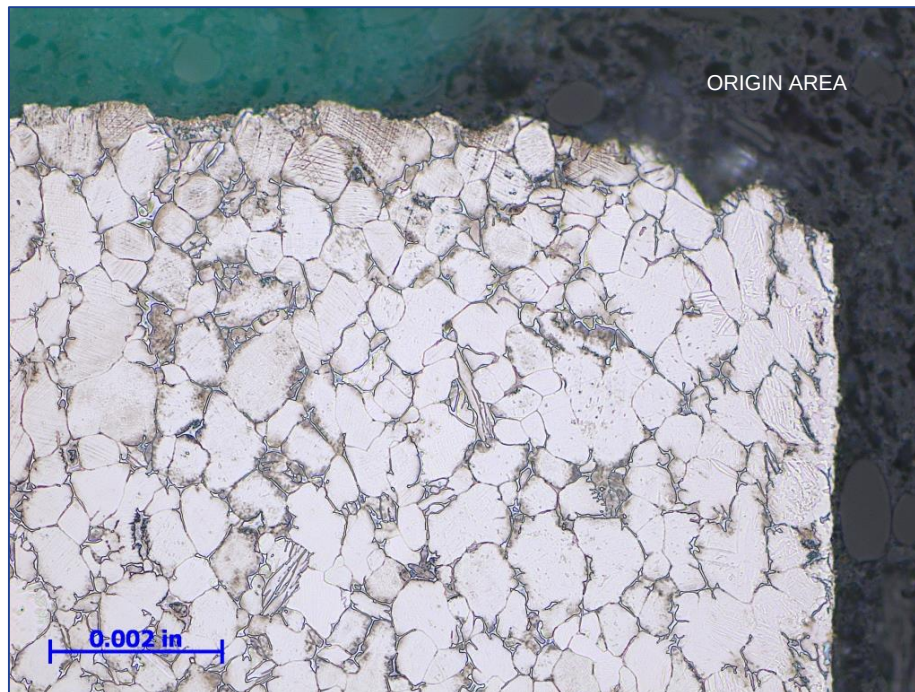
#### FWD TANG 3 O'CLOCK

Metallographic evaluation of the origin area on the forward tang at the 3 o'clock position showed typical microstructure for properly processed near-alpha titanium alloy Ti-8Al-1Mo-1V with no evidence of material anomalies or manufacturing deficiency. Metallographic evaluation of the fatigue origins revealed some texturing of the microstructure.
