# Metallurgical Investigation Report

## FA Log No. 2017- 18137

### **METALLURGICAL EVALUATION OF A RELEASED FAN BLADE FROM ENDEAVOR AIRLINES CF34-3B1**

ESN 873-642  
S/N KGACA251  
P/N 6018T30P14

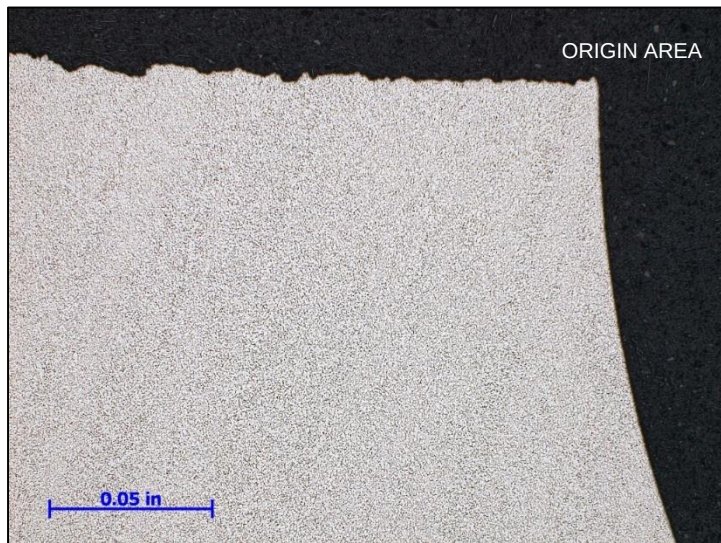
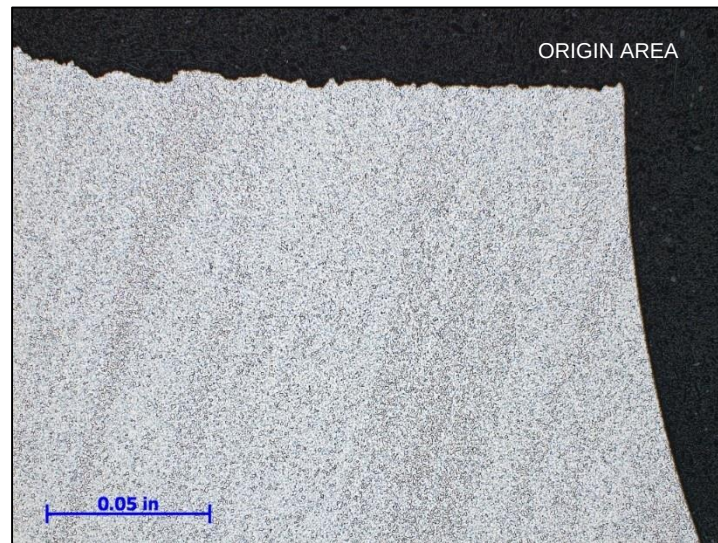
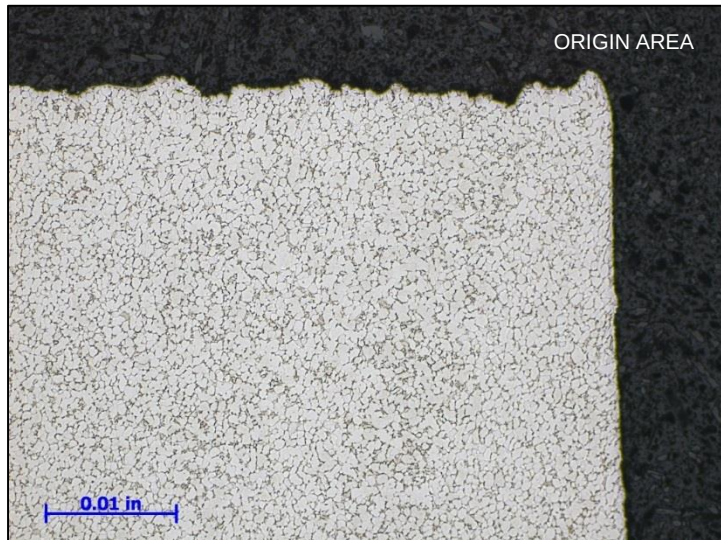
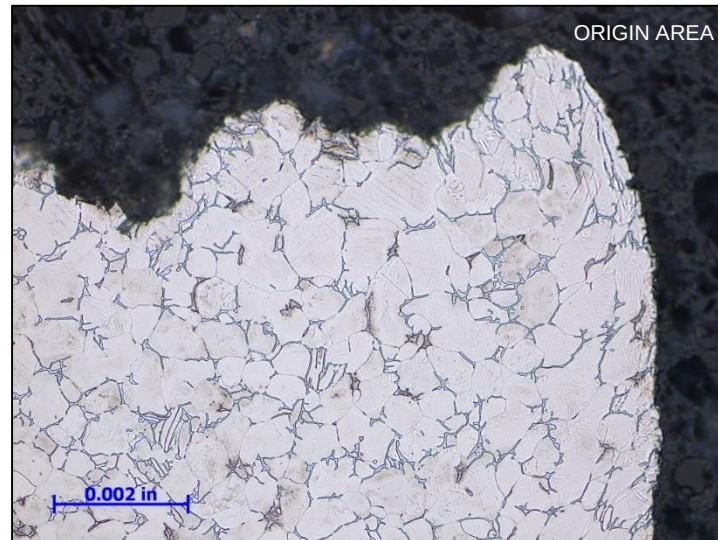
#### FWD TANG 9 O'CLOCK

Metallographic evaluation of the origin area on the forward tang at the 9 o'clock position showed typical microstructure for properly processed near-alpha titanium alloy Ti-8Al-1Mo-1V with no evidence of material anomalies or manufacturing deficiency. Metallographic evaluation of the fatigue origins revealed some texturing of the microstructure.

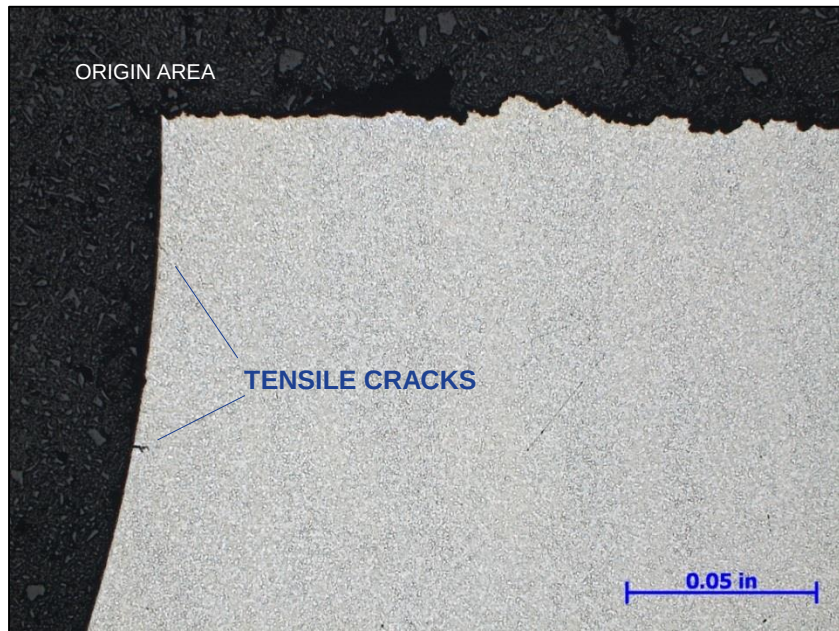
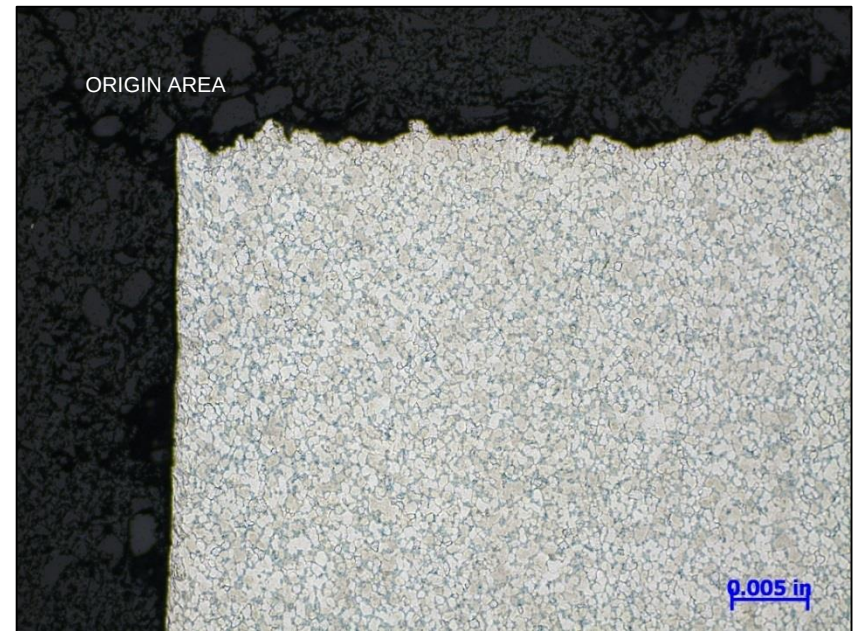
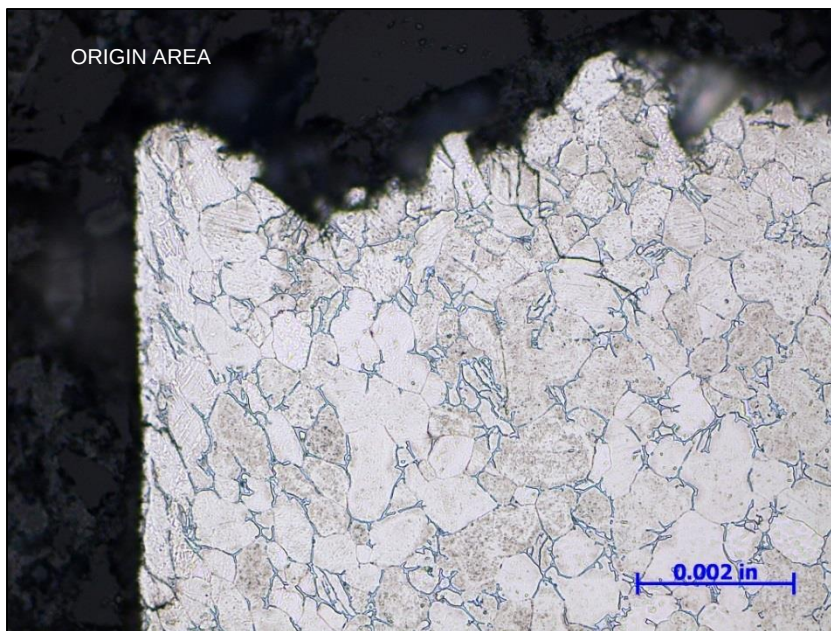
#### MID TANG 9 O'CLOCK

Metallographic evaluation of the origin area on the aft tang at the 9 o'clock position showed typical microstructure for properly processed near-alpha titanium alloy Ti-8Al-1Mo-1V with no evidence of material anomalies or manufacturing deficiency. Metallographic evaluation revealed tensile cracking on the surface of the pin hole.

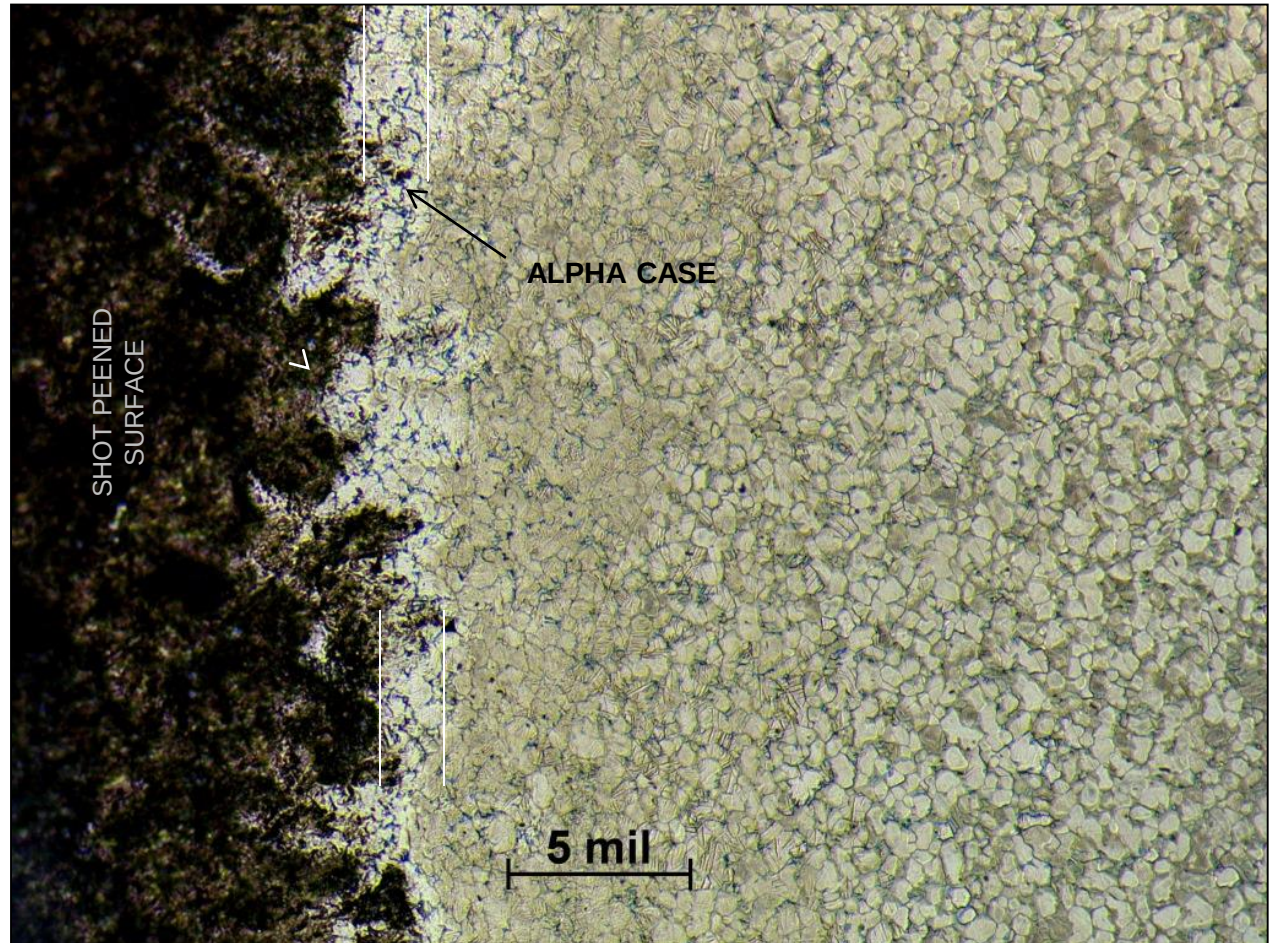
Mid Tang Face  
From S/N KGACA251

Less than 2/10 mil  
alpha case

Metallographic evaluation of blade S/N KGACA251 was performed by mounting the specimen on a 4° angle. Ammonium bifluoride etch revealed a white layer at the surface that was consistent with alpha case. Metallographic evaluation of S/N KGAK5302 showed no evidence of alpha case.

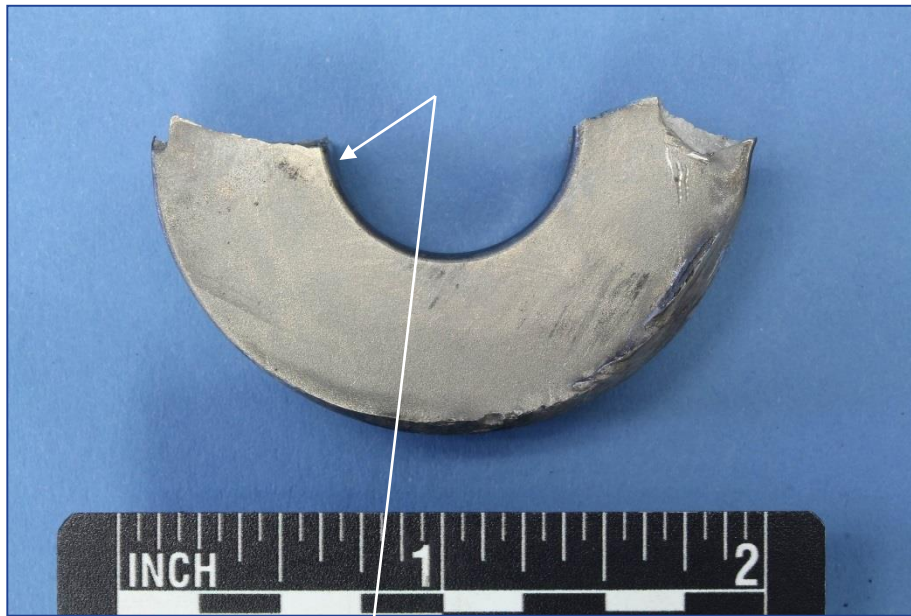
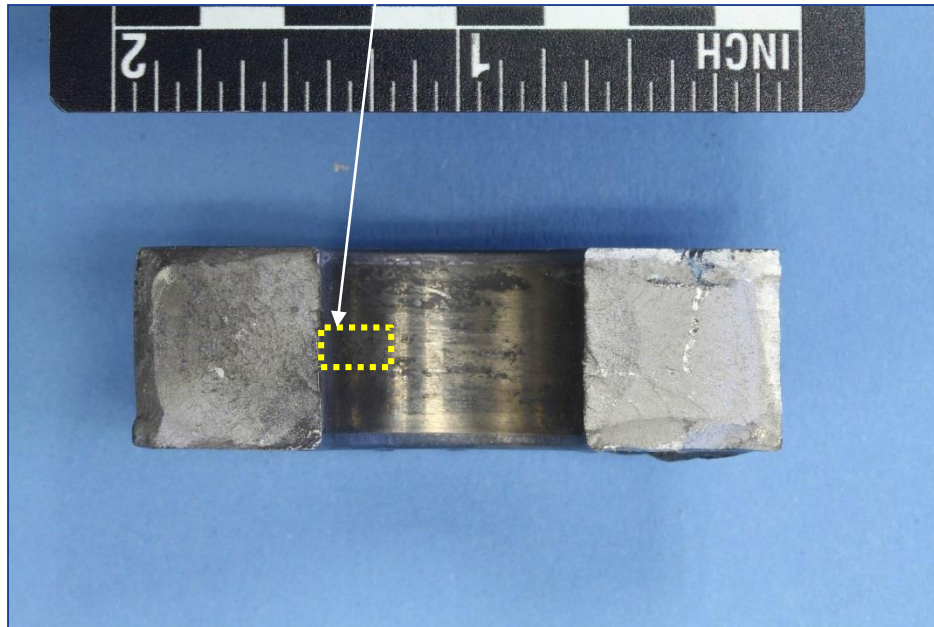
Residual stress analysis was performed on the pin holes from the event blade S/N KGACA251 and four additional fan blades at the area indicated on the mid tangs shown above. Results of the residual stress analysis showed a significant amount of the compressive residual stress from the original shot peening was lost during the creep hot form process and subsequently was not restored. See page 36.

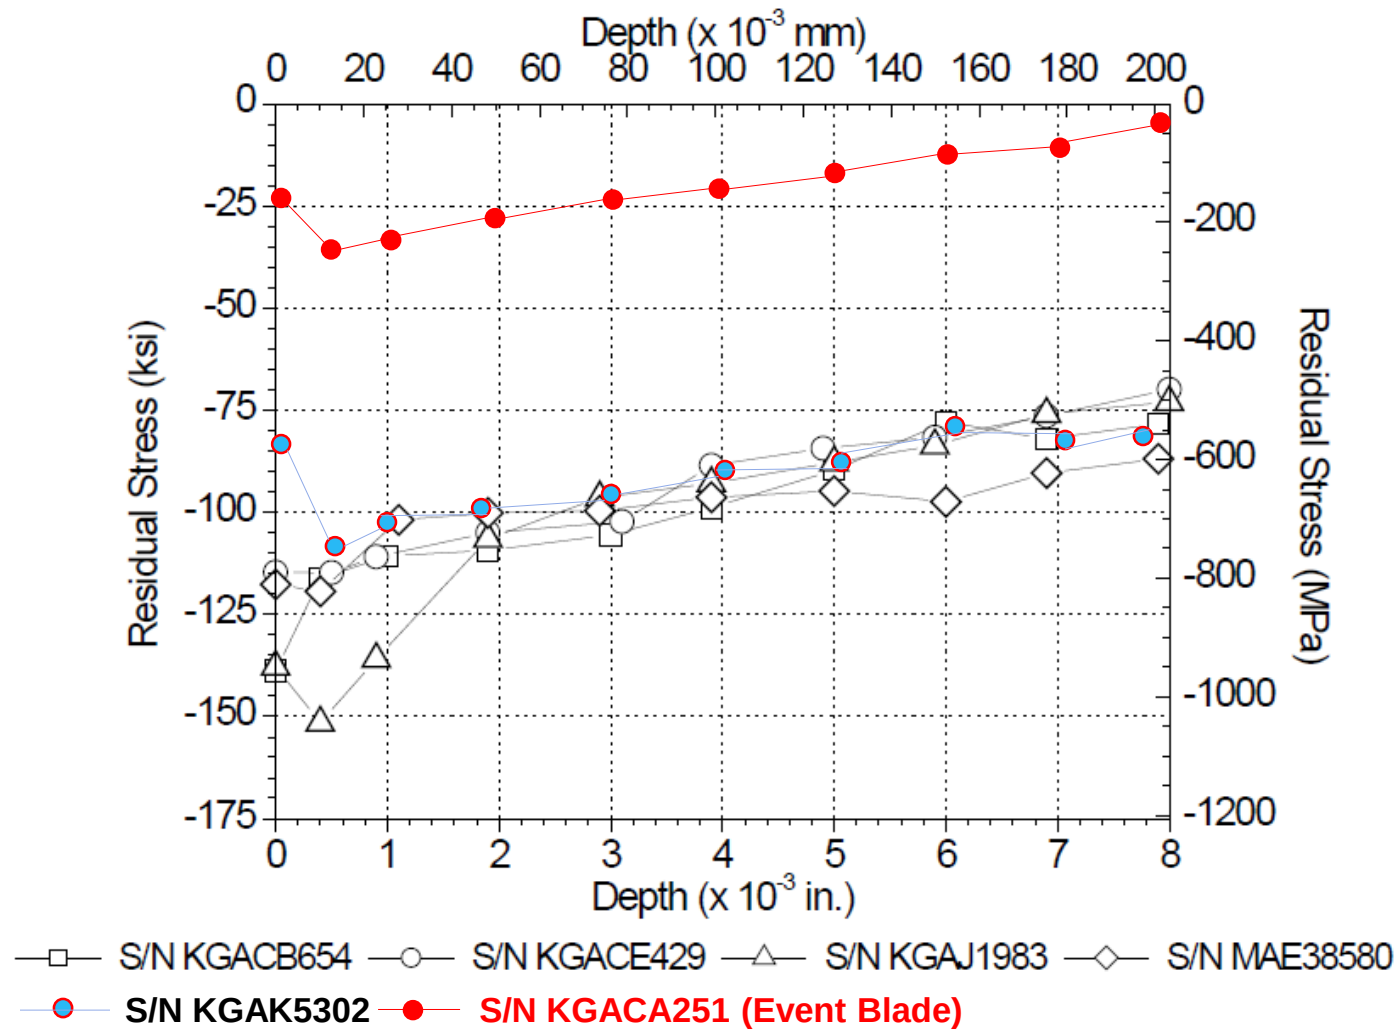
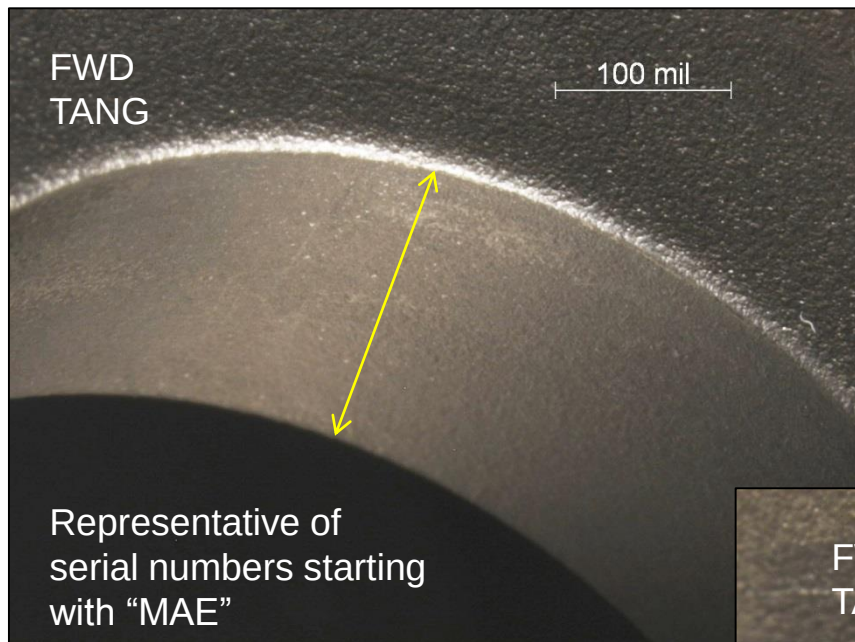
Visual examination of the blade set from ESN 873-642 revealed that one blade (No. 09) with a "KGA" serial number similar to the event blade S/N KGACA251 exhibited pin hole radii much larger than the remaining twenty-six (26) blades. Subsequent measurements revealed blade No. 09 had radii that exceeded the maximum allowed per the drawing. Measurements of the failed blade (No. 22) showed it also had radii exceeding the drawing limit. Subsequent analysis showed this condition had a minimal effect on stress and was not considered a major contributor.

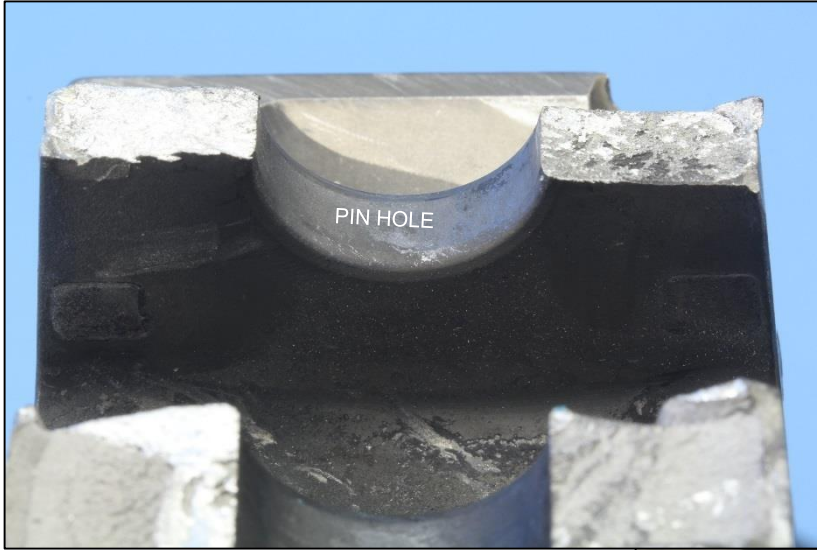
## FWD TANG

Views of the forward tang from the event blade showing the contact area in the pin hole.

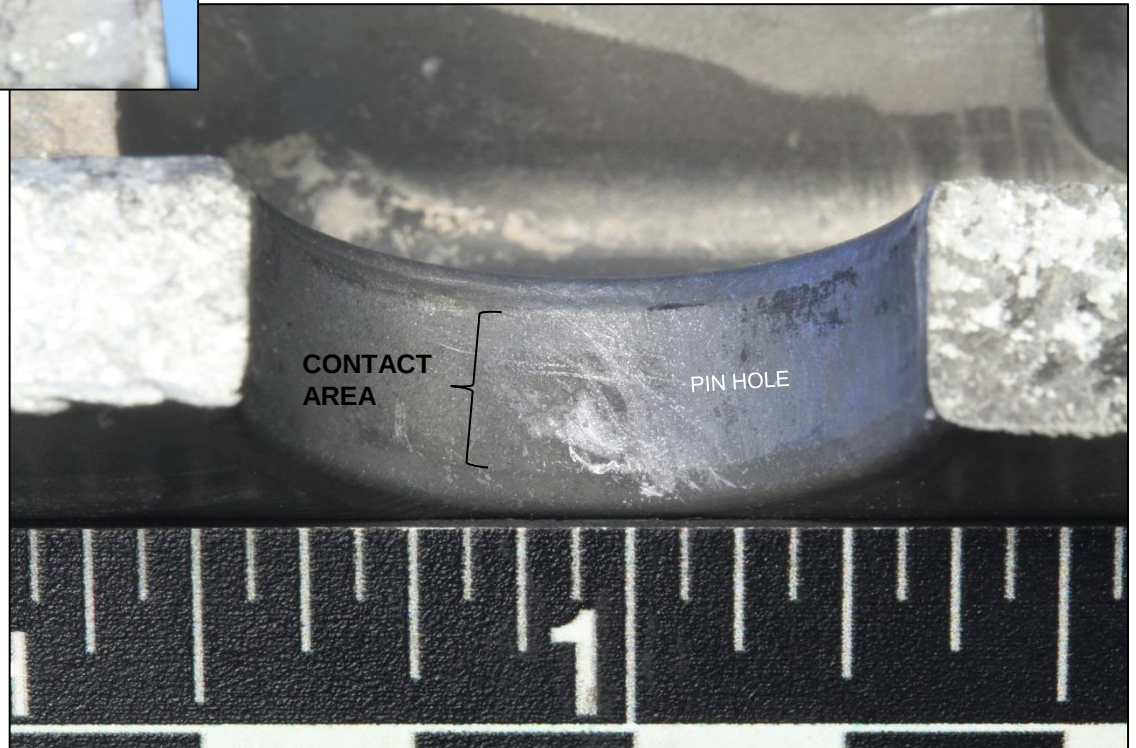
Views of the forward tang from the event blade showing the contact area in the pin hole. The excerpt from the drawing shows the radii to be over the maximum limit of 0.040 inch.

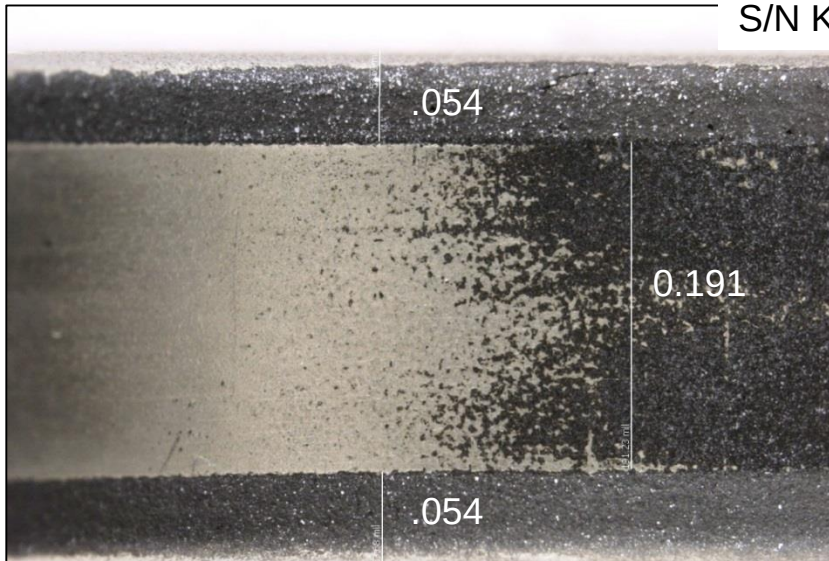
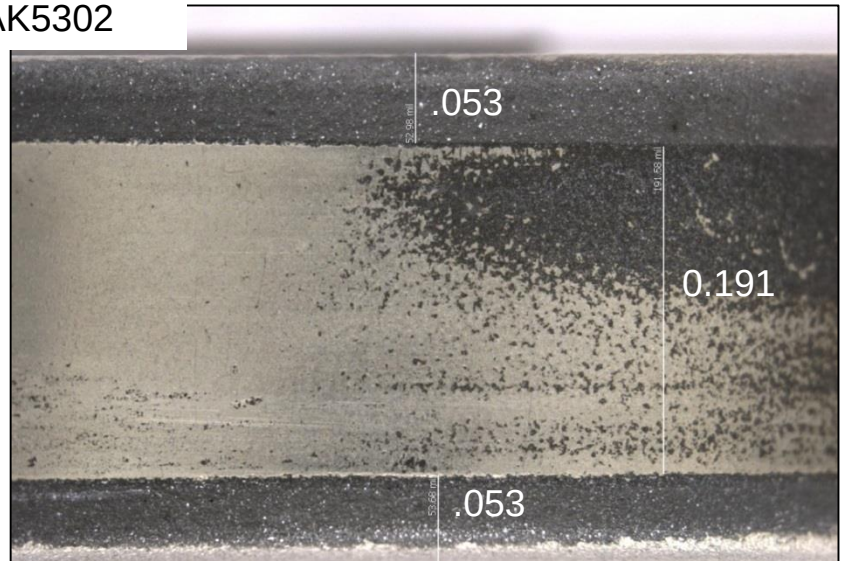
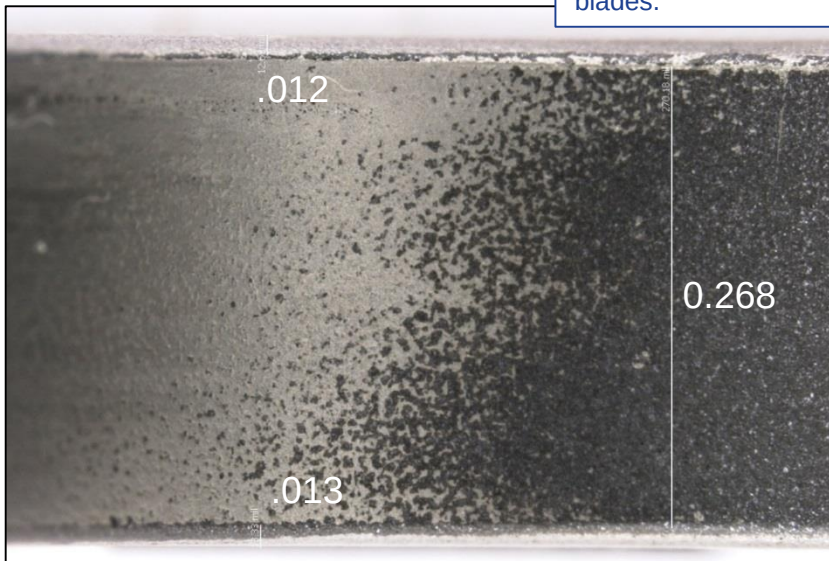
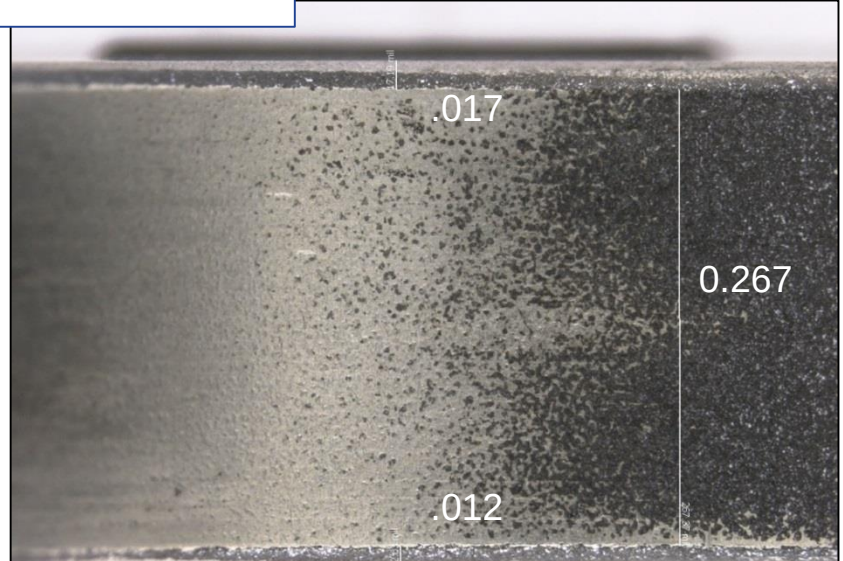
Representative photos showing the contact area difference between the "MAE" and the "KGA" fan blades.
