**NATIONAL TRANSPORTATION SAFETY BOARD**  
**Office of Aviation Safety**  
**Washington, D.C. 20594**

**POWERPLANT GROUP CHAIRMAN'S FACTUAL REPORT**  
**NTSB No: ENG17IA017**

Location: Dayton, Ohio

Aircraft: McDonnell Douglas MD-83, N881GA, Allegiant Air, LLC, Flight 636

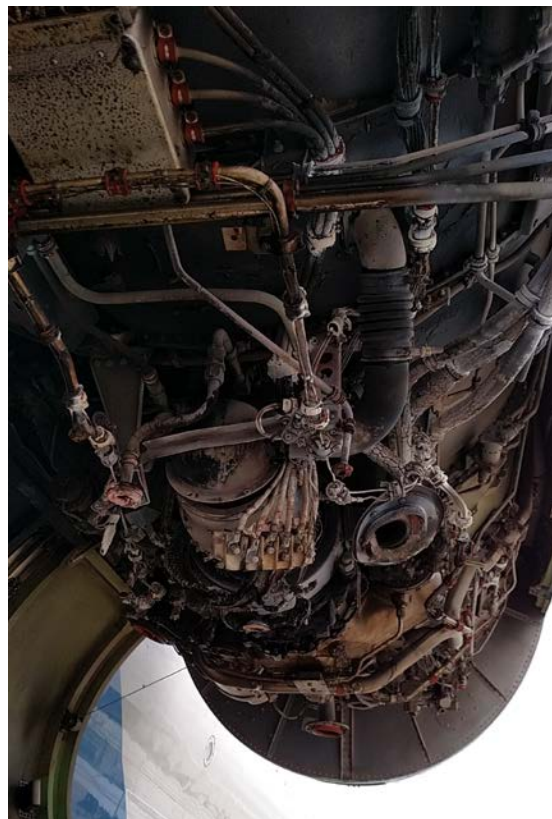
**Photo 1- Bottom of the Engine Prior to Removal from Airplane**

Allegiant Air maintenance crews provided photographs of the engine and cowl damage after the incident. Sooting and discoloration were concentrated at the 6 o'clock position around the generator and CSD (**Photo 1**). The external engine lines in the area exhibited thermal damage. There was oil pooling and loose metal fragments resting in the cowl at the 6 o'clock position. The CSD-to-oil cooler return line was severed in-line with the plane of rotation of the generator rotor (**Photo 2**). The generator case was fragmented and mostly missing.

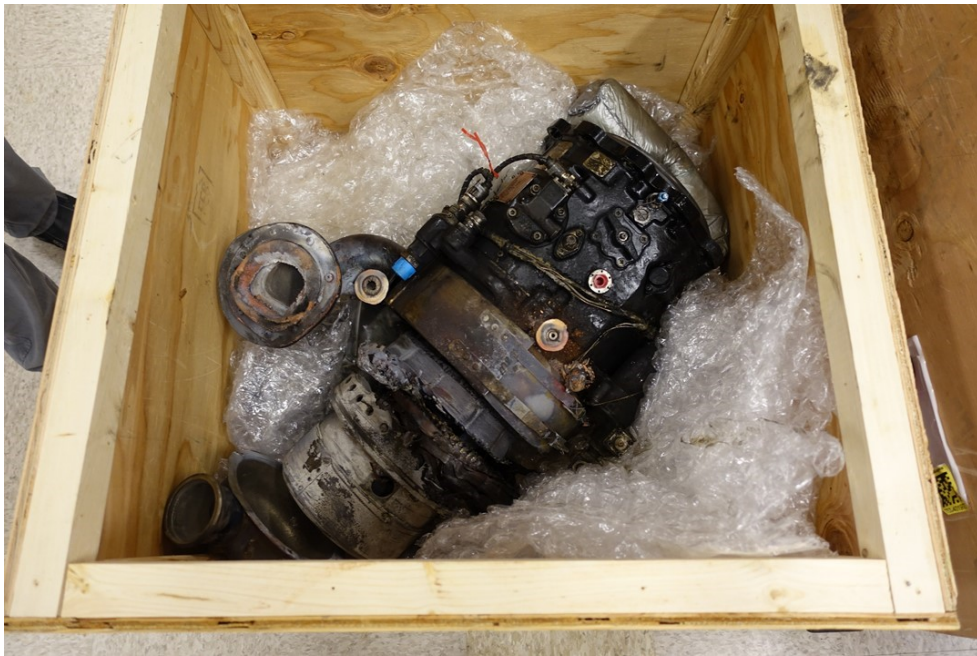
**Photo 3- CSD and Generator, As Received**

The constant speed drive and generator were secured in a wooden crate as an assembly when the investigative team arrived (**Photo 3**). The CSD chip detector plug had been removed prior to shipment and was in a plastic bag attached to the CSD with a twist tie. The chip detector had metal debris accumulation on the magnetic electrode (**Photo 4**). All CSD and generator external surfaces were discolored and heavily sooted. The CSD harness spiral wrap and wires exhibited thermal damage, including charring and melting of the wire jackets. No oil was visible in the CSD oil sight glass. The CSD to engine accessory gearbox mounting lugs were all intact and in good condition. The CSD mounting pad forward face had witness marks from the 11 to 6 o'clock positions, consistent with gearbox adapter ring flat head screw contact (**Photo 5**). The cooling air exhaust duct that is integral to the shroud assembly between the CSD and generator had a crack at the elbow and the seal was thermally damaged. The metal surrounding the seal was deformed.

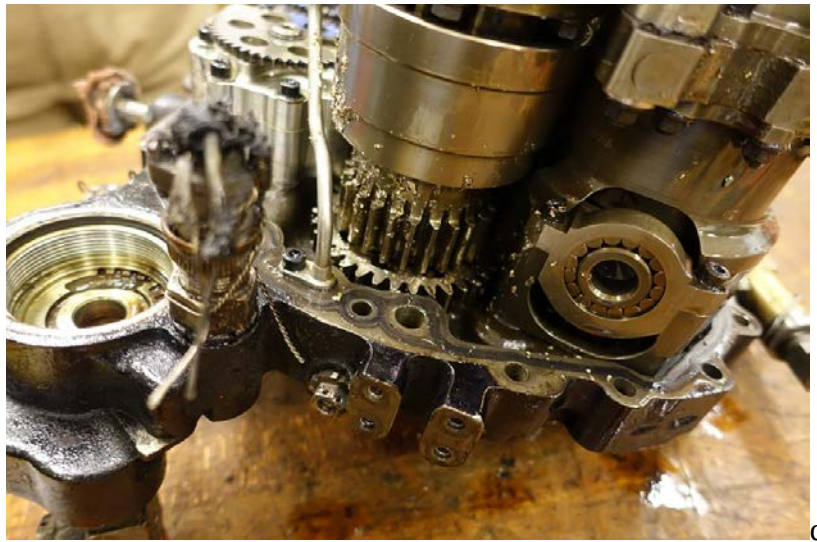
**Photo 6- CSD Internal Gears**

The CSD was separated from the generator for disassembly. The CSD input spline could not be manually rotated. The oil filter was removed, and a small amount of fine metal debris was observed in the filter pleats. After removal of the CSD case, all visible gears were intact. Fine metal debris was observed on all internal surfaces and some larger ferrous objects, including hydraulic pump and motor piston fragments were separated and loose in the case (**Photos 6 and 7**). The CSD-to-generator disconnect was not extended.<sup>4</sup> The CSD shaft and bearings were intact and the bearings could be individually rotated with some resistance.

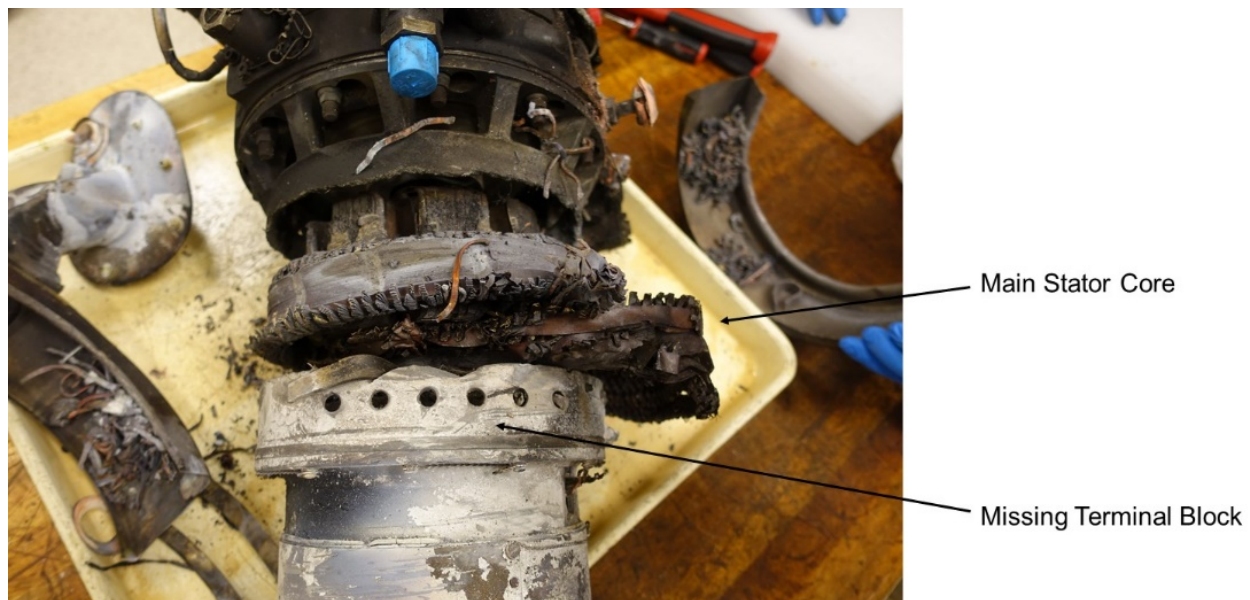
**Photo 8- Generator Case Damage**

The middle section (about 4.75 inches) of the main generator frame case was separated and missing 360 degrees around the generator. The main stator core was fractured into two pieces axially and the aft section was deformed and extruded about 5 inches radially out of the generator case (**Photo 8**). The cases over the exciter and permanent magnet generator (PMG) were mostly intact but exhibited circumferential scoring and thermal damage. The terminal block and leads were separated and missing. The impeller fan located on the aft end of the was missing all vanes and the remaining section of the fan forward frame exhibited heavy rub damage (**Photo 9**). The forward generator drive end was thermally damaged. The balls in the forward bearing were all present but the bearing shields were separated, and the grease was consumed. The bearing could be rotated with light resistance. The generator spindle splines were intact and in good condition (**Photo 10**). The generator spindle did not
