NATIONAL TRANSPORTATION SAFETY BOARD  
OFFICE OF AVIATION SAFETY  
WASHINGTON, D.C. 20594

**POWERPLANTS GROUP CHAIRMAN'S FACTUAL REPORT**

NTSB ID No.: ENG17IA026

Location: G344 airway northeast of CUTE intersection  
Date: June 7, 2017  
Time: 0950 universal coordinated time  
Aircraft: Boeing 747-451, N668US, Delta Air Lines flight 276

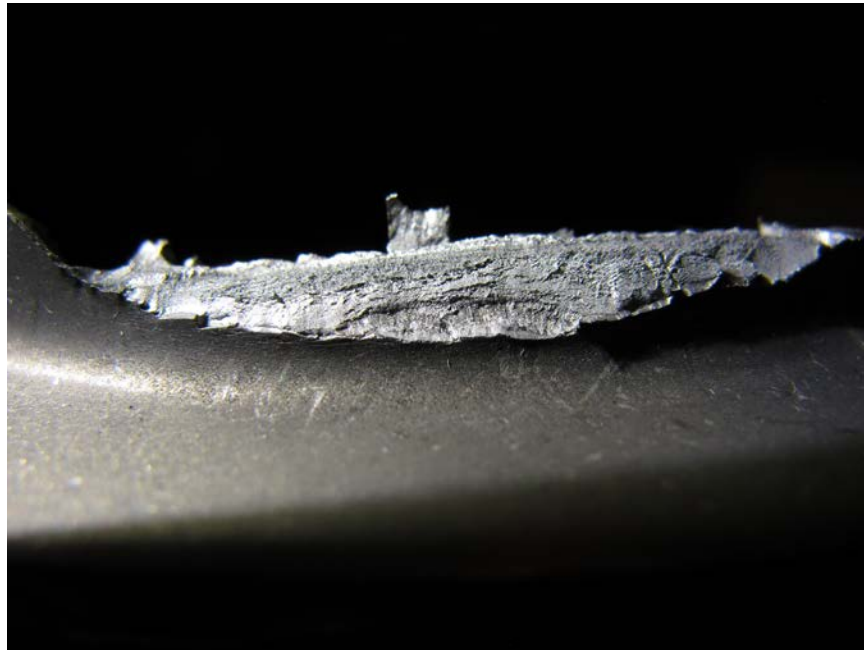
All of the 5th stage compressor blades were fractured through the airfoil between the blade root platform and about 0.85-inches above the blade root platform. Several of the 5th stage compressor blades were displaced aft of their normal installed position. There was evidence of the orange RTV [room temperature vulcanizing] rubber on the blade locks that corresponded to the orange RTV noted in the 5th stage compressor disk's blades slots. The front and rear faces of the blade root platforms as well as the front and rear faces of the blade roots had circumferential rubbing damage. There was one 5th stage compressor blade, part number (PN) 58H305, that had a flat, planar fracture surface with an elliptical-shaped area radiating from the convex side of the root max thickness area of the blade.<sup>7</sup> (Photo No. 1)

Photo No. 1: Close up view of 5th stage compressor blade fracture surface showing an elliptical shaped area radiating from the convex side of the airfoil. (P&W)

The examination of the 5th stage compressor blades revealed fracture surfaces that were either consistent with overstress or were too damaged and smeared to determine the cause of the separation. The P&W Materials Laboratory reported that the damage to the 5th stage compressor blades as well as the other HPC blades was consistent with previous 5th stage compressor blade primary fractures. (Refer to Section 2.3)

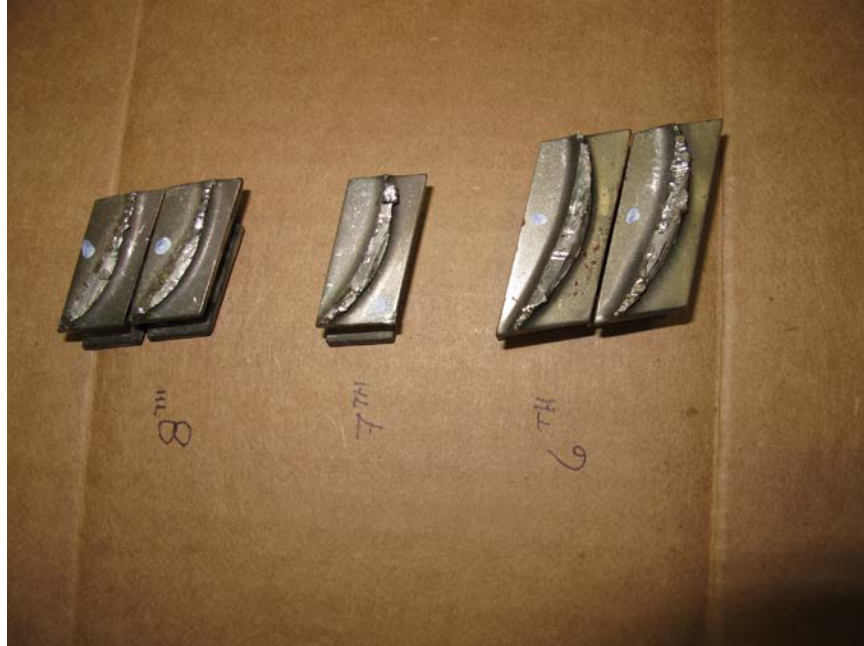
All of the 6th and 7th stage compressor blades were fractured through the airfoil between the blade root platform and about 0.28-inches above the blade root platform. Over half of the 6th and 7th stage compressor blades had fracture surfaces with elliptical-shaped features on the convex side of the airfoil in the mid-chord area. (Photos Nos. 2, 3, and 4)

Photo No. 2: 6th, 7th, and 8th stage compressor blades fractured transversely across the airfoil adjacent to the blade root platform. (P&W)

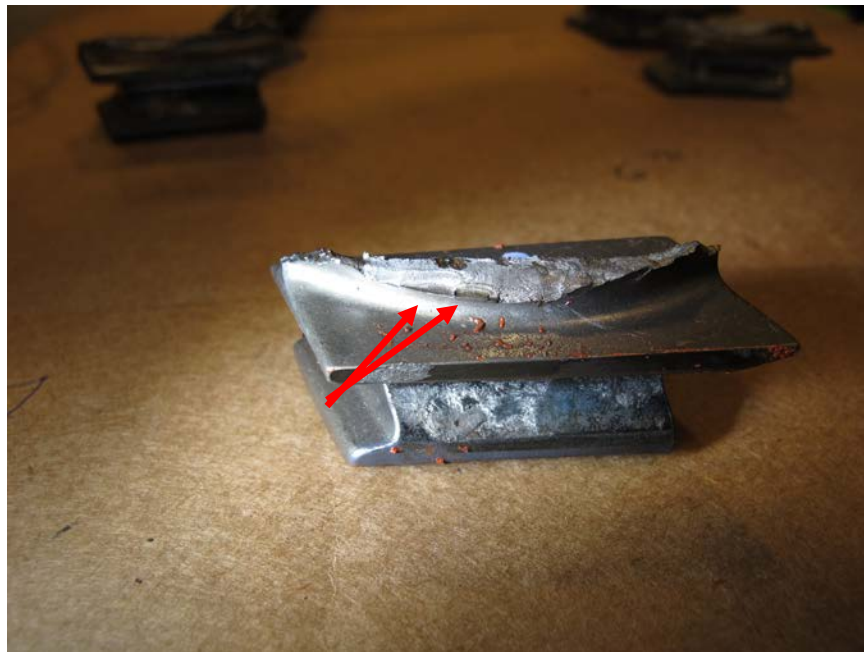
Photo No. 3: Close up view of a 6th stage compressor blade showing two elliptical-shaped areas on the convex side of the fracture surface. (P&W)

The examination of the 6th and 7th stage compressor blades revealed that all of the blades were fractured transversely across the airfoil adjacent to the blade root platform. The examination of the blades' fracture surfaces showed mostly overstress features or were smeared due to secondary damage. The examination of the 6th and 7th stage blades did reveal a number of blades that had shallow thumbnail-shaped fatigue progressions from multiple origins on the convex side of the airfoil in the mid-chord area. The lab report stated that none of these fatigue progressions were primary to the engine event.

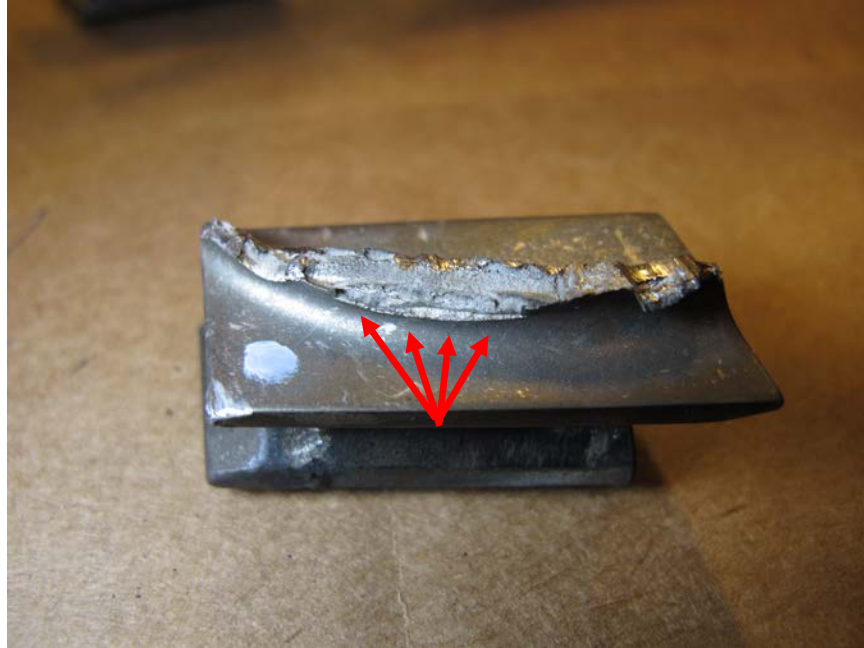
Photo No. 4: Close up view of a 7th stage compressor blade showing elliptical-shaped area on the convex side of the fracture surface. (P&W)

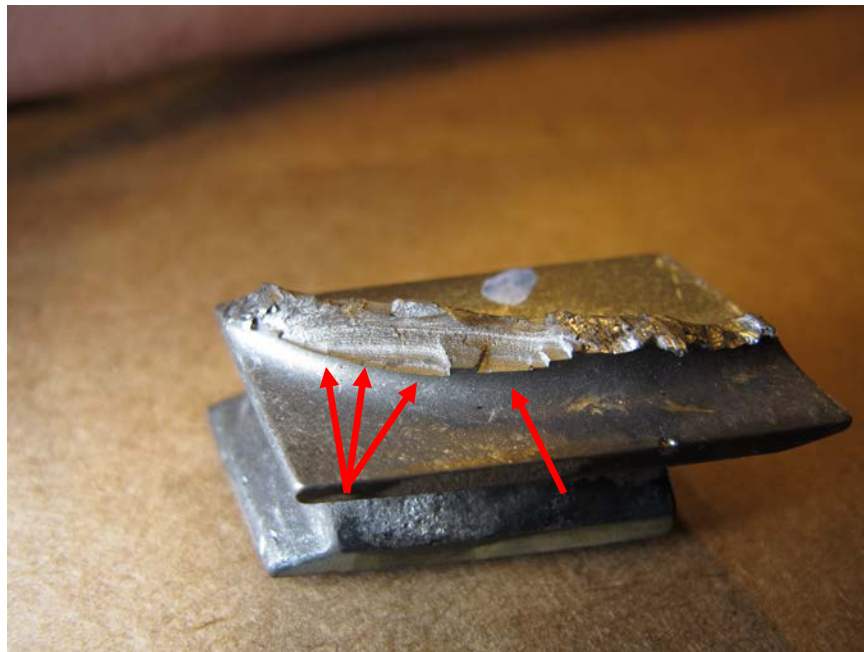
All of the 8th stage compressor blades were fractured through the airfoil between the blade root platform and about 0.2 inches above the blade root platform. There were a number of 8th stage compressor blades that had elliptical-shaped areas on the fracture surfaces on both the convex and concave surfaces in the mid-chord area. (Photo No. 5)

Photo No. 5: Close up view of an 8th stage compressor blade showing several elliptical-shaped areas on the convex side of the fracture surface. (P&W)

The examination of the 8th stage compressor blades showed that they were also all fractured transversely across the airfoil adjacent to the blade root platform. The lab report stated that the fracture surfaces were heavily smeared from secondary damage. However, there were features on the fracture surfaces that indicated that the fatigue progression was from multiple origins along the convex side of the airfoil. There were several blades that had fatigue progressions from both the convex and concave surfaces that according to the lab report was indicative of reverse bending. The lab report stated that some blades had fatigue cracks that had progressed through the thickness of the airfoil. The lab report also stated that none of these fatigue progressions were primary to the engine event.

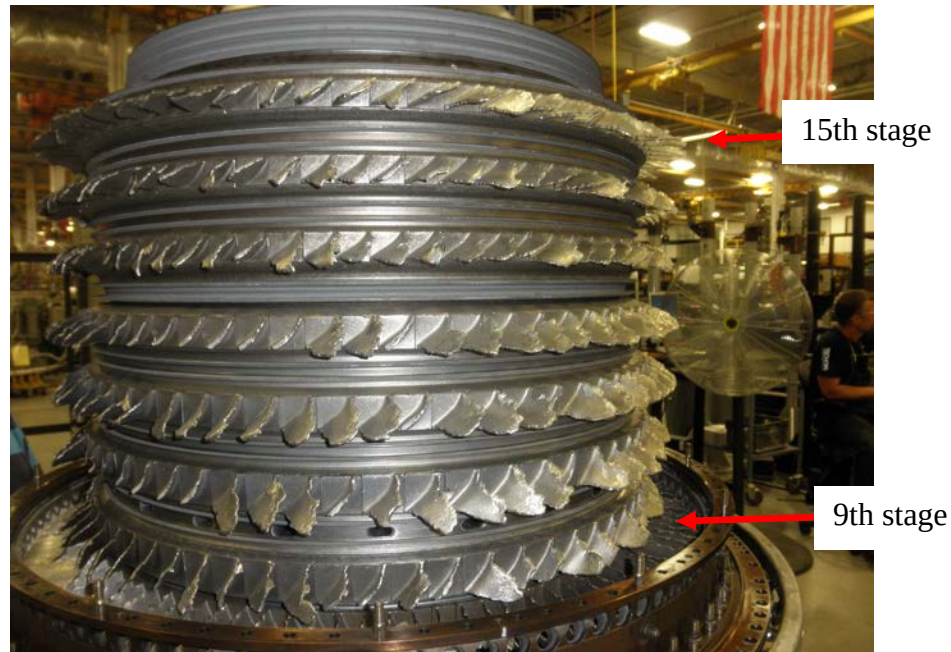
All of the 9th stage compressor blades were fractured through the airfoil between the blade root platform and about 1.5-inches above the blade root platform. (Photo No. 6) There was one 9th stage compressor blade that had elliptical-shaped areas on the fracture surfaces on both on the convex and concave surfaces in the mid-chord area. The longer blades were bent opposite the direction of rotation. (Photo No. 7)

Photo No. 6: View of HPC stages 9 through 15 showing damaged, fractured, and bent airfoils. (P&W)

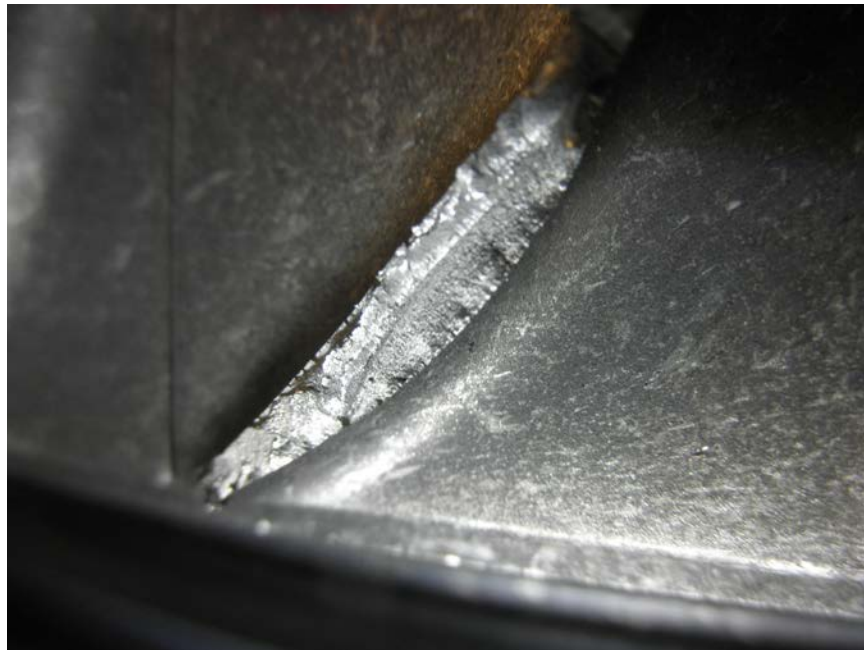
Photo No. 7: Close up view of a 9th stage compressor blade showing elliptical-shaped area on the convex side of the fracture surface. (P&W)

The examination of the 9th stage compressor blades showed that they were all fractured across the airfoils at various lengths above the blade root platform. The fracture surfaces on all of the blades except one were indicative of overstress and/or were damaged due to smearing and secondary damage. There was one 9th stage compressor blade that was fractured between about 0.010- and 0.020-inches above the blade root platform that had fatigue progressions from multiple origins along the convex and concave sides of the airfoil in the mid chord area that was indicative of reverse bending. The lab report stated that the fatigue was not primary to the engine event. The lab report stated that 38 of the 9th stage compressor blades had multiple cracks in the mid chord area predominately on the convex side of the airfoil adjacent to the blade root platform. Those cracks were broken open and found to be small, shallow fatigue cracks. According to P&W, similar fatigue cracking had been noted on other PW4000 engines following repeated surge (compressor stall) events. P&W also noted that the fatigue cracking could have been the result of the unusual aerodynamic and vibratory stresses that occurred during the run down of the HPC rotor after the event occurred or due to the multiple impacts of upstream debris cascading through the engine.

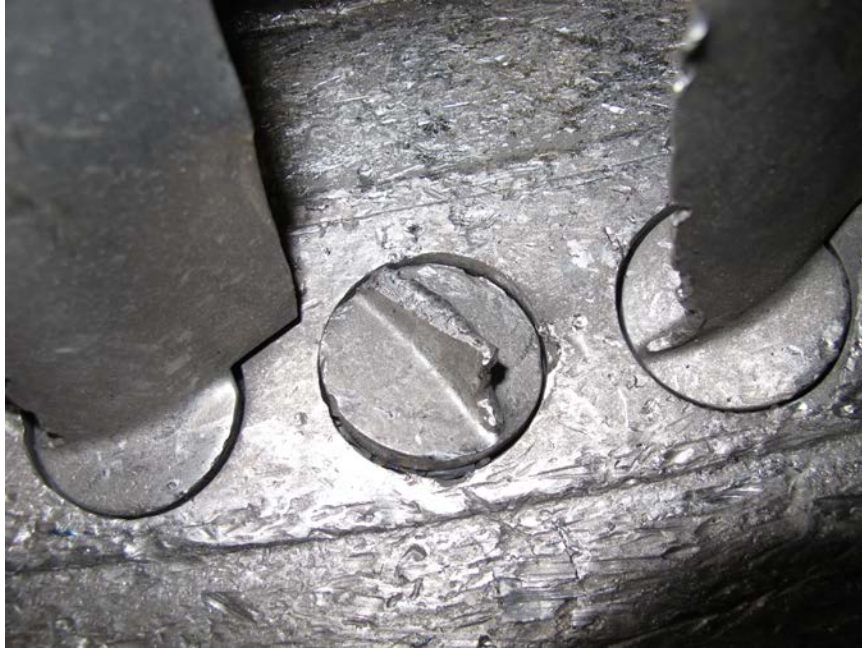
All of the 5th stage variable stator vanes (VSV) were in place except for two, one in the upper case and one in the lower case, that were fractured transversely across the airfoil adjacent to the outer button. The outer buttons for the two fractured VSVs were not flush with the HPC front case flow path. The fractured VSV that was in the upper compressor case had a flat planar fracture surface along the concave side of the airfoil. (Photo No. 8) The fracture surface of the VSV in the lower compressor case half was coarse and irregular. (Photo No. 9) The 5th stage VSV airfoils had nicks and dents on the leading and trailing edges. Although the VSV rigging check showed that the VSVs were in rig, the vanes were at various angles when the front compressor case was opened.

Photo No. 8: View of the fractured outer end of the 5th stage VSV in the upper compressor case half. (P&W)

Both of the fractured 5th stage compressor VSVs were examined at P&W's Materials Laboratory. Both of the VSVs were fractured transversely across the airfoil directly adjacent to

the outer button. The report stated the examination of the two VSVs showed that the fracture surfaces were heavily damaged. The examination of the undamaged portions of the fracture surfaces on each VSV did not show any evidence of fatigue.

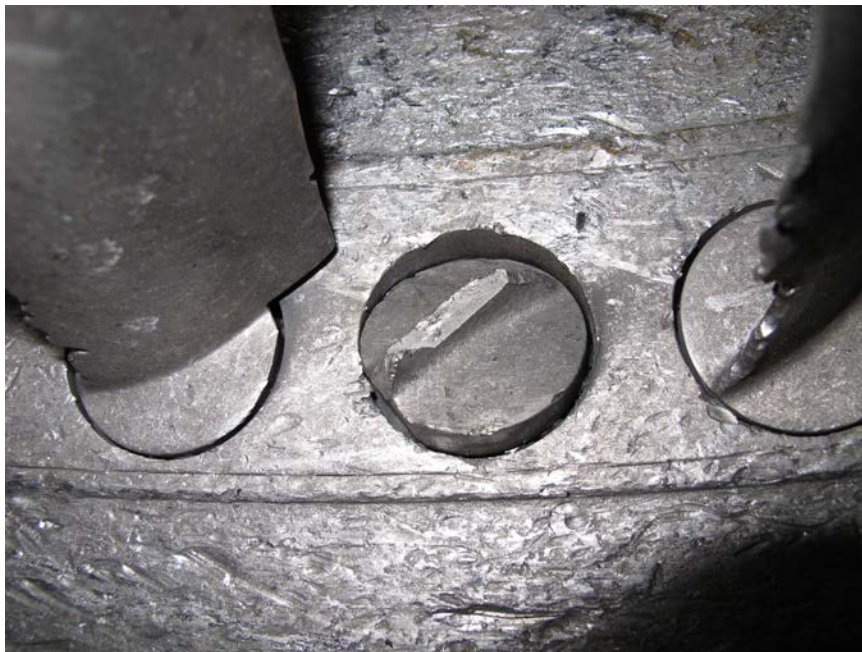
Photo No. 9: View of the fractured outer end of the 5th stage VSV in the lower compressor case half. (P&W)

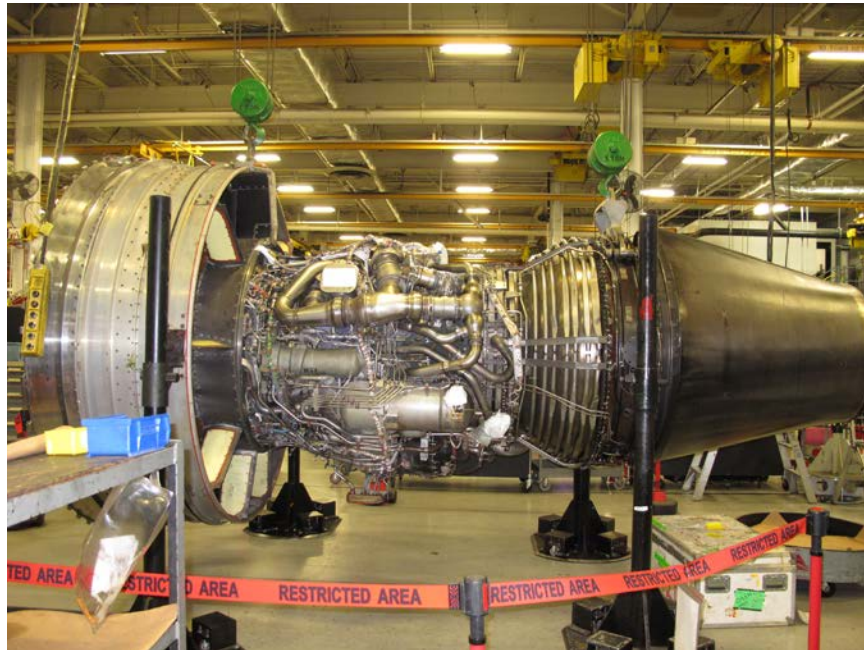
The engine was complete from the fan case front flange and the spinner cap to the exhaust nozzle aft edge. The tail plug was still in place on the rear of the turbine exhaust case inner duct. The engine did not have any indications of an uncontainment, case rupture, or an under cowl fire. (Photos Nos. 10 and 11) There was no notable distress to the front and rear engine mounts. (Photos Nos. 12 and 13) There were no indications of leakage of a flammable fluid.

Photo No. 10: View of left side of engine showing no indications of an uncontainment, case rupture or an undercowl fire. (P&W)

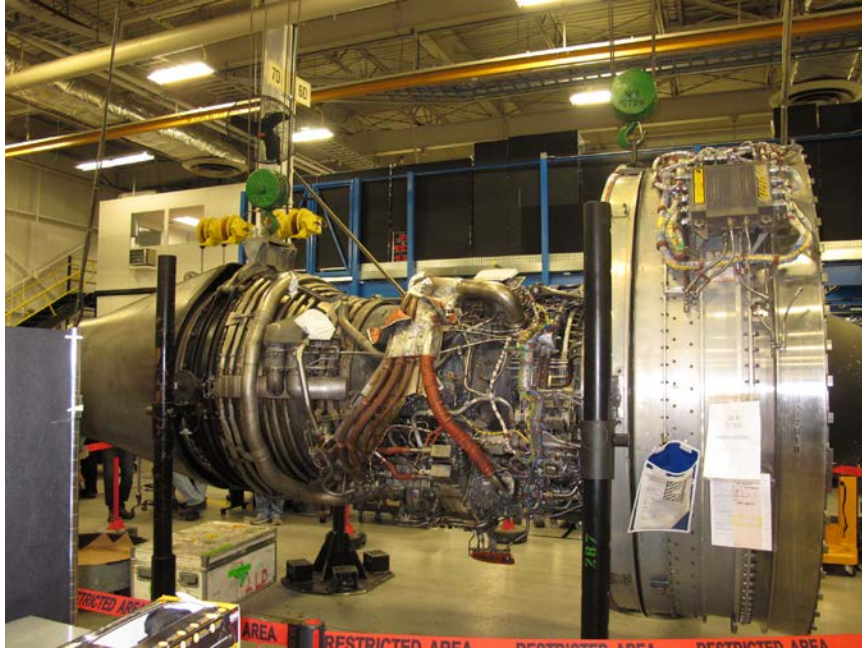
Photo No. 11: View of right side of engine showing no indications of an uncontainment, case rupture, or an undercowl fire. (P&W)

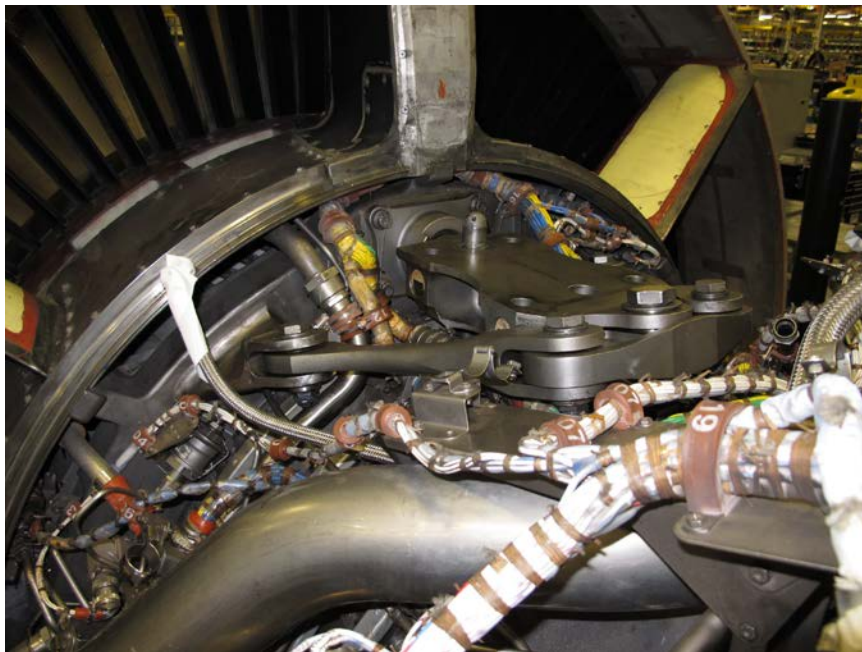
Photo No. 12: View of forward engine mount showing no apparent distress. (P&W)

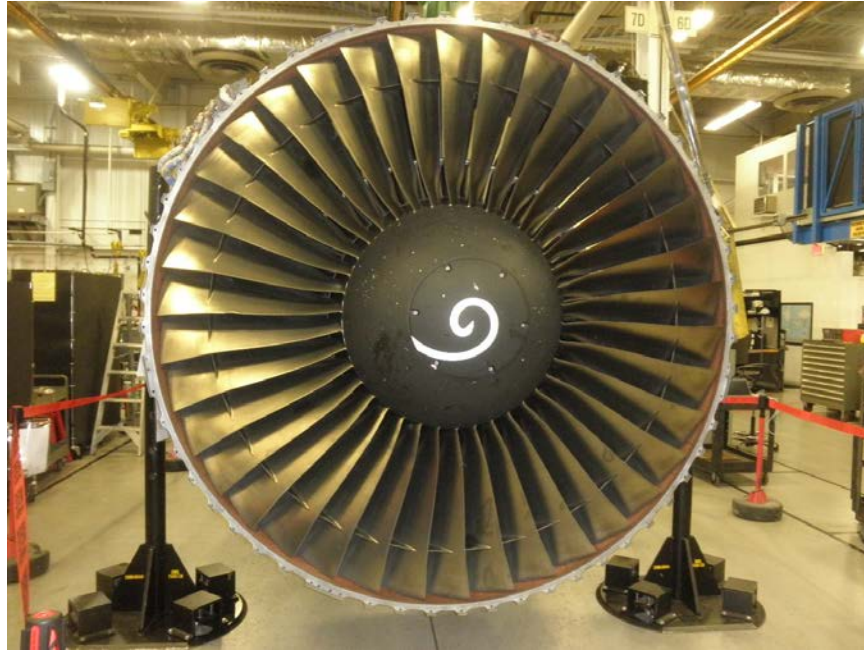
The front compressor hub was undamaged. All of the fan blades were in place and did not have any unrepaired damage. (Photo No. 14) The tips of the fan blades did not have any indications of rubbing with the fan blade rub strip. There were two fan blades that had areas on the leading edge that had been previously blend repaired. The mid span shrouds were not shingled and they did not have any evidence of having been shingled.<sup>9</sup>

Photo No. 14: View of front of the engine showing the spinner, spinner cap, and all of the fan blades were in place and that there was no damage to any of those components. (P&W)

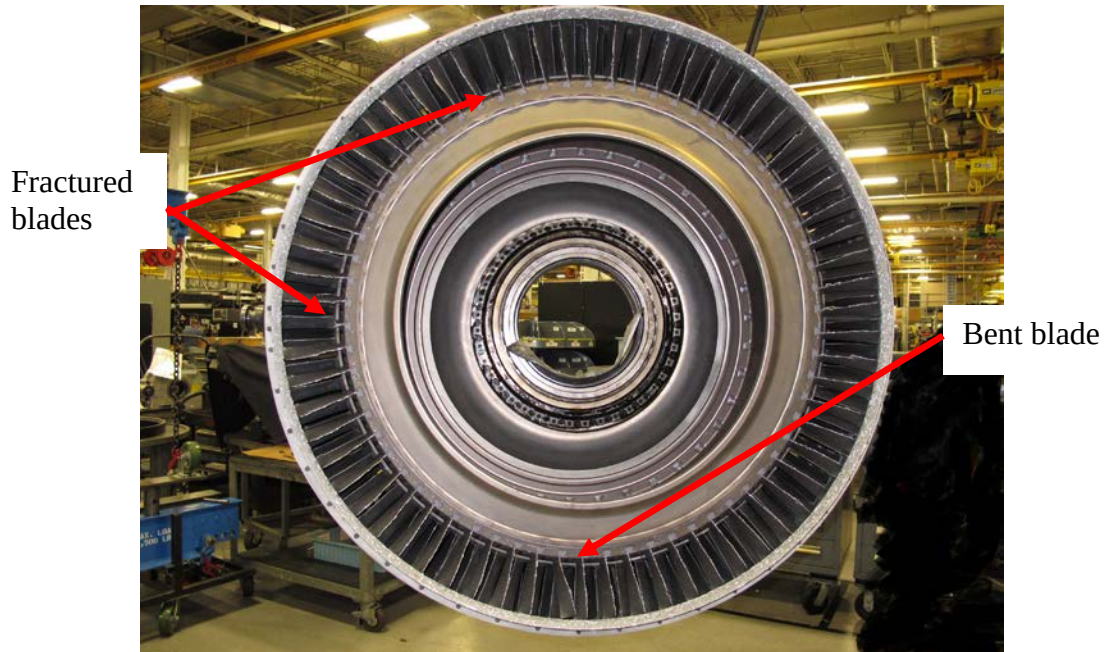
The 4th stage compressor blades were all in place. (Photo No. 15) There were two blades that were fractured transversely across the airfoils about 0.5- and 0.75-inches above the blade root platform. The fractured blades' fracture surfaces had shear lips at an angle to the

Photo No. 15: View of rear of the LPC showing all of the 4th stage compressor blades are in place, although two are fractured and one is bent opposite the direction of rotation. (P&W)

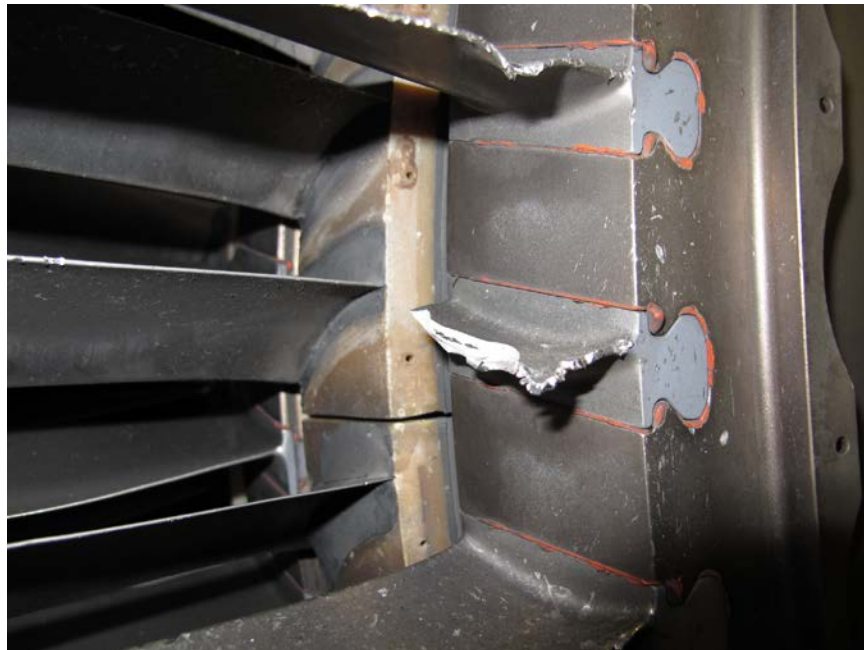
surface of the airfoil. (Photos Nos. 16 and 17) All of the 4th stage compressor blades had nicks and dents along the trailing edges and many of the blades had nicks and dents on the leading edges. There were two blades that had small tears on the trailing edge. There was one blade that was bent opposite the direction of rotation. (Photo No. 18) The 4th stage compressor blade rub strip had circumferential gouges around the entire circumference.

Photo No. 16: Close up view of fractured 4th stage compressor blade. (P&W)

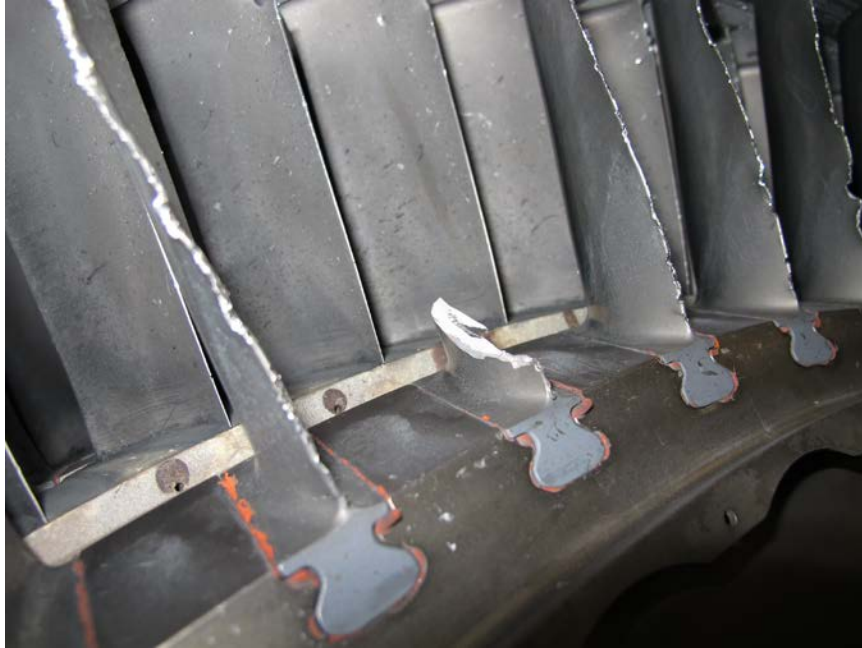
Photo No. 17: Close up view of fractured 4th stage compressor blade. (P&W)

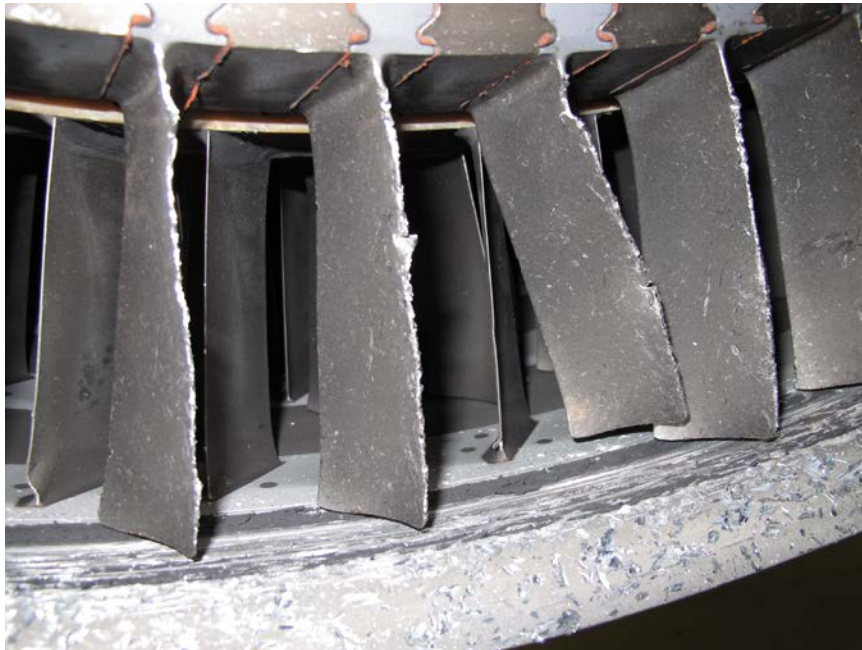
Photo No. 18: Close up view of bent 4th stage compressor blade also showing damage to the trailing edges of the other 4th stage compressor blades. (P&W)

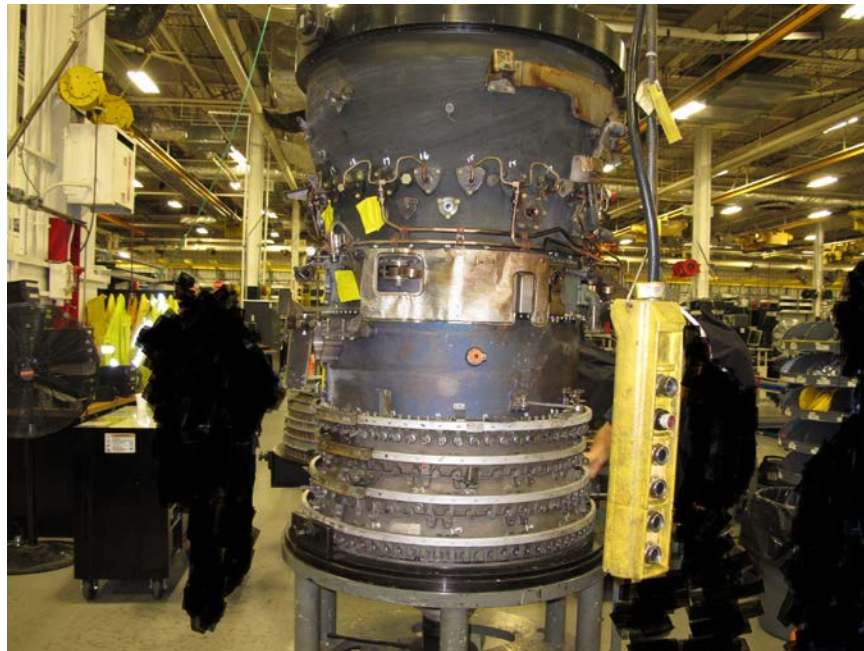
The exterior of the compressor upper and lower front split cases and the rear compressor case did not have any damage. (Photo No. 19) The interior of the upper and lower front split cases had circumferential scoring and rub marks on the compressor blade rub strips and scoring between the VSV airfoils. (Photo No. 20) The HPC ring case did not have any thermal distress. The three HPC heatshields under the ring case were in place and did not have any thermal distress.

Photo No. 19: View of HPC showing all of the VSV rings were in place and no exterior damage to the front and rear compressor cases. (P&W)

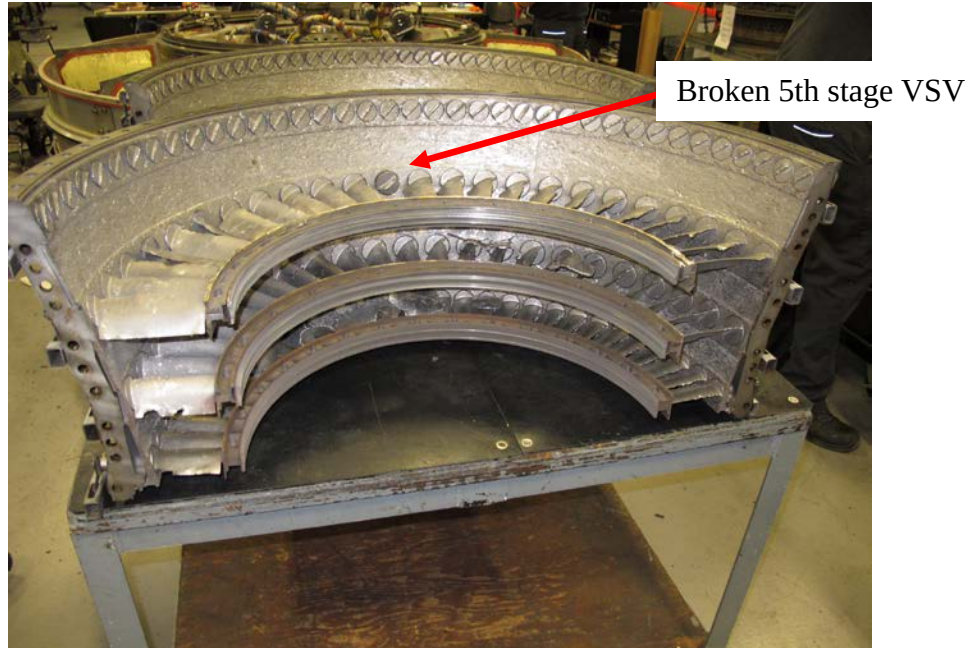
Photo No. 20: View of the interior of a front HPC case half showing circumferential scoring and gouging in the HPC blade rub strips. Also shown are the HPC IGVs and the HPC 5th stage VSV broken adjacent to the outer button. (P&W)

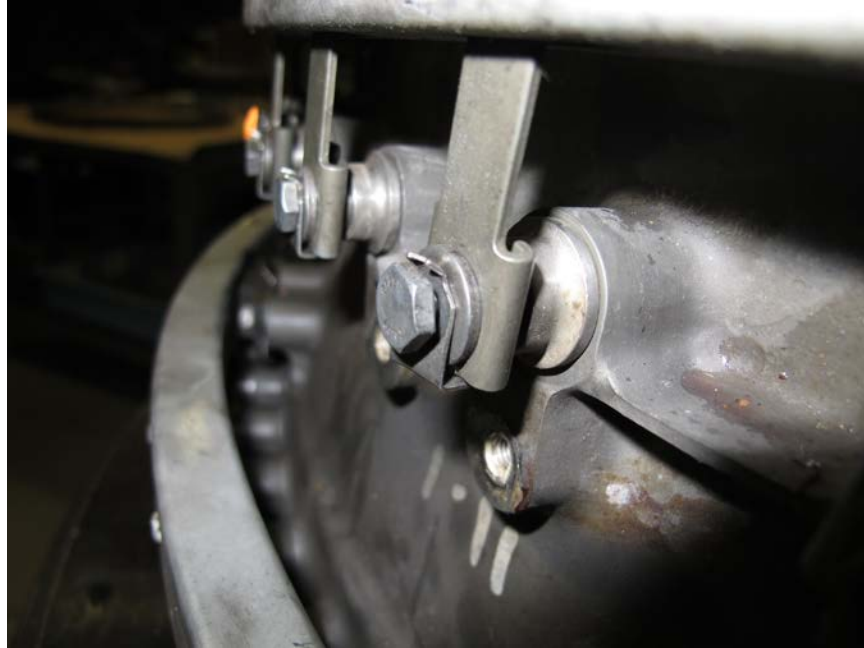
The VSV bell crank could be moved from the open to closed to open position using a wrench with a crowfoot wrench adapter. When the bell crank was moved, metallic sounds could be heard from within the front compressor case. When the bell crank was moved, all four stages of the unison rings moved concurrently. The rigging of the VSVs was checked and it was found to be in rig. All of the inlet guide vanes (IGV), 5th, 6th, and 7th stage unison rings were in place. The IGV and the 6th and 7th stage VSV lever arm claws were in place and engaged with the vane stems with the bolts and tab locks in place. The 5th stage VSV lever arm claws were in place and engaged with the vane stems, but there were five locations where the tab locks had twisted out of position (Photo No. 21) and the respective bolt was loose. In addition, there were two locations where the bolt and tab locks were missing. (Photo No. 22) The tack welds on the IGV, 5th, 6th, and 7th stage unison rings were intact.

Photo No. 21: Close up view of a 5th stage VSV lever arm with the tab lock twisted out of position. (P&W)

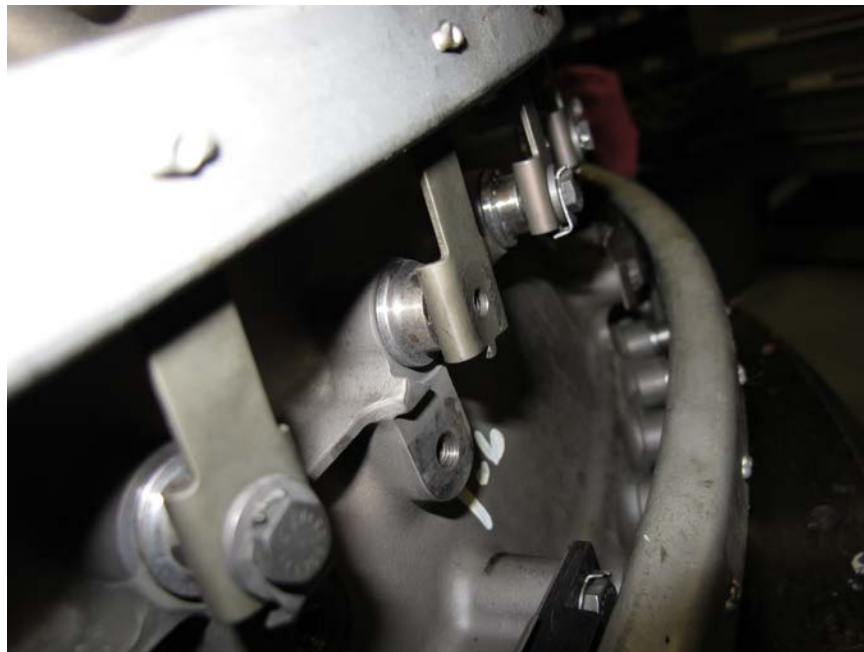
Photo No. 22: Close up view of a 5th stage VSV lever arm showing the bolt and tab lock missing. (P&W)

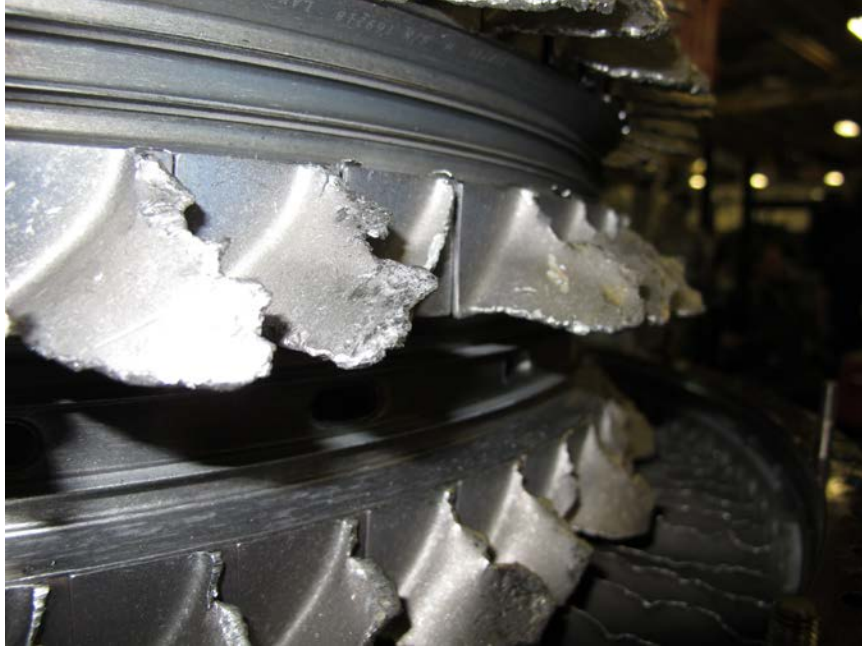
The 10th stage compressor blades were all in place. (Refer to Photo No. 6) Of the 62 10th stage compressor blades, there were 17 blades that were fractured transversely across the airfoil adjacent to the blade root platform. The blades that were fractured adjacent to the blade root platform were distributed randomly around the entire rotor. The fracture surfaces on those blades were coarse with an irregular shape and texture. The remaining 10th stage compressor blades were fractured across the airfoil between about 1- to 1.5-inches above the blade root platform. The blades had nicks and dents on the leading and trailing edges and on the concave sides of the airfoils. The leading edges were worn down at an angle from the blade root platform to the fractured end. There were several blades with pieces missing from the trailing edges as well as tears in the trailing edges. The ends of the blades were bent opposite the direction of rotation. (Photo No. 23)

Photo No. 23: Close up view of damaged 10th stage compressor blades. (P&W)

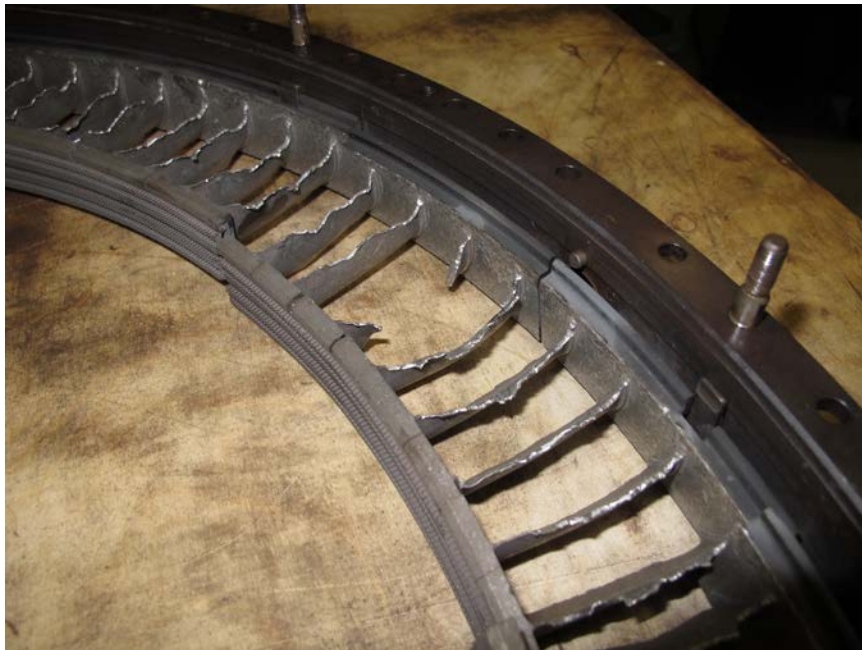
The 10th stage compressor stator segments were all in place and all of the 10th stage compressor stator vanes were present, although there were two vanes that had the center part of the airfoil, about 1.25- and 1.75-inches, missing. The vanes had nicks and dents on the leading and trailing edges and on the convex and concave surfaces of the airfoil. There were several vanes that had tears on the trailing edges. The trailing edges were bent in the direction of rotation. (Photo No. 24)

Photo No. 24: Close up view of the damaged 10th stage compressor stator. (P&W)

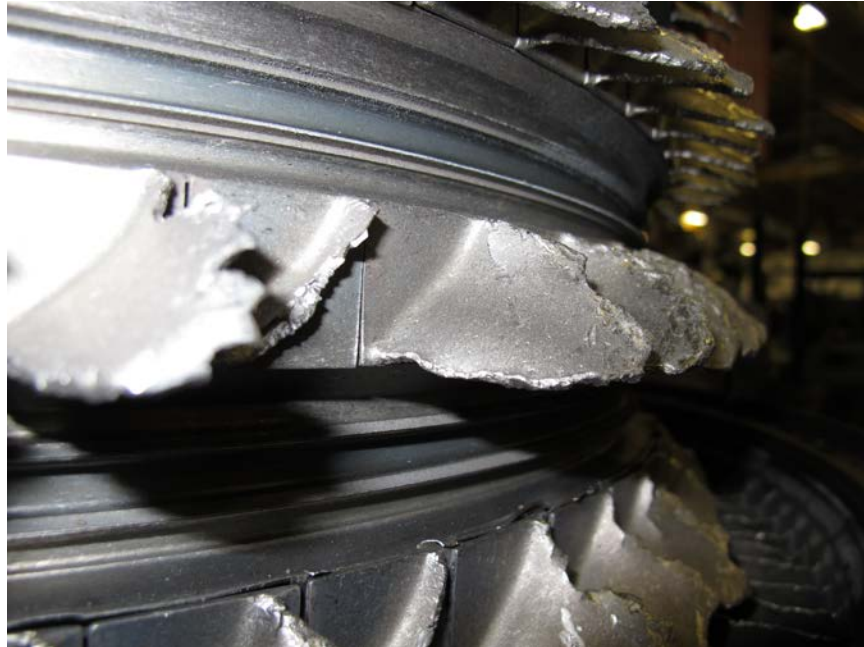
The 11th stage compressor blades were all in place. (Refer to Photo No. 6) Of the 68 11th stage compressor blades, there were 4 that were fractured transversely across the airfoil adjacent to the blade root platform. The four blades that were fractured adjacent to the blade root platform were distributed around the entire rotor. All of the remaining 11th stage compressor blades were fractured across the airfoil about 1.25-inches above the blade root platform. The blades' leading and trailing edges and concave airfoil surfaces had nicks and dents. The leading edges were worn back at an angle from the platform to the fractured end. There were several blades that had tears in the trailing edges. The ends of the blades were bent opposite the direction of rotation. (Photo No. 25)

Photo No. 25: Close up view of damaged 11th stage compressor blades. (P&W)

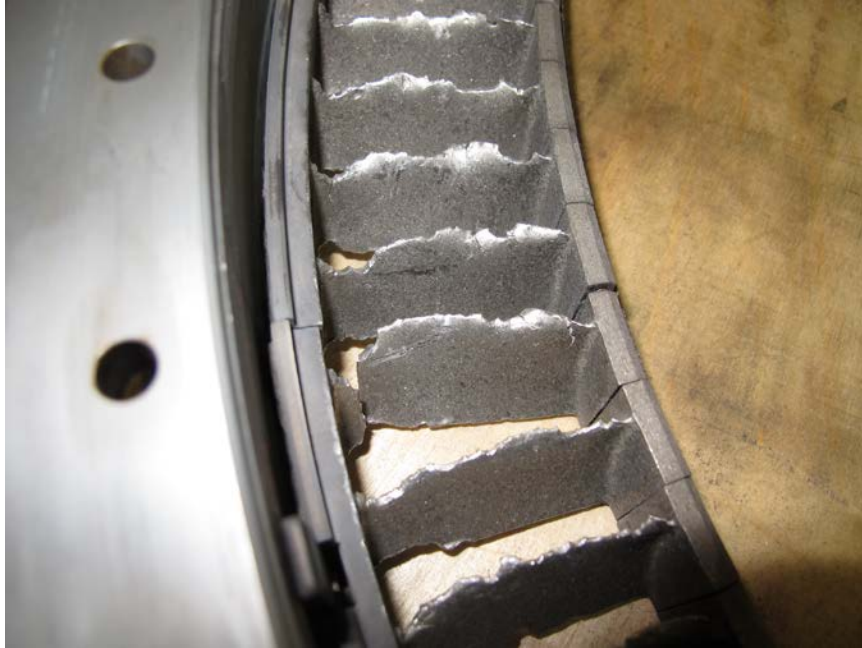
The 11th stage compressor stator segments were all in place and all of the 11th stage compressor stator vanes were in place. There were six compressor stator vanes that were fractured between the leading and trailing edges adjacent to the outer shroud. The leading and trailing edges and the airfoils' convex and concave surfaces had nicks and dents. There were pieces missing from the trailing edges. The trailing edges were bent in the direction of rotation. (Photo No. 26)

Photo No. 26: Close up view of damaged 11th stage compressor stator. (P&W)

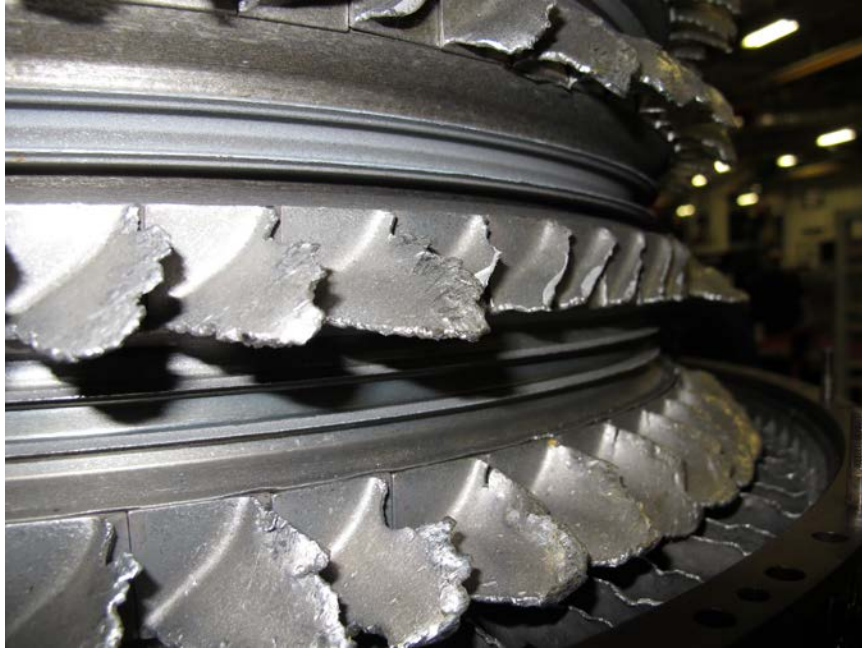
The 12th stage compressor blades were all in place. (Refer to Photo No. 6) Of the 72 12th stage compressor blades, there were 26 blades that were fractured transversely across the airfoil adjacent to the blade root platform. The blades fractured adjacent to the platform were distributed around the entire rotor. The remaining 12th stage compressor blades were all fractured across the airfoil between about 0.9- and 1.25-inches above the blade root platform. The fractured ends of the longer blades were bent opposite the direction of rotation. All of the 12th stage compressor blade airfoils had nicks and dents on the leading and trailing edges as well as the concave side of the airfoil. There were several 12th stage compressor blades that had tears in the trailing edge adjacent to the blade root platform. There were several of the 12th stage blades that were fractured adjacent to the blade root platform that had areas with planar elliptical-shaped fracture surfaces. The examination of those fracture surfaces showed that the elliptical-shaped areas were on the concave sides of the airfoil radiating towards the convex side surfaces. Additionally, the fracture surfaces were grainy with no indications of arrest marks and were surrounded by shear lips. (Photo No. 27)

Photo No. 27: Close up view of damaged 12th stage compressor blades. (P&W)

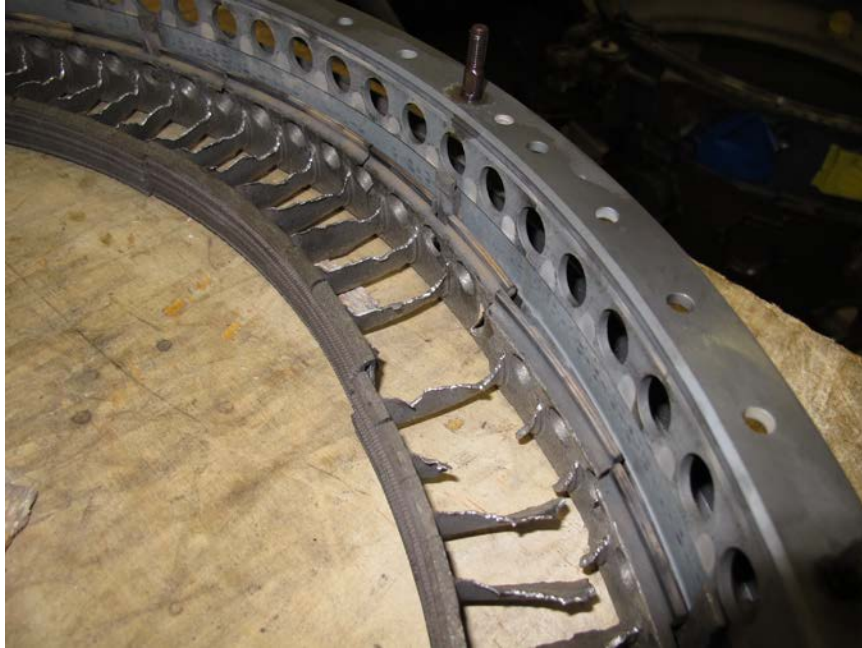
The 12th stage compressor stator segments were all in place and the 12th stage compressor stator vanes were all present. There were 13 airfoils that were fractured between the leading and trailing edges adjacent to the outer shroud. The leading and trailing edges and the airfoils' convex and concave surfaces had nicks and dents. All of the vanes had pieces missing from the trailing edge between the midspan area and the outer end. There was one vane that was missing the middle approximately 1.25-inches of the airfoil. There was a second vane that was fractured transversely across the airfoil at the inner end and the outer portion of the airfoil was pulled out of the outer shroud and was missing. The missing vane was from the clockwise end of the segment. The outer diameter of the shroud at the location of the missing vane had the remains of the two tack welds and there appeared to be evidence of braze material in the airfoil's slot. (Photo No. 28)

Photo No. 28: Close up view of damaged 12th stage compressor stator. (P&W)

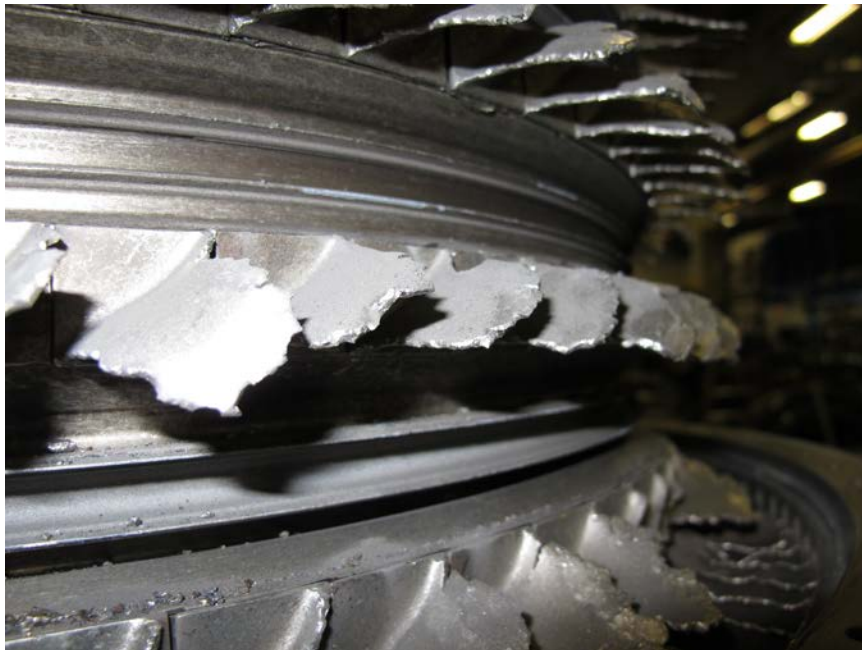
The 13th stage compressor blades were all in place. (Refer to Photo No. 6) All of the blades were fractured across the airfoils between about 0.25- and 1.5-inches above the blade root platform. The blades' airfoils were battered with nicks and dents on the leading and trailing edges as well as the concave side of the airfoil. The longer blades were bent opposite the direction of rotation. There was one blade that had a tear on the leading edge of the airfoil. (Photo No. 29)

Photo No. 29: Close up view of damaged 13th stage compressor blades. (P&W)

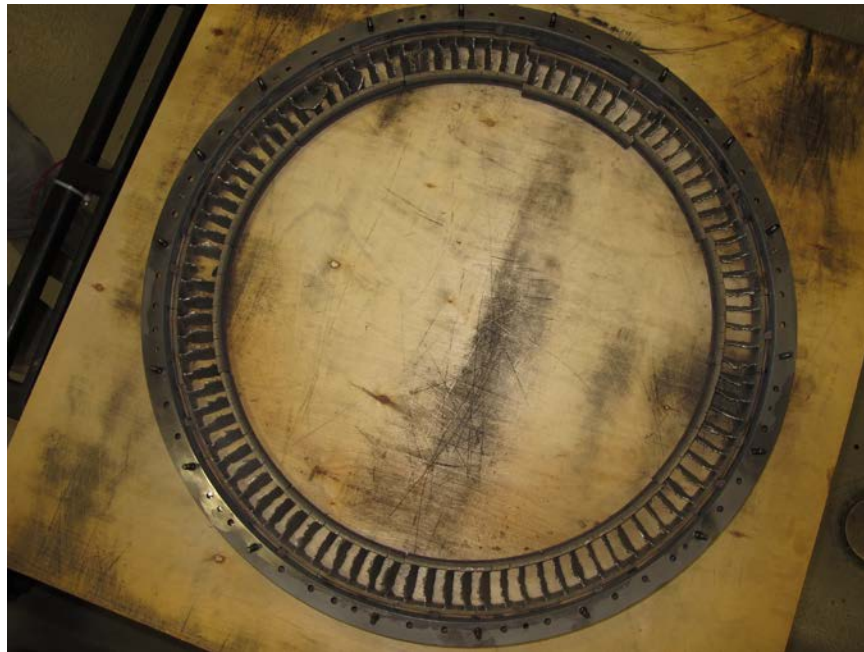
The 13th stage compressor stator segments were all in place and all of the 13th stage compressor stator vanes were present, although there was one vane that was missing approximately 0.6-inches from the center of the airfoil. There were five vanes that were fractured axially between the leading and trailing edges adjacent to the outer shroud. The vanes' airfoils had nicks and dents on the leading and trailing edges and the convex and concave sides of the airfoil. All of the vanes were missing parts of the trailing edges and the trailing edges were bent in the direction of rotation. (Photo No. 30)

Photo No. 30: View of 13th stage compressor stator. (P&W)

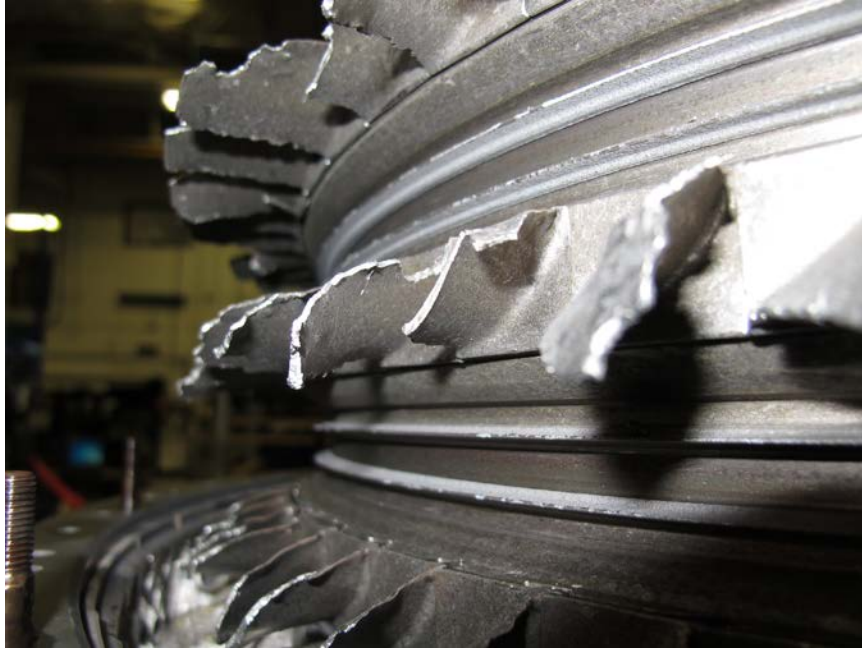
Photo No. 31: Close up view of damaged 14th stage compressor blades. (P&W)
