NATIONAL TRANSPORTATION SAFETY BOARD  
OFFICE OF AVIATION SAFETY  
WASHINGTON, D.C. 20594

**POWERPLANTS GROUP CHAIRMAN'S FACTUAL REPORT**

NTSB ID No.: ENG17IA026

Location: G344 airway northeast of CUTE intersection  
Date: June 7, 2017  
Time: 0950 universal coordinated time  
Aircraft: Boeing 747-451, N668US, Delta Air Lines flight 276

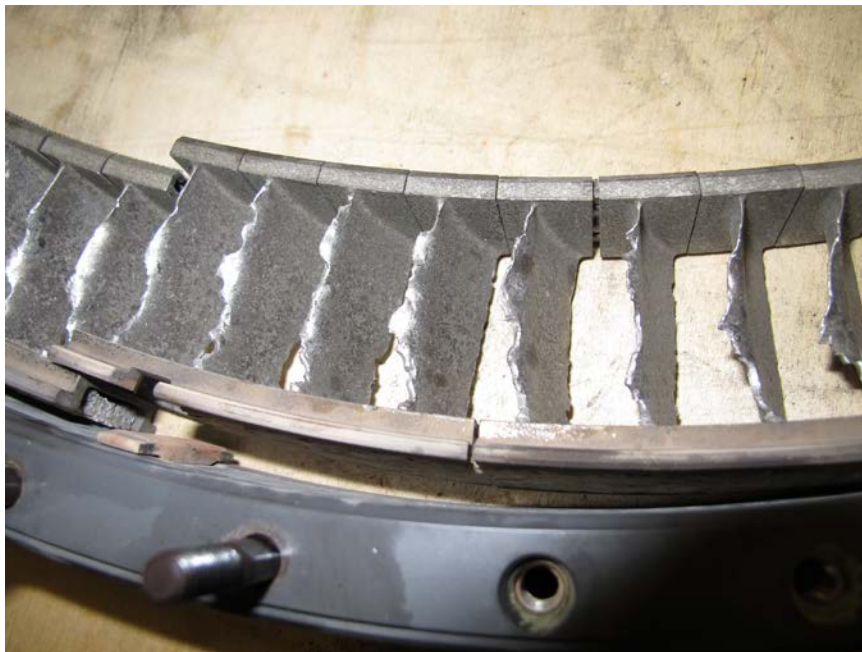
Photo No. 32: Close up view of damaged 14th stage compressor stator. (P&W)

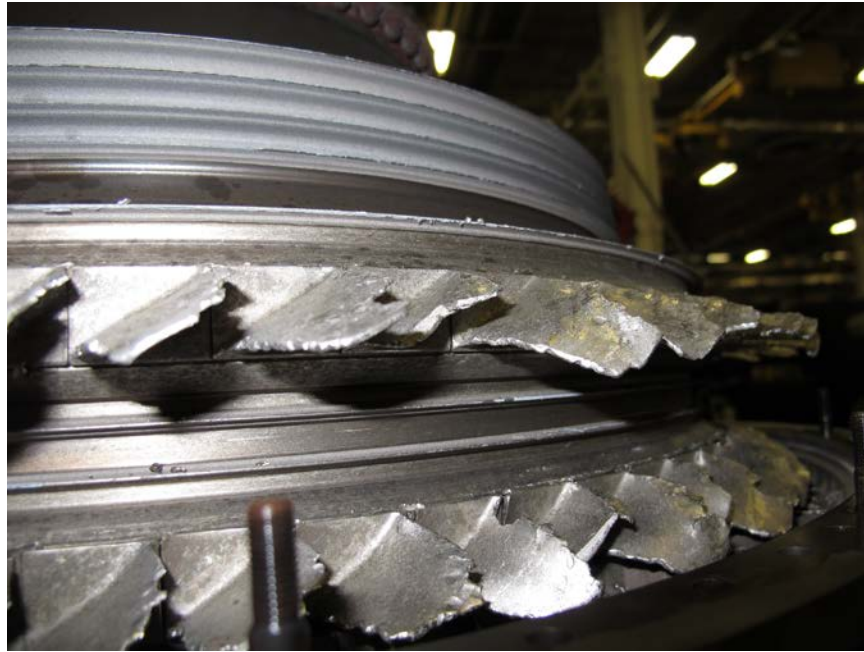
The 15th stage compressor blades were all in place. (Refer to Photo No. 6) All of the blades had nicks, dents and tears in the leading and trailing edges. Most of the blades had sections of the leading and trailing edges from about the midspan area outboard to the tip missing. Most of the blades were full length. There were two 15th stage compressor blades that were fractured across the airfoil about 0.75- and 0.87-inches above the platform. There were also several blades that had the airfoils bent forward. (Photo No. 33)

Photo No. 33: Close up view of damaged 15th stage compressor blades. (P&W)

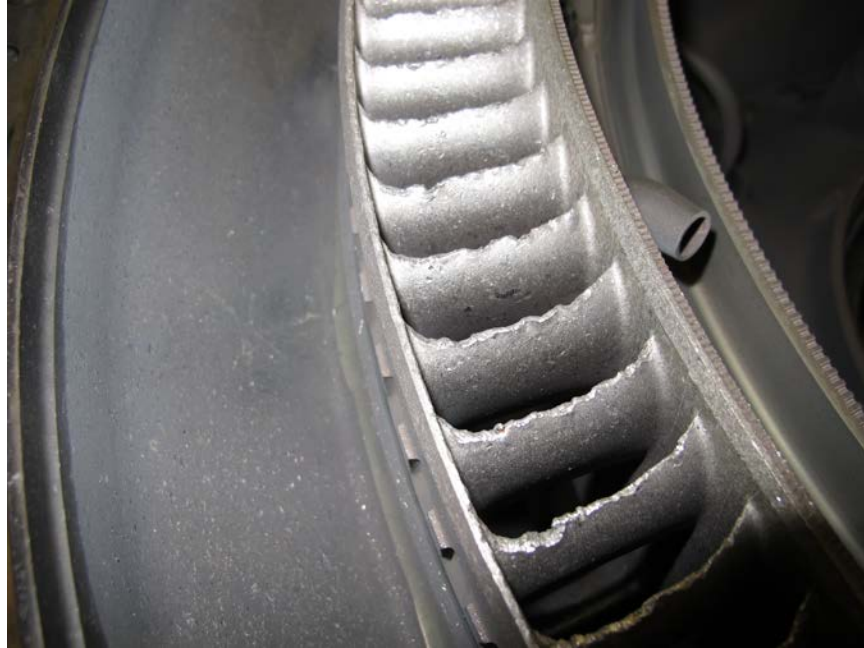
The 15th stage compressor stators were in place in the diffuser case. All of the airfoils were battered with nicks and dents on the leading edges as well as the convex and concave surfaces. (Photo No. 34)

Photo No. 34: Close up view of damaged 15th stage compressor stator vanes. (P&W)

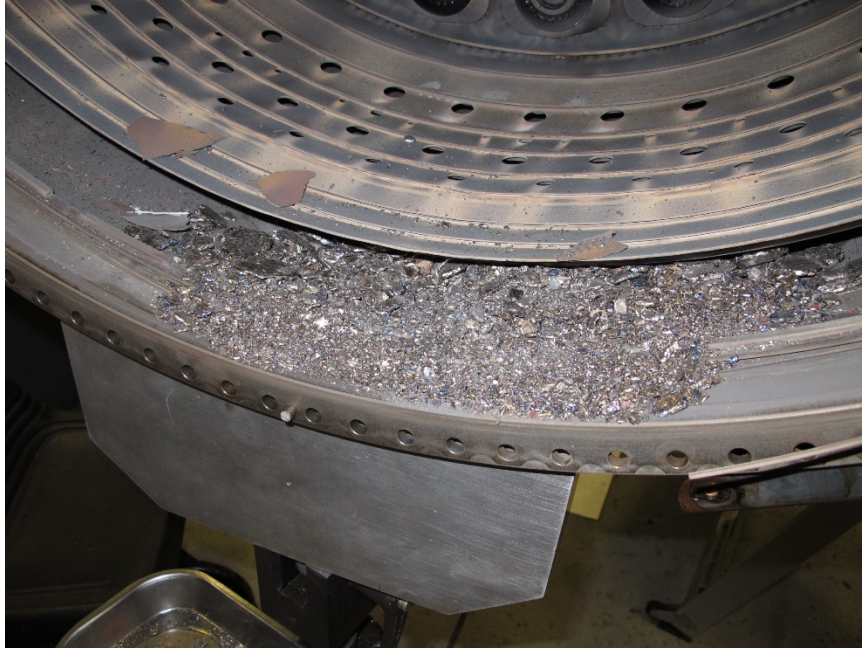
The diffuser case did not have any thermal distress. There was a large quantity of broken compressor blade airfoil fragments as well as BB-sized metal particles in the bottom of the diffuser case. (Photo No. 35)

Photo No. 35: Close up view of the interior of the diffuser case showing small metal particles in the bottom of the case. (P&W)

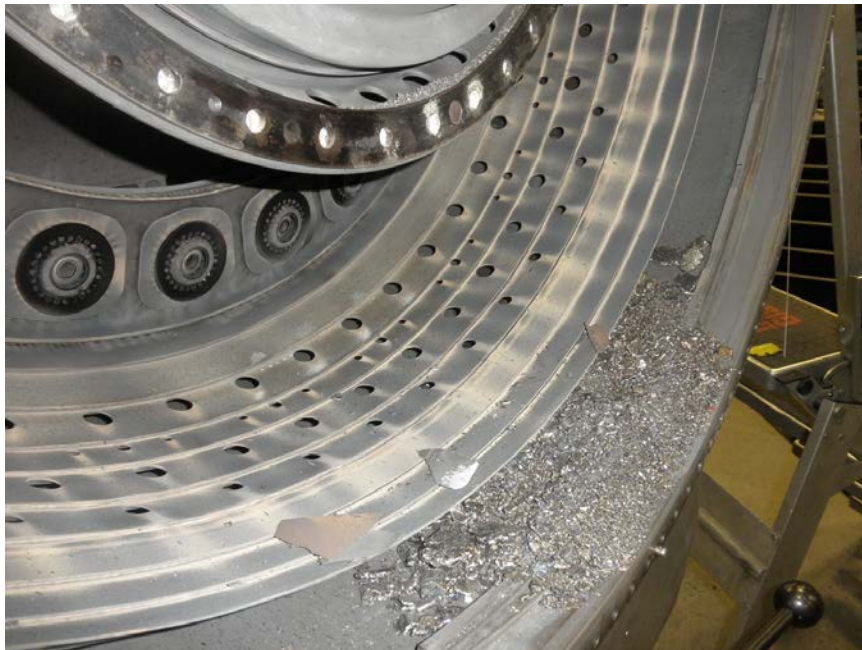
Photo No. 36: View of interior of outer combustion chamber liner showing no thermal distress.

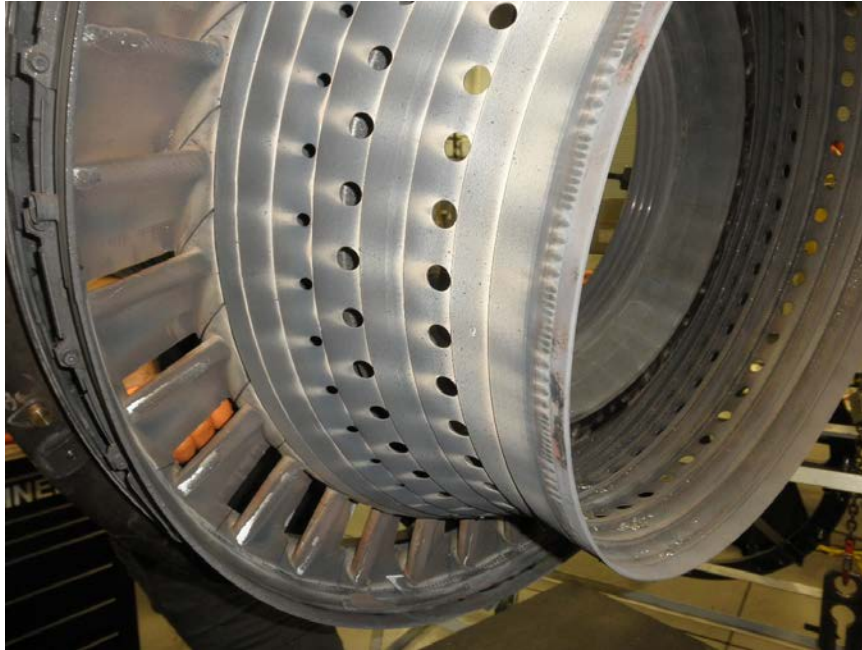
Photo No. 37: View of interior of inner combustion chamber liner showing no thermal distress.

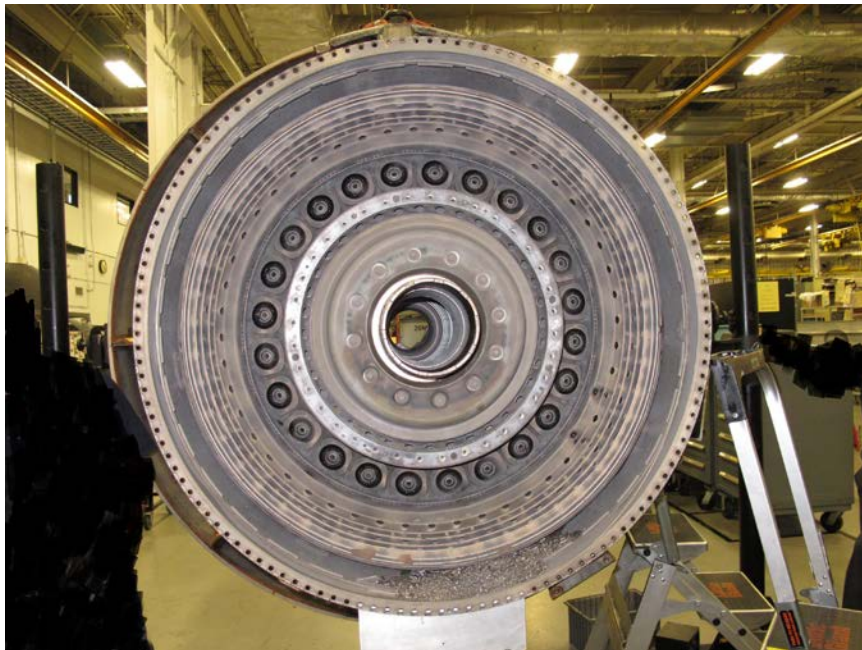
Photo No. 38: View of combustor liner showing all of the fuel nozzles were in place. (P&W)

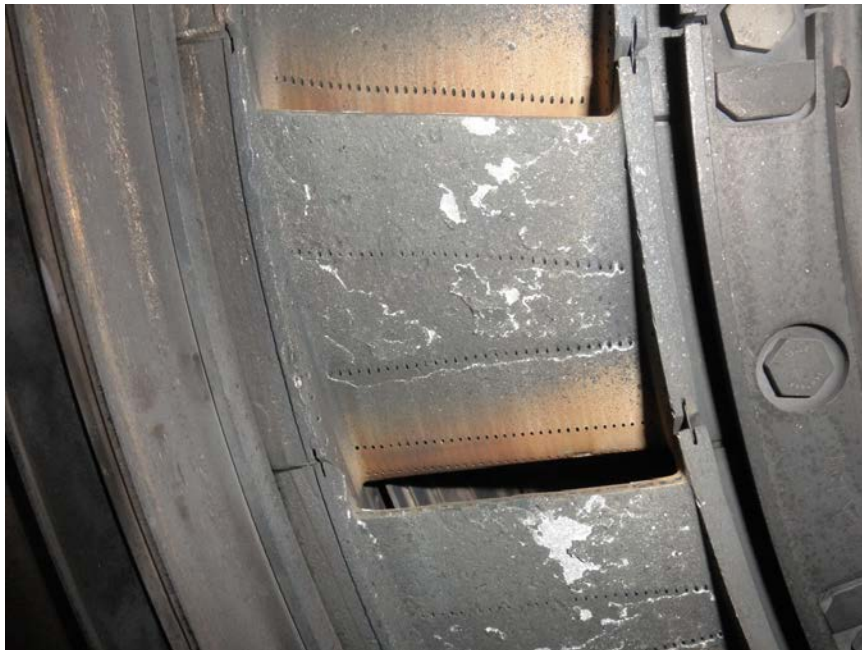
Photo No. 40: Close up view of 1st stage turbine vanes showing light coating of metal spray.

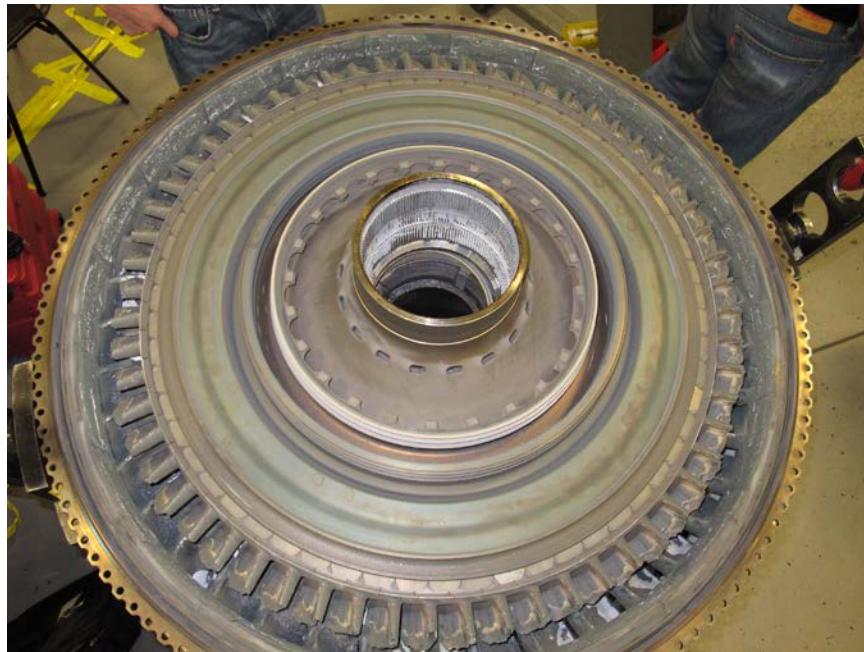
The 1st stage turbine hub was intact and the 1st stage turbine front side plate was in place on the hub. There was no evidence of oil streaking on the front face of the 1st stage turbine hub. (Photo No. 41) All of the 1st stage turbine blades were in place in the hub, but all of the blades were fractured about 2-inches above the blade root platform. All of the fracture surfaces were coarse and jagged. (Photo No. 42)

Photo No. 41: View of front of HPT stage 1 disk and front side plate showing disk intact and front side plate in place with no oil staining. (P&W)

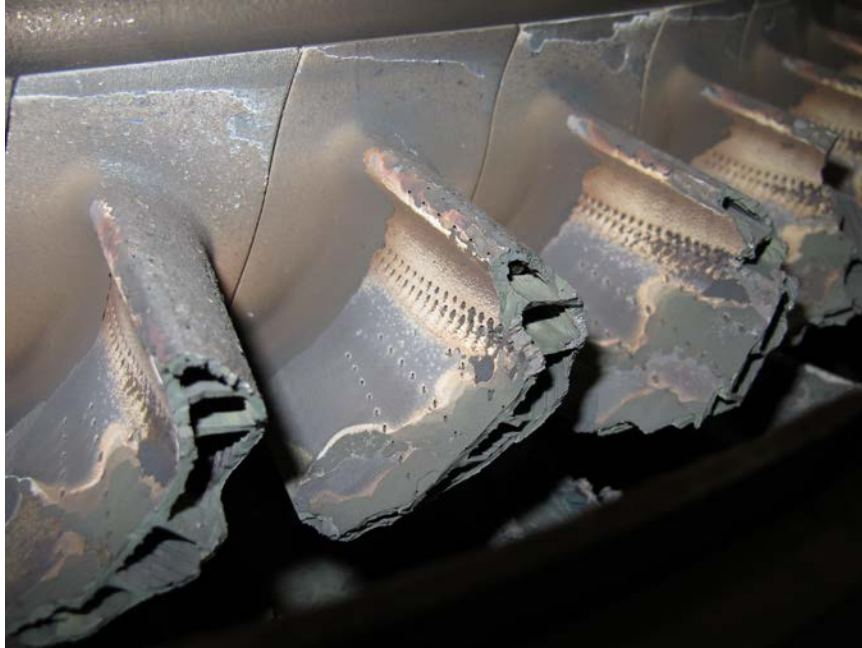
Photo No. 42: Close up view of 1st stage turbine blades showing coarse fracture surface on ends of the blades. (P&W)

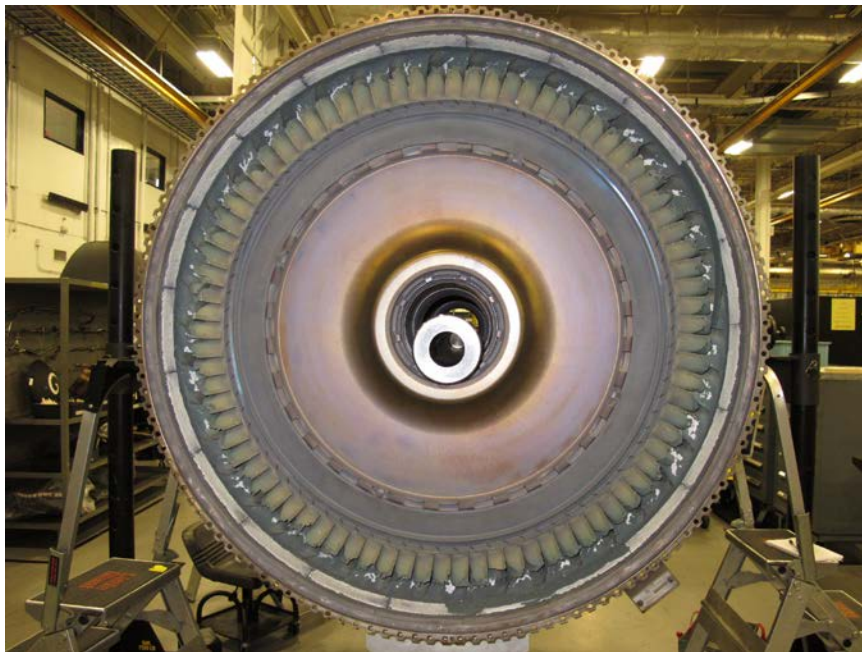
Photo No. 43: View of 2nd stage disk and rear side plate showing disk was intact and rear side plate was in place. (P&W)

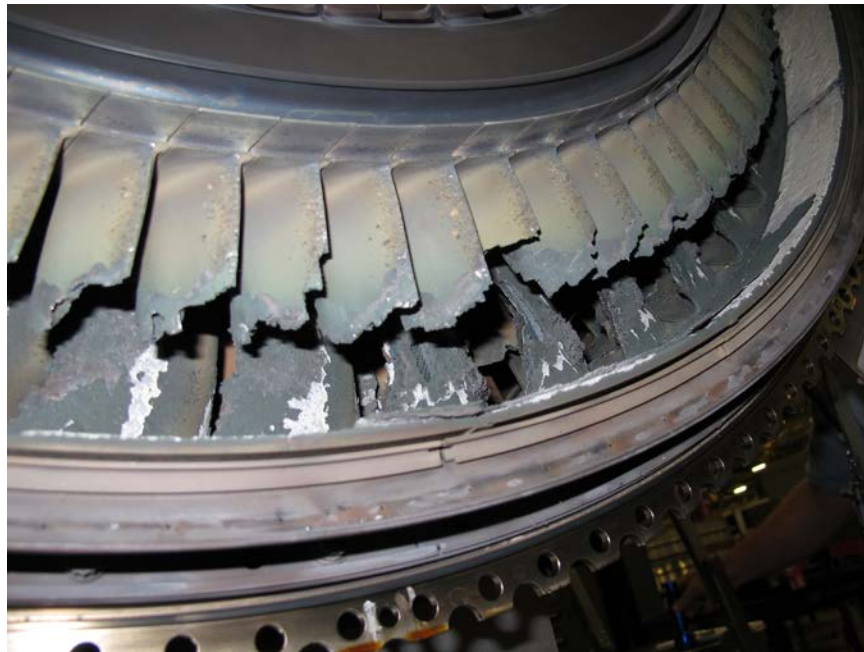
All of the 2nd stage turbine blades were in place in the disk. (Refer to Photo No. 43) There were two 2nd stage turbine blades that were fractured about 1.75- and 2-inches above the blade root platform. The remainder of the 2nd stage turbine blades were fractured on the leading edges about an inch above the blade root platform that continued to about 2.25 inches above the platform at the mid chord area to the trailing edge. The fracture surfaces were coarse and grainy. The coating on the 2nd stage turbine blades had a green tint and was flaking off the airfoils adjacent to the fractures. (Photo No. 44)

Photo No. 44: View of 2nd stage turbine blades showing they were in place and had coarse fractured ends. (P&W)

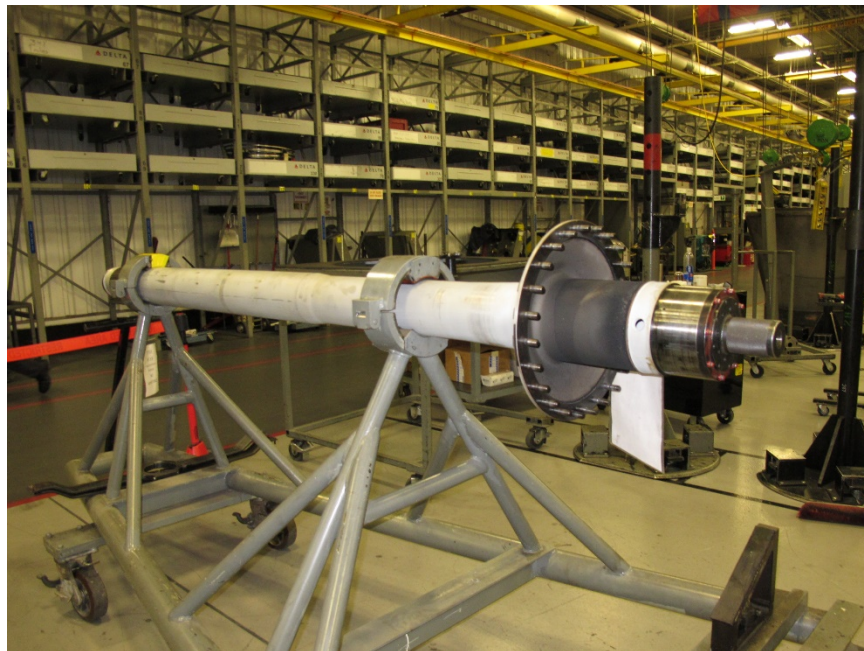
Photo No. 45: View of LPC drive shaft after it was removed from the engine and separated from the LPT showing it was intact and did not have any rub marks. (P&W)

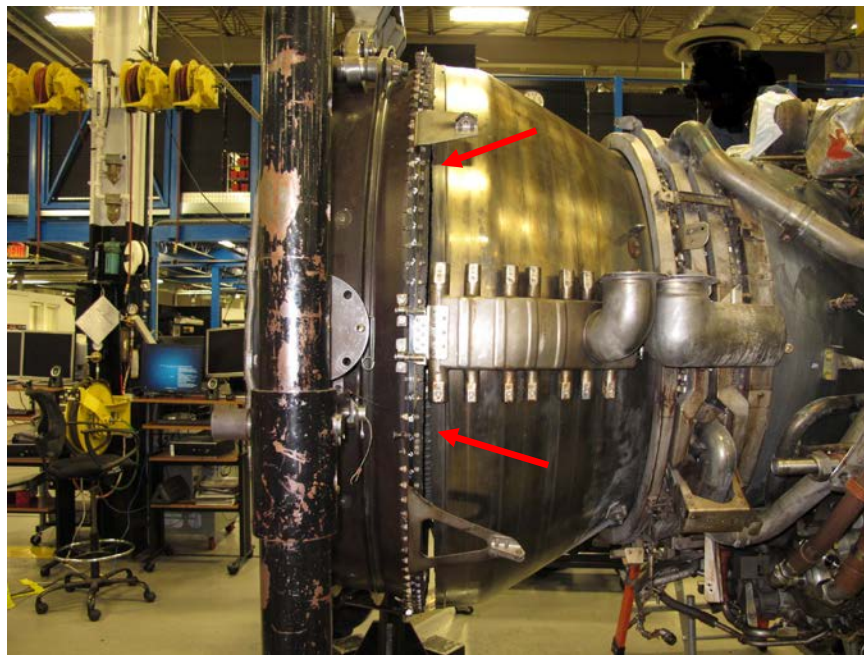
Photo No. 46: Right side of engine showing circumferential split in LPT case. (P&W)

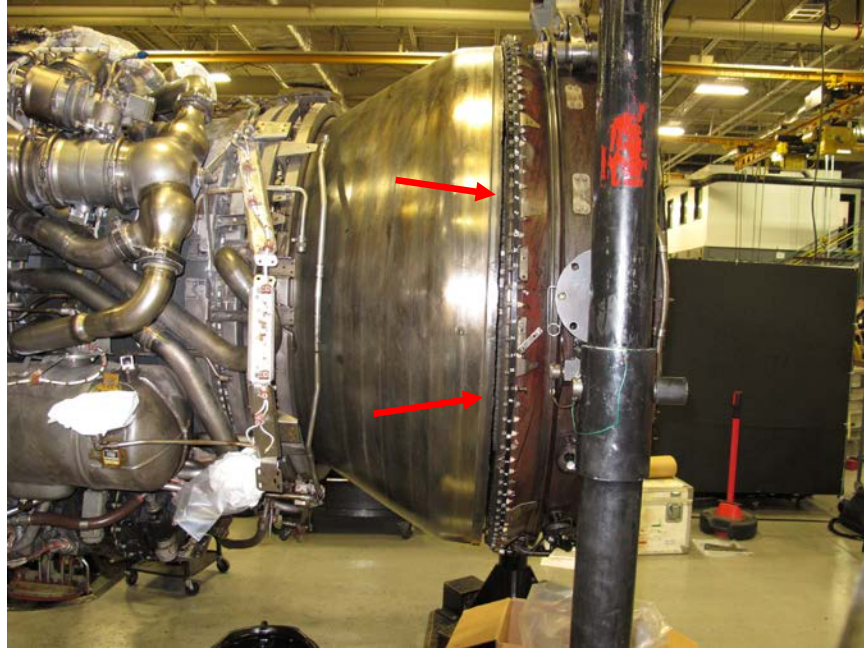
Photo No. 47: Left side of engine showing circumferential split in LPT case. (P&W)

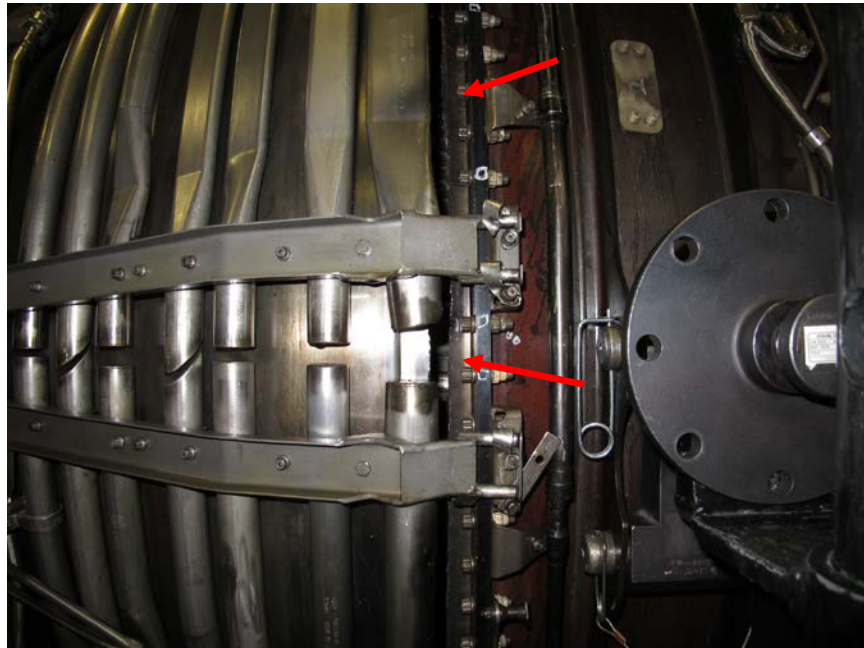
Photo No. 48: Close up of left side of engine showing proximity of split in LPT case to the rear flange. (P&W)

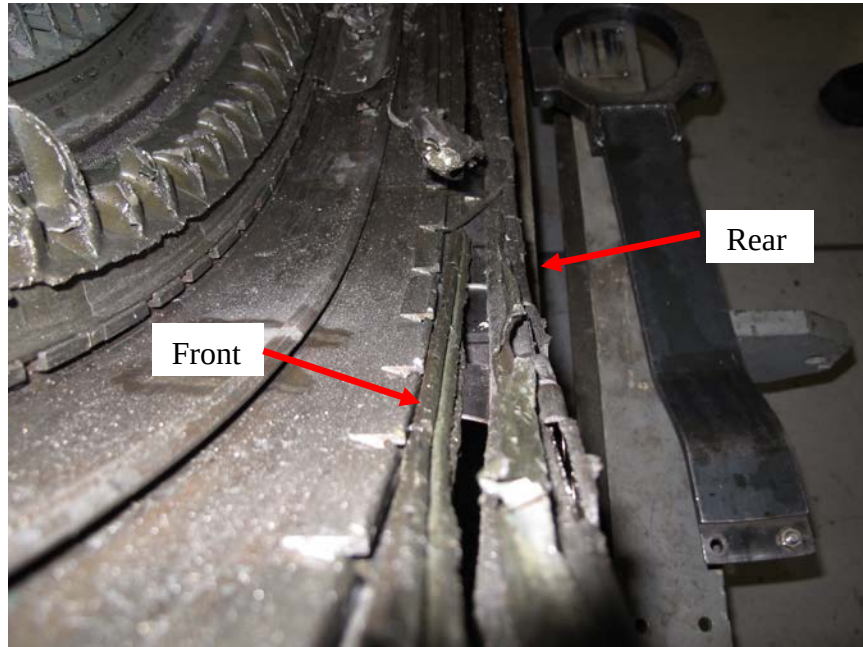
Photo No. 49: View of some fragments of the front and rear 6th stage BOAS that were placed inside of the LPT case showing the cuts in both match each other. (P&W)

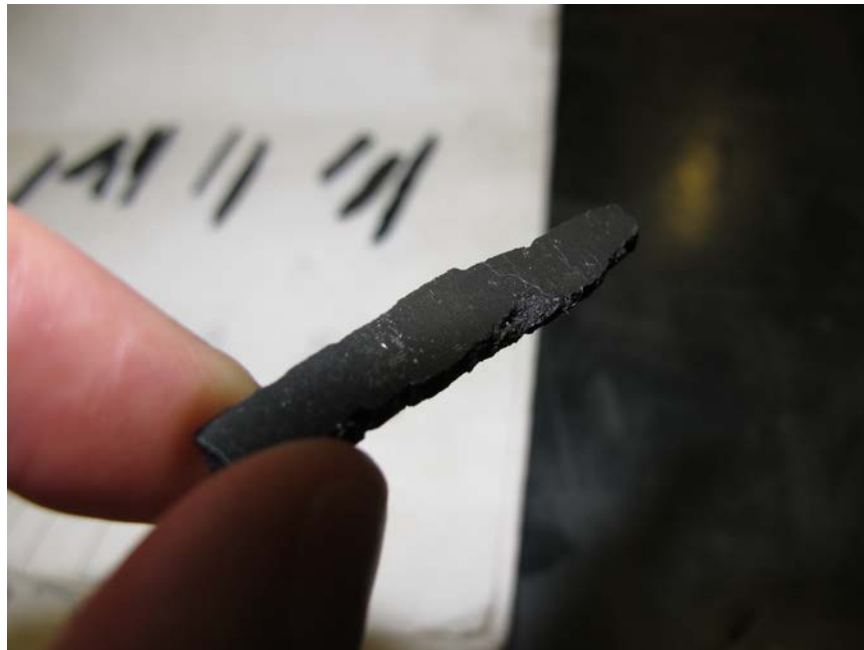
Photo No. 51: Close up view of metal shard found in turbine debris that had machining marks similar to machining marks on outside of LPT case. (P&W)

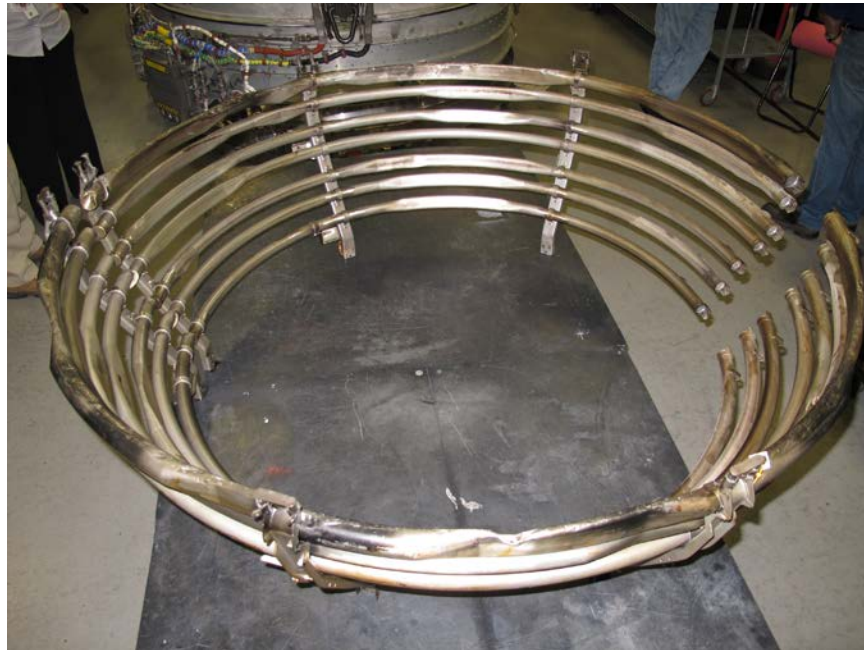
Photo No. 52: View of the upper and lower turbine case cooling air manifolds showing no damage to manifolds Nos. 1 through 6, but damage to manifold No. 7. (P&W)

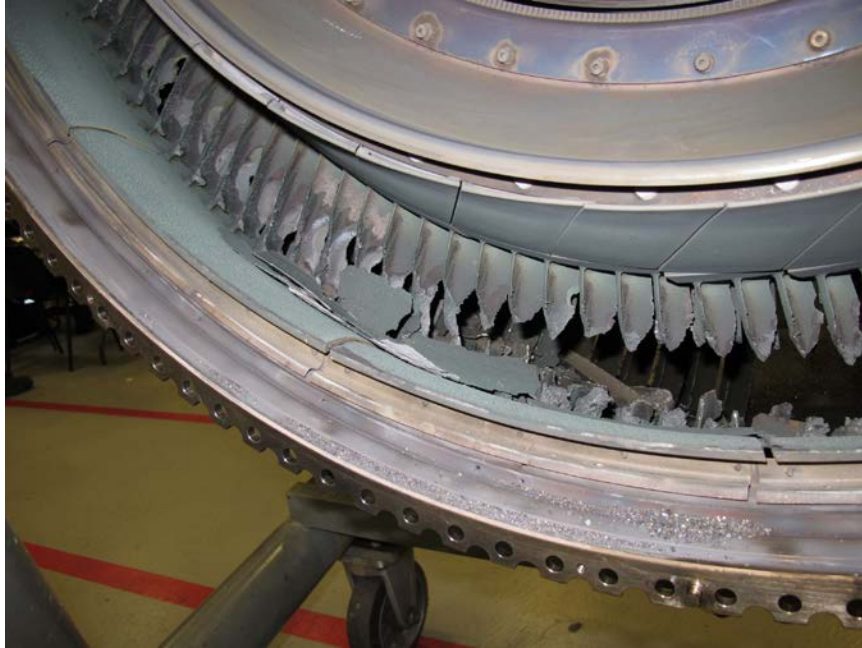
Photo No. 53: View of outer transition duct segments showing green-tinted metal spray material on segments as well as metal spray material on the bottom of the engine. (P&W)

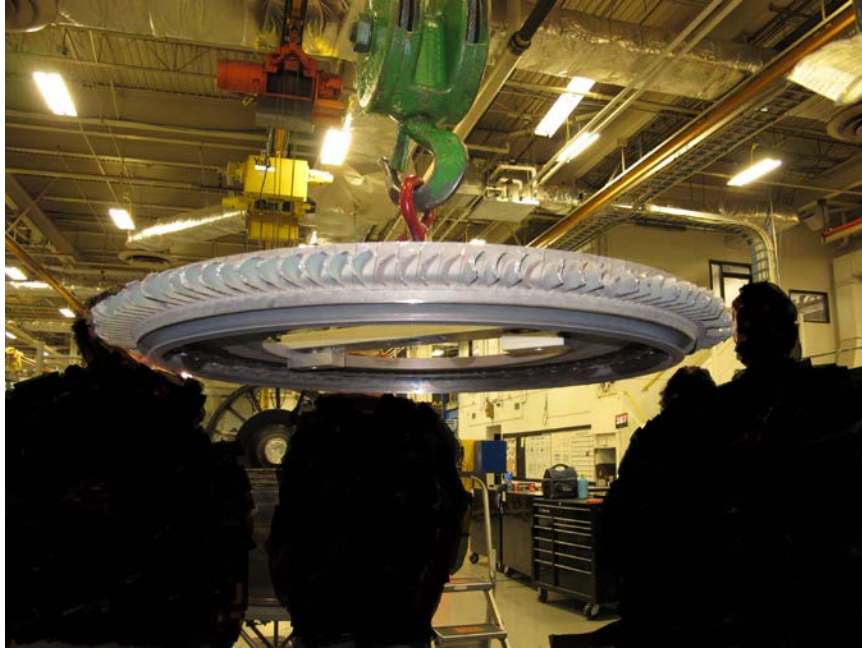
Photo No. 54: View of 3rd stage turbine disk showing that it was intact. (P&W)

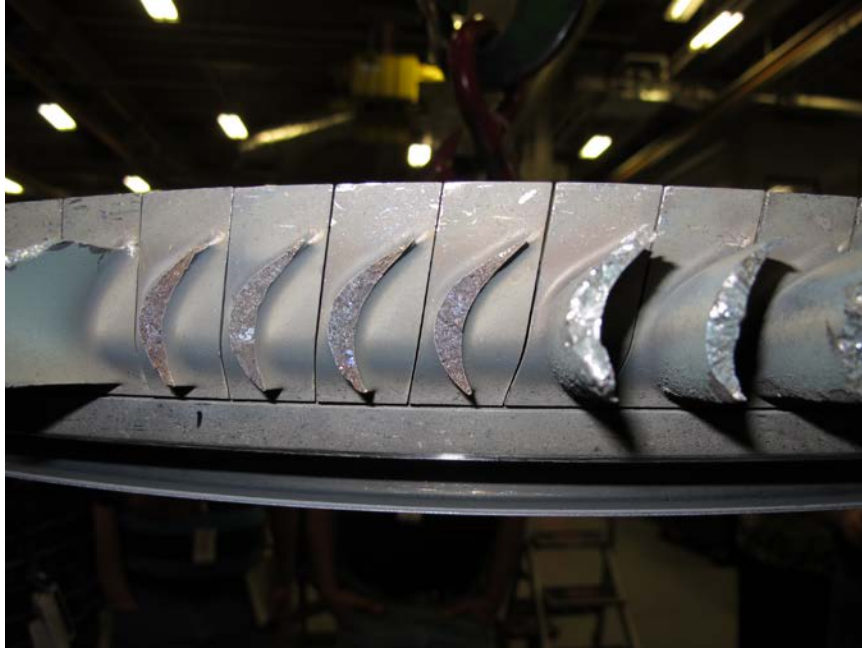
Photo No. 58: Close up view of 3rd stage turbine blades showing coarse fracture surface.  
(P&W)

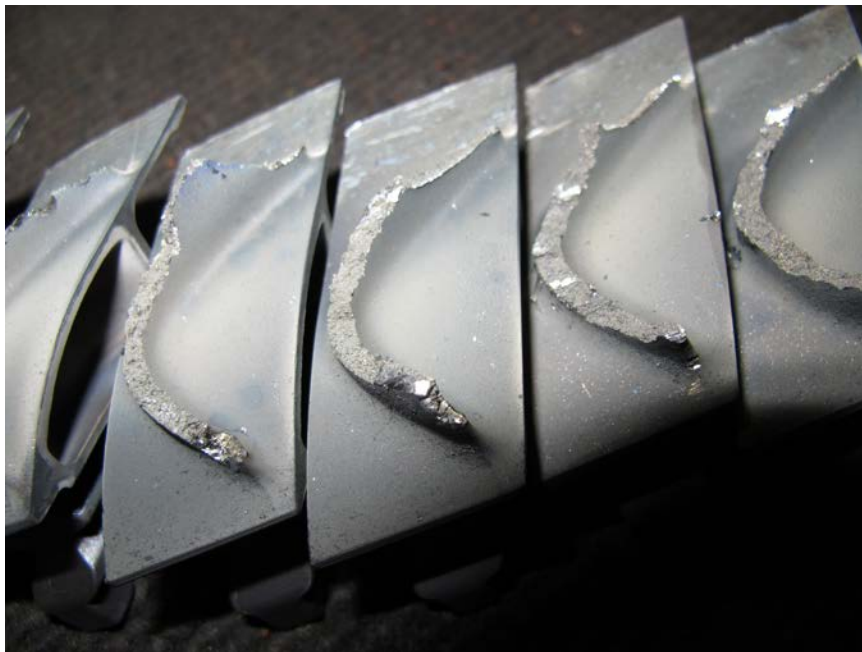
Photo No. 59: Close up view of 4th stage turbine blades showing coarse fracture surface.  
(P&W)

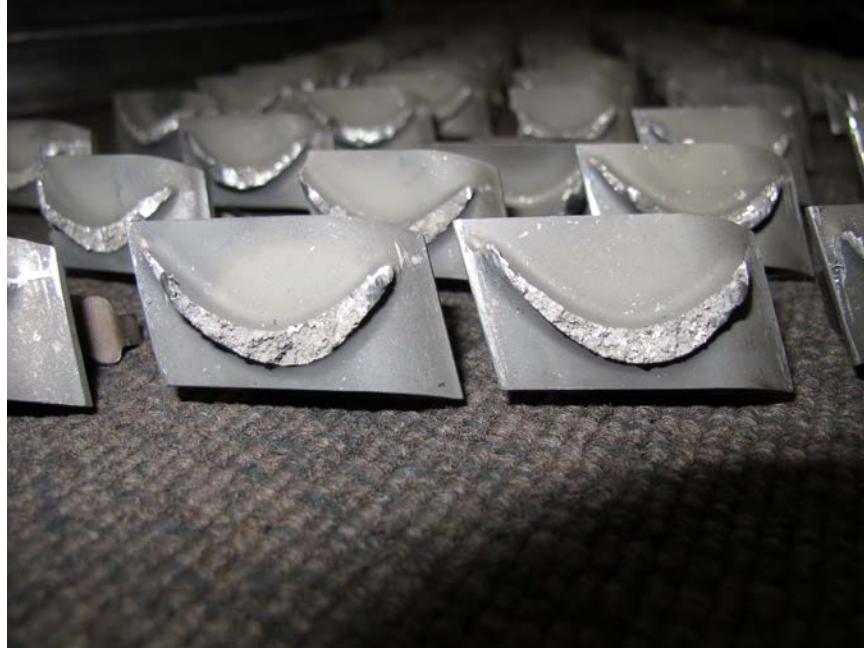
Photo No. 60: Close up view of 5th stage turbine blades showing coarse fracture surface.  
(P&W)

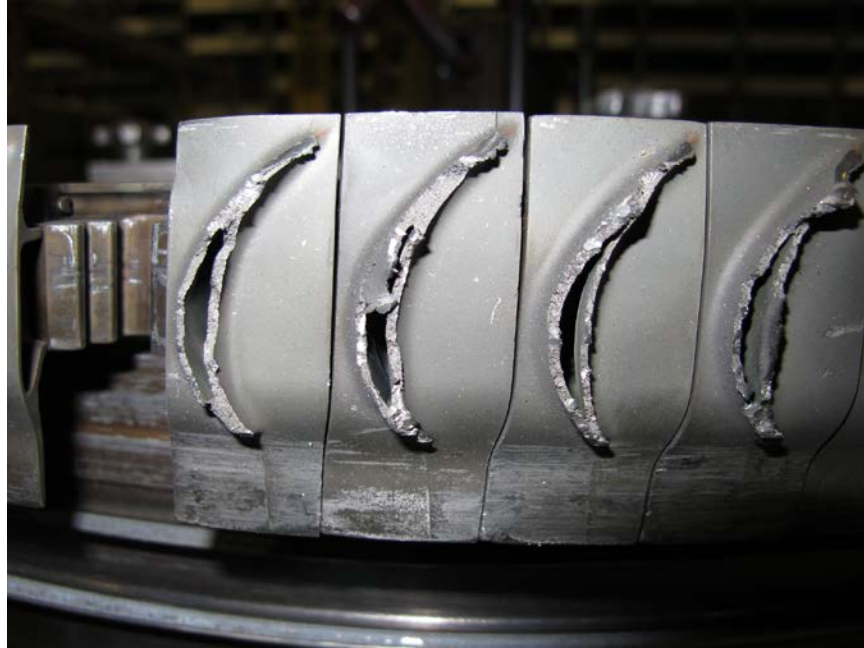
Photo No. 61: Close up view of 6th stage turbine blades showing coarse fracture surface. (P&W)

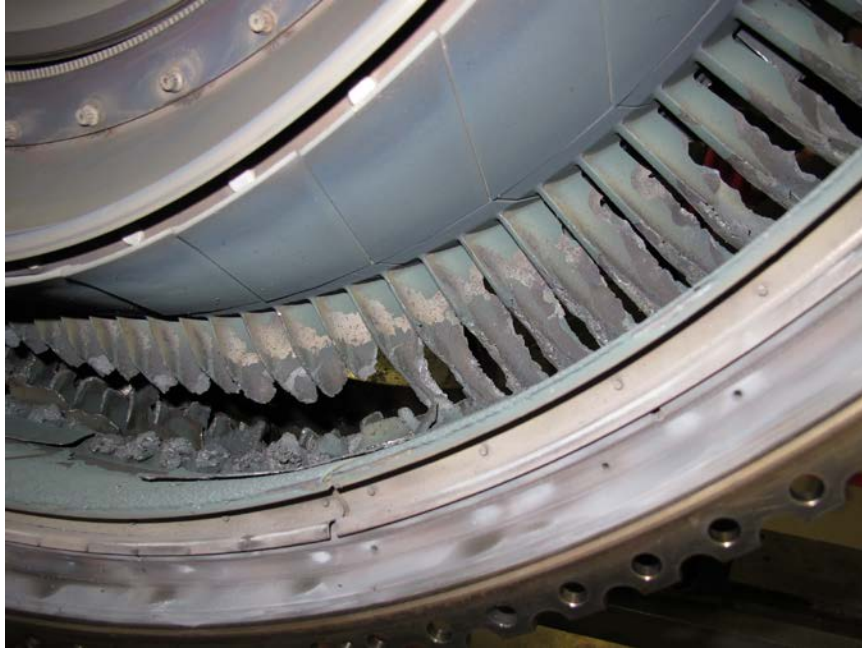
Photo No. 62: View of 3rd stage turbine vanes leading edges showing section burned out completely and other vanes partially burned away. (P&W)

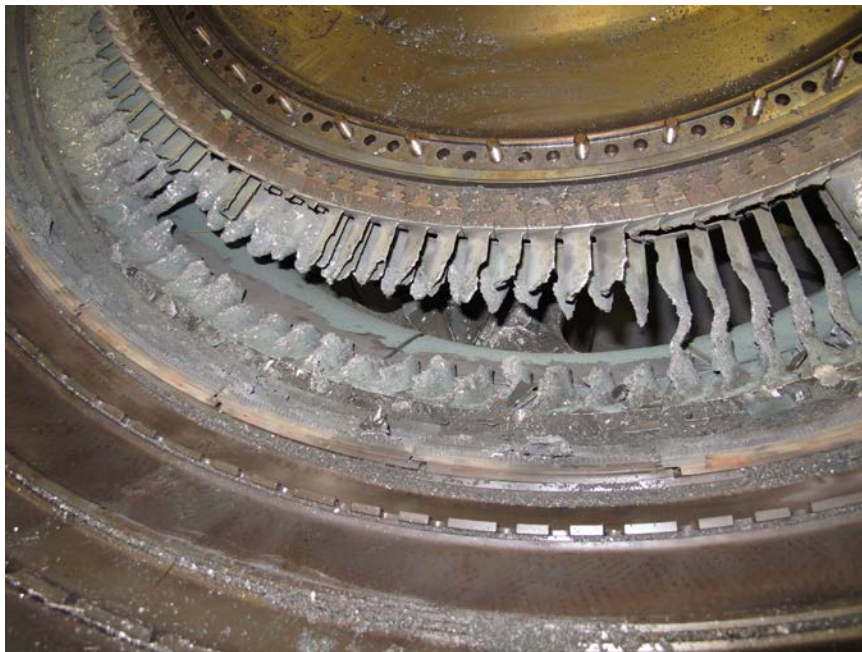
Photo No. 63: View of 3rd stage turbine vanes trailing edges showing section burned out completely and other vanes partially burned away. (P&W)

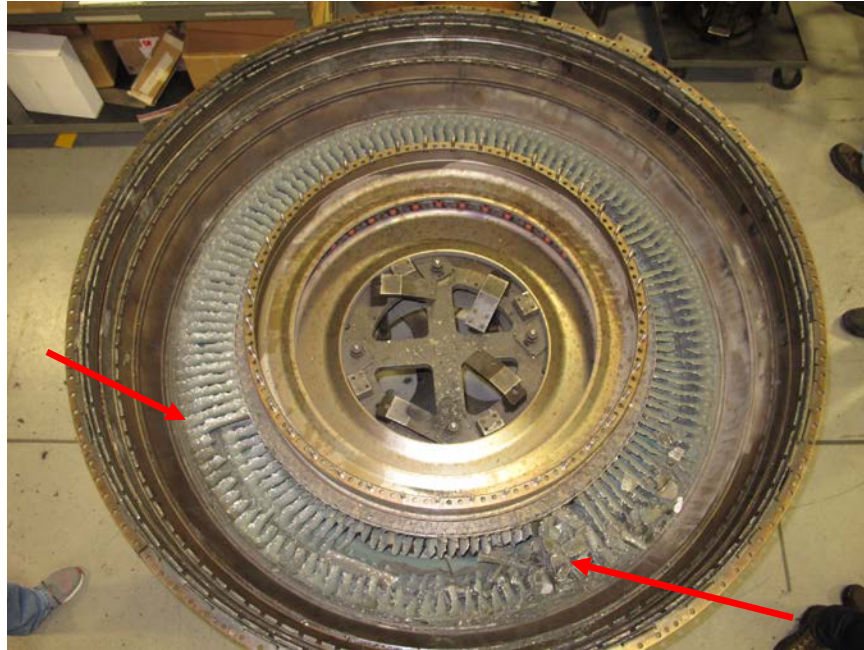
Photo No. 64: View of the 4th stage turbine vanes showing a section was missing between the arrows. (P&W)

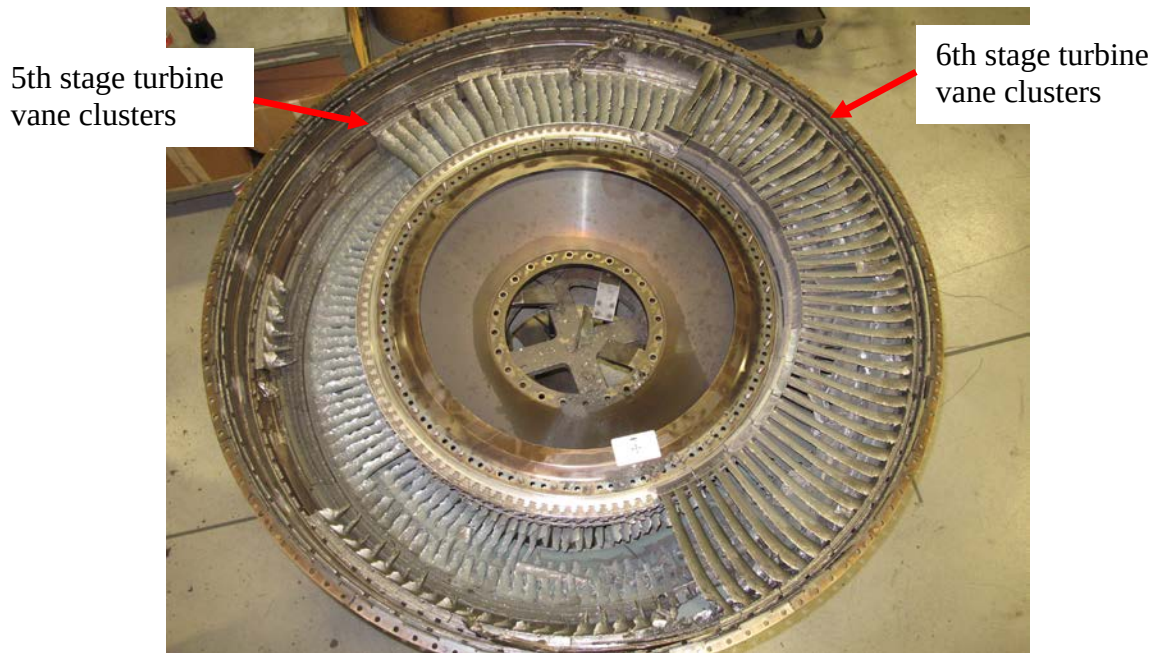
Photo No. 65: View of the 5th and 6th stage turbine vanes showing missing vanes. (P&W)

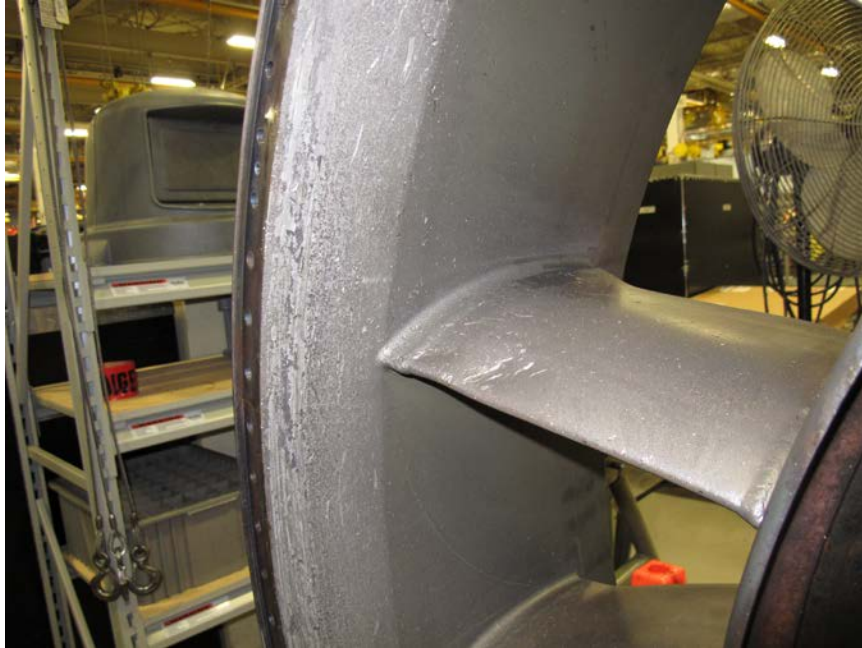
Photo No. 66: View of interior surface of turbine exhaust case and turbine exhaust case strut showing impact nicks, dents, and gouging on both. (P&W)

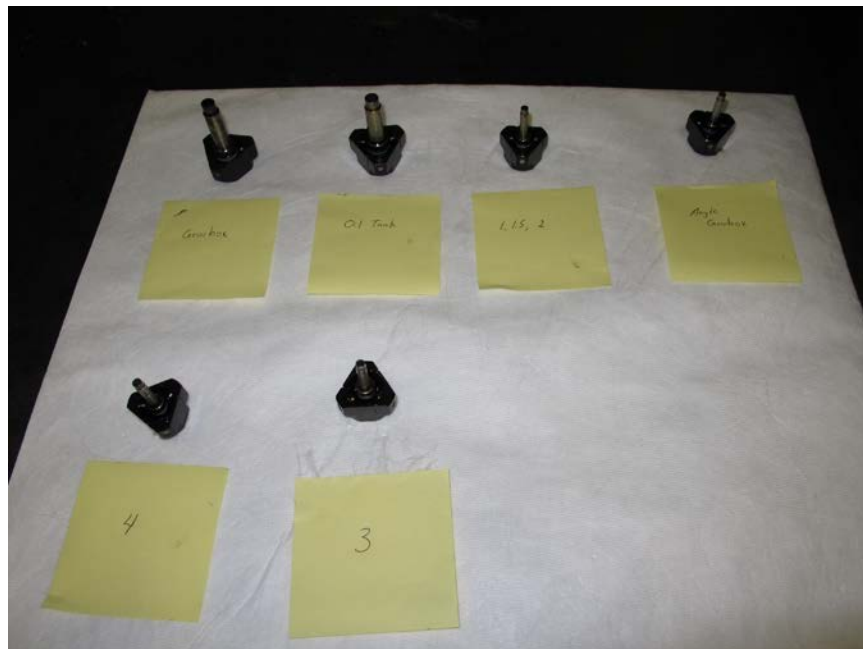
Photo No. 68: Magnetic chip detectors with minute bits of debris. (P&W)

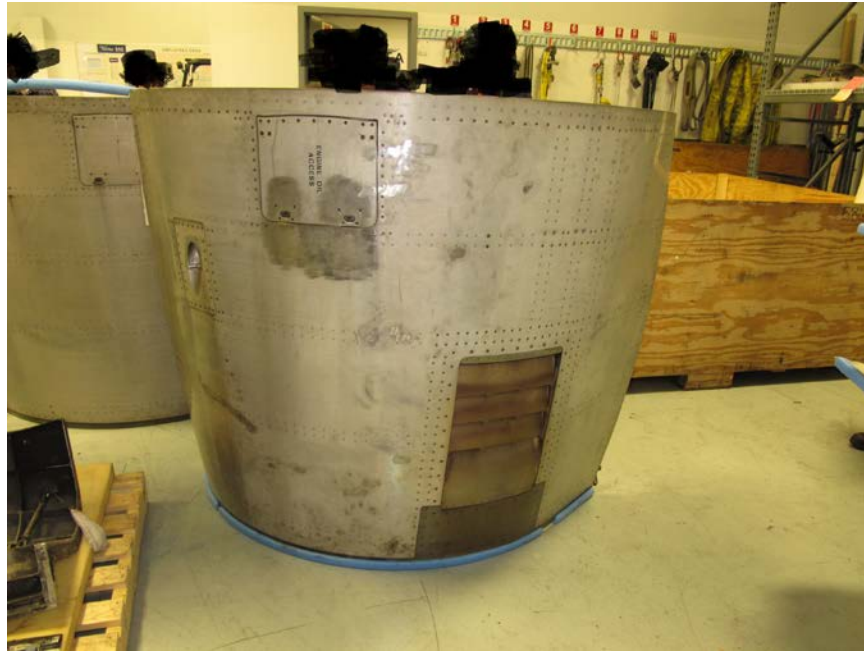
Photo No. 69: View of the outboard core cowl exterior showing no penetrations. (P&W)

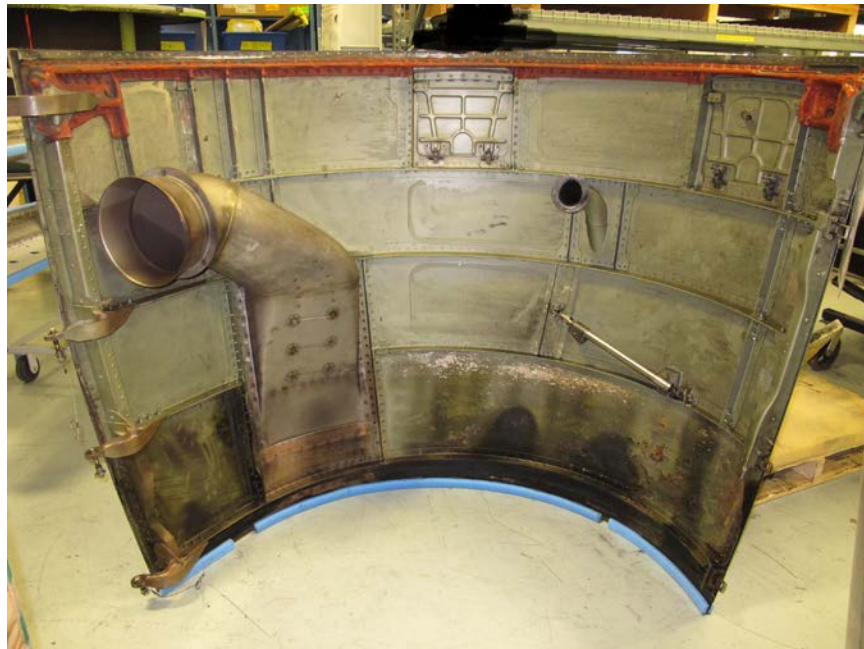
Photo No. 70: View of the outboard core cowl interior showing no penetrations. (P&W)

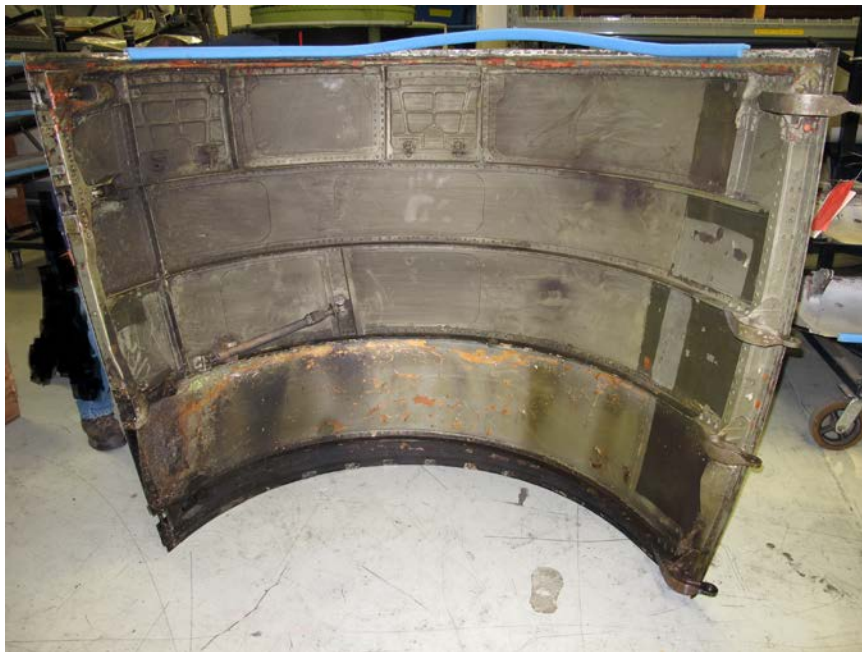
Photo No. 72: View of the inboard core cowl interior showing no penetrations. (P&W)

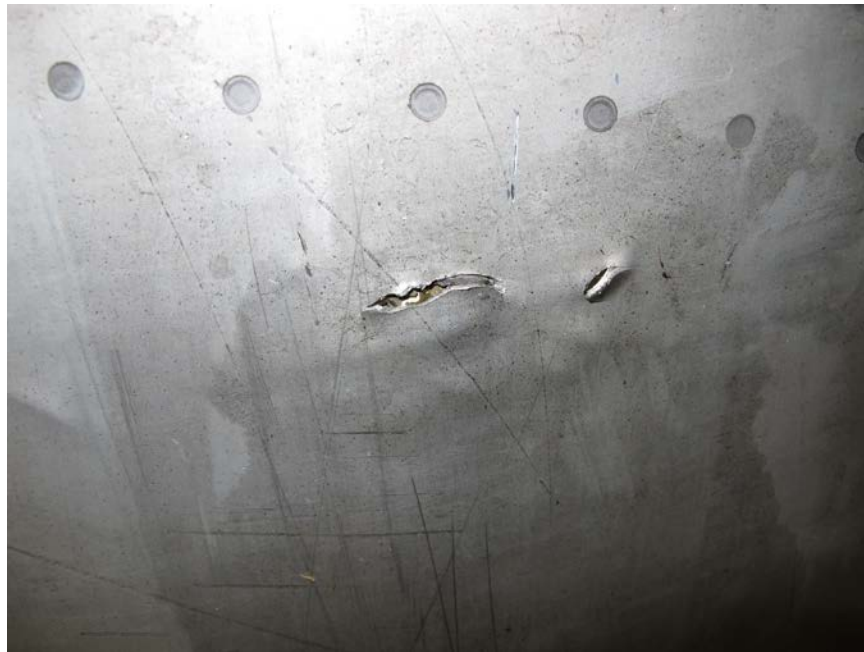
Photo No. 73: Close up view of the two splits in the skin of the inboard core cowl. (P&W)

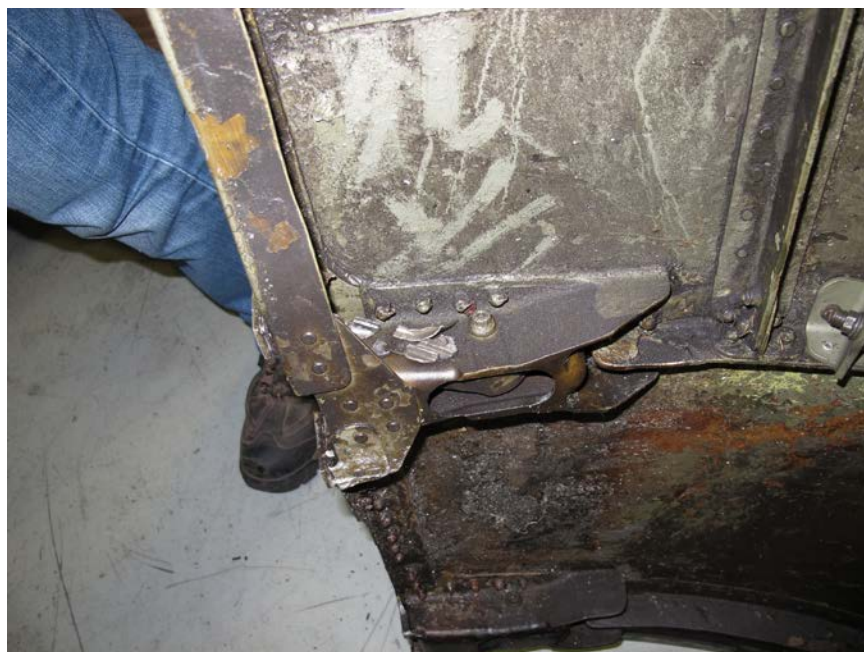
Photo No. 74: Close up view of airfoil debris on the inside of the inboard core cowl. (P&W)

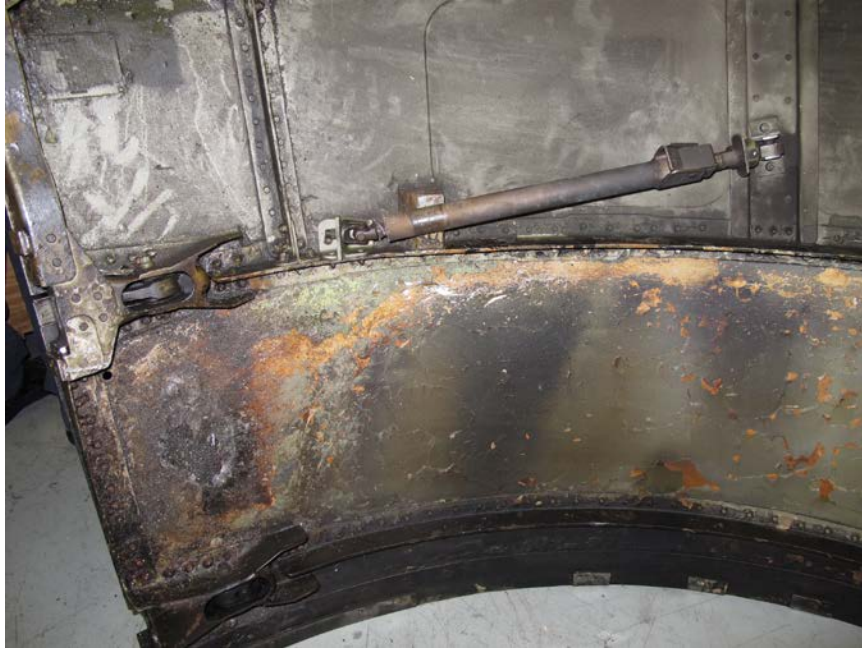
Photo No. 75: View of damage to inside of inboard core cowl. (P&W)
