NATIONAL TRANSPORTATION SAFETY BOARD  
OFFICE OF AVIATION SAFETY  
WASHINGTON, D.C. 20594

**POWERPLANTS GROUP CHAIRMAN'S FACTUAL REPORT**

NTSB ID No.: ENG17IA026

Location: G344 airway northeast of CUTE intersection  
Date: June 7, 2017  
Time: 0950 universal coordinated time  
Aircraft: Boeing 747-451, N668US, Delta Air Lines flight 276

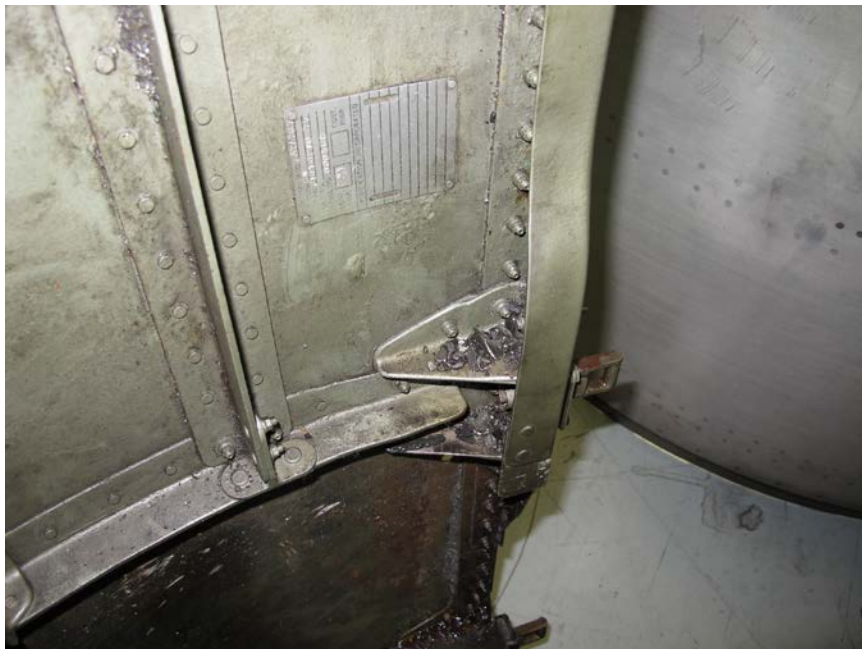
Photo No. 76: Close up view of airfoil debris on the inside of the outboard core cowl. (P&W)
