**NATIONAL TRANSPORTATION SAFETY BOARD**  
**Office of Aviation Safety**  
**Washington, D.C. 20594**

**POWERPLANT GROUP CHAIRMAN'S FACTUAL REPORT**  
**NTSB No: ENG17IA028**

Aircraft: Bombardier CRJ700, N715SK, SkyWest Airlines Flight 2985

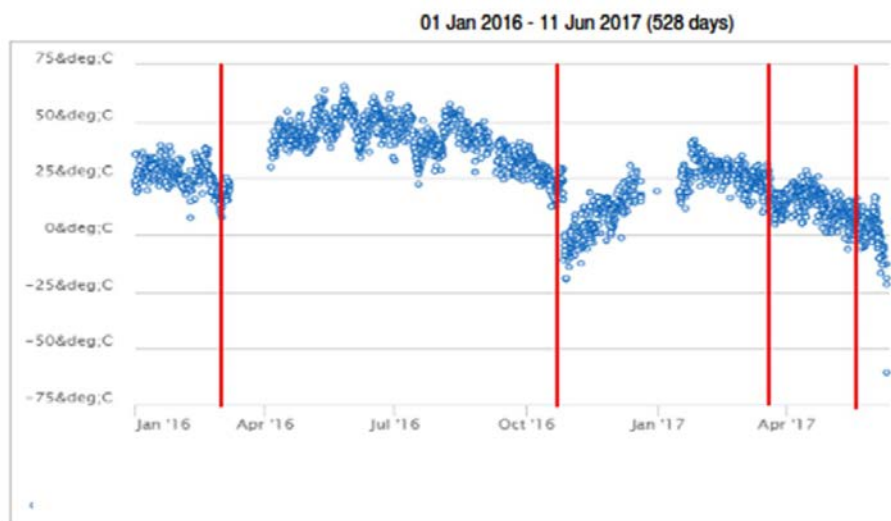
**Figure 1- Exhaust Gas Temperature Hot Day Margin, Red Lines Identify CNR Issue Dates**

According to GE Aviation records, four high priority engine CNRs were sent to SkyWest Airlines due to low or decreasing takeoff exhaust gas temperature hot day margin (EGTHDM) in combination with low or decreasing delta core speed (increasing physical core speed) prior to the incident. The notifications were sent in February 2016, October 2016, March 2017, and May 2017. The probable cause listed on all four CNRs was compressor efficiency, and the first recommended maintenance action listed on the CNR was to perform a core engine water wash in accordance with the GE LMM procedures. SkyWest completed core engine water washes on March 7, 2016, November 2, 2016, April 1, 2017, and May 6, 2017. The first two water washes increased engine margin, but the third and fourth were ineffective (**Figure 1**). Following the water wash on May 6, 2017, SkyWest performed a high pressure compressor (HPC) BSI on June 6, 2017 and no anomalies were observed. On June 9, 2017, SkyWest scheduled the incident engine for removal and replacement on June 14<sup>th</sup>, 2017.

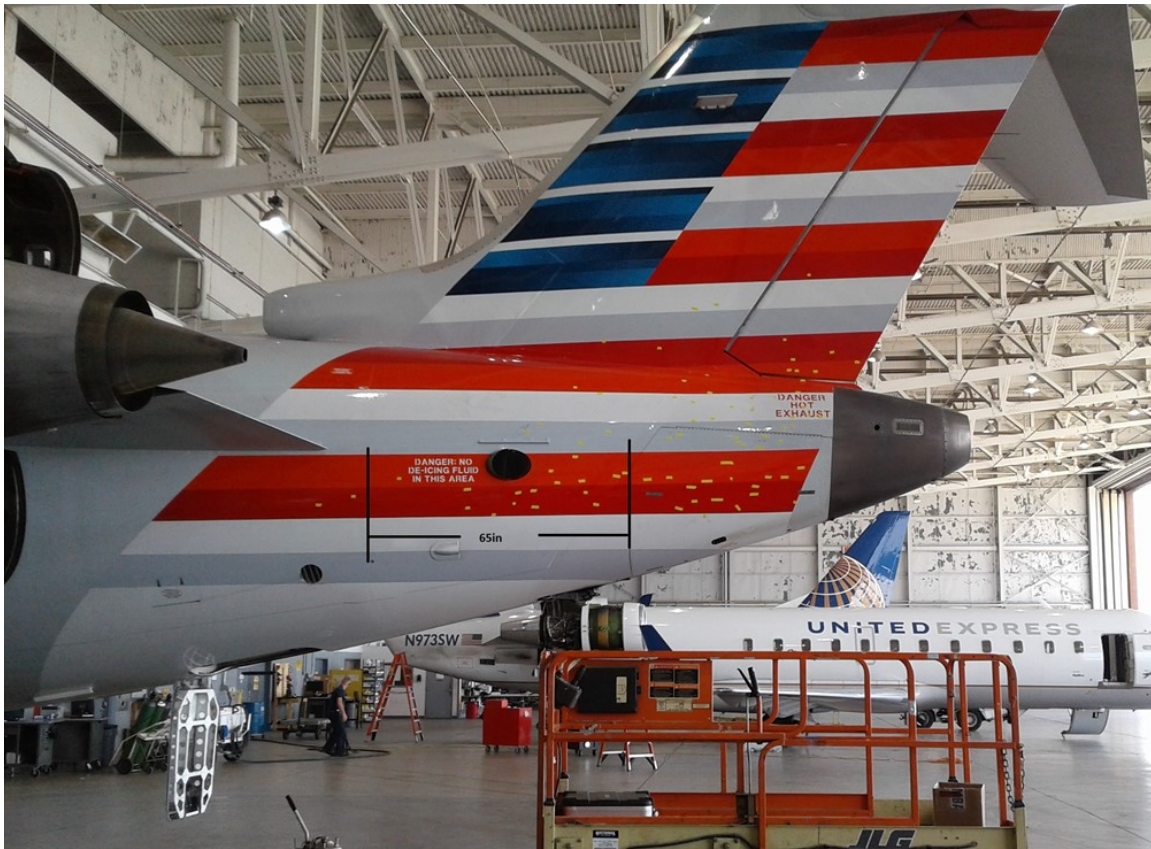
SkyWest Airlines reported multiple small fuselage impacts aft of the No.1 engine following the incident event. At the request of the NTSB, SkyWest created a damage map to identify the impact locations (**Photo 1**). All damage was determined to be repairable in accordance with the Bombardier structural repair manual (SRM).

**Photo 1- Empennage Damage Map, Impacts Marked with Yellow Tape**

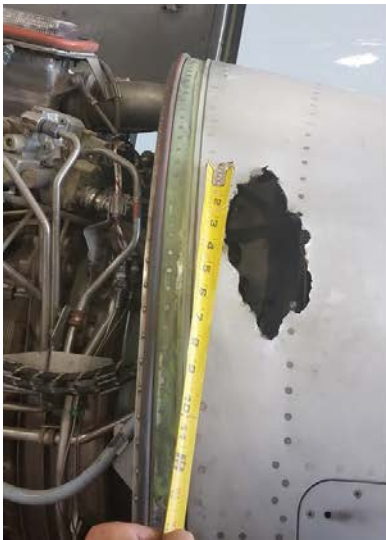
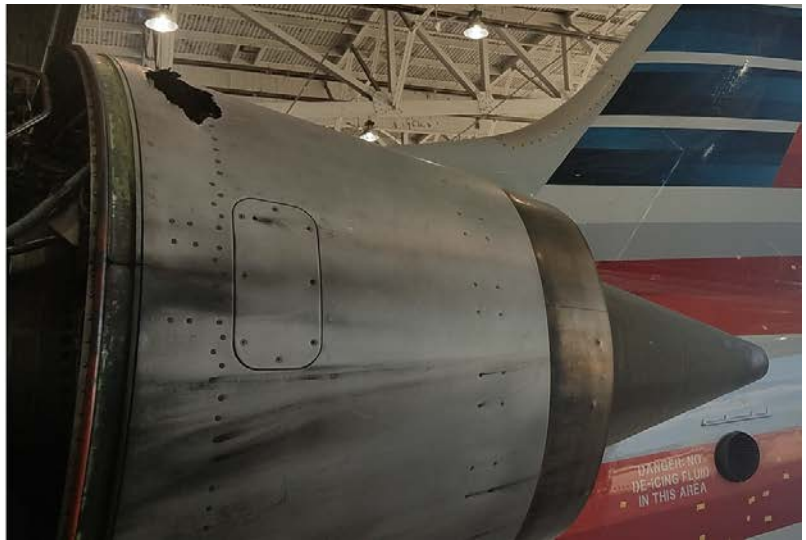
The aft core cowl had a hole at the 10 o'clock position, 4 inches aft of the cowl forward flange. The hole measured 7.5 inches circumferentially by 4 inches axially (**Photo 2**).

**Photo 2- Aft Core Cowl Damage**

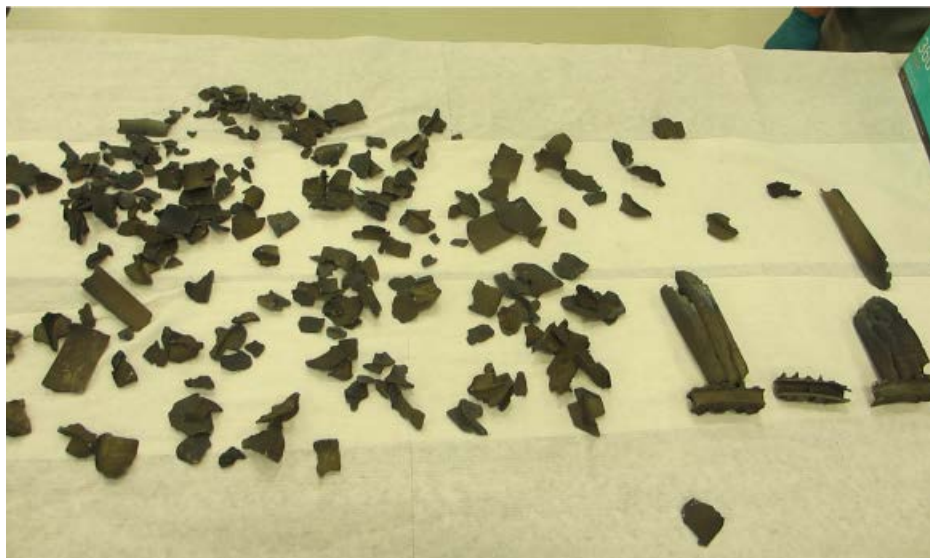
The engine was secured in a shipping container when the investigative team arrived at StandardAero. The engine was transferred to a work stand for examination and disassembly (**Photos 3, 4, and 5**). A cardboard box with engine fragments that were recovered at ORD by airport operations was included in the shipping container (**Photo 6**). A part number was visible on one of the fragments, and it was confirmed that the part was from a CF34 low pressure turbine nozzle.

**Photo 6- Debris Recovered by ORD Airport Operations**

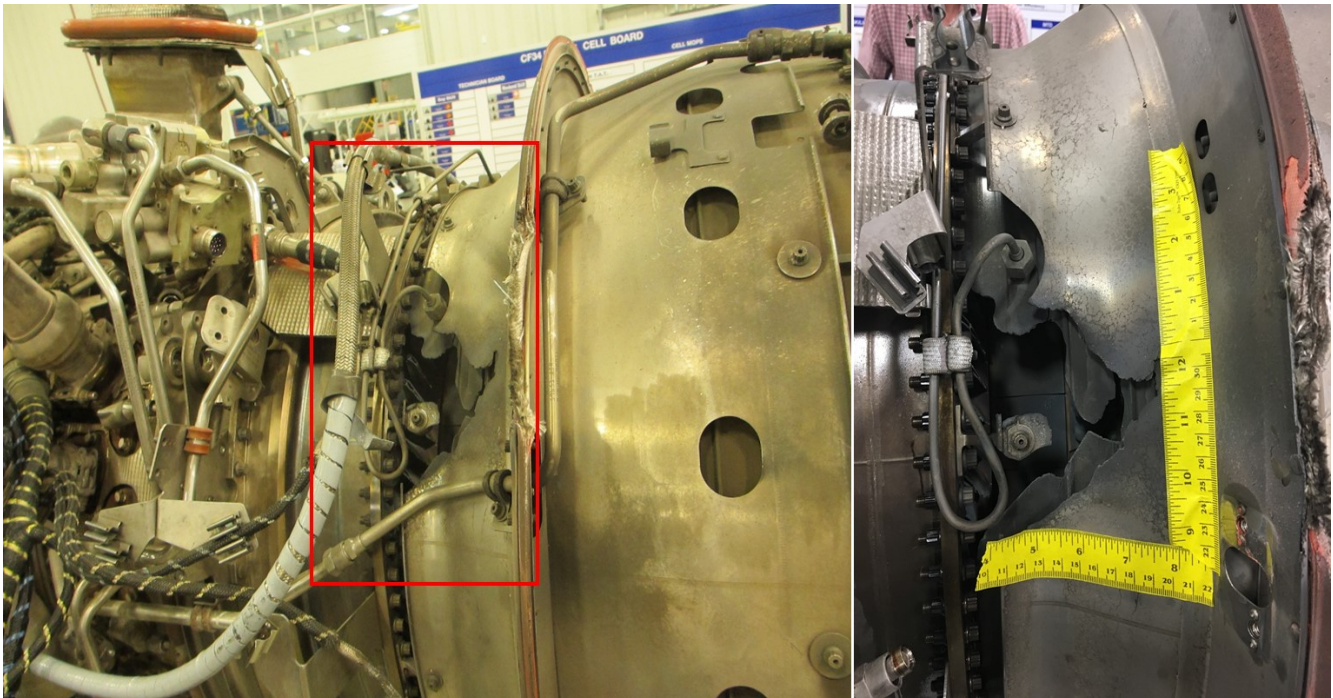
A visual examination of the engine was conducted beginning at the fan module. The fan blades and fan case were complete and in good condition, but the fan (N1 spool) was seized and could not be rotated by hand. The LPT case had a hole at the 10 o'clock position at the forward flange that measured 6

inches circumferentially by 4 inches axially (**Photo 7**). The edges of the hole were thermally damaged. The material around the hole was not extruded/deformed radially outward. The spiral wrap on the igniter lead that ran directly over the case hole was consumed and the rubber seal located on the LPT case baffle immediately aft of the hole exhibited thermal distress. Minor discoloration was observed around the edges of the LPT case hole, but minimal sooting and discoloration were observed on other exterior engine surfaces.

**Photo 7- LPT Case Hole**

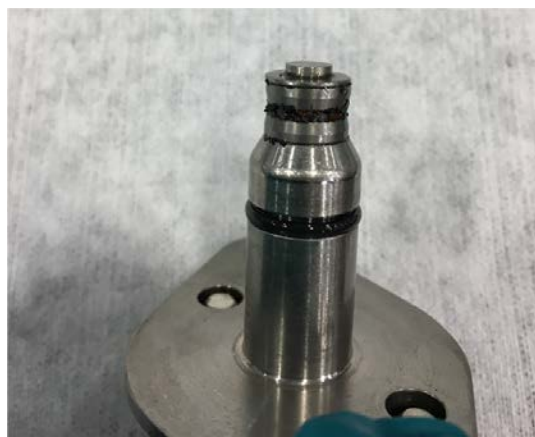
Engine oil from the gearbox, A sump, B sump, C sump, and oil filter housing were run through a paper filter and no debris was visible. The master chip detector plug was removed and had a small amount of debris accumulation that is considered normal for similar service run engines according to StandardAero mechanics (**Photo 8**).

**Photo 8- Master Chip Detector Plug**

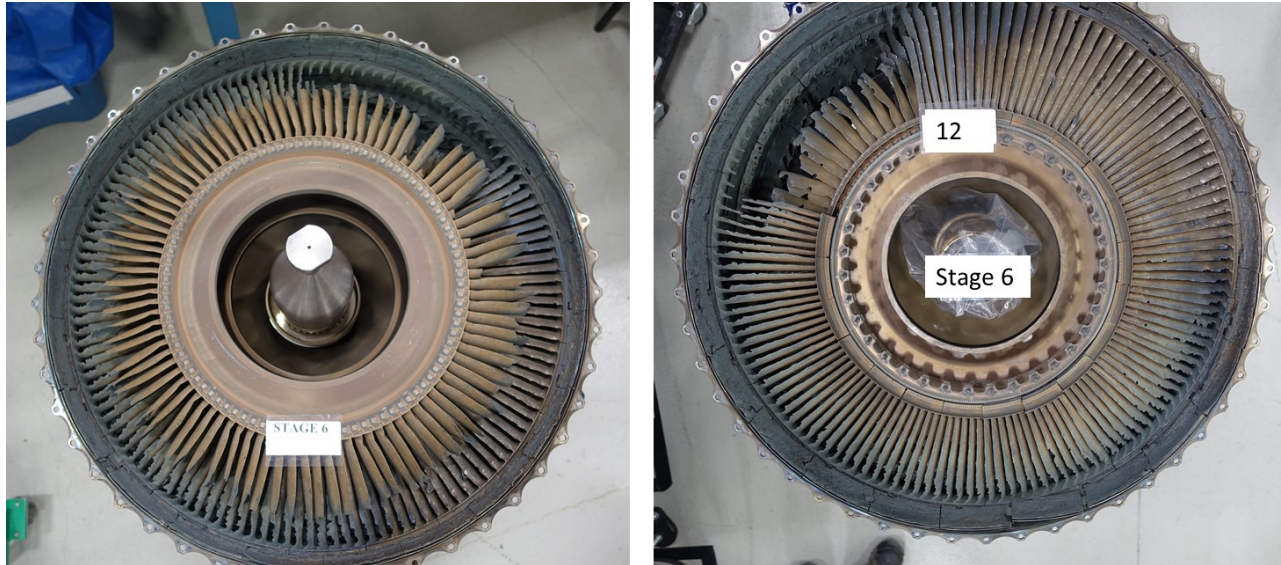
The LPT was removed from the engine and disassembled into stages. All LPT 6<sup>th</sup> stage rotor blades were separated at locations ranging from the blade platform to three-quarter span. The LPT 6<sup>th</sup> stage nozzle was missing vane airfoils between the 10 and 12 o'clock positions, and all remaining vane airfoils exhibited impact damage including: deformation on the pressure and suction sides, missing material on the trailing edge, and discoloration (**Photo 9**).

**Photo 9- (L) LPT 6<sup>th</sup> Stage Rotor, (R) LPT 6<sup>th</sup> Stage Nozzle**

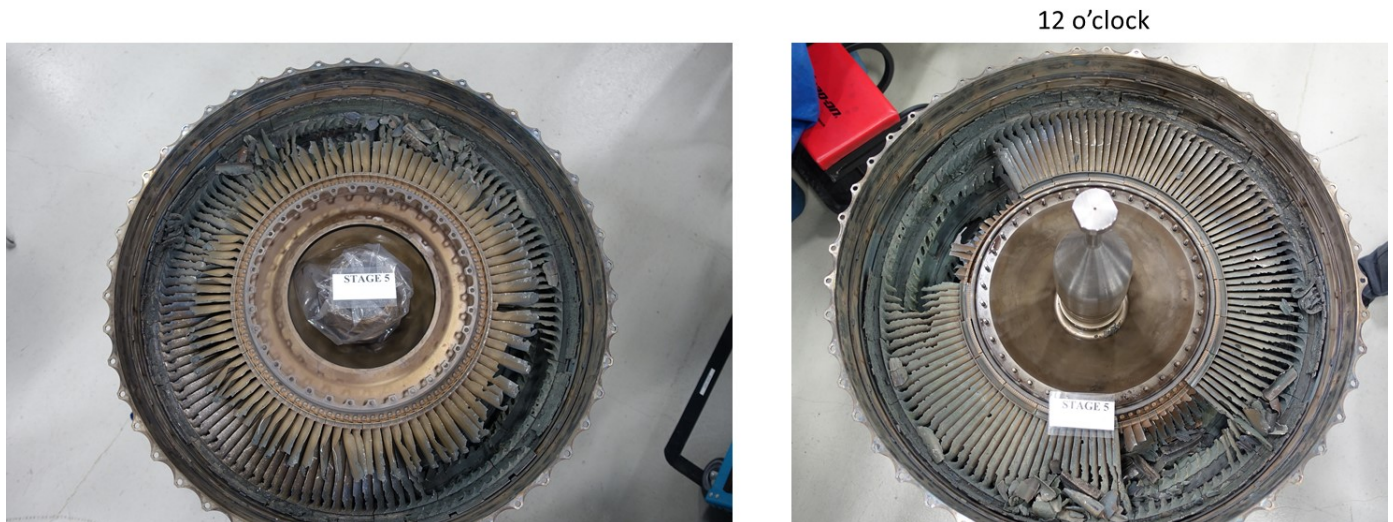
All LPT 5<sup>th</sup> stage rotor blades were separated between the quarter and midspan. The remaining blade stubs exhibited extensive hard body impact damage and material transfer. The LPT 5<sup>th</sup> stage nozzle vane airfoils were separated at the inner and outer diameter platforms between the 9 and 11 o'clock positions and the 4:30 and 6 o'clock positions. The outer diameter vane platforms between the 9 and 11 o'clock position had a concentrated area of thermal damage (**Photo 10**).

**Photo 10- (L) LPT 5<sup>th</sup> Stage Rotor, (R) LPT 5<sup>th</sup> Stage Nozzle**

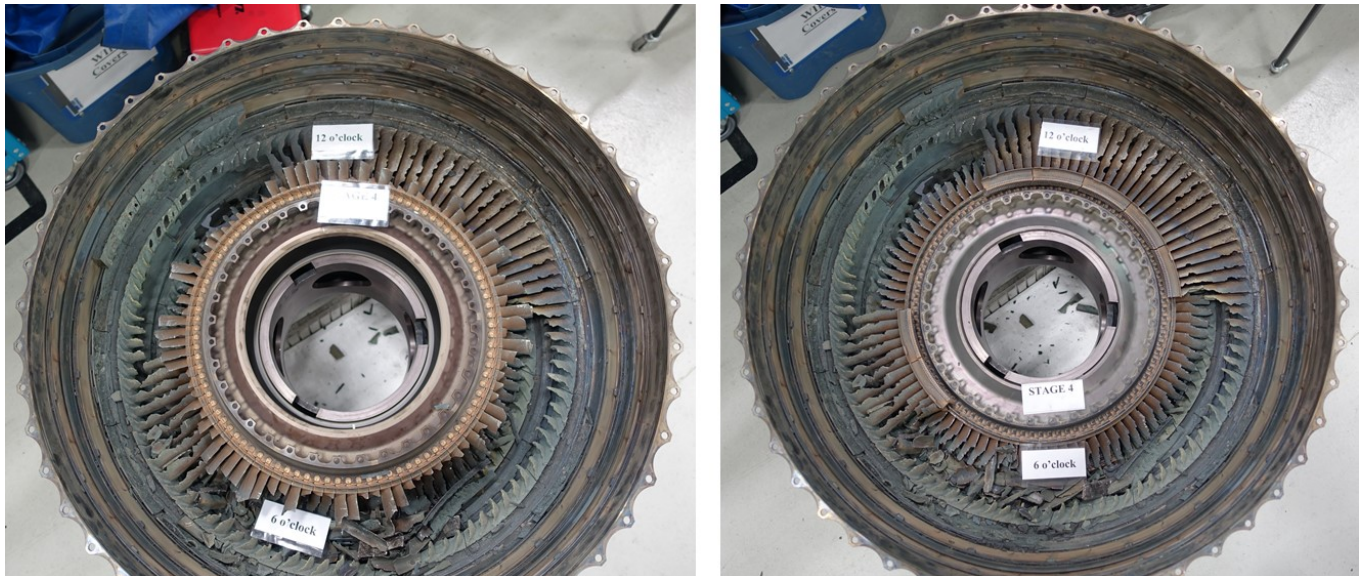
All LPT 4<sup>th</sup> stage rotor blades were separated between the blade platform and one-third span. The remaining blade stubs exhibited impact damage and deformation. The LPT 4<sup>th</sup> stage vane airfoils were separated and missing at the inner and outer vane platforms between the 8:30 and 11:30 positions and between the 3 o'clock and 7:30 positions. All remaining nozzle vanes had impact damage and deformation. The outer diameter nozzle vane platforms were thermally damaged between the 10 and 11 o'clock positions (**Photo 11**).

**Photo 11- (L) LPT 4th Stage Rotor, (R) LPT 4th Stage Nozzle**

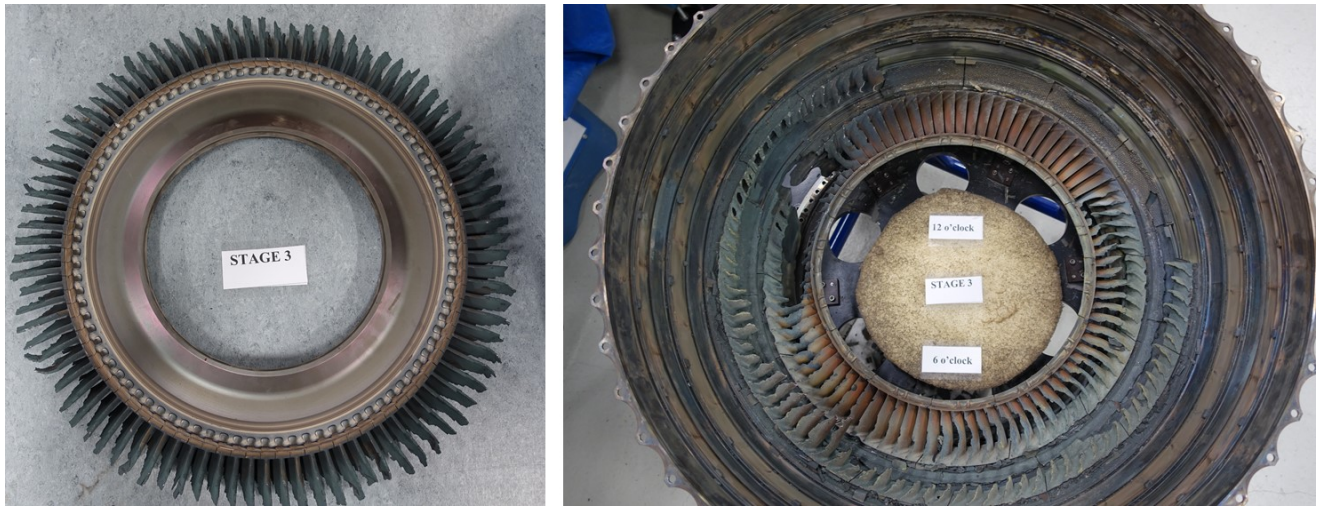
All LPT 3<sup>rd</sup> stage rotor blades were separated at about the half span and remaining blade stubs had impact damage. The LPT 3<sup>rd</sup> stage nozzle vane airfoils were separated at the inner and outer diameter vane platforms between the 9 o'clock and 10:30 positions. The LPT case hole previously mentioned was located forward of the 3<sup>rd</sup> stage vane nozzle, at the 10 o'clock position. The nozzle vane airfoils between the 2 and 3 o'clock positions exhibited thermal damage at the mid span. The nozzle vanes between the 11 and 1 o'clock position were intact with minor impact damage. All other 3<sup>rd</sup> stage nozzle vane airfoils exhibited impact damage and were missing material along the trailing edge (**Photo 12**). The ITT probes located at the 4 and 9 o'clock positions were missing material, and the remaining probe pieces were flush with the outer transition liner (OTL). The ITT probe at the 4 o'clock position was also missing material and about a one-inch piece of the probe remained protruding from the OTL. The ITT probe at the 1 o'clock position was intact and in good condition. The OTL had thermal damage at the 3 to 4 o'clock positions and the 9 to 11 o'clock positions.

**Photo 12- (L) 3rd Stage LPT Rotor, (R) 3rd Stage LPT Nozzle**

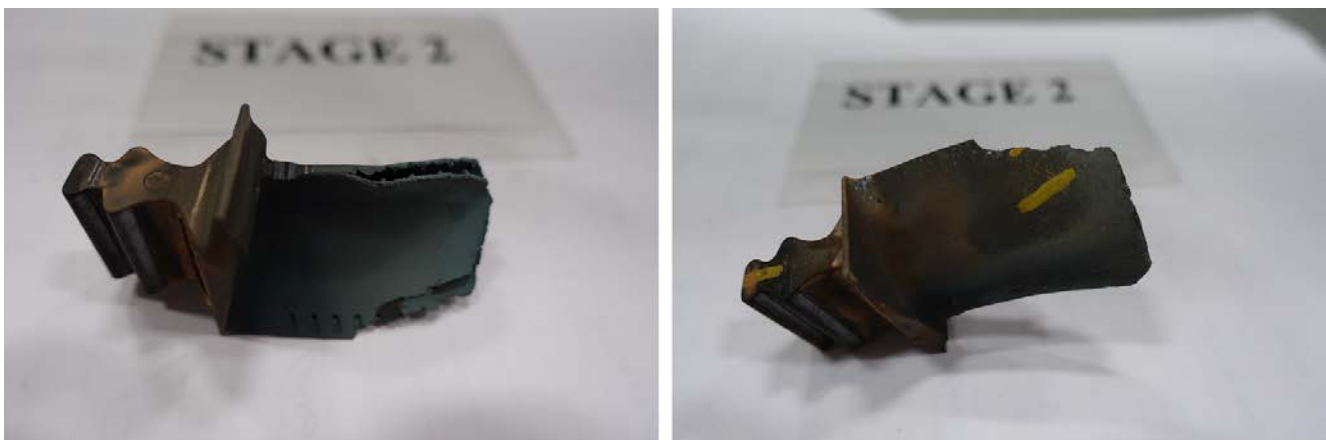
The HPT 2<sup>nd</sup> stage rotor blades were all present but had a combination of thermal and impact damage to the leading edge that exposed the blade cooling air circuits, as well as trailing edge material loss at the blade tip (**Photo 13**). A groove was rubbed into all blades at the leading edge near the platform, consistent with the HPT 2<sup>nd</sup> stage nozzle inner platform trailing edge contact. The HPT 2<sup>nd</sup> stage rotor shroud had thermal damage between the 3 and 4 o'clock positions and more severely between the 9 and 11 o'clock positions. The HPT inner case that houses the HPT 2<sup>nd</sup> stage nozzle had burn through at the 10 o'clock position coincident with the hole in the LPT case (**Photo 14**). One nozzle vane segment had separated and was missing at the 10 o'clock position. The surrounding vanes exhibited thermal and impact damage. Thermal damage including vane airfoil deformation was also observed at the 3 o'clock position (**Photo 15**).

**Photo 13- HPT 2<sup>nd</sup> Stage Rotor Blade**

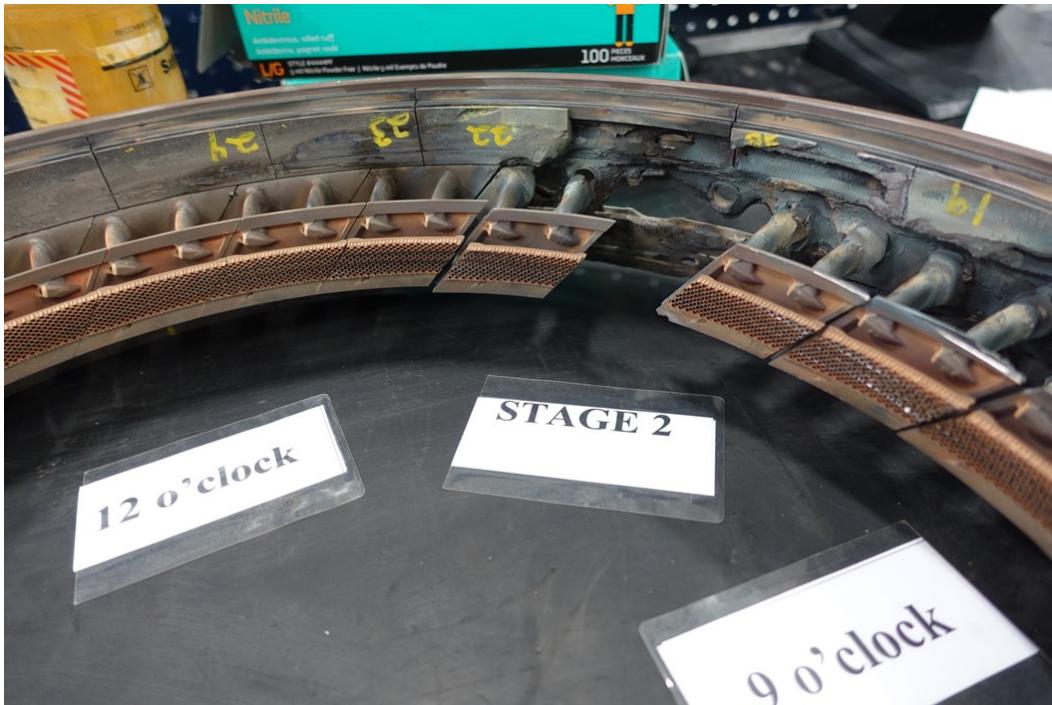
**Photo 14- HPT Inner Case Burn Through and Missing HPT 2<sup>nd</sup> Stage Nozzle Segment**

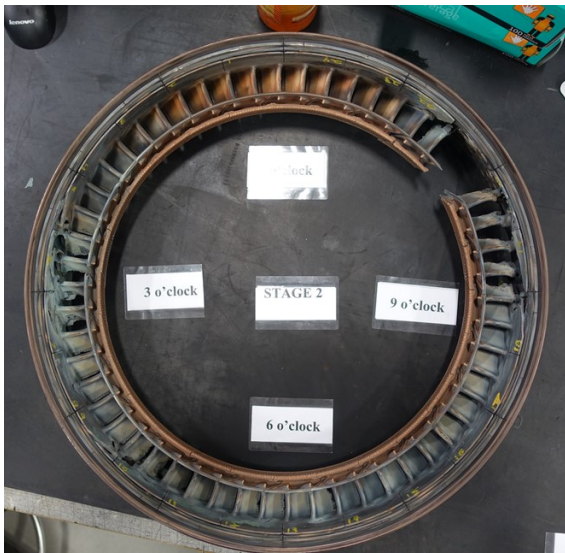
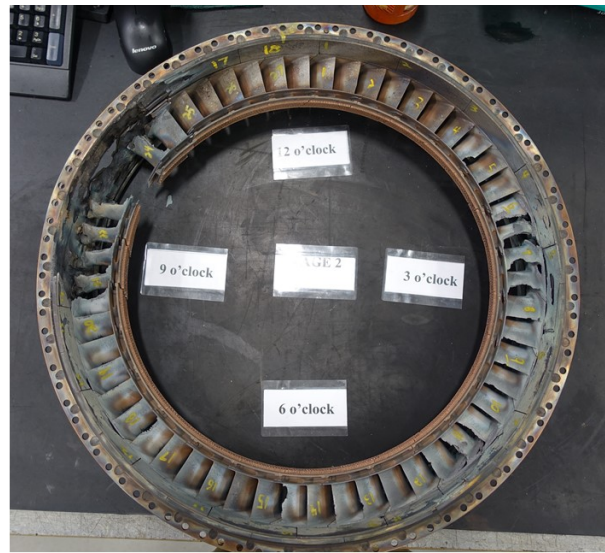
**Photo 15- HPT 2<sup>nd</sup> Stage Nozzle (L) Pressure Side, (R) Suction Side**

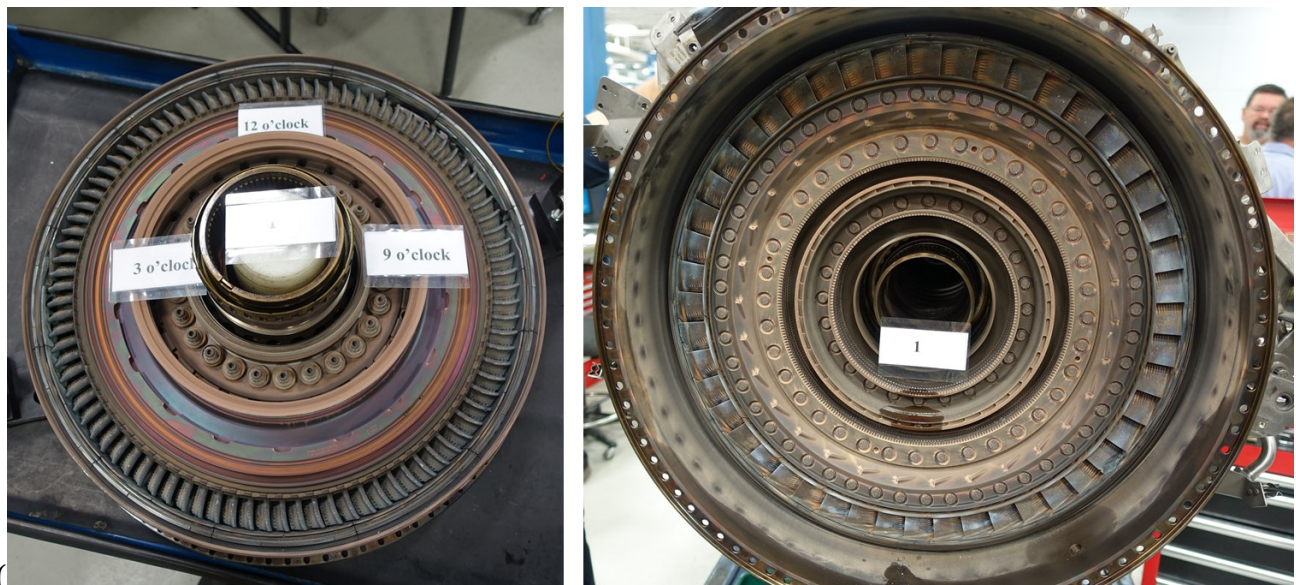
The HPT 1<sup>st</sup> stage rotor blades were all present and several blades had minor trailing edge material loss at the tip. The HPT 1<sup>st</sup> stage blade shrouds exhibited thermal damage between the 9 and 11 o'clock positions and minor thermal damage at the 3 o'clock position. The HPT 1<sup>st</sup> stage nozzle assembly was removed as part of the combustor liner assembly. The nozzle vane airfoils were intact with minor discoloration that was considered normal for similar service run engines according to StandardAero (**Photo 16**).

**Photo 16- (L) HPT 1<sup>st</sup> Stage Rotor LE, (R) HPT 1<sup>st</sup> Stage Nozzle TE**

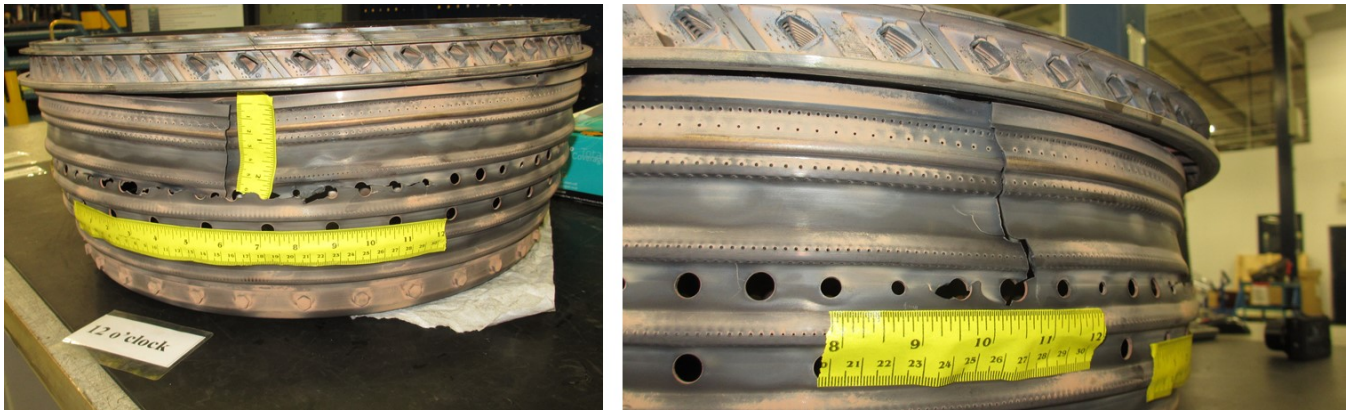
GE documentation identifies the combustion outer liner sections by panel numbers, P0-P4 (**Photo 17**). The combustion outer liner on the incident engine had a 12 inch long circumferential crack that ran between the cooling air holes on panel P2, from the 10 o'clock to 12:30 positions. The circumferential crack was connected to an axial crack that ran approximately 2.5 inches from panel P2 to the aft flange/trailing edge of the panel P4 (interface with the HPT 1<sup>st</sup> stage nozzle). At the junction of the circumferential and axial cracks, the liner surface was displaced about 1.5 inches radially in towards the engine centerline (**Photo 18**). A second 2.5 inch axial crack was also present at the 2 o'clock position between panel P2 and the trailing edge of panel P4. There was no circumferential cracking in the area around the second crack.

**Photo 18- Combustion Outer Liner Cracks (L) 12 o'clock, (R) 2 o'clock**

Following the prior incident event, GE revised the on wing combustion liner inspection criteria in the LMM to clarify pass/fail criteria for axial cracks and burn through holes. The initial manual revision was issued on April 1, 2018 and the applicable text and figure are shown below in **Figures 3 and 4**.

GE released category 2<sup>5</sup> service bulletins, SB 72-A0326 (CF34-8C engines) and SB 72-A0211 (CF34-8E engines) on October 17, 2018. The SB recommends a one-time BSI of panel P4 on combustion outer liners with more than 15,000 flight hours time since new or time since repair.

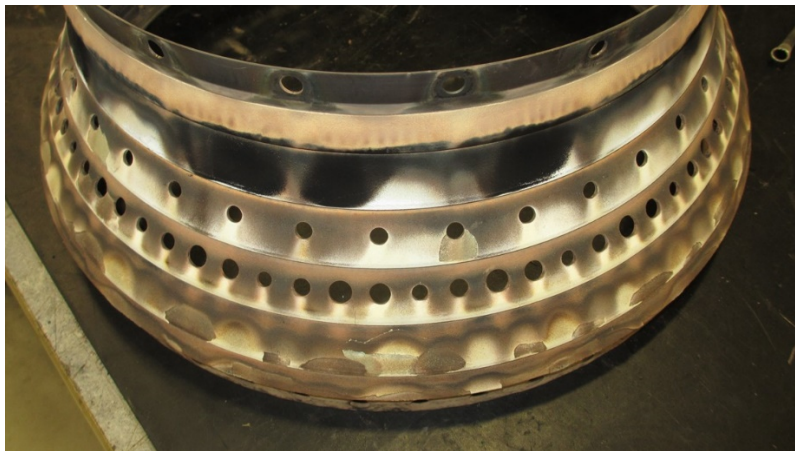
The inner combustion liner was intact but exhibited discoloration and thermal barrier coating loss (**Photo 19**). The fuel injector swirlers were intact and moved freely. The combustor baffles were all present but had extensive discoloration/coking accumulation (**Photo 20**). The fuel injectors had minor discoloration but appeared to be in good condition and free of obstructions. Two fuel injectors located at the 11:30 and 7 o'clock positions had a wear step on the metal sleeve around the fuel injector tip that was uncommon according to StandardAero mechanics. The fuel injectors were all removed and shipped to Woodward in Rockford, Illinois to be flow tested.

**Photo 19- Combustion Inner Liner**

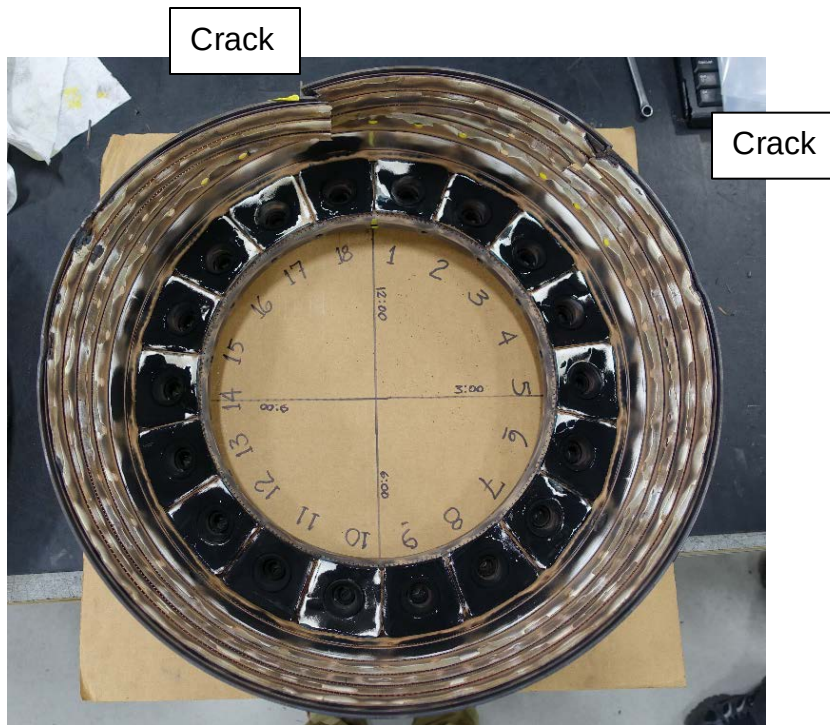
**Photo 20- Combustor Baffles and Outer Liner**
