**NATIONAL TRANSPORTATION SAFETY BOARD  
OFFICE OF AVIATION SAFETY  
WASHINGTON, D.C. 20594**

NTSB ID: ENG18IA036  
POWERPLANT GROUP CHAIRMAN'S FACTUAL REPORT

March 4, 2022

Location: Atlanta, Georgia  
Date: September 5, 2018  
Time: 2332 Eastern Daylight Time  
Aircraft: Boeing 757-232, N668DN, MSN 25141, operated by  
Delta Air Lines

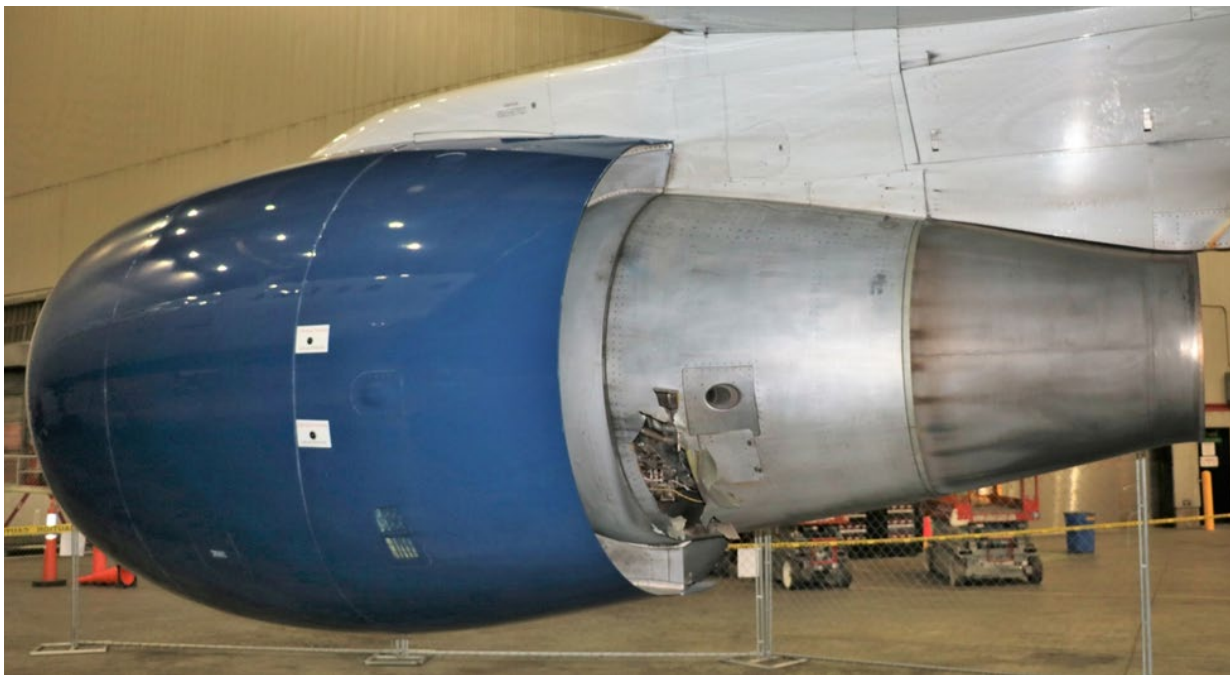
Post-incident airplane inspection noted holes in the right nacelle inboard<sup>1</sup> core cowl and engine, and minor damage to the right wing and fuselage.

Figure 1. View of inboard side of right nacelle

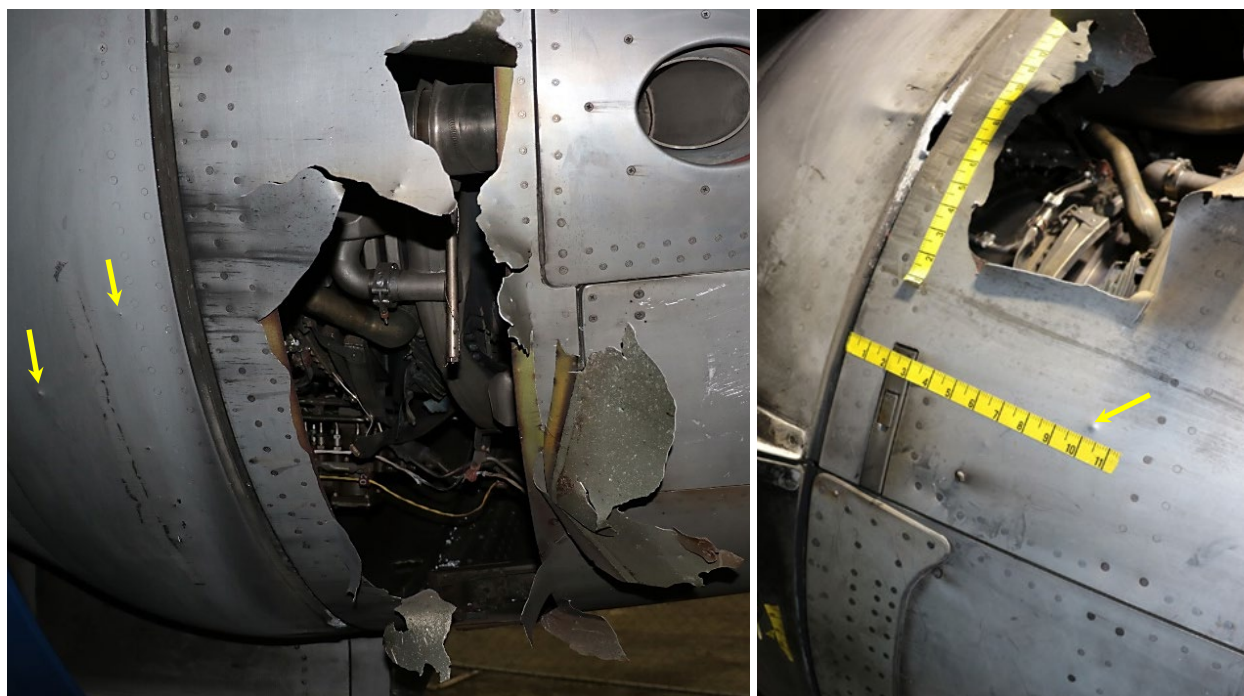
There was a 27 1/2-inch circumferential by 10 1/2-inch axial<sup>3</sup> hole in the right inboard core cowl just forward of the HPC S14 overboard bleed port between 7 and 10 o'clock.<sup>4</sup> The edges of the hole were petaled outward. Dents were noted 7 1/2 inches forward of the thrust reverser cowl aft end at 9 o'clock, 3 1/2 inches forward of the thrust reverser cowl aft end at 8 o'clock, and 10 inches aft of the forward core cowl edge at 6 o'clock. See Figure 3.

Figure 3. Two photographs of the right nacelle showing hole through inboard side with local dents noted

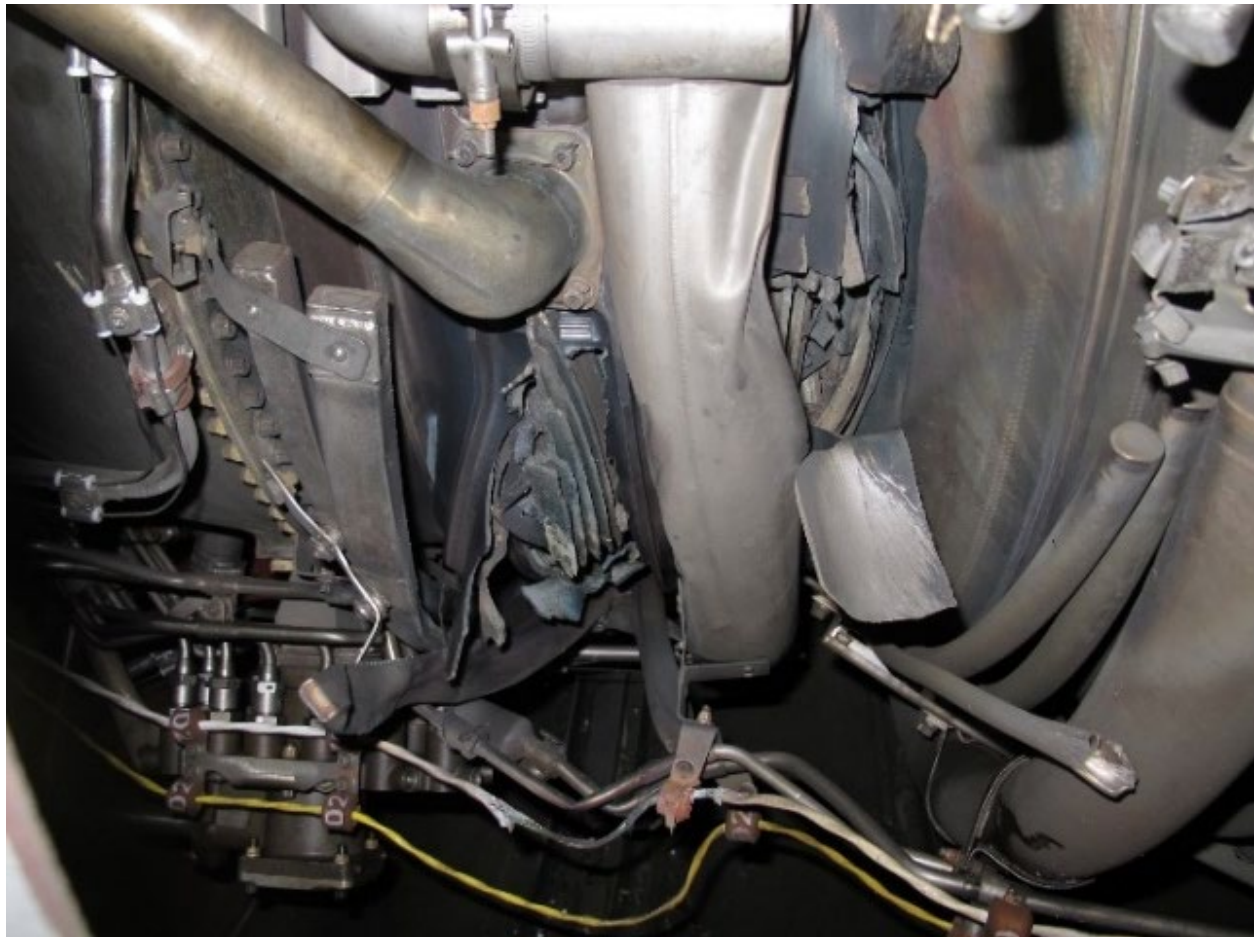
There was a 14-inch circumferential by 3-inch axial hole in the engine HPT case along the plane of the HPT S2 vanes at 7 o'clock. A 6-inch-long debris fragment identified as lenticular seal

material was protruding from this breach. There was a 7-inch circumferential by 2 1/2-inch axial hole in the LPT case in plane with the outer transition duct at 8 o'clock. See Figures 4 and 5.

Figure 4. HPT and LPT case breaches. A fragment of lenticular seal is protruding from the HPT

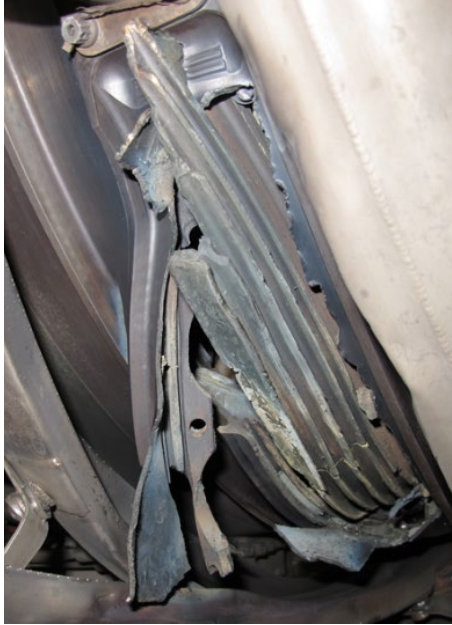
Figure 5. Debris fragment

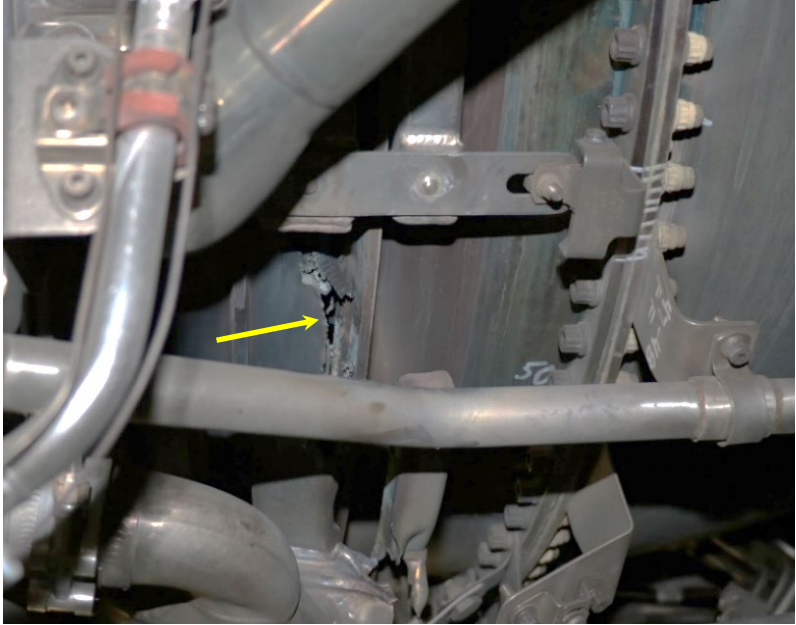
There was a 6-inch circumferential by 1 1/2-inch axial breach in the HPT case along the plane of the HPT S1 blades at 5 o'clock. See Figure 6.

Figure 6. HPT case breach at 5 o'clock

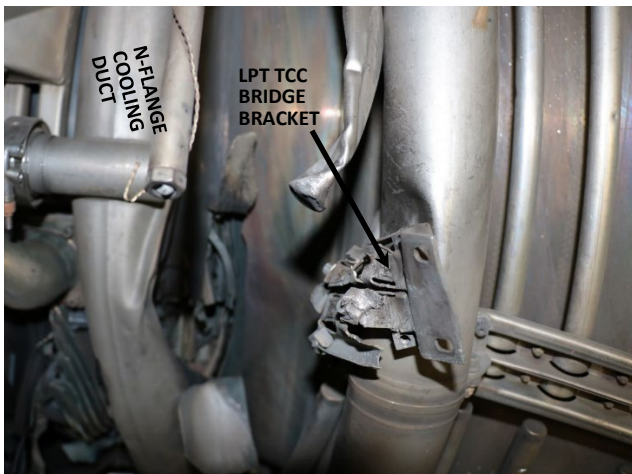
The external engine plumbing in the vicinity of the case breaches was outwardly crushed and deformed consistent with impacts from debris exiting the engine. The affected hardware included the HPT active clearance control and LPT turbine clearance control (TCC), the HPT-to-LPT flange (N-flange) cooling duct and the LPT TCC bridge bracket. See Figure 7. An LPT TCC plenum tube manifold coupling was liberated at 5 o'clock. See Figure 8. The TCC tube coupling was recovered from inside the thrust reverser.

Figure 7. Damage to externals

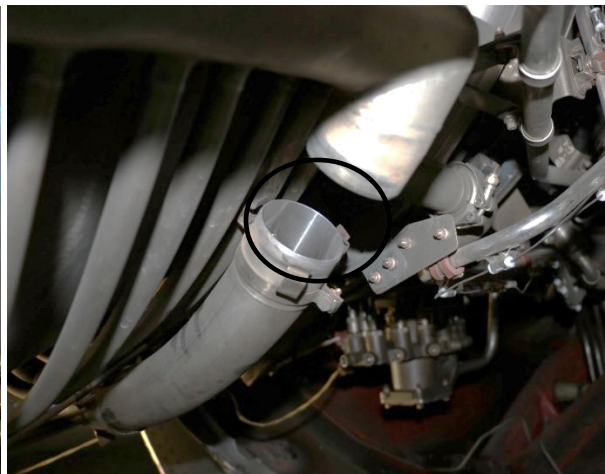
Figure 8. LPT TCC plenum tube manifold with liberated coupling

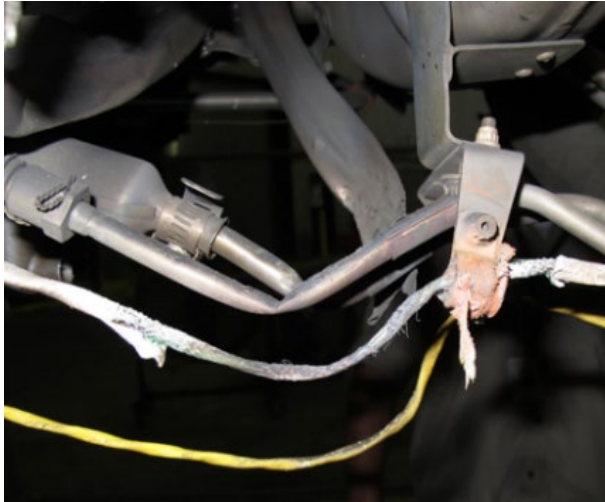
Thermal distress was noted to a P-clamp and a small length of EGT signal wire insulation in the

Figure 9. Degraded wire coating and P-clamp cushion

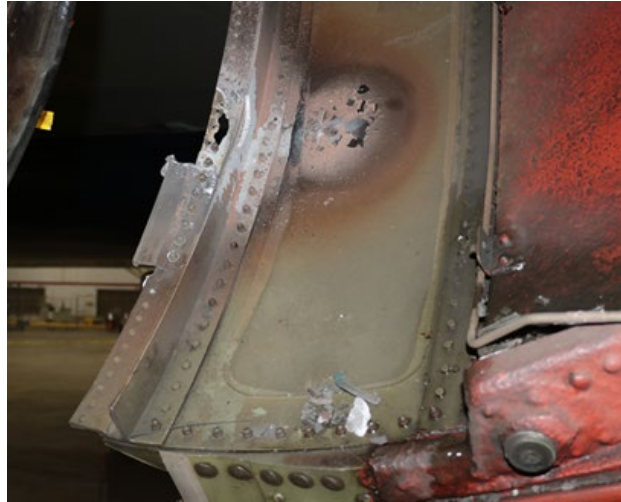
Figure 10. Inboard thrust reverser cowl thermal damage

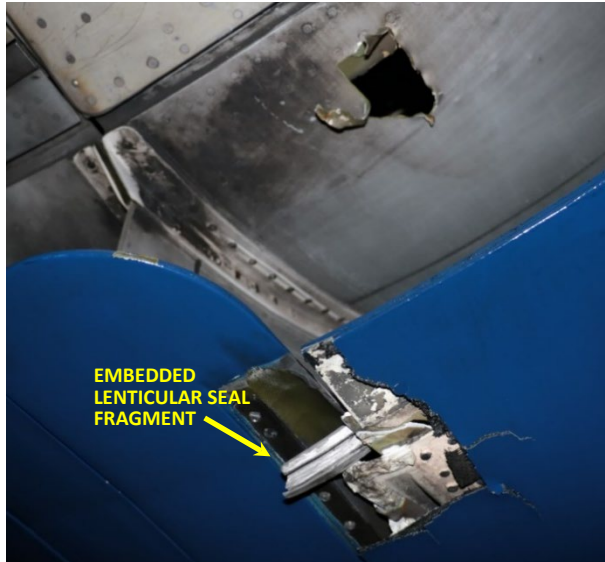
A 5-inch-long piece of debris protruded from a 5-inch circumferential by 8-inch axial hole in the thrust reverser outer structure at 5 o'clock. An axially coincident 2-inch circumferential by 3-inch axial hole in the thrust reverser inner structure was found when the thrust reverser was opened. The edges of these holes were petaled outward. See Figure 11.

Figure 11. Holes through the inner and outer outboard thrust reverser structure.

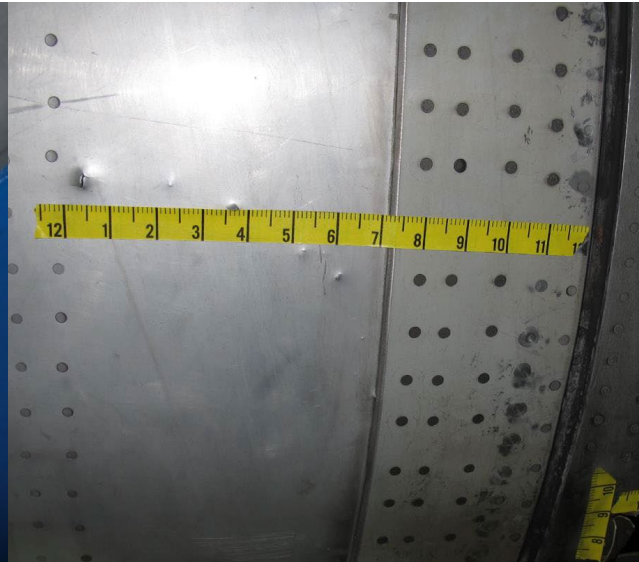
A line of small dents extended horizontally at 4 o'clock from 6 inches aft to 11 1/2 inches aft of the outboard core cowl forward edge. There was a through-crack in the aftmost dent. See Figure 12.

Figure 12. Row of dents in outboard core cowl

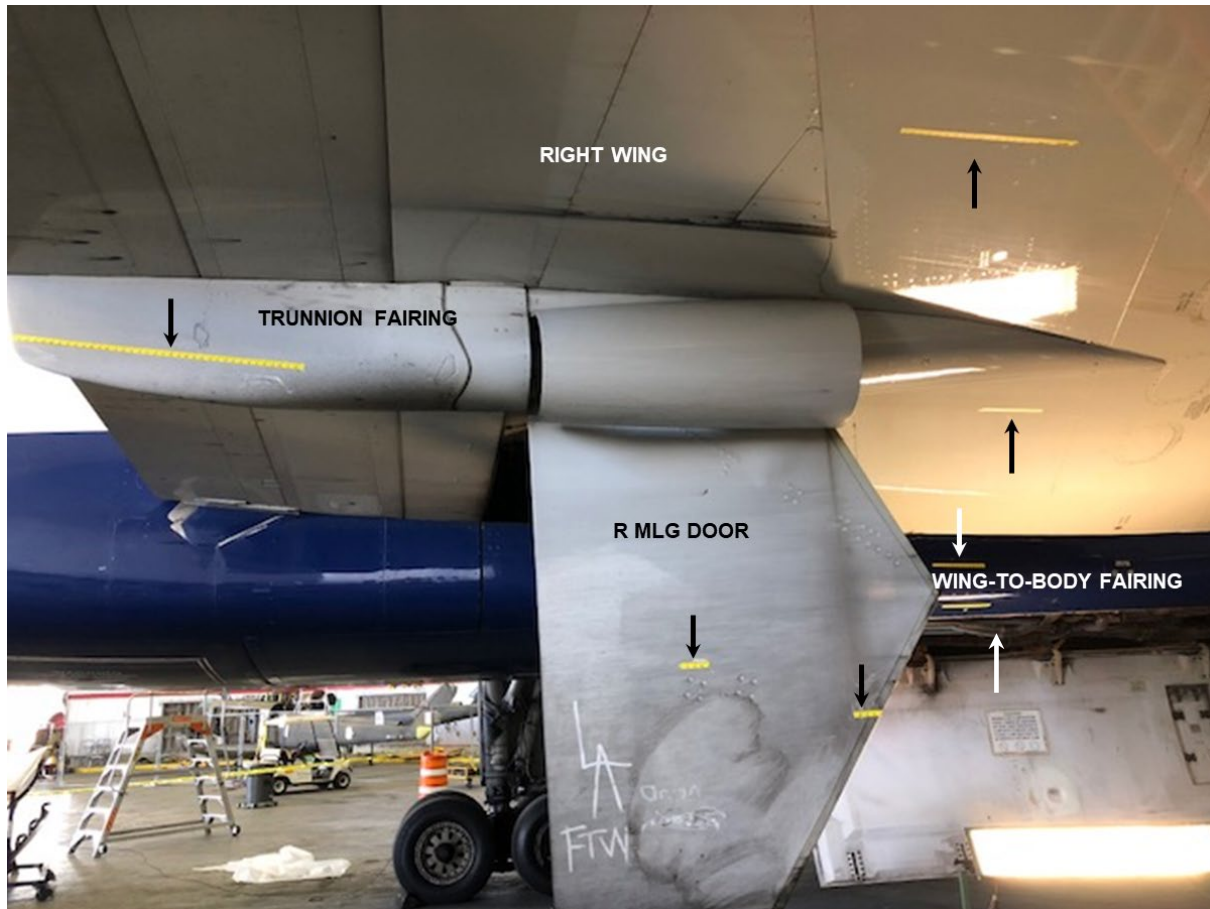
There was a cluster of small scrapes and a 6-inch-long horizontal scuff at the aft end of the trunnion fairing. Local scratches and gouges were found on the underside of the right wing inboard and outboard of the trunnion fairing. There were three small sites of impact damage, including a through-puncture, on the right wing-to-body fairing. The right main landing gear (R MLG) door outer surface displayed two small nicks/scratches. See Figure 13. Light impact damage was also observed along the right horizontal stabilizer leading edge. All the damage was consistent with external impact.

Figure 13. Airplane damage

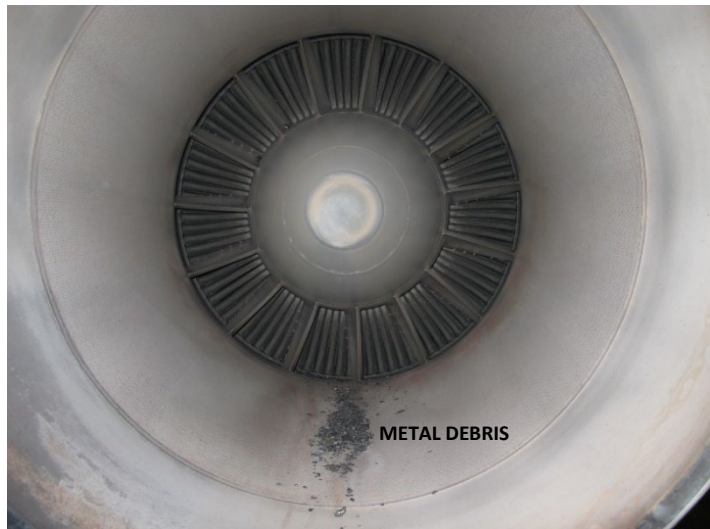
There was no obvious fan blade damage. The LPT S7 turbine blades were intact. Metal debris was collected from inside the tailpipe. See Figures 16 and 17.

Figure 17. Engine exhaust with intact S7 airfoils

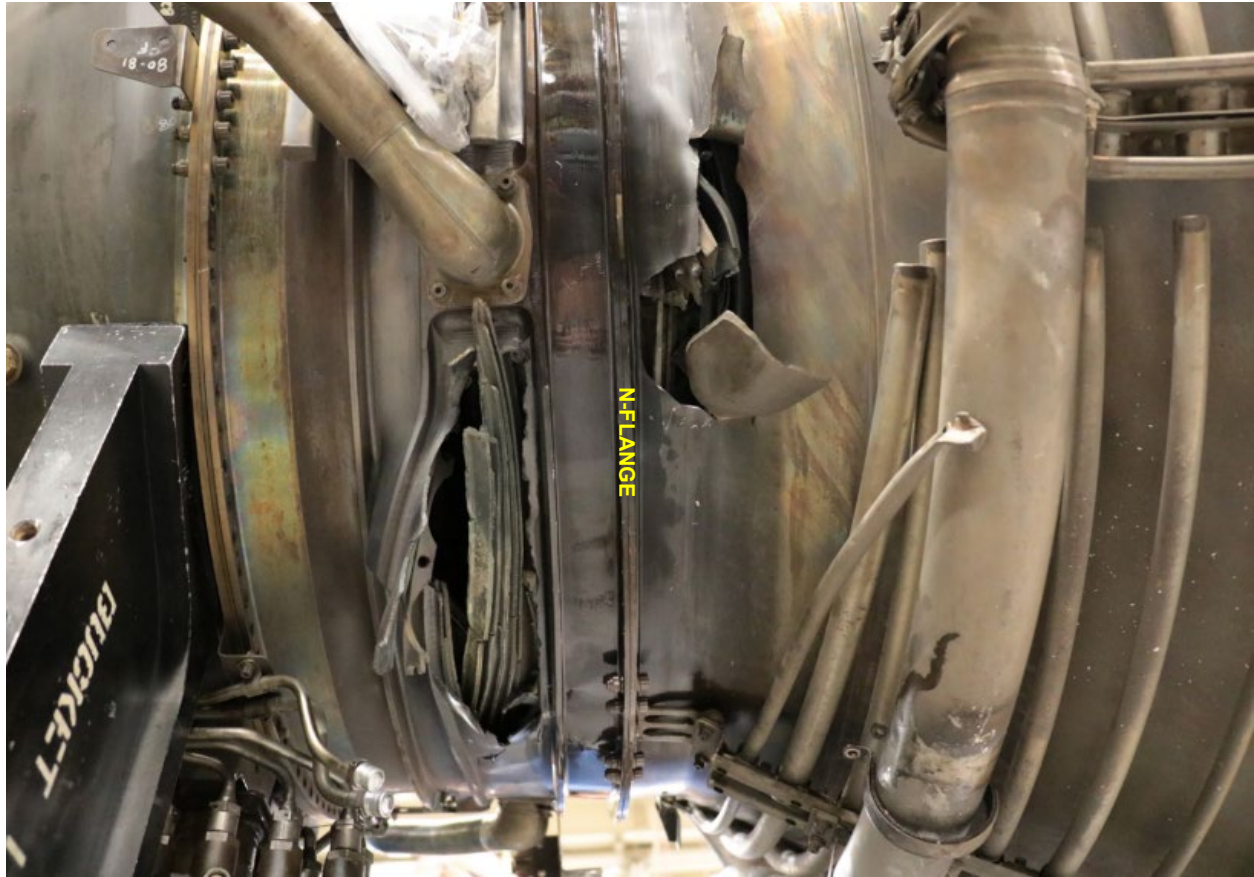
The engine external components were removed as required to separate the LPT module from the engine. The turbine cooling system externals were inspected for pre-incident discrepancies with no anomalies noted. No secondary damage to flammable fluid tubes was found. See Figure 18.

Figure 18. View of the primary engine case breaches following externals removal

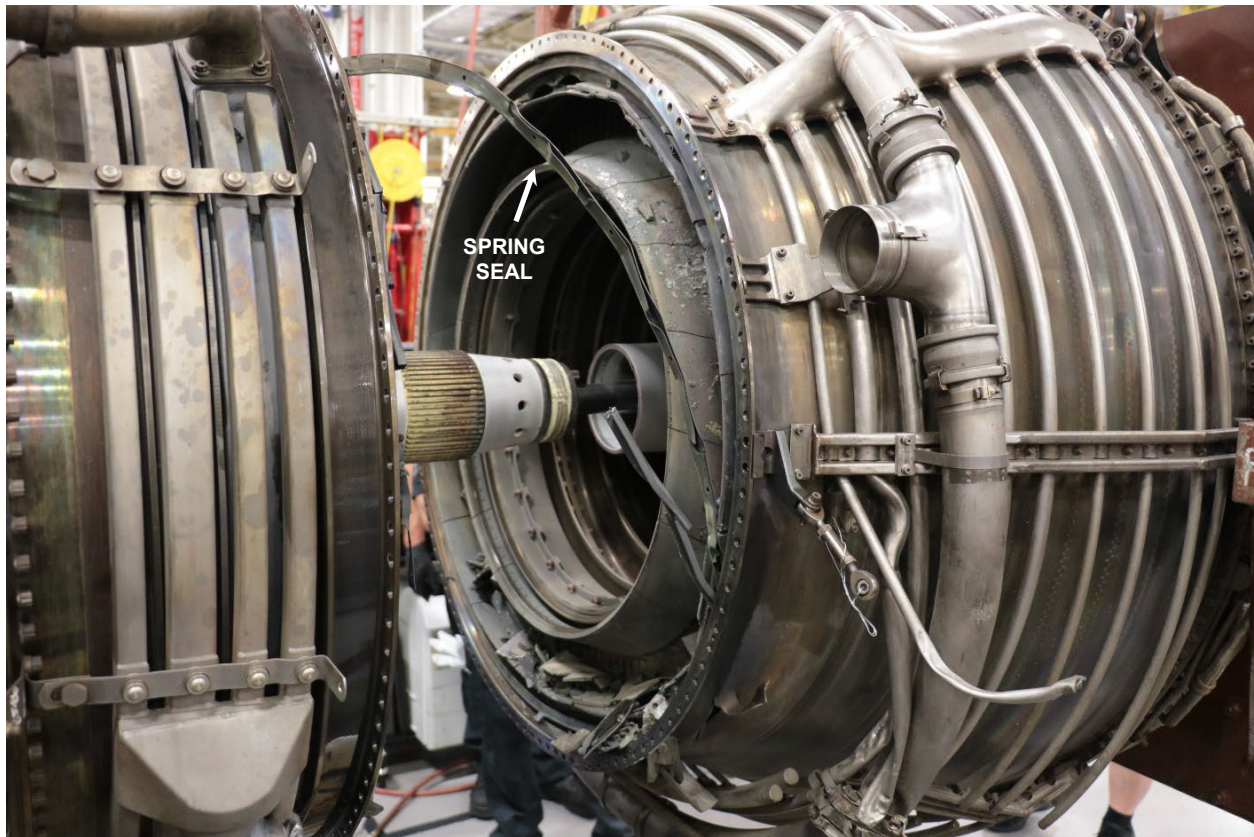
The LPT was removed from the engine at the N-flange. The LPT-to-HPT spring seal was dislodged from the HPT case between 6 and 1 o'clock. It was cut to facilitate LPT removal. See Figure 19.

Figure 19. LPT separation from HPT, showing displaced spring seal and loose debris lying in the LPT case at 6 o'clock

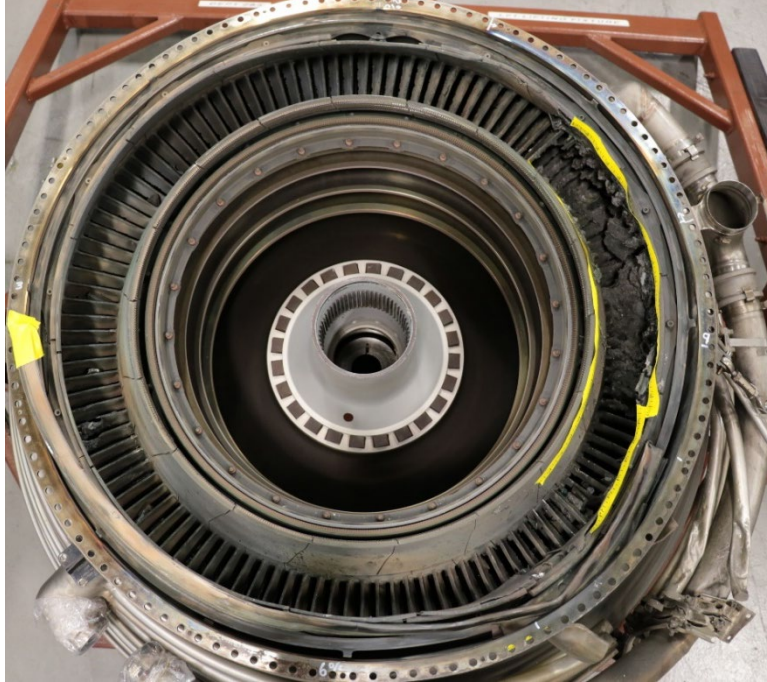
The LPT gas path components over a 30° arc of the LPT centered on 9 o'clock were thermally consumed or had the appearance of re-hardened slag. See Figure 20. This damaged extended from the LPT S3 vanes to the S5 vane leading edges. See Figure 21.

Figure 20. LPT module forward end

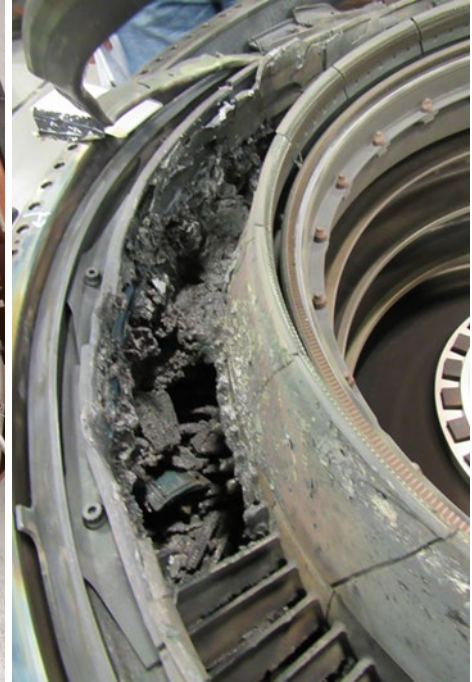
Figure 21. LPT gas path thermal damage

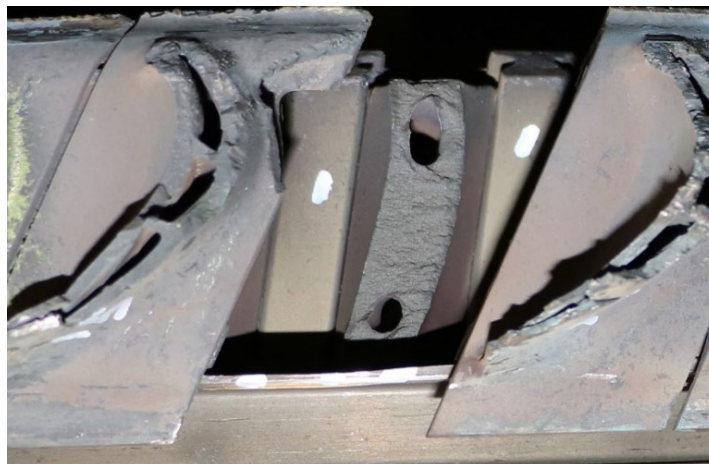
Inspection of the HPT aft end found that all but two of the HPT S2 blades were fractured about one inch above the platform. Blade 29 was fractured 1/4 inch above the platform and blade 16 was fractured below the platform. Secondary damage obscured the fracture surfaces of the above-platform fractures. The below-platform fracture surface was clean and uniformly granular. See Figure 22.

Figure 22. HPT S2 blade below-platform fracture surface

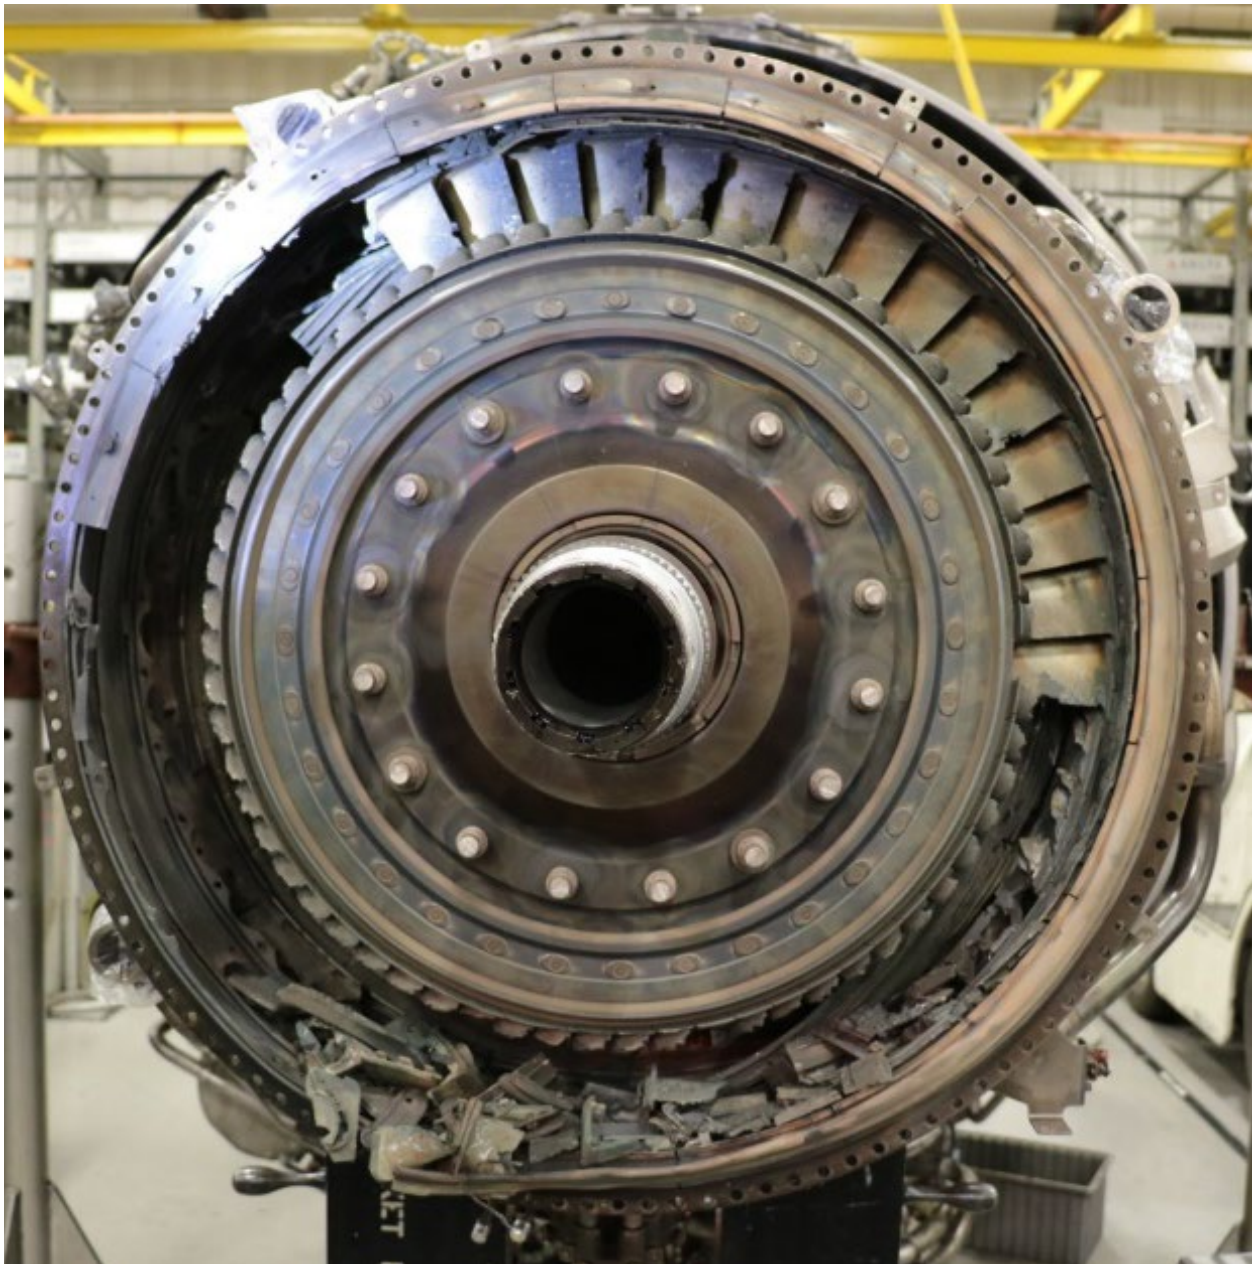
The HPT S2 hub was intact. Eight of the 32 side plate rivets, rivets 25, 26, 28, 29, 30, 31, 32, and 1, were loose. S2 BOAS supports 12 through 16 were liberated; all other supports were present. The S2 BOAS were liberated between 6 and 11 o'clock; all other BOAS were intact. The HPT S2 vanes between 3 and 11 o'clock were liberated. A large amount of debris was lying inside the case at 6 o'clock. See Figure 23.

Figure 23. Aft view of HPT module

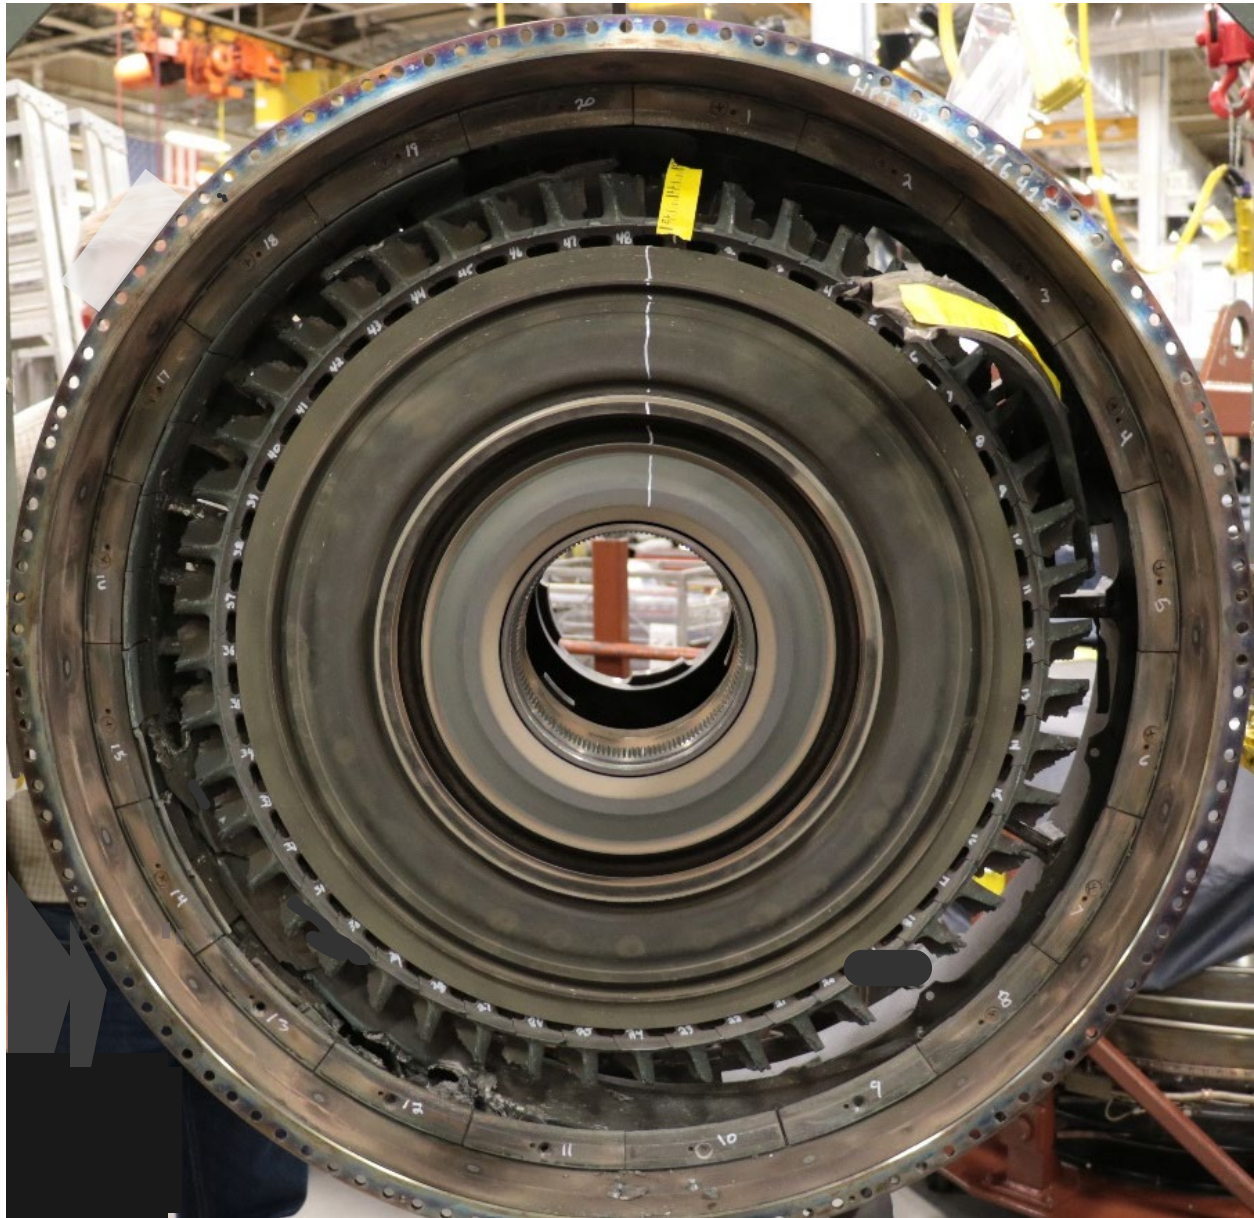
disk was intact. All HPT S1 blades were fractured approximately one inch above the platform. A 30° arc of the tangential on-board injector (TOBI) seal knife edges were slightly damaged. The HPT S1 BOAS supports were intact. The HPT S1 BOAS were liberated between 5 and 1 o'clock and the other BOAS were intact. See Figure 24. A piece of lenticular seal was spiralled over the S1 blade stubs at 10 o'clock and extended forward about 12 inches. See Figures 24 and 25.

Figure 24. HPT forward end showing HPT S1 damage and S2 air seal fragment extending over S1 HPT

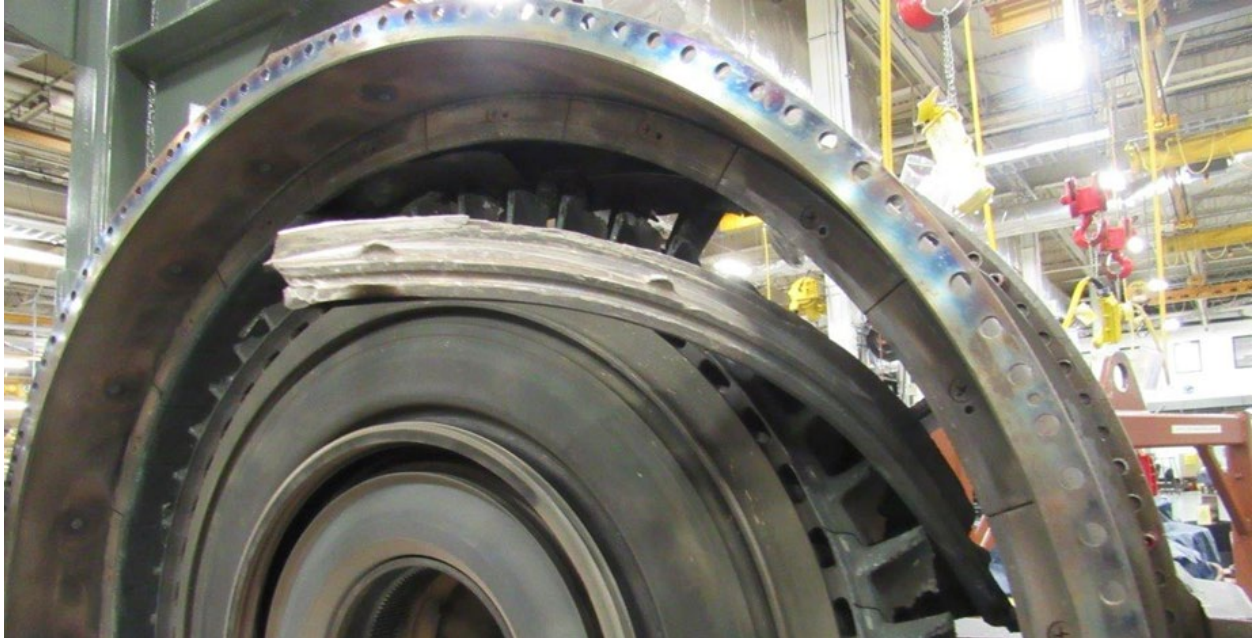
Figure 25. Air seal fragment protruding from forward end of the HPT module

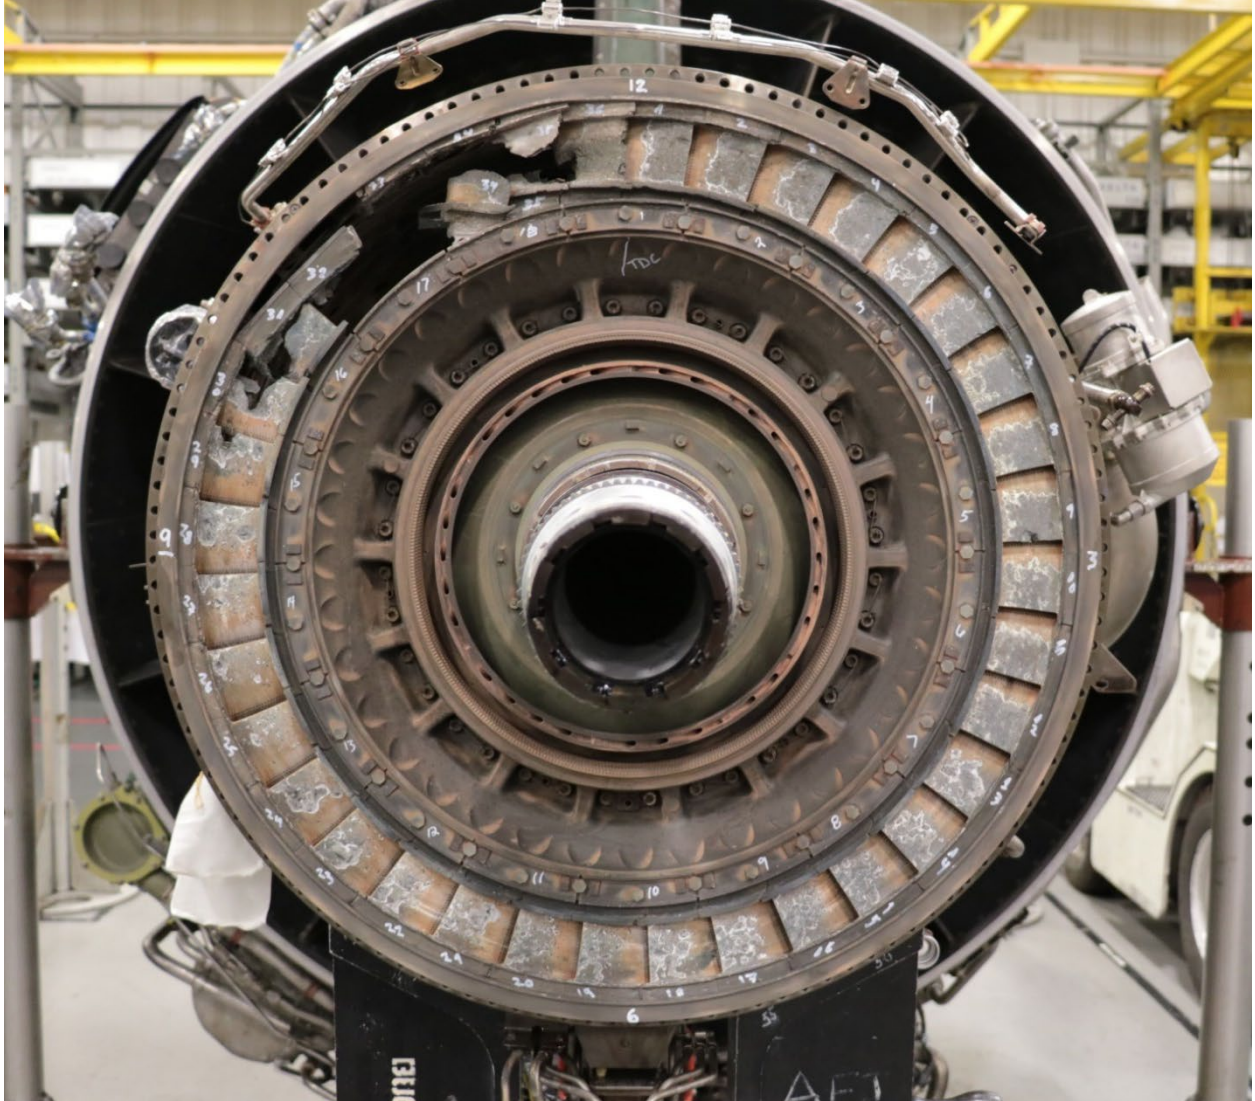
The HPT S1 vanes between 9 and 12 o'clock were fractured or liberated where the lenticular seal segment protruding from the front of the HPT case had penetrated. Combustor damage was observed forward of the HPT S1 turbine vane assembly penetration. See Figure 26.

Figure 26. HPT S1 turbine vane assembly, showing penetration by lenticular seal

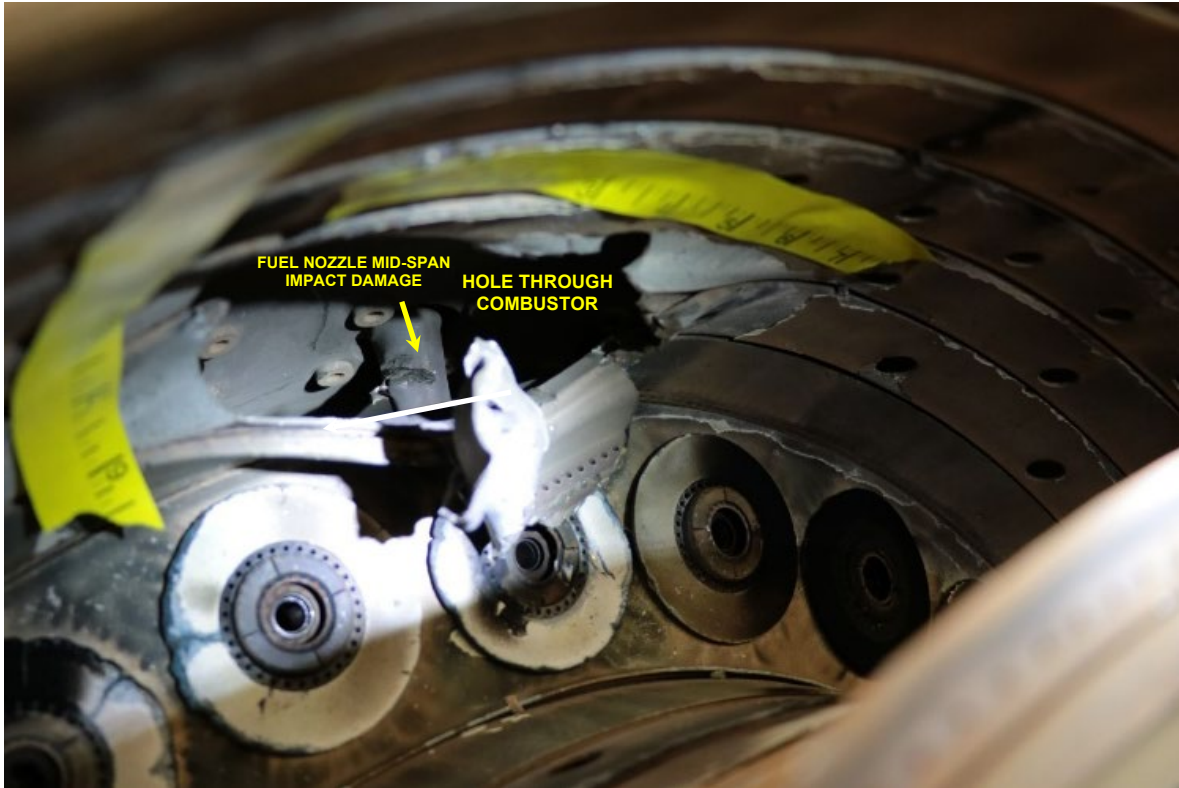
The HPT S1 turbine vane assembly was removed. Two lenticular seal pieces were found lying between the outer liner and the diffuser case at 6 o'clock. These pieces lacked the darkened color of the other lenticular seal fragments. The combustion outer liner dome was inwardly deformed at 10 to 11 o'clock and there was a 5-inch circumferential by 2 1/2-inch axial hole in the deformed area. Two fuel nozzles in line with the penetration were damaged. See Figure 27.

Figure 27. Combustion chamber showing liner penetration and damaged fuel nozzle

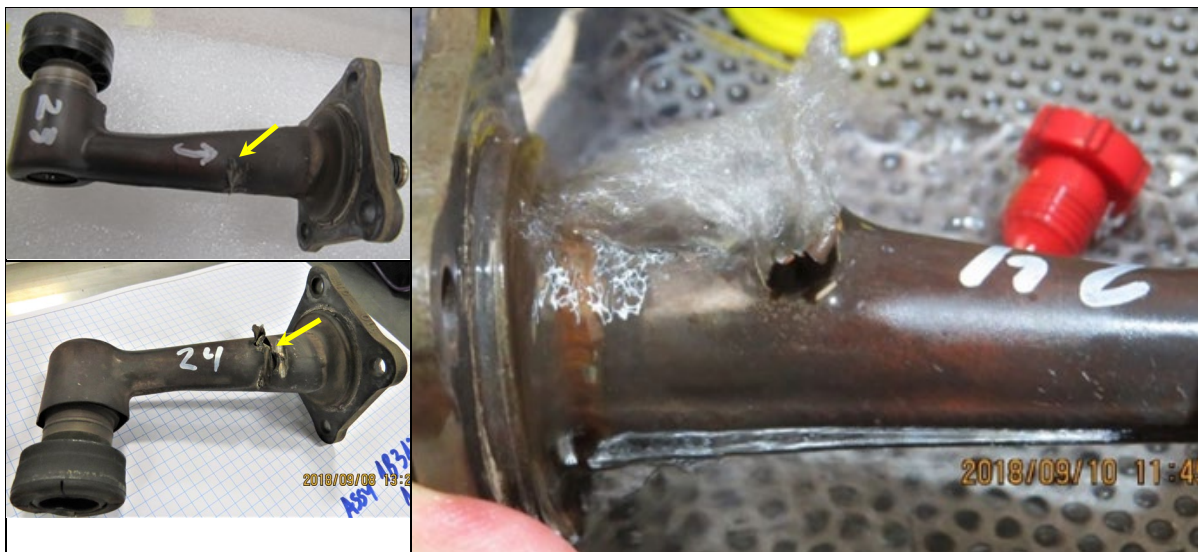
Fuel nozzles 23 and 24 were damaged mid span. Fuel nozzle 24 was punctured through the stem and heat shield and leaked when shop air was applied. Fuel nozzle 23 did not leak when shop air was applied. Stoddard solvent at 150 psig was applied to the inlet of fuel nozzle 24 and solvent sprayed from damaged stem portion of the nozzle. See Figure 28.

Figure 28. Mid-span impact damage to fuel nozzles 23 and 24 and leakage observed through stem of fuel nozzle 24

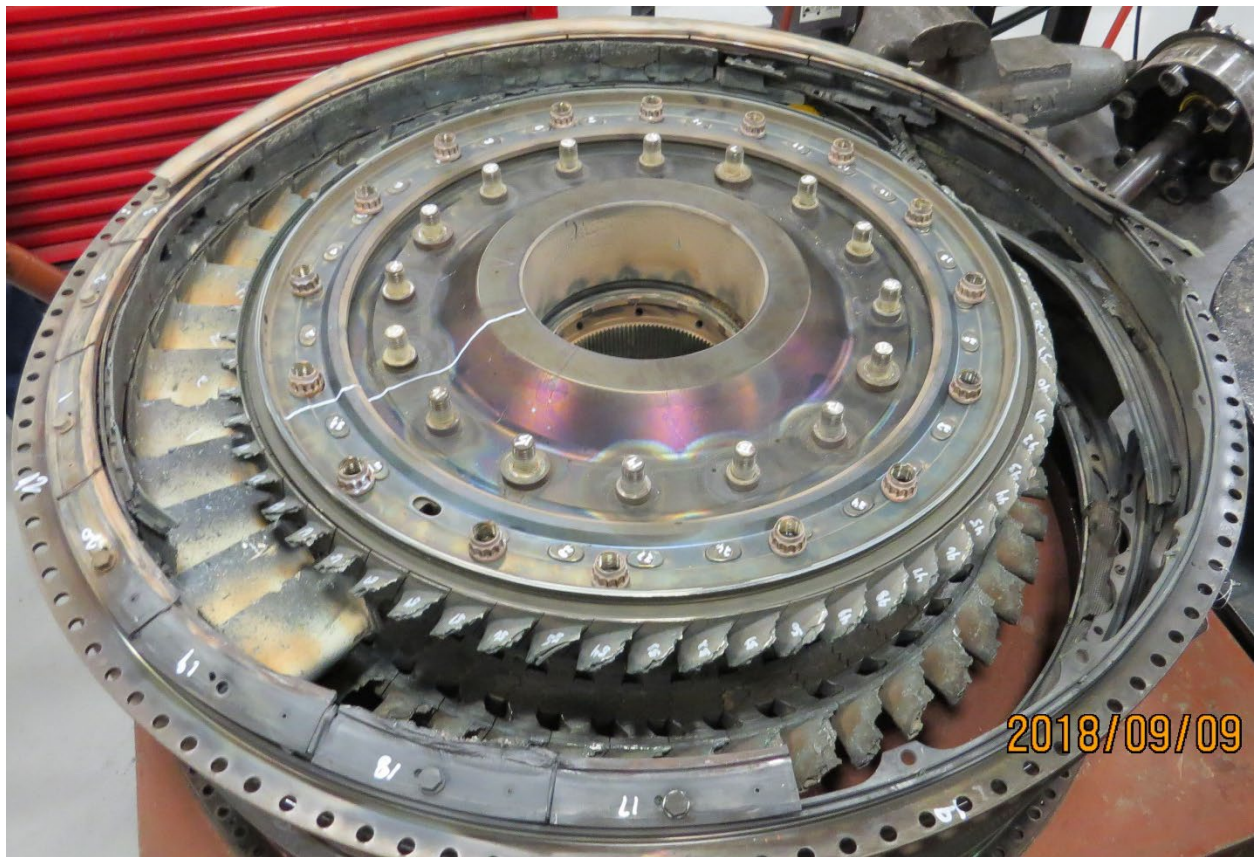
The 16 HPT rotor tie rod nuts were removed with a torque wrench set at 155 in-lbs. No torque exceeded the 155 in-lb setting. Nuts 5, 7, 9, 13 and 15 required less effort to remove. See Figure 29.

Figure 29. Aft view of HPT with HPT S2 hub retention nuts removed

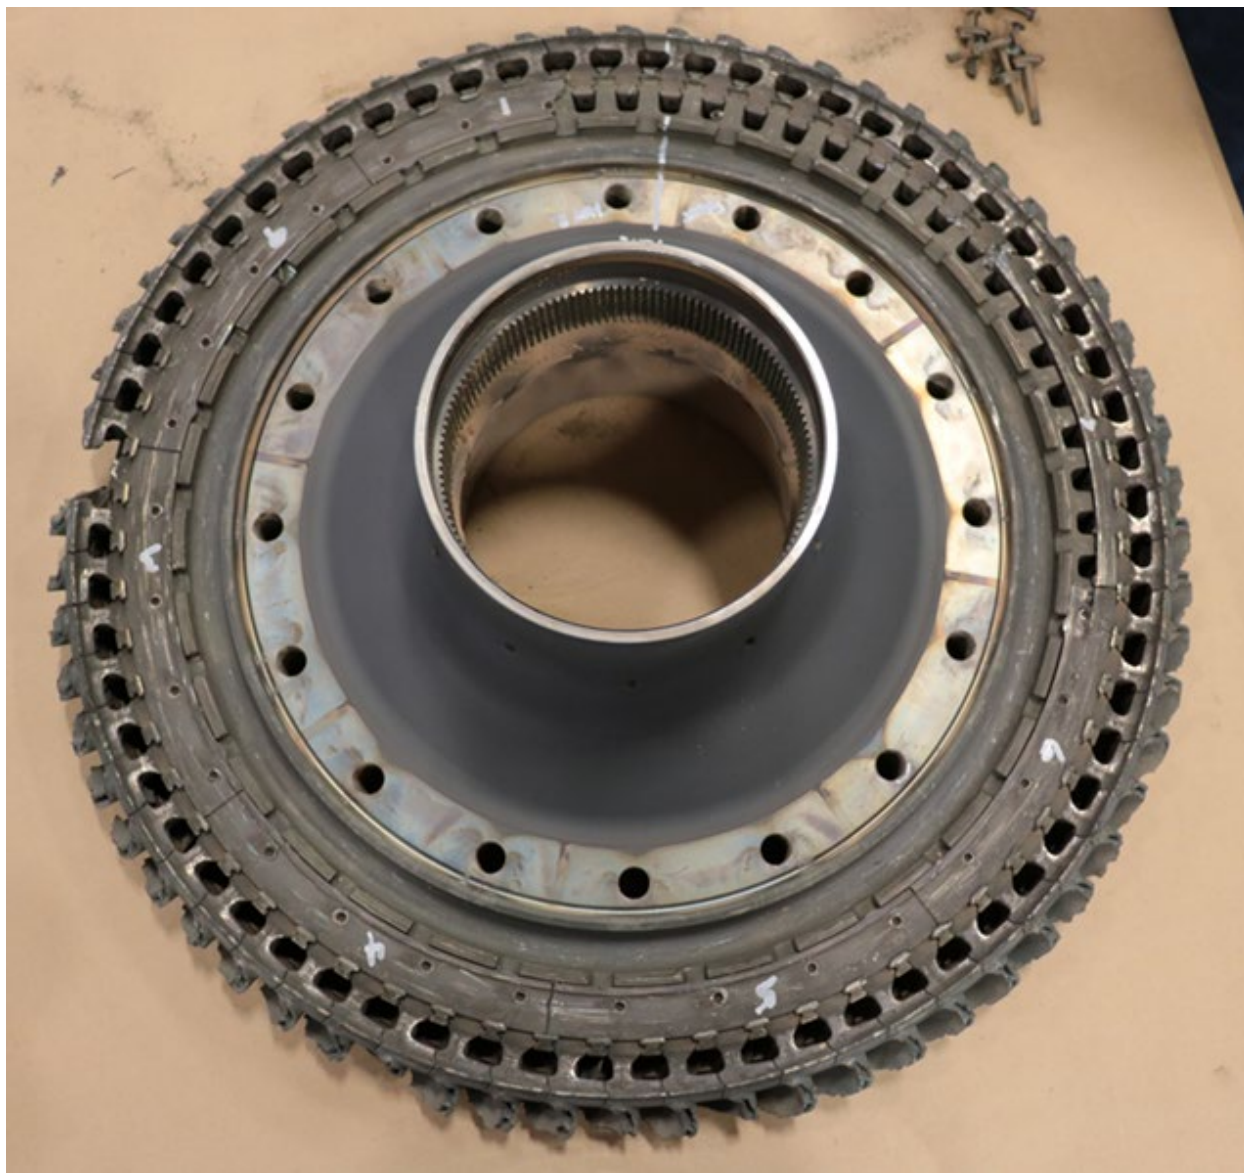
The upstream face of the HPT S2 hub exhibited heavy circumferentially oriented scoring from the radial snap and outboard. See Figure 30.

Figure 30. HPT S2 upstream face
