**NATIONAL TRANSPORTATION SAFETY BOARD  
OFFICE OF AVIATION SAFETY  
WASHINGTON, D.C. 20594**

NTSB ID: ENG18IA036  
POWERPLANT GROUP CHAIRMAN'S FACTUAL REPORT

March 4, 2022

Location: Atlanta, Georgia  
Date: September 5, 2018  
Time: 2332 Eastern Daylight Time  
Aircraft: Boeing 757-232, N668DN, MSN 25141, operated by  
Delta Air Lines

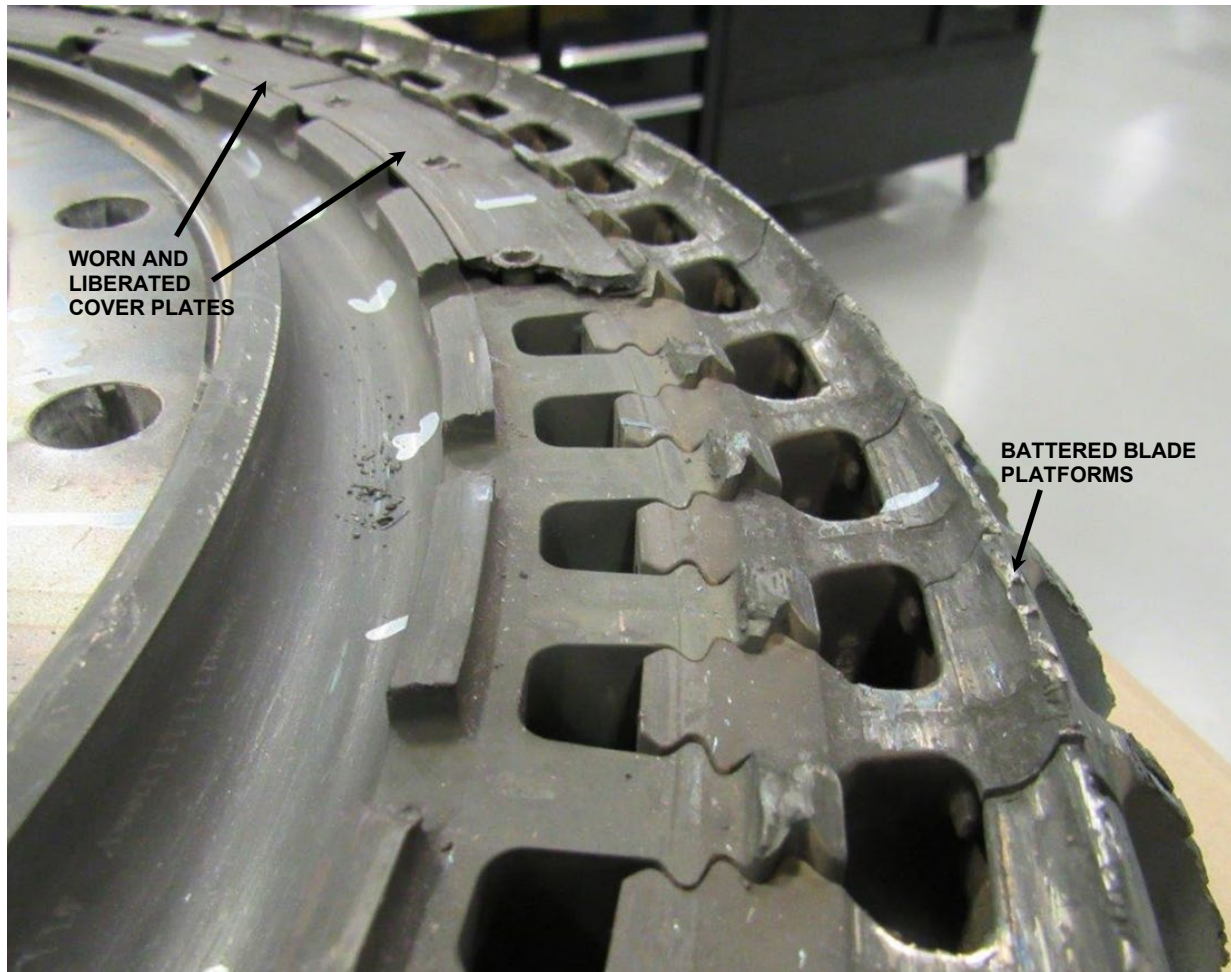
The ends of the cover retention rivet plugs were worn and were missing material. Five of the side cover plates were intact, the others were partially or completely liberated. Much of the forward blade platforms were worn away and the remaining material was battered. See Figure 31.

Figure 31. Detail of HPT S2 forward upstream scoring and impact damage

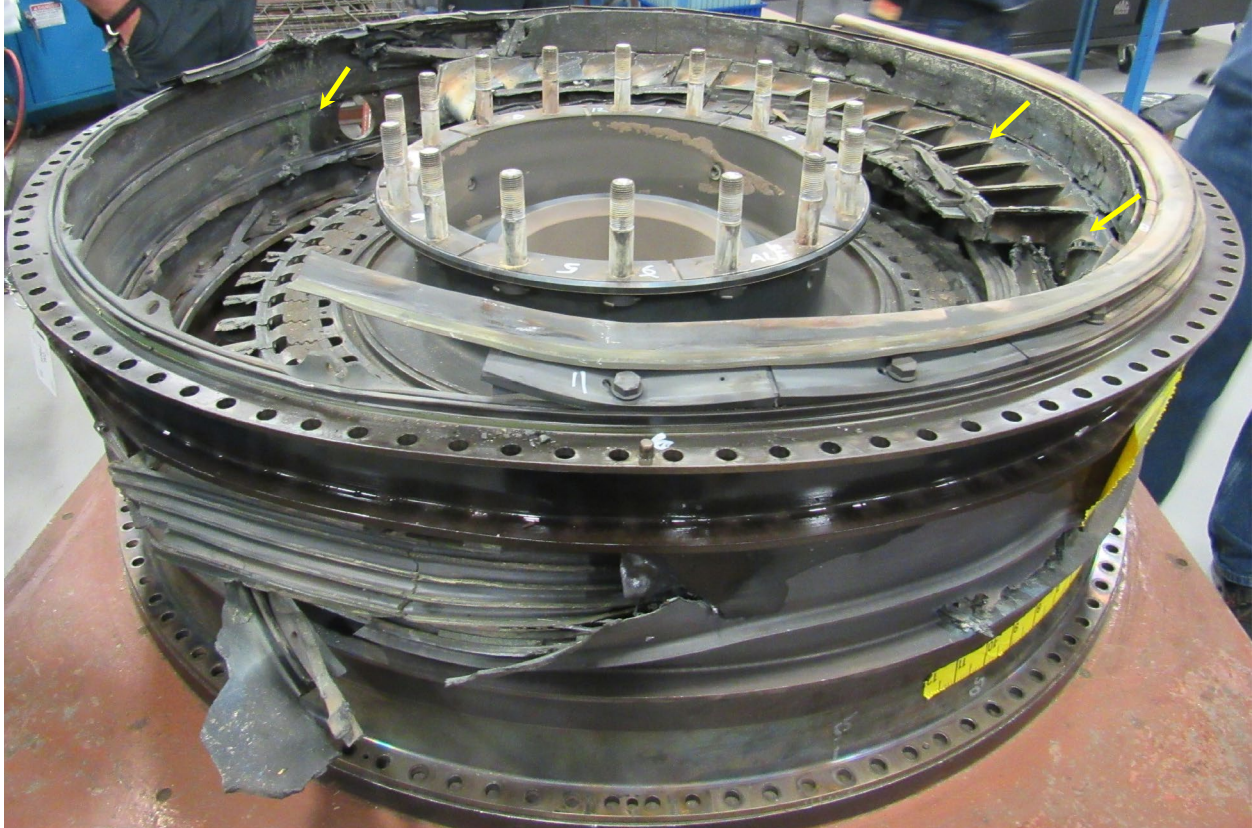
The HPT S2 vanes were liberated between 3 and 11 o'clock. The S2 vane inner air seal honeycomb material was destroyed and could not be evaluated. See Figure 32.

Figure 32. Aft end of HPT with S2 hub removed with destroyed S2 vane segments noted (arrows)

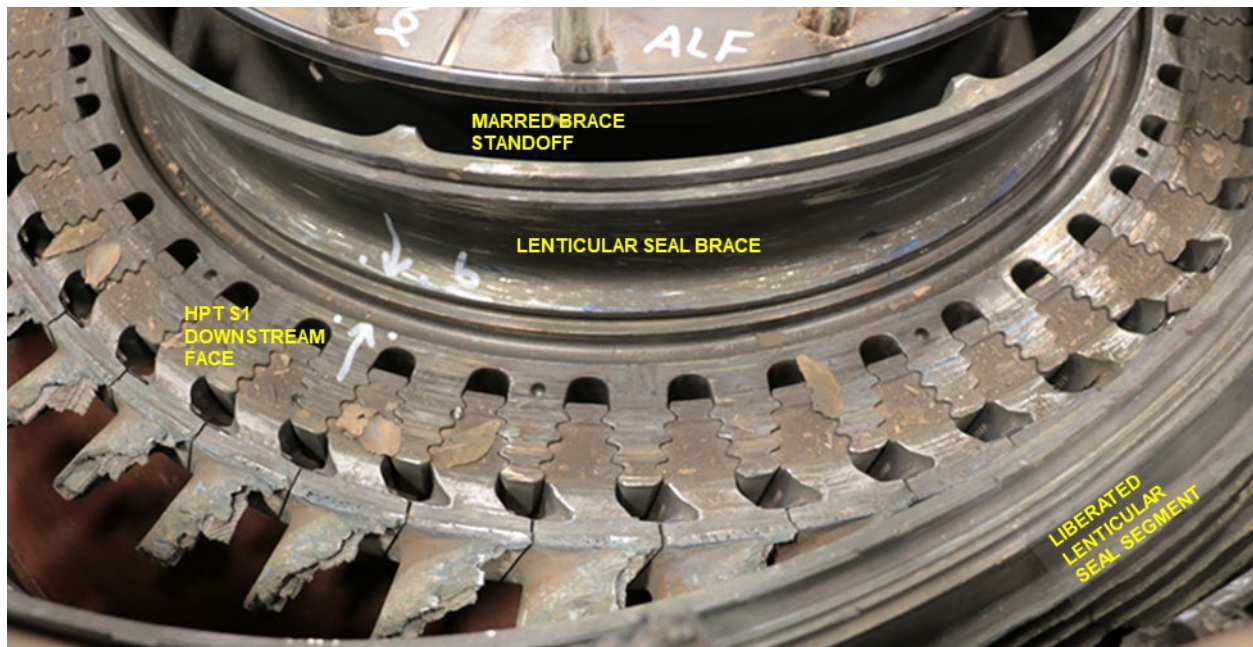
A segment of released lenticular seal was curled around the HPT case inner surface. The lenticular seal brace was exposed. The brace was intact. Its outer surface was circumferentially scored and splattered with metal and the tips of the standoffs on the aft brace edge were marred. The HPT S1 disk downstream side was circumferentially scored from the radial snap outboard. The scoring had consumed the rear platforms of the blades. All the S1 rear side plates were liberated. See Figure 33.

Figure 33. HPT S1 disk downstream face

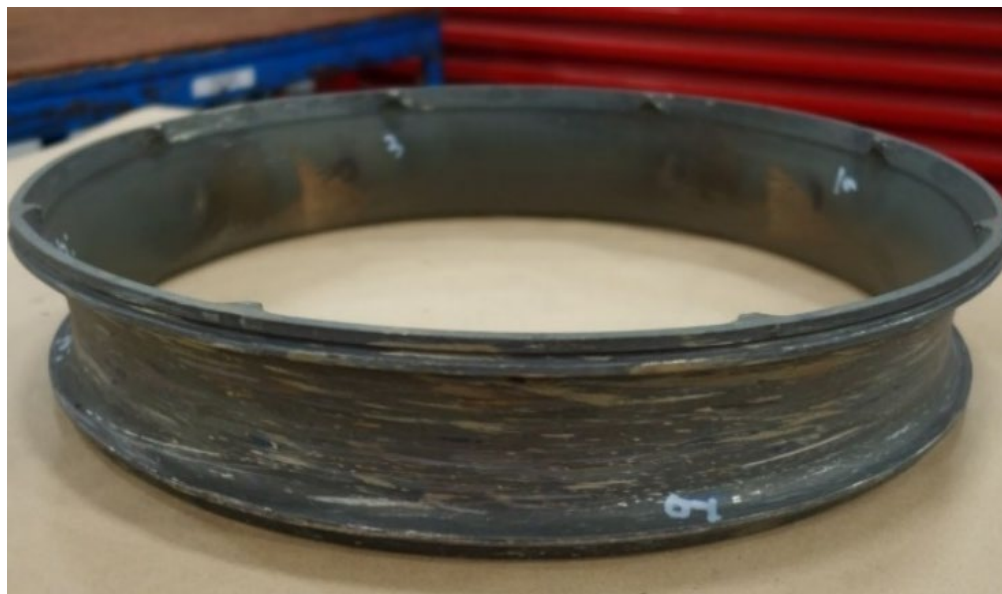
Figure 34. Lenticular seal inner brace piece

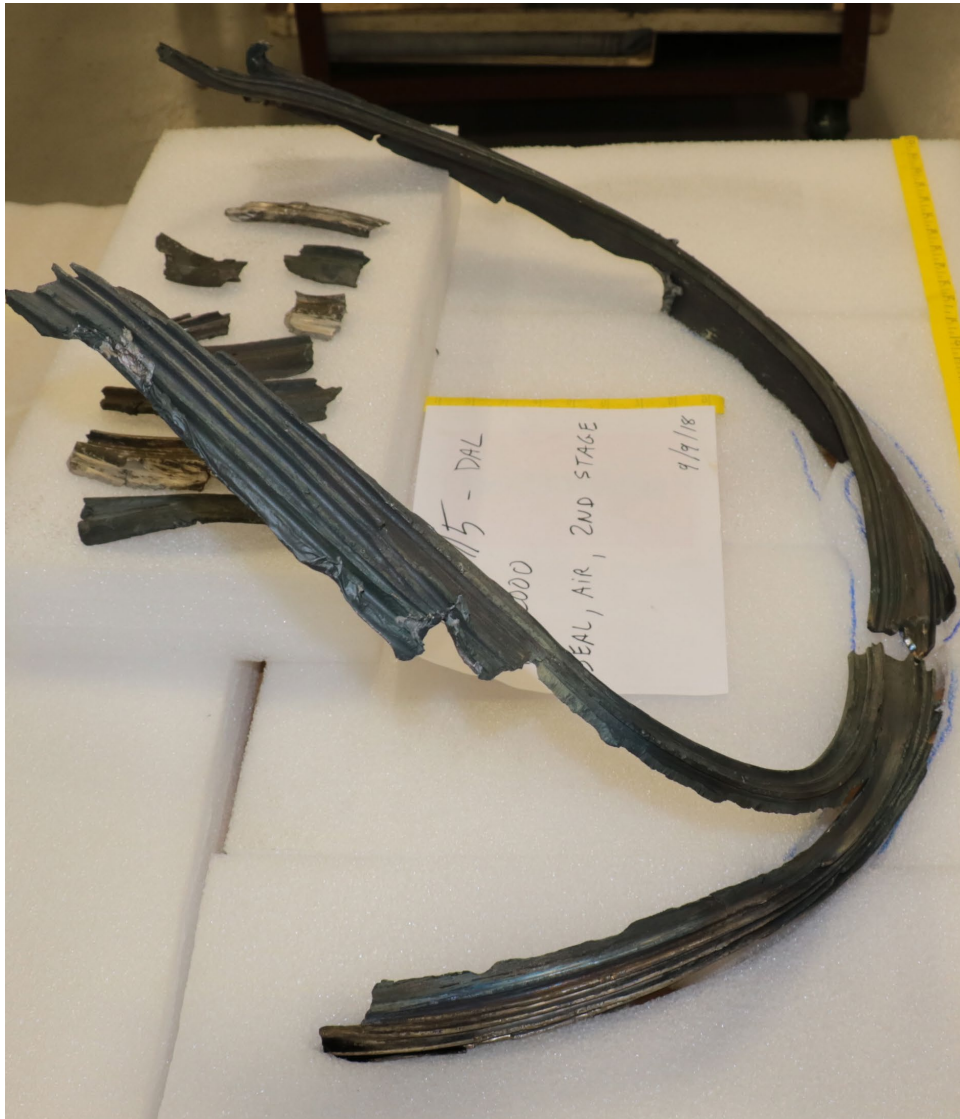
Nine lenticular seal fragments, including two larger seal sections and the intact brace, were recovered. A rough reconstruction of the lenticular seal fragments confirmed the 64-inch circumference of an intact seal. See Figures 34 and 35.

Figure 35. Eleven recovered lenticular seal fragments

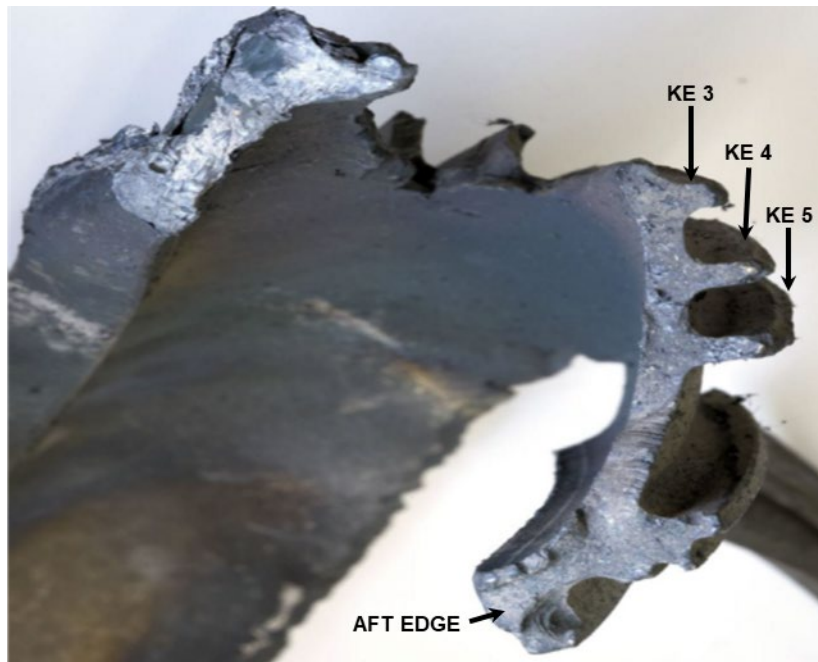
Pratt & Whitney MPE examined the lenticular seal brace and the two large and nine small seal fragments. Visual and binocular review found significant thermal distress to much of the seal, which was attributed to the event. An axial fracture at the end of one of the larger recovered segments (designated Piece A) was identified as the primary fracture location. The surface included the full seal cross section. The surface was fractured or significantly damaged forward of knife edge 3. The surface from aft of knife edge 3 to the aft seal edge showed discernible fracture features. Knife edges

3, 4 and 5 were fractured outboard of their pedestals and no significant knife edge material remained. See Figure 36. The mating fracture surface on an end of the other large fragment (Piece B) was destroyed. See Figure 37.

Figure 36. Magnified view of primary fracture on end of Piece A  
Photographs courtesy of Pratt & Whitney

The Piece A fracture surface was oxidized and covered with deposits and metal splatter, obscuring most signs of directionality. Remnant river lines and beach marks were observed that indicated progression from the knife edge region toward the aft edge. No origin area could be identified. The fracture path in the knife edge region was mostly flat but the topography suggested an initiation location forward of knife edge 3. The crack began to turn circumferentially aft of knife edge 5 while continuing to progress toward the aft edge. Scanning electron microscope (SEM) examination of the fracture surface found no original fracture features.

On March 15, 2019, PW2000 SB 72-754 (upgrade to the new-PN lenticular seal with the temperature-resistant  $\text{Al}_2\text{O}_3$  coating) R2 changed the bulletin compliance category from CAT 7 (do when supply of superseded parts is fully used) to CAT 5 (perform at next module exposure).

On August 14, 2019, PW2000 SB 72-754 R3 released new part numbers (PNs) and instructions for rework of the lenticular seal with chromium carbide-coated knife edges to the improved-durability  $\text{Al}_2\text{O}_3$  knife edge coating (modify PN 1A8209 to PN 1A8209-002 or PN 1A8209-001 to PN 1A8209-003).

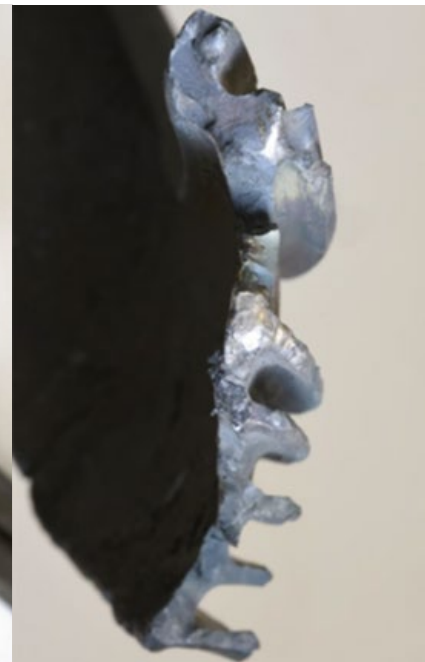
Figure 37. Mating surface on Piece B
