# Metallurgical Investigation Report

## FA Log No. 18712

**METALLURGICAL EVALUATION OF  
CFM56-7B STG. 1-2 HPC SPOOL AND  
STG. 1 HPC VSV TRUNNION/LEVER  
ARM HARDWARE FROM ESN 875-  
318 OPERATED BY UNITED AIRLINES**

**Final Report Date: June 14, 2019**

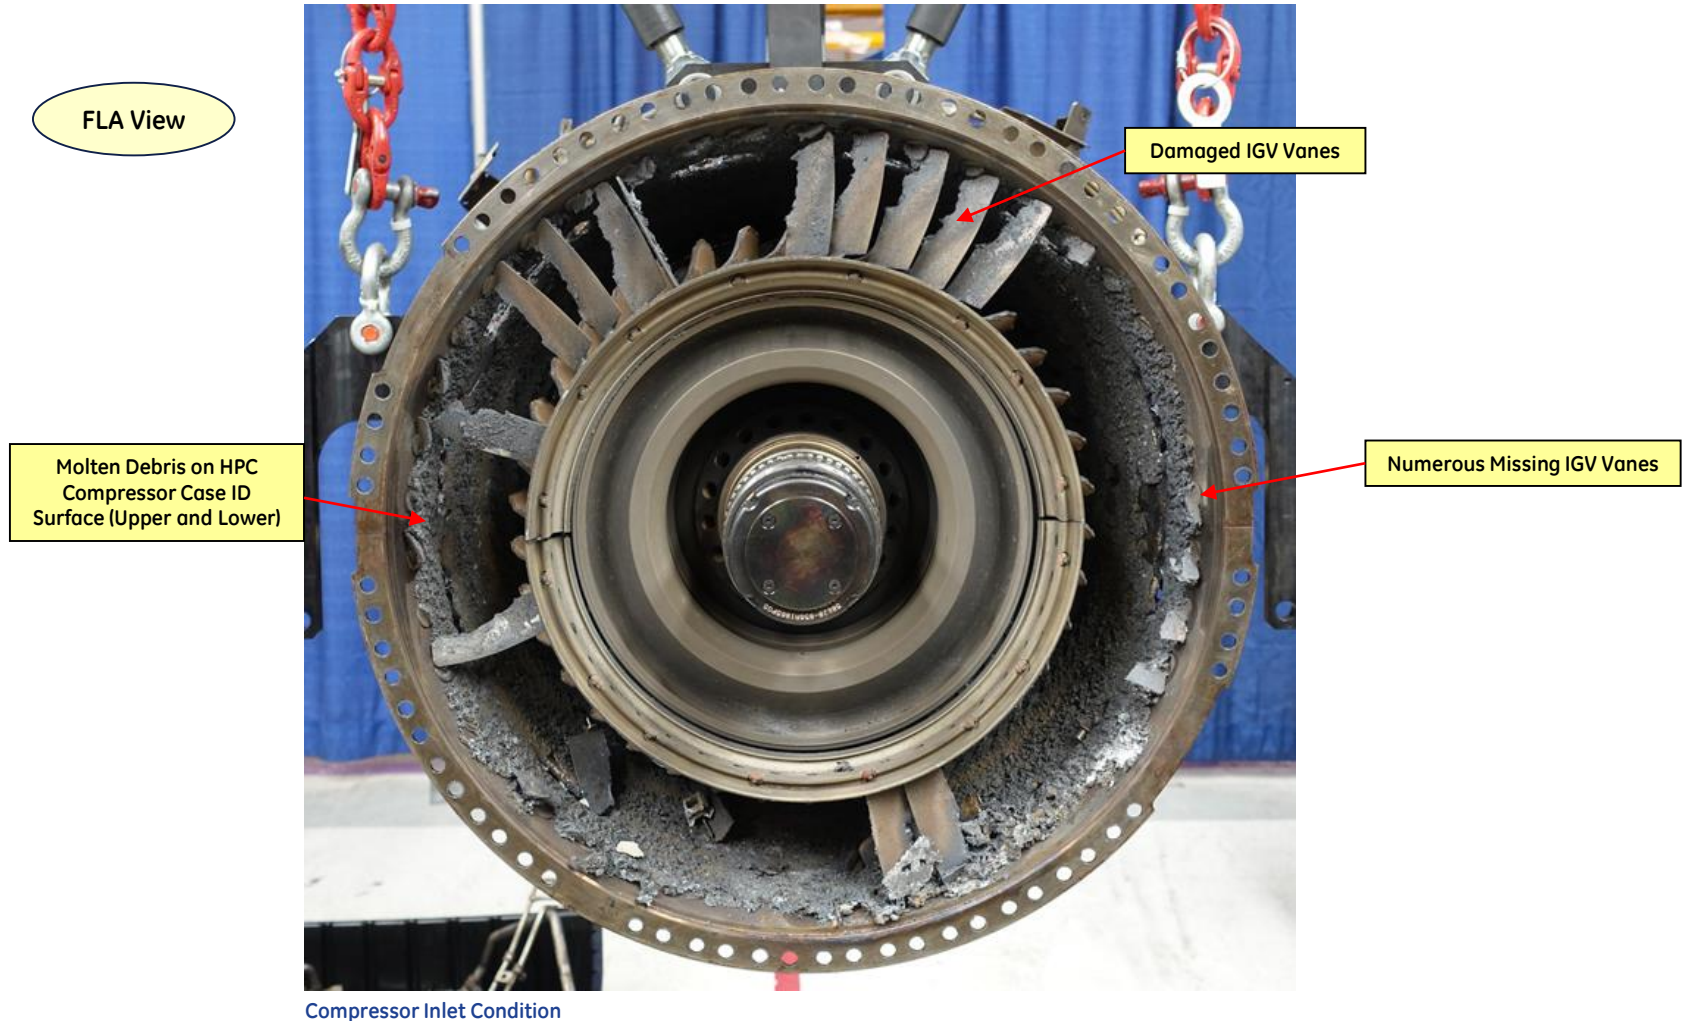
- Missing IGV Vanes and Significant Amounts Molten Material in Compressor Inlet

Figure 1. Photograph looking into compressor inlet (FLA). Numerous missing IGV's and abundant molten metal splatter observed on HPC Case ID surface.

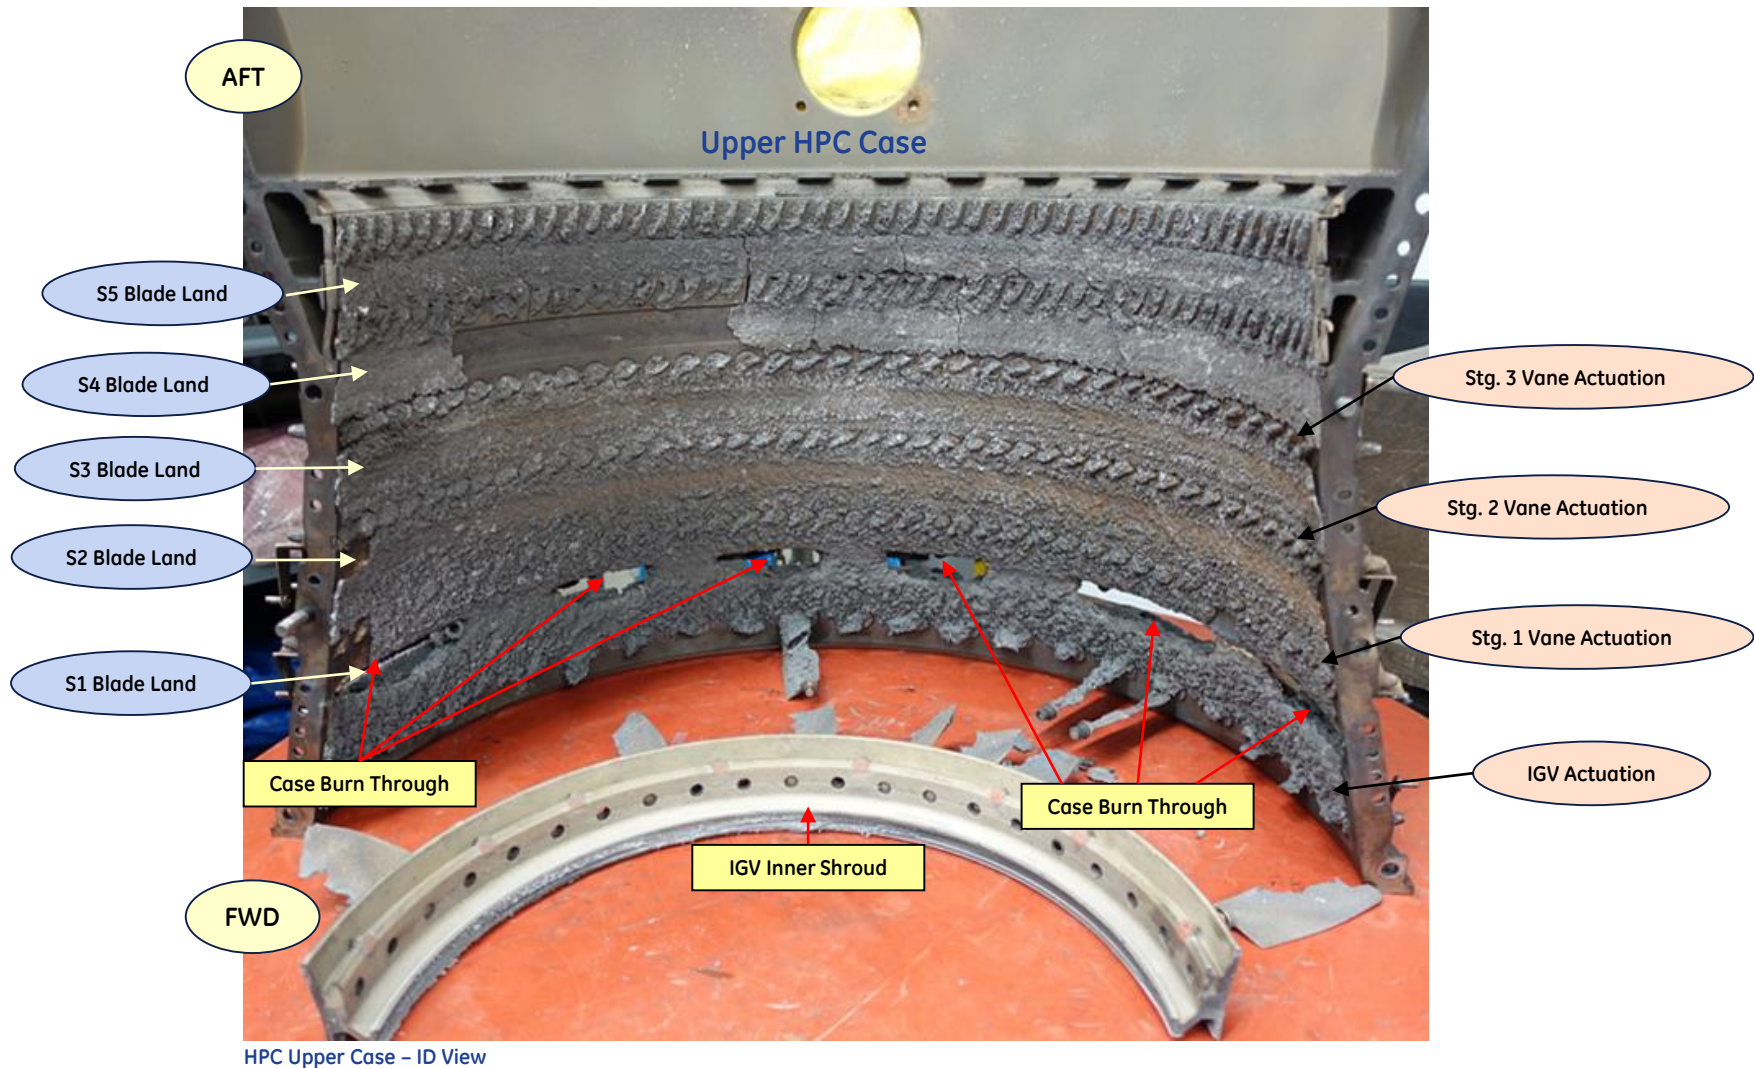
- Considerable Amounts of Molten Material on Inside Surface of Upper HPC Case - Burn Throughs Occurred Between Thicker Button Rub Button Pad Regions in Plane With Stg. 1 HPC Rotor

Figure 10. Photograph documenting inside surface condition of upper HPC Case. With exception of a few IGV Vanes all HPC Vanes airfoils were missing.

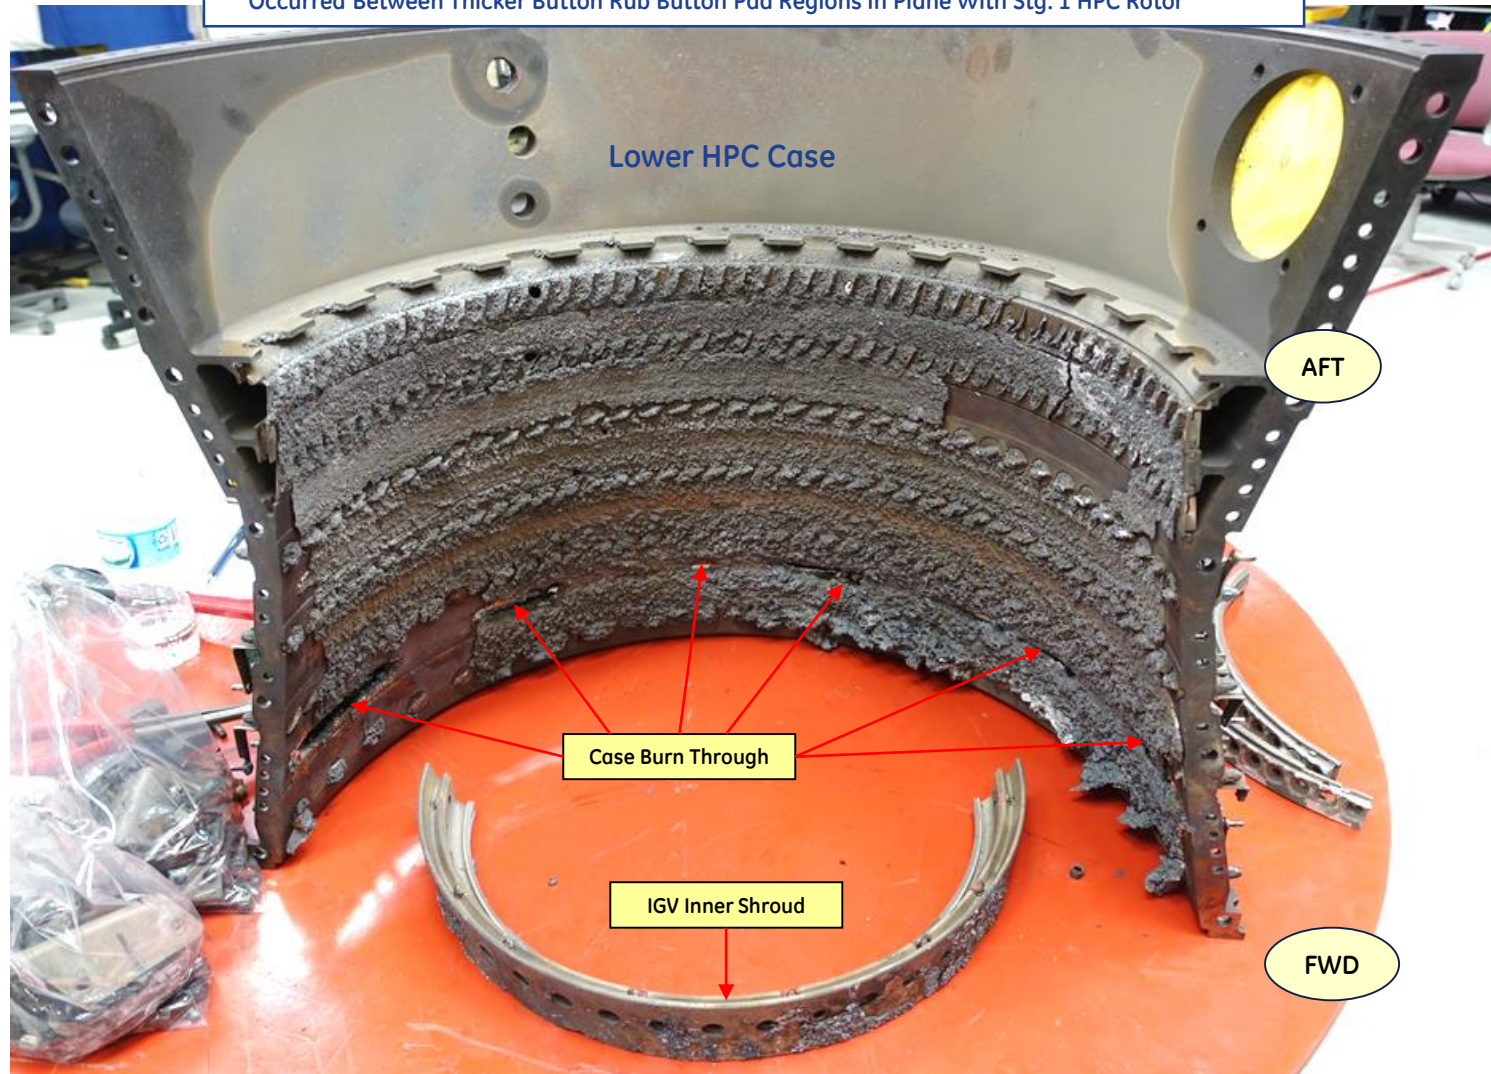
HPC Lower Case – ID View

- Considerable Amounts of Molten Material on Inside Surface of Lower HPC Case - Burn Throughs Occurred Between Thicker Button Rub Button Pad Regions in Plane With Stg. 1 HPC Rotor

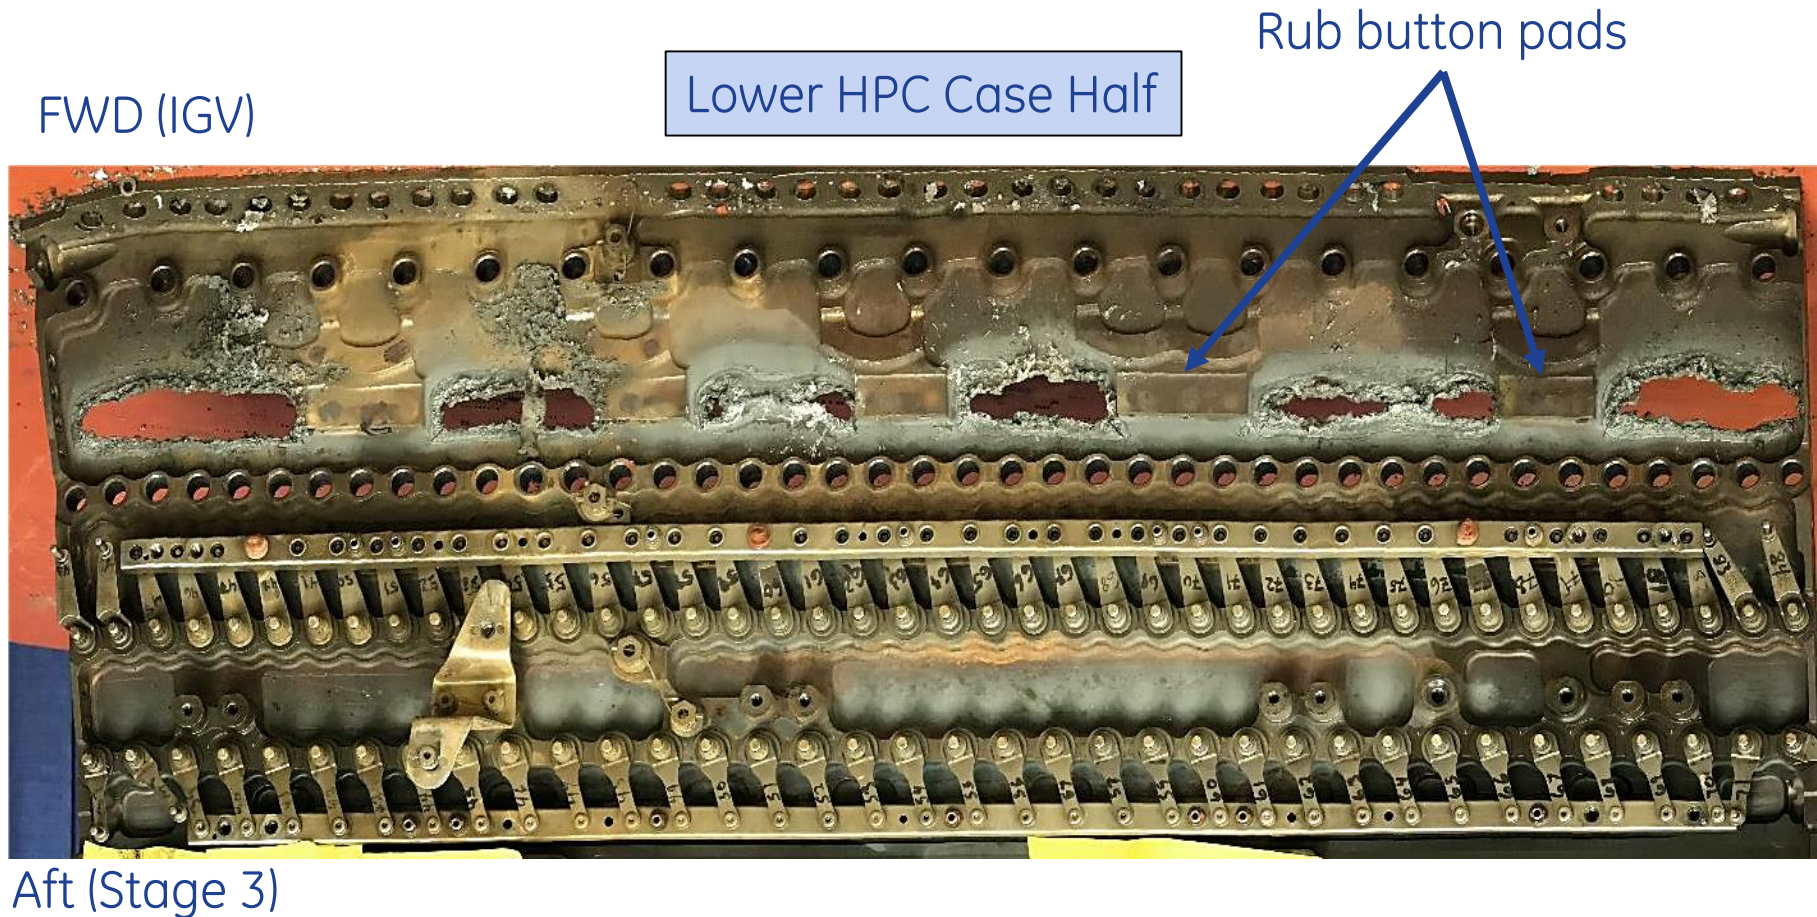
- Panoramic View of Lower HPC Case Following Removal of Stg. 1 HPC Actuators Showing Burn Through Location in Line With Stg. 1 HPC Blades

Figure 14. Photograph documenting locations of lower HPC Case burn through in line with Stg. 1 HPC Blades. Flanges and rub button pads were only locations which did not get consumed during the event.

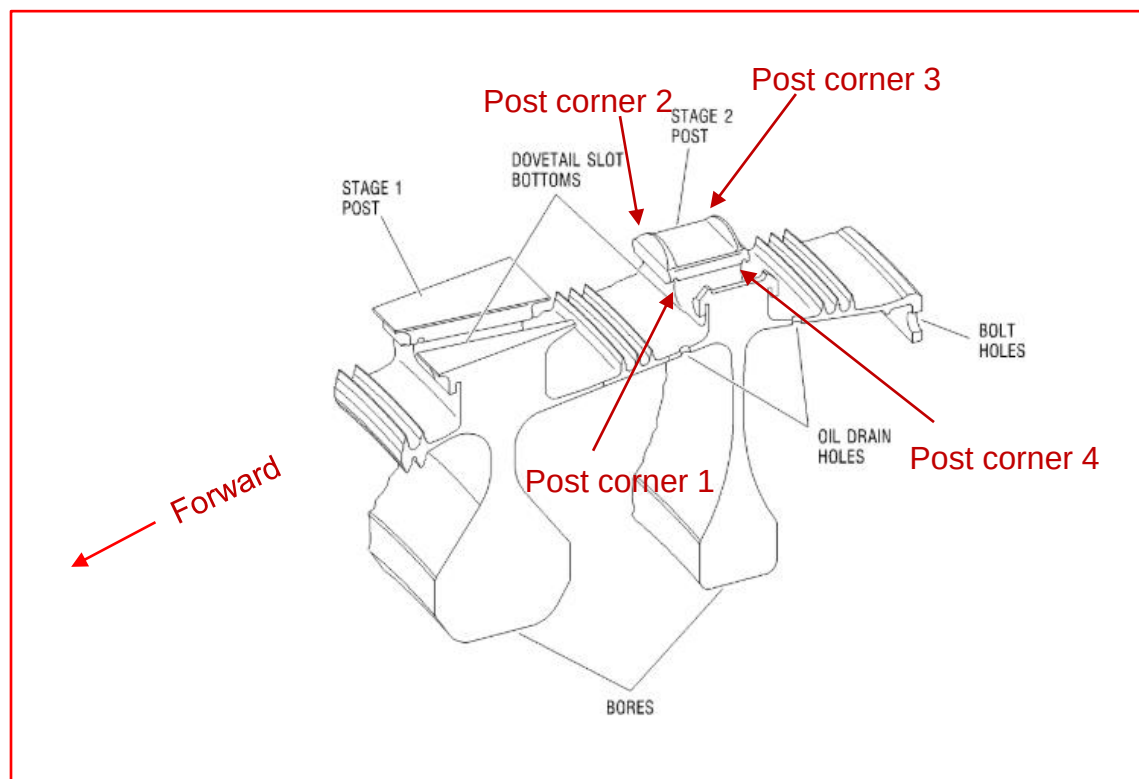
Figure 18. Sketch showing Stg. 2 HPC disk post corner nomenclature. Eight (8) Stg. 2 HPC Blades were liberated with ten (10) Stg. 2 disk posts exhibited missing material.

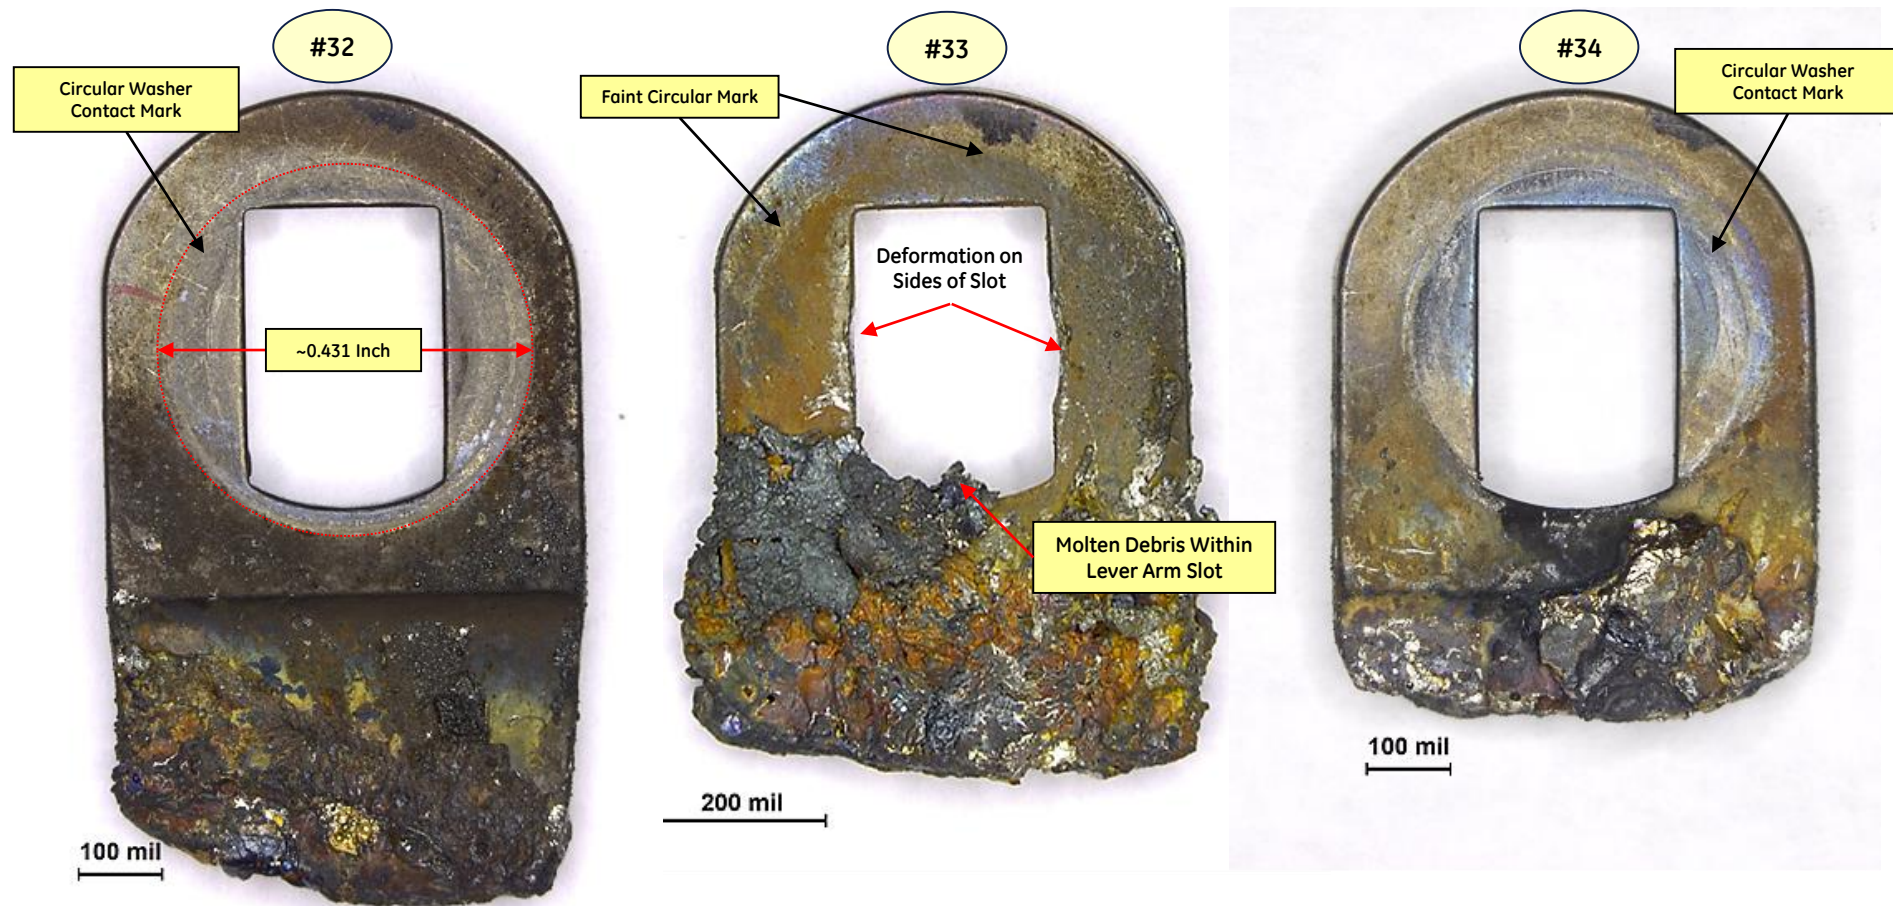
Figure 20. Photographs documenting OD side condition of remaining Stg. 1 HPC lever arms from locations from locations #32, #33 and #34 in the uncleaned condition. Distinct difference in OD surface condition present between location #33 (nut and washer absent) and location #32 and #34 (nut and washer present).

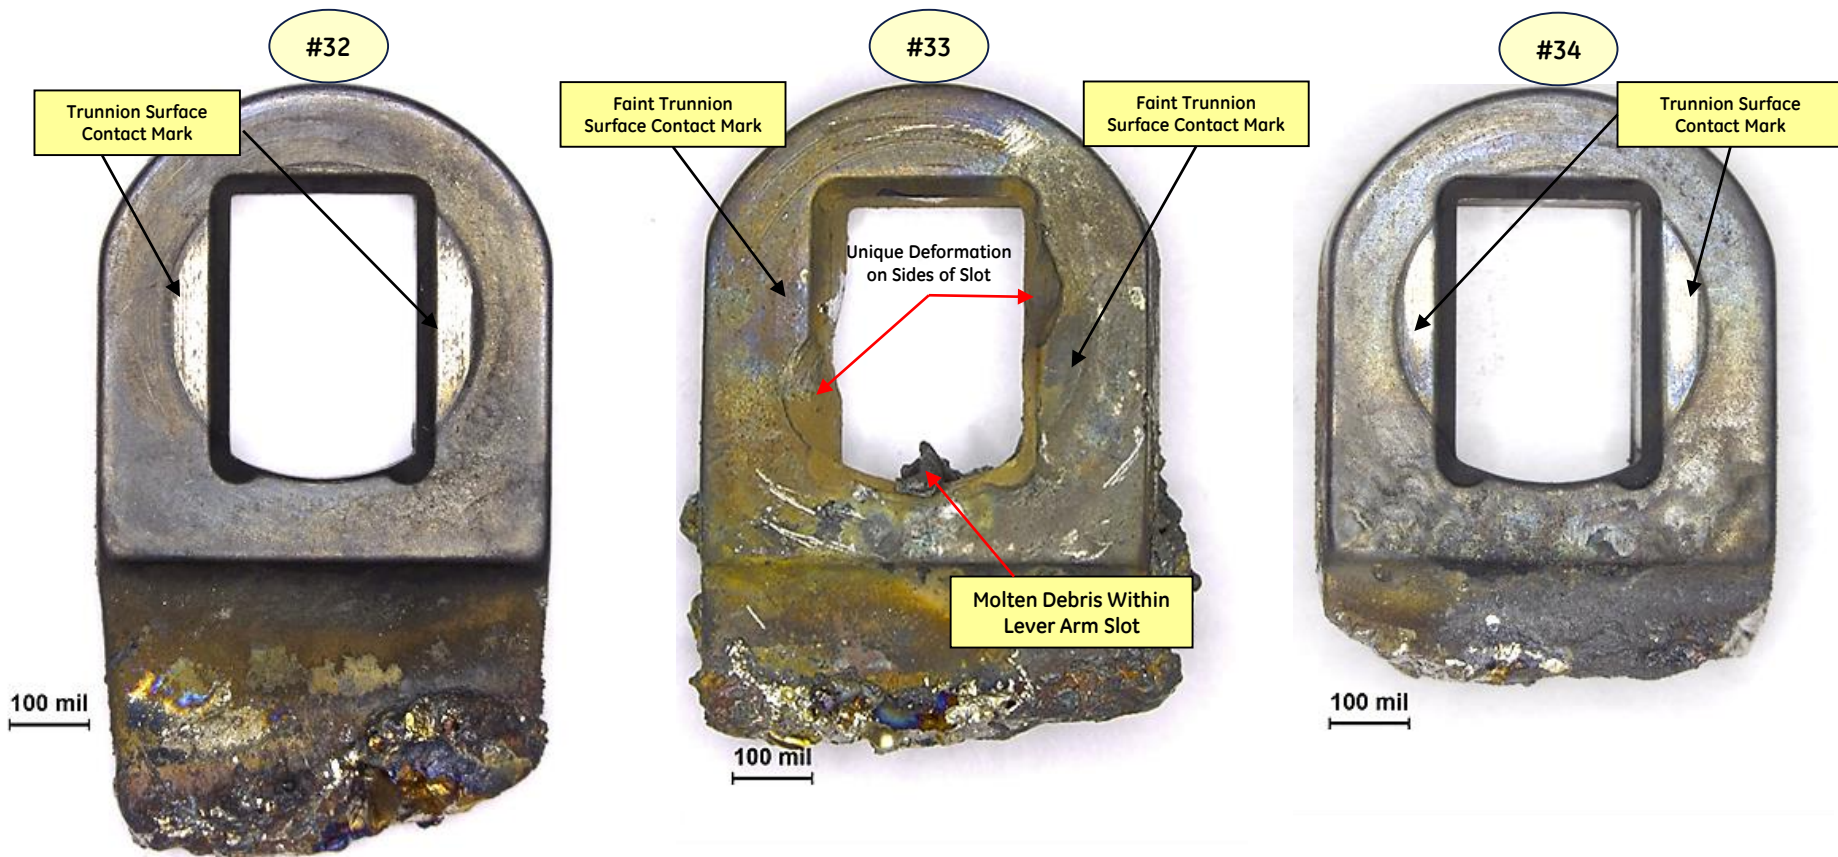
Figure 21. Photographs documenting ID side condition of remaining Stg. 1 HPC lever arms from locations from locations #32, #33 and #34 in the uncleaned condition. Note unique deformation pattern within slot of lever arm #33 attributed to abnormal contact with trunnion D-head outboard surface.

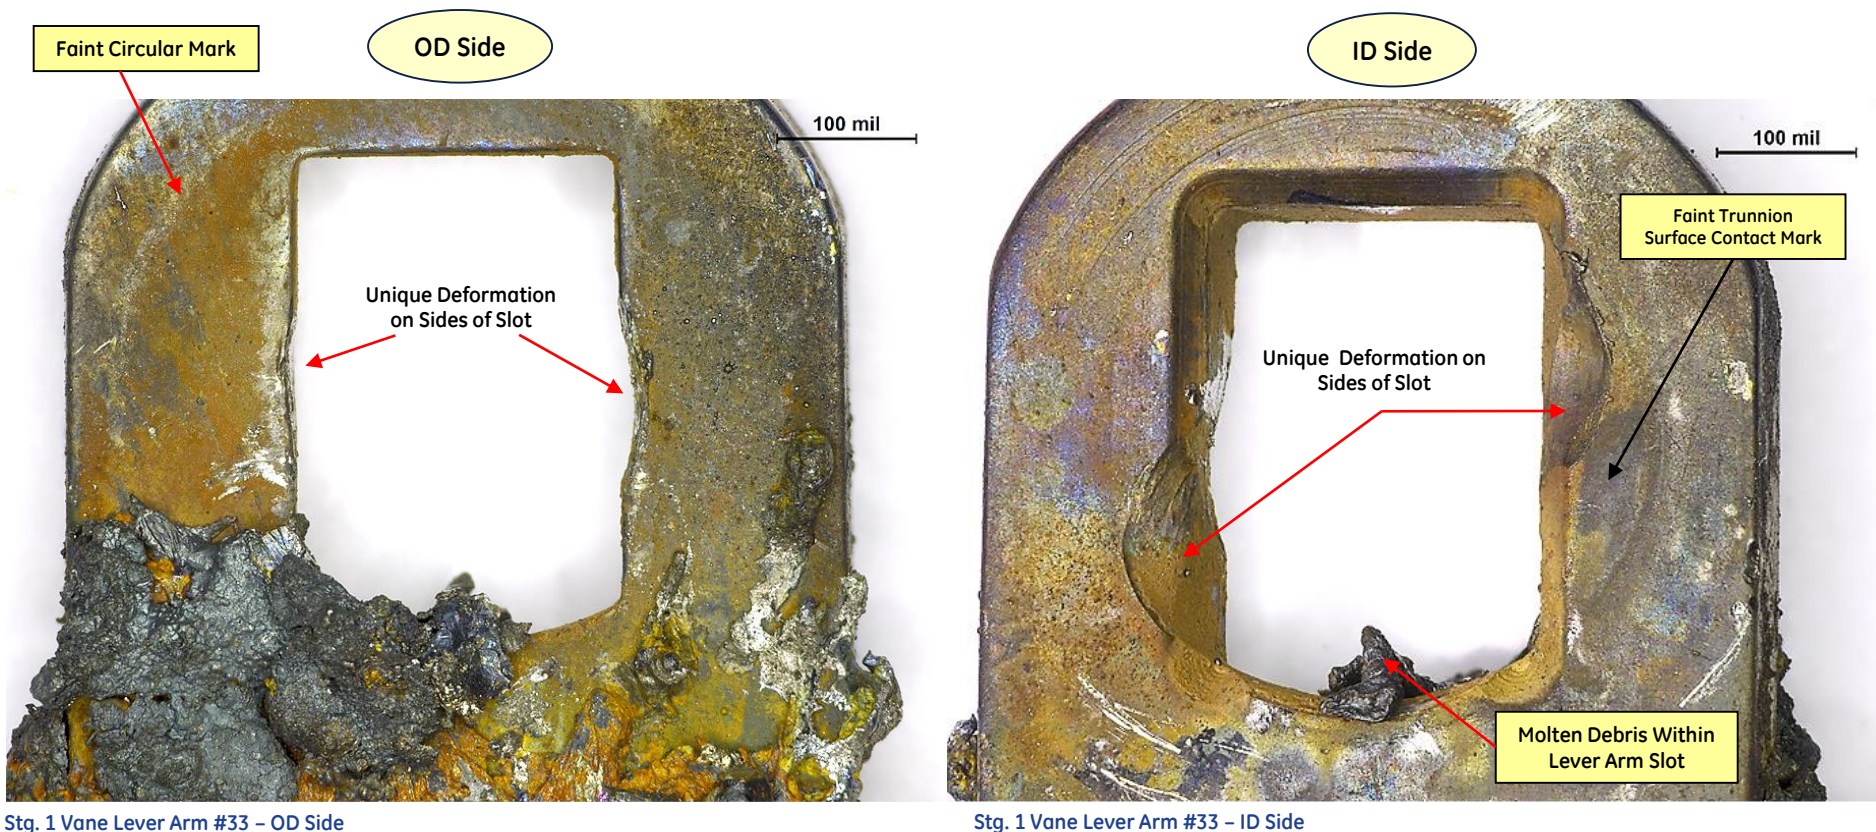
Figure 22. Photographs documenting ID side condition of remaining Stg. 1 HPC lever arms from locations from locations #32, #33 and #34 in the uncleaned condition. Note unique deformation pattern within slot of lever arm #33 attributed to abnormal contact with trunnion D-head outboard surface .

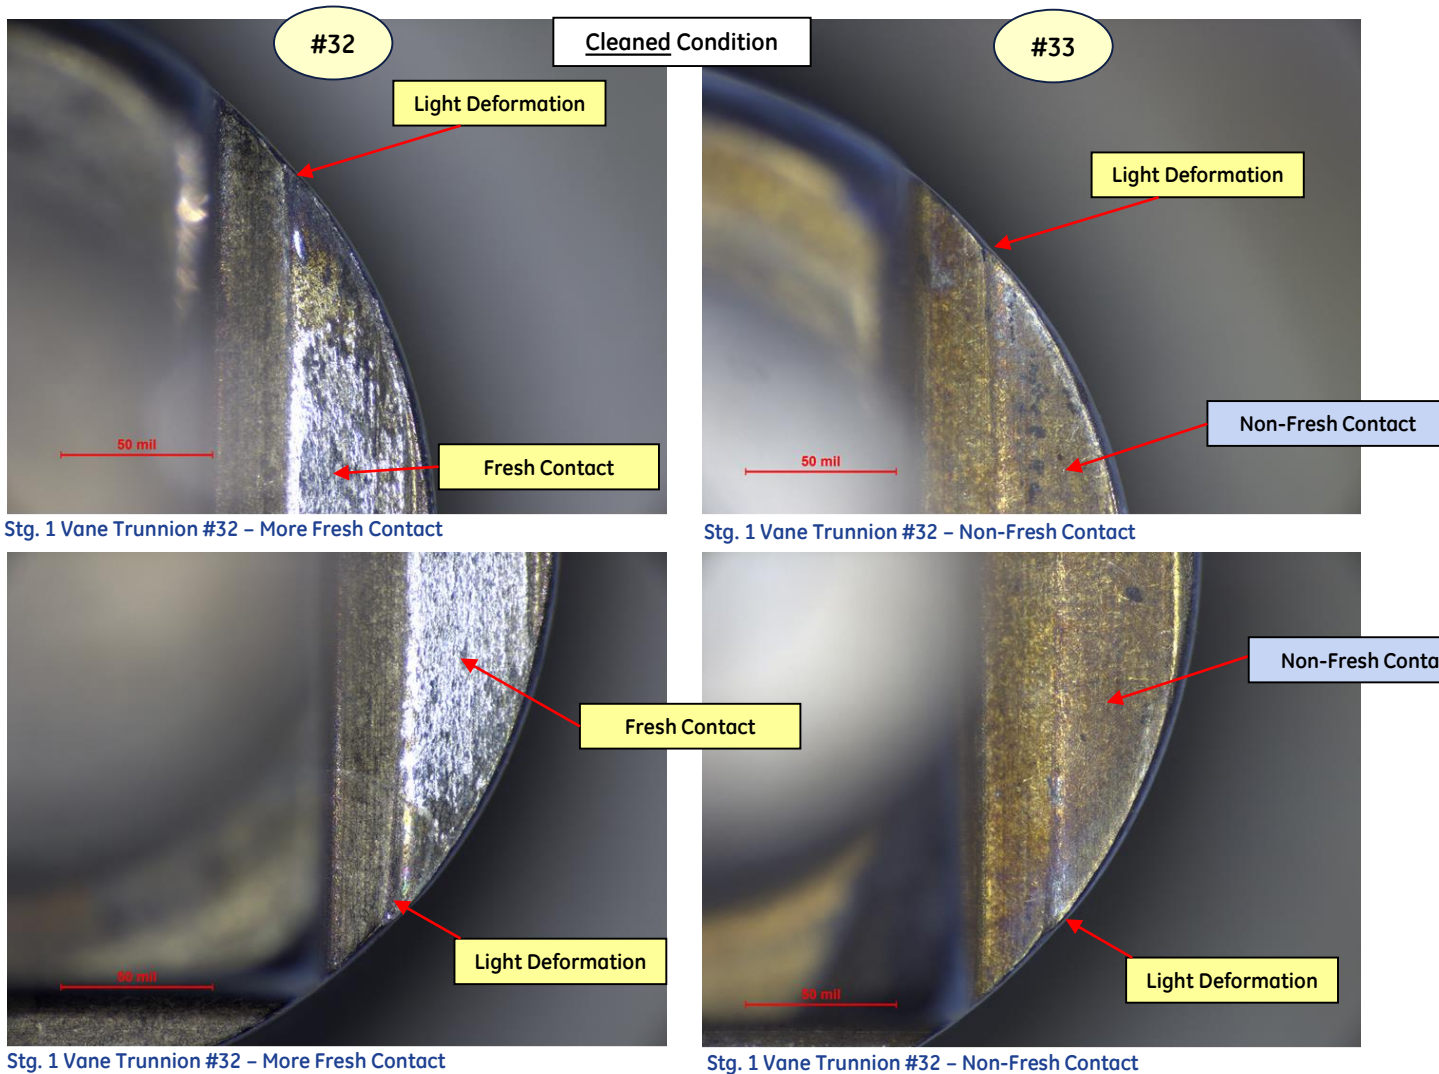
- Similar Light Deformation Observed at Edge of Trunnion Face For Both Stg. 1 Vane Trunnion #32 and #33 Implying Lever Arm #33 Properly Installed at Some Point

Figure 26. Photographs showing closer views comparing Stg. 1 HPC trunnion contact patterns at locations #32 and #33 in the cleaned condition. Faint, similarly shaped contact pattern now observed at location #33 indicating properly installed lever arm at some point.

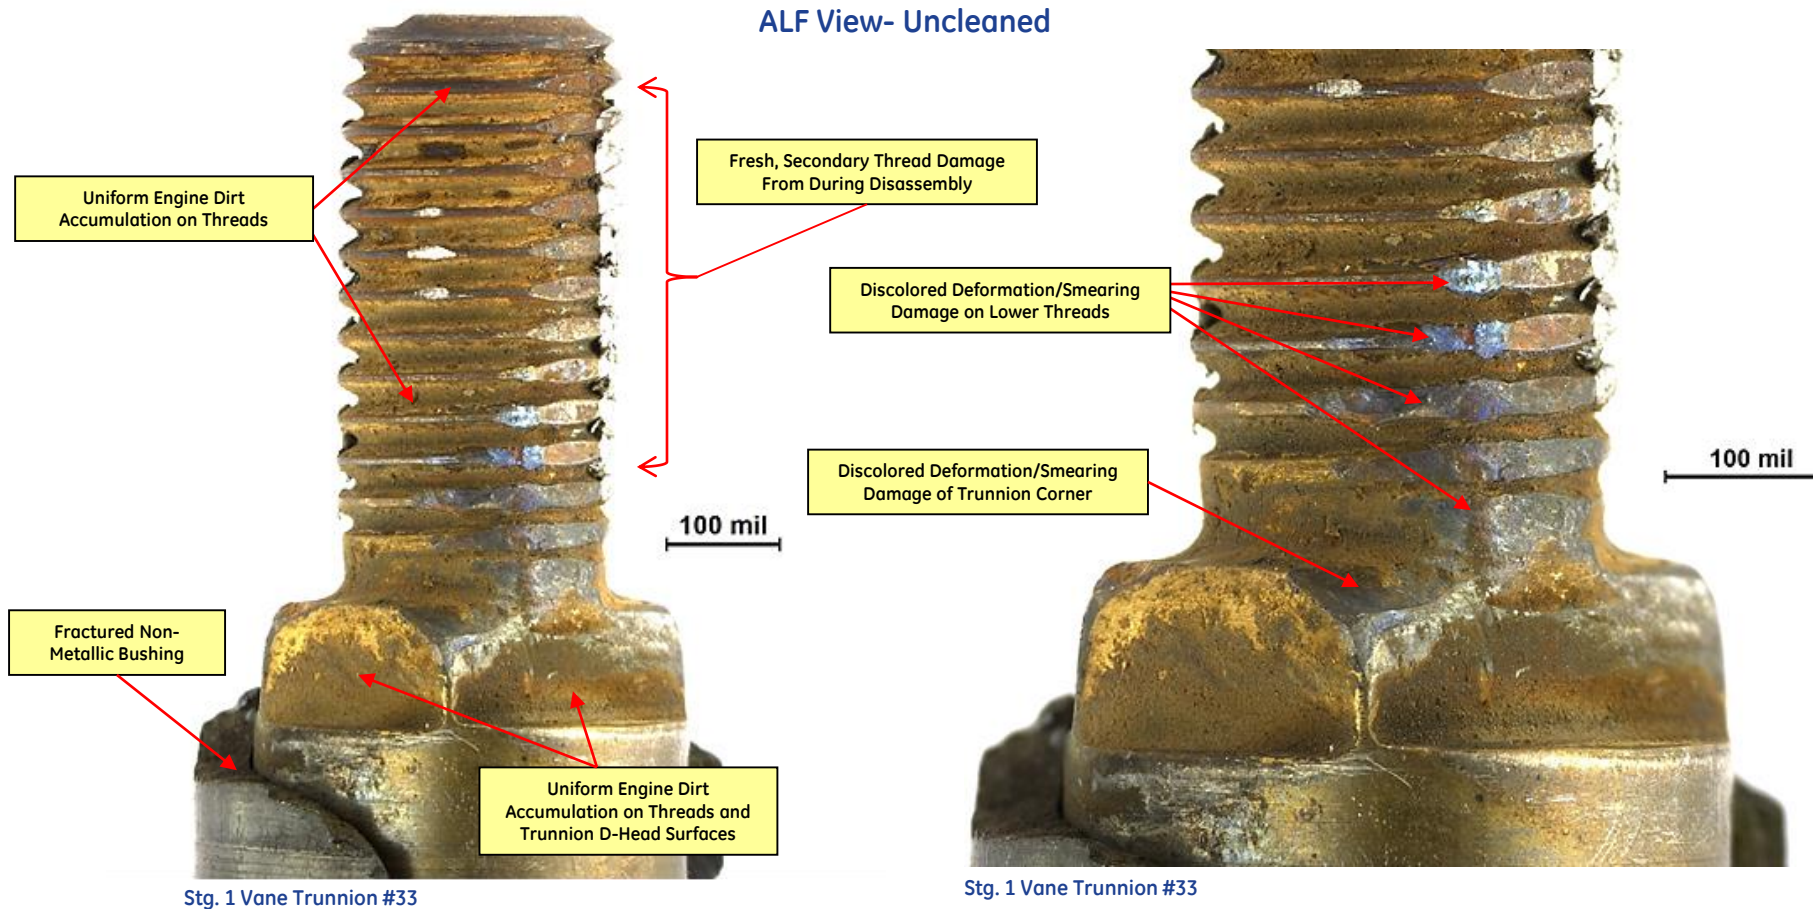
- Uniform Engine Dirt Accumulation Present on Stg. 1 Vane Trunnion Threads at Location #33 Indicating Nut Missing During Engine Operation
- Uniform Engine Dirt Accumulation on Trunnion D-Head Surfaces at Location #33 Indicating Mating Lever Arm Slot Not Properly Seated During Engine Operation
- Deformed/Smeared Trunnion Corner and Lower Threads Attributed to Disengagement of Mating Lever Arm

Figure 27. Photographs documenting thread condition of Stg. 1 HPC Trunnion #33 in the uncleaned condition.

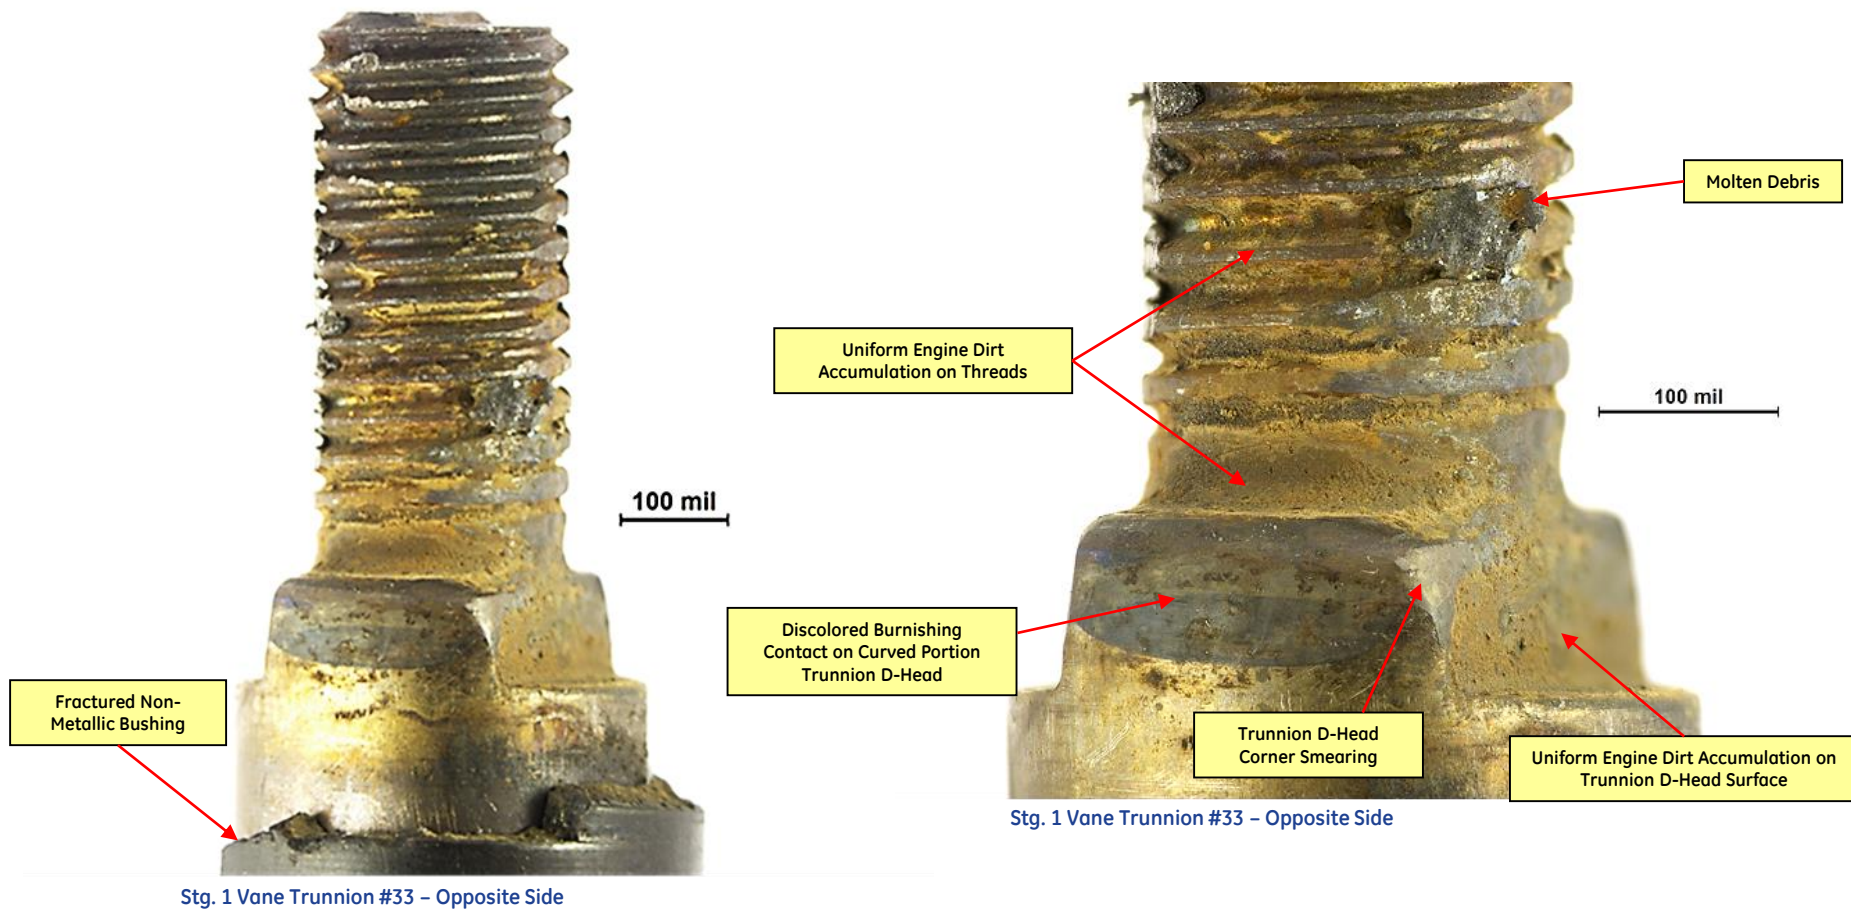
Figure 28. Photographs documenting thread condition of Stg. 1 HPC Trunnion #33 in the uncleaned condition (opposite side).

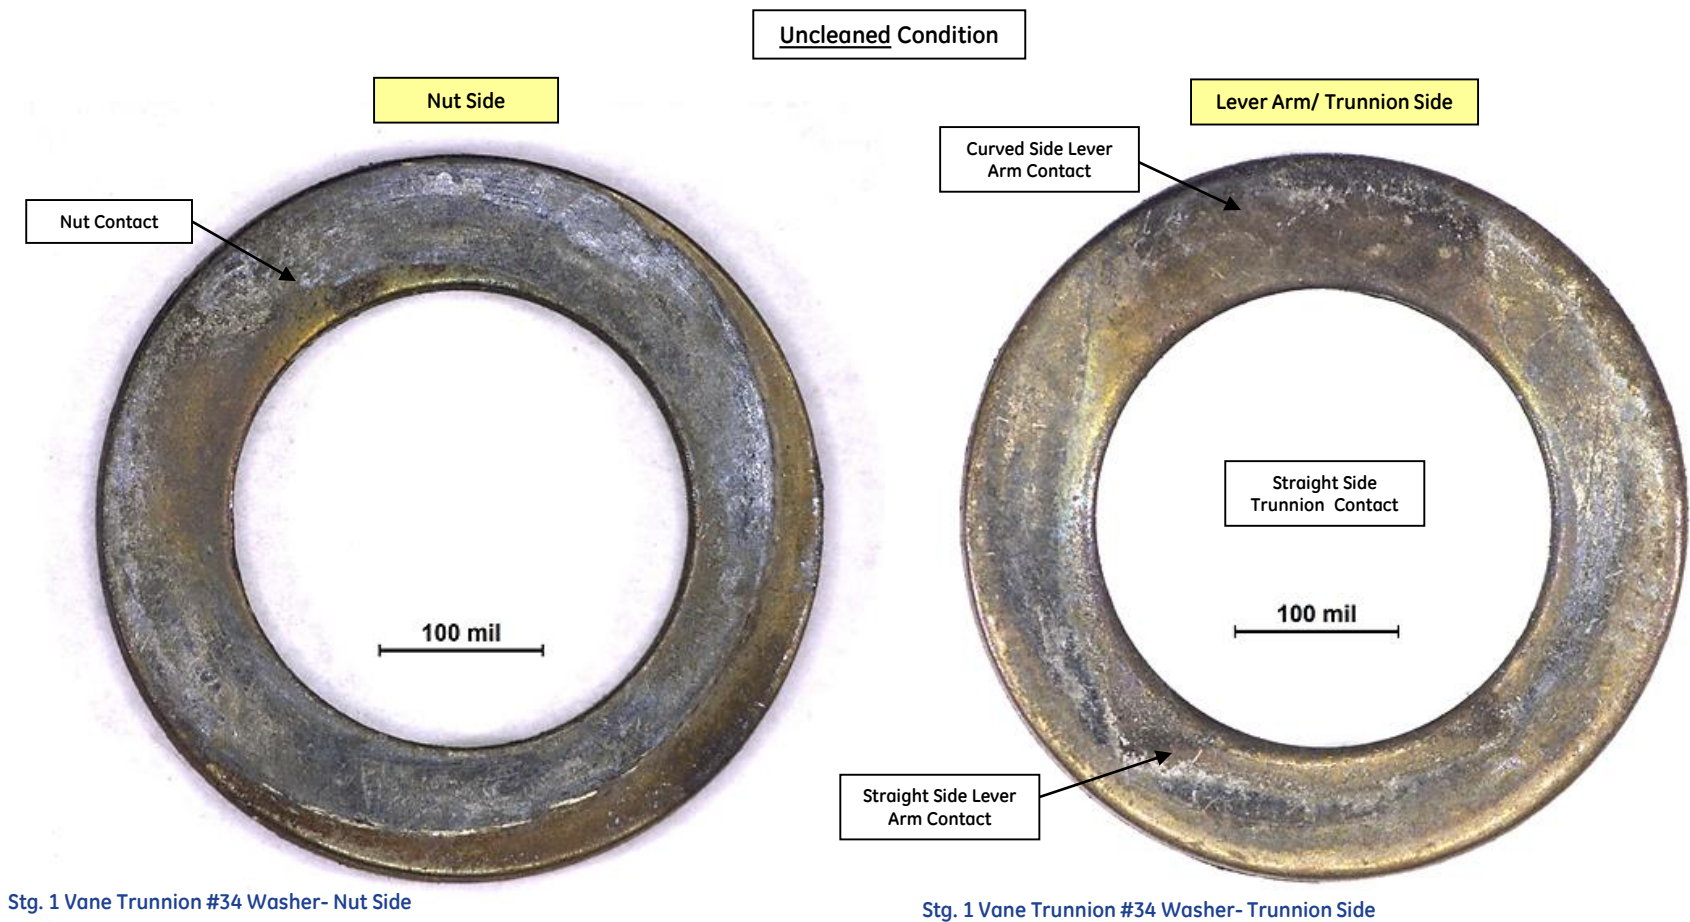
- General Condition of Stg. 1 Vane Trunnion #34 Washer – Trunnion Witness Marks From Contact With Retaining Nut and Lever Arm Face

Figure 37. Photographs documenting contact patterns present on both sides of washer from Stg. 1 HPC Trunnions #34 in the uncleaned condition.

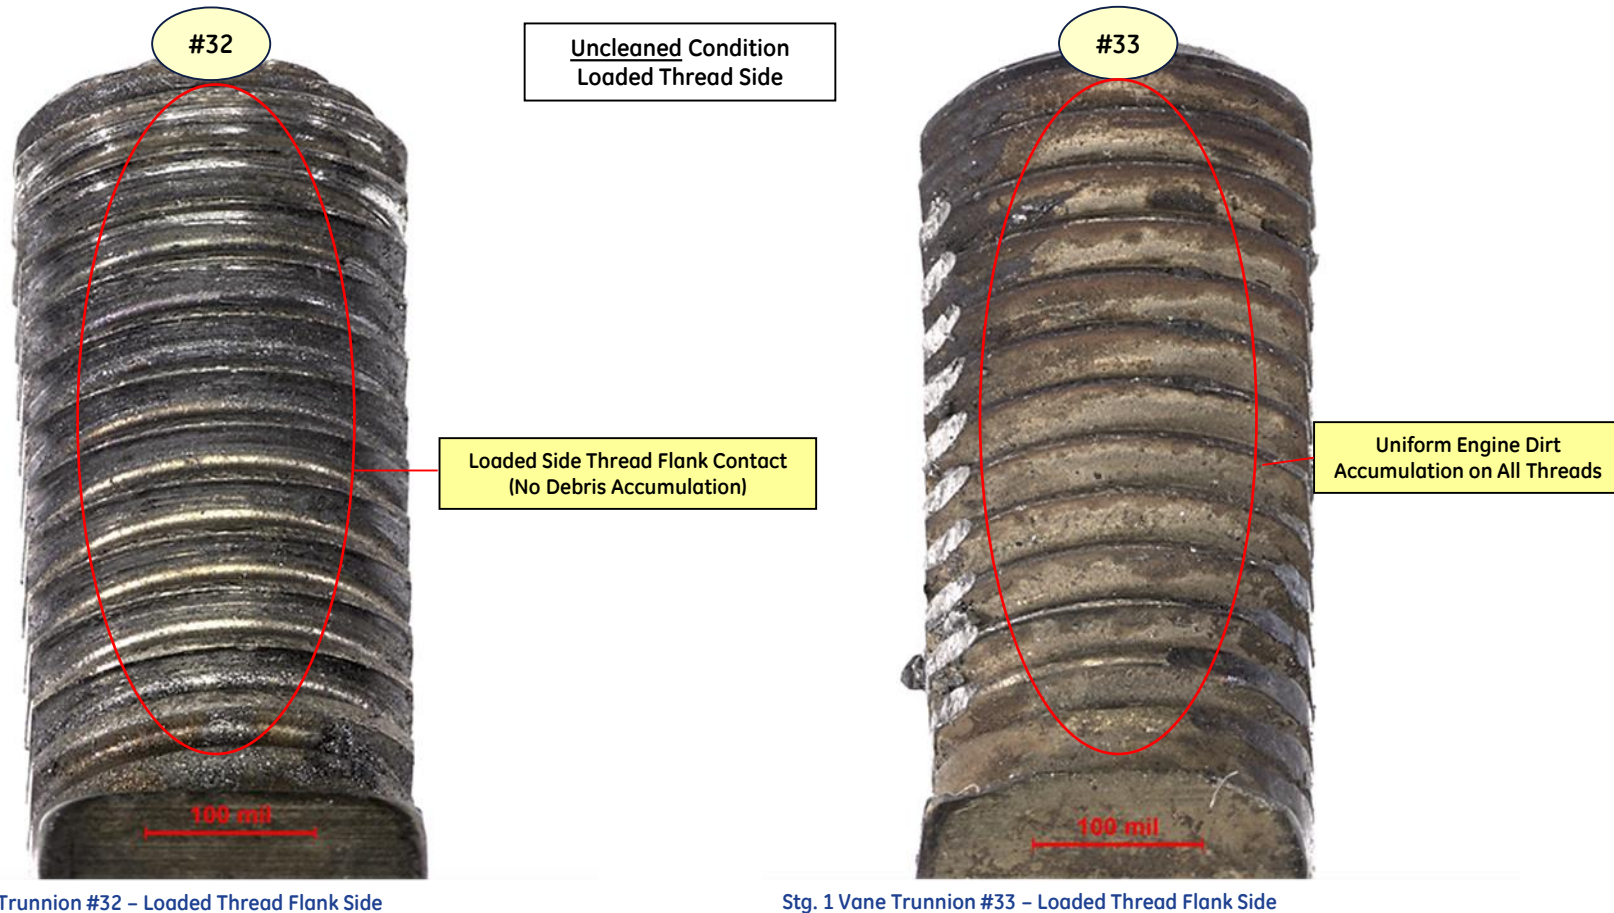
- Thread Comparison Between Stg. 1 Vane Trunnion #32 With Nut and Stg. 1 Vane Trunnion #33 Without Nut (No Cleaning)
- Circumferential Contact Marks Observed on Loaded Side Thread Flanks on Trunnion #32 Consistent With Nut Contact
- Debris Obscured Any Evidence of Loaded Side Thread Flank Contact on Trunnion #33

Figure 38. Photographs comparing loaded thread side of Stg. 1 HPC Trunnions #32 and #33 in the uncleaned condition.

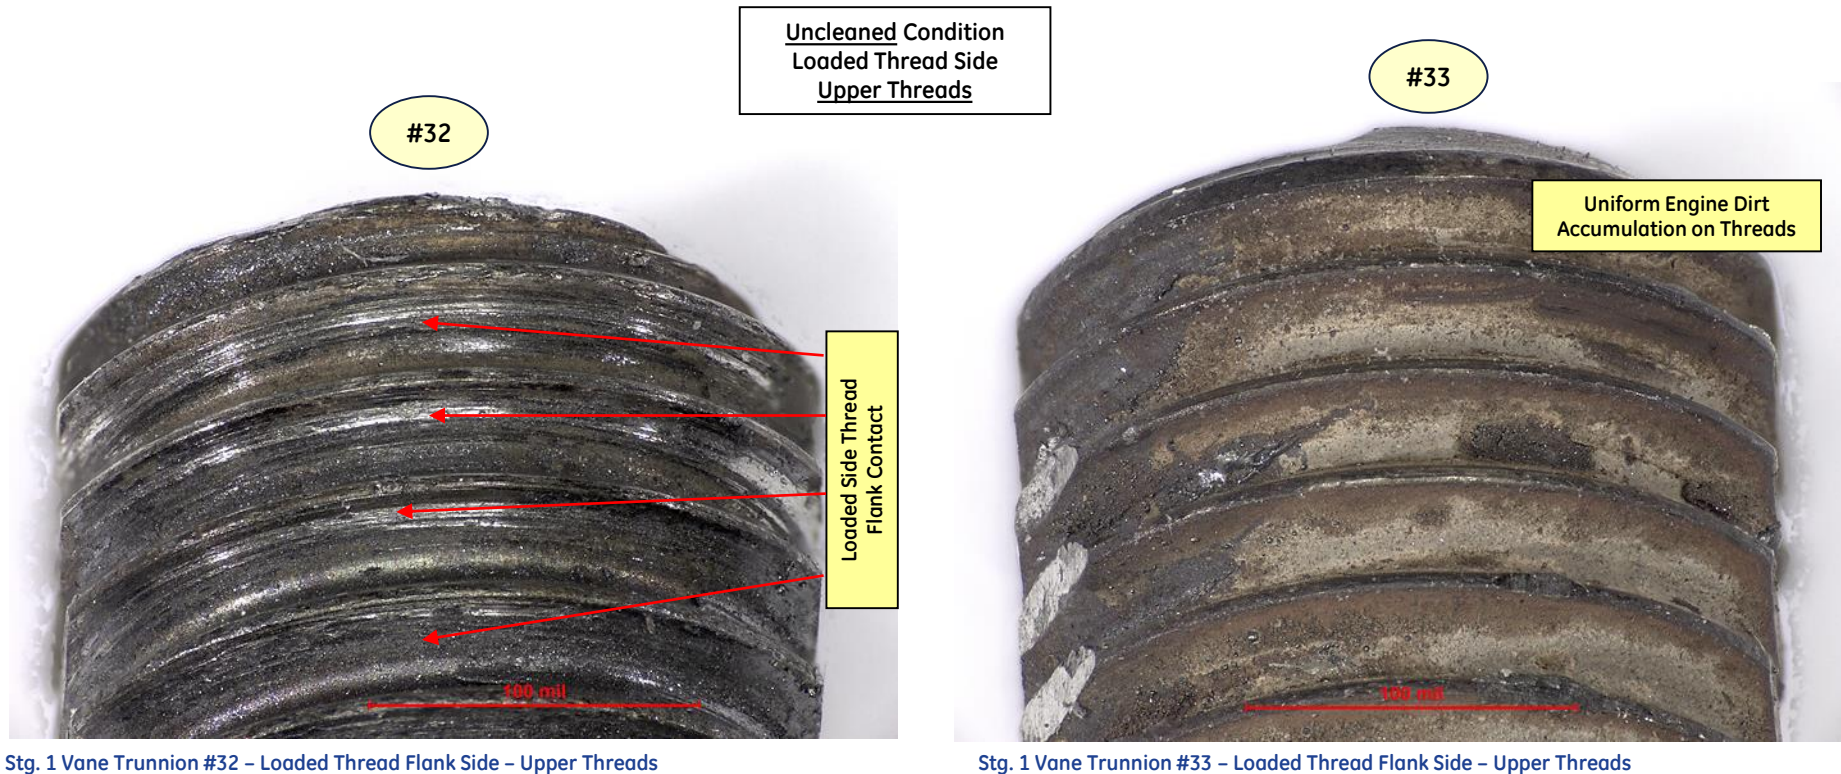
- Thread Comparison Between Stg. 1 Vane Trunnion #32 With Nut and Stg. 1 Vane Trunnion #33 Without Nut
- Circumferential Contact Marks Observed on Upper Loaded Side Thread Flanks on Trunnion #32 Consistent With Nut Contact
- Debris Obscured Any Evidence of Upper Loaded Side Thread Flank Contact on Trunnion #33

Figure 40. Photographs showing closer views comparing loaded thread side of Stg. 1 HPC Trunnions #32 and #33 in the uncleaned condition (upper threads).
