# Metallurgical Investigation Report

## FA Log No. 18712

**METALLURGICAL EVALUATION OF  
CFM56-7B STG. 1-2 HPC SPOOL AND  
STG. 1 HPC VSV TRUNNION/LEVER  
ARM HARDWARE FROM ESN 875-  
318 OPERATED BY UNITED AIRLINES**

**Final Report Date: June 14, 2019**

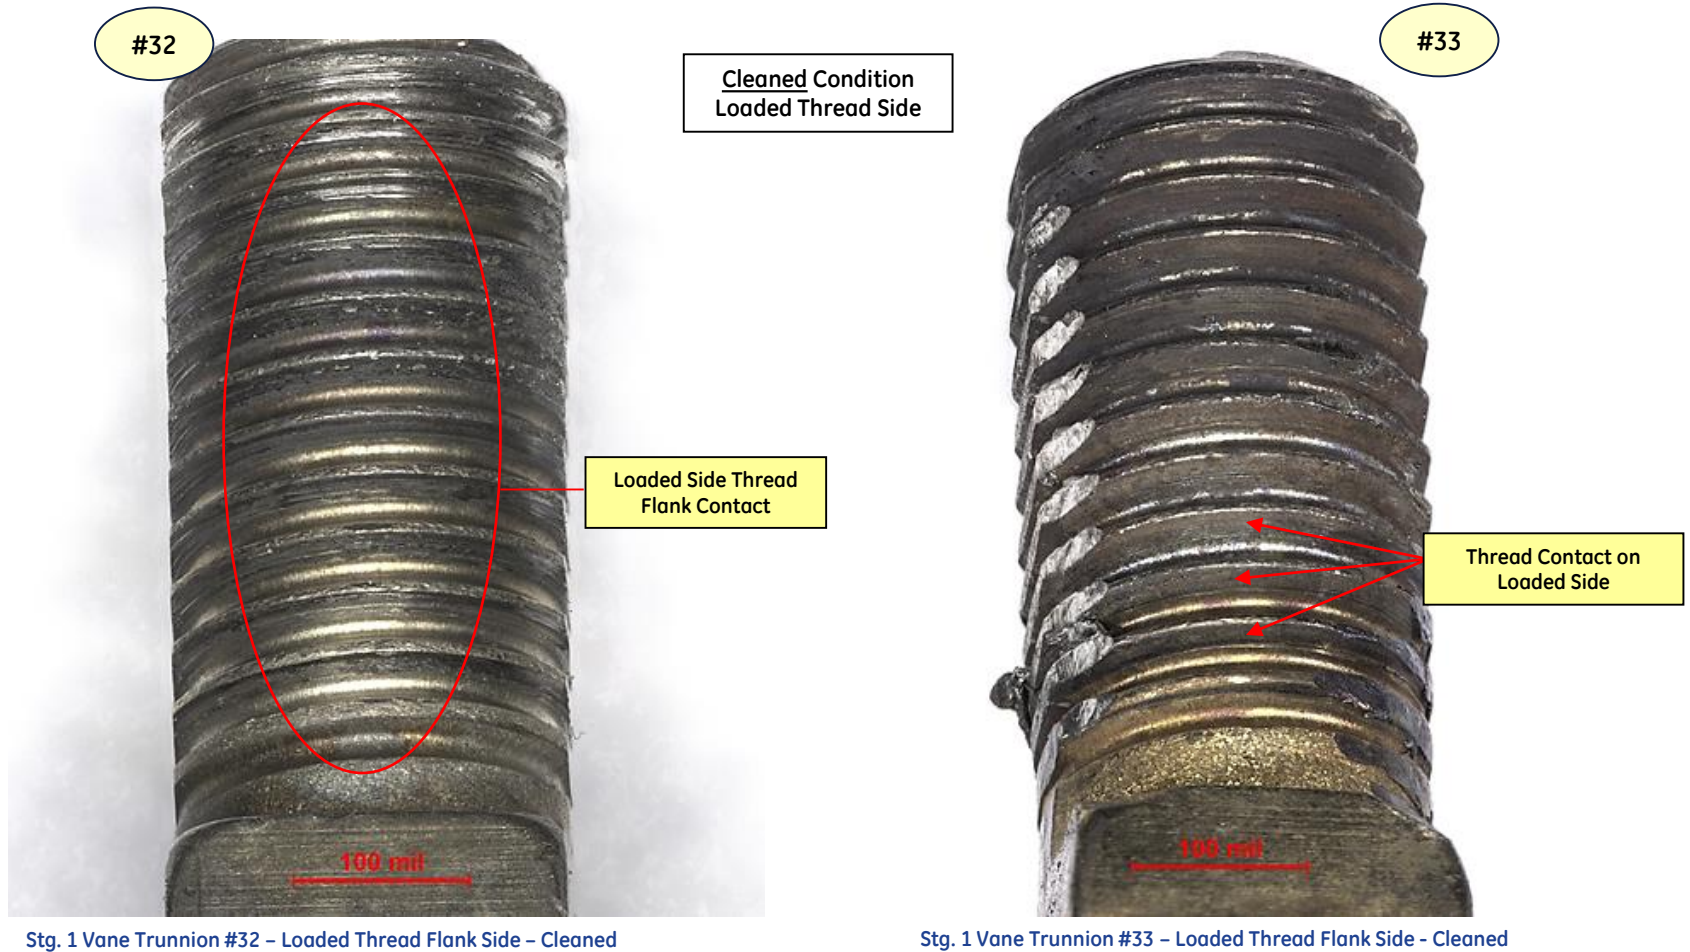
- Thread Comparison Between Stg. 1 Vane Trunnion #32 With Nut and Stg. 1 Vane Trunnion #33 Without Nut (Cleaned)
- Circumferential Contact Marks Observed on Loaded Side Thread Flanks on Trunnion #32 Consistent With Nut Contact
- Removal of Debris Revealed Visual Evidence of Circumferential Contact Marks on Loaded Thread Flanks on Trunnion #33 Implying Retaining Nut Had Been Run Down Threads at Some Point

Figure 41. Photographs comparing loaded thread side of Stg. 1 HPC Trunnions #32 and #33 in the cleaned condition.

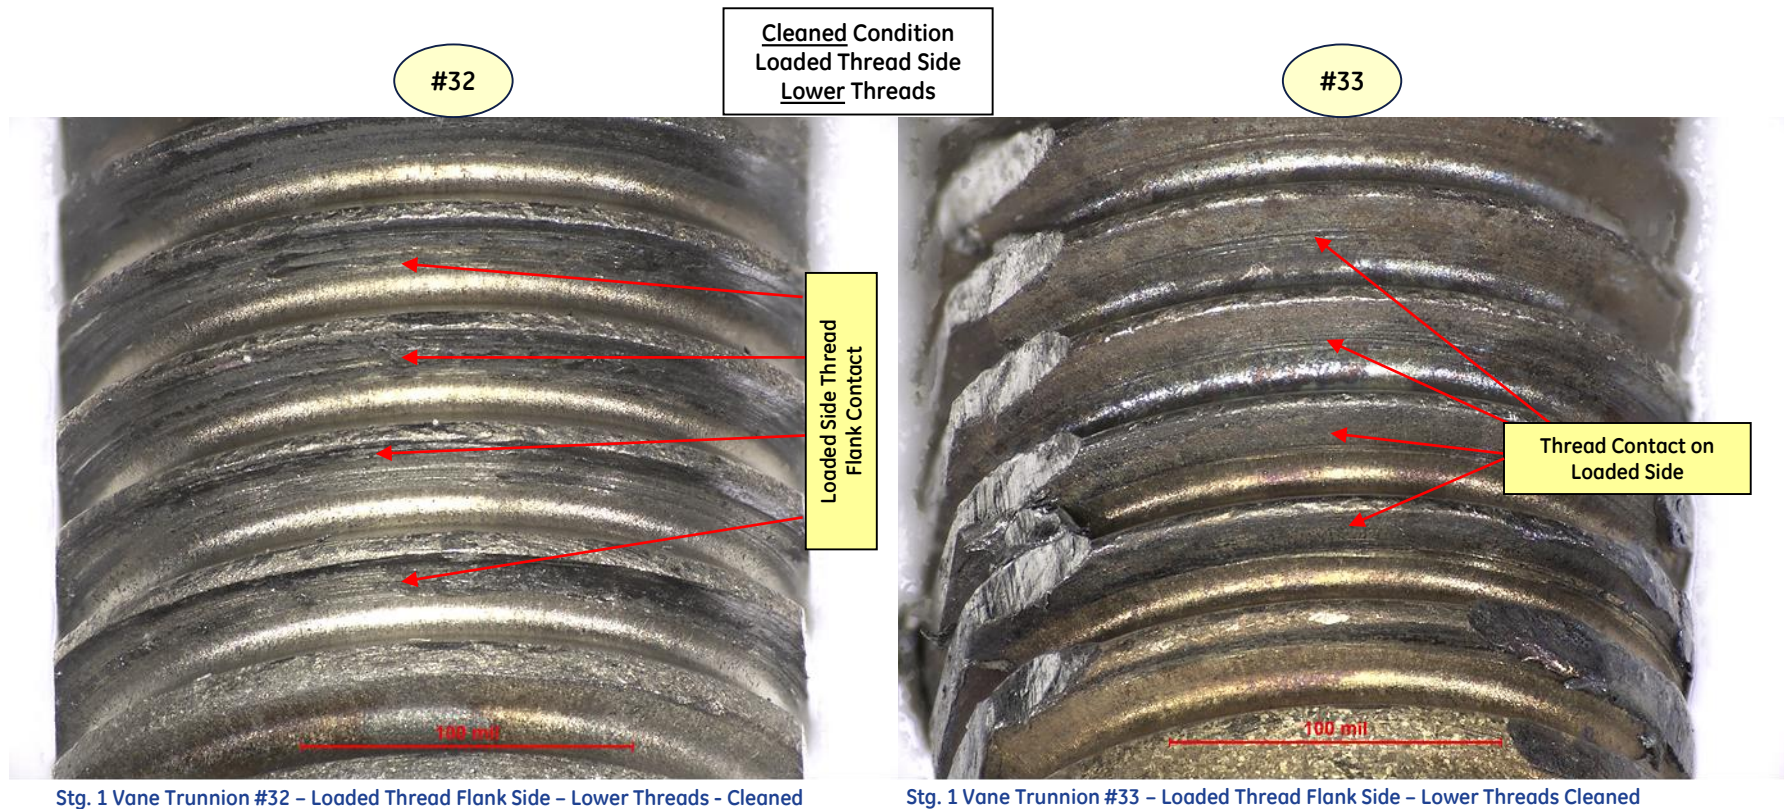
- Thread Comparison Between Stg. 1 Vane Trunnion #32 With Nut and Stg. 1 Vane Trunnion #33 Without Nut (Cleaned)
- Circumferential Contact Marks Observed on Loaded Side Thread Flanks on Trunnion #32 Consistent With Nut Contact
- Removal of Debris Revealed Visual Evidence of Circumferential Contact Marks on Loaded Thread Flanks on Trunnion #33 Implying Retaining Nut Had Been Run Down Threads at Some Point

Figure 42. Photographs showing closer views comparing loaded thread side of Stg. 1 HPC Trunnions #32 and #33 in the cleaned condition (lower threads).

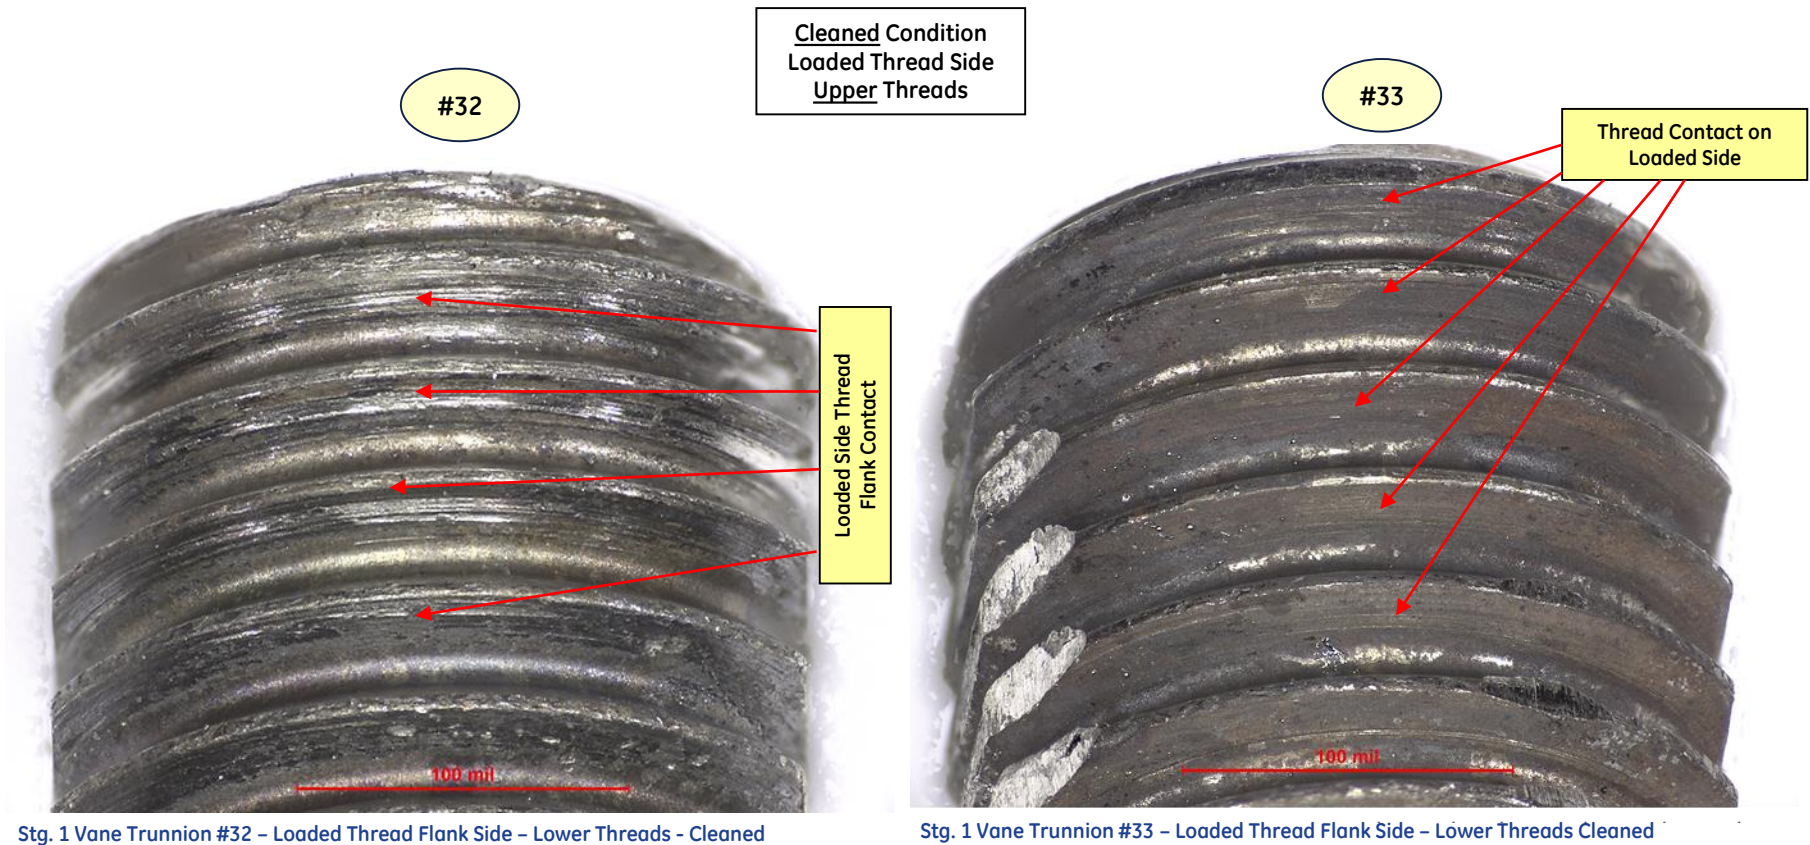
- Thread Comparison Between Stg. 1 Vane Trunnion #32 With Nut and Stg. 1 Vane Trunnion #33 Without Nut (Cleaned)
- Circumferential Contact Marks Observed on Loaded Side Thread Flanks on Trunnion #32 Consistent With Nut Contact
- Removal of Debris Revealed Visual Evidence of Circumferential Contact Marks on Loaded Thread Flanks on Trunnion #33 Implying Retaining Nut Had Been Run Down Threads at Some Point

Figure 43. Photographs showing closer views comparing loaded thread side of Stg. 1 HPC Trunnions #32 and #33 in the cleaned condition (upper threads).

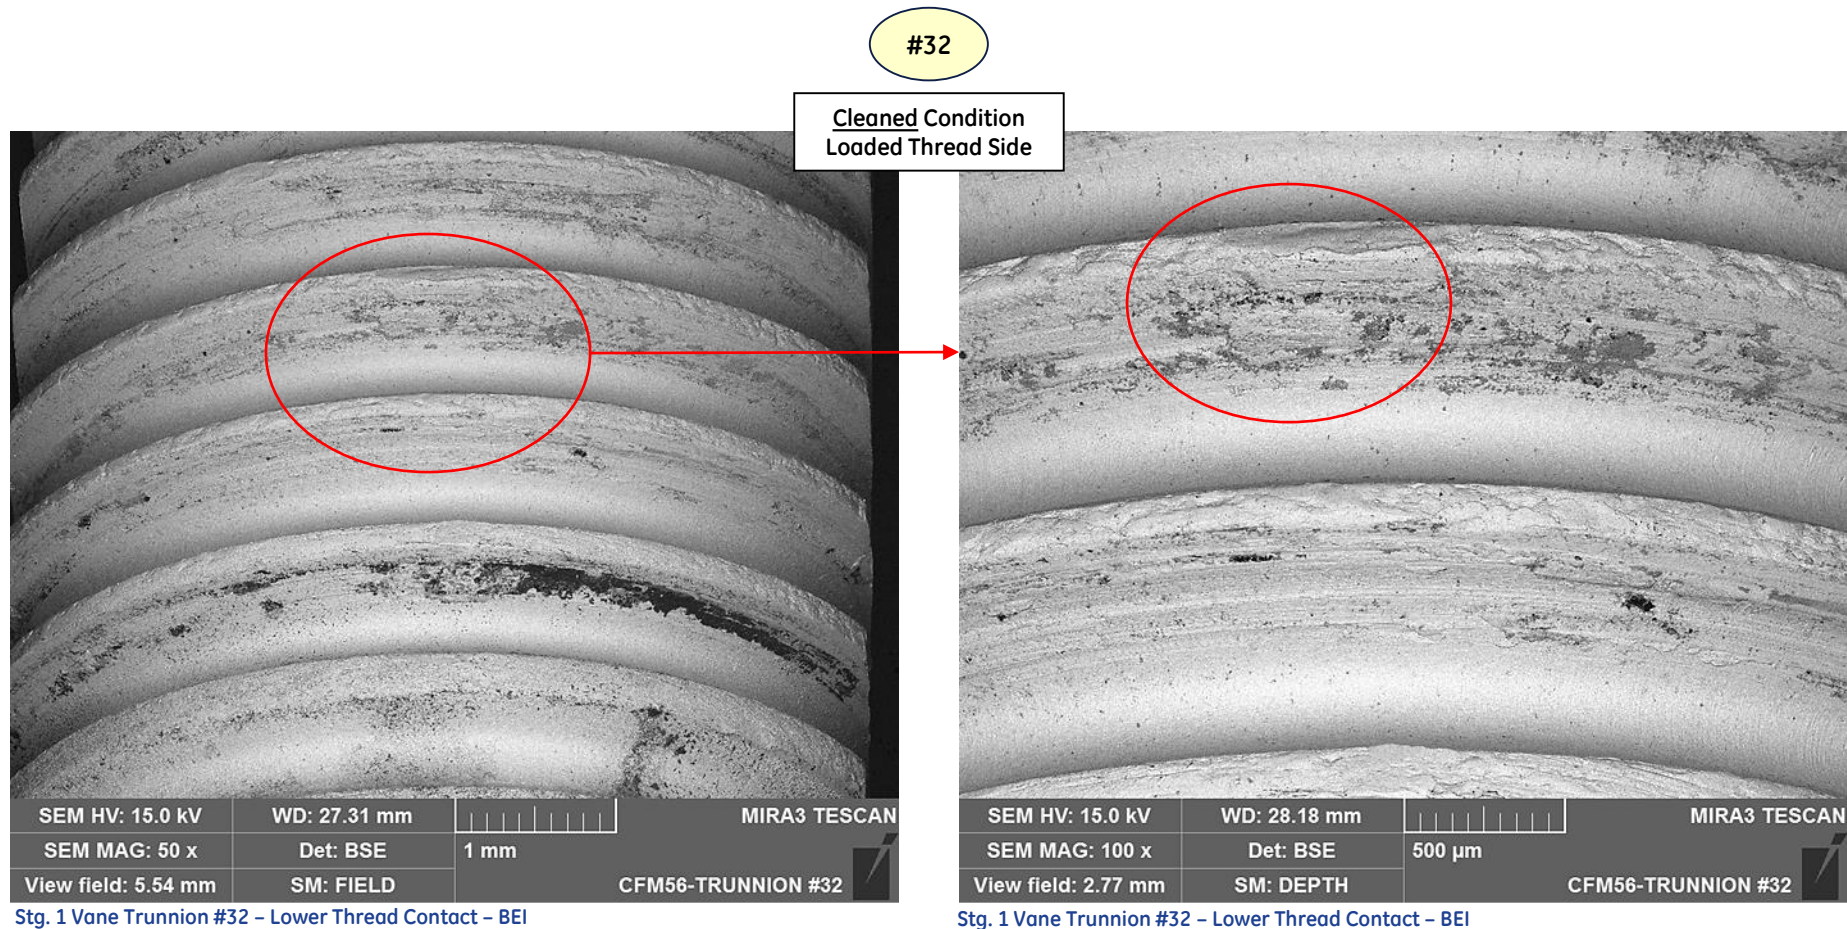
- Circumferential Loaded Side Thread Flank Contact Observed on Lower Threads of Stg. 1 Vane Trunnion #32 Considered Consistent With Nut Contact

Figure 45. SEM backscatter (BEI) images documenting Stg. 1 HPC Trunnion #32 threads in the cleaned condition (lower threads).

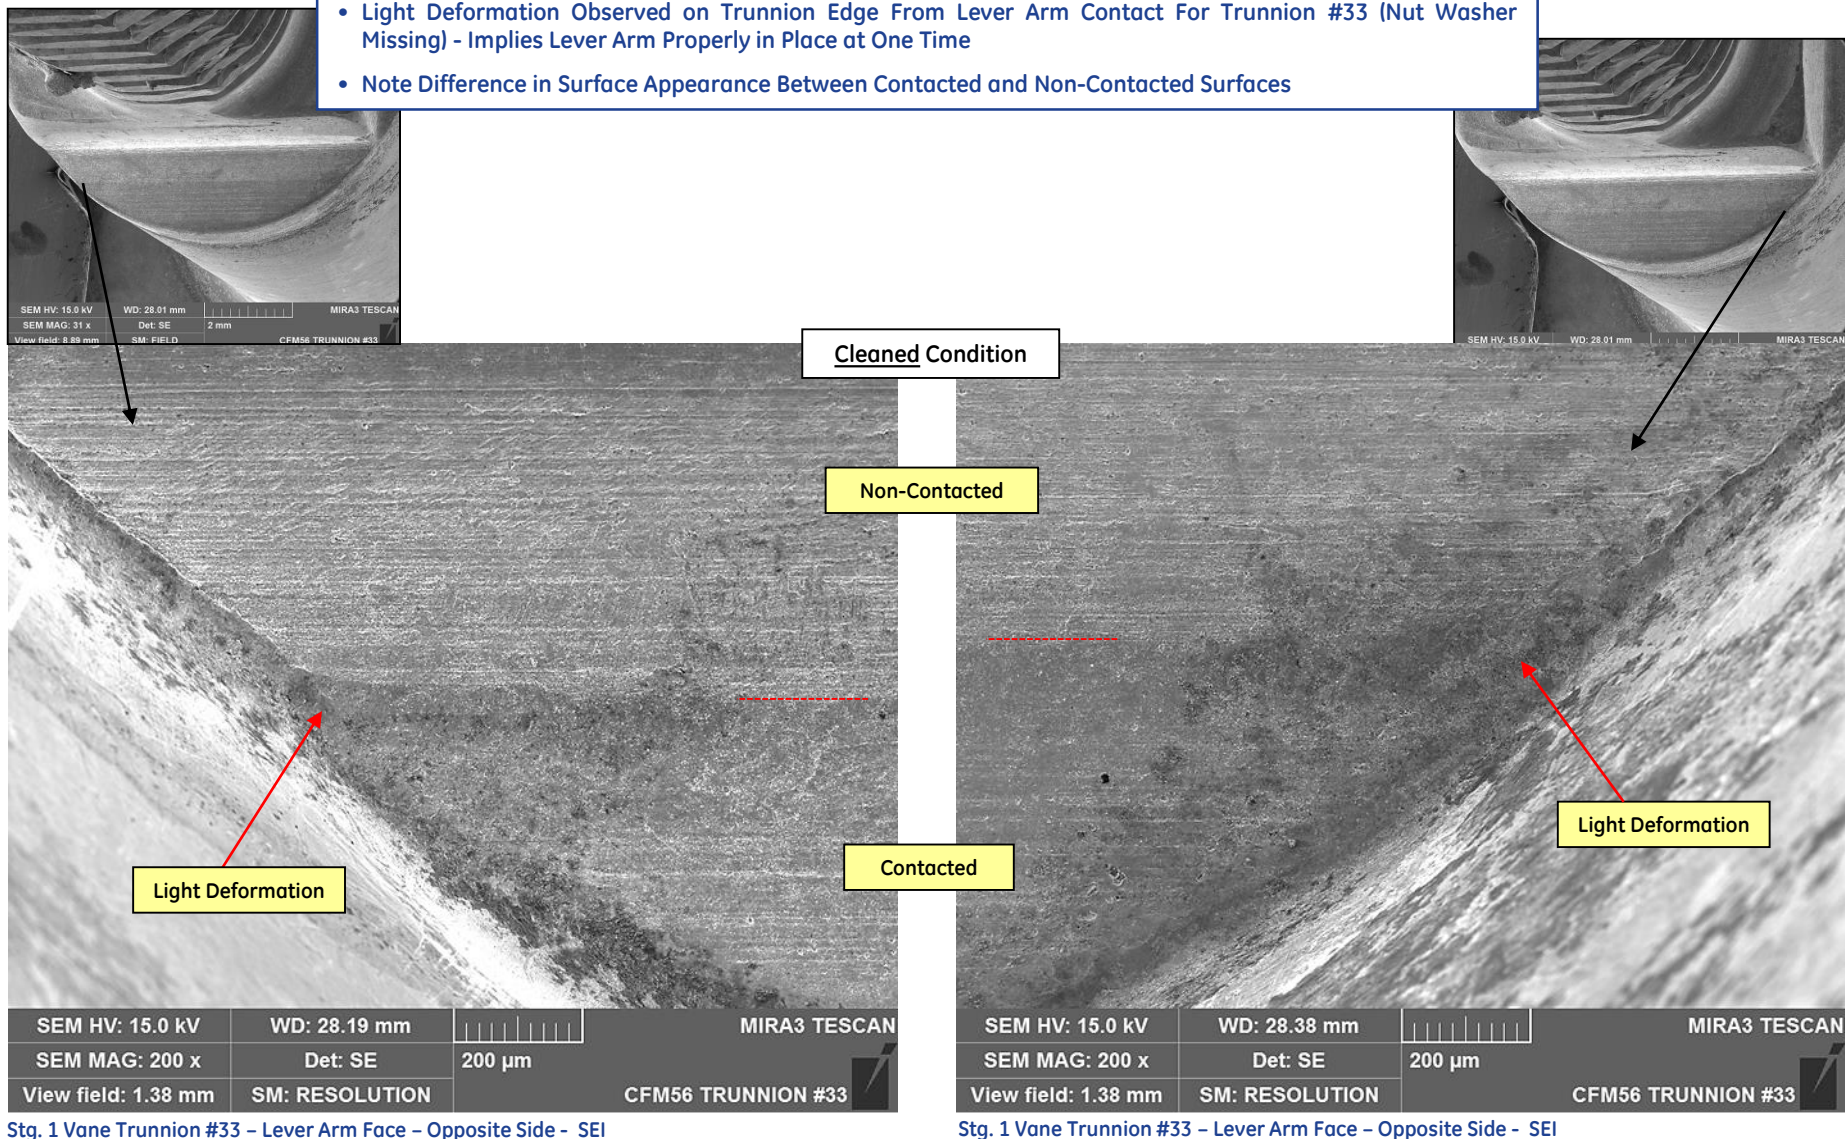
- Light Deformation Observed on Trunnion Edge From Lever Arm Contact For Trunnion #33 (Nut Washer Missing) - Implies Lever Arm Properly in Place at One Time
- Note Difference in Surface Appearance Between Contacted and Non-Contacted Surfaces

Figure 57. Closer SEM backscatter secondary (SEI) images documenting presence of witness mark and light deformation (opposite side) attributed to contact with a properly installed lever arm at some point on Stg. 1 Vane Trunnion #33.

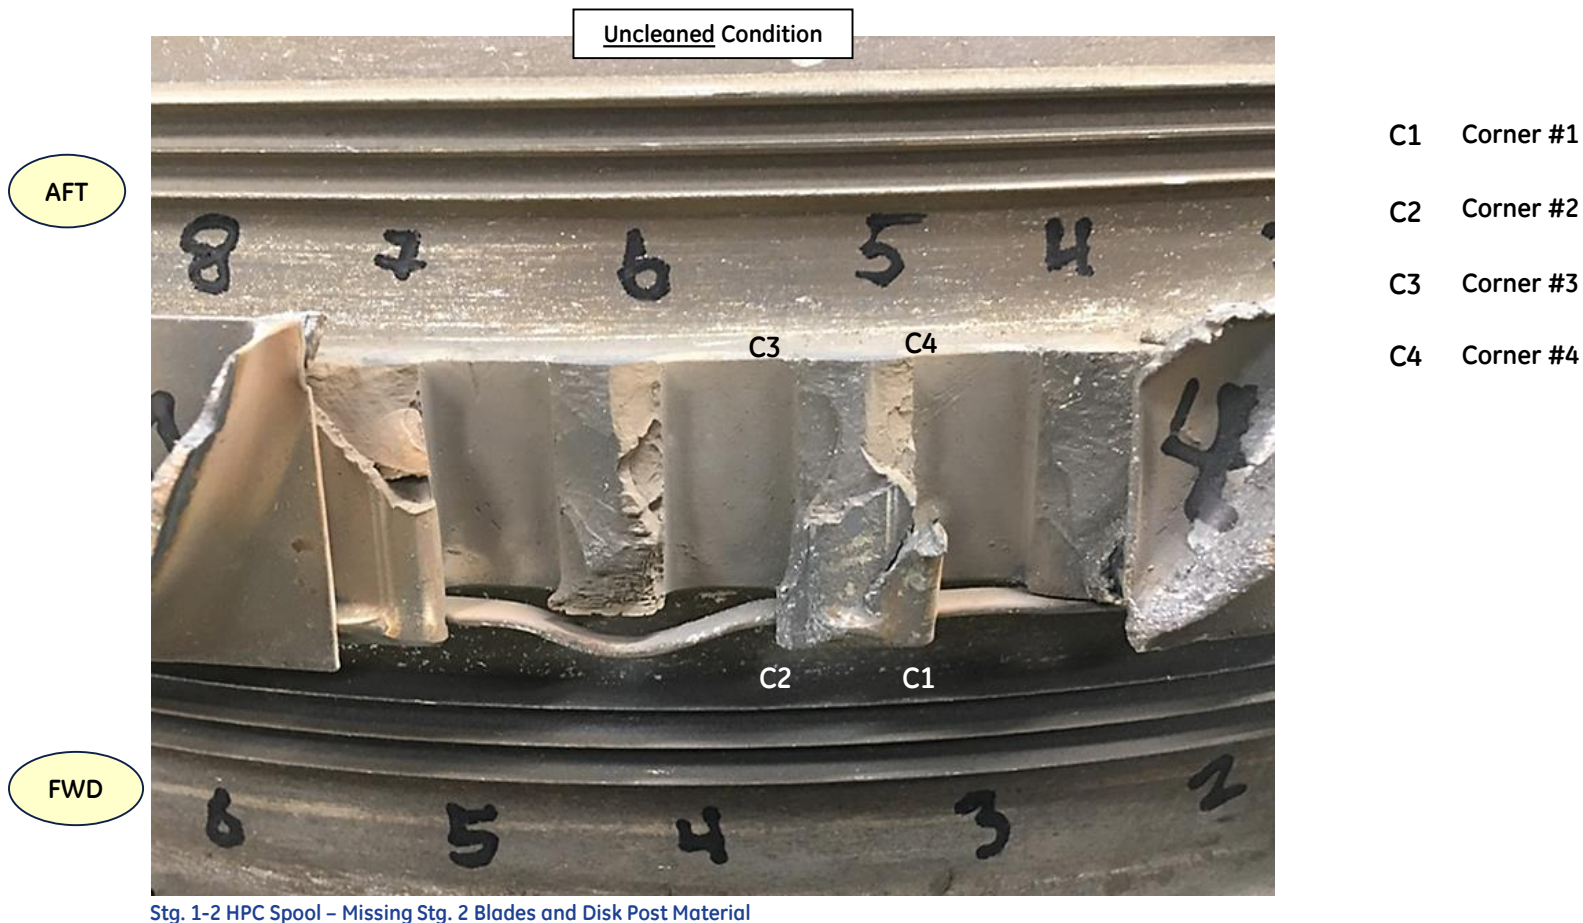
- Missing Stg. 2 HPC Blades #5, #6 and #7 – Missing Stg. 2 Disk Post Material at Posts #4, #5, #6 and #7
- “Beachmark” Features Consistent With Fatigue Observed on Post #7-Corner #4

Figure 73. Photograph showing closer view of missing Stg. 2 HPC Blades and Stg. 2 disk post material.

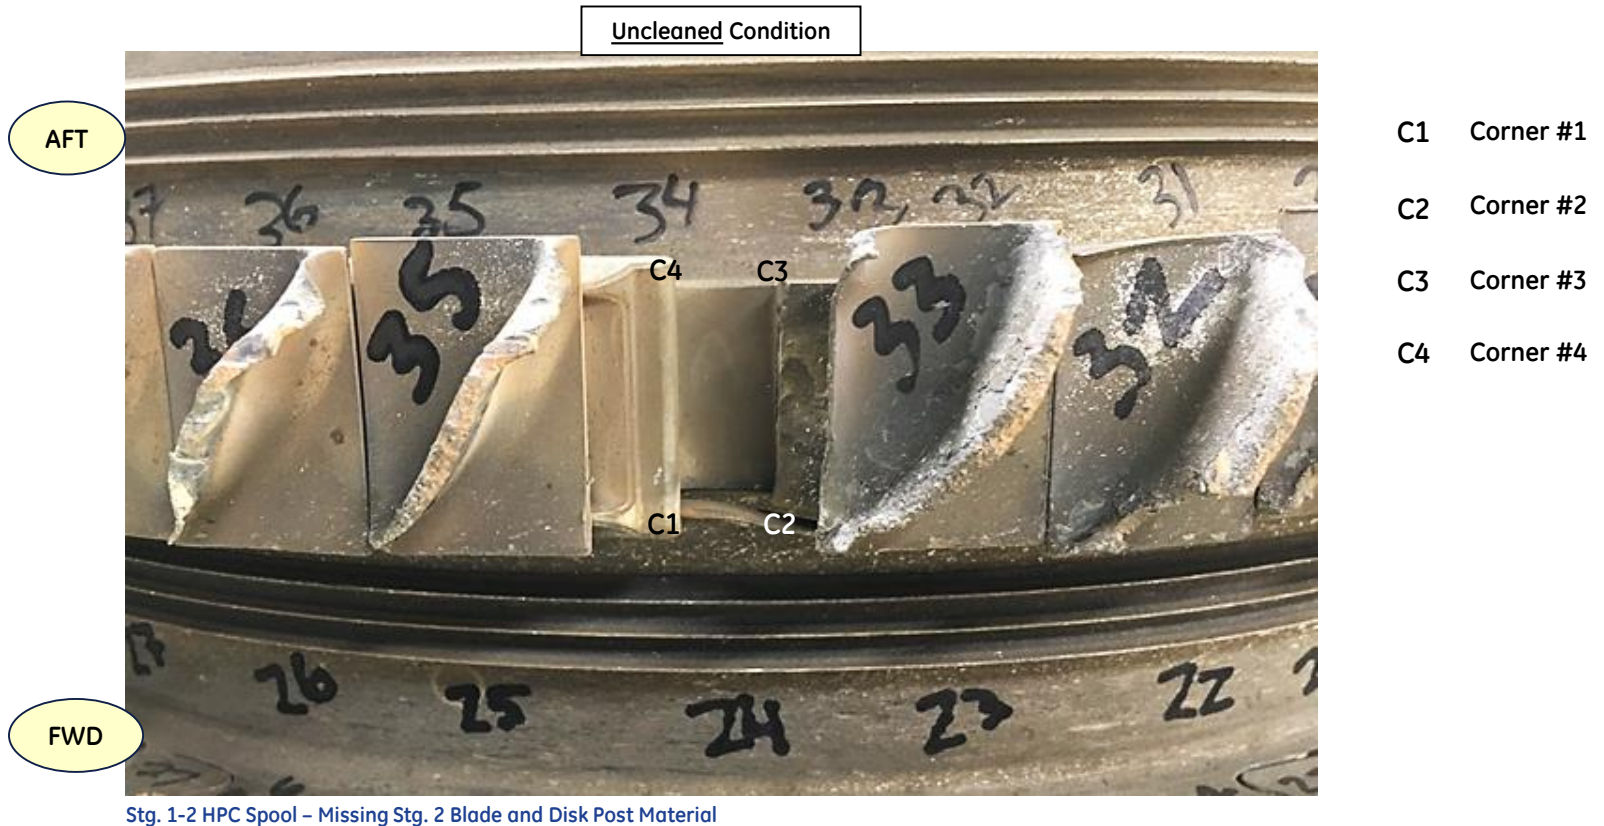
- Missing Stg. 2 HPC Blades #34 – Missing Stg. 2 Disk Post Material at Posts #33

Figure 74. Photograph showing closer view of missing Stg. 2 HPC Blade and missing Stg. 2 disk post material.

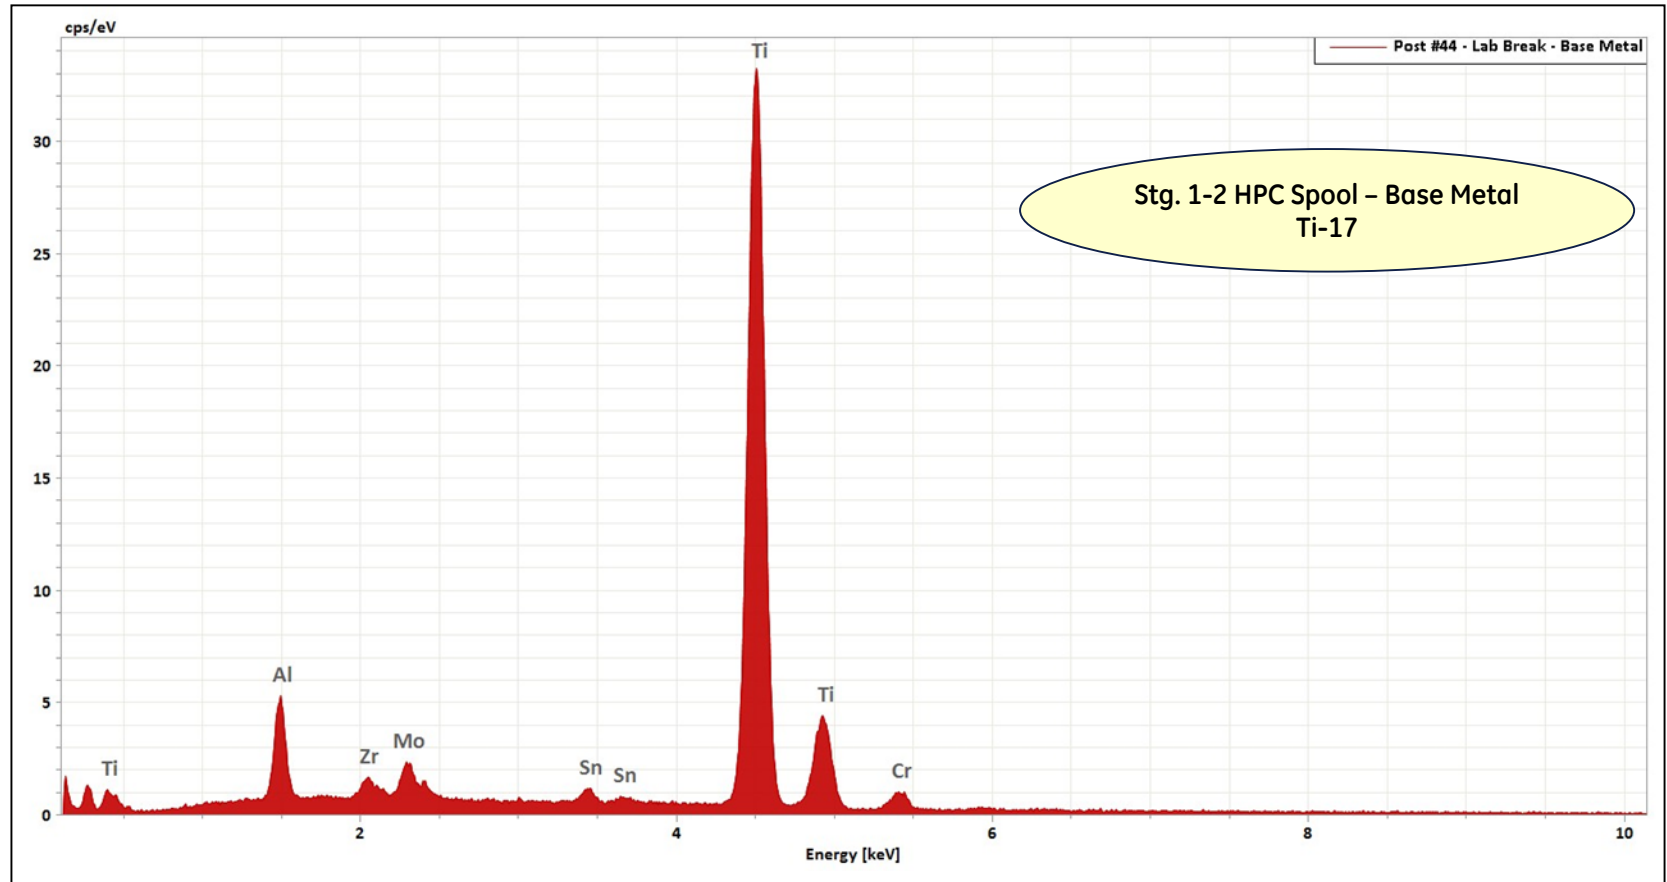
Figure 100. EDS spectra obtained from fresh tensile lab fracture from Stg. 2 disk post #44 fracture surface consistent with required Ti-17 material.
