**NATIONAL TRANSPORTATION SAFETY BOARD**  
**Office of Aviation Safety**  
**Washington, D.C. 20594**

**POWERPLANT GROUP CHAIRMAN'S FACTUAL REPORT**  
**NTSB No: ENG19IA029**

Aircraft: Airbus A220-300 (MSN 55030), HB-JCM, Swiss International Air Lines, Flight LX348

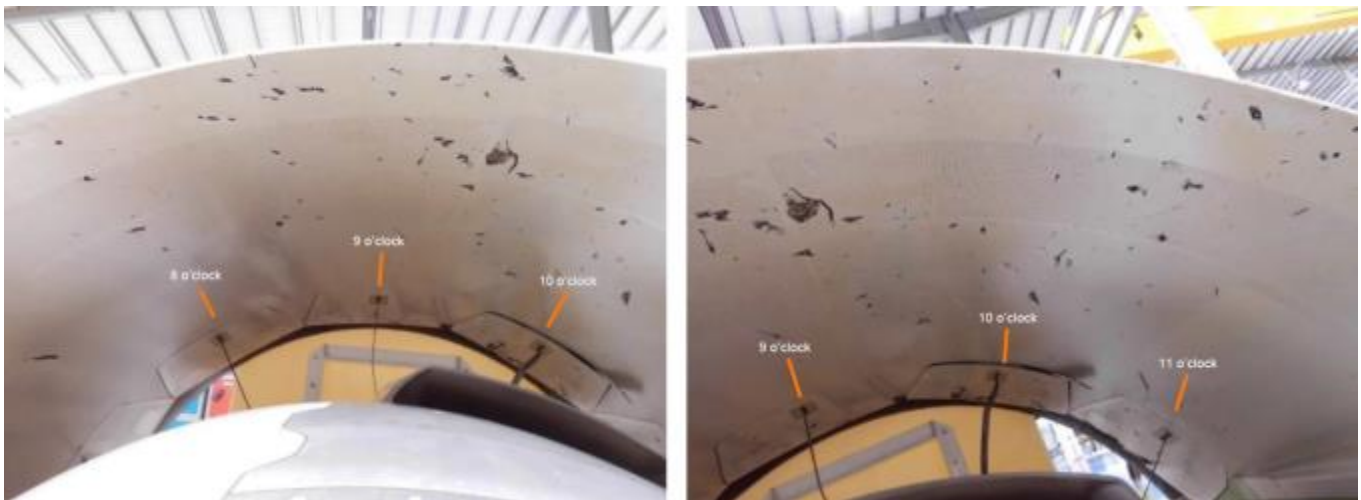
The left TR sleeve perforated skin had impact damage including nicks and gouges, mostly concentrated between the 7 and 12 o'clock positions, along the full length of the sleeve (**Photo 1**). The forward lip of the TR blocker doors also exhibited impact damage and deformation between the 7 and 12 o'clock positions (**Photo 2**). The blocker door #9 drag link (10 o'clock position) was deformed and the pivot block was sheared at the inner fixed structure (IFS) attachment (**Photo 3**). The IFS and IFS upper and lower bifurcation perforated skin had small impact gouges along the length of the TR.

**Photo 1- Left Thrust Reverser Sleeve Perforated Skin Impact Damage**

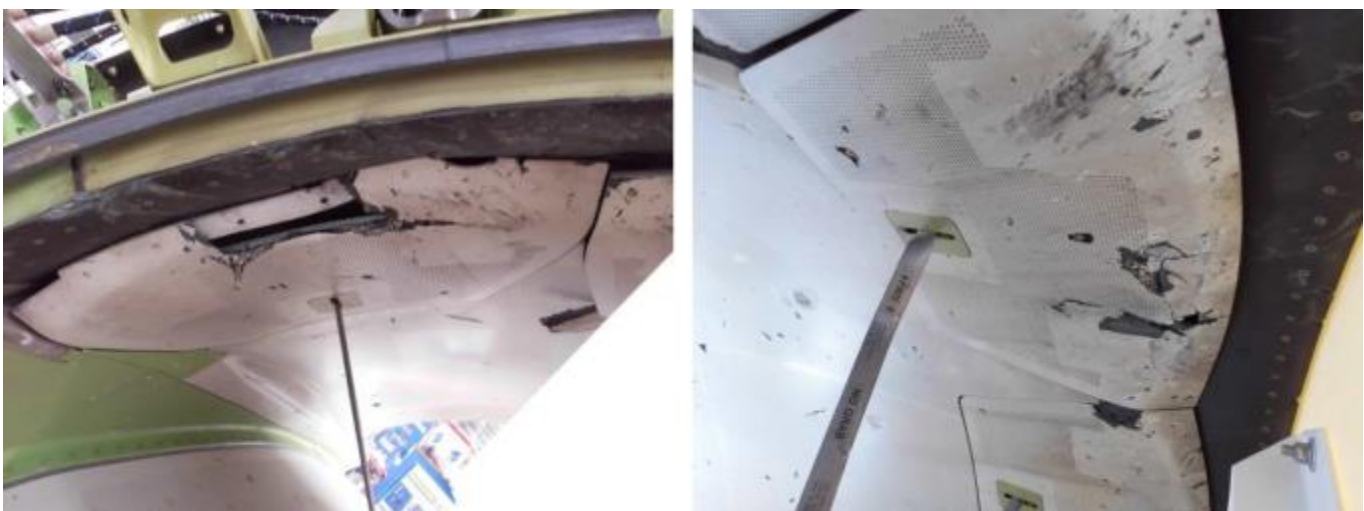
**Photo 2- Left Thrust Reverser Blocker Door Impact Damage (L) Door #10, (R) Door #9**

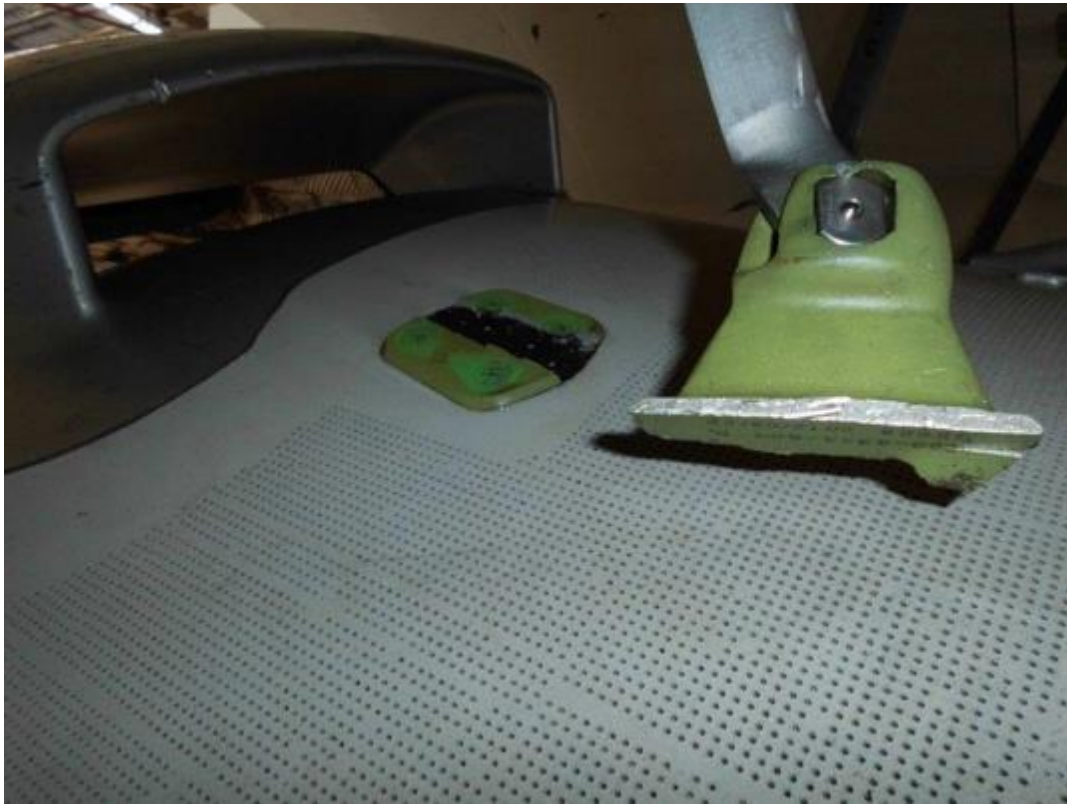
**Photo 3- Left Thrust Reverser Blocker Door #9 Drag Link, Pivot Block Sheared at Inner Fixed Structure Attachment**

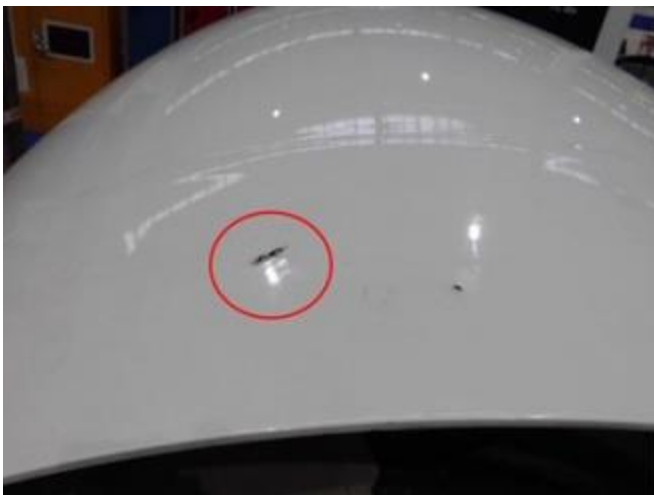
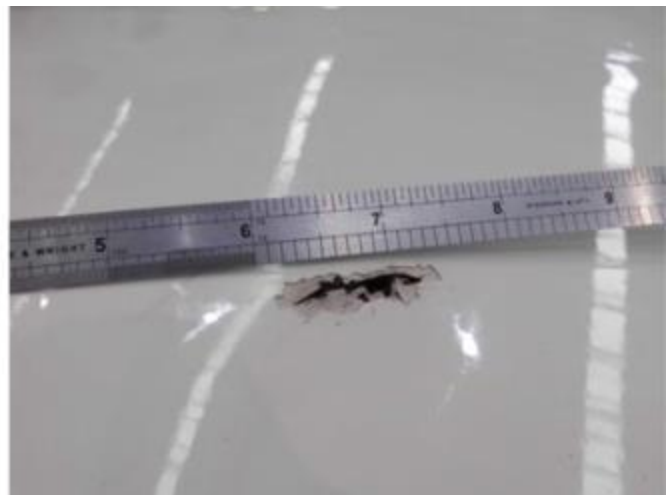
The left TR sleeve outer skin had two penetrations, at about the 8:30 and 9 o'clock positions. The larger penetration located at about the 8:30 position was an approximately 1 inch long slice, 6 inches from the sleeve trailing edge (**Photo 4**). The penetration was approximately 60 inches axially aft of the LPC IBR 1 plane of rotation. There was no evidence of high energy radial engine fragment penetration through the TR sleeve.

**Photo 4- Left Thrust Reverser Sleeve Outer Skin Penetration, 8:30 Position**

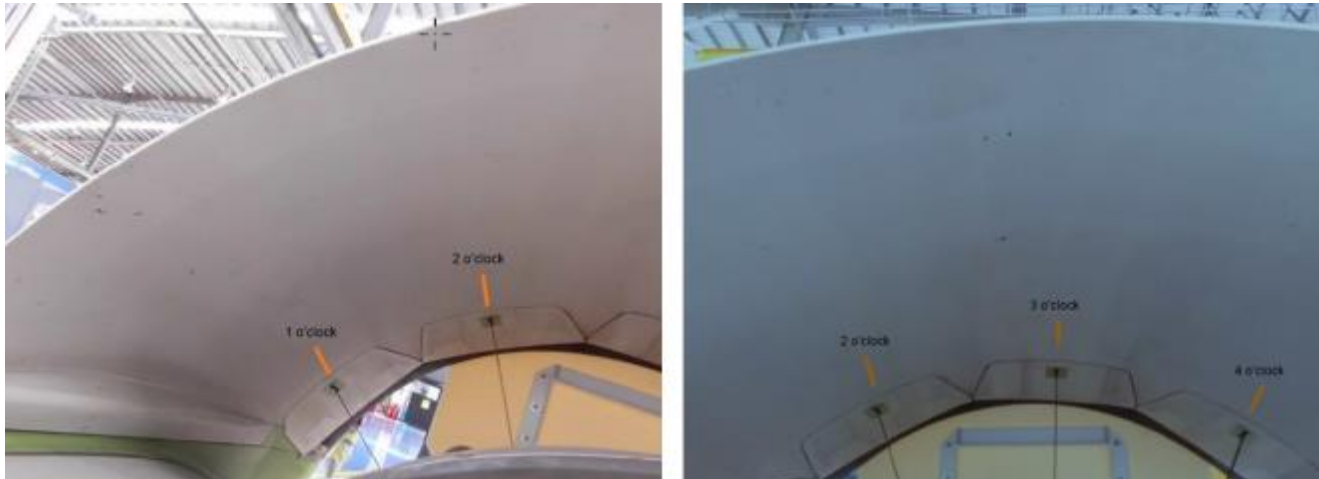
The right TR sleeve perforated skin had minor impact damage between the 12 and 2 o'clock positions, concentrated near the trailing edge of the sleeve (**Photo 5**). The IFS perforated skin and IFS upper and lower bifurcation perforated skin had multiple small nicks and gouges.

**Photo 5- Right Thrust Reverser Sleeve Perforated Skin**

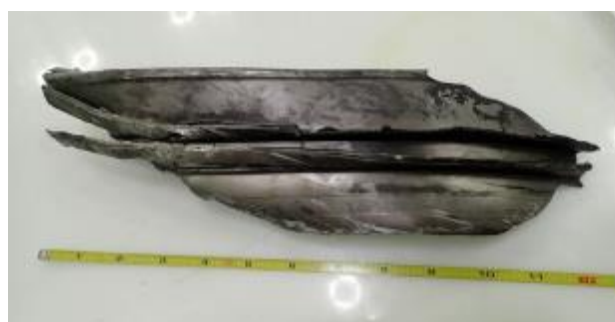
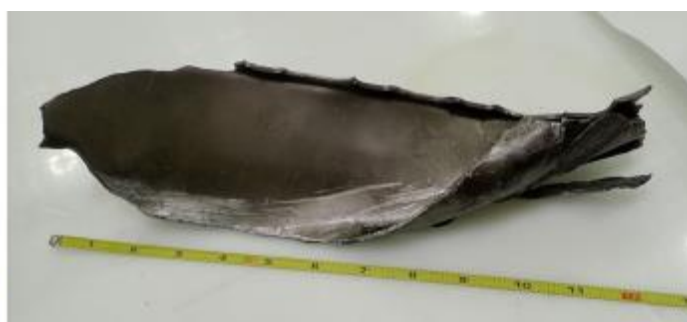
The engine was secured in work pedestals and the quick engine change hardware and buyer furnished equipment were removed when the investigation team arrived (**Photos 6, 7, and 8**). A BSI of the engine was completed prior to the teams' arrival to assist in teardown workscope development. The loose debris that was collected in the nacelle after the event flight landed at CDG was bagged and shipped with the engine for examination. One of the loose fragments had features that appeared to be consistent with the separated LPC IBR 1 (**Photo 9**).

**Photo 9- Engine Fragment Recovered in Nacelle**

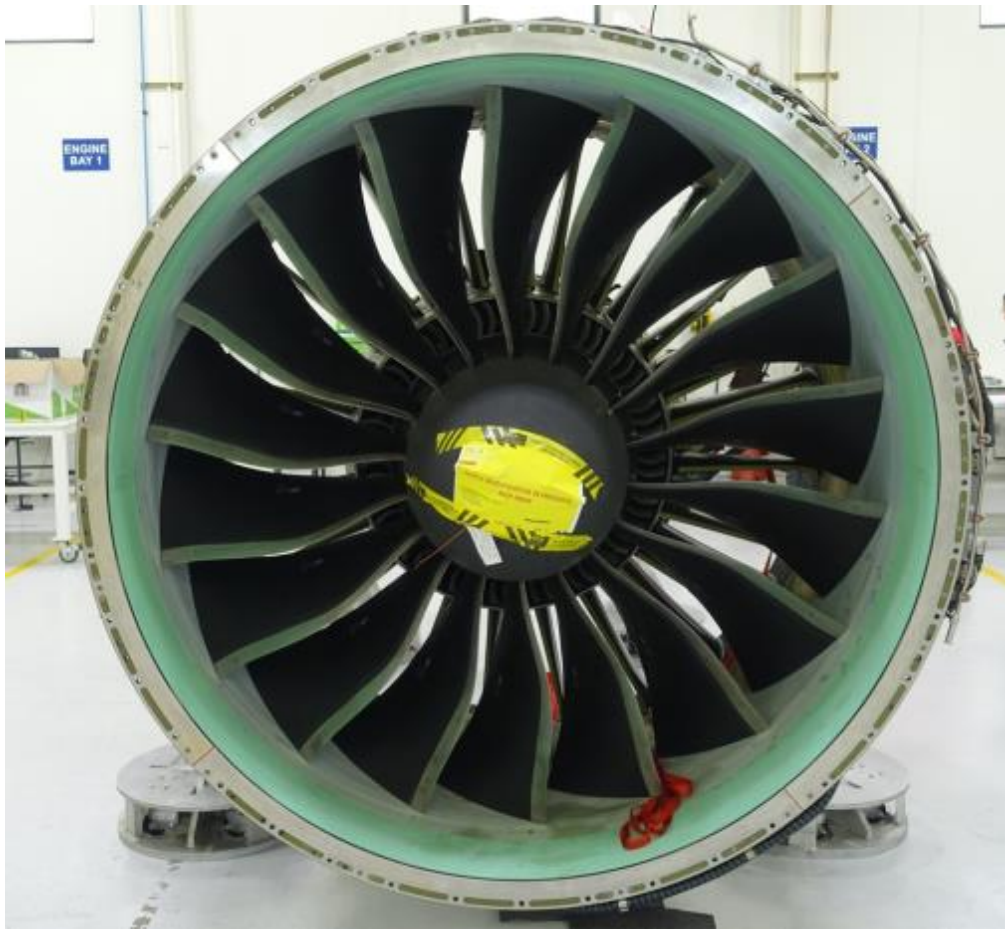
A visual inspection was completed to document the condition of the engine prior to disassembly. The fan spinner was secured and in good condition. The fan could not be rotated by hand. The fan blades were all complete but trailing edge deformation/nicks were observed along the span of each blade (**Photo 10**). There was light fan case rub strip damage between the 10:30 and 11 o'clock positions, coincident with the fan blade tip path between the  $\frac{3}{4}$  chord and the trailing edge. There was oil staining at the 6 o'clock position of the fan case. Eight consecutive FEGVs between the 10 o'clock and 11:30 positions had trailing edge impact damage and material loss that varied between  $\frac{1}{3}$  and  $\frac{1}{2}$  of the vane chord. The FEGV outer skin covers on the concave side of the damaged FEGV's were separated, exposing the internal vane structural compartments. Small metallic balls, which are part of the FEGV construction, were found on multiple engine surfaces. The fan exit stators were intact and in good condition. The thrust links and forward mount were in good condition. The aft mount attachment appeared intact, but the right hand side rotation bushing could not be rotated by hand.

**Photo 10- Engine Fan**

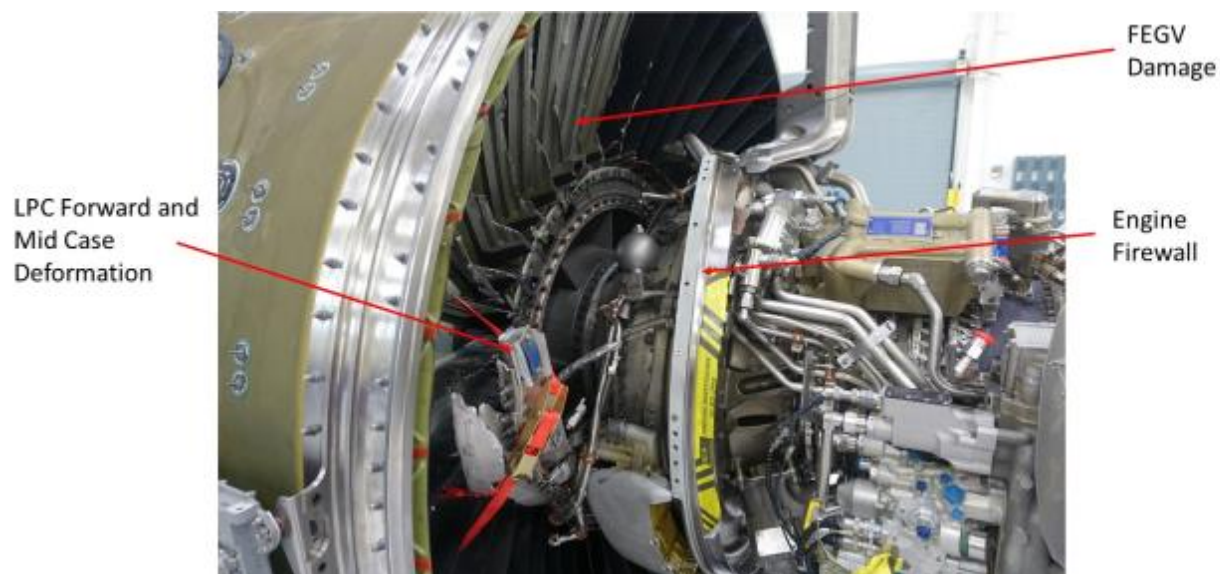
The forward and mid LPC cases had a hole from the 9 to 1 o'clock positions, axially from the forward flange of the LPC case to the aft flange of the mid LPC case. The case material around the hole exhibited deformation/tearing and a section of the flange was displaced radially outboard where it was secured with a SWISS strap prior to shipment (**Photos 11 and 12**). Air and oil lines (AP25, LP48, LP50) that are routed over the LPC case where the hole was located were severed and the severed ends were bent. There was no LPC IBR 1 or stator visible through the LPC case hole. The engine firewall located axially between the LPC case and the compressor intermediate case (CIC) had a joint that was separated at the 11 o'clock position where the firewall flange bolts were broken. The No. 4 bearing air cooler (buffer air heat exchanger) located at the 12:30 position on the LPC case was displaced aft and radially outboard at the forward side of the cooler. When the air cooler was later removed, there was impact damage on the inboard side and the front right and rear left attaching bolts were separated. The remaining bolts and attaching brackets were deformed.

**Photo 11- LPC Case Hole and FEGV Damage**

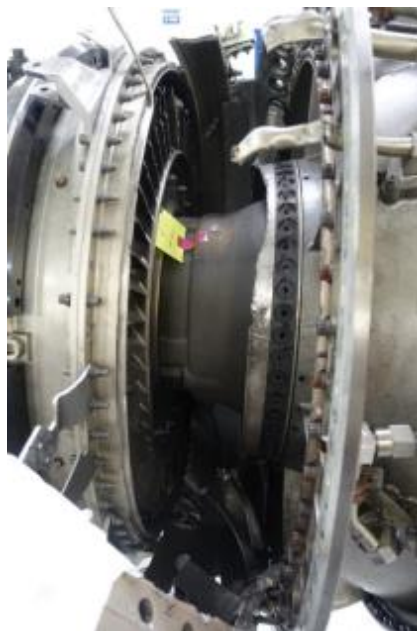
**Photo 12- LPC Case Hole**

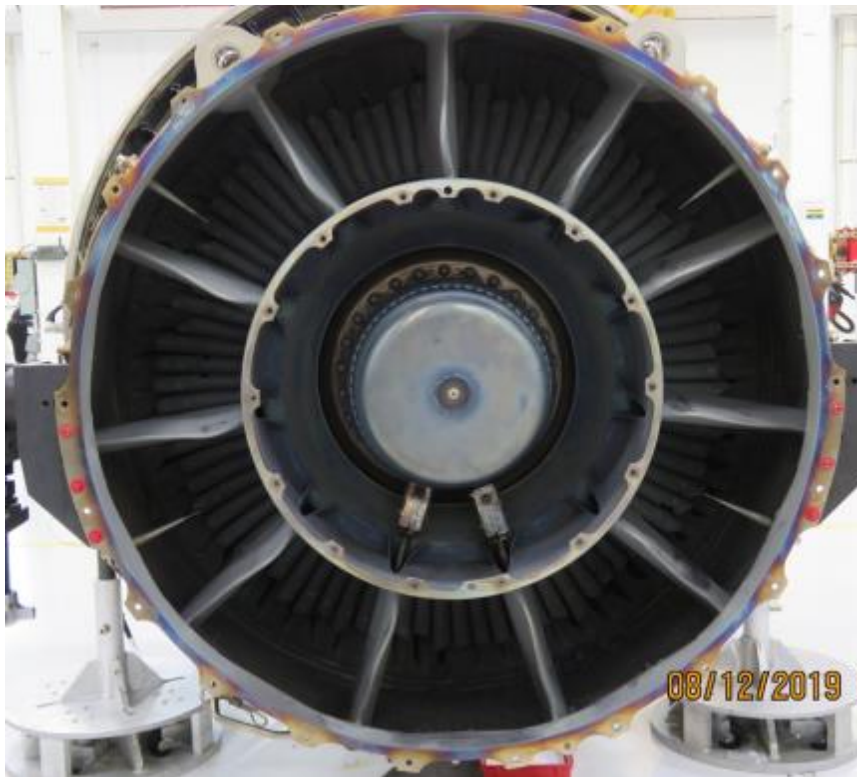
The LPT S3 blades were viewed through the turbine exhaust case (TEC) struts and were uniformly broken at about the  $\frac{2}{3}$  spanwise location (**Photo 13**). The LPT S3 blade fracture surfaces appeared jagged and coarse. Visible LPT S3 nozzle vanes exhibited trailing edge impact damage along the blade span.

**Photo 13- LPT Stage 3 Blades Visible Through TEC**

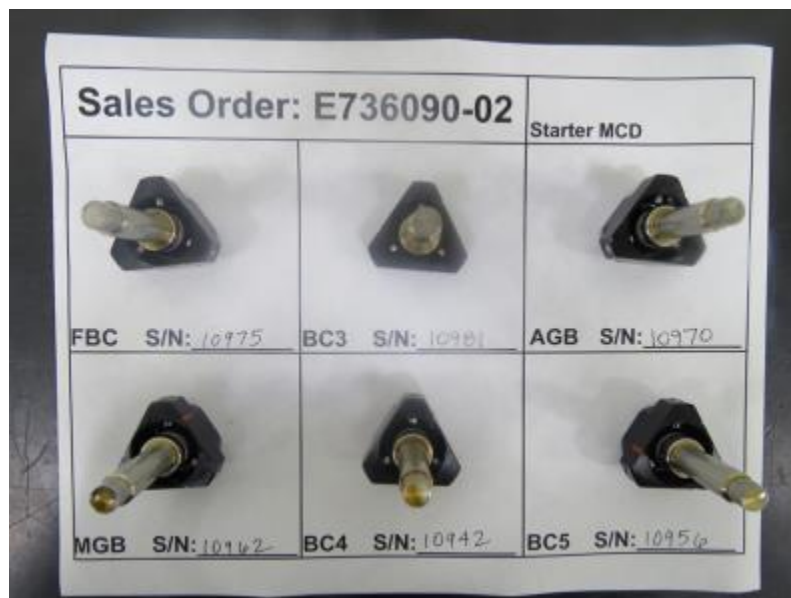
The magnetic chip collector (MCC) plugs were removed and there was no metal debris accumulation visible (**Photo 14**). The last chance oil strainers were removed and had no debris accumulation. The angle gearbox MCC had metallic beads accumulated on the magnet when the MCCs were checked at CDG following the incident. The angle gearbox MCC was cleaned prior to engine shipment and SWISS provided a photo of the original MCC condition for reference.

**Photo 14- MCDs, as Received at Columbus Engine Center (Photo Courtesy of Pratt & Whitney)**

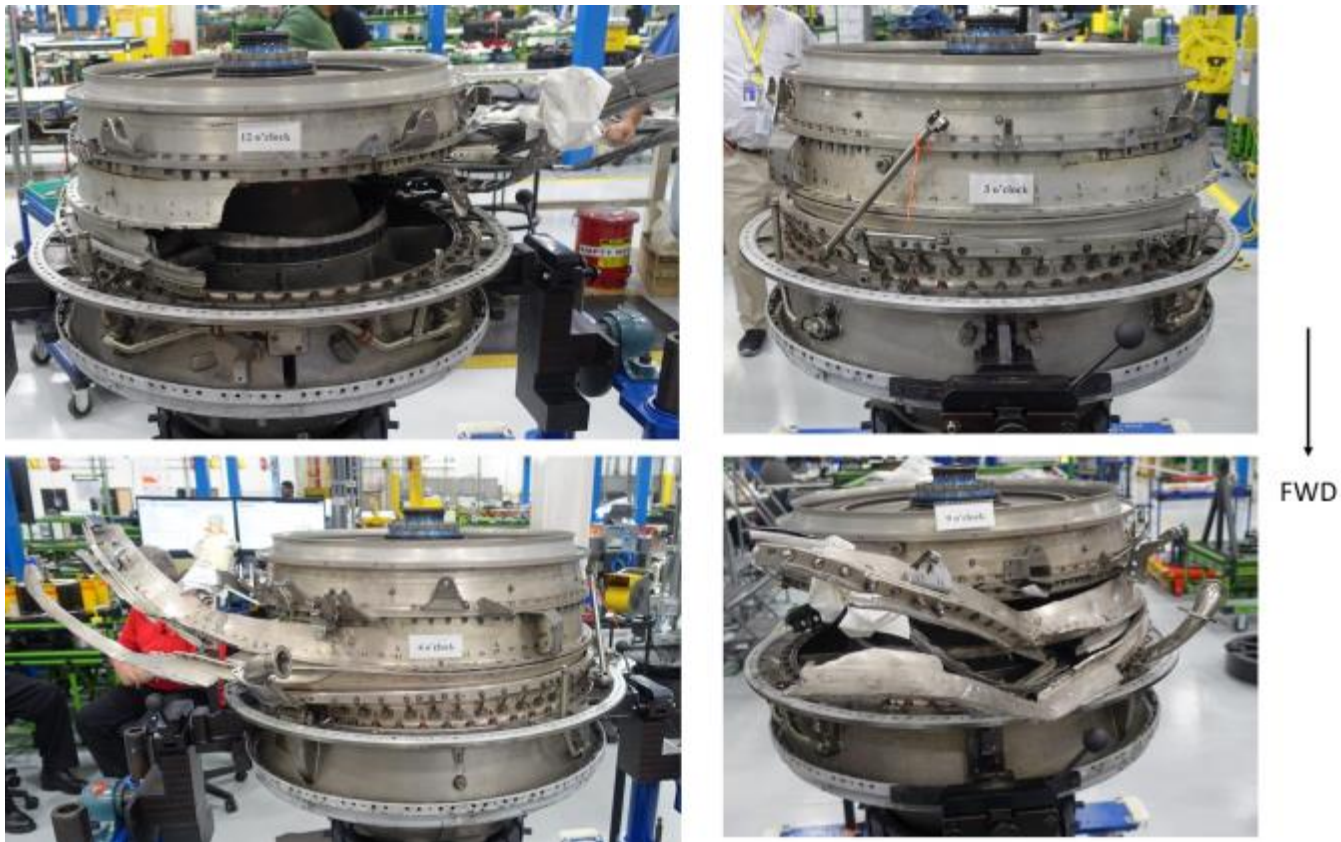
The fan blades were all complete, but several blades exhibited minor impact damage at random locations along the trailing edge. Bolt torques were measured in the tightening direction at the LPC forward case-to-fan intermediate case and the LPC aft case-to-CIC and all were within expected values, except on the flange bolts adjacent to the hole. The LPC cases were photographed to document the hole (**Photo 15**). The LPC IGVs were separated and missing from the 8 to 1 o'clock positions and the remaining IGV's (31 of 55) exhibited impact damage and were rotated to a fully closed position, so that each IGV overlapped the next (**Photo 16**). One IGV located at the 3 o'clock position was rotated to a different angle relative to the adjacent IGVs. The IGV aft inner ring segment was missing material at the edge between the 10 o'clock and 12:30 positions and between the 2:30 and 6 o'clock positions.

Photo 15- LPC Module

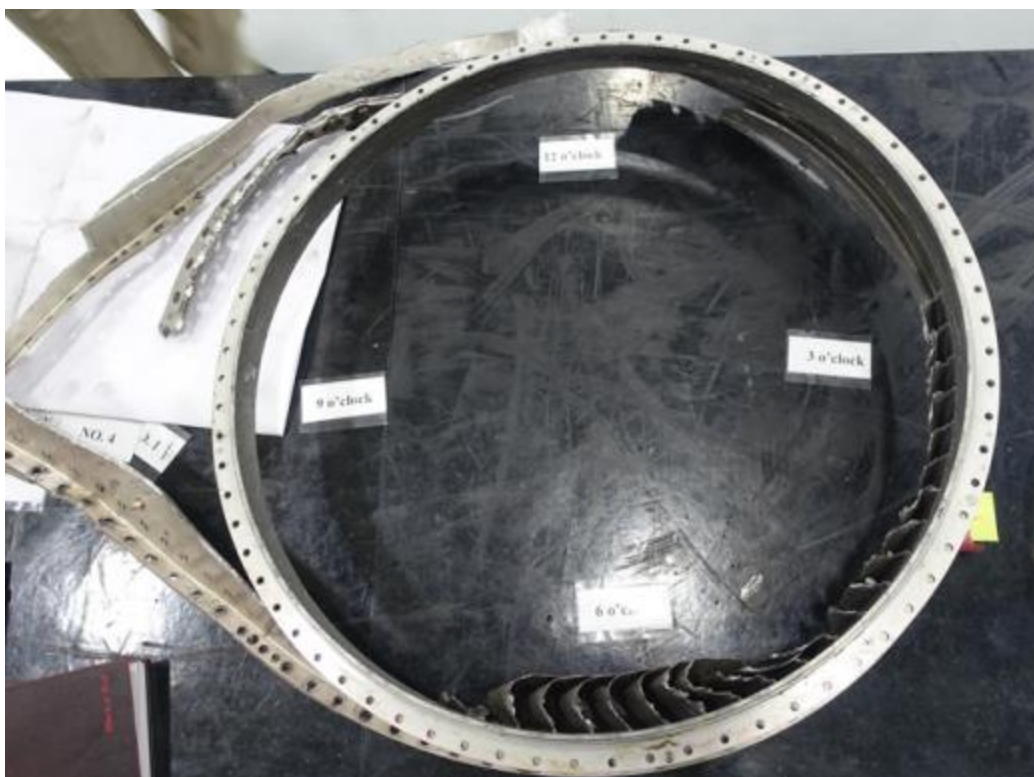
Most of the LPC IBR 1 was separated and missing. The LPC S1 stator vanes were separated and missing from the 6 to 3 o'clock positions. The remaining stator vanes appeared to be folded against the case inner surface (**Photo 17**). The LPC IBR 2 had three blades fractured and separated at the blade root. Of the three fractured blades, two were consecutive and the third was on the opposite side of the rotor (~140 degrees apart). Two small fragments of the IBR 1 flange remained fastened to the IBR 2. Three IBR 1-to-IBR 2 attaching bolts were missing and five were sheared of the 24 total bolts (**Photo 18**). The remaining IBR 2 blades exhibited leading and trailing edge impact damage/tearing and material loss, most concentrated near the blade tips. The LPC S2 stator vanes were all present but exhibited leading and trailing edge impact damage and deformation (**Photo 19**). The LPC IBR 3 blades were all present but had leading edge and trailing edge impact damage (**Photo 20**). The LPC hub had no visible damage. What remained of the IBR 1 outer air seal had rub damage and was missing material. The No. 2 bearing was not removed from the housing, but visible ball bearings were oil wetted and could be spun smoothly by hand.

**Photo 17- LPC S1 Stator**

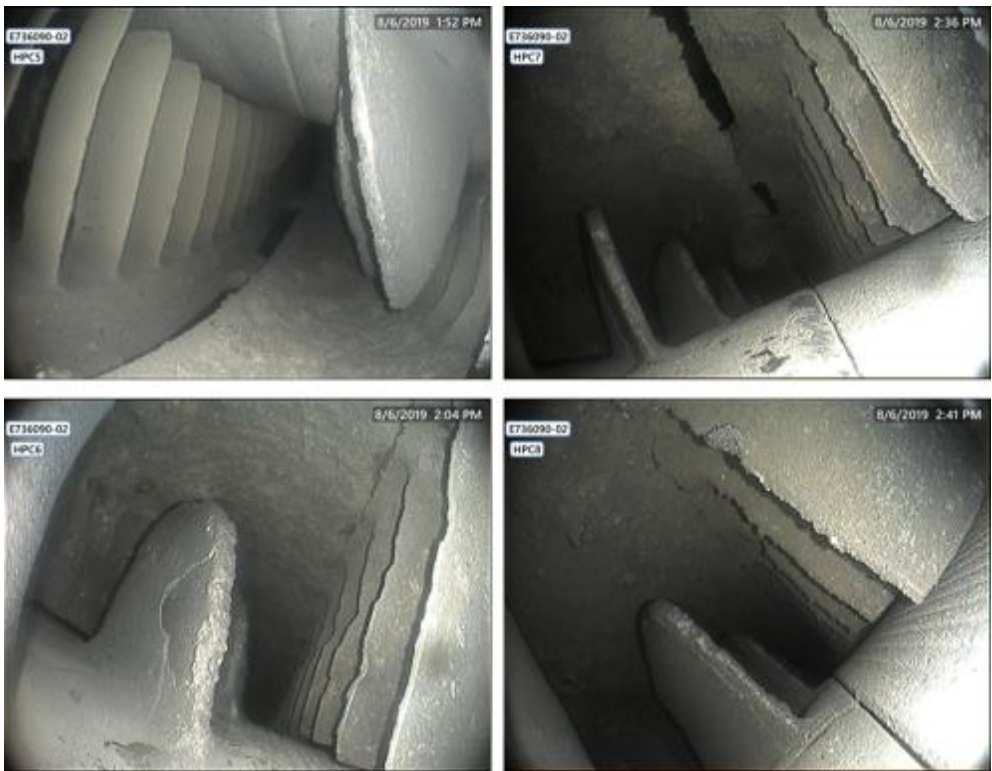
BSI inspection photos of the engine core were reviewed to document the internal condition. HPC S1-S4 exhibited impact damage on the leading and trailing edges of all blades and vanes. Thermal damage including HPC blade and vane material loss was observed on the HPC S5-S8 borescope photos. The HPC S5-S8 blade and vane surfaces also appeared to have material adhered to both the pressure and suction surfaces (**Photo 21**). The combustor liner appeared intact. The HPT S1 blades and vanes appeared complete but were thermally damaged. Less severe thermal damage was also observed on HPT S2.

**Photo 21- HPC S5-S8 Condition**

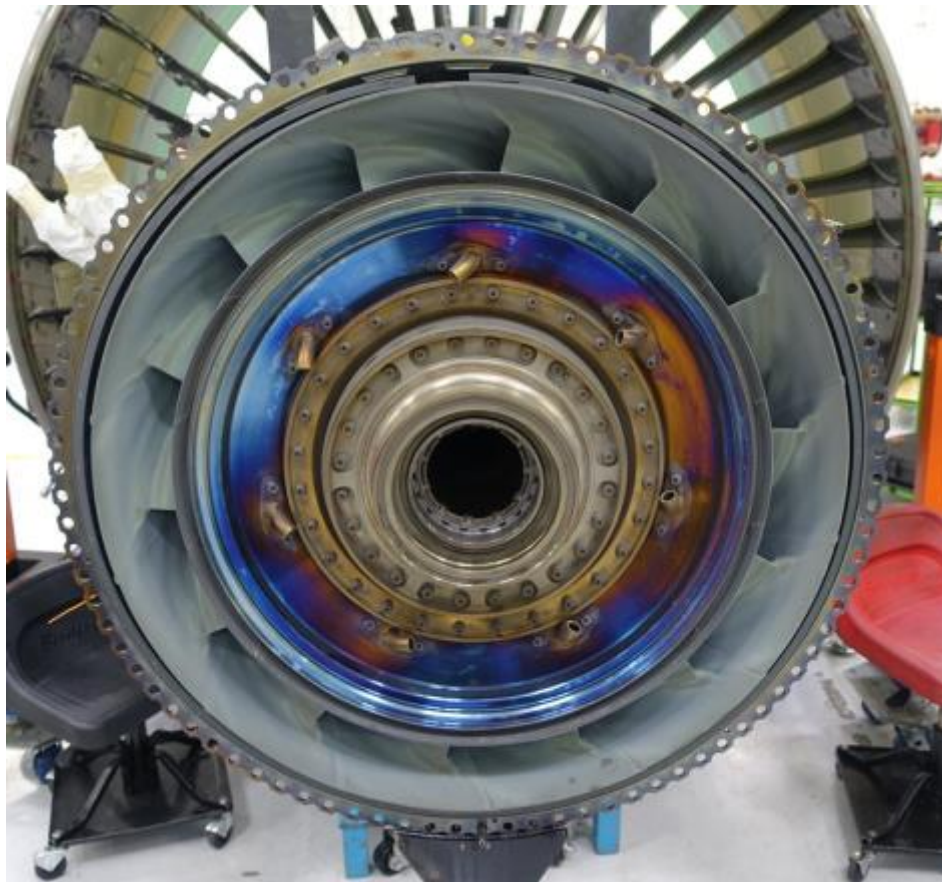
The turbine intermediate case (TIC), including the TIC vanes were in good condition when viewed from the aft side after removal of the LPT module (**Photo 22**). The deep blue color is normal for service run engines according to P&W engineering. According to Columbus Engine Center powerplant engineering, the TIC vanes appeared green rather the brown color commonly noted on service run engines. The No. 4 brush seal was in good condition.

**Photo 22- Turbine Intermediate Case**

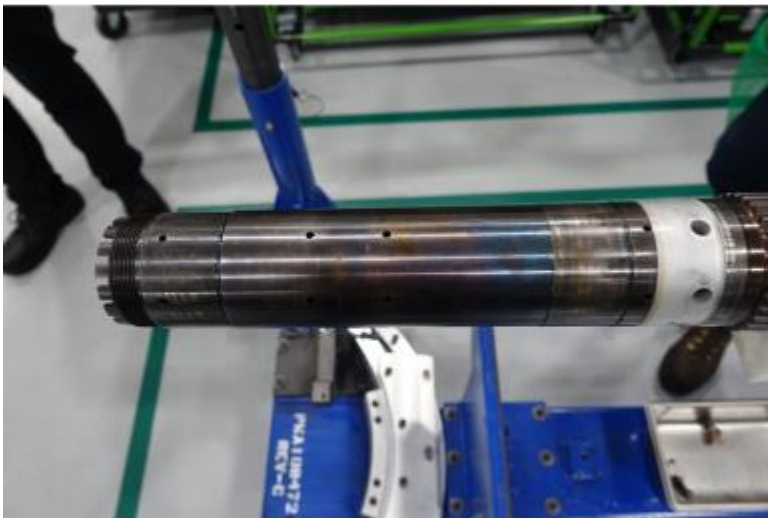
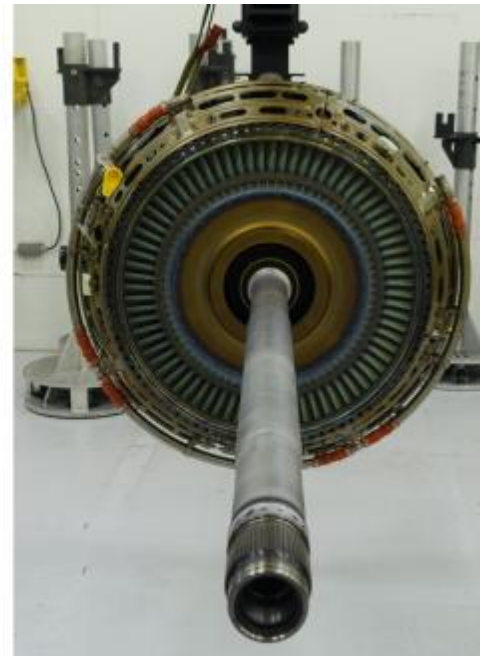
The LPT shaft was removed and there were no indications of rub damage or unusual wear marks (**Photo 23**). The LPT S1 blades were complete but exhibited minor impact damage to the blade leading edges and more severe impact damage/tearing on the trailing edges. The LPT S2 vanes had both leading and trailing edge impact damage (**Photo 24**). The LPT S2 blades were fractured at about the  $\frac{1}{3}$  spanwise location and the blade fracture surfaces were jagged and coarse (**Photo 25**). According to Columbus Engine Center, the blades appeared green rather than the brown color typically observed on similar service run engines. The LPT S3 vanes had leading and trailing edge impact damage (**Photo 26**). The LPT S3 blades were uniformly fractured about the midspan and the blade fracture surfaces were jagged and coarse (**Photo 27**). The LPT S2 and S3 blade outer air seals and vane inner air seals exhibited rub damage and were missing material. The seals in both areas had to be cut or chiseled during disassembly of the LPT. The No. 5 and No. 6 bearings were both oil wetted and could be spun smoothly by hand.

**Photo 23- LPT Shaft, (L) Aft End, (R) LPT S1 Blades, Leading Edge**

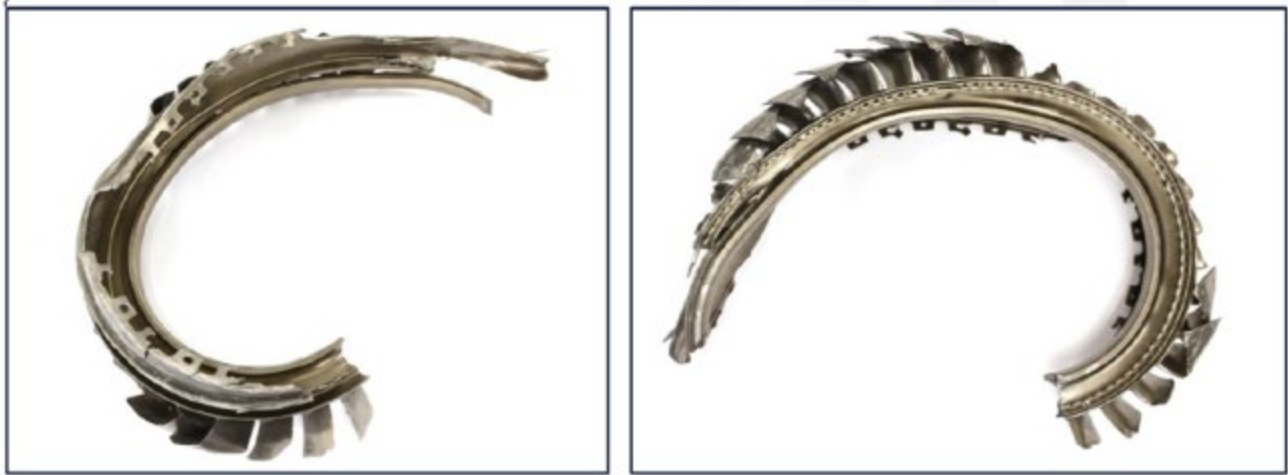
The recovered IBR 1 center bore was complete but a section of the rim, including four airfoils were separated and missing (**Photo 29**). The missing section of the IBR was roughly equivalent to the size of the IBR 1 piece that was recovered loose in the nacelle of ESN P736090 (incident engine covered in this report). The recovered IBR 1 weighed 73.8% of the total nominal part weight. The IBR 1 exhibited a primary fracture at the pressure side of airfoil #16 that progressed in fatigue from an origin at the runout of the leading edge root radius (**Photo 30**). The fracture surface and section of the rim containing airfoils #16 and #17 were sectioned from the IBR and then further cut down for scanning

**Photo 29- Engine Serial Number P736195 LPC IBR 1, as Received**

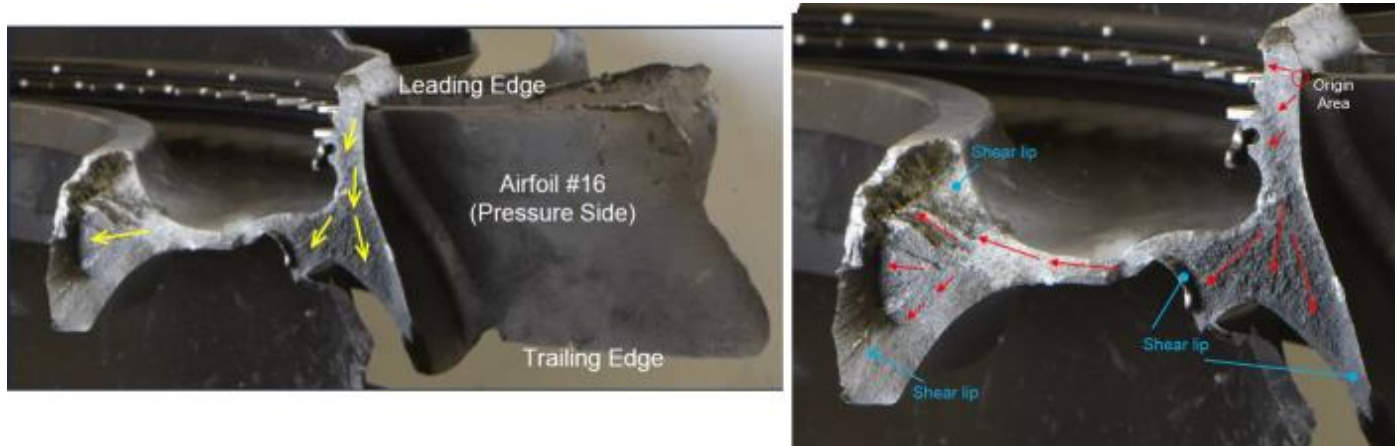
electron microscopy (SEM) examination. The SEM evaluation identified cleavage features on the fracture surface consistent with high cycle fatigue (HCF). The crack origin initiated approximately 0.0033 inch (0.084 millimeter) beneath the material surface (**Photo 31**). There were no material or processing anomalies visible at the crack origin. The material composition was consistent with Ti-6AL-4V titanium alloy and had surface impact marks that indicated peening<sup>4</sup> in accordance with drawing specification. According to the P&W materials engineers, crack origins 0.003 – 0.005 inches subsurface are within the expected zone of the compressive residual stress die out from peening. A residual stress analysis was performed and confirmed compressive residual levels were consistent with design specification.

**Photo 30- LPC IBR 1 Fracture Surface. (L) Fracture Surface with Airfoil Visible, (R) Fracture Surface Features**

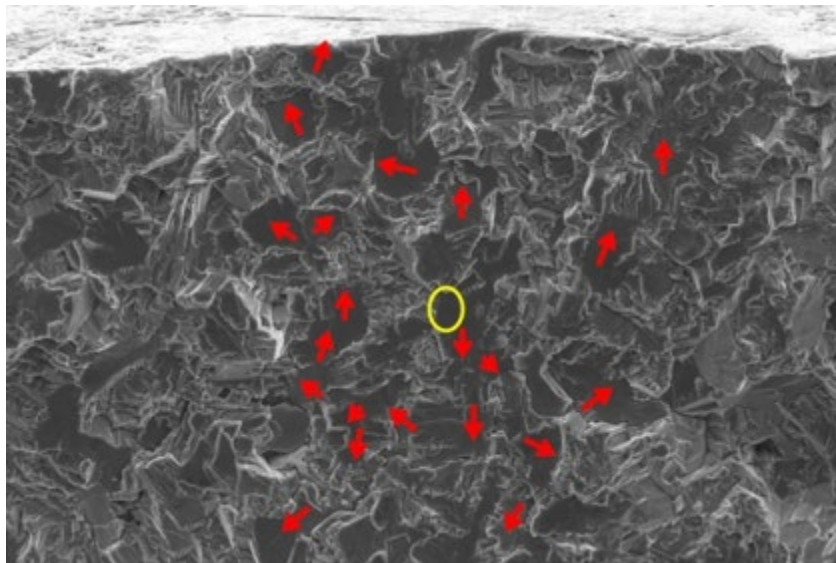
**Photo 31- LPC IBR 1 Fracture Origin and Crack Progression on Airfoil #16, Pressure Side Leading Edge Root Radius**

A SEM and binocular examination of the fracture surface revealed that the stable fatigue progression extended approximately 0.275 inches aft of the origin area (as measured along the rim) and 0.19 inches deep. The fatigue region had no cyclic markers or evidence of a discrete change between fatigue and overstress. The P&W MPE report titled “Metallurgical Investigations of SWISS PW1524G-3 Engine No. 736195” is available in the investigation docket. A NTSB materials engineer attended the group exam and concurred with the P&W metallurgy findings.

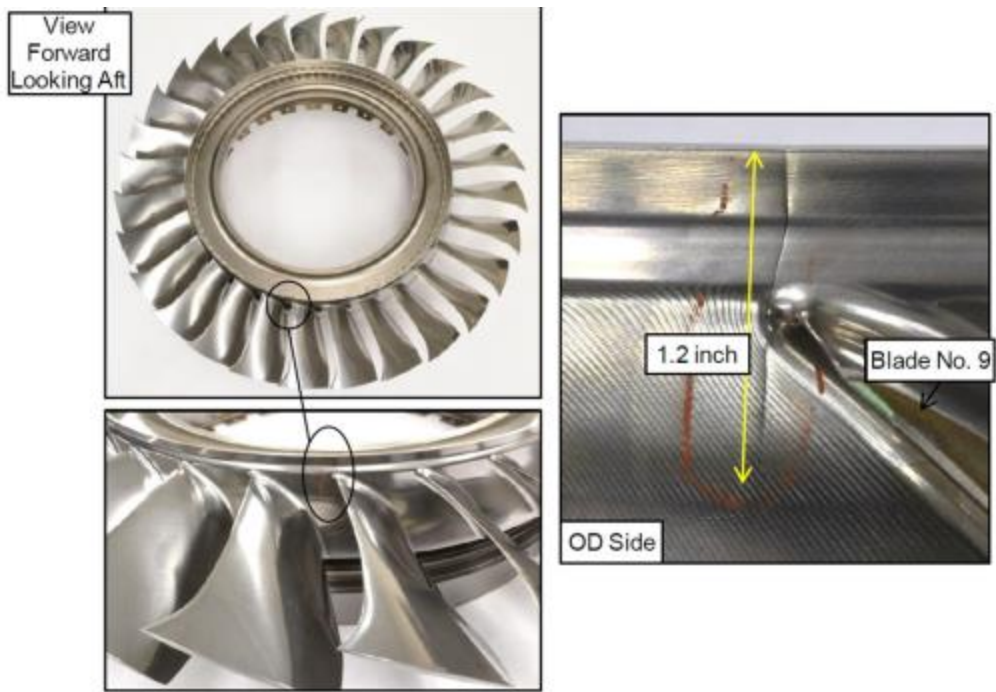
The SWISS incident on July 25, 2019 was the first of three Airbus A220-300 PW1524G-3 and one PW1521G-3 LPC IBR 1 separation events. Following the recovery and materials analysis of the IBR 1 from ESN P736195 (the second reported event – see Section 6.1 for details), P&W released a service bulletin (SB) SB PW1000G-A-72-00-0125-00A-930A-D that was mandated by FAA airworthiness directive (AD) 2019-19-11 that required operators to perform recurrent BSIs of the LPC IBR 1. The inspections identified two additional LPC IBR 1 crack findings (**Photo 32**). The hardware from the two LPC IBR 1 BSI crack findings were sent to the P&W MPE Lab for analysis and the crack type and origin location were consistent with the findings from ESN P736195 (**Photo 33**). A summary of the fracture findings are listed below in **Table 2**. A detailed discussion of corrective actions is covered later in this report.

**Photo 32- Engine Serial Number P736218 Crack Finding**

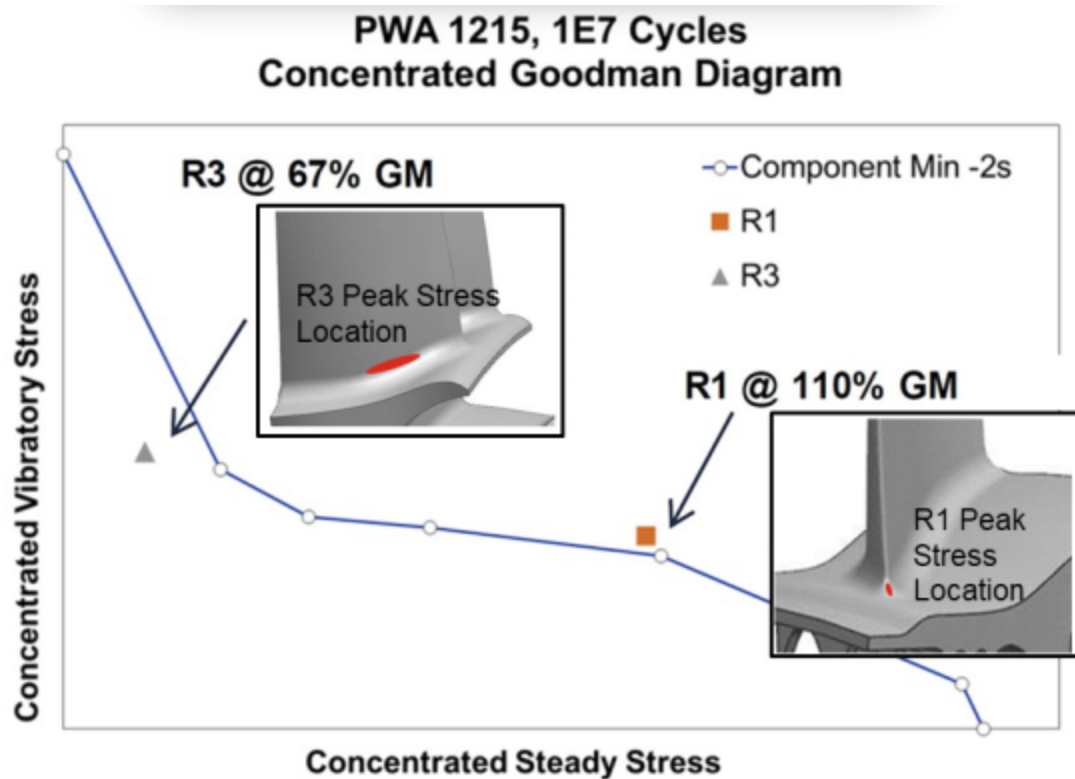
Test data from the original engine certification process was re-evaluated to factor in the additional stress on the LPC IBRs caused by the acoustic coincidence. The highest stress location/critical area for the IBR 3 1<sup>st</sup> bending mode and IBR 1 stiffwise bending mode was identified by finite element analysis (FEA). When the additional stress caused by the blade flutter response was applied to the Goodman diagram<sup>5</sup> for each IBR, IBR 3 was still within material limits (calculated value below the stress curve) but the IBR 1 combined stress exceeded the material fatigue limit (calculated value above the stress curve) (**Figure 5**).

**Figure 5- LPC IBR 3 and IBR 1 Goodman Plots**

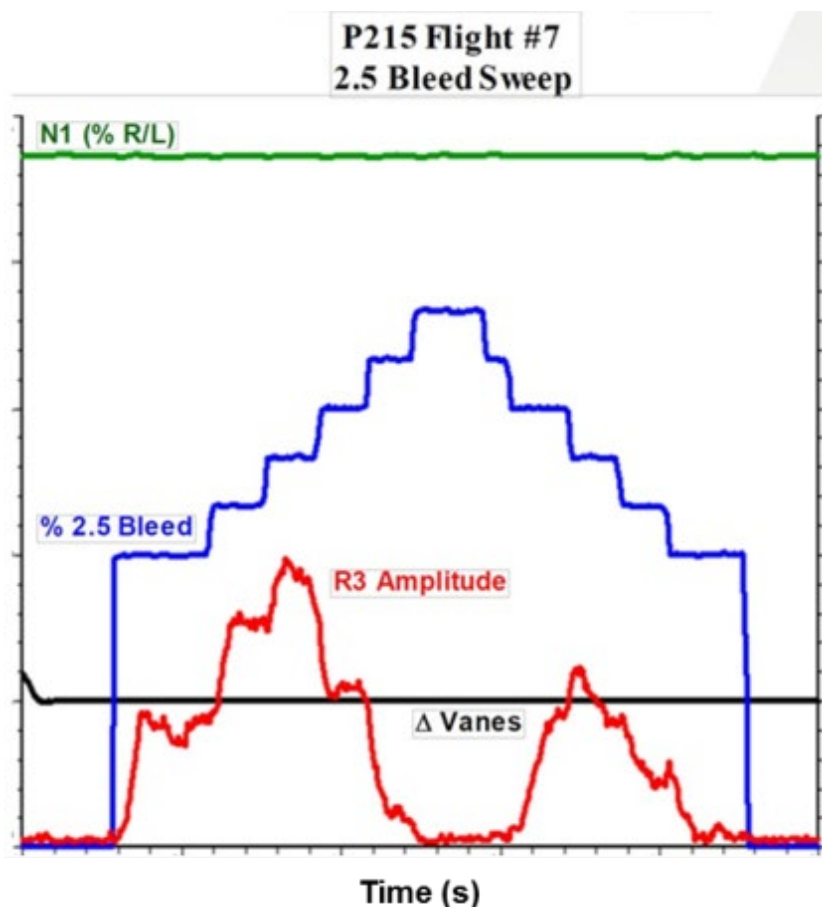
To further support the 2.5 bleed valve acoustic resonance hypothesis, a flight test point was performed where the 2.5 bleed valve was incrementally cycled open and closed while the LPC vanes were held in a fixed closed position at a constant engine N1 speed. The plots from the flight test showed that opening and closing the 2.5 bleed valve in these conditions resulted in increased LPC IBR 3 pressure fluctuations and correlated flutter response (**Figure 9**).

**Figure 9- 2.5 Bleed Valve Influence on Flutter Onset**
