# Metallurgical Investigation Final Report

**Subject:** Metallurgical Investigation of Swiss International Air Lines PW1524G Engine No. 736195

**Date:** October 23<sup>rd</sup>, 2019

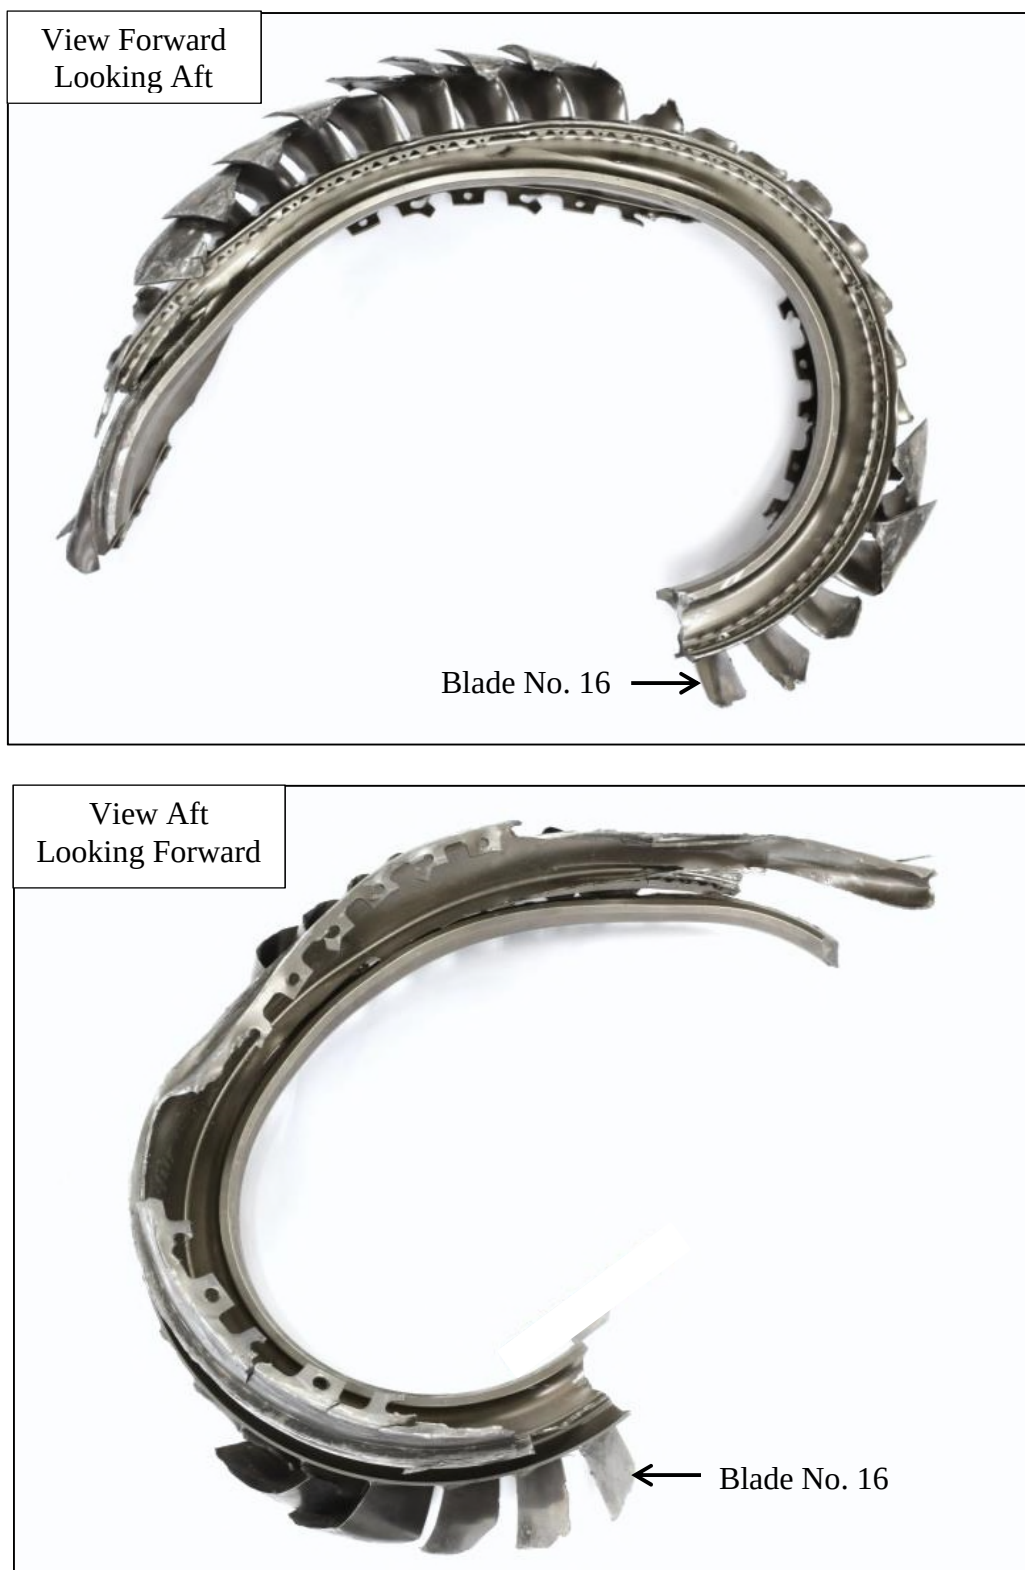
Significant secondary distress was noted resulting from the fracture and release of LPC R1. The recovered portion of LPC R1 was severely distorted (elongated). Several of the blades were bent

opposite the direction of rotation and exhibited airfoil cracks and/or fractures consistent with rapid tensile-shear overstress.

**Figure 1.** Views of the recovered portion of LPC R1 in the as-received condition.

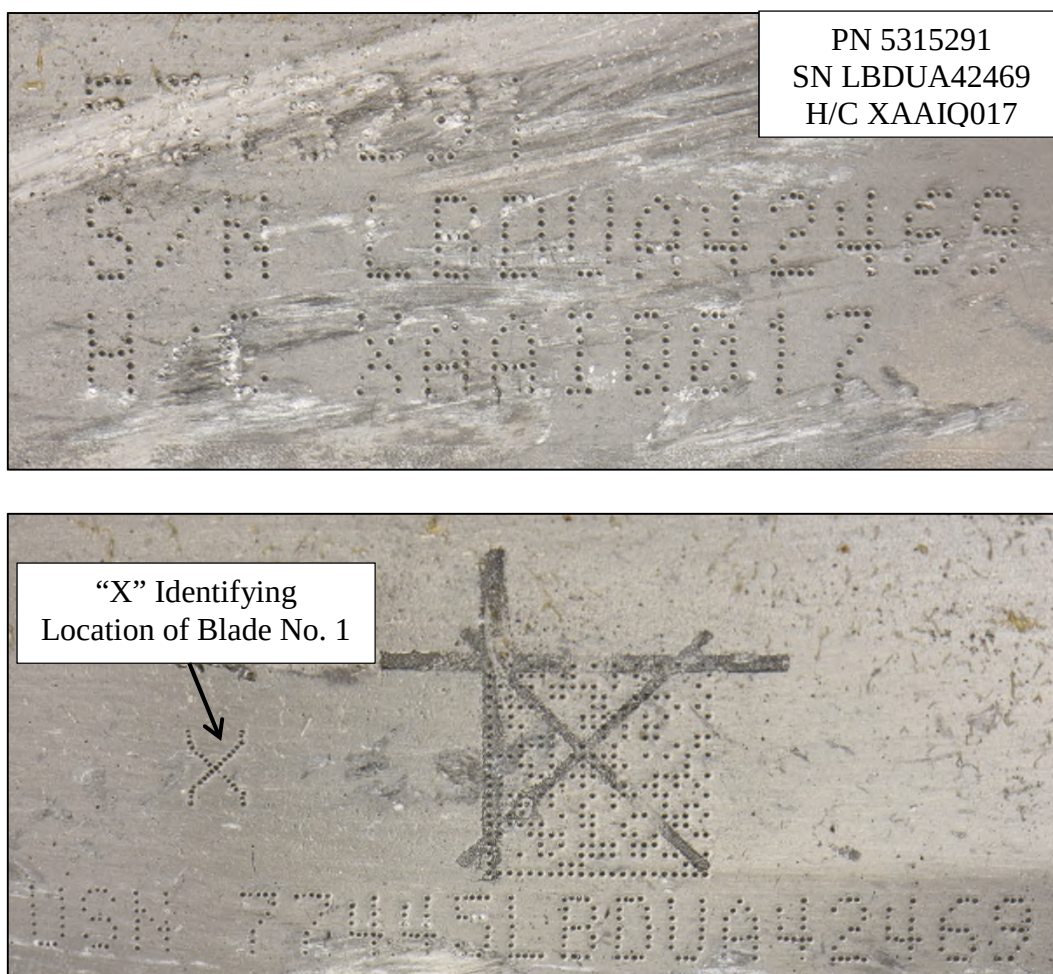
The part identification markings (part number: 5315291, serial number: LBDUA42469, and heat code: XAAFT 0007) were located on the OD surface of the LPC R1 aft spacer (**Figure 2**). An “X” marking located on the OD surface of the spacer identifies the location of blade (airfoil) no. 1. The blade position number is determined by starting at blade no. 1 and counting in the clockwise direction as viewed aft looking forward. The mass of the recovered portion of LPC R1 was determined to be [REDACTED], indicating that approximately 73.8% (by mass) of the LPC R1 was recovered.

**Figure 2.** Views showing the LPC R1 part identification markings.

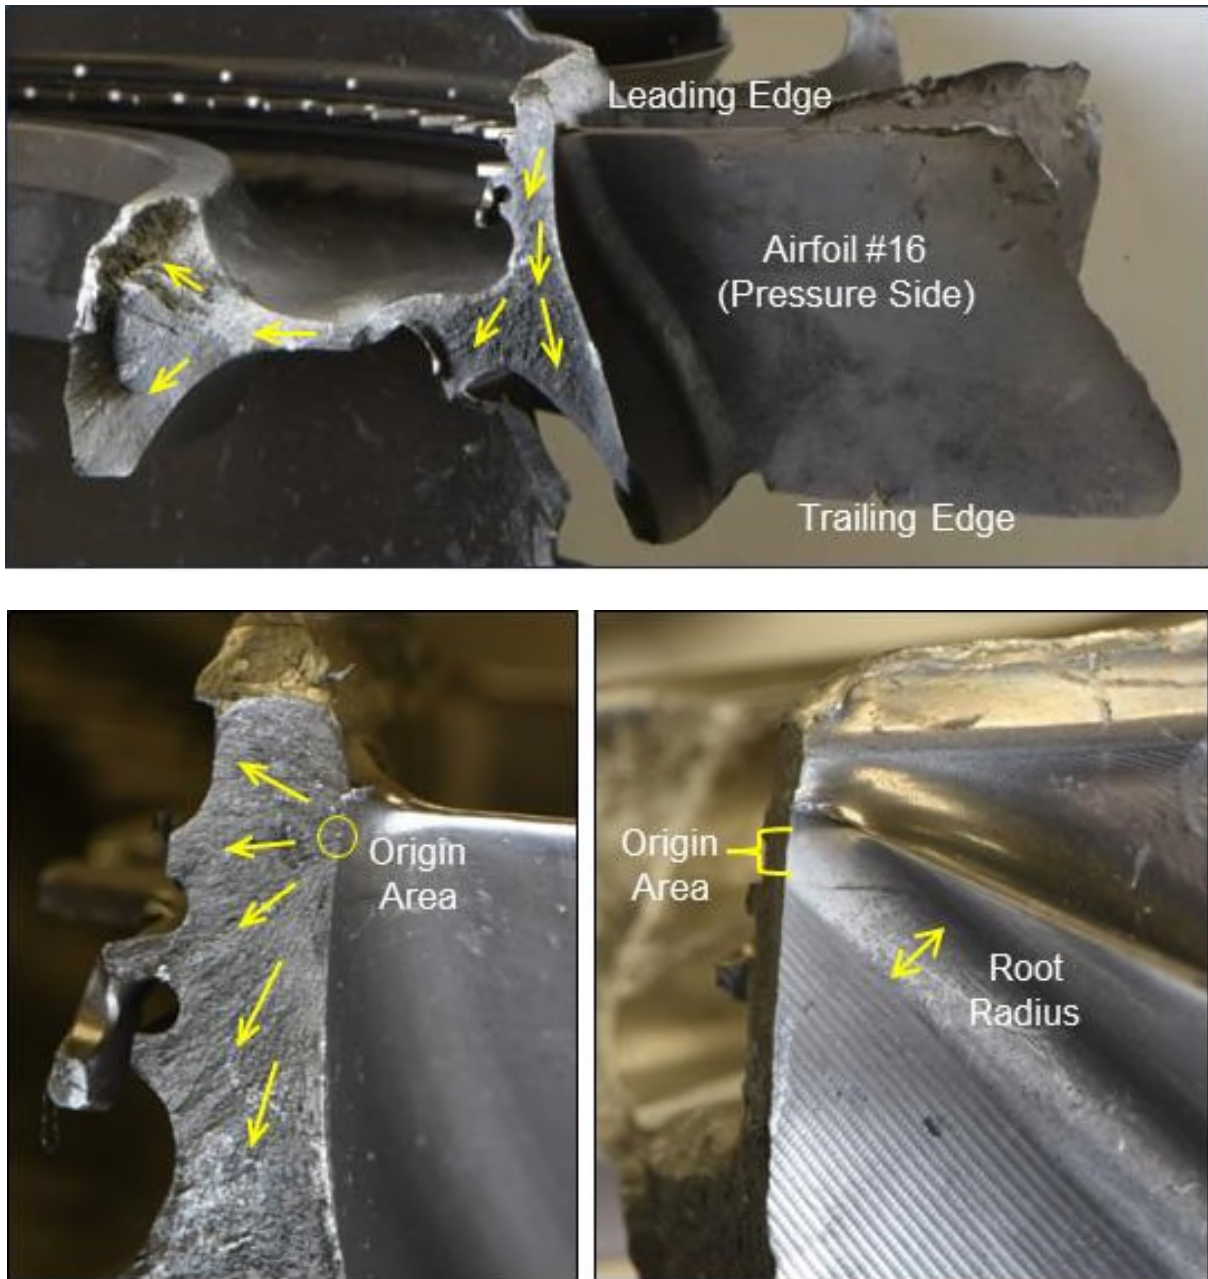
The recovered portion of LPC R1 exhibited a primary radial fracture thru the rim and bore adjacent to blade no. 16. Only one-half of the primary radial fracture was recovered. The fracture direction was assessed by the presence of river lines and shear lip formation. Progressive features indicated that the fracture progressed from an origin area located at the pressure side leading edge (PSLE) root radius of blade no. 16 (**Figure 3**).

**Figure 3.** Views showing the direction of fracture progression from a primary origin area at the pressure side leading edge (PSLE) root radius of blade no. 16.

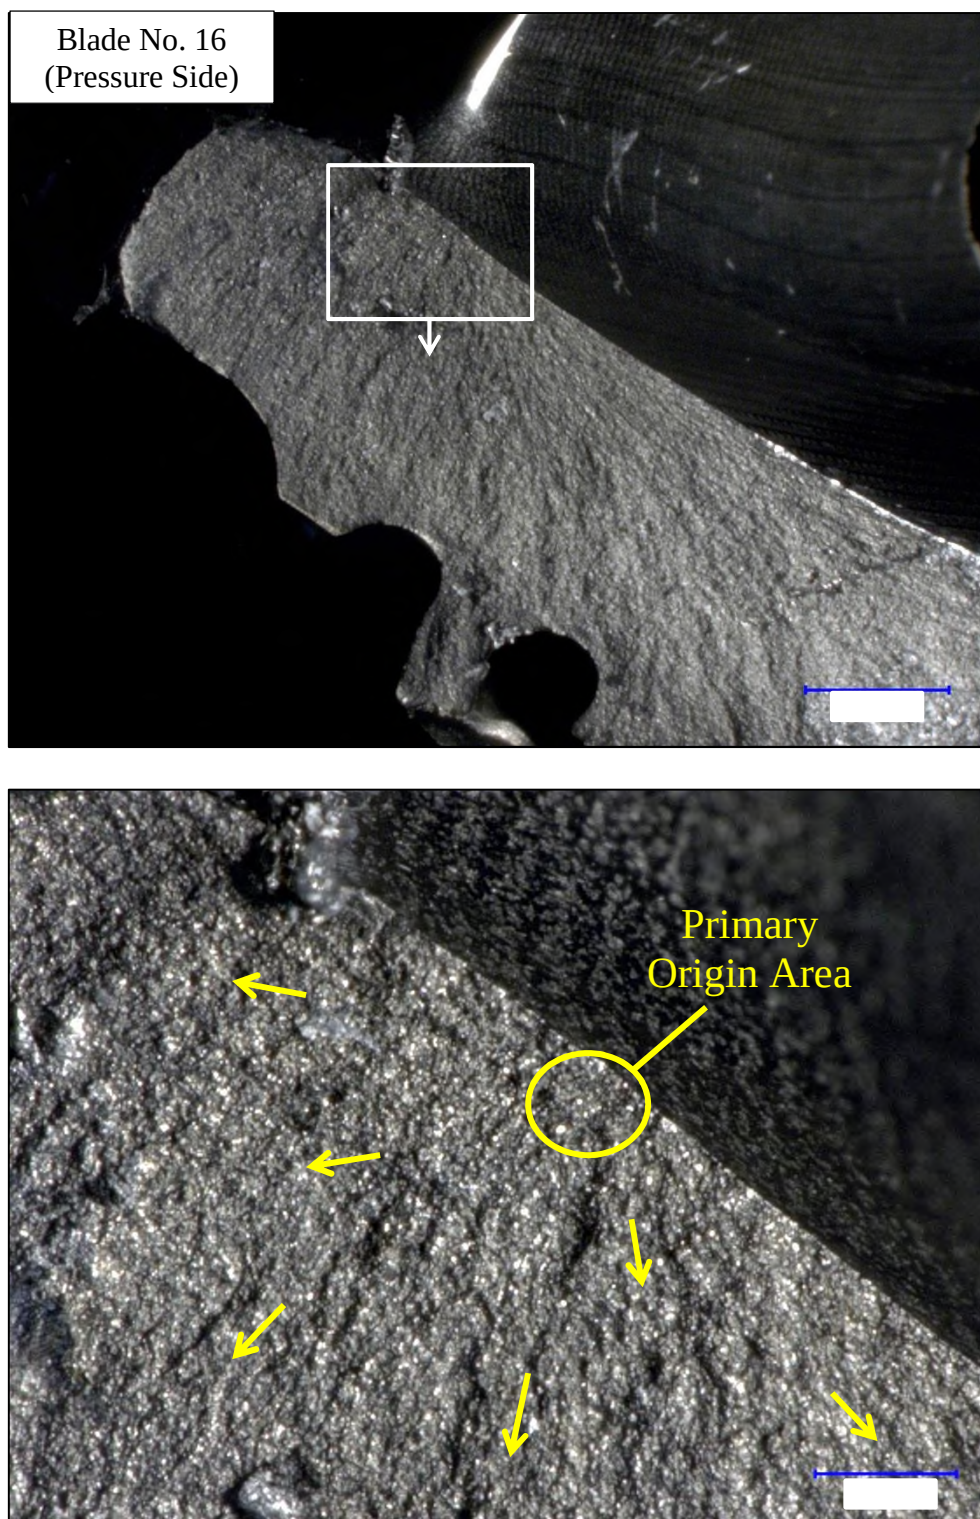
Binocular microscope examination confirmed fatigue progression from a primary origin area at the PSLE root radius of blade no. 16 (**Figure 4**). The origin area was located in the region of the rim/flow path side of the root radius run-out.

Fatigue progressed in the radial/thru-thickness direction toward the forward balance flange, and along the rim in the forward and aft directions. The fracture mode subsequently transitioned to progressive overstress/tearing prior to final overstress fracture thru the remaining rim section and in the radial direction through the web and bore.

The fracture surface did not exhibit any evidence of discrete cyclic markers (macro-arrest lines) in the region of fatigue based on the optical examination. Evidence of remnant machining (milling) lines and slight dimples/indentations from shot peening were observed in the root radius region of blade 16. There was no unusual surface damage noted, with the exception of secondary damage associated with the fracture event.

**Figure 4.** Views showing fatigue progression from a primary origin area at the PSLE root radius of blade no. 16.

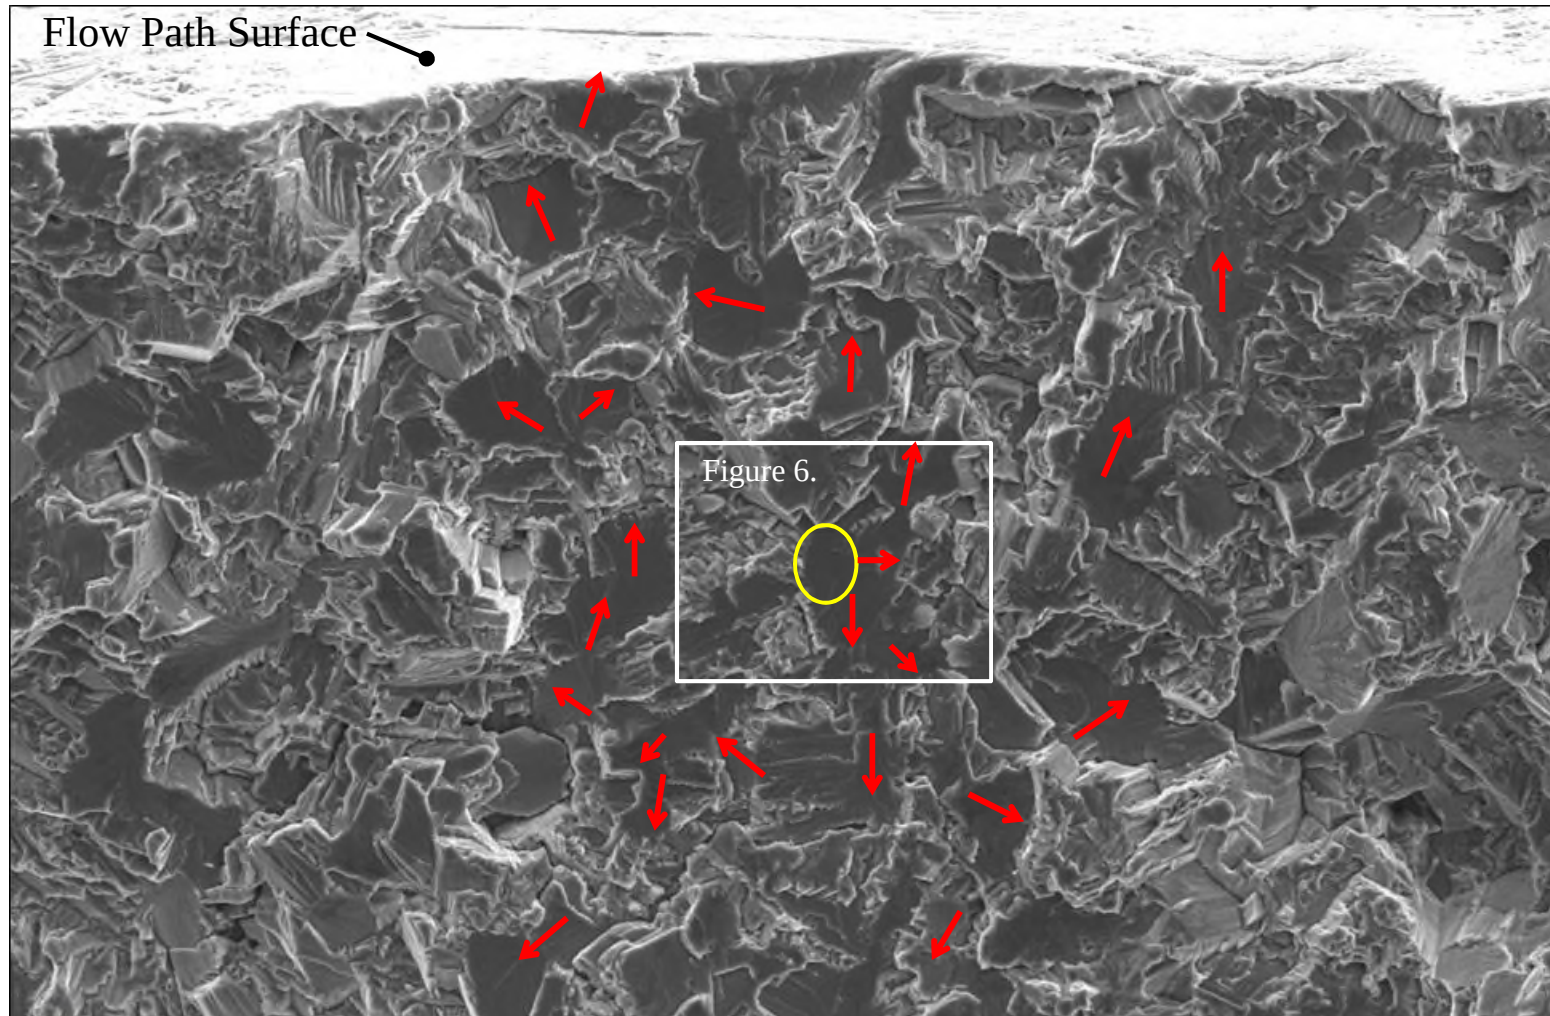
SEM evaluation in the region of fatigue identified cleavage fracture features that were consistent with a high cycle mode of fatigue initiation and progression. The early stages of fatigue exhibited predominantly faceted growth consistent with high cycle fatigue (HCF). There were no areas of striated growth observed. The faceted growth direction thru primary alpha grains was used to determine the crack growth direction and identify the fatigue origin (initiation site).

**Figure 5.** SEM view showing the direction of fatigue progression (arrows) from the primary origin area (ellipse).

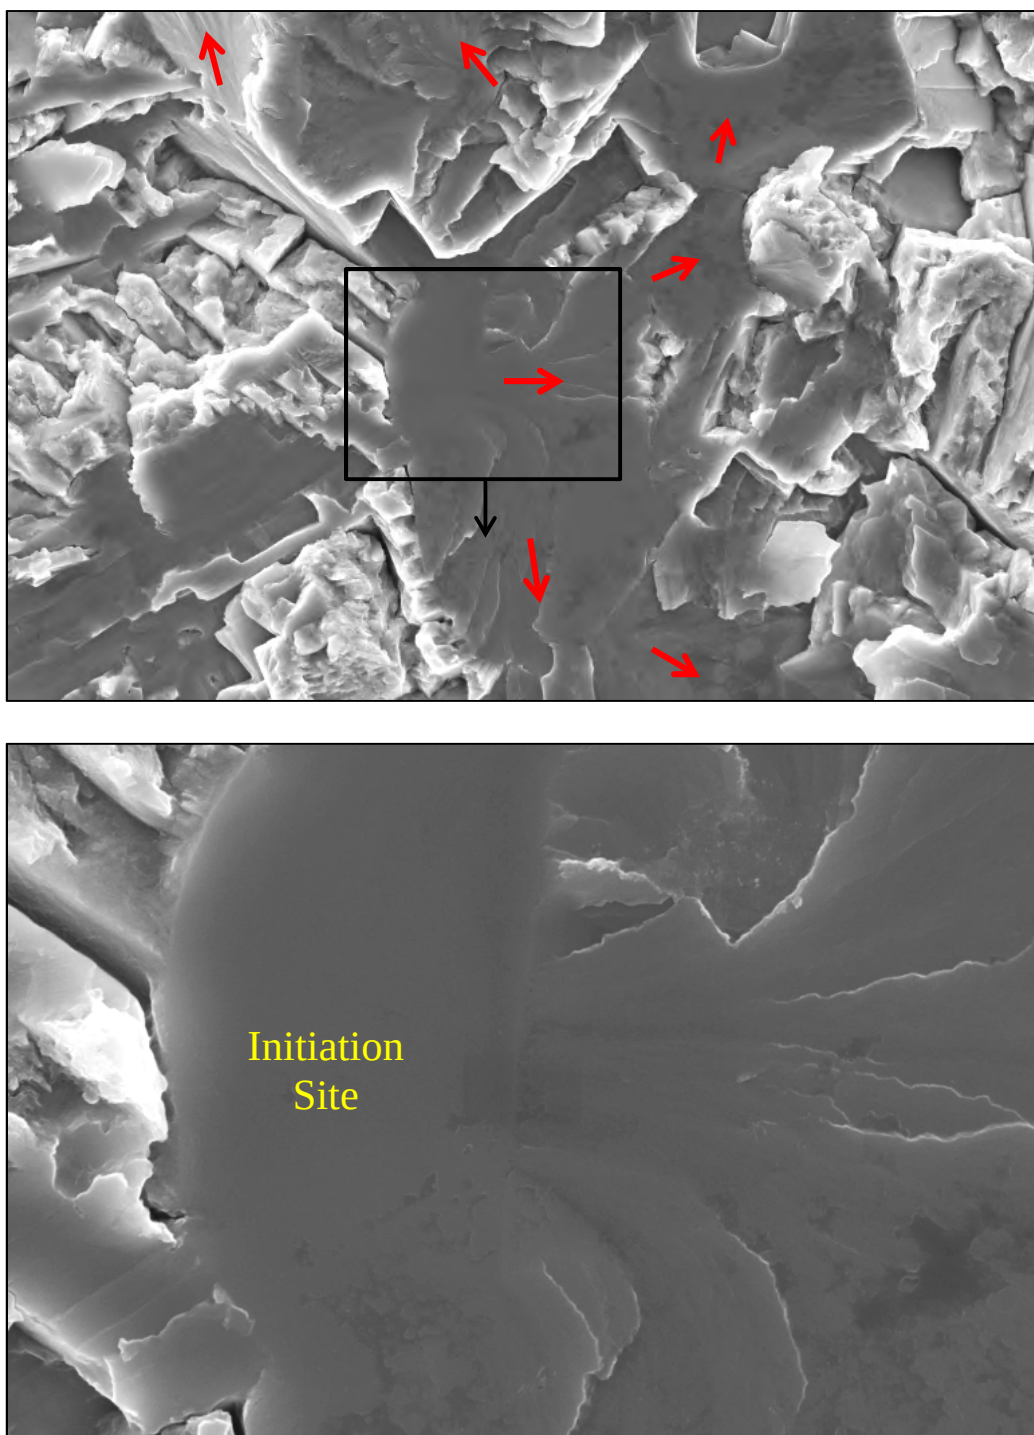
The initiation site was determined to be located 0.0033 inch (85  $\mu$ m) below the surface (**Figure 5 - 6**). Faceted growth was observed progressing away from the sub-surface initiation site in all directions including toward the flow path surface. The sub-surface initiation site was located

within the zone of the expected compressive residual stress die-out from peening. There was no evidence of any anomalies observed in the vicinity of the origin area.

**Figure 6.** SEM views showing a sub-surface initiation site located 0.0033 inch below the flowpath surface.

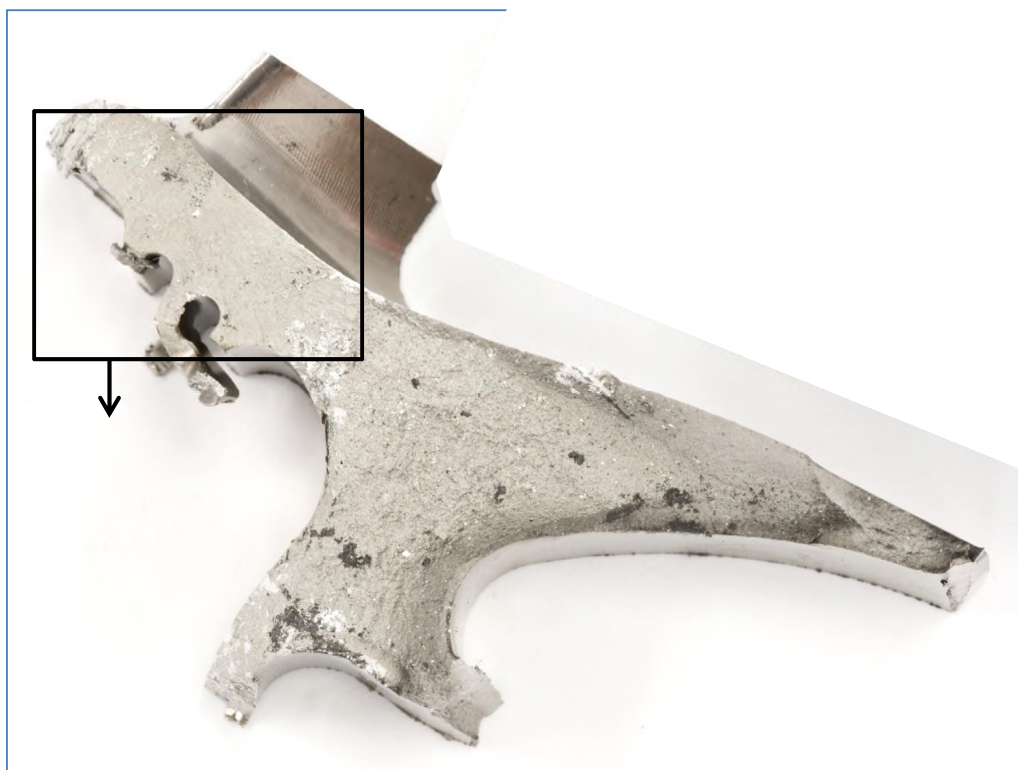
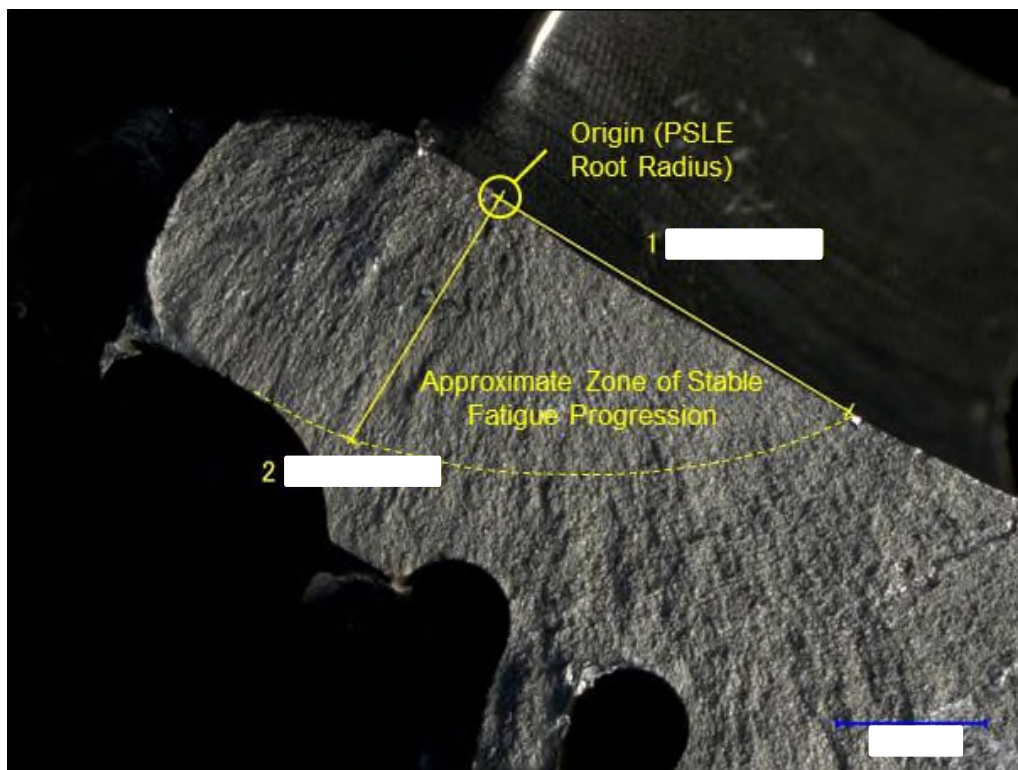
The extent (zone) of stable fatigue progression was determined from both binocular microscope and SEM evaluations. The stable fatigue progression was determined to extend up to 0.275 inch in the aft axial direction along the flow path surface and up to 0.190 inch in the radial (thru thickness) direction measured from the origin area (**Figure 7**). The aspect ratio of the fatigue crack was estimated to be approximately 2.9:1. A narrow zone exhibiting mixed fatigue and dimple rupture overstress fracture features was observed beyond the zone of stable fatigue progression. The fracture terminated in final ductile dimple overstress.

**Figure 7.** View showing the extent of stable fatigue progression.

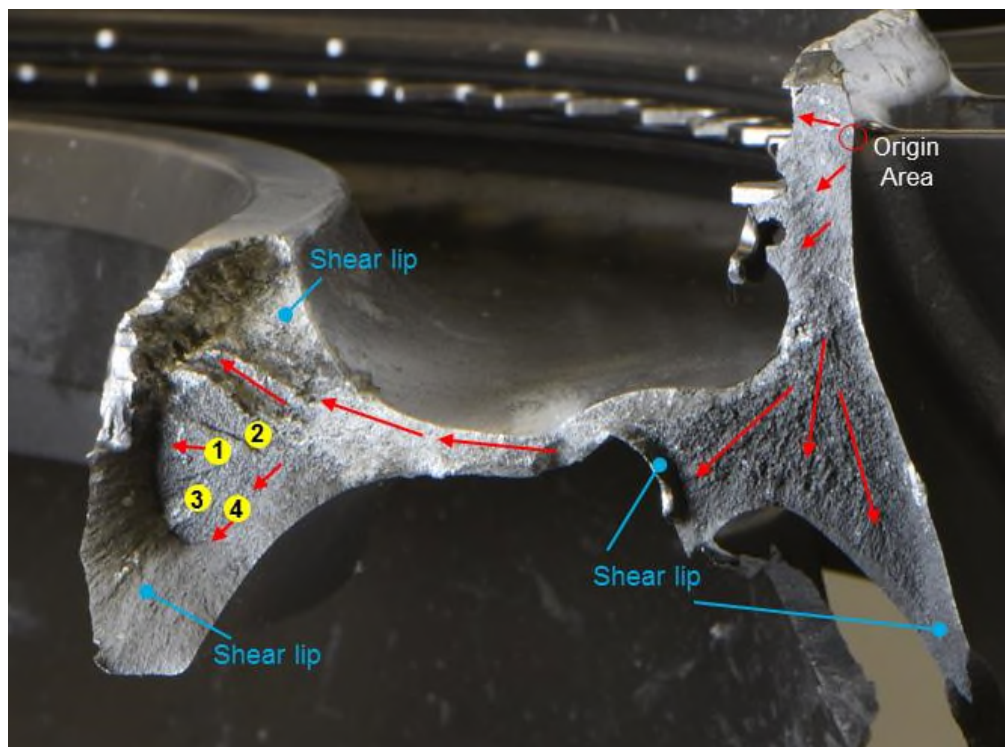
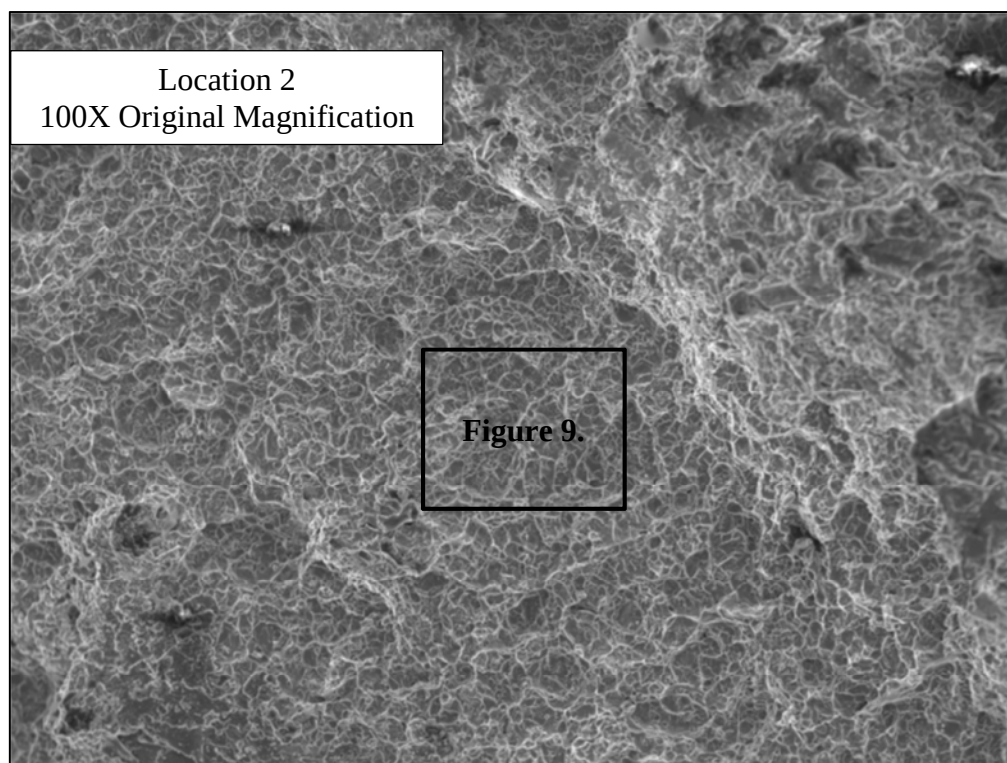
The bore fracture region was examined under the SEM for documentation and confirmation of the fracture direction and mode. SEM examination of the bore region revealed ductile dimple overstress fracture features (**Figures 8 - 9**). The formation of shear lips and the presence of ductile dimple fracture features indicated that the radial fracture terminated in the region of the bore.

**Figure 8.** SEM view in the bore fracture region.

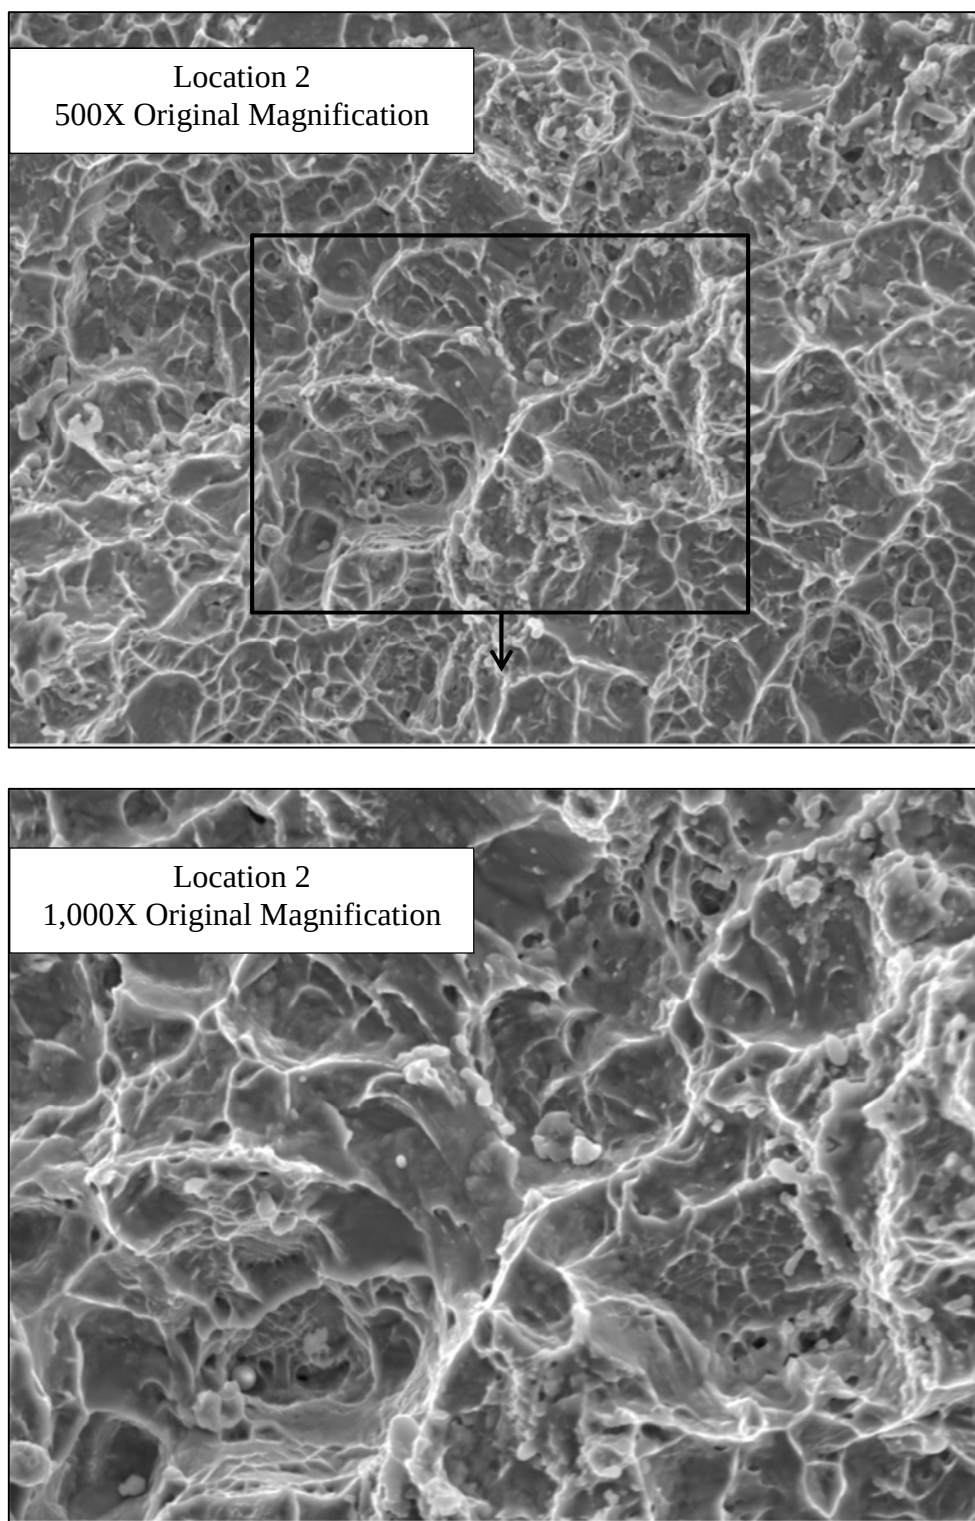
**Figure 9.** SEM views in the bore fracture region showing ductile dimple overstress features.

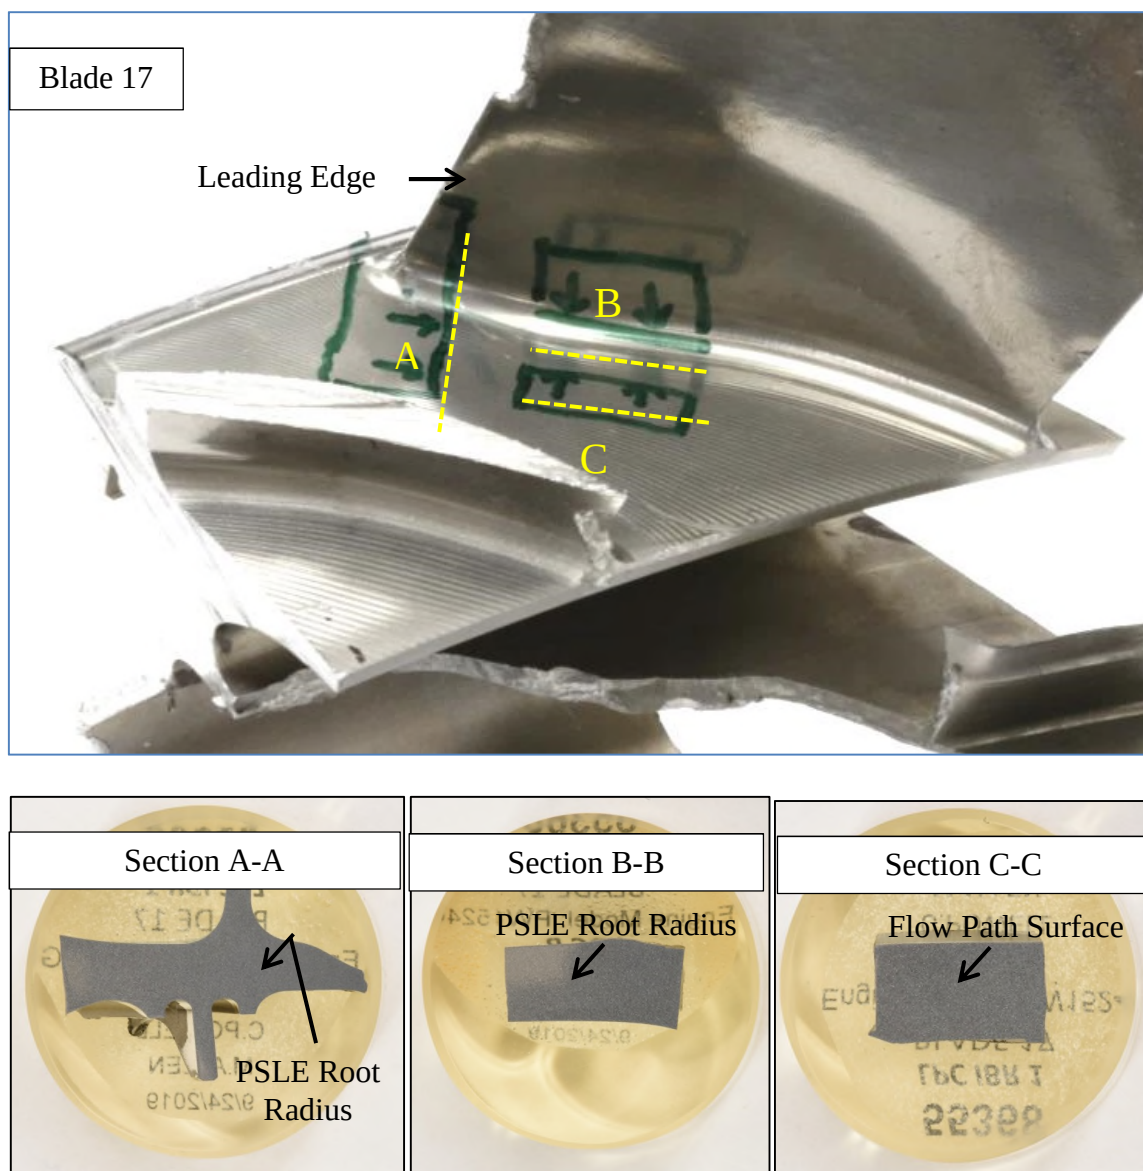
Three (3) metallographic sections were prepared through blade no. 17 in order to evaluate the general and surface microstructure (**Figure 10**). Transverse sections were taken spanwise through the leading edge (LE) root radius, chordwise through the pressure side root radius, and in the axial direction through the platform/flow path surface.

**Figure 10.** Views showing the location of metallographic sections taken thru blade no. 17 (upper image) and the metallographic mounts (lower image).

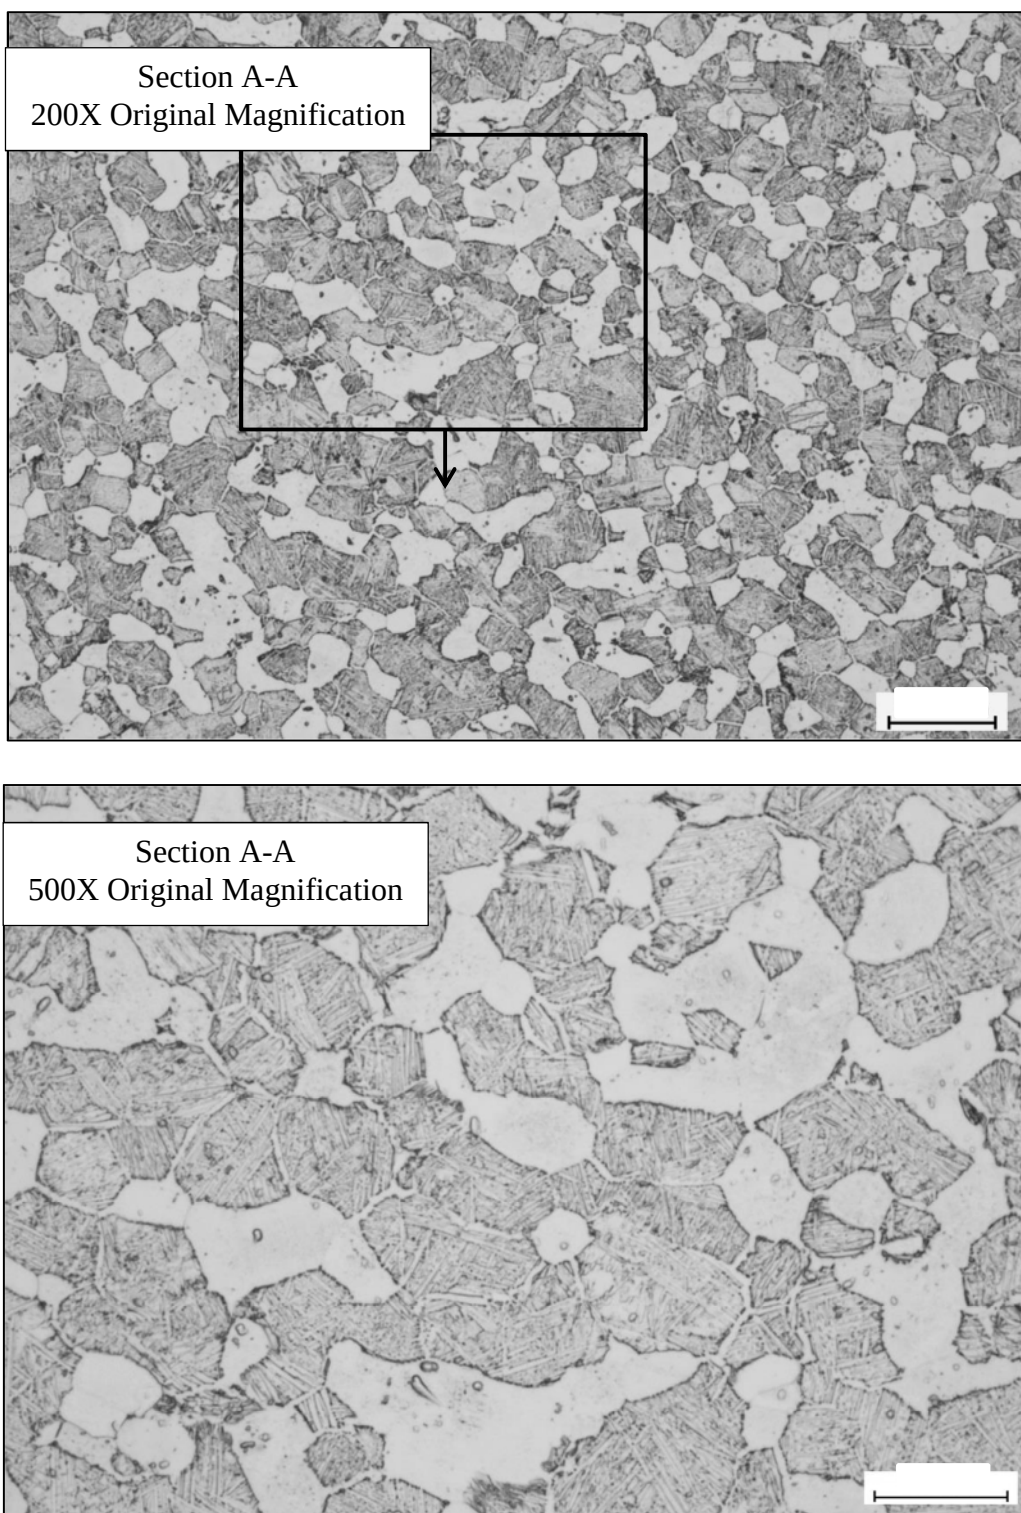
The general microstructure consisted of alpha-beta processed Ti-6Al-4V titanium alloy (**Figure 11**). There was no evidence of any distorted surface microstructure (bent grain or white etching layer) associated with abusive machining (**Figure 12**). The microstructure conformed to the quality requirements for rotor grade Ti-6Al-4V titanium alloy. There were no material or processing abnormalities detected.

**Figure 11.** Photomicrographs showing the general microstructure (typical) consisting of alpha-beta processed Ti-6Al-4V titanium alloy.

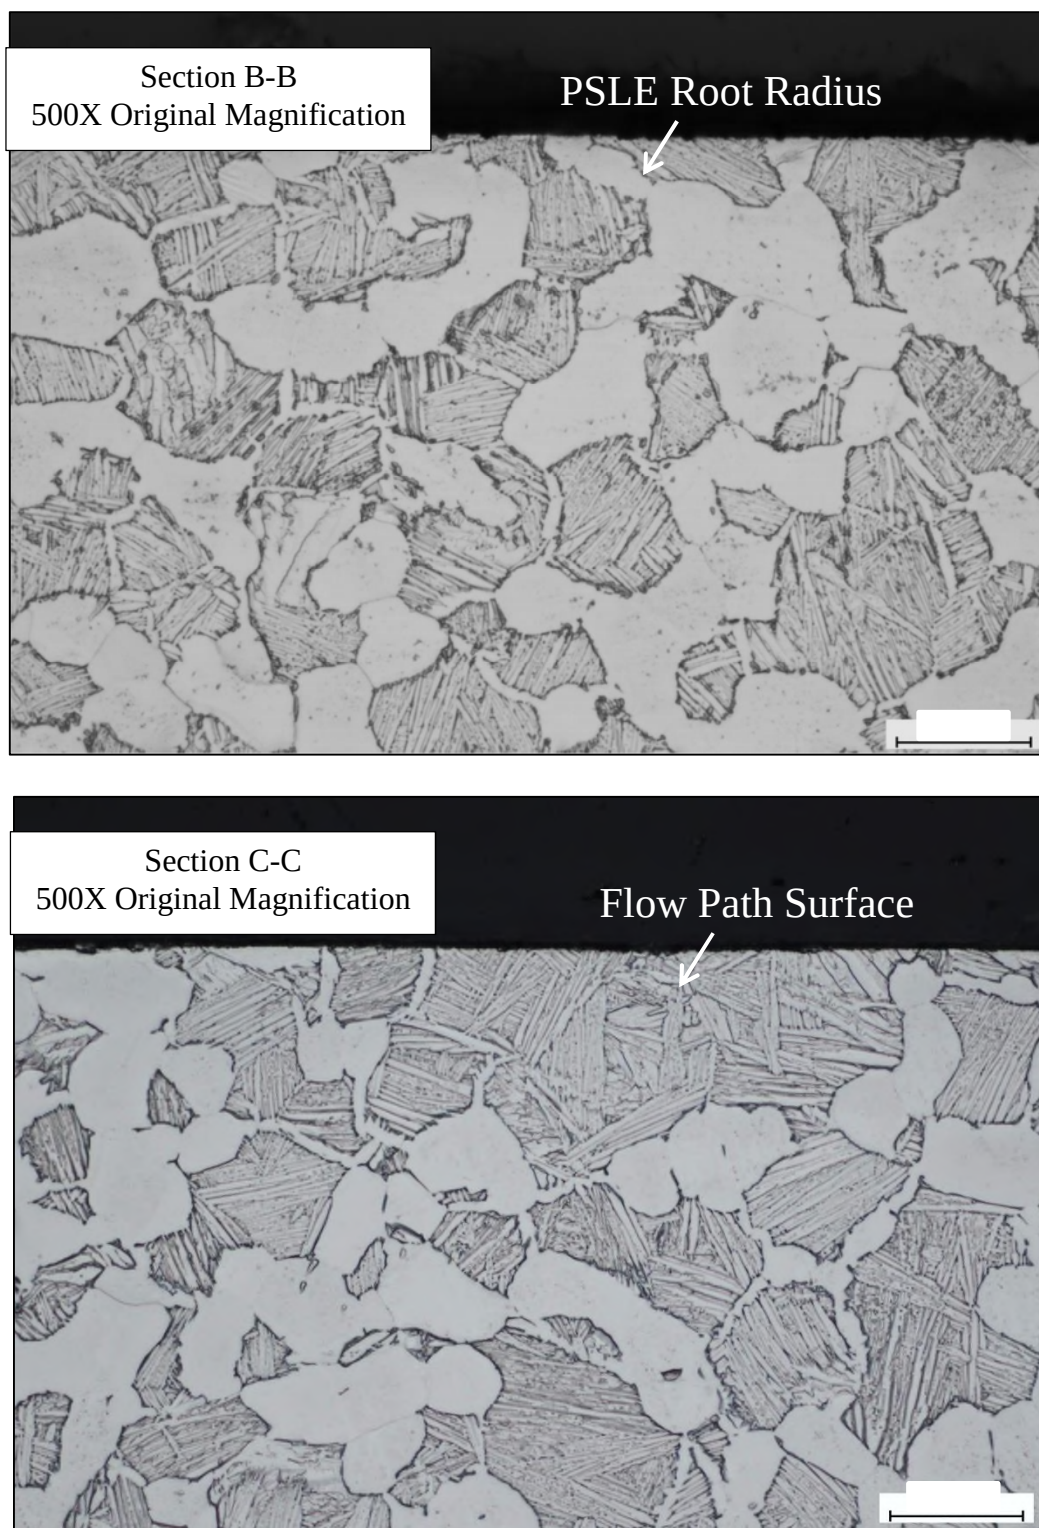
**Figure 12.** Photomicrographs showing the surface microstructure at the PSLE root radius (upper image), and the platform (lower image).

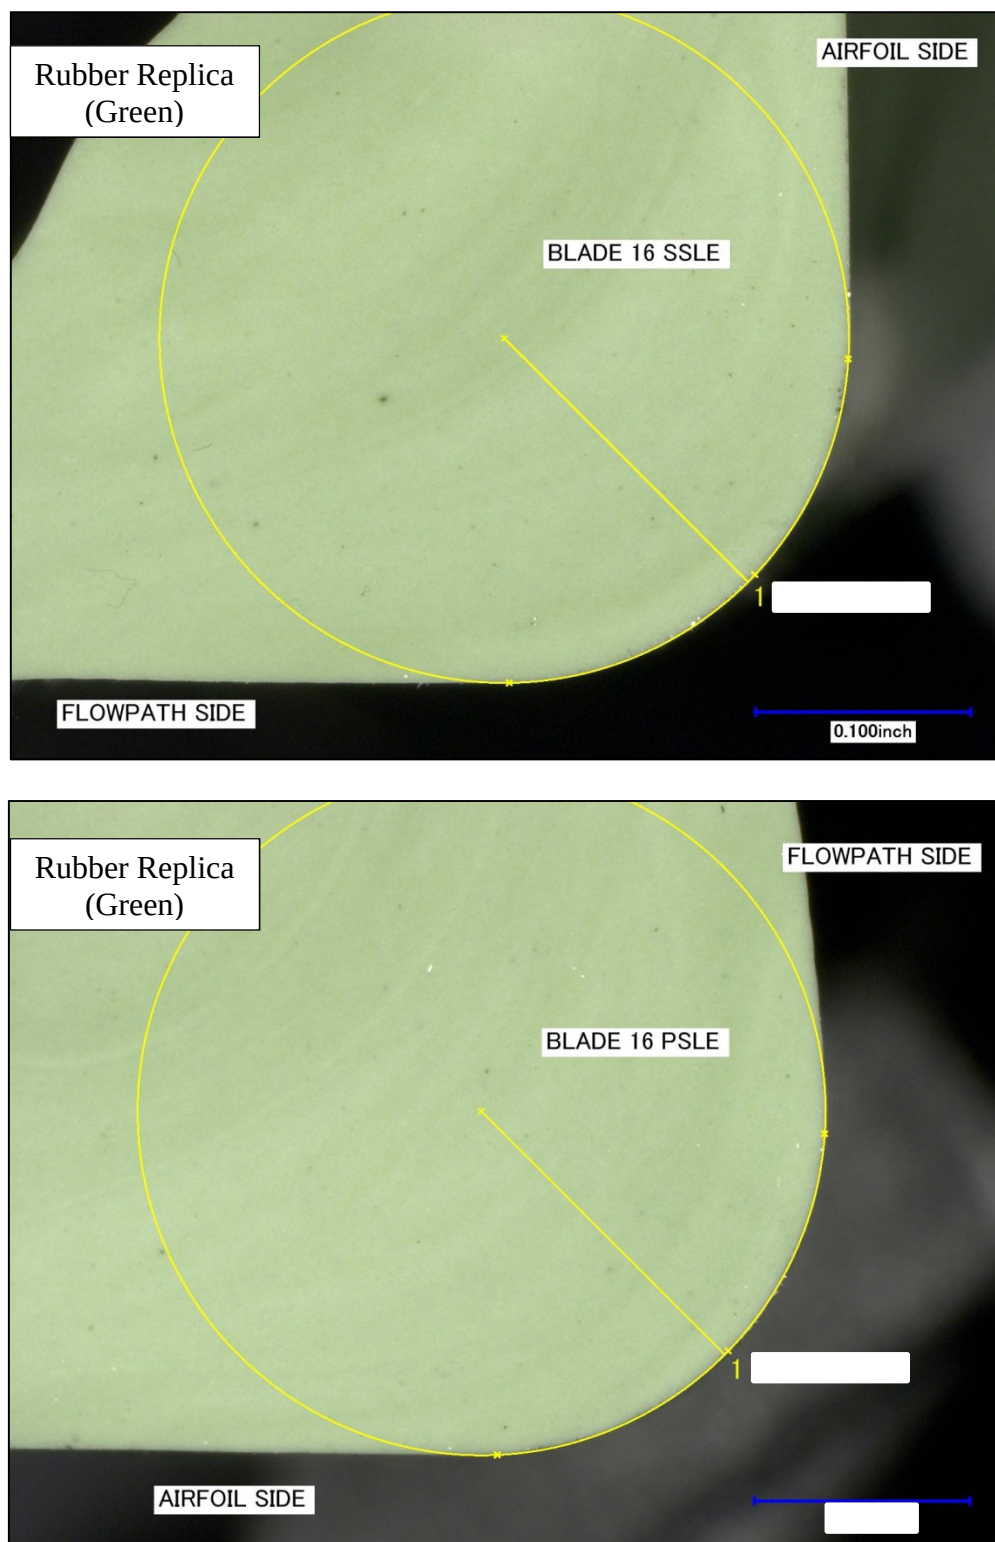
Rubber replicas were taken at the pressure and suction side root radius locations on blade no. 16 (**Figure 13**). The root radius at the pressure and suction side of blade no. 16 was determined to be [REDACTED] (typical) at both locations from measurement of the rubber replicas using a digital microscope. The radius measurements conformed to the part drawing requirements.

**Figure 13.** Views showing the root radius measurement at the pressure and suction side leading edge of blade no. 16.

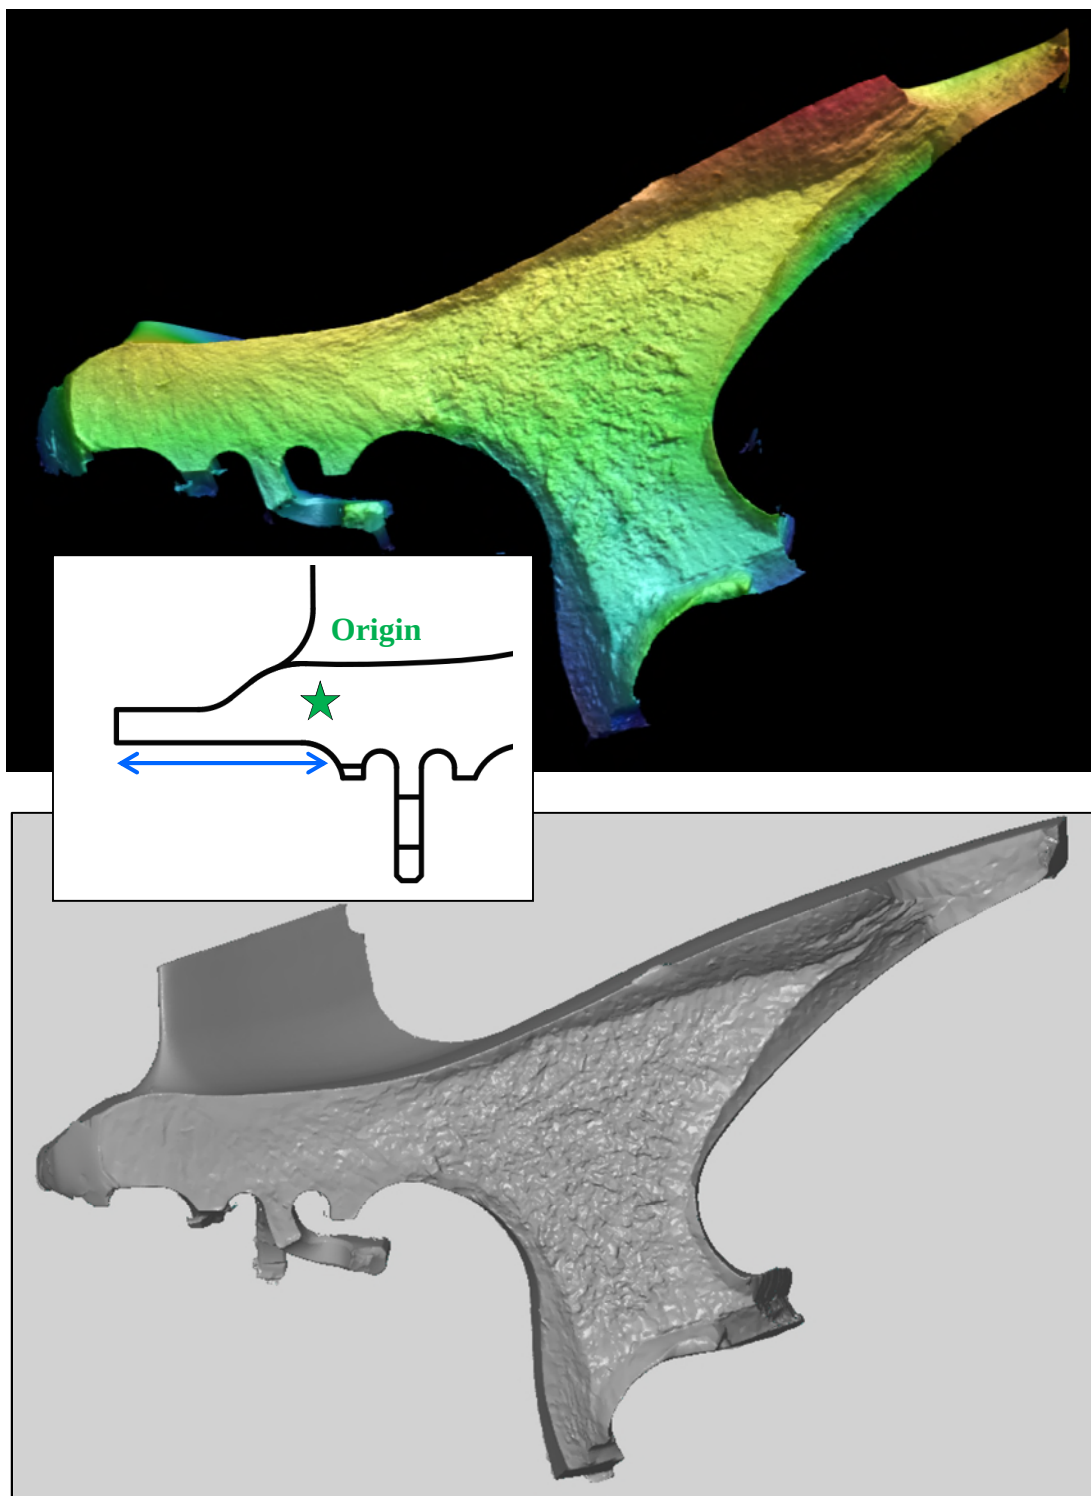
A non-contacting optical measurement system was used to generate a three-dimensional rendition of the primary fracture surface region in order to illustrate the changes in fracture surface morphology with fracture mode transitions (**Figure 14**). A blue light dimensional scan of the primary fracture surface was also performed in order to assess the location of the origin area relative to reference datums/geometric features on the airfoil and rim. The axial location of the origin area was estimated to be located approximately 0.511 inch aft from the edge (forward face) of the platform. The tangential location of the origin area was estimated to be approximately 0.050 inch from the point of tangency between the airfoil fillet and the platform surface.

**Figure 14.** Views showing three-dimension renditions of the primary fracture surface region using a non-contacting optical measurement system (upper image) and a blue light dimensional scan (lower image).
