# Metallurgical Investigation Final Report

**Subject:** Metallurgical Investigation of Swiss International Air Lines PW1524G Engine No. 736195

**Date:** October 23<sup>rd</sup>, 2019

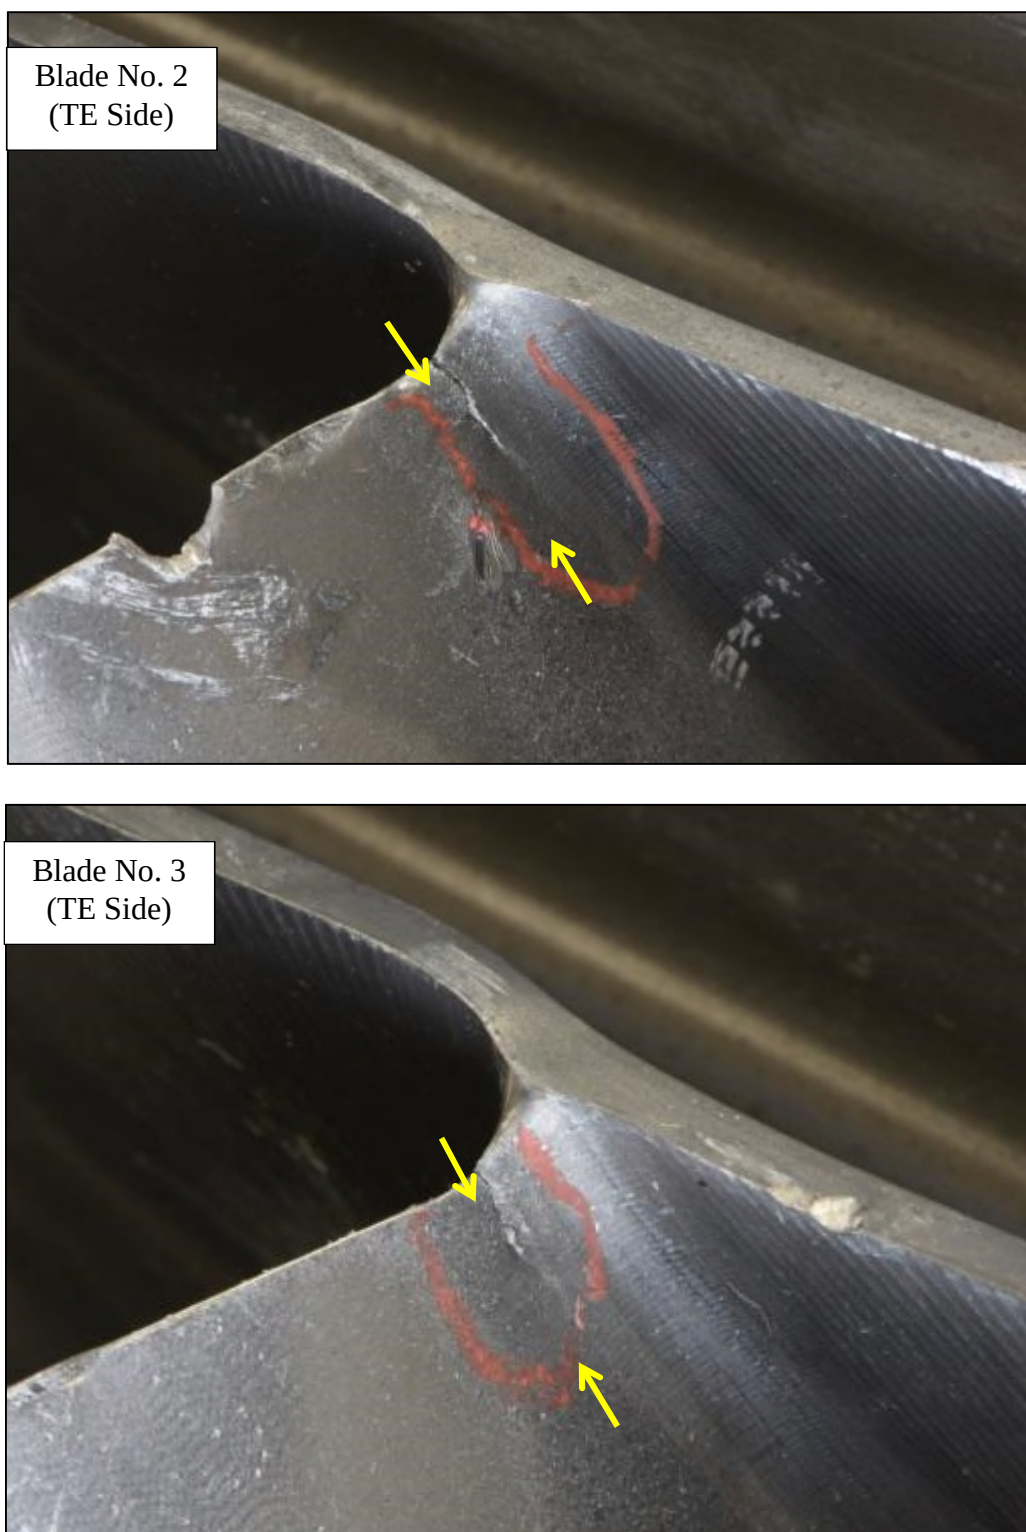
The recovered portion of LPC R1 (with blade nos. 16 and 17 extracted) was processed through an aqueous cleaning procedure and a fluorescent penetrant inspection (FPI) was performed using ultra high sensitivity fluid. No crack indications were identified in the vicinity of the PSLE root radius region. Blade nos. 2, 3, 7, and 8 exhibited crack indications at the airfoil trailing edge root radius run-out (airfoil side), **Figure 15**. Additional crack indications were identified on the aft spacer (**Figure 16**). The crack indications were reviewed optically (visually and under the binocular microscope). The crack indications appeared consistent with secondary distress (tearing) resulting from the fracture and release of the LPC R1 fragment.

**Figure 15.** Views showing crack indications (arrows) at the trailing edge root radius runout (airfoil side) of blade nos. 2 and 3.

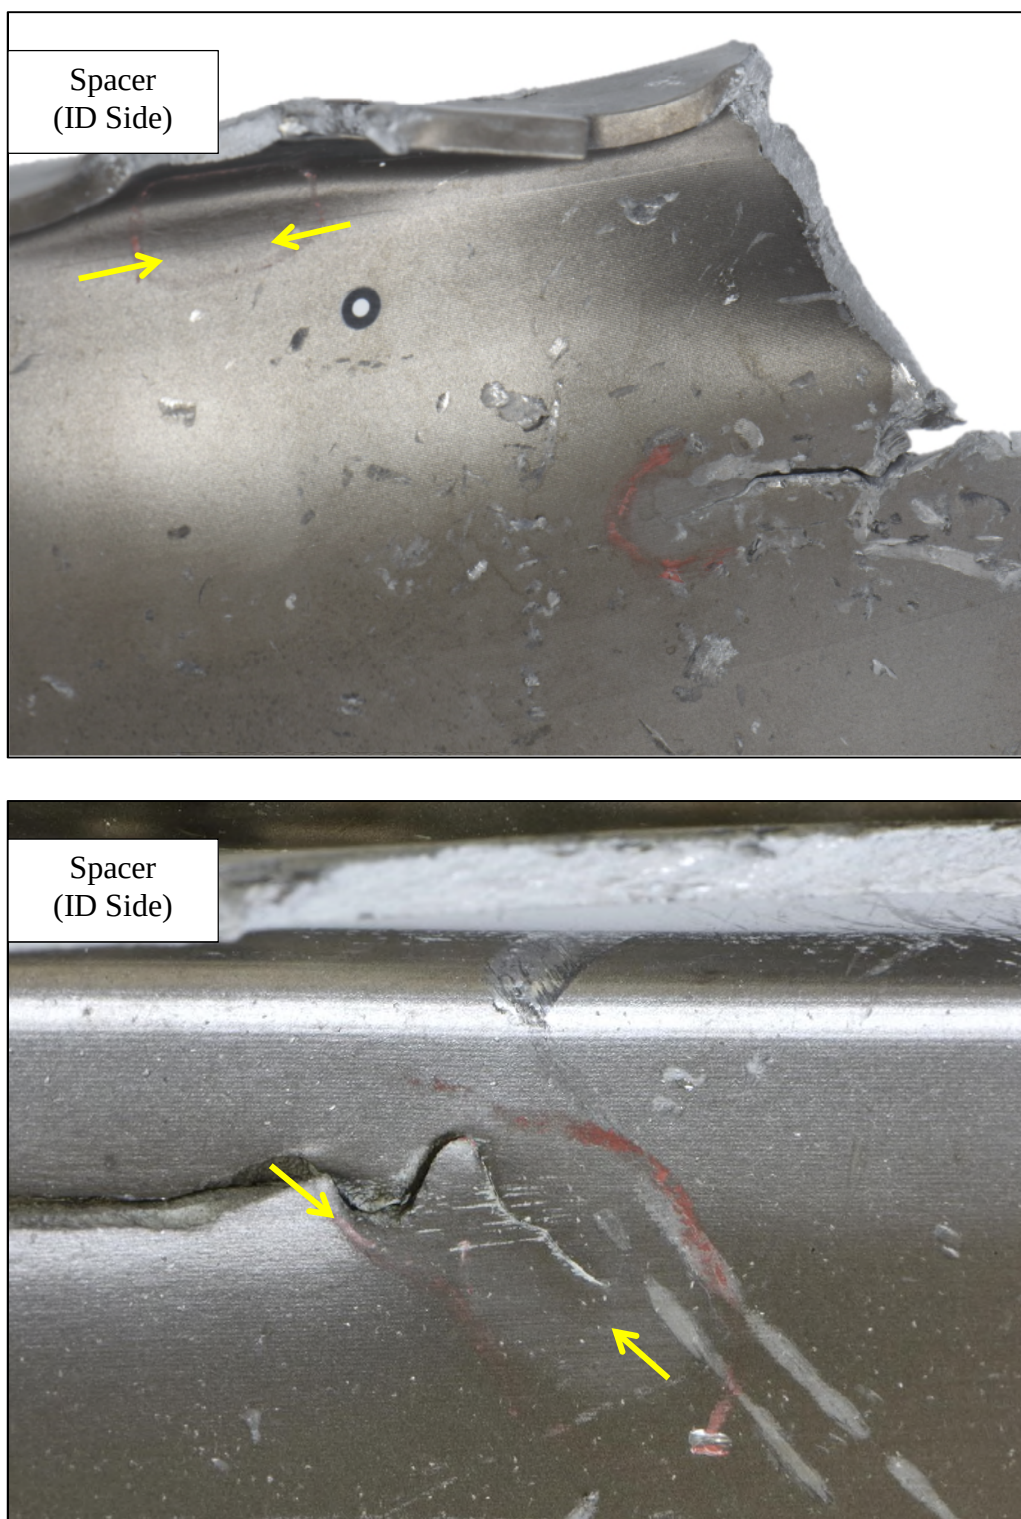
**Figure 16.** Views showing crack indications (arrows) at the ID side of the aft spacer.
