**NATIONAL TRANSPORTATION SAFETY BOARD**  
**Office of Aviation Safety**  
**Washington, D.C. 20594**

**POWERPLANTS GROUP CHAIRMAN'S FACTUAL REPORT**  
**NTSB No: ENG19IA034**

Aircraft: Swiss International Air Lines, Airbus A220-300, Registration Number HB-JCA,

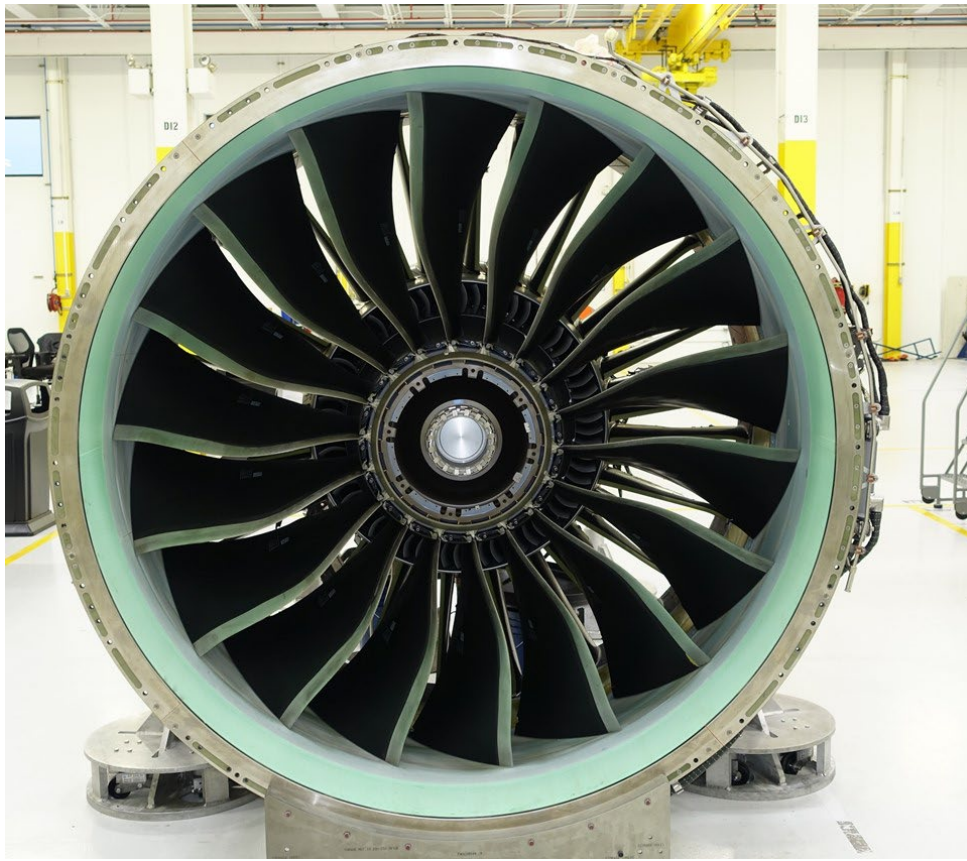
**Photo 4- Engine Fan**

A visual inspection was performed to document the condition of the engine prior to disassembly. The “A” flange exhibited no visual evidence of damage and appeared to be in good condition. The fan blades were all complete but trailing edge deformation/nicks were observed at varying locations along the blade span on 17 of the 18 fan blades (**Photo 4**). There was light 360 degree circumferential rub on the fan blade rub strip in plane with the fan blade tip path (full chord width). Multiple small rub strip penetrations were also observed around the fan case circumference. The fan exit guide vanes (FEGV) exhibited minor trailing edge deformation between the 4 and 7 o’clock positions and severe trailing edge damage, including material loss from the 7 to 10 o’clock positions. The FEGV outer skin covers were separated on multiple vanes, exposing the internal vane structural compartments. The fan exit stators were intact and in good condition.

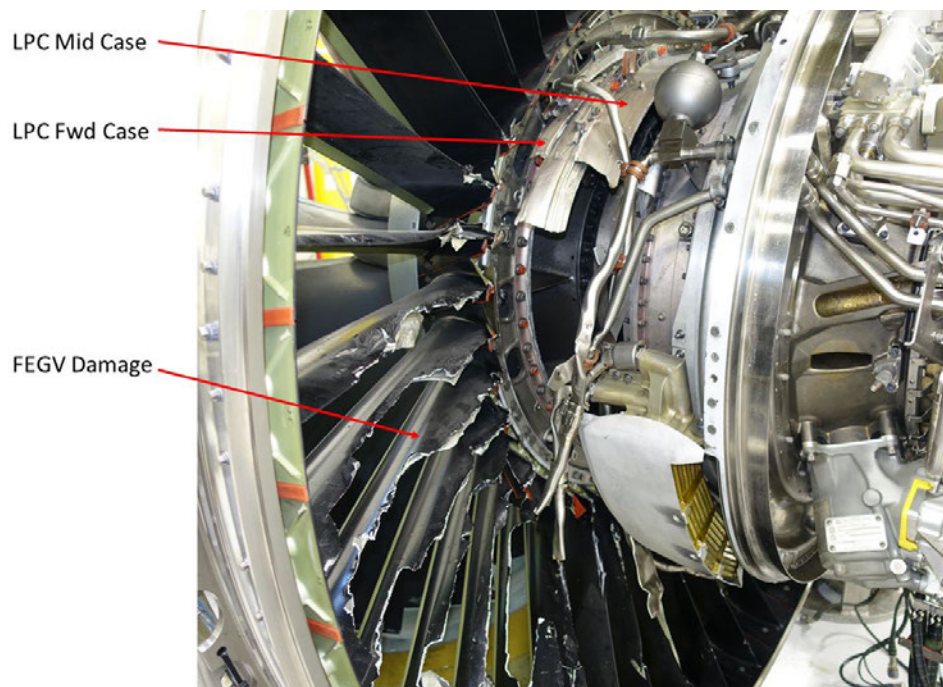
The LPC forward case was missing from the 3 to 11 o'clock positions. The LPC mid case had a 360 degree circumferential crack approximately  $\frac{3}{4}$  inch forward of the LPC mid-to-aft case flange (LPC 3) and the LPC mid case was missing from the 7 to 10 o'clock positions (**Photo 5**). The remaining LPC mid case material from the 1 to 7 o'clock positions was bent radially outward from the engine centerline (**Photos 6 and 7**). The LPC mid-to-aft case flange (LPC 3) and LPC aft case were intact. Air and oil lines that were routed over the LPC case where the hole formed were severed and the ends of the separated lines were bent. There was no LPC IBR 1 or S1 stator visible through the LPC case hole. The engine firewall, located axially between the LPC case, and the compressor intermediate case was intact. The No. 4 bearing air cooler (buffer air heat exchanger) located at the 12:30 position on the LPC case remained secured to the engine flanges by four brackets and there was no evidence of external damage (**Photo 7**). The IGV bellcrank was disconnected and the IGV actuator rod end was bent.

**Photo 5- LPC Case Hole and FEGV Damage, Left Side of Engine**

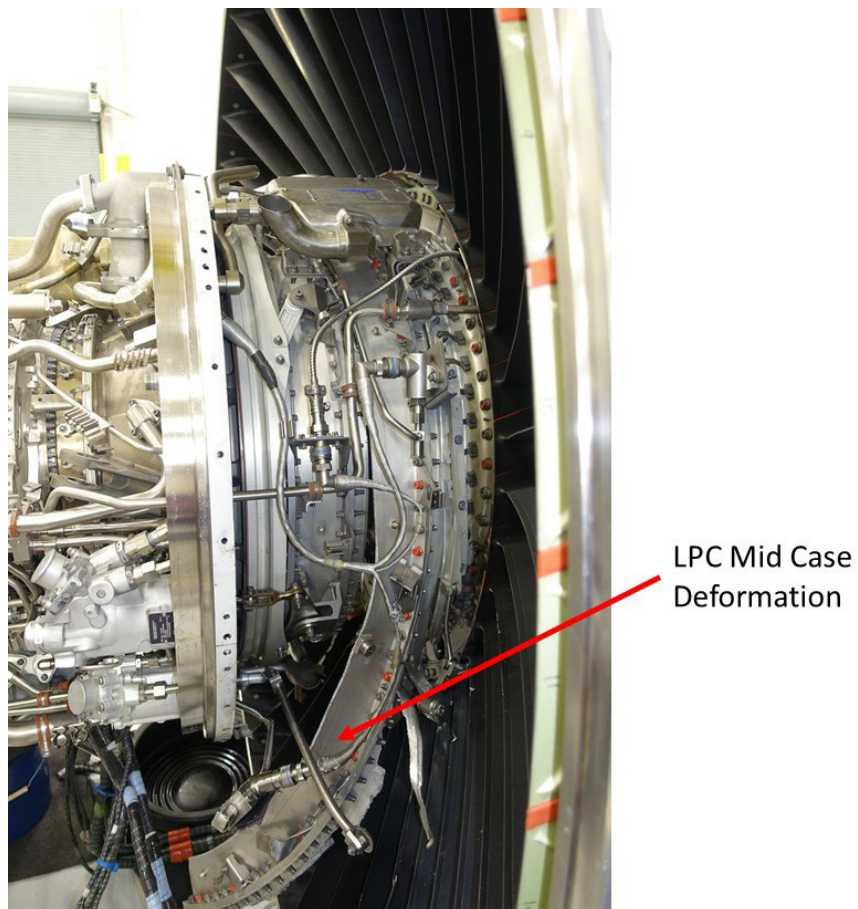
**Photo 6- LPC Case Hole, Right Side of Engine**

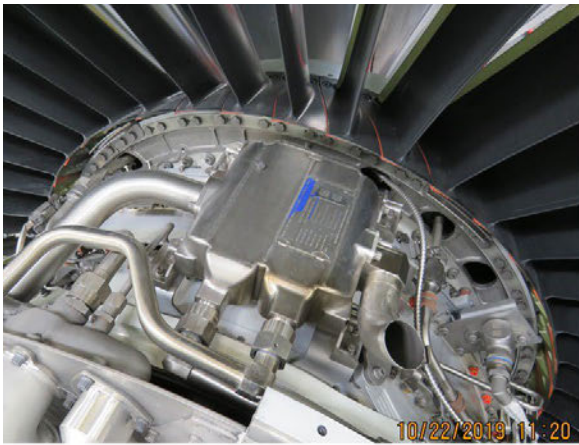
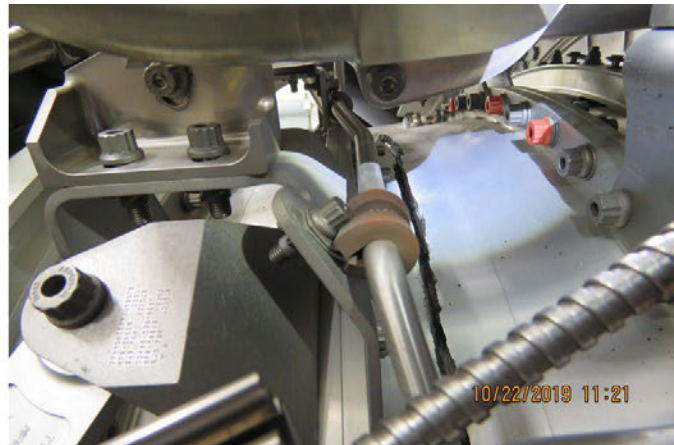
**Photo 7- (L) Buffer Air Heat Exchanger on Engine, (R) LPC Mid Case Crack Under Exchanger**

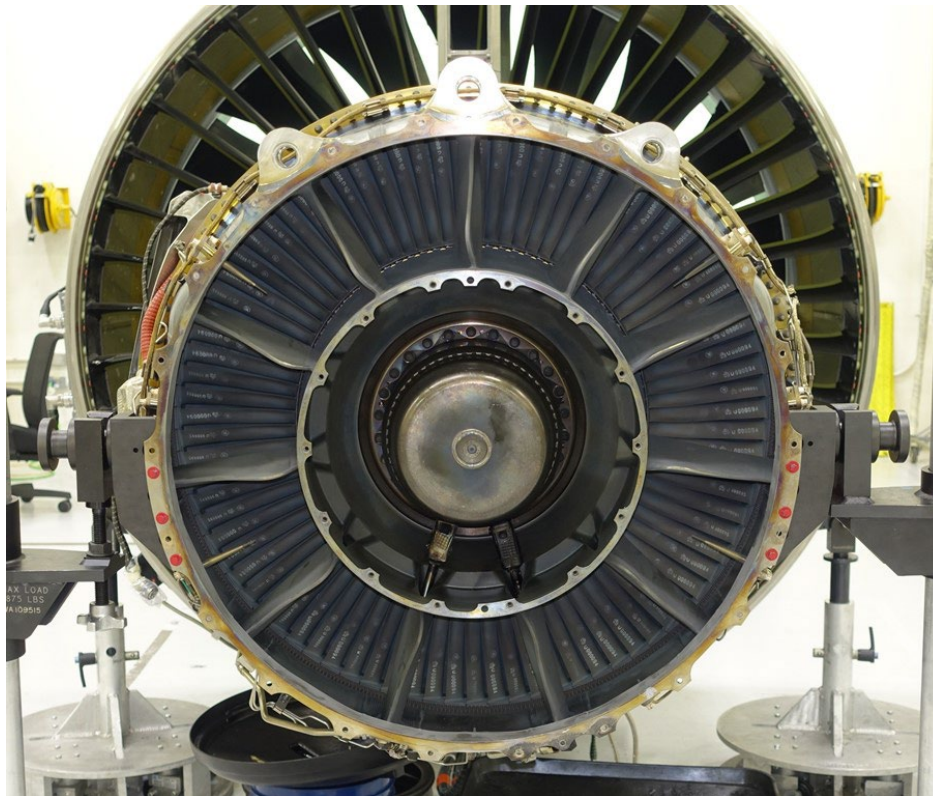
The LPT S3 blades and S3 nozzle vanes visible through the turbine exhaust case (TEC) struts were intact and did not appear damaged (**Photo 8**).

**Photo 8- LPT Stage 3 Blades Visible Through TEC**

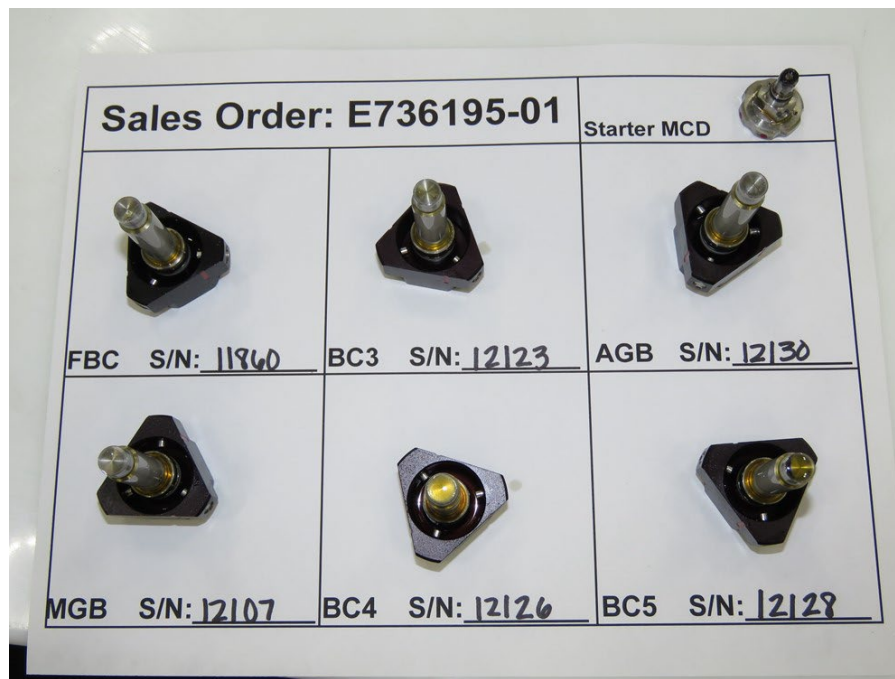
The magnetic chip detectors (MCD) were removed by P&W mechanics when the engine arrived at CEC and there was no metal debris accumulation on the electrodes (**Photo 9**).

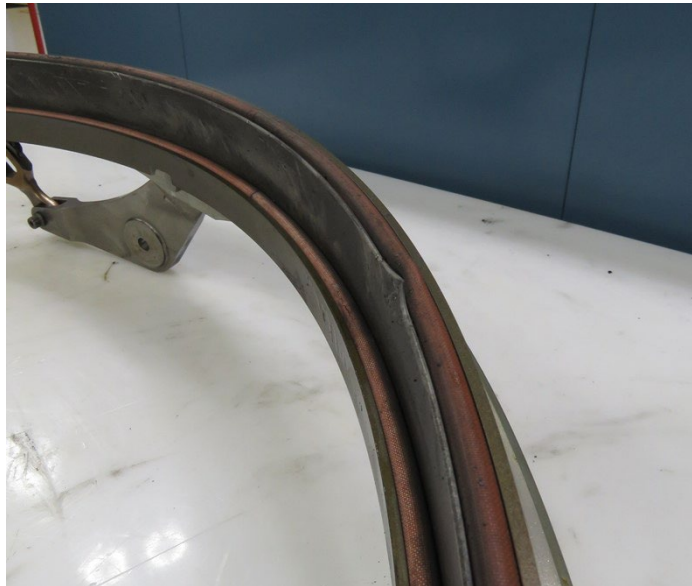
The 2.5 bleed ring was not rotated while installed on the engine but after removal it was confirmed that all actuation hardware was intact and free to rotate. The bleed ring seal was examined and appeared intact, but the metal portion of the ring exhibited deformation consistent with impact damage (**Photo 16**). The fan drive gear system was viewed aft looking forward and all visible gearing was in intact and did not appear damaged. The fan hub was rotated, and the fan drive system sun gear properly rotated and meshed with the star gears (**Photo 17**).

**Photo 16- 2.5 Bleed Air Ring Damage**

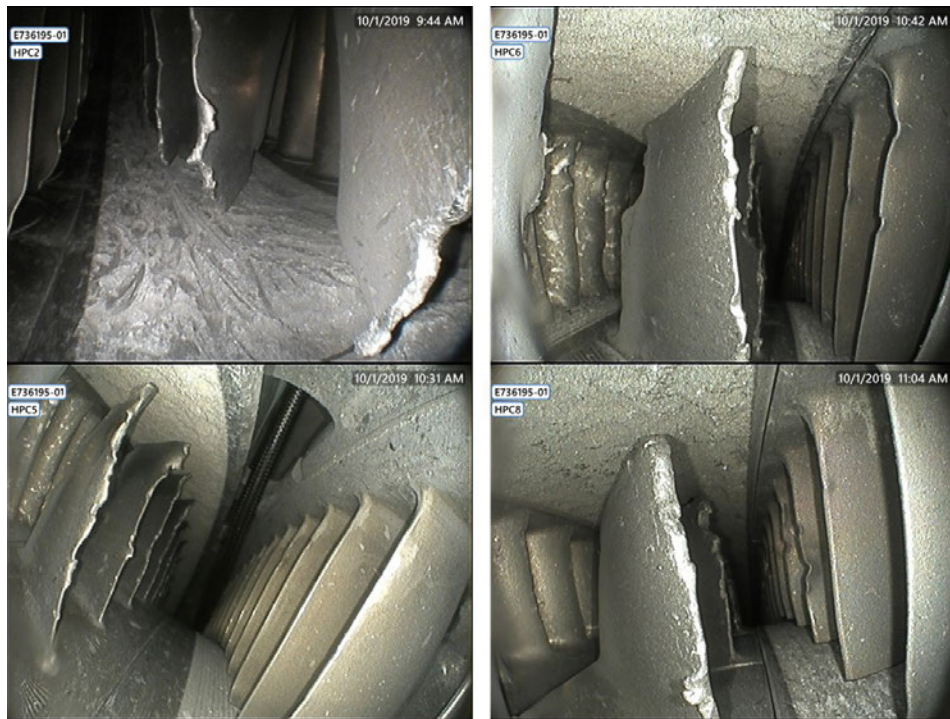
**Photo 18- HPC Borescope Photos**

BSI inspection photos were used to evaluate the condition of the engine core. All HPC stages exhibited leading and trailing edge impact damage but there was no evidence of fire (**Photo 18**). Multiple HPC stages exhibited rubbing. The combustion liner and fuel nozzles were intact, but material had adhered to combustor surfaces. Both the HPT S1 and S2 vanes and blades were missing material, and the thermal barrier coating was flaking (**Photo 19**).

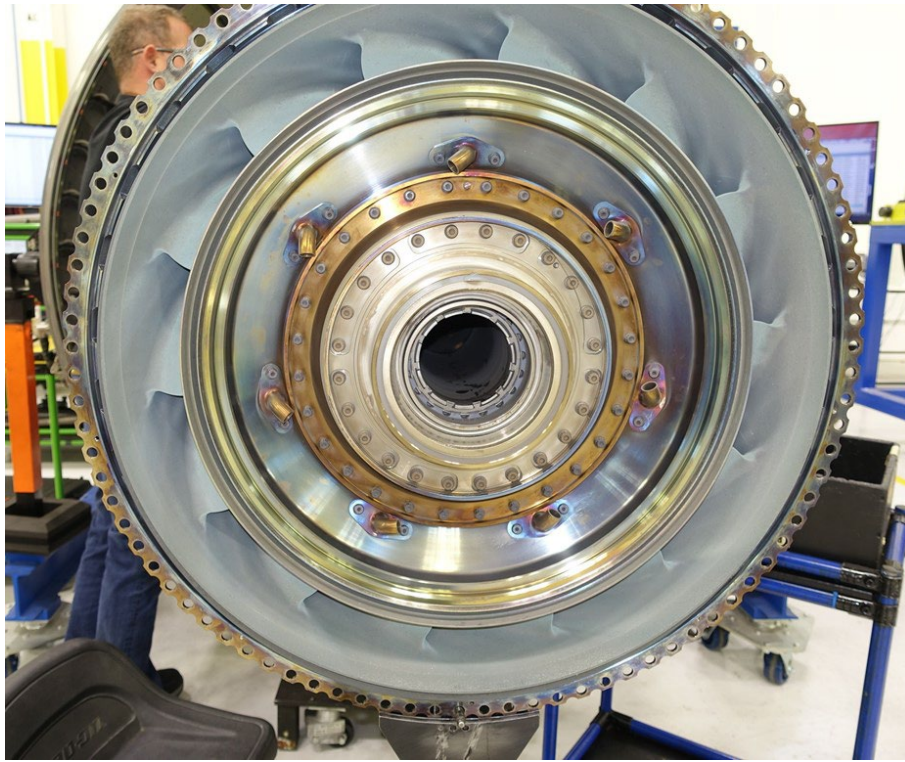
**Photo 20- Turbine Intermediate Case**

The turbine intermediate case (TIC), including the TIC vanes did not appear damaged when viewed from the aft side, after removal of the LPT module (**Photo 20**).

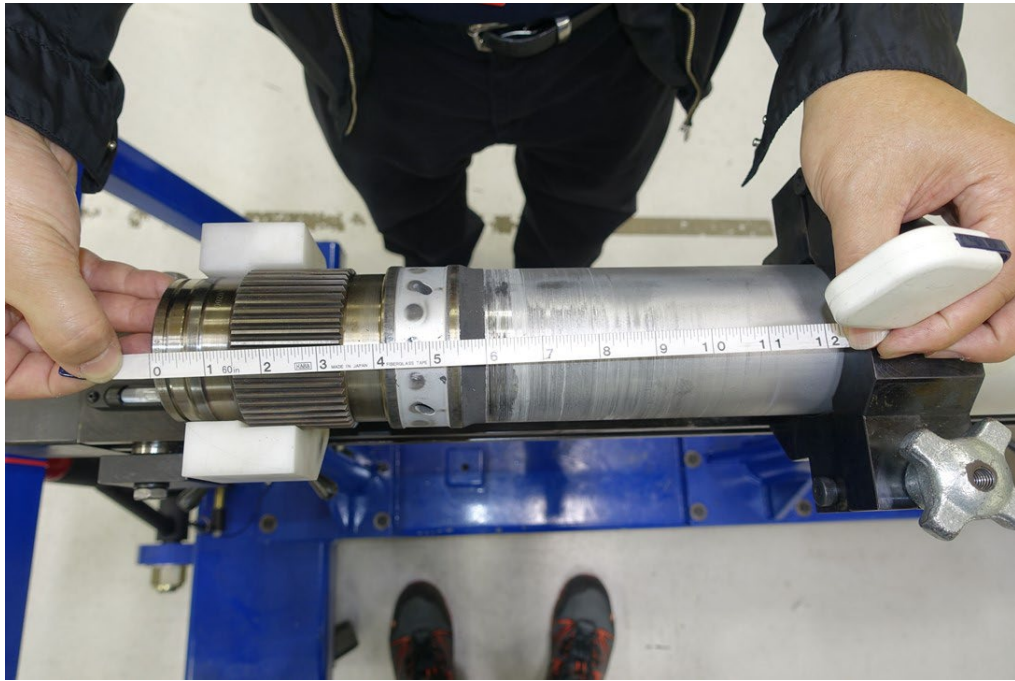
The LPT shaft was removed and there was approximately 5 inches of rub around the shaft near the forward spline (**Photo 21**). A coincident rub and seal damage was observed on the inside diameter of the HPC front hub, near the No. 3 bearing seal support, and thermal discoloration was noted on the outside diameter of the bearing seal support bore (**Photo 22**). Another series of coincident rubs were noted between the LPT S1 hub and the TIC (**Photo 23**). CEC mechanics stated they were able to smoothly rotate the LPT assembly by hand after the module was separated from the engine. The leading edge of all LPT S1 blades were intact and in good condition. The LPT module was not further disassembled because there was no evidence of significant internal damage.

**Photo 21- LPT Shaft Rub**

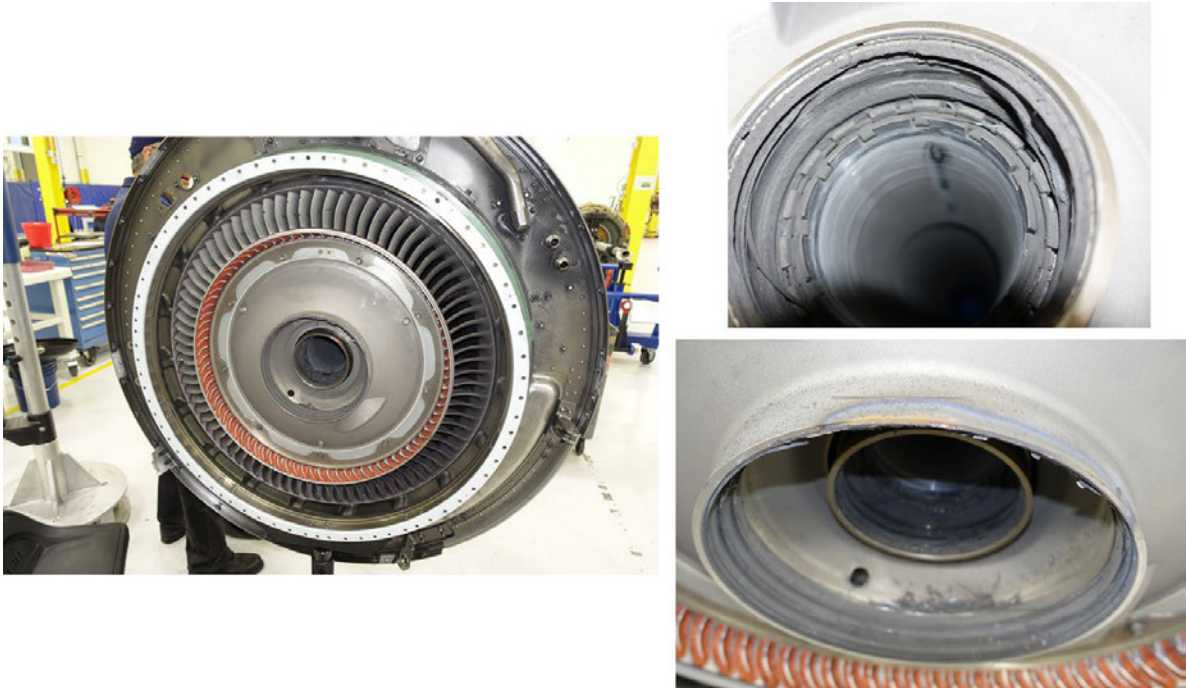
**Photo 22- No. 3 Bearing Seal Support and HPC Front Hub Inner Diameter Rub**

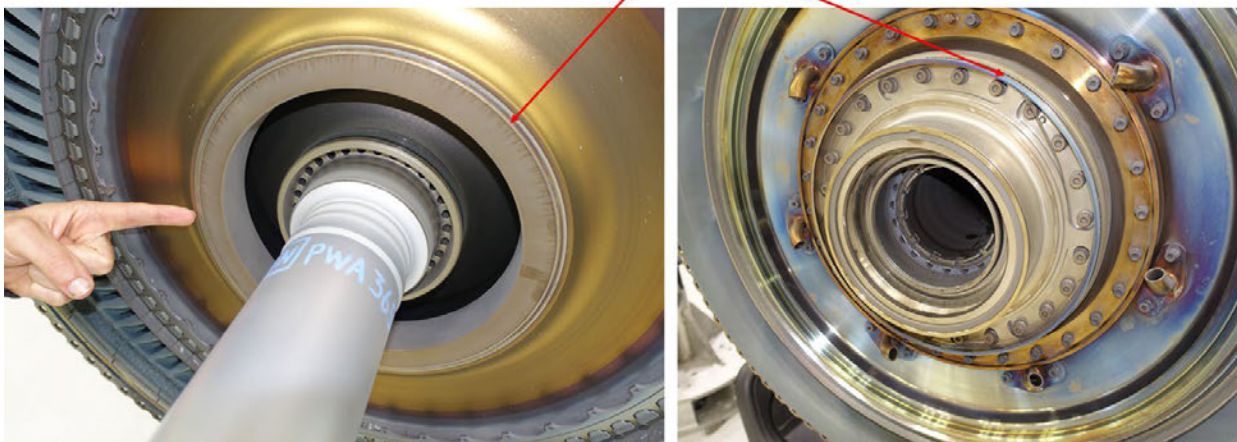
**Photo 23- LPT S1 Hub and Turbine Intermediate Case Rub**

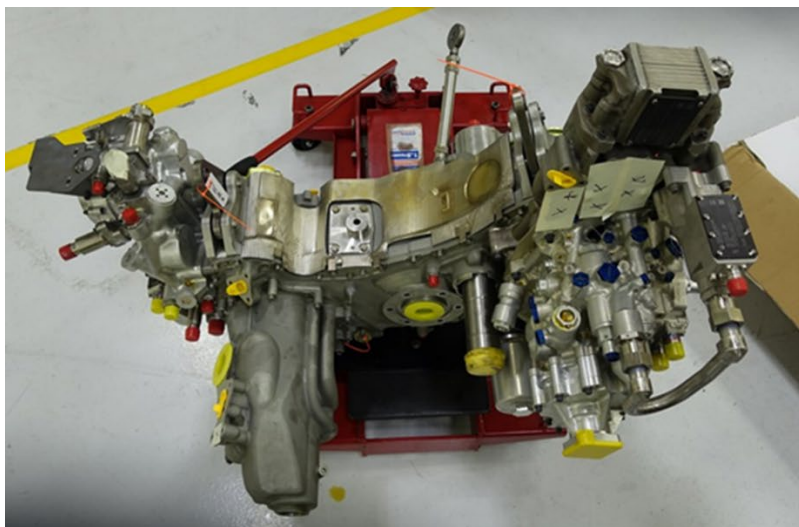
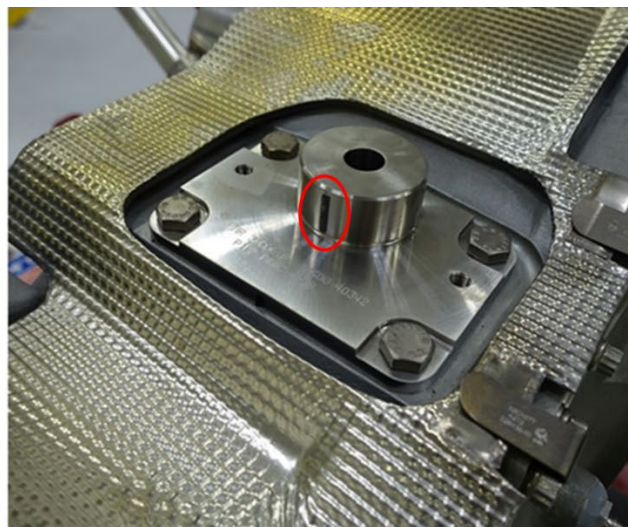
A main gearbox (MGB) alignment check was performed with the MGB locating guide tool and it was confirmed that alignment met maintenance manual specifications. The MGB aft mount link bushing was seized and could not be rotated by hand. The MGB centering puck exhibited two marks 180 degrees apart on the inboard and outboard side of the engine with coincident marks on the engine input recess (**Photo 24**).

**Photo 24- MGB and MGB Centering Puck Marks**

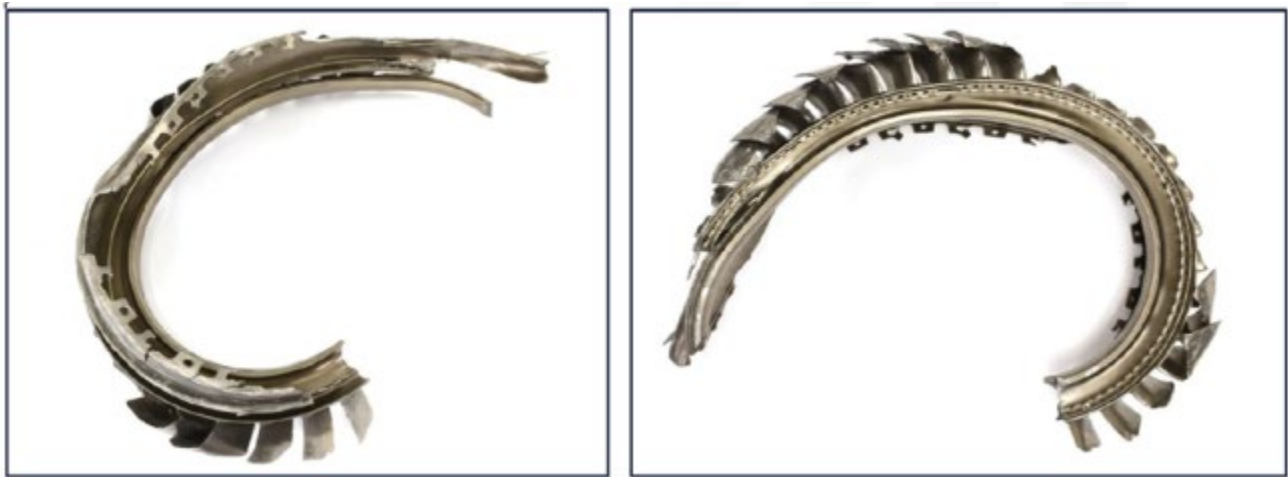
The recovered LPC IBR 1 center bore was complete but a section of the rim, including four airfoils were separated and missing (**Photo 25**). The missing section of the IBR 1 was roughly equivalent to the size of the IBR 1 piece that was recovered loose in the nacelle of ESN P736090 following the first PW1500G LPC IBR 1 event on September 25, 2019. Details of the September 25, 2019, event can be found under NTSB case number ENG19IA029 in the Case Analysis and Reporting Online (CAROL) system on the NTSB website<sup>5</sup>.

**Photo 25- Engine Serial Number P736195 LPC IBR 1, as Received**

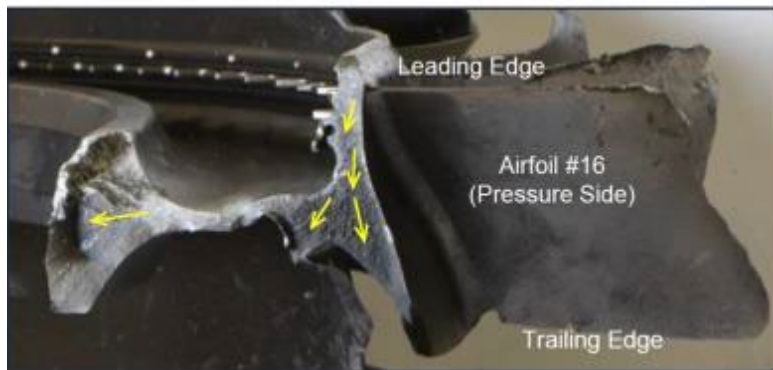
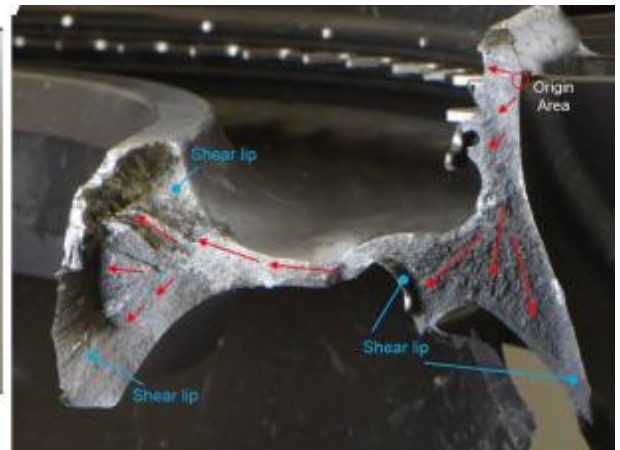
The recovered LPC IBR 1 fragment weighed 73.8% of the total nominal part weight. The IBR 1 exhibited a primary fracture at the pressure side of airfoil No. 16 that progressed in fatigue from an origin at the runout of the leading edge root radius (**Photo 26**). The fracture surface and section of the rim containing airfoils Nos. 16 and 17 were sectioned from the IBR and then further cut down for scanning electron microscopy (SEM) examination. The SEM examination identified cleavage features on the fracture surface consistent with high cycle fatigue (HCF). The crack origin initiated approximately 0.0033 inch (0.084 millimeter) beneath the material surface (**Photo 27**). There were no material or processing anomalies visible at the crack origin. The material composition was consistent with Ti-6AL-4V titanium alloy and had surface impact marks that indicated peening<sup>6</sup> in accordance with drawing specification. According to the P&W materials engineers, crack origins 0.003 – 0.005 inches subsurface are within the expected zone of the compressive residual stress die out from peening. A residual stress analysis was performed and confirmed compressive residual levels were consistent with design specification.

**Photo 26- LPC IBR 1 Fracture Surface.  
(L) Fracture Surface with Airfoil Visible, (R) Fracture Surface Features**

A SEM and binocular examination of the fracture surface revealed that the stable fatigue progression extended approximately 0.275 inches aft of the origin area (as measured along the rim) and 0.19 inches deep. The fatigue region had no cyclic markers or evidence of a discrete change between fatigue and overstress. The P&W MPE report titled “Metallurgical Investigations of SWISS PW1524G-3 Engine No. 736195” is available in the investigation docket. A NTSB materials engineer attended the group exam and concurred with the P&W MPE Laboratories findings.

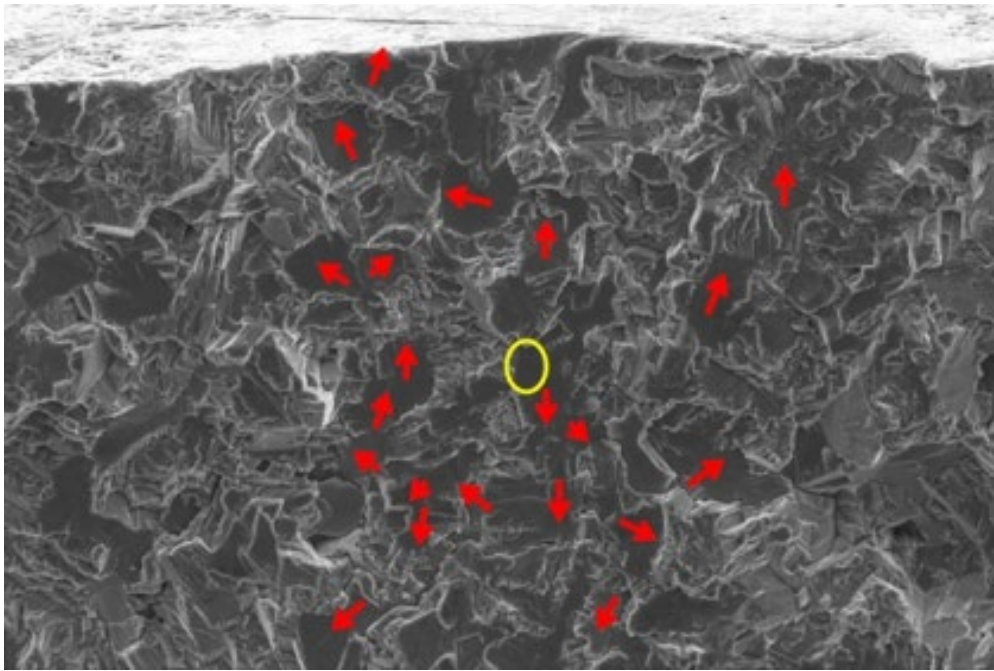
**Photo 27- LPC IBR 1 Fracture Origin and Crack Progression on Airfoil No. 16, Pressure Side Leading Edge Root Radius**

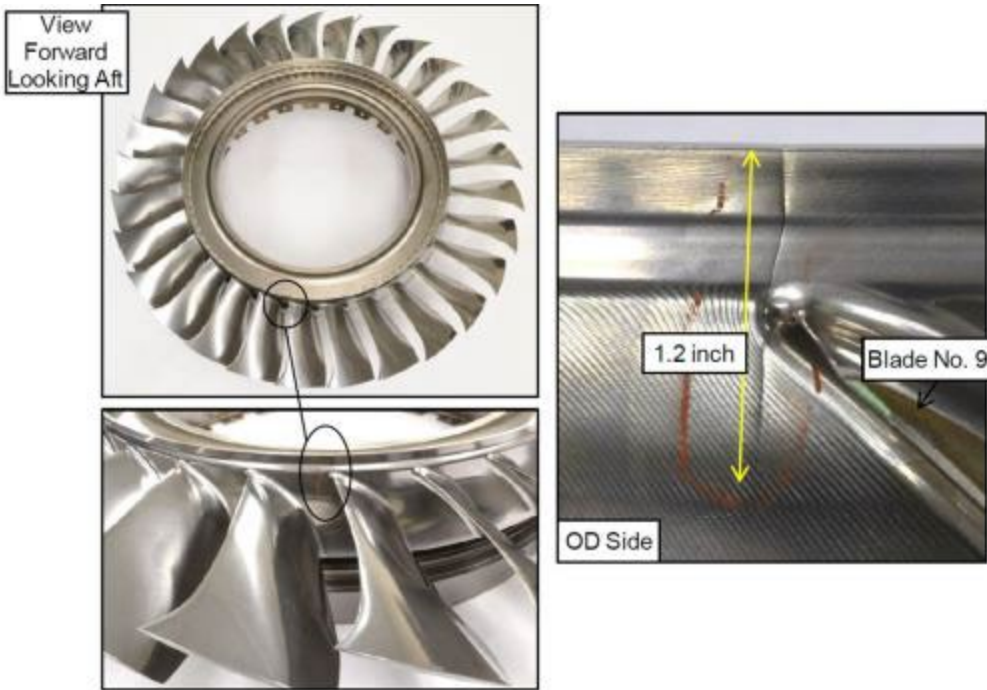
The SWISS incident on July 25, 2019, was the first of three Airbus A220-300 PW1524G-3 and one PW1521G-3 LPC IBR 1 separation events. Following the recovery and materials analysis of the LPC IBR 1 from ESN P736195 (incident covered in this report), P&W released SB PW1000G-A-72-00-0125-00A-930A-D that recommended operators to perform recurrent BSIs of the LPC IBR 1. The SB was mandated by FAA Airworthiness Directive (AD) 2019-19-11. The inspections identified two additional LPC IBR 1 crack findings (**Photo 28**). The hardware from the two LPC IBR 1 BSI crack findings were sent to the P&W MPE Lab for analysis and the crack type and origin location were consistent with the

**Photo 28- Engine Serial Number P736218 Crack Finding**

The BSIs mandated by the AD 2019-19-11 identified LPC IBR 1 cracks on two additional engines. The IBR 1 cracks originated at the same approximate location as the crack documented on the recovered IBR 1 fragment from ESN P736195 (incident engine detailed in this report). In response to the crack findings, the FAA issued AD 2019-21-11 on October 29, 2019, effective immediately. The AD adjusted the LPC inspection interval on the higher thrust rated variants of the PW1500G series engines (PW1521G, PW1521G-3, PW1524G, PW1524G-3, PW1525G, and PW1525G-3) installed as zero time spares to 15 cycles, recurrent every 15 cycles until the engine reached 50 cycles. After the engine reached 50 engine cycles since new, the inspection interval was increased to every 50 cycles until the engine reached 300 cycles since new<sup>12</sup>. Other PW1500G engine model variants were required to continue LPC inspections at 50 hour intervals in accordance with the original SB/AD instructions.

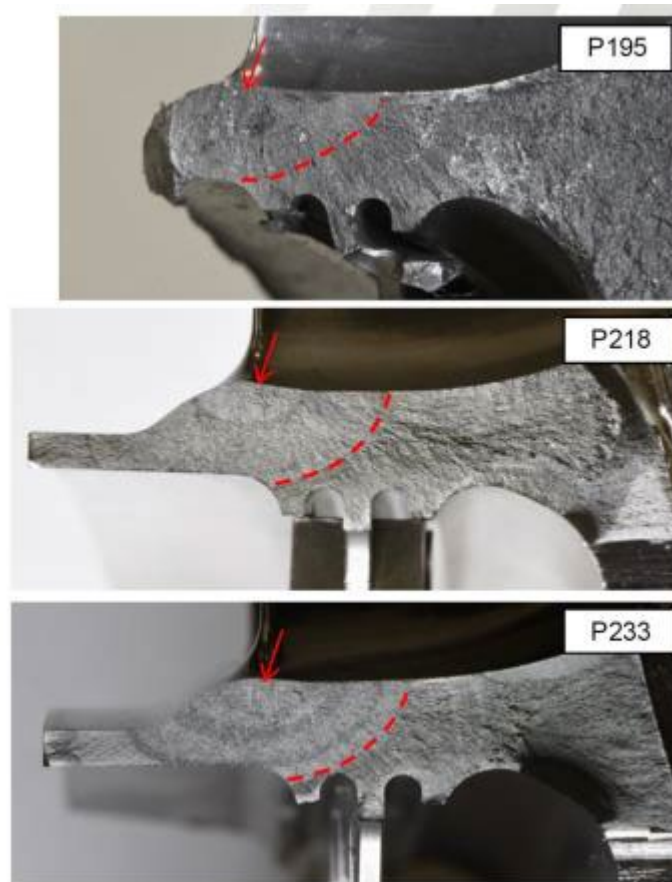
findings from ESN P736195 (**Photo 29**) A summary of the fracture findings are listed below in **Table 2**. A detailed discussion of corrective actions is covered later in this report.

**Photo 29- LPC IBR 1 Crack/Fracture Surfaces**
