# NATIONAL TRANSPORTATION SAFETY BOARD

## MATERIALS LABORATORY FACTUAL REPORT

Report No. 20-044

Place : Penobscot, ME  
Date : November 16, 2019  
Vehicle : Agusta A109E, N901EM  
NTSB No. : ENG20IA005  
Investigator : Chich Shin (AS-40)

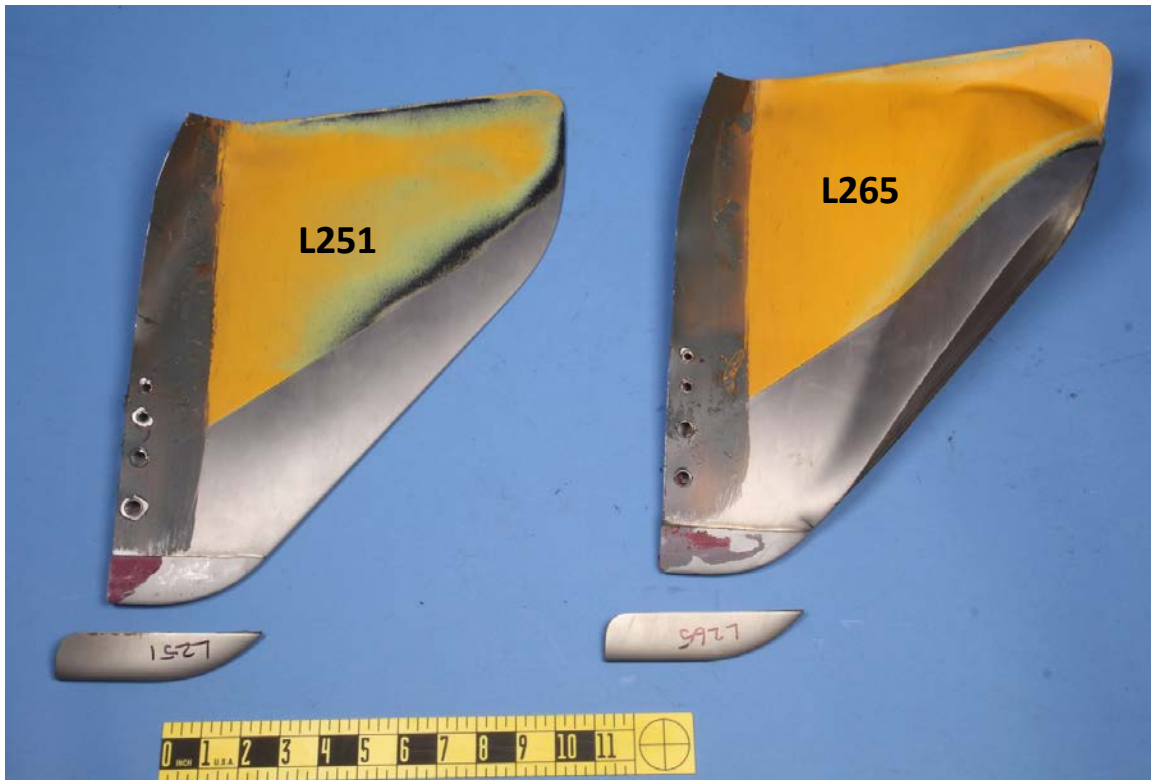
The submitted tip caps are shown in Figure 1. The tip caps were identified as L265 and L251 on their upper surfaces.

Figure 1: Overall photo of the lower surfaces on the two submitted tip caps.

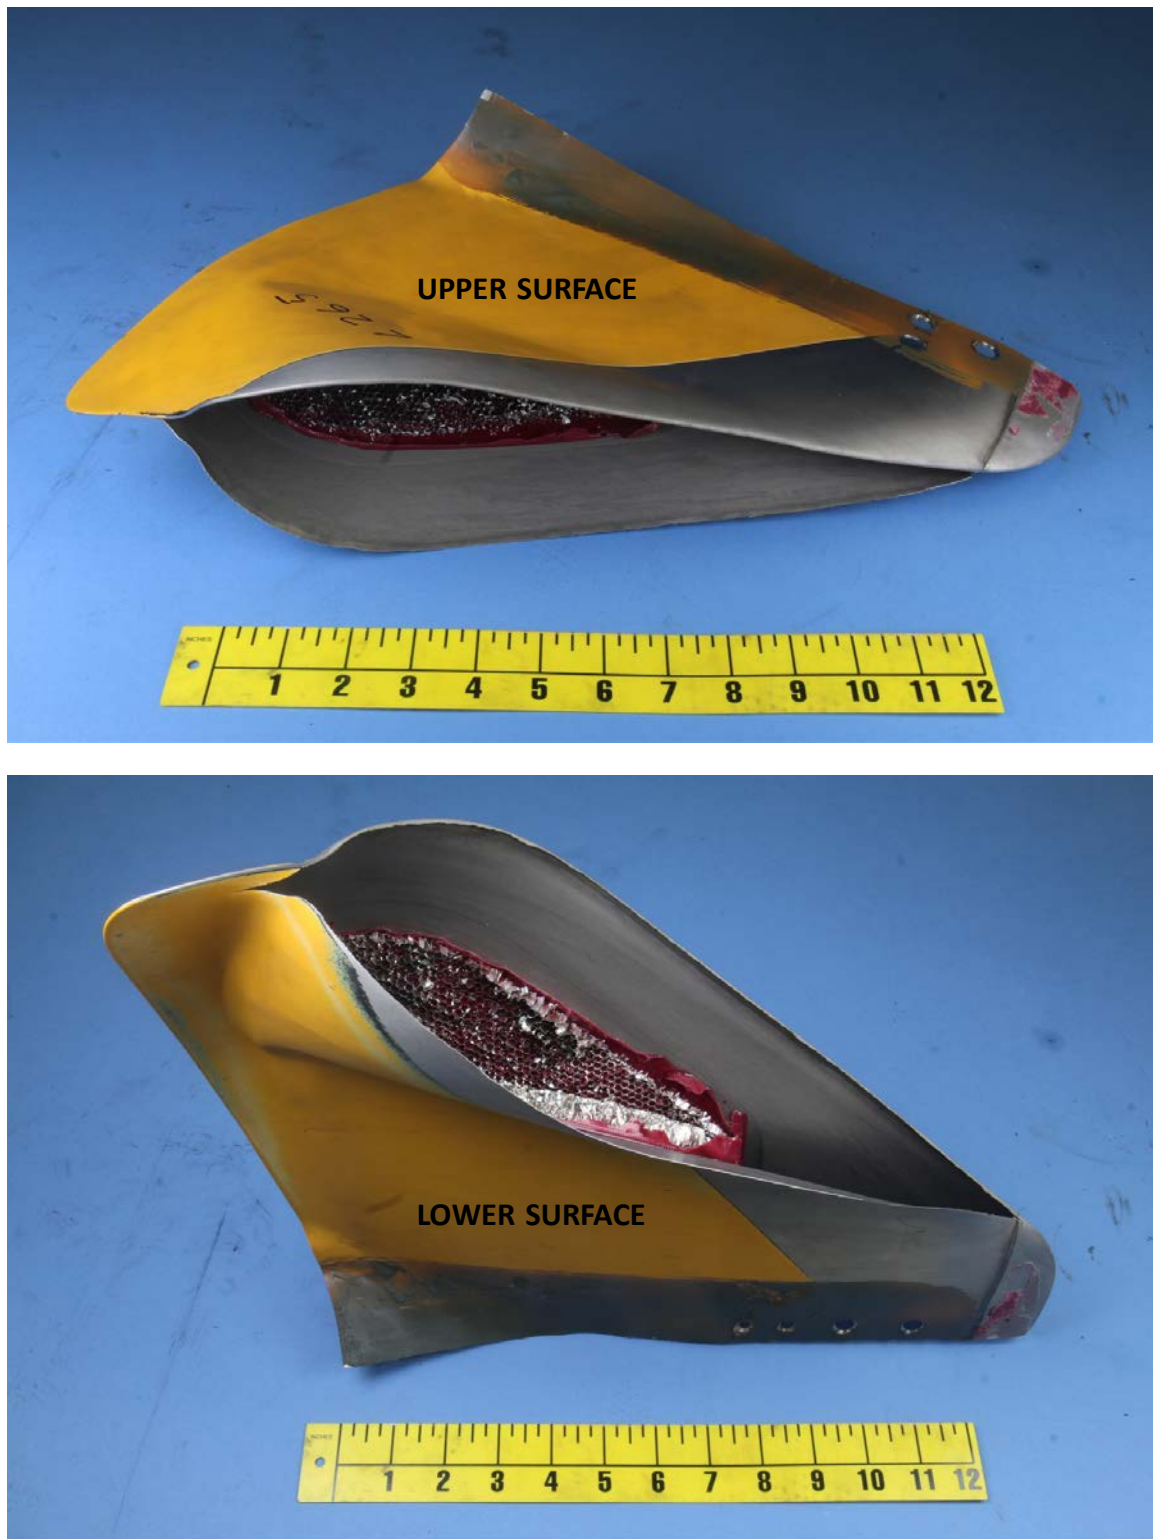
The L265 tip cap had separated along approximately 18 inches of the leading edge and bowed open, as shown in Figure 2. Figures 3-5 show that the separation appeared to be adjacent to the weld along the lip of the leading edge. Three areas along the separation were sectioned from the tip cap; the three locations were labeled A, B, and C. Microscopic examination determined the separation occurred through the lower surface of the tip cap. The fracture surface on the separation was relatively flat with multiple ratchet marks and thumbnail-shaped areas visible on the fracture surface. The fracture surface features were consistent with multiple initiation fatigue cracking. The fatigue cracking emanated from the internal edge of the lower surface at the toe of the weld. A Digital microscope images of the fracture surfaces in Locations A, B, and C are shown in Figures 6, 7, and 8, respectively.

Figure 2: Overall photos of the upper surface on the L265 tip cap (top) and a view inside the separated area of the L265 tip cap (bottom).

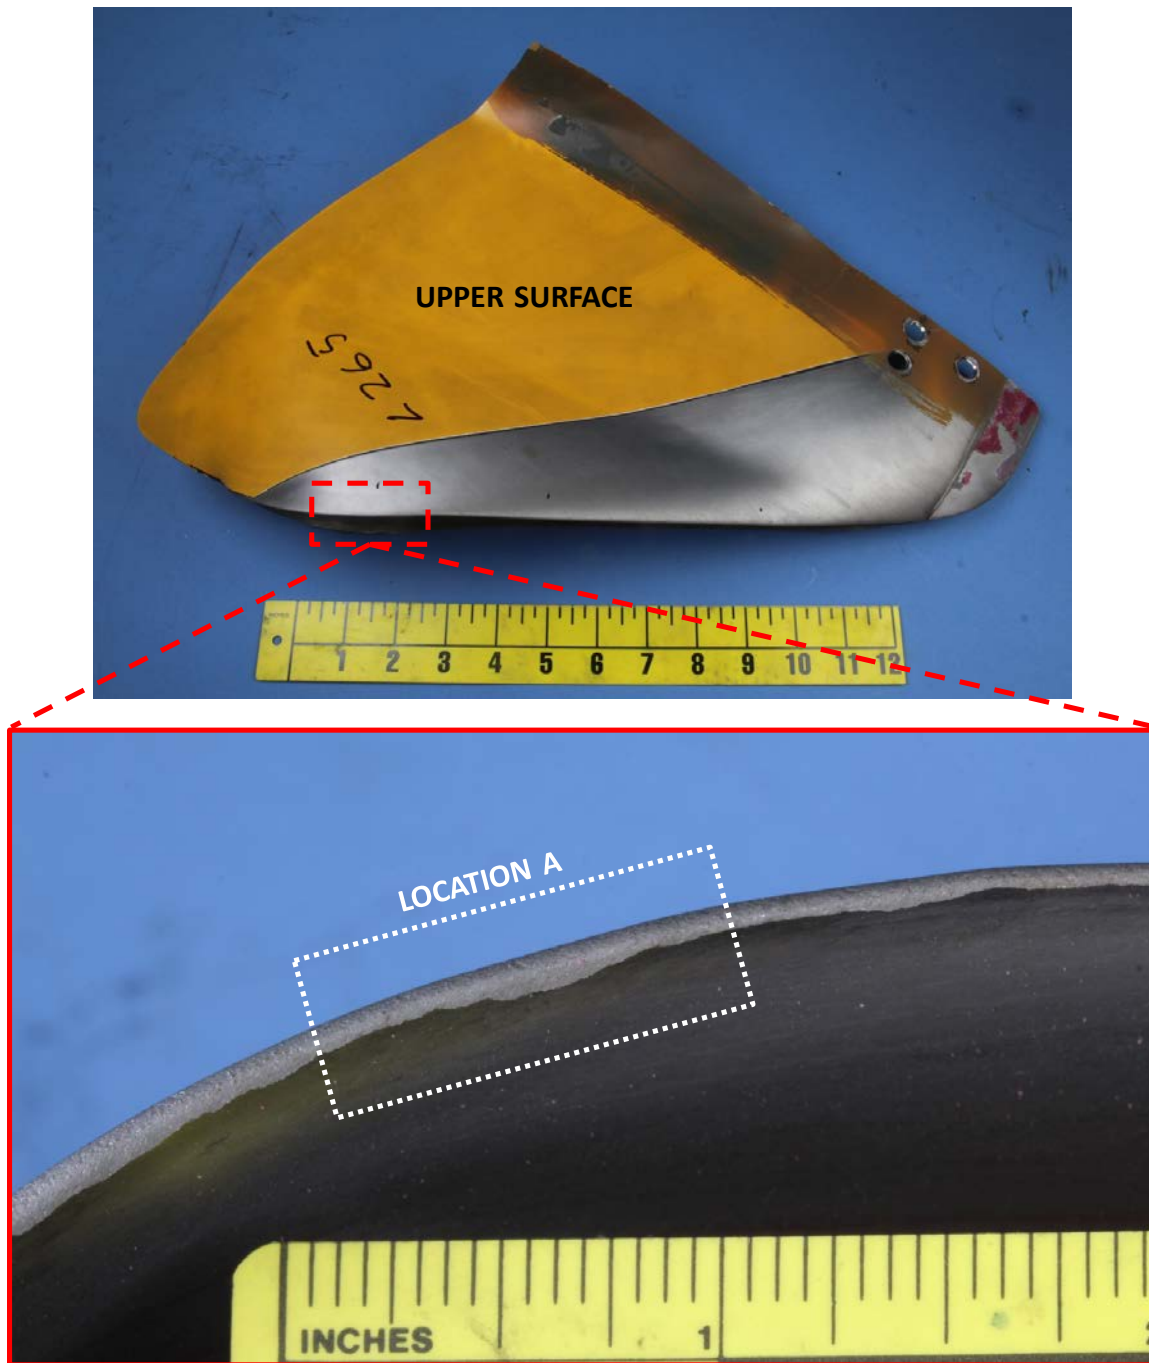
Figure 3: Overall photo of the upper surface on the L265 tip cap is shown in the top. A close-up photo of the separation at the leading edge weld is shown in the bottom. The area indicated as Location A was sectioned for further examination.

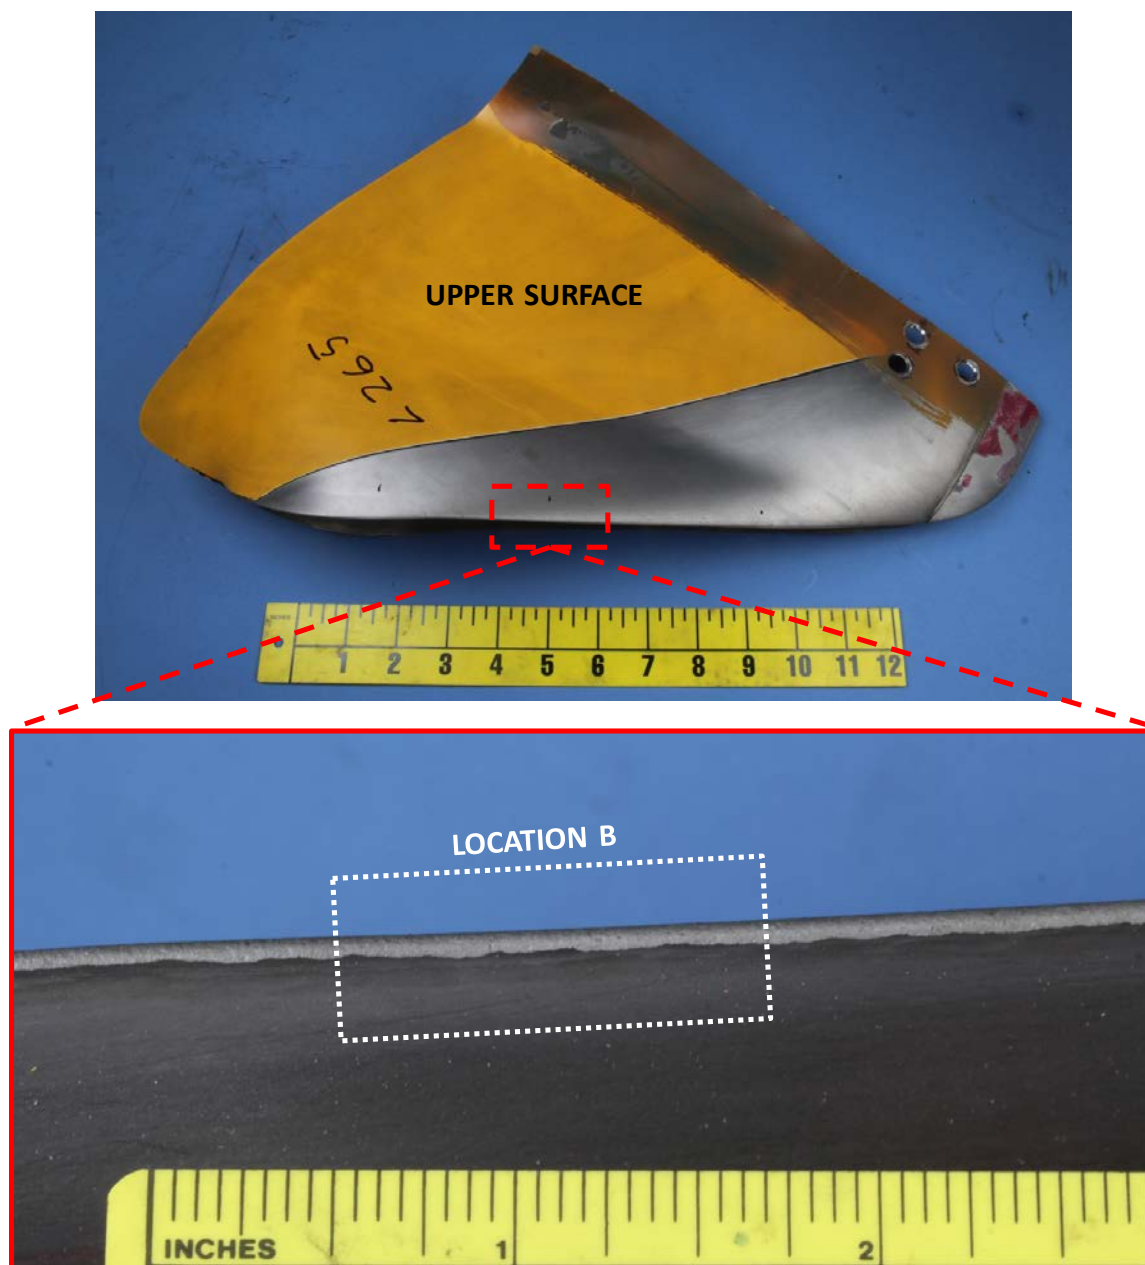
Figure 4: Overall photo of the upper surface on the L265 tip cap is shown in the top. A close-up photo of the separation at the leading edge weld is shown in the bottom. The area indicated as Location B was sectioned for further examination.

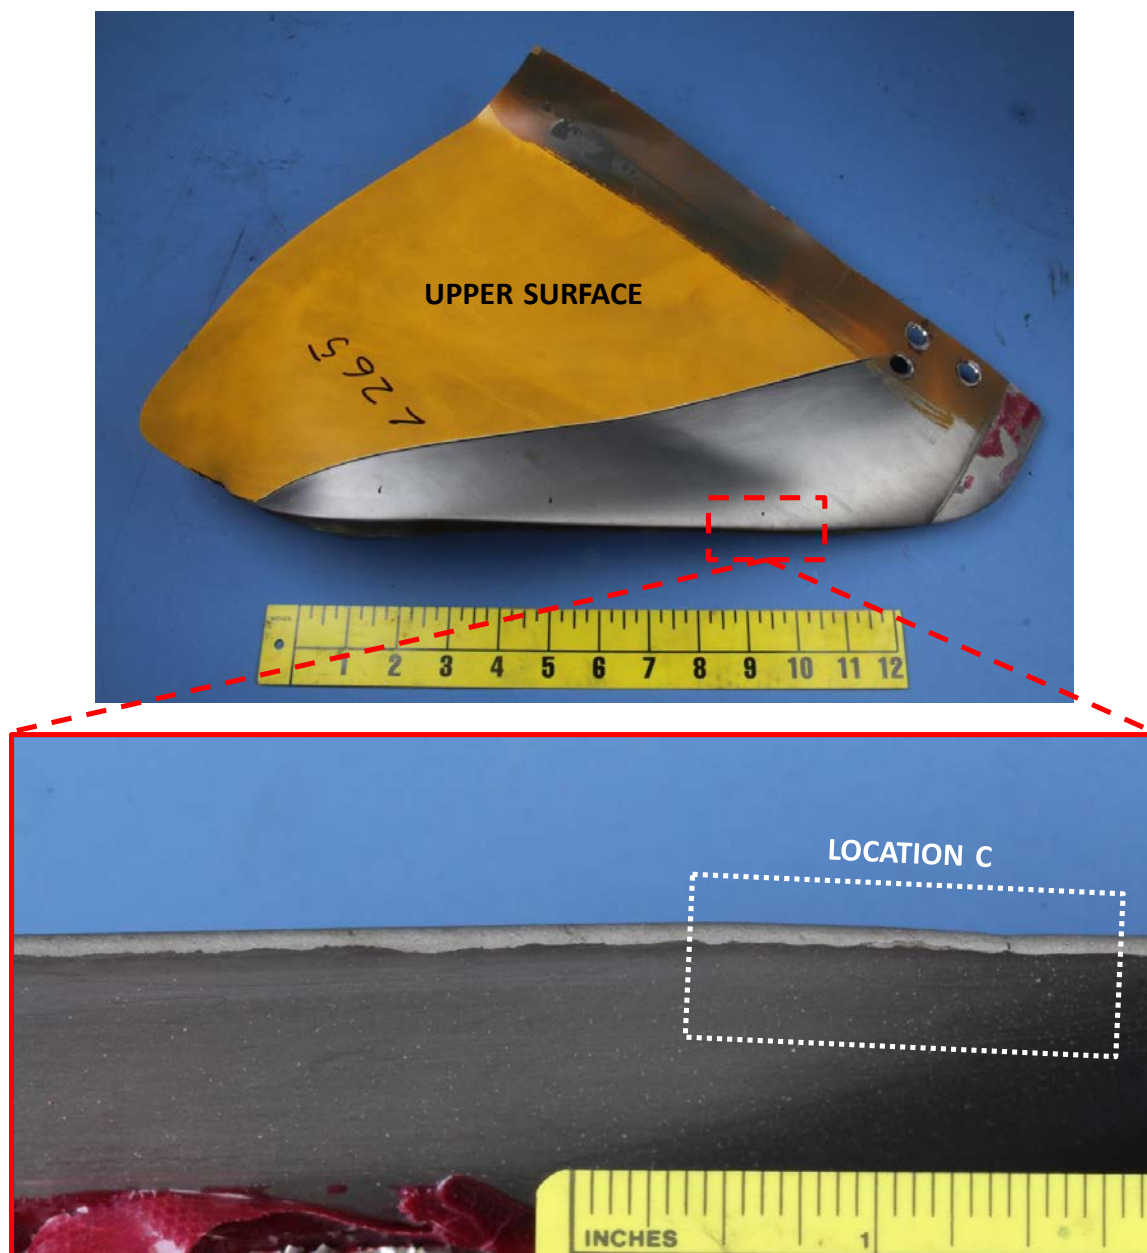
Figure 5: Overall photo of the upper surface on the L265 tip cap is shown in the top. A close-up photo of the separation at the leading edge weld is shown in the bottom. The area indicated as Location C was sectioned for further examination.

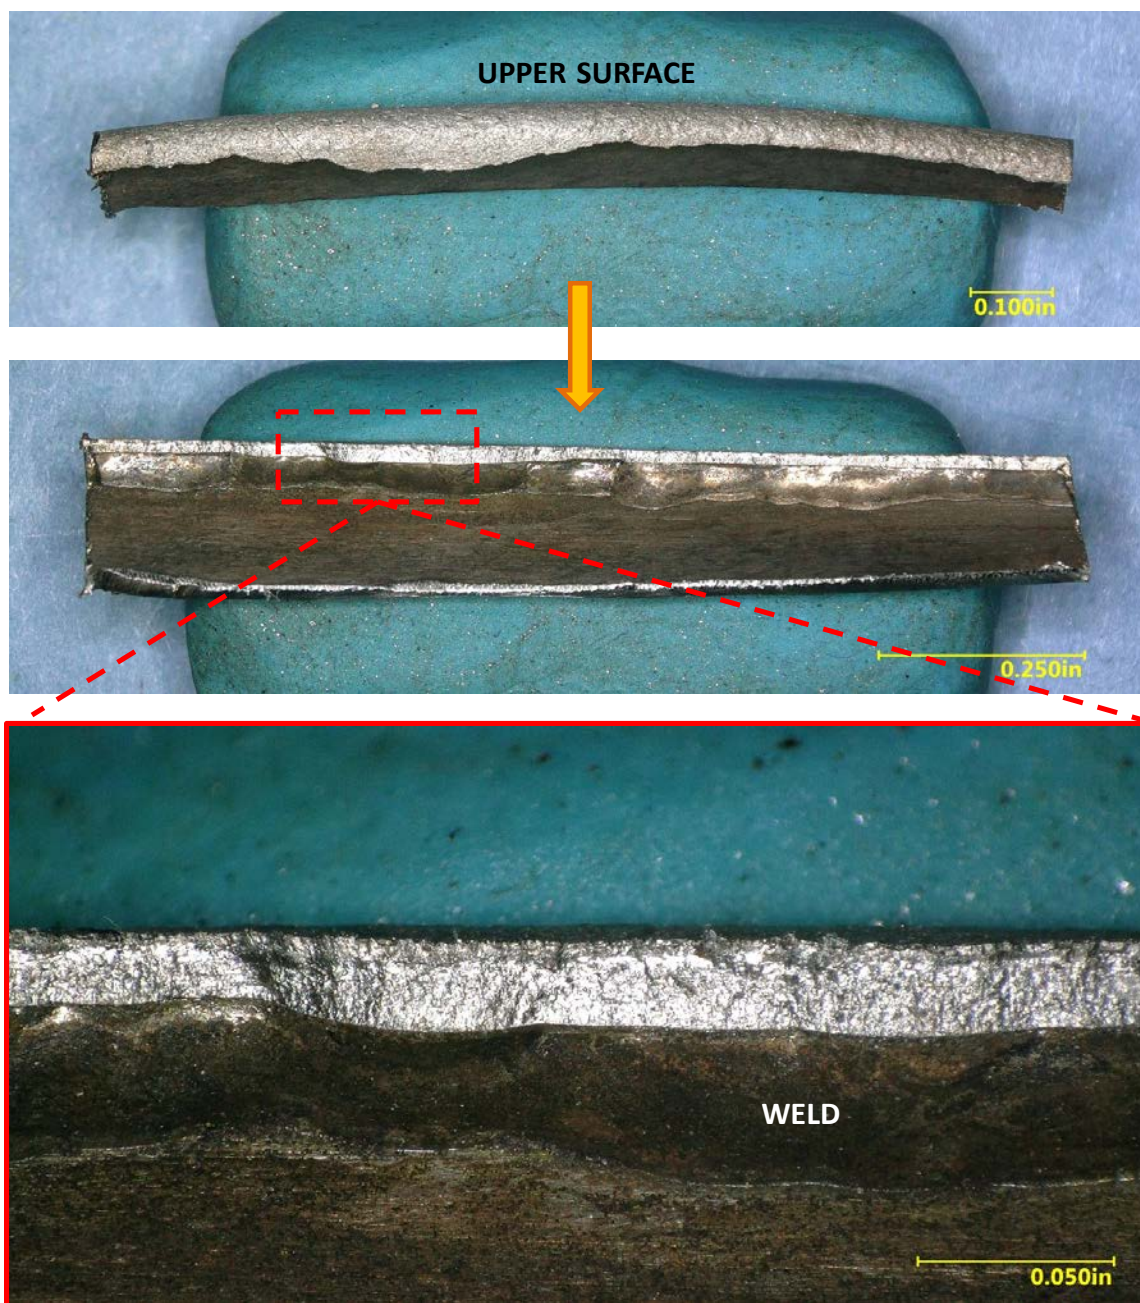
Figure 6: Digital microscope images of Location A from the L265 tip cap after sectioning. Multiple ratchet marks and features consistent with fatigue cracking were observed.

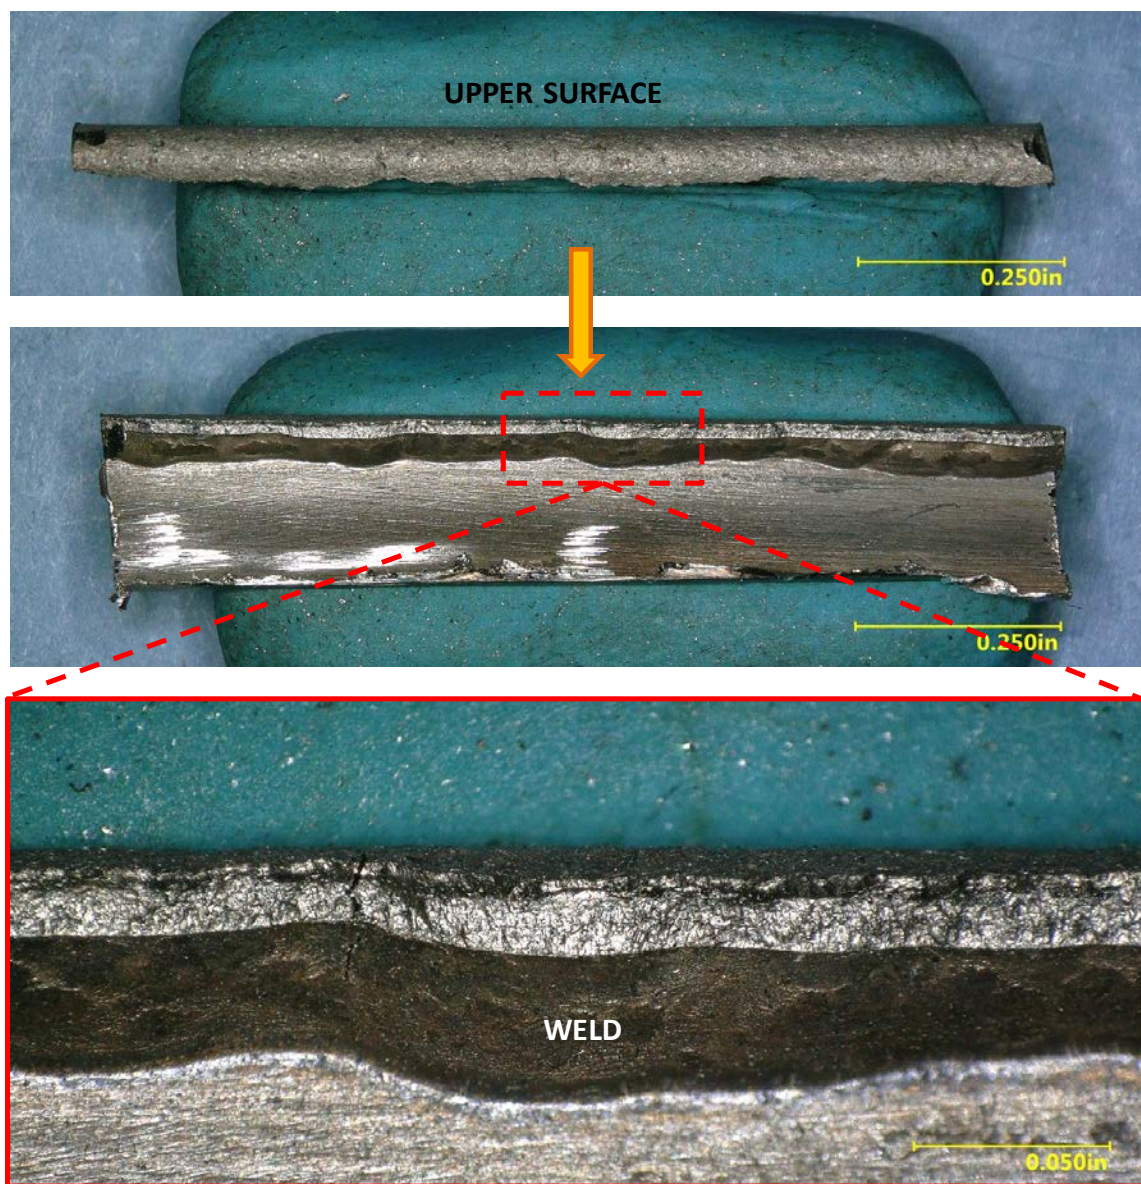
Figure 7: Digital microscope images of Location B from the L265 tip cap after sectioning. Multiple ratchet marks and features consistent with fatigue cracking were observed.

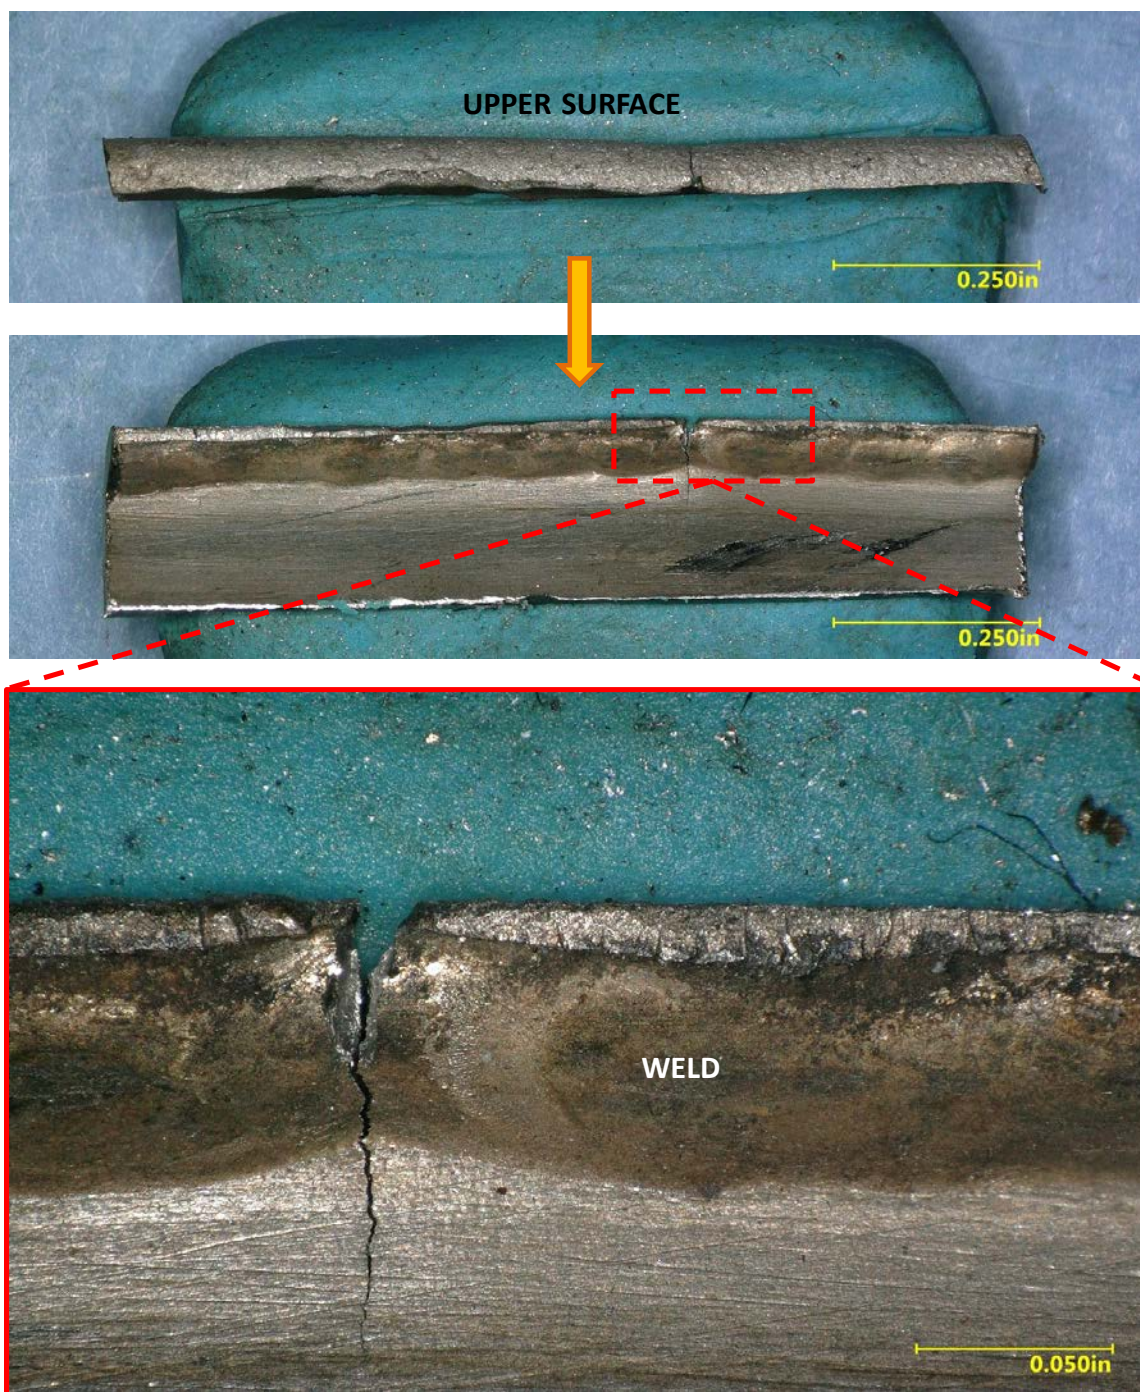
Figure 8: Digital microscope images of Location A from the L265 tip cap after sectioning. Multiple ratchet marks and features consistent with fatigue cracking were observed.

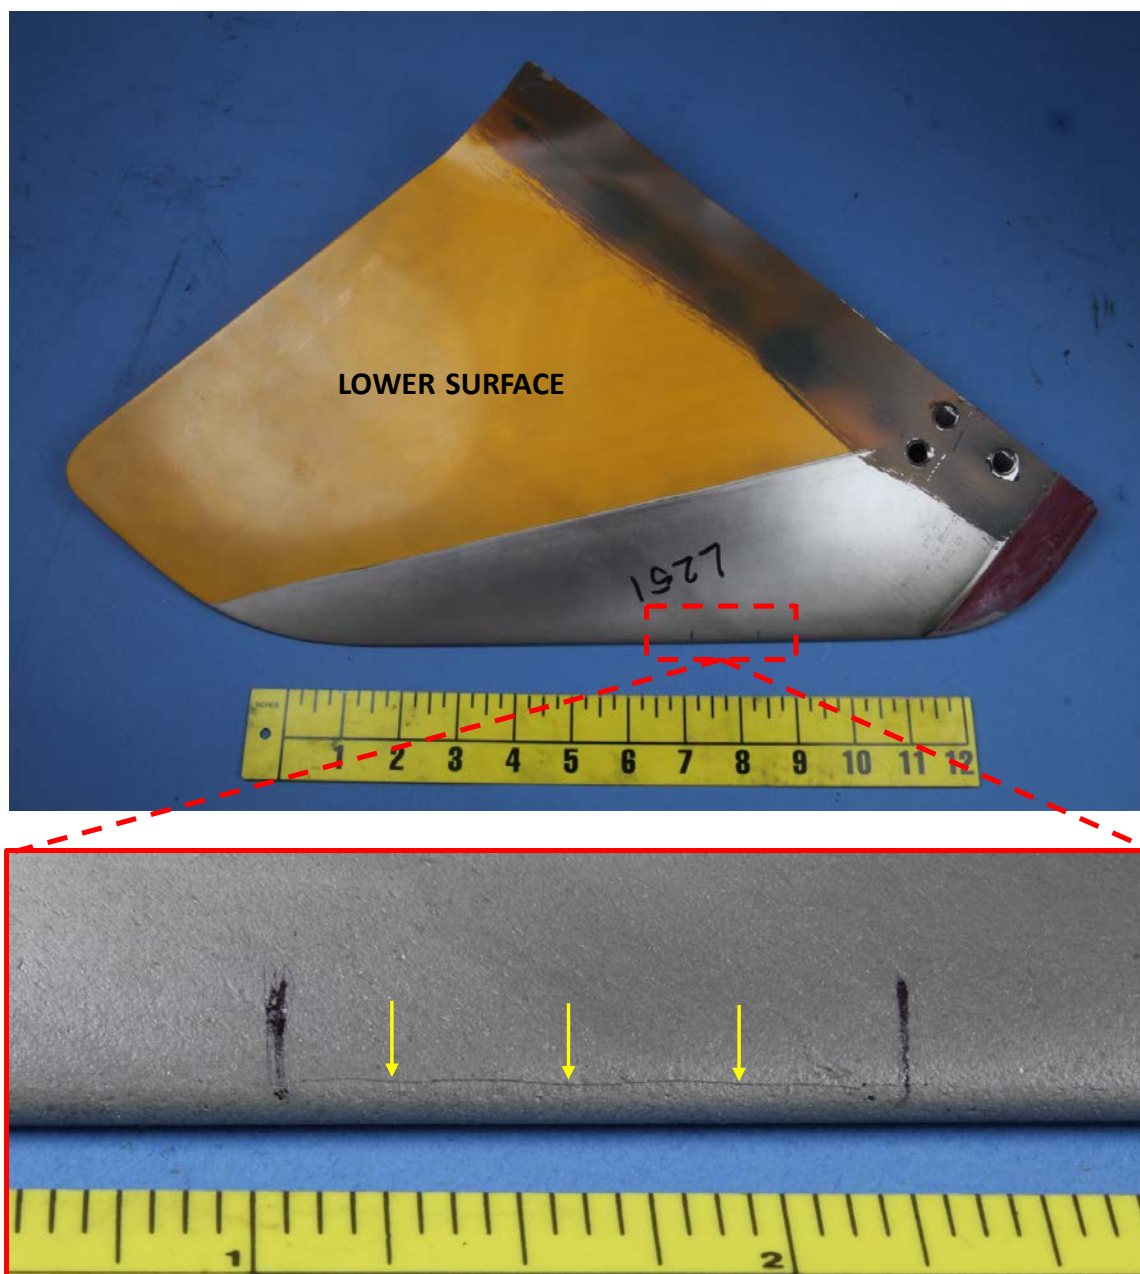
A crack was visible on the lower surface of the L251 tip cap, as shown in Figure 9. The crack measured approximately 1.25 inches long. Digital images of the crack are shown in Figure 10. The portion of the tip cap with the crack was sectioned and the crack was mechanically exposed in the laboratory. The fracture surface appeared similar to the

Figure 9: Overall (top) and close-up (bottom) photos of the lower surface on the L251 tip cap. The yellow arrows point to a crack in the lower surface.

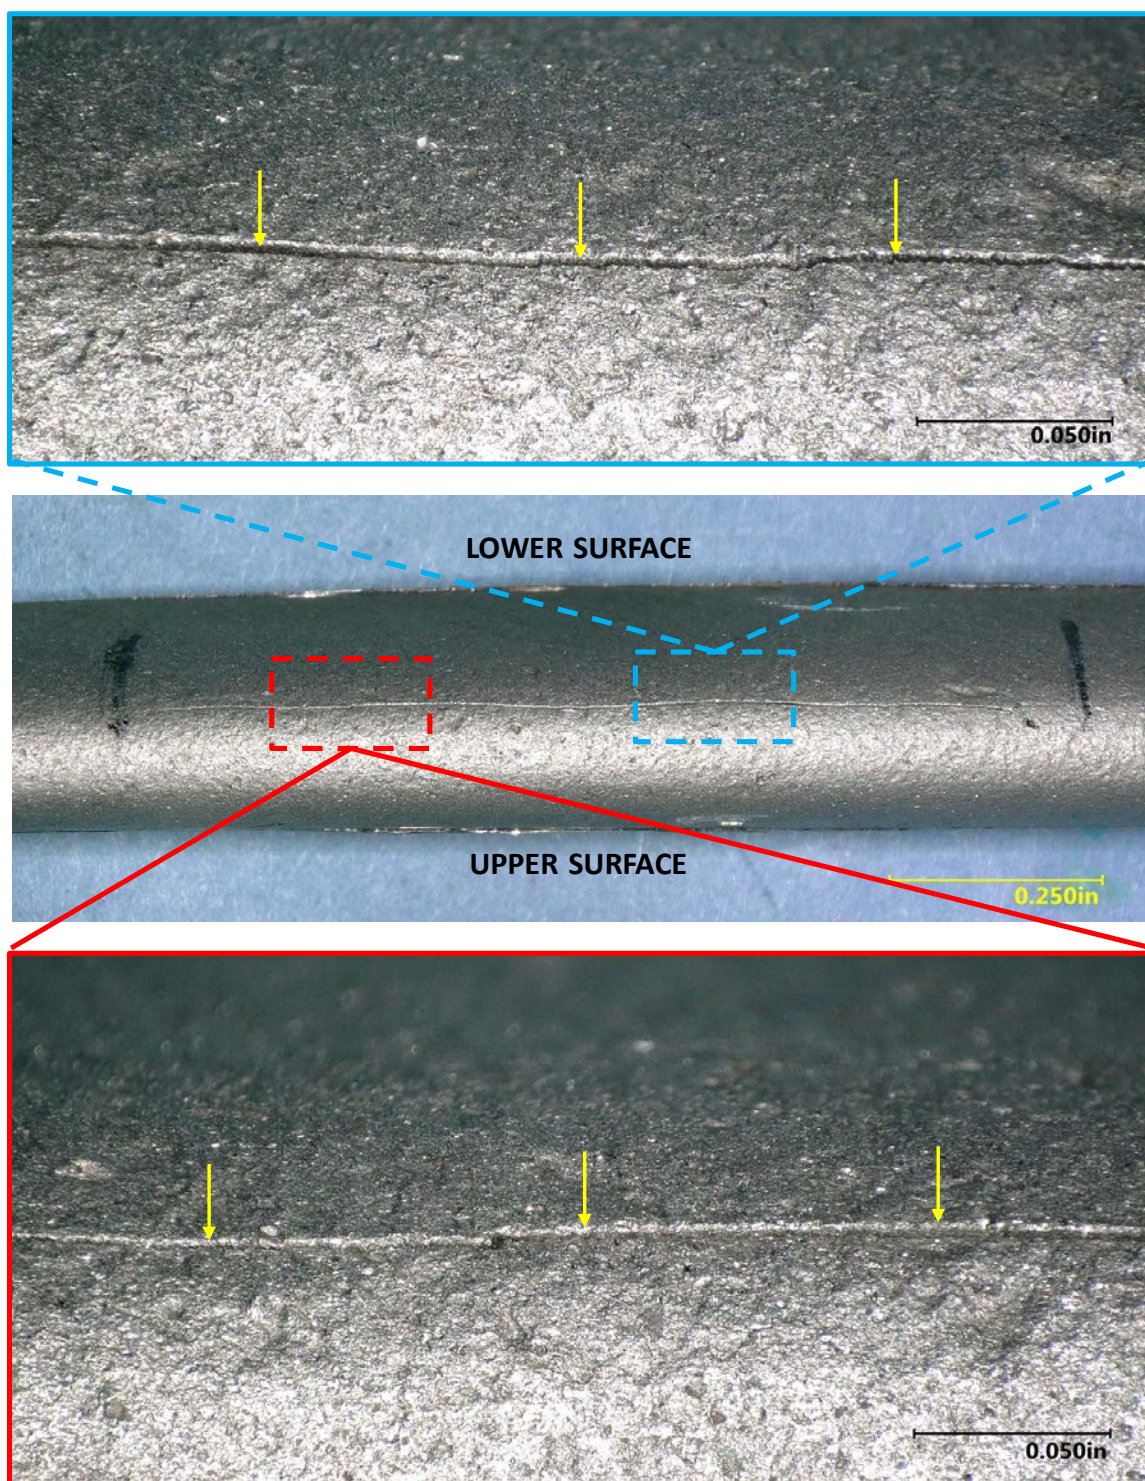
Figure 10: Digital microscope images of the lower surface on the L251 tip cap. The yellow arrows point to a crack in the lower surface.

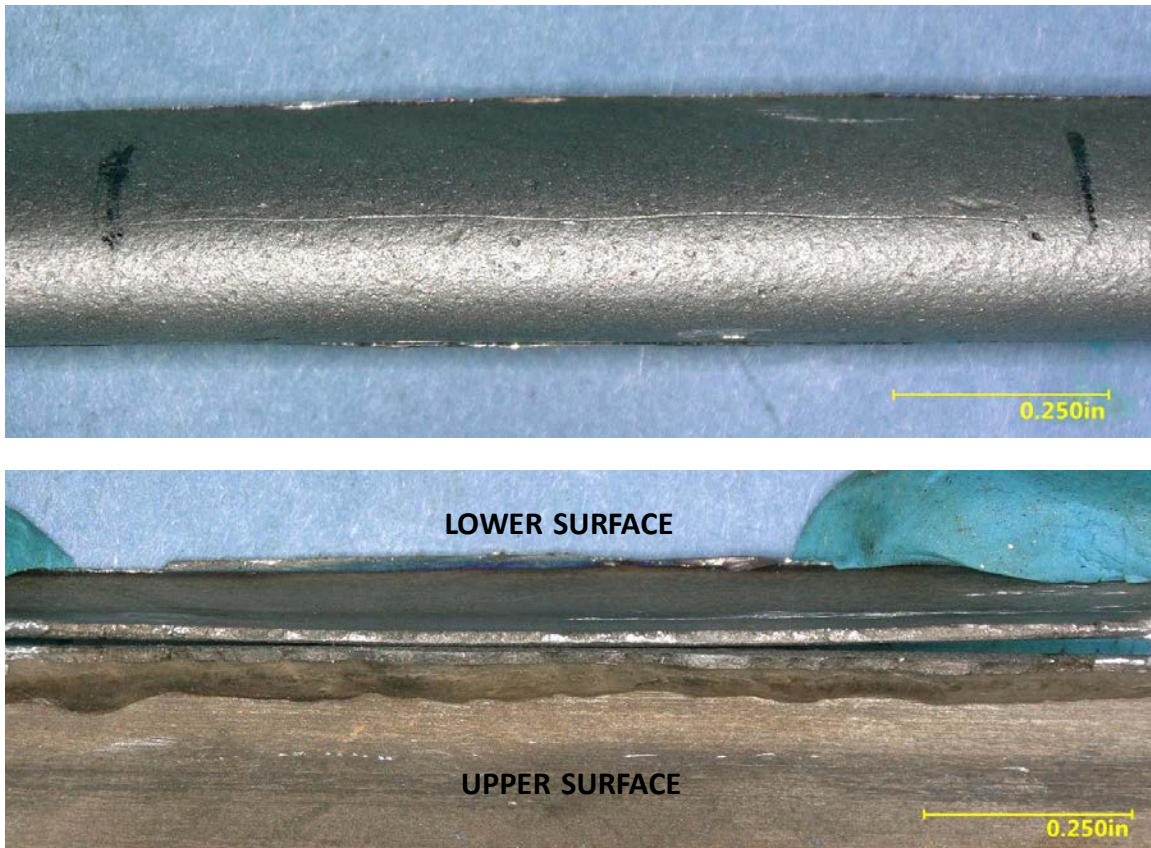
Figure 11: Digital microscope images of the lower surface on the L251 tip cap. The top image shows the tip cap intact, while the lower image shows the tip cap after mechanical exposure of the crack in the laboratory.

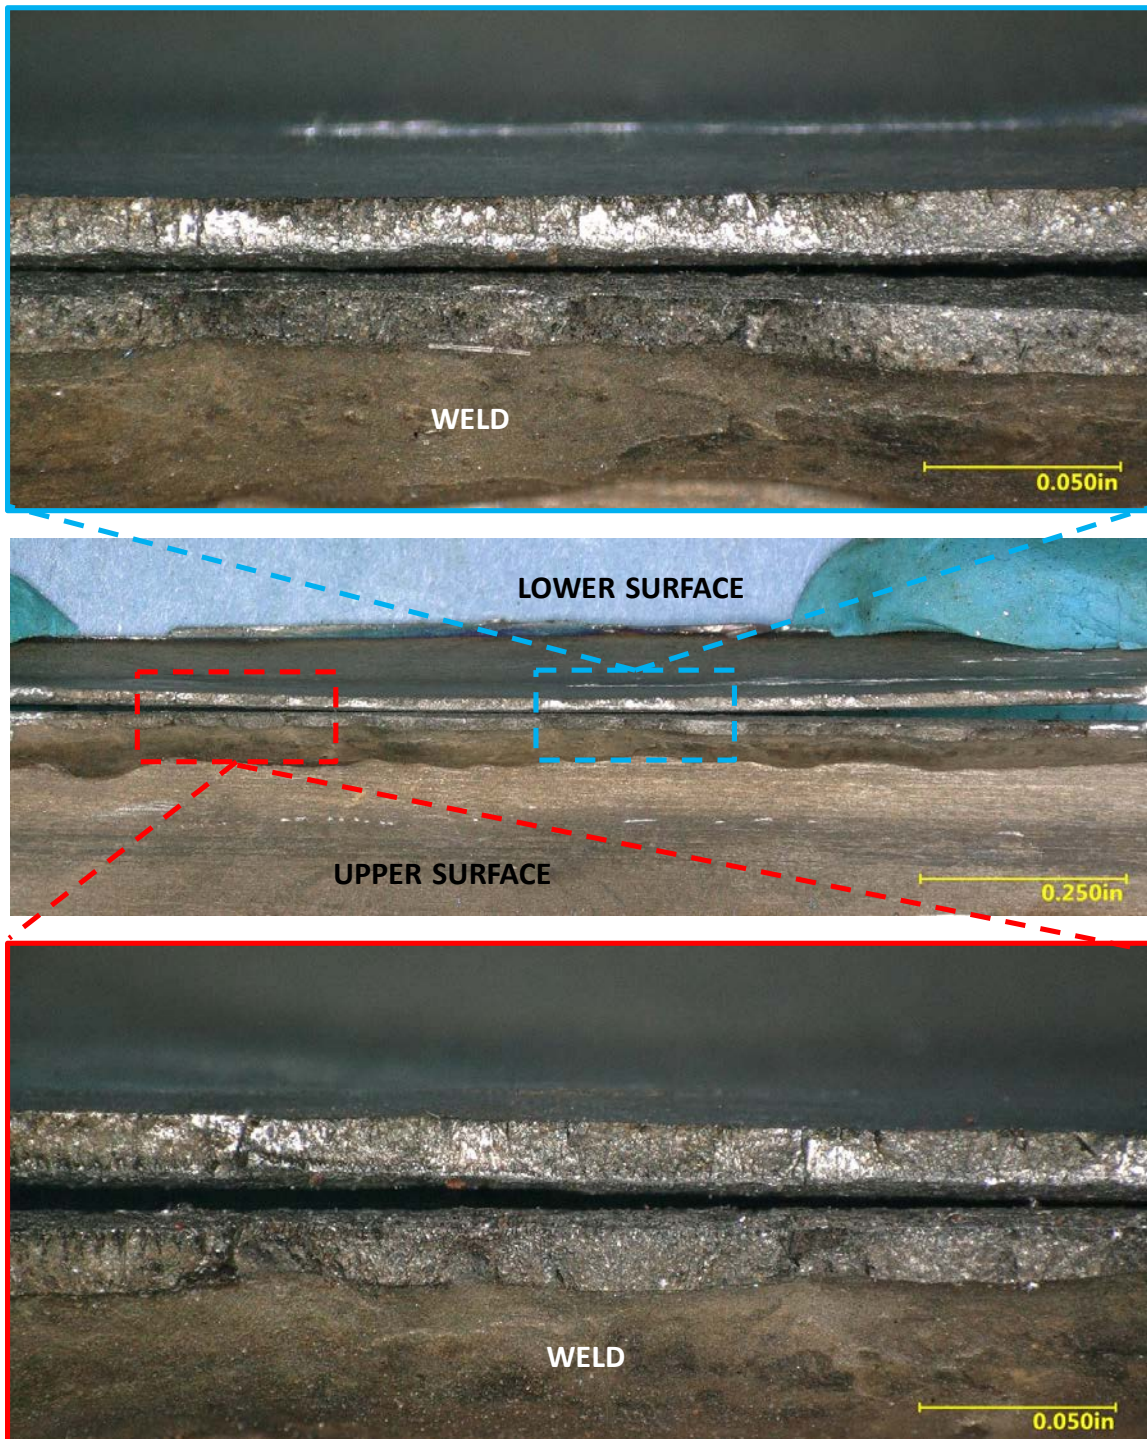
fracture surface on the L265 tip cap, with multiple initiation fatigue cracking emanating from the internal edge of the lower surface at the toe of the weld. Digital microscope images of the exposed fracture surface on the L251 tip cap are shown in Figure 12.

Figure 12: Digital microscope images of the fracture surface of the crack in the L251 tip cap after mechanical exposure in the laboratory. Multiple ratchet marks and features consistent with fatigue cracking were observed.

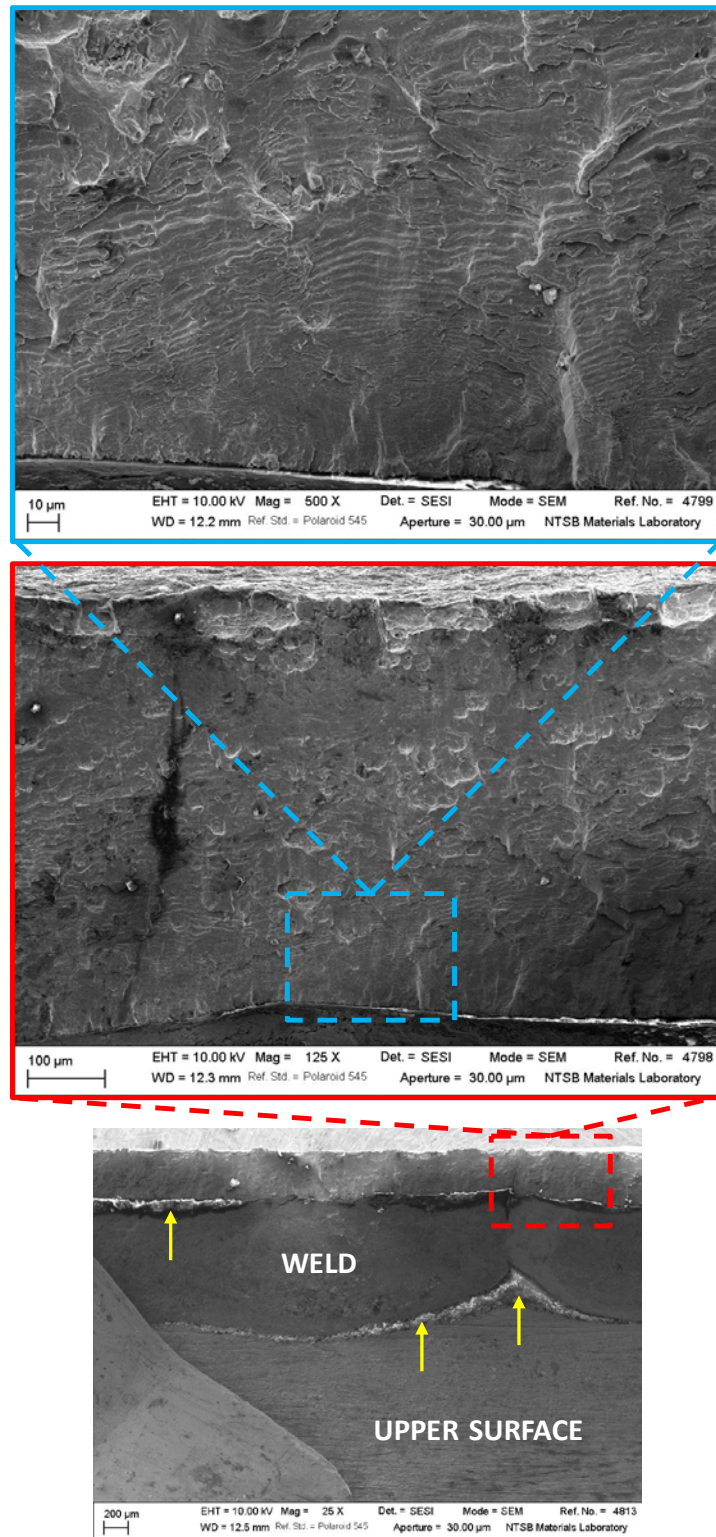
The sectioned pieces of tip cap were examined using a Zeiss Auriga 40 field emission (FE) scanning electron microscope (SEM). SEM images of the L265 tip cap are shown in Figures 13-15 and the L251 tip cap are shown in Figure 16. The fracture surfaces on both tip caps had micro features consistent with multiple initiation fatigue cracking. Fatigue striations were also observed on the fracture surfaces that were emanating from the internal edge of the tip cap lower surface. A few thumbnail-shaped fatigue patterns were observed emanating from the external edge of the lower surface, likely secondary activation that occurred as the fatigue cracking from the internal edge progressed through the cross-section of the lower surface.

Small areas of accumulated material were observed along the toes of the weld on the upper and lower surfaces of the L265 tip cap (yellow arrows, Figures 13-15). The accumulated material was likely due to a contamination or other anomaly during manufacturing. Similar accumulated material was not observed on the L251 tip cap.

Figure 13: Secondary electron (SE) SEM images of the fracture surface on the L265 tip cap in Location A. Fatigue striations were observed emanating from the internal edge of the lower surface at the toe of the weld. The yellow arrows point to areas of accumulated material observed along the toes of the weld.

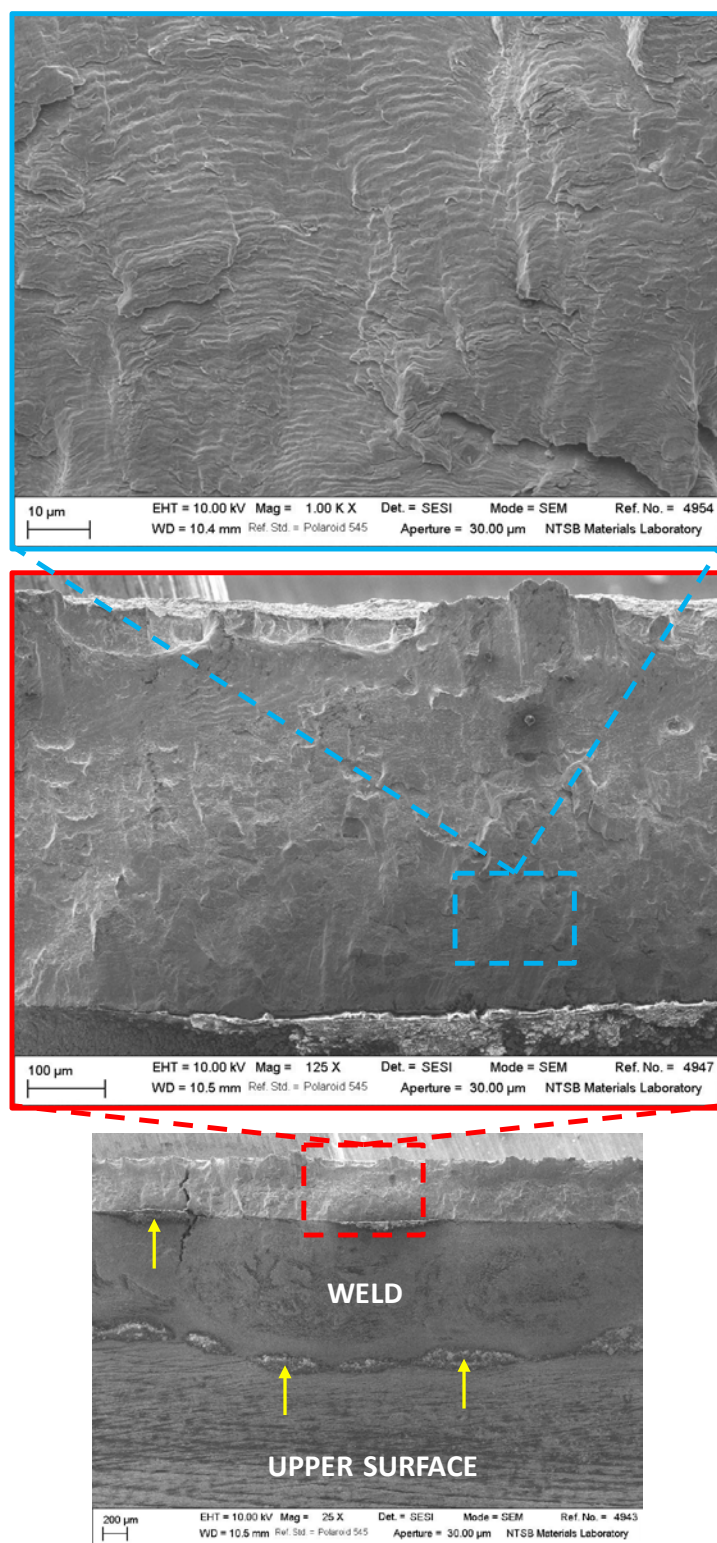
Figure 14: SE SEM images of the fracture surface on the L265 tip cap in Location B. Fatigue striations were observed emanating from the internal edge of the lower surface at the toe of the weld. The yellow arrows point to areas of accumulated material observed along the toes of the weld.

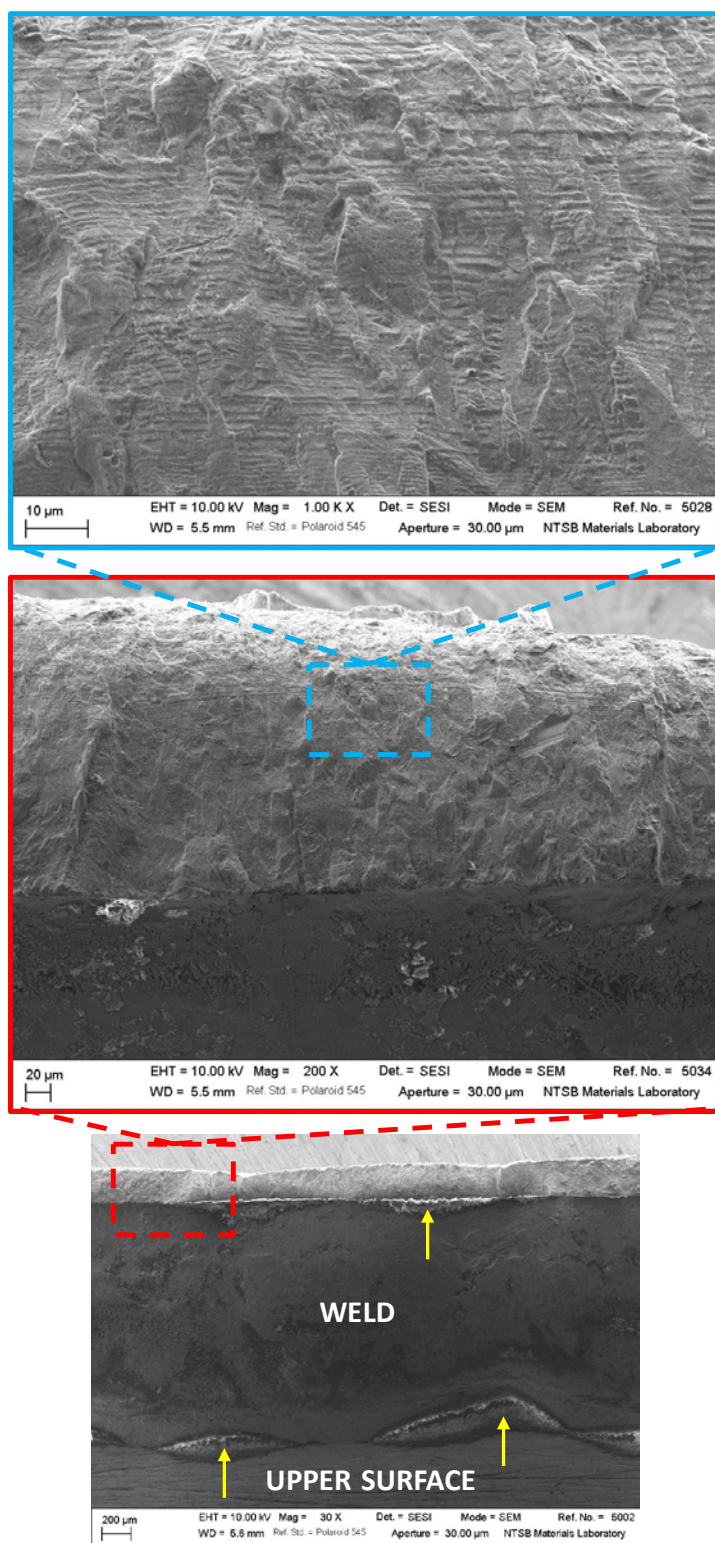
Figure 15: SE SEM images of the fracture surface on the L265 tip cap in Location C. Fatigue striations were observed emanating from the internal edge of the lower surface at the toe of the weld. The yellow arrows point to areas of accumulated material observed along the toes of the weld.
